United States  
Department of  
Agriculture

Forest  
Service

Subject: April 19, 2011 Inspection of the Red Ink Maid/Big Seam Mine

**Photo Log**  
**April 20, 2011 inspection of the Red Ink Maid/Big Seam Mine**  
**Page 1 of 2**

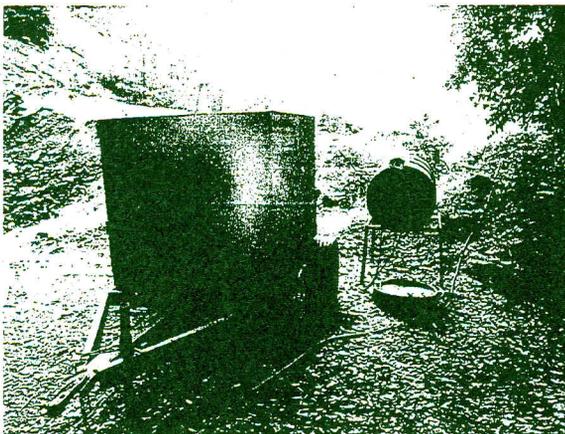
The compressor and generator had pans to collect dripping engine oil and fluids. The fuel tank did not have any secondary containment vessel other than a pan under the valve (Photo 5).

Photo 5. Pans under equipment and fuel tank
