Central Valley Regional Water Quality Control Board

NOTICE OF VIOLATION, 3 SEPTEMBER 2014 INSPECTION REPORT, RECOLOGY HAY ROAD, SOLANO COUNTY

INSPECTION REPORT

DISCHARGER: Recology Hay Road
LOCATION & COUNTY: 6426 Hay Road, Vacaville, Solano County
CONTACT(S): Bryan Clarkson, Group Environmental Manager, Recology
INSPECTION DATE: 3 September 2014
INSPECTED BY: Andrew Altevogt, Howard Hold, Mary Boyd, and Marty Hartzell with the Central Valley Regional Water Quality Control Board (Water Board)
ACCOMPANIED BY: Paul Yamamoto (Group Vice President, Recology), Bryan Clarkson Group Environmental Manager, Recology), Chris Taylor (landfill manager, Recology Hay Road), and Tim Daleiden (Engineering and Operations Manager, Recology)

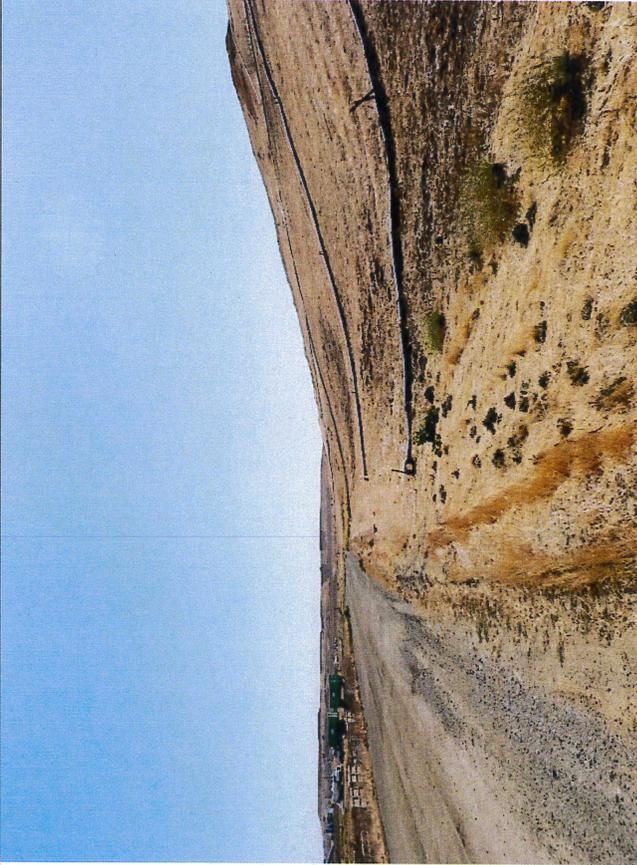
Disposal Module 2.2, Downspouts and Interim Cover: The downspout configuration shown in Photograph 1 is typical for the facility. It appears that these downspouts do not discharge into a maintained runoff ditch, which may result in ponding of water at the toe of the slopes. This downspout configuration may be a contributing factor for the detection of liquids in pan lysimeters, which the Discharger has reported occurs after heavy rain events. In Photograph 2, it appears that a downspout terminated midway down the slope.

Looking east at the base of Disposal Module (DM) 2.2. This picture shows the downspouts designed to manage runoff from the slope. As constructed, this structure does not comply with Title 27 Section 20365(a) which states: *Units and their respective containment structures shall be designed and constructed to limit, to the greatest extent possible, ponding, infiltration, inundation, erosion, slope failure, washout, and overtopping under the precipitation conditions specified in Table 4.1 (of this article) for each class of waste management unit (Unit).*

As shown in this photograph, there are no runoff ditches at the toe of the downspout. Rain water has nowhere to move to, rather it ponds adjacent to the slope. The Discharger must enhance their runoff channels as outlined in the WDRs and Title 27.

1. The down spout terminations should be reconfigured to prevent ponding at the toe of the slopes and to prevent intrusion of liquids through the covers and into the disposal units. The runoff collection/drainage system at DM-3.3 should be improved to prevent the formation of rills and gullies.
2. Liquids extracted from pan lysimeters may not be discharged back into a leachate collection and removal system
3. Pumping of liquids from the low-flow pond to the high-flow pond is not permitted by the WDRs. The discharge pipe from the "Big Pond" shall be capped.
4. Compost leachate is still used for dust control.

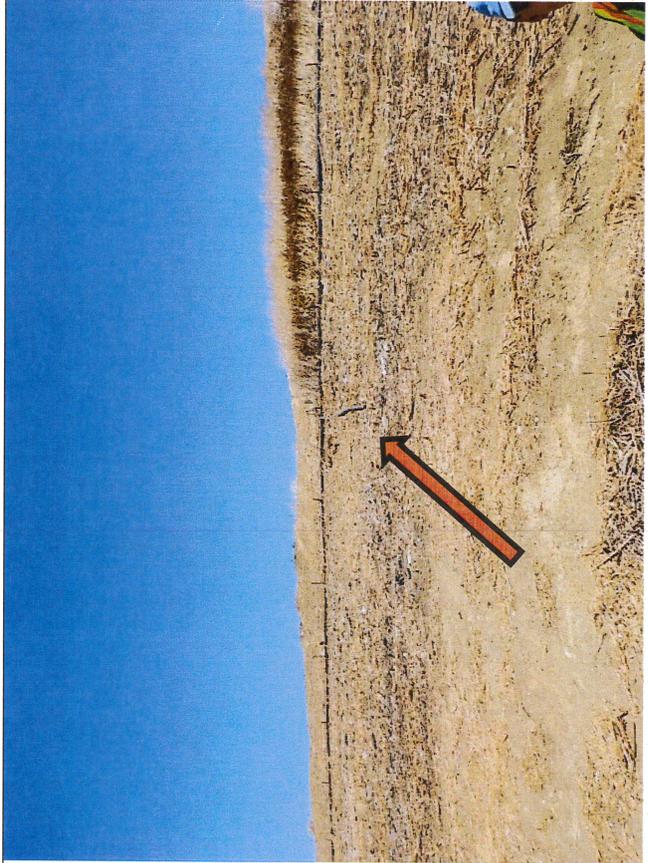
Photograph2

View looking up the southern side slope of DM-2.2, which shows a downspout terminating midway down the slope. In addition this slope needs to be prepared for the winter rains. Currently there is no control on this slope to prevent sheet flow of turbid water.

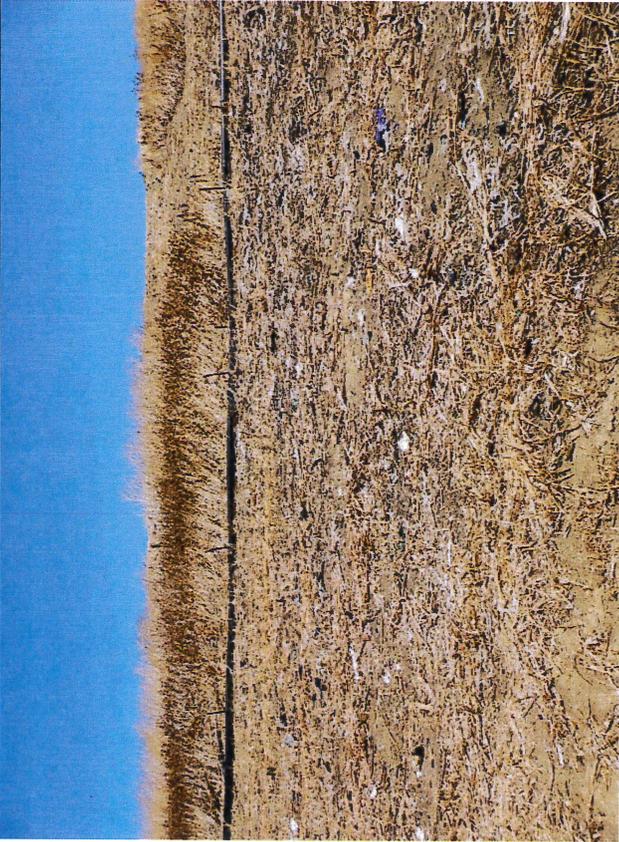
Photograph 3

The interim cover at this module appears to be insufficient, as indicated by the exposed waste shown in Photograph 3. As shown in Photograph 12, there is an area under visqueen plastic, which the Discharger confirmed was a "leachate seep". Seeping leachate is a condition that suggests that the LCRS is backing up, or the interim cover is not sufficient to prevent percolation of rainfall, or both. Prior to the beginning of the wet season, 31 October, the Discharger must repair this slope.

View of the southern side slope at DM-2.2 showing exposed waste. The interim cover appears to be insufficient at this module.

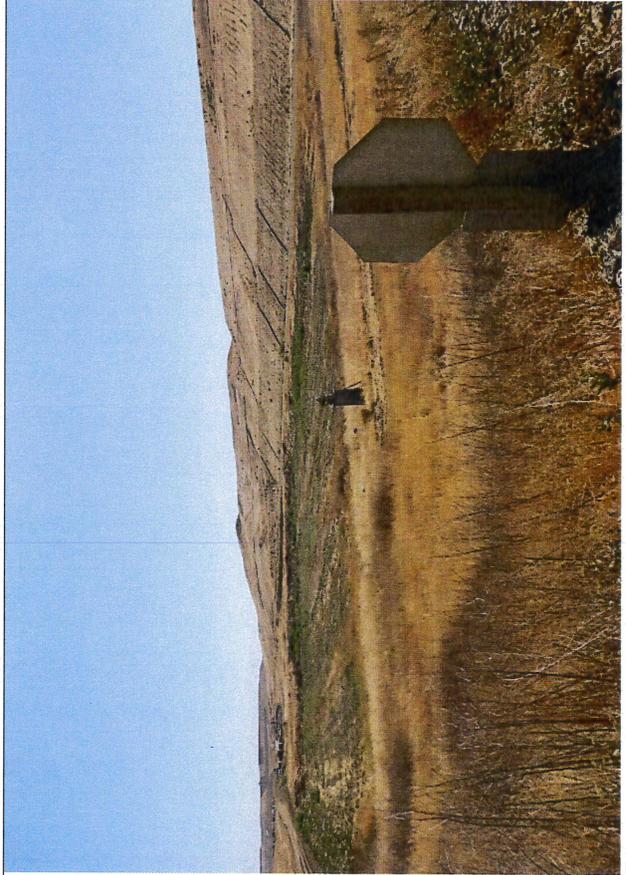
Photograph 4

Looking east at the "stormwater holding pond", which is located between DM-1 and DM-2.2. Also included in the photograph is the sump pump for the DM-1 sump, which was not operational. This was shut off after the groundwater basin was dug in the adjacent parcel.

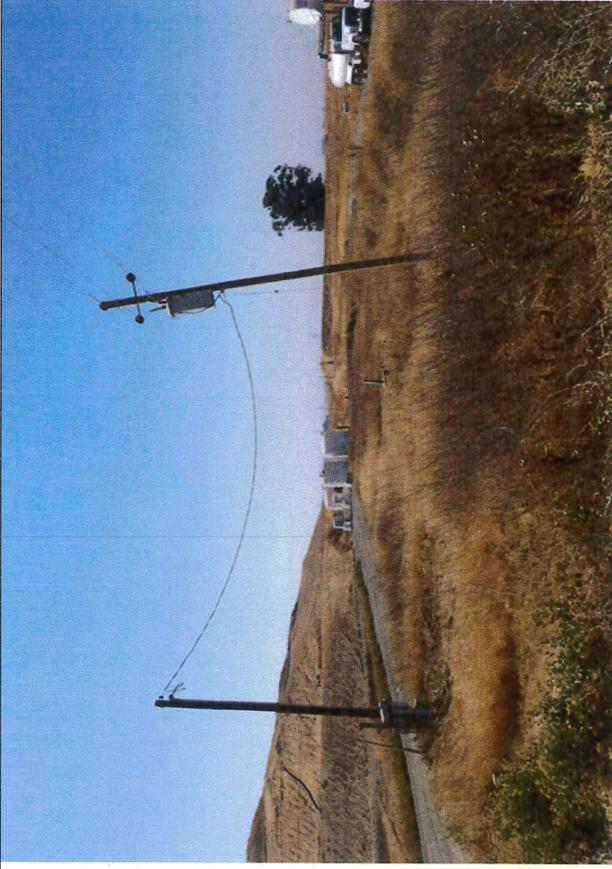
Photograph 5

Looking south toward the Leachate Tank farm situated at the base of Module DM-2.2. Situated between the two power poles is the underground groundwater "slurry wall". Staff asked if there was any surveyed marker that could be observed in the field. The Discharger did not know of any benchmarks installed which identified the location of the slurry wall.

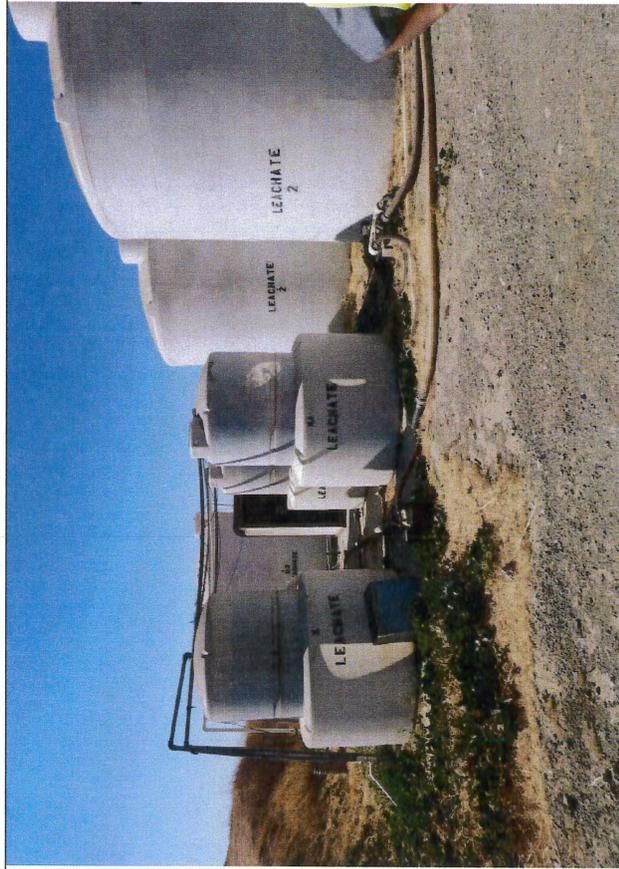
Photograph 6

Close up of the Leachate tanks. Liquid is removed from the tanks by a vacuum truck and shipped to the nearby wastewater treatment facility.

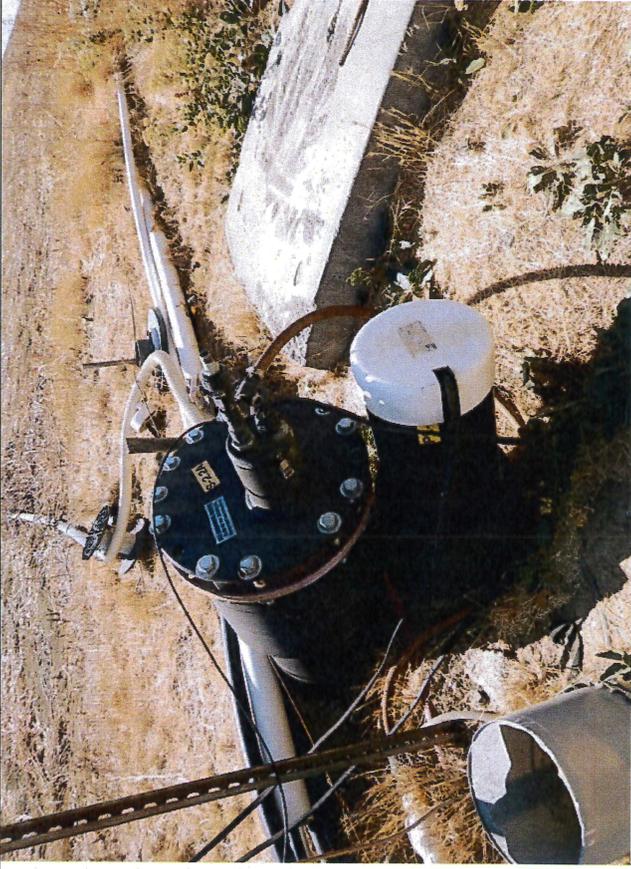
Photograph 7

Disposal Module 2.2A, Pan Lysimeter and Leachate Sump: Liquids detected in the pan lysimeter are pumped back into the leachate collection and recovery system (LCRS) instead of to the above ground holding tanks. Without specific approval in the WDRs, any discharge of pan lysimeter liquids to the LCRS is considered a violation of Construction Specification D6. The leachate storage tanks and access ports to the LCRS and pan lysimeter are shown in Photographs 5-7.

Pictured here are sumps S-2.2A (Leachate sump) and the Pan Lysimeter PLS 2.2A. The leachate sump is the pipe on top. The clear flexible line branching off the side of the S-2.2A is the gas extraction system. The Discharger pumps water from the pan lysimeter into the LCRS sump rather than into an above ground tank. Discharge to the LCRS without approval in the WDRs is a violation of Construction Specification D.6.

1. The Discharger places liquid from the pan lysimeters directly into the LCRS for storage. The discharge of liquid from a pan lysimeter into an LCRS is a violation of WDRs Construction Specification D6, which requires the LCRS to be maintained such that only "free draining" liquid is allowed in the sump. Therefore, the Discharger must cease the practice immediately.

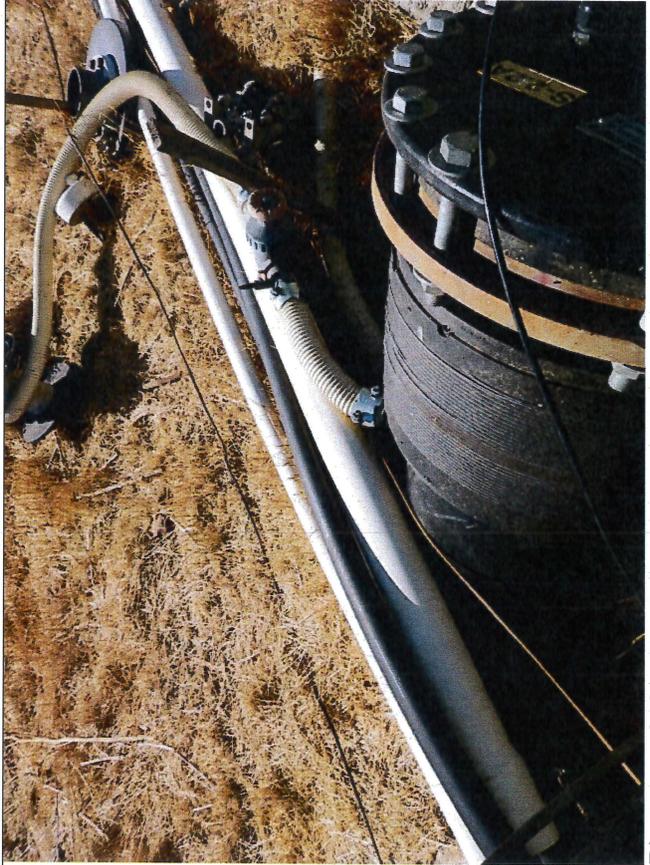
Photograph 8

An up-close view of the gas lines and other piping associated with the landfill gas collection system.

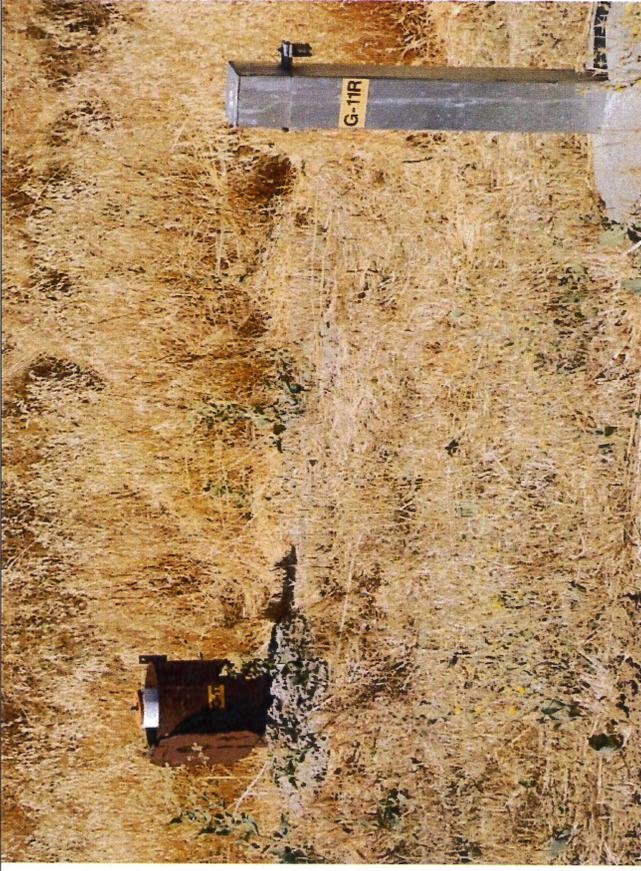
Photograph 9

Monitoring Well G-11, Condition: Groundwater monitoring well G-11 was unlocked and the expansion cap was not properly placed, as shown in Photographs 9 and 10.

Monitoring wells G-11 and G-11R are installed on the opposite side of the groundwater slurry wall from the landfill. Monitoring well G-11R was secured.

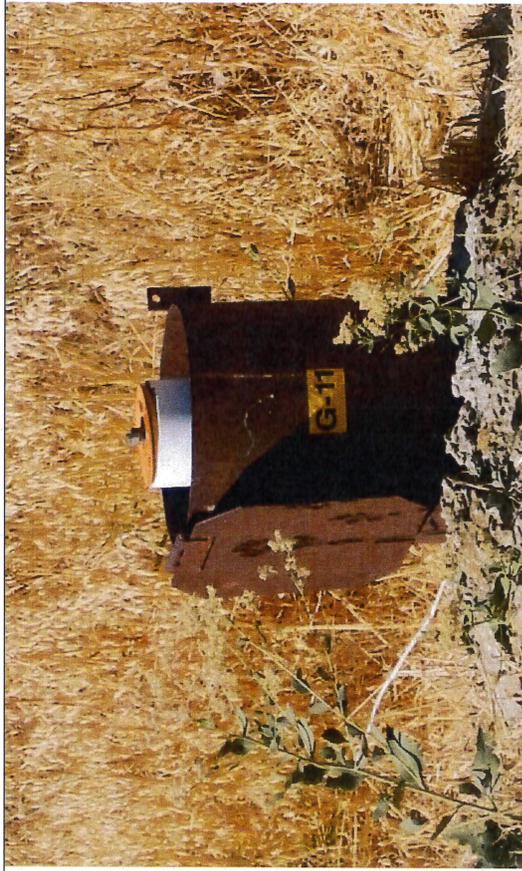
Photograph 10

Monitoring well G-11 is not locked and the well expansion cap is not properly placed on the well. This should be corrected immediately.

5. Monitoring well G-11 must be repaired so that it is capped and locked and so that the expansion cap is properly seated.
6. The capacity of the drainage channel behind the borrow pit shall be evaluated to determine if the vegetation has reduced the capacity with the threat of flooding.
7. The leachate seep observed on the south slope of DM 2.2 must be repaired.
8. The winterization plan must include a discussion about storm water management for DM-1.

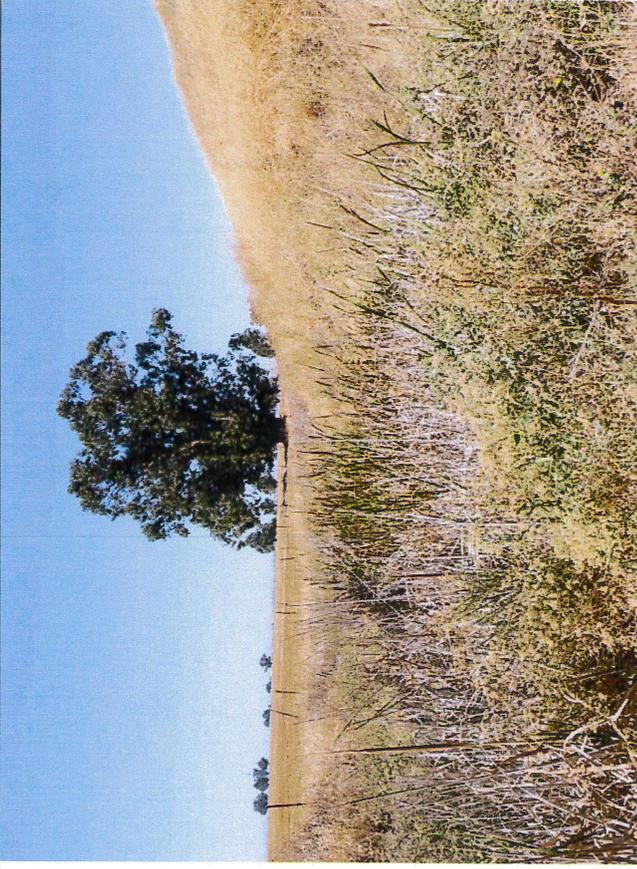
Photograph 11

Borrow Pit, Drainage Channel: As shown in Photograph 11, the drainage channel for the borrow pit appears to have a thick growth of vegetation and cattails. While vegetation can perform as a filtering mechanism to reduce suspended material, it can also reduce the channel capacity.

View looking west at the discharge channel from the borrow pit. This portion of the channel is located on the south side of the borrow pit. Heavy growth of cattails and vegetation were observed during the inspection. Staff recommends that the Discharger determine whether the growth has reduced capacity, which could lead to flooding.

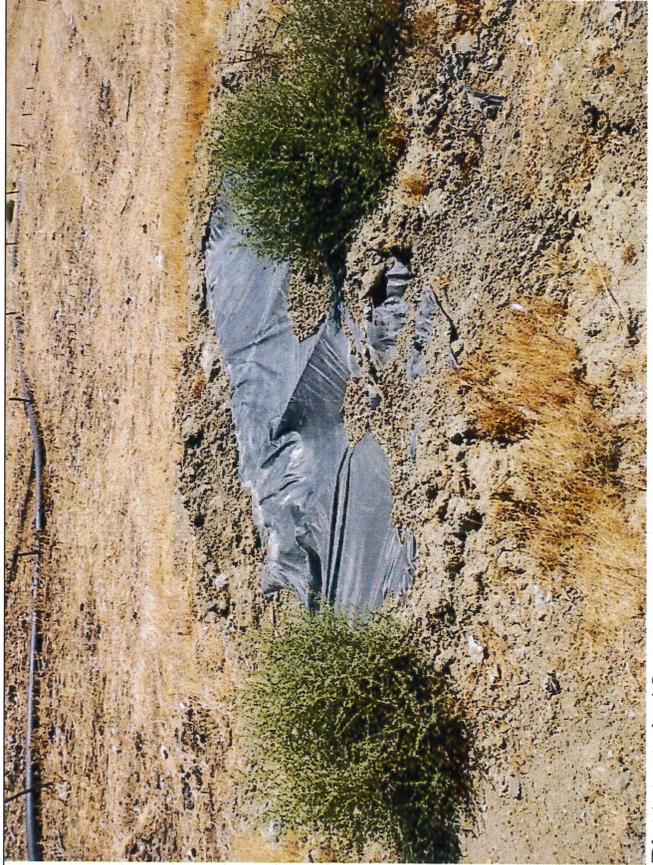
Photograph 12

At the base of Unit DM 2.2 there is an area under visqueen plastic. When staff asked the Discharger what this was, they responded a "leachate seep". It was unclear how long this area has been under plastic. The Discharger must address this in the forthcoming winterization plan.

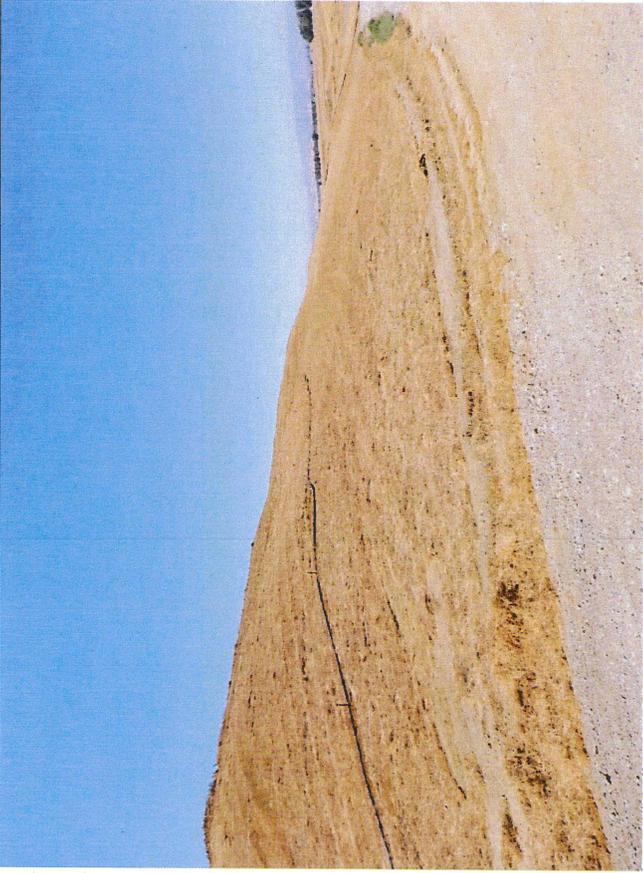
Photograph 13

Exterior Slopes of DM 11.1/11.2: The inspection confirms that there are no runoff ditches installed to move water off this units slope. See Photograph 13.

Looking west along the north face of DM-11. There are no runoff ditches installed to move water off this slope.

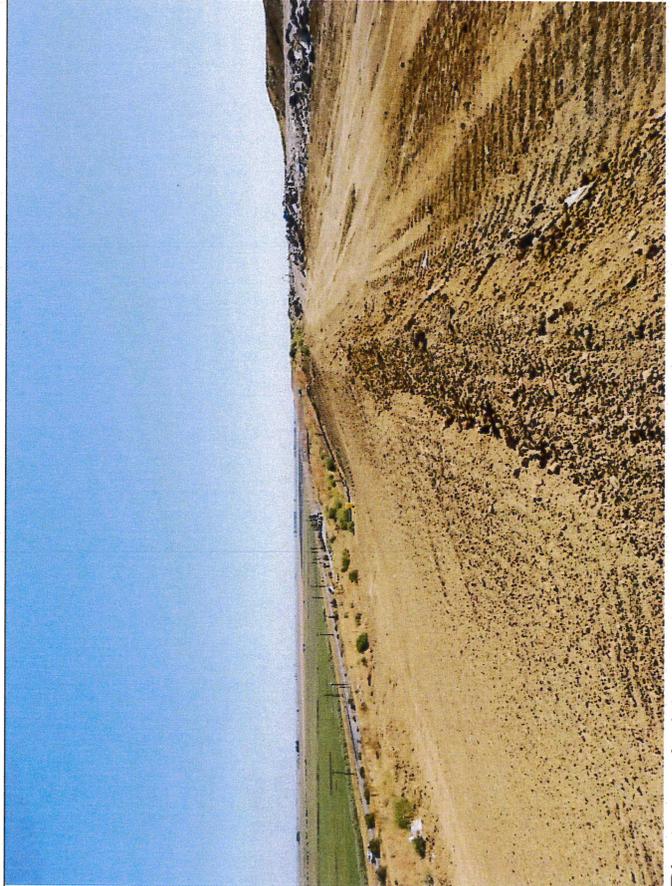
Photograph 14

DM-1 Winter Pad: As shown in Photograph 14, the Discharger is preparing the area on DM-1 for winter operations. The Discharger should include in their winterization plan a discussion of how stormwater will be managed for DM-1 winter operations.

This photo is looking east, along the DM-11. The Discharger is preparing the area for winter operations. Because this work is in progress, no downspouts have been installed.

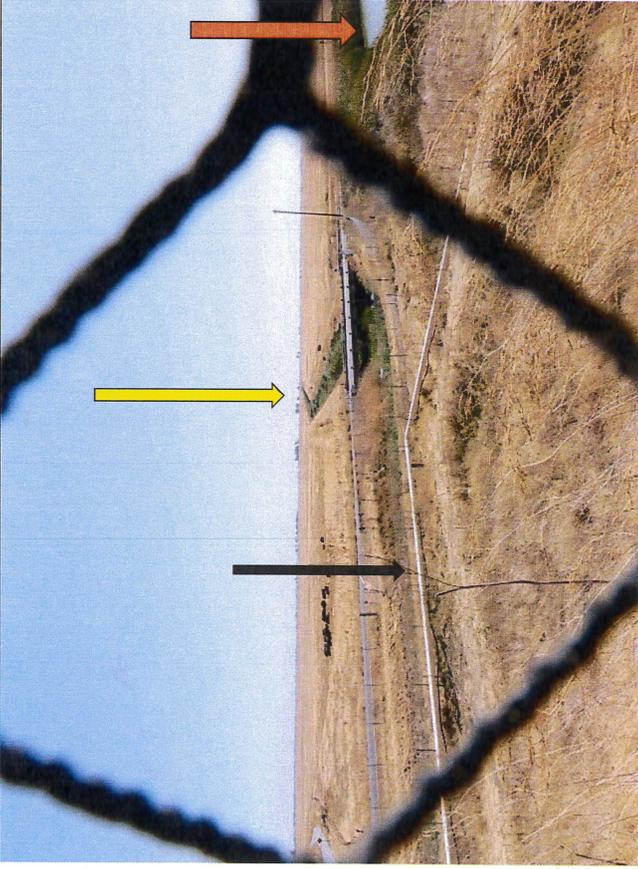
Photograph 15

View from the south-east corner of DM-3.2 and over-looking the A-1 Channel and the bird sanctuary. The yellow arrow indicates the A-1 Channel and the red arrow indicates the bird sanctuary. The black arrow indicates a landfill gas PVC header pipe. The A-1 Channel crosses State Highway CA-113 at this location.

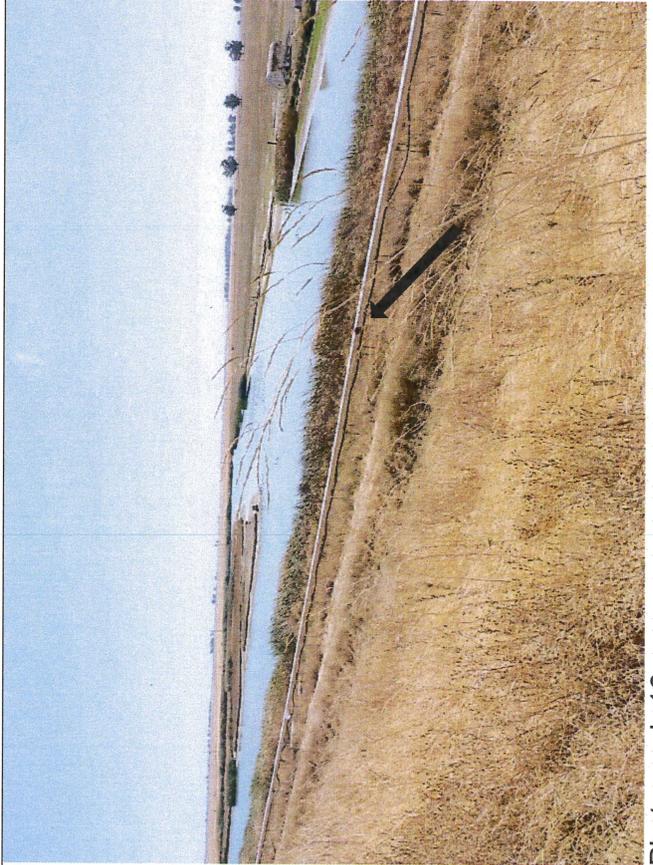
Photograph 16

Bird Sanctuary: As shown in Photograph 16, the Bird Sanctuary is a mitigated wetlands situated at the southeastern corner of the site. The Discharger informed us that storm water samples are collected from the discharge point of the pond. According to the industrial storm water permit, storm water samples must be collected at the edge of operations; therefore the sampling location must be changed such that storm water is sampled prior to discharge into the Bird Sanctuary.

View of the bird sanctuary. View from the south side of DM-3.3 looking south over the bird sanctuary. Black arrow indicates the PVC header pipe for the landfill gas extraction system. The Discharger is sampling storm water after passing through the Bird Sanctuary. According to the storm water permit. The samples must be collected at the edge of operations; therefore the sampling location must be changed such that storm water is sampled prior to discharge into the Bird Sanctuary.

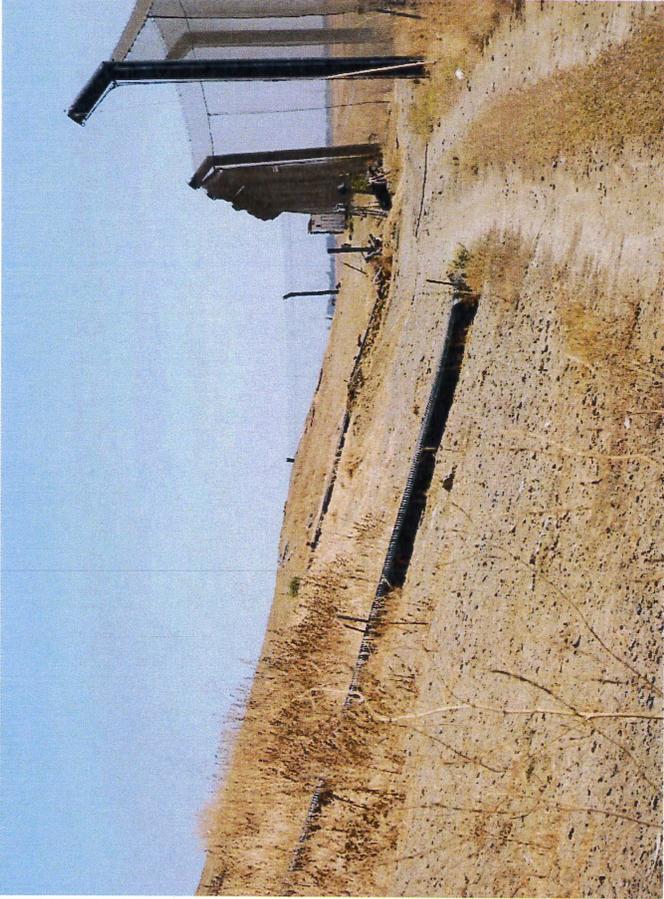
Photograph 17

Disposal Module 3.3, Bench and Side Slopes: As shown in Photograph 17, any runoff carried down the slope by the downspouts will discharge onto the road. Rain water has nowhere to move to, rather it ponds adjacent to the slope. The Discharger must enhance their runoff channels as outlined in the WDRs and Title 27. As constructed, this structure does not comply with Section 20365(a) which states: *Units and their respective containment structures shall be designed and constructed to limit, to the greatest extent possible, ponding, infiltration, inundation, erosion, slope failure, washout, and overtopping under the precipitation conditions specified in Table 4.1 (of this article) for each class of waste management unit (Unit).*

From the service road, looking east along the slope of Unit DM 3.3/3.2. Note that any runoff carried down the slope by the downspouts will discharge onto the road. Rain water has nowhere to move to, rather it ponds adjacent to the slope. The Discharger must enhance their runoff channels as outlined in the WDRs and Title 27. As shown in this photograph, there are no runoff ditches at the toe of the downspout.

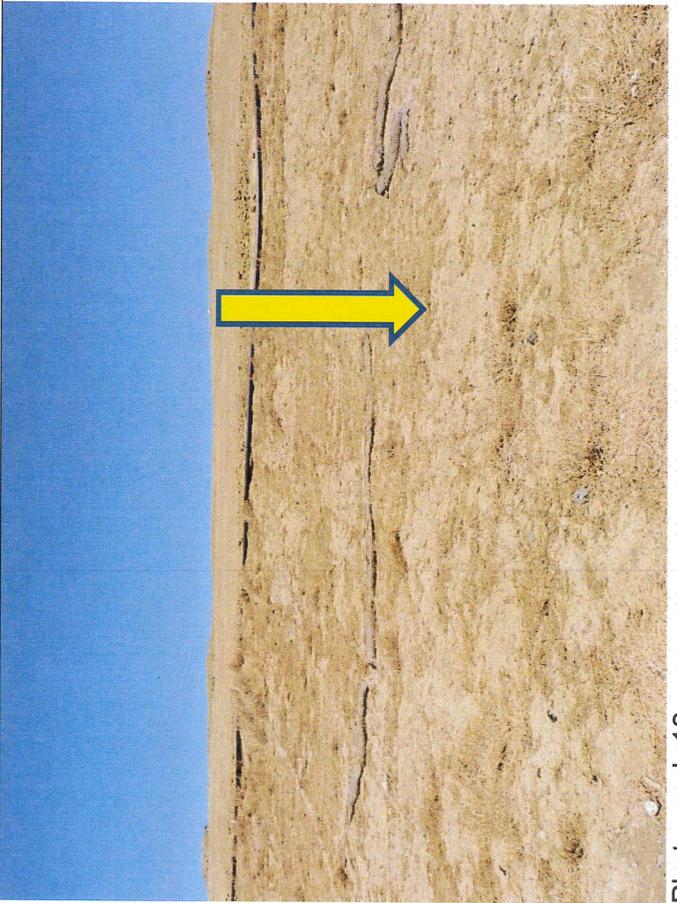
As an example of the inadequate management of runoff, Photograph 18 shows the southern side slope of DM-3.3 had evidence of rills. In addition, just below the rills, a gully had formed, as shown in Photograph 19. The formation of rills and gullies is an indication of inadequate control of surface water runoff.

Rill formation on DM-3.3. View from the south bench, looking up the slope. These slopes show evidence of rills, which form during runoff of rainwater. The rills are located up-slope from an erosion gully shown in the next photograph. Rill and gully formation are an indication of inadequate runoff controls.

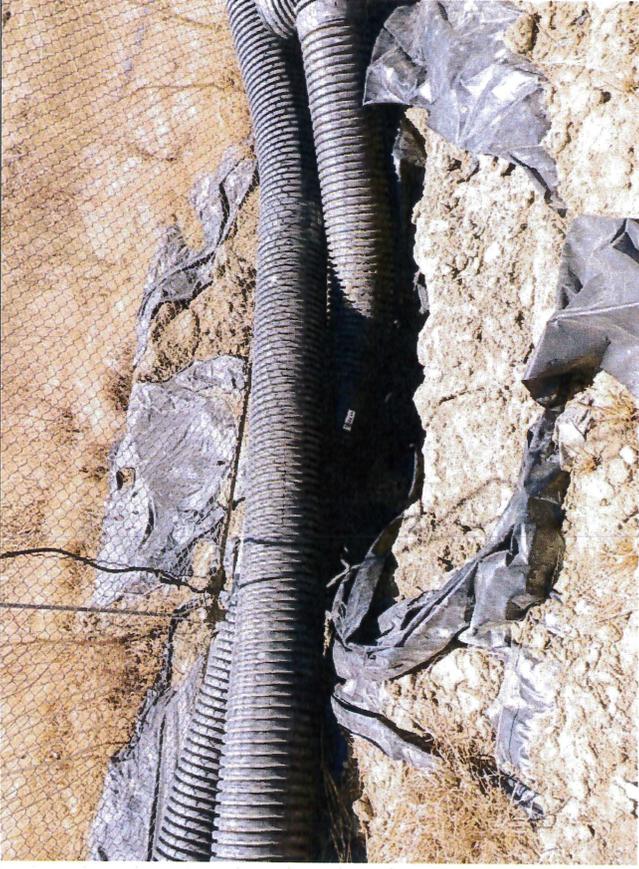
Photograph 19

View of plastic sheeting which is partially covering erosion at the bench of the DM-3.3 side slope. This gully may have been formed from ponding of runoff rainwater from the DM-3.3 side slope, which was likely followed by overtopping of the ponded area and the subsequent erosion and gully.

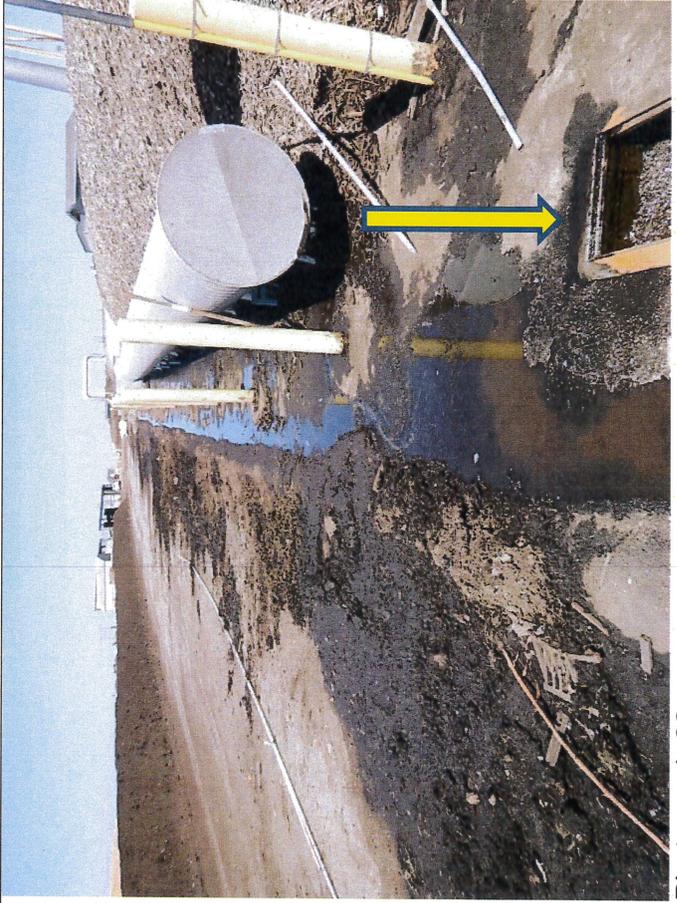
Photograph 22 shows the ponding of leachate on the concrete portion of the composting area. Also observed was debris within the sump. This may reduce the efficiency of the sumps which may result in ponding of water during a sizable rain event.

Compost leachate generated during the composting process. The windrow to the right is covered under a "Bio-Filter". No "Ag-Bags" were in use at the time of the inspection. The arrow points to a collection sump. Note the debris in the sump that may reduce the efficiency of the sump.

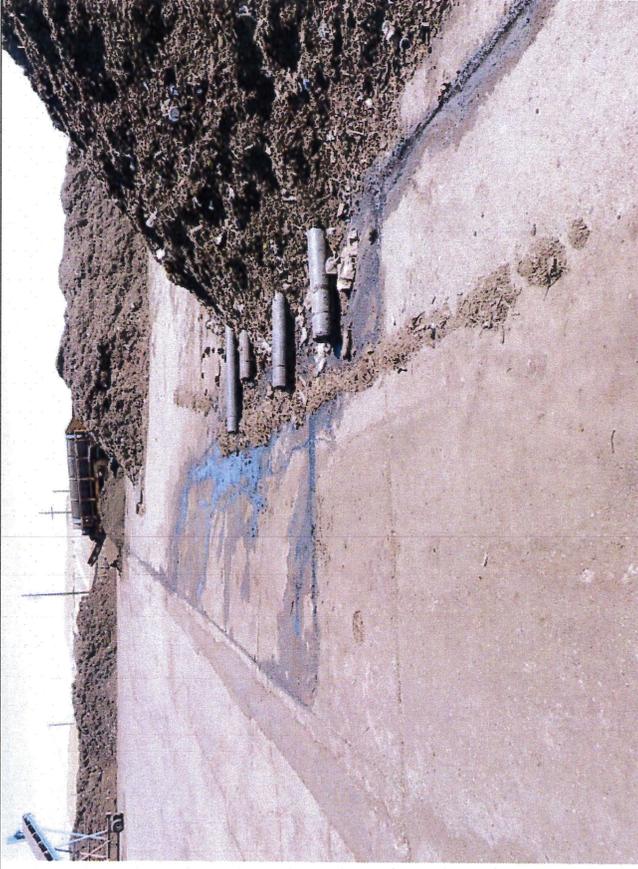
Photograph 23

View of food waste composting operations and leachate runoff. Leachate drains across the surface and through channel drains to a collection drainage ditch prior to discharge into the ponds. Currently, the facility is using a static pile system, which does not comply with WDRs requirement for an in-vessel system.

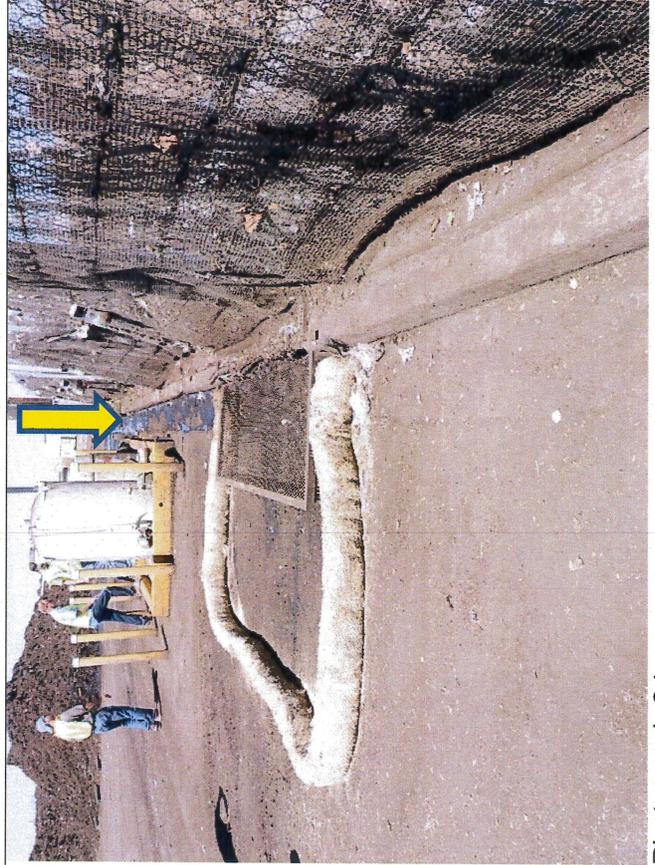
Photograph 24

View, looking north, of the food waste composting drainage ditch. Runoff flows along this drainage ditch to a sump and then is directed to either the low-flow pond or the high-flow pond. The arrow points at the curb where leachate is being directed to the sump.

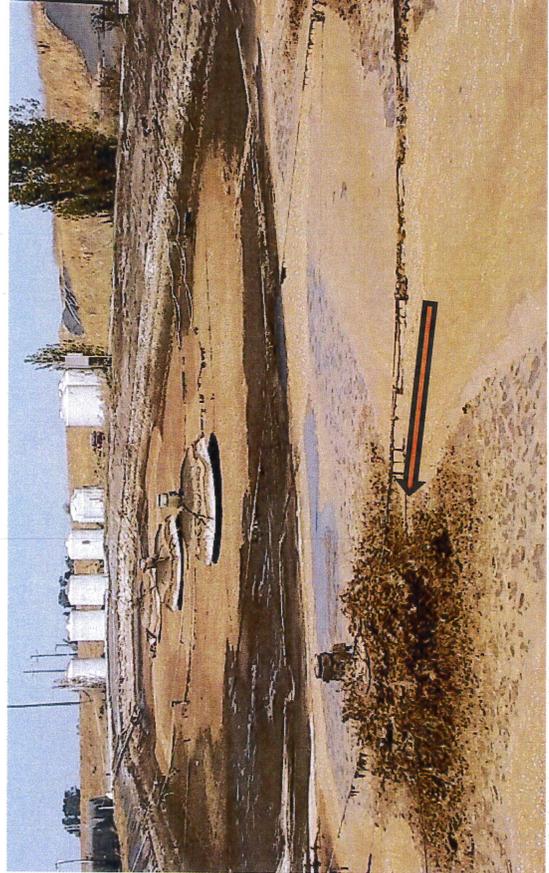
Photograph 26

As shown in Photograph 26, one of four aerators in the low-flow pond was in operation at the time of the inspection, and the pond liquids appeared to be dark brown. The Discharger pumps liquids from the low-flow pond to the high-flow pond. Liquids in the high-flow pond appeared to have a yellowish tinge. Photograph 28 shows the pump and pipe used to remove liquid from the pond for dust control (a practice which does not comply with the WDRs).

View of the low-flow leachate pond for the food waste composting operations. The arrow points to a typical aerator for this pond, which the Discharger installed to mitigate odor problems associated with the pond. Liquids are pumped out of the pond to an adjacent high-flow pond. The process of pumping liquids out of the low-flow pond and over to the high-flow pond does not comply with the WDRs. Only one of four aerators was operating at the time of the inspection.

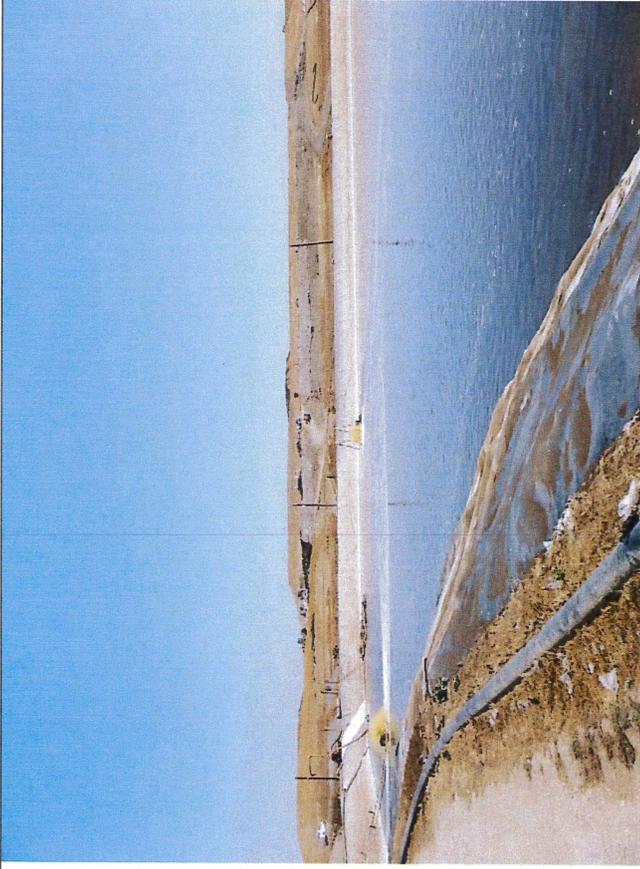
Photograph 27

High-flow pond. View of the high-flow pond from the south-west side looking north. This pond contains leachate, which does not comply with the WDRs.

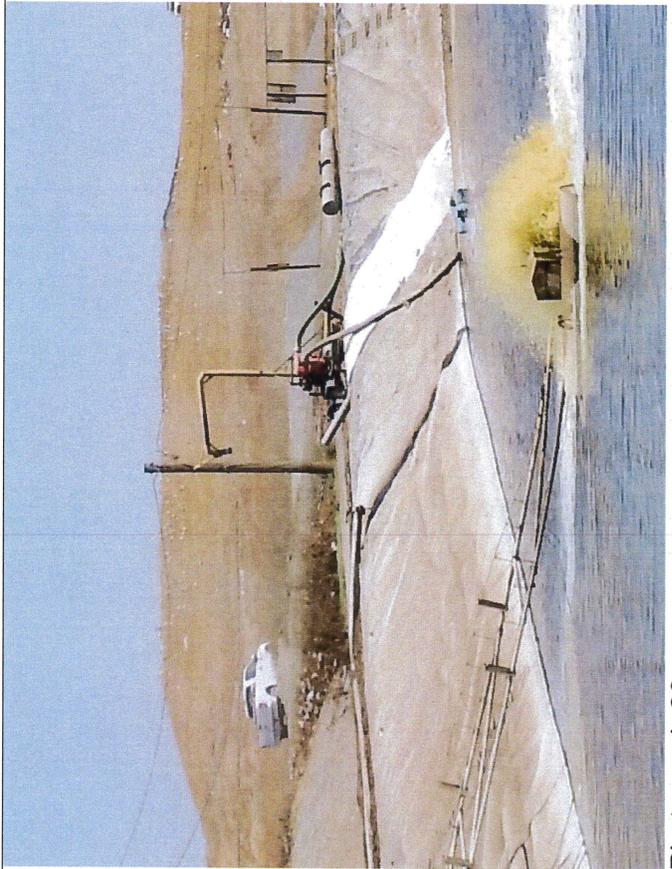
Photograph 28

A close up of the high-flow pond shows the pump and spout used to remove liquid from the pond for dust control. The photograph also shows a paddle wheel aerator in operation. There were three of five aerators operating at the time of the inspection.

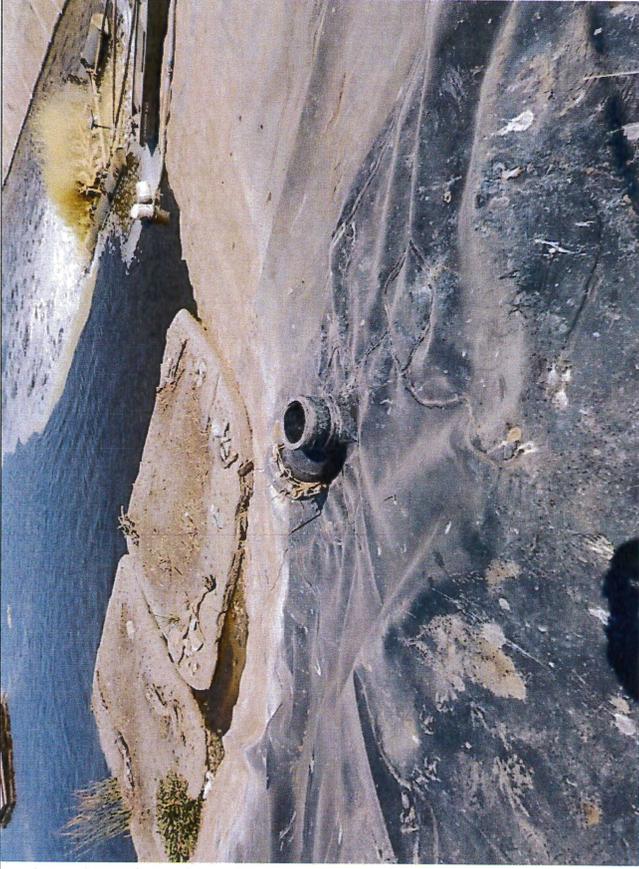
Photograph 29

An overflow drain in the high-flow pond is shown in Photograph 29. The system of pumping liquids from the low-flow pond to the high-flow pond does not comply with the WDRs.

Overflow standpipe in the high-flow pond, which eventually discharges to off-site surface water drainage channels. Note the aerator in the upper right corner of the photograph.
