CLEANUP AND ABATEMENT ORDER NO. R5-2015-0701

Attachment C – 28 October 2014 Baker Ridge Inspection Report

INSPECTION REPORT

28 OCTOBER 2014 BAKER RIDGE INSPECTION REPORT

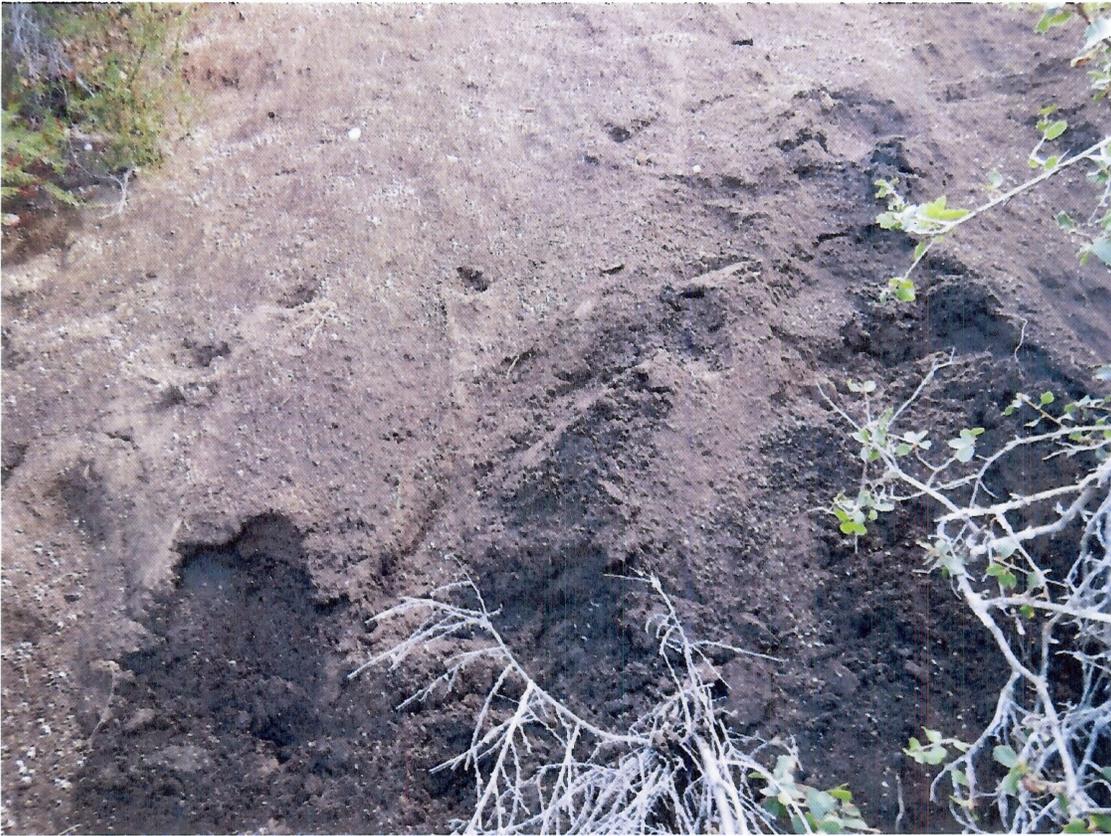
The lower terrace was constructed by grading down a ridge and pushing the graded material to the west and southeast piling it to form an approximately 0.9 acre rectangular terrace with approximately 5 feet tall berms around the perimeter. On the northwest corner of the lower terrace (Way Point 100) Central Valley Water Board staff (Staff) found a storm water drainage discharge for the lower terrace surface. Directly adjacent to and below this discharge site staff encountered a large amount of potting soil that had been dumped over the edge and down the side slopes of the lower terrace (Photograph #1) as well as tires, metal, and other debris that had been incorporated into the fill of the terrace. The debris had been exposed by erosion (Way Point 101, Photograph #2). The potting soil covered an area on the side slope of approximately 1900 ft² and had an average depth of more than 12 inches. There was evidence that some of the potting soil, through visible rills, had washed downhill prior to our inspection. A sample was taken from the center of the potting soil mass (Way Point 102).

Photograph #1. Way Point 102 – Potting soil that was dumped on fill/side slope of lower terrace.

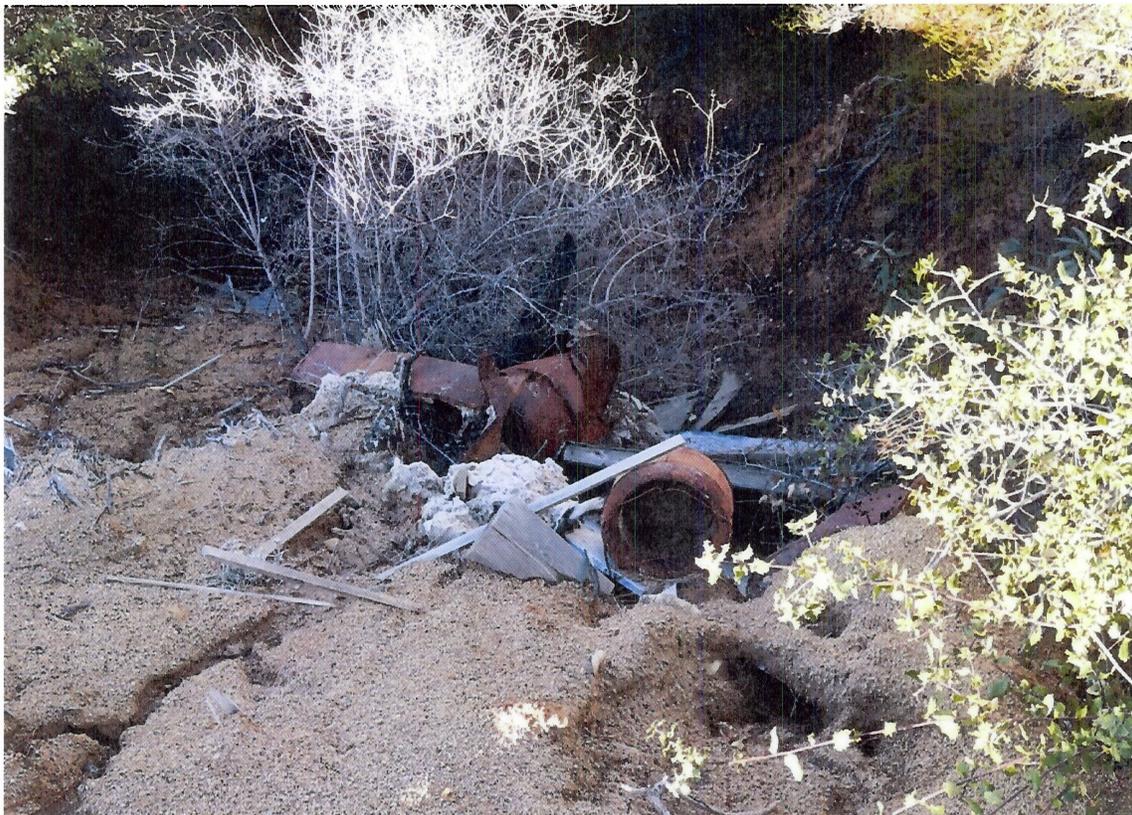
Photograph #2. Way Point 101 – Tires and metal incorporated into fill material, now exposed by erosion.

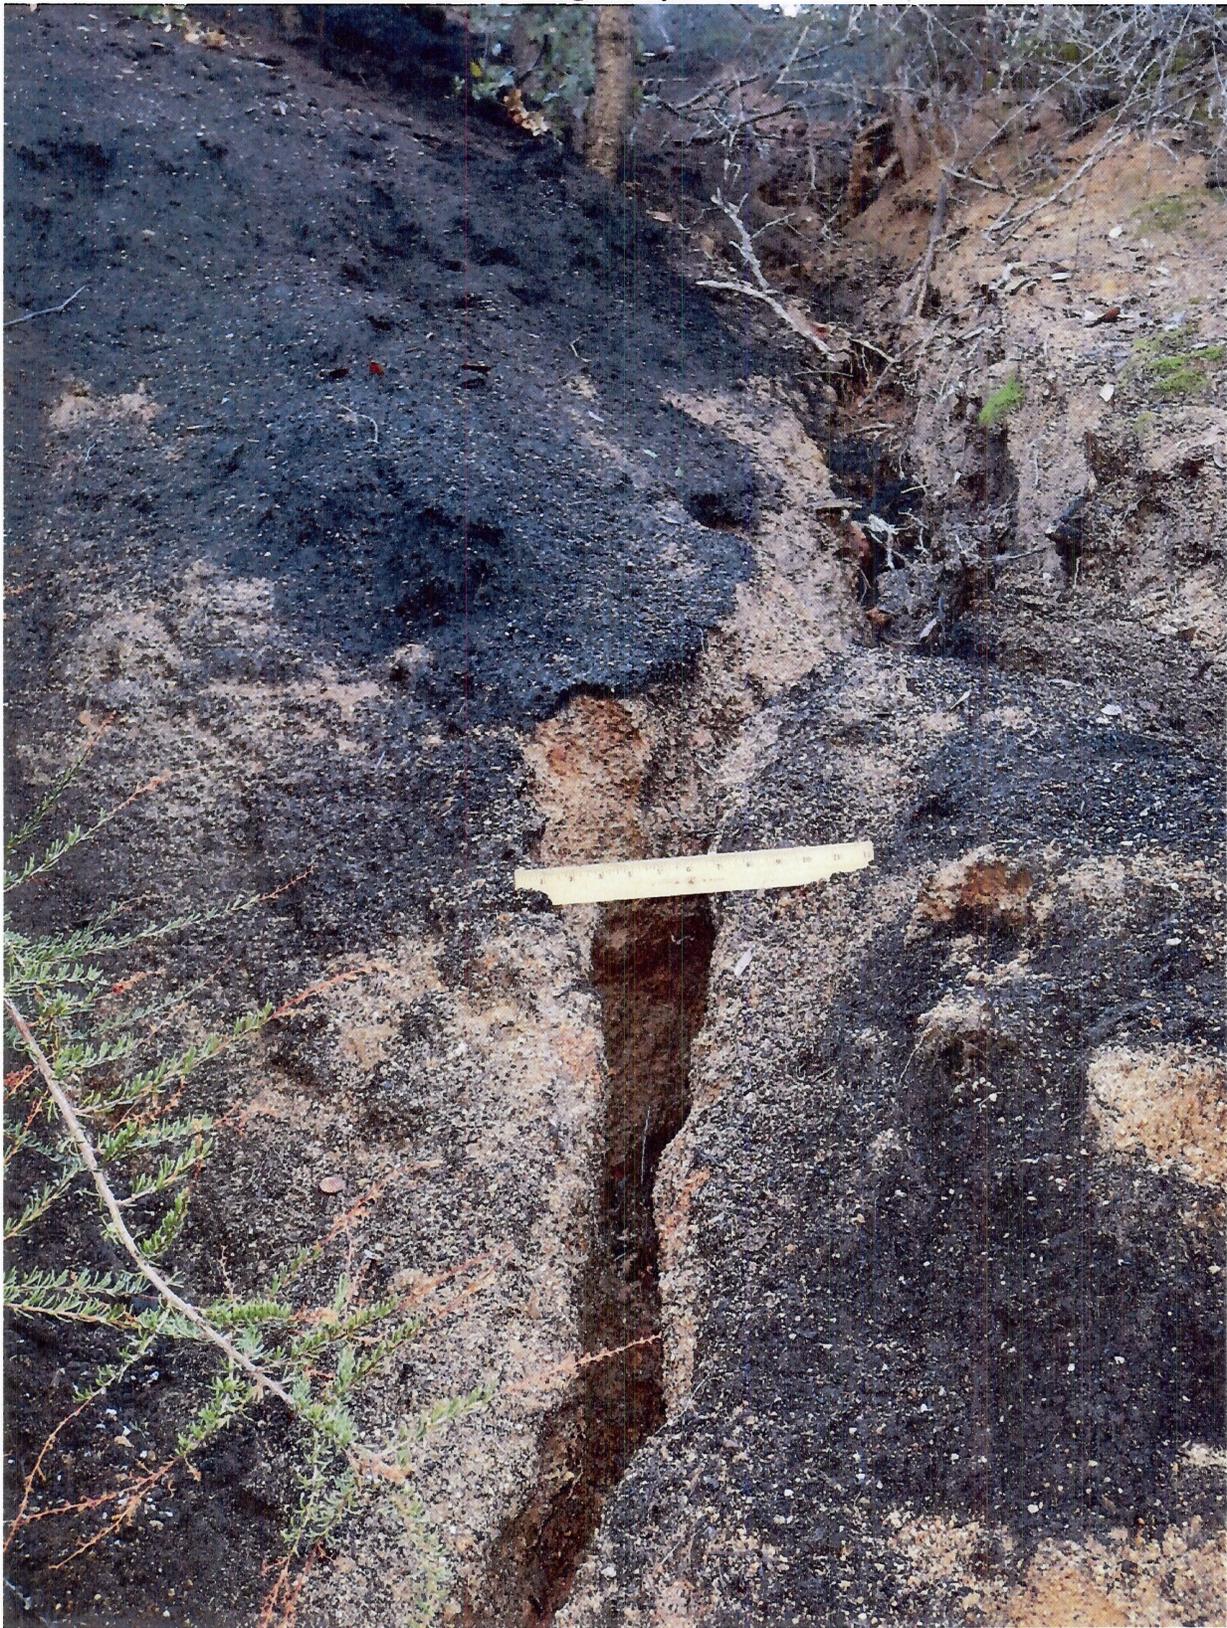
Photograph #3. Rill through dumped potting soil on fill/side slope of lower terrace leading directly to watercourse.

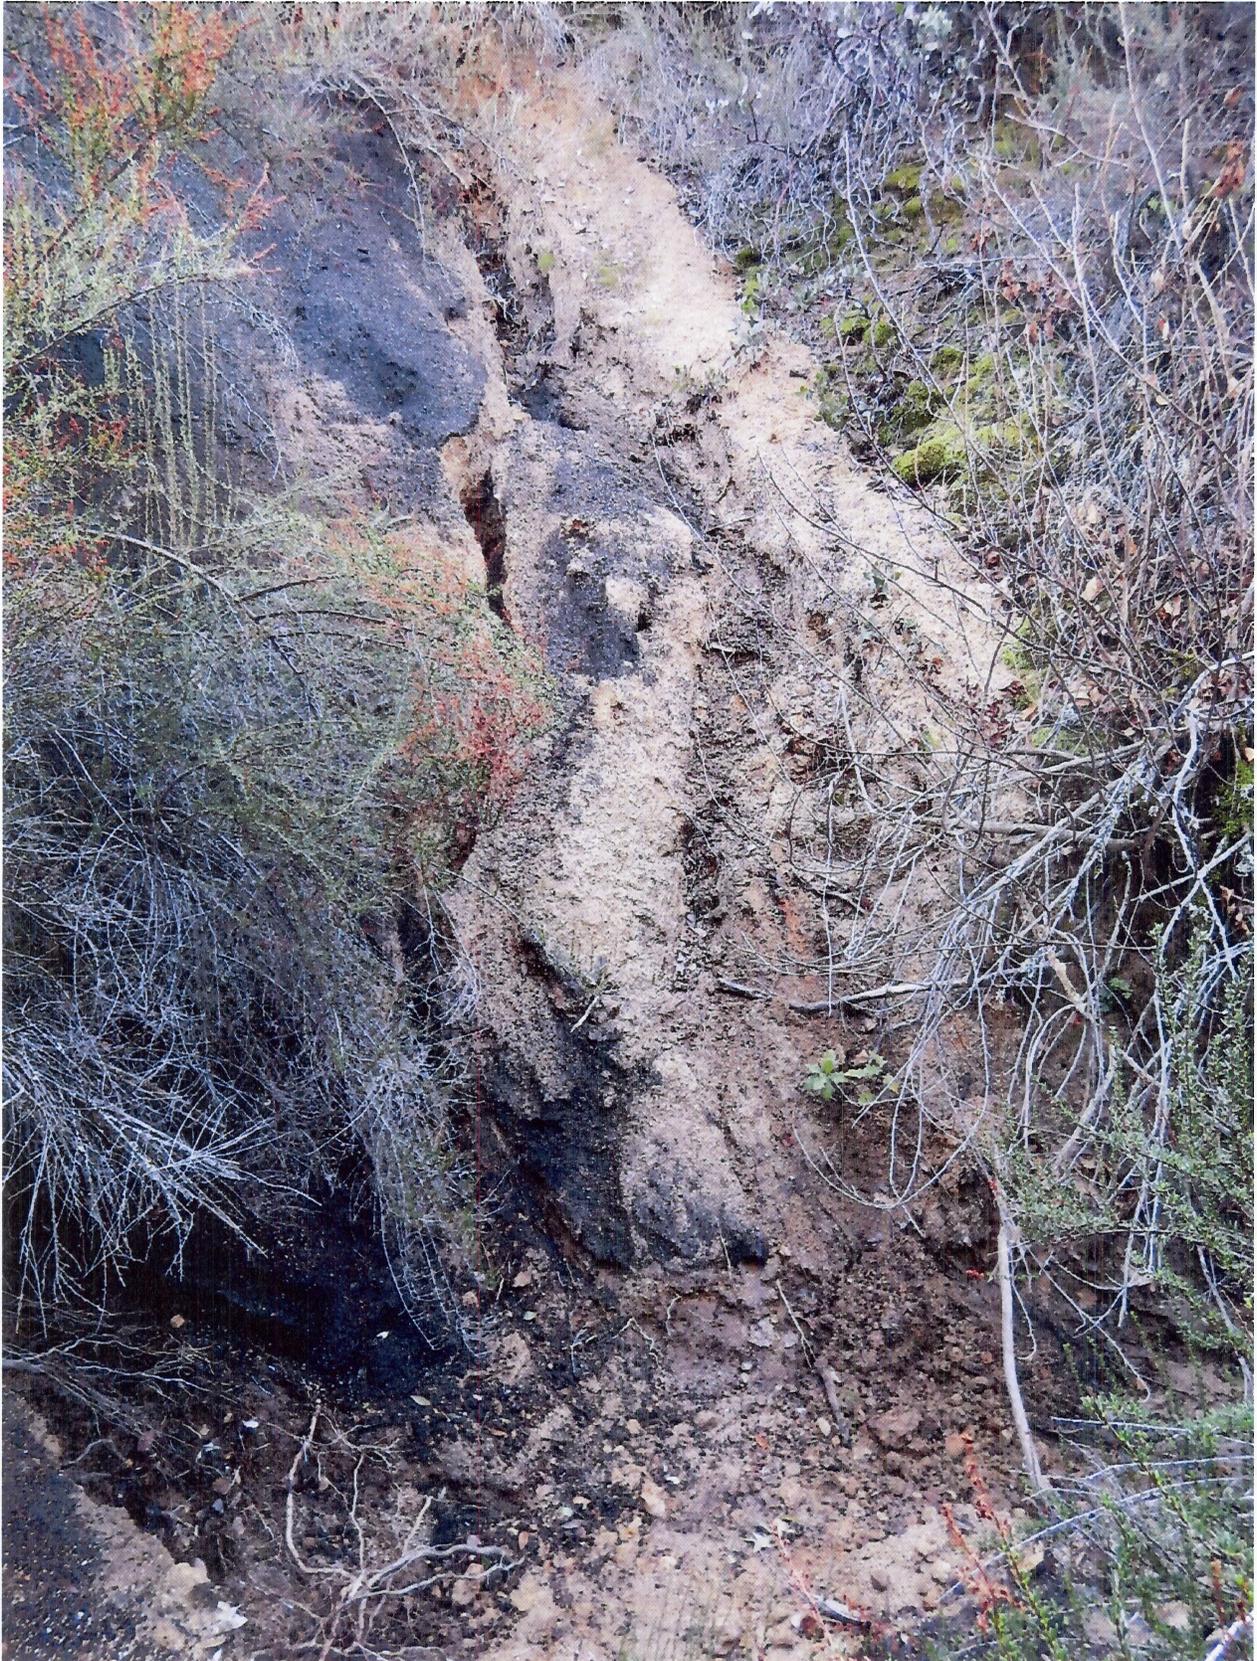
Staff followed the fill slope erosion scars, created by storm water drainage discharge from the lower platform surface, down the fill/side slope of the lower platform to a Class III (intermittent) watercourse below. The fill/side slope was approximately 60 feet long with greater than 55% slopes, as measured using a measuring tape and inclinometer. Staff measured one rill with a length of 54 feet, an approximate average width of at least 4 inches, and an approximate average depth of at least 6 inches on this fill/side slope (Photograph #3). Upon reaching the watercourse, Staff discovered clear evidence that storm water, sediments, and potting soil from the terrace surface, fill/side slopes, and potting soil dump had discharged directly into the watercourse (Way Point 103, Photograph #4).

Photograph #4. Way Point 103 – Sediments from lower terrace surface and fill/side slopes in watercourse.

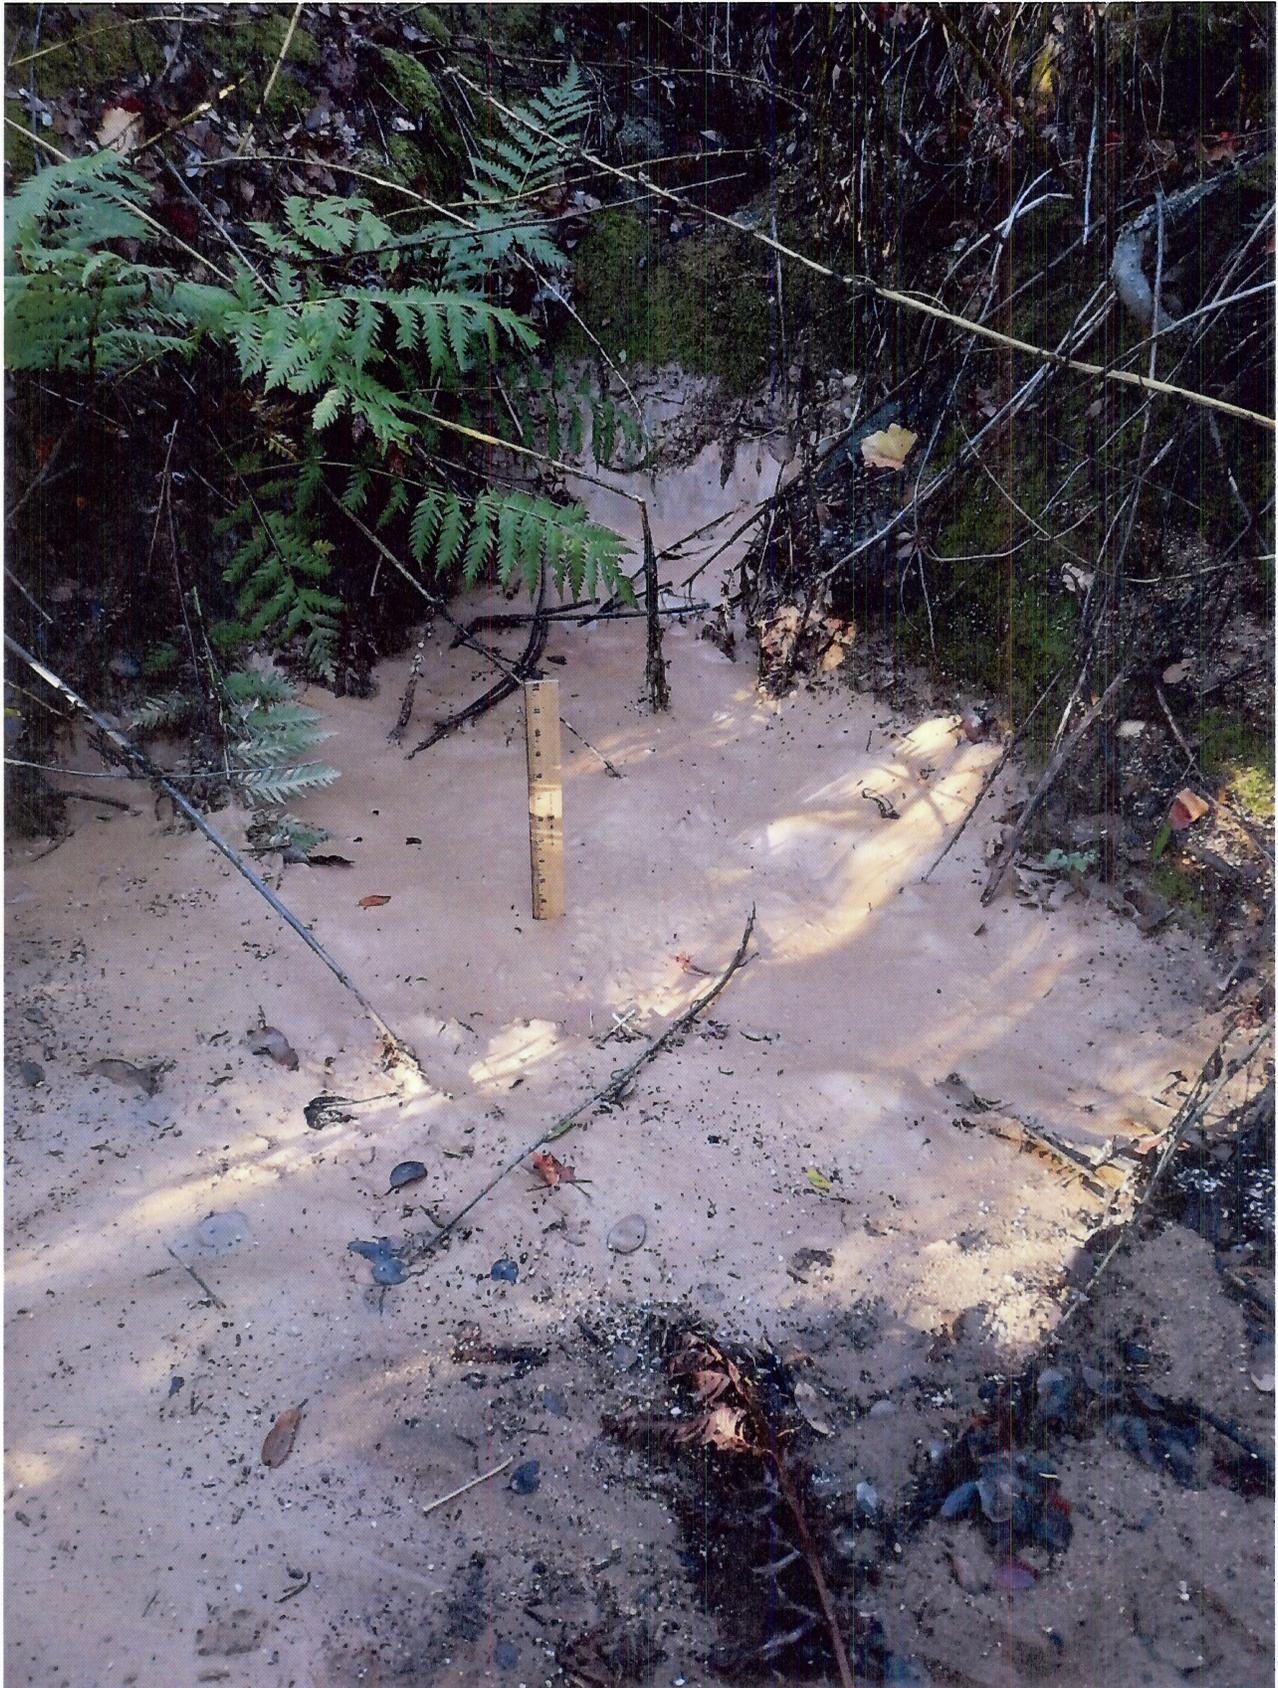
Photograph #5. Way Point 104 – Area where very fine sediments (Silts & Clays) have accumulated along one side of the watercourse.

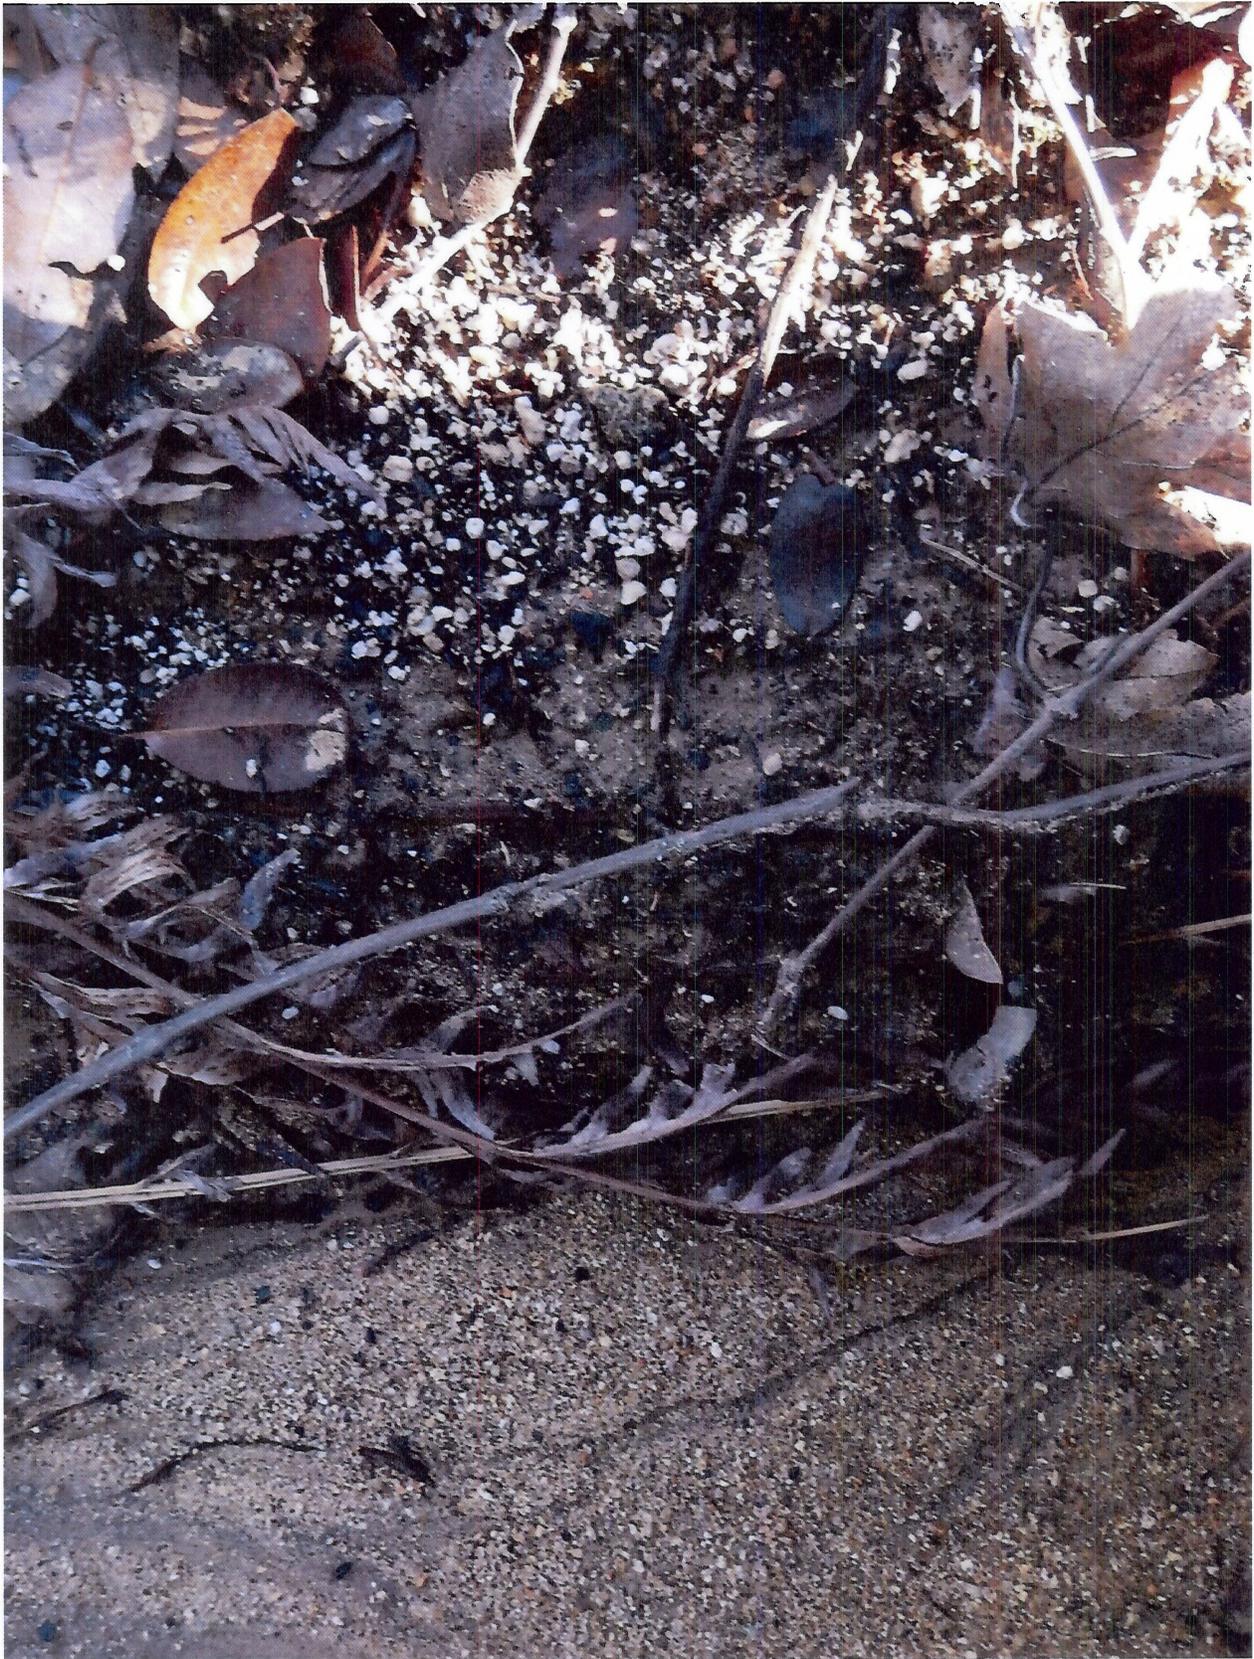
Staff began following the watercourse, which did not have water flowing in it at the time but was very wet, downstream. The stream substrate was composed of fine material with the same color and composition as the fill/side slopes of the lower terrace. Approximately 40 feet downstream from Way Point 103 Staff discovered an area where during the most recent precipitation event a back eddy had formed allowing very fine sediments to become entrapped and fall out of suspension (Way Point 104, Photograph #5). Staff continued downstream documenting the composition of the stream substrate as well as areas where perlite from the potting soil had accumulated in and on the banks of the watercourse (Way Points 105 -109, Photograph #6).

Photograph #6. Way Point 106 – Perlite from potting soil entrapped on banks of watercourse.

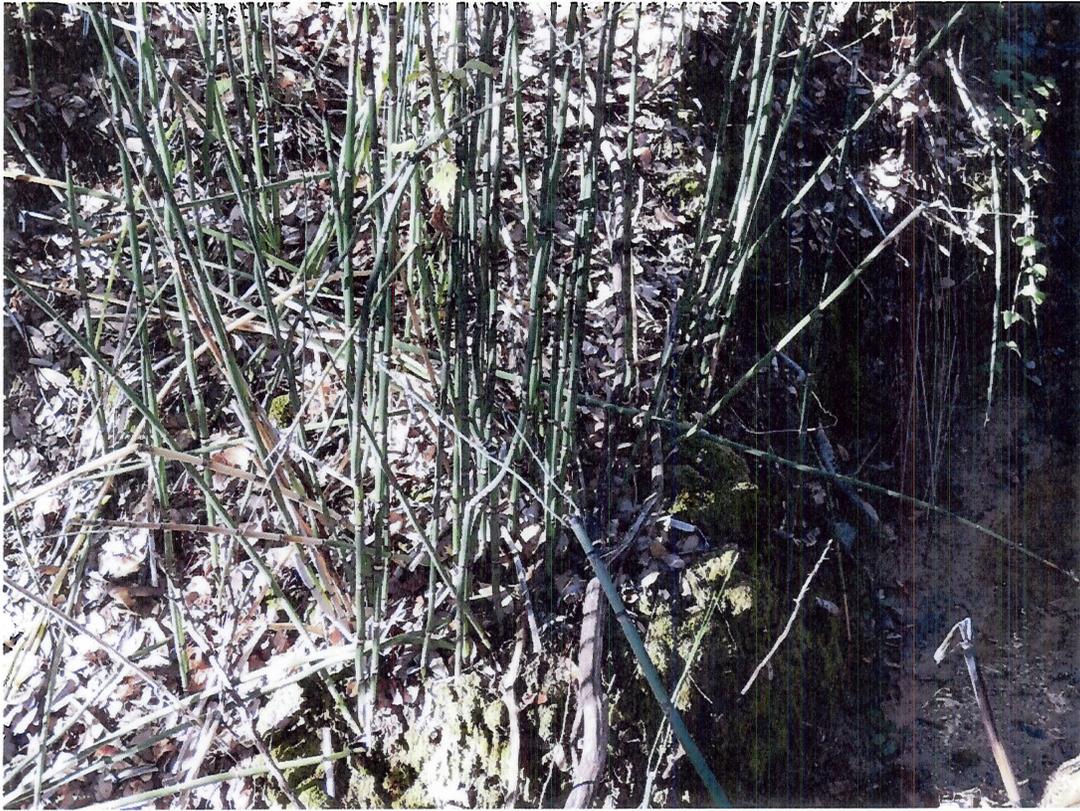
At Way Point 108 Staff encountered flowing water in the watercourse along with two ephemeroptera (mayfly) larvae within the watercourse and aquatic plants along its banks (Photograph #7). At this point the watercourse changes from Class III (intermittent) to Class II (aquatic life bearing). Staff continued downstream until they reached the confluence of another class III watercourse (Way Point 109) that originated at the toe of the fill/side slope of the south side of the lower terrace. Staff followed the class III watercourse up to the toe of the fill/side slope of the south side of the lower terrace.

Photograph #7. Way Point 108 – Hydrophytic plants where the watercourse class changes from Class III to Class II (aquatic life bearing).

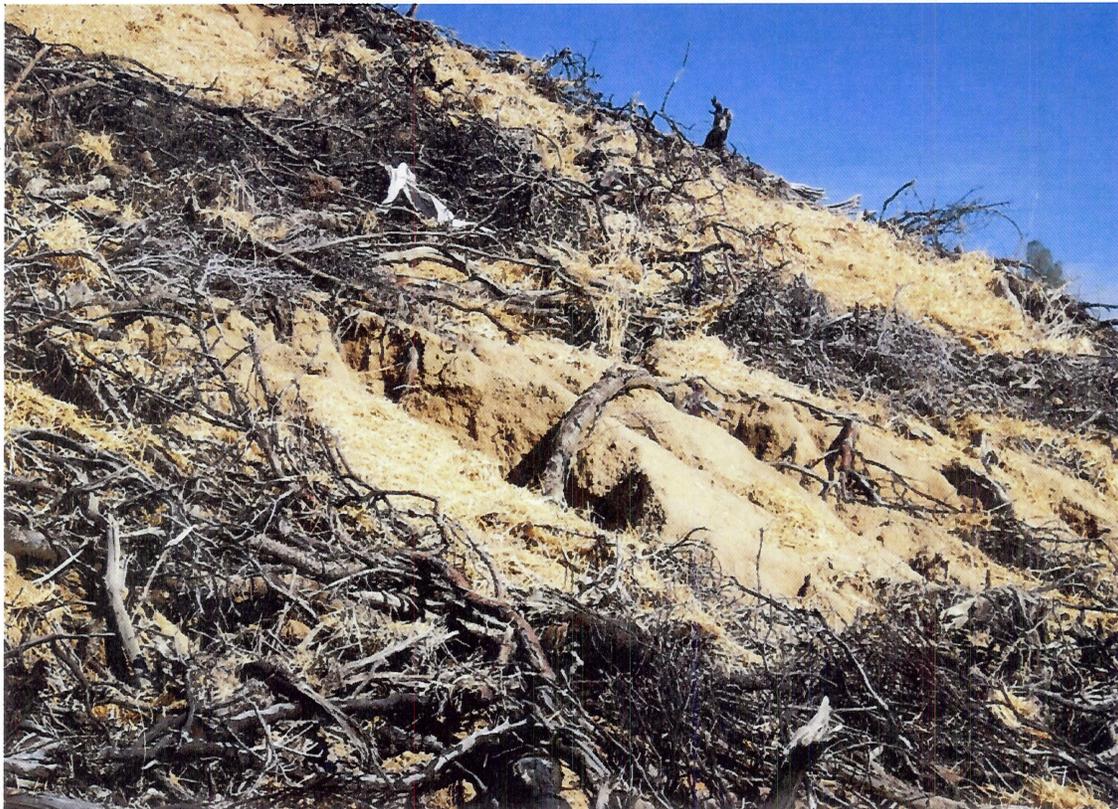
From Way Point 110 Staff took multiple photos of the slash that was used, but failed as evident from the deep rills under the slash, to protect the side slopes of the southeastern side of the lower terrace from erosion (Photograph #8). At Way Point 111 Staff found a stake with writing presumably used to plan and construct the lower terrace. This suggests that the terrace design and construction was conducted by individuals with knowledge in grading techniques and intent. At Way Point 112 Staff took multiple photos of the previously mentioned heavy equipment being used on the fill/side slope of the east side of the lower terrace to push the slash down the hill and remove rills that had formed as a result of the failed erosion controls (Photograph #9).

Photograph #8, Way Point 110 – Slash used in a failed attempt to protect steep (+55%) fill/side slopes from erosion.

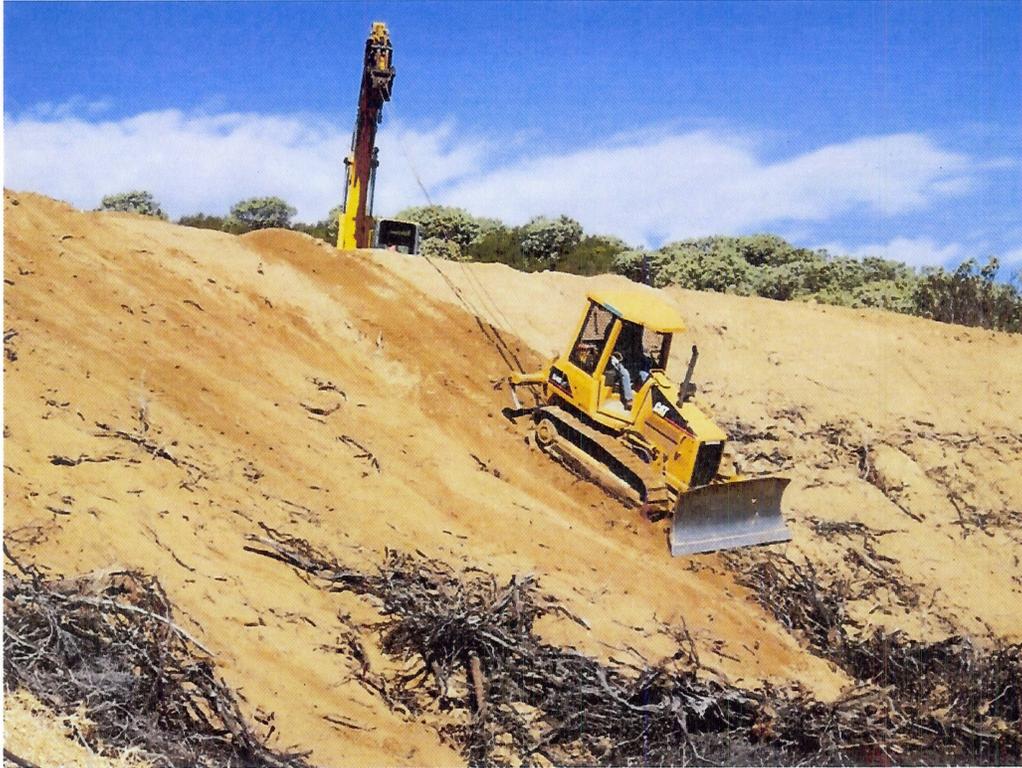
Photograph #9, Way Point 112 – Heavy equipment being operated on steep (+55%) fill/side slopes

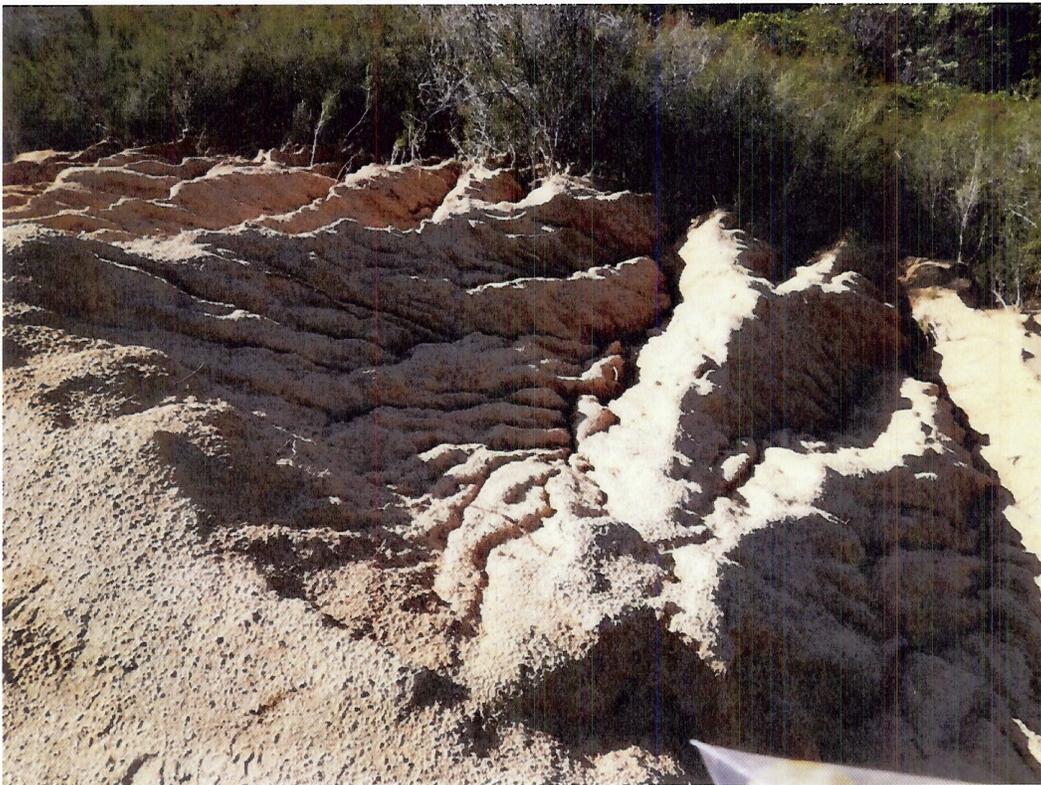
From Way Points 113 and 114 Staff took multiple photos of the large scale rill erosion that had occurred on the unprotected southern and western slopes of the lower terrace. There was no evidence that erosion control measures had ever been placed on these slopes (Photograph #10), and from Way Point 114 Staff could see that sediment from this erosion had reached the watercourse below.

Photograph #10. Way Point 113 – Large scale rill erosion on the unprotected steep (+60%) south and west fill/side slopes of the lower terrace.

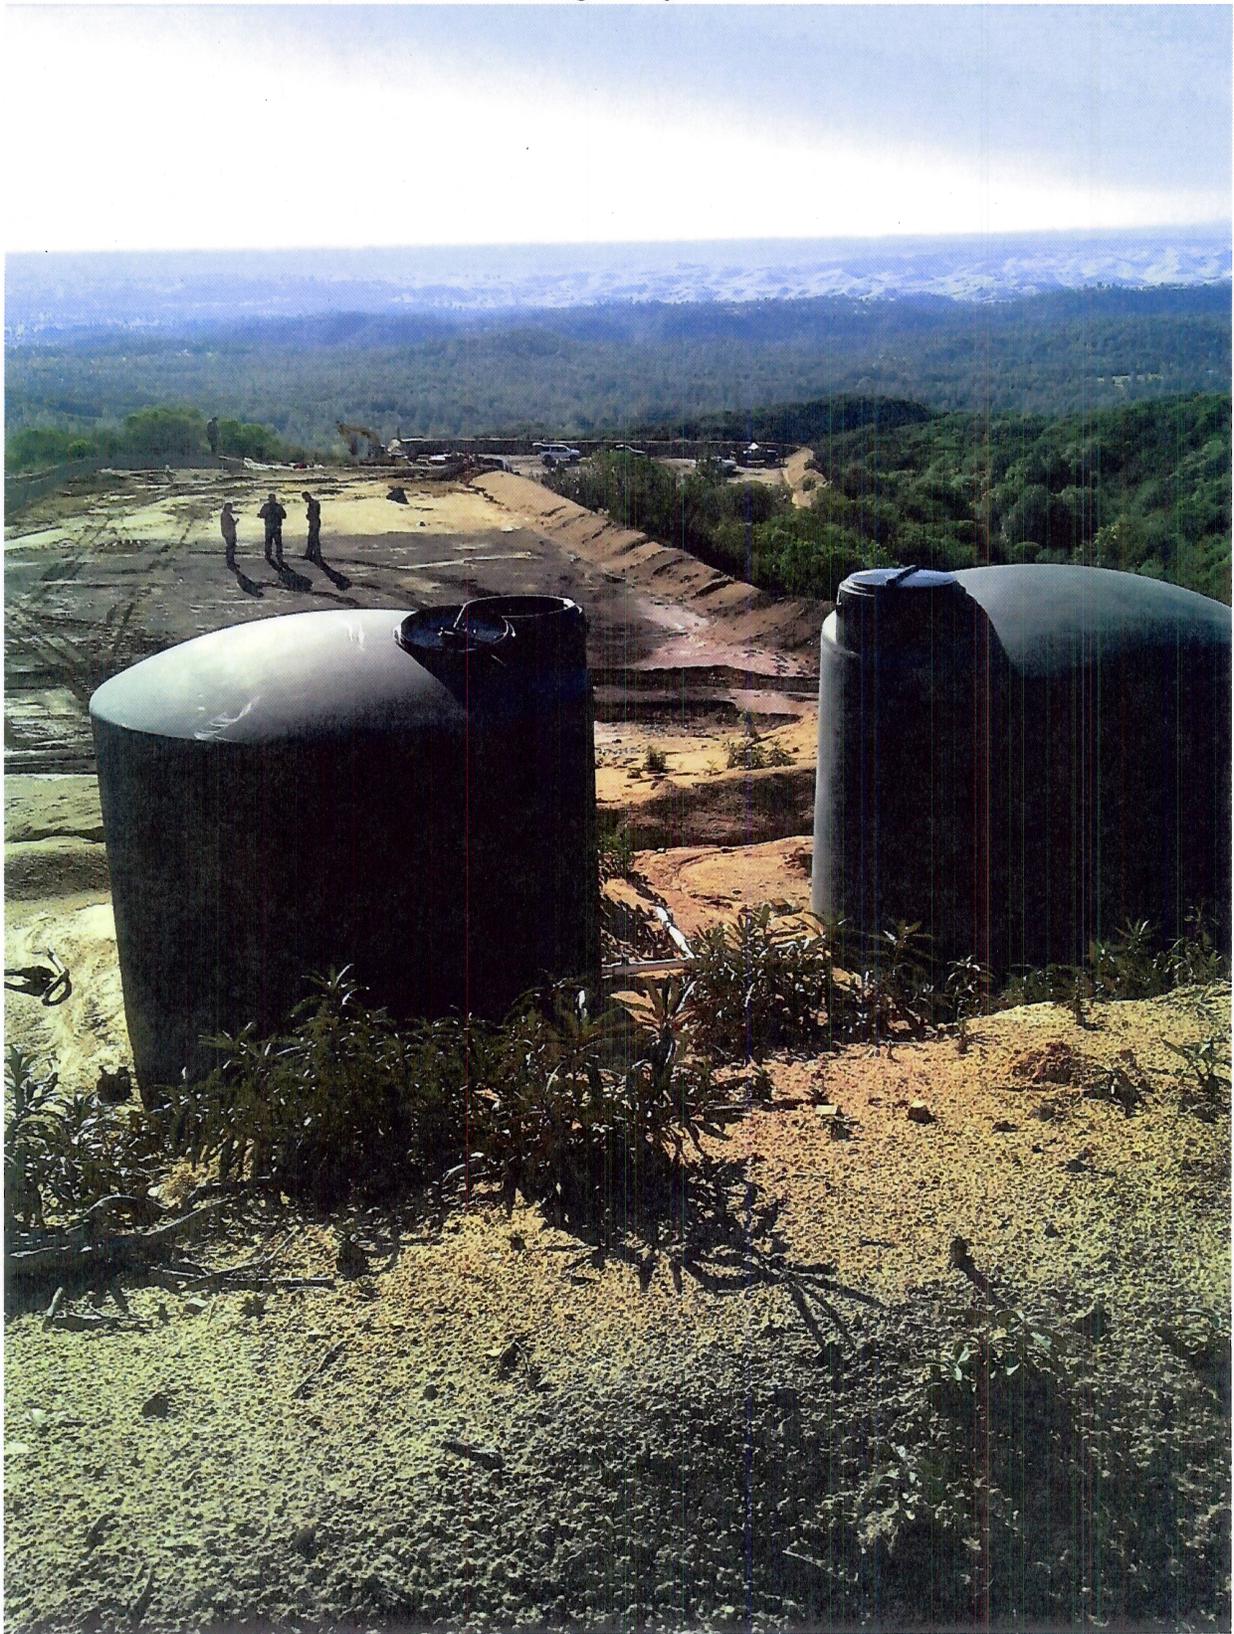
The upper terrace was constructed similar to the lower, by grading material to form a rectangular native soil surface with large berms around the perimeter. Using a GPS, Staff determined that this terrace surface is approximately 0.3 acres in size. Two 3000 gallon water tanks were located upslope and to the north northwest of the upper terrace surface (Photograph #11) and Staff found another area of dumped potting soil on the east fill/side slope of the upper terrace. At the time of the inspection the 1 water tank was full and the other approximately half full and there were no pipes connected to these tanks.

Photograph #11 – Two 3000 gallon tanks in front of upper (foreground) and lower (background) terraces.

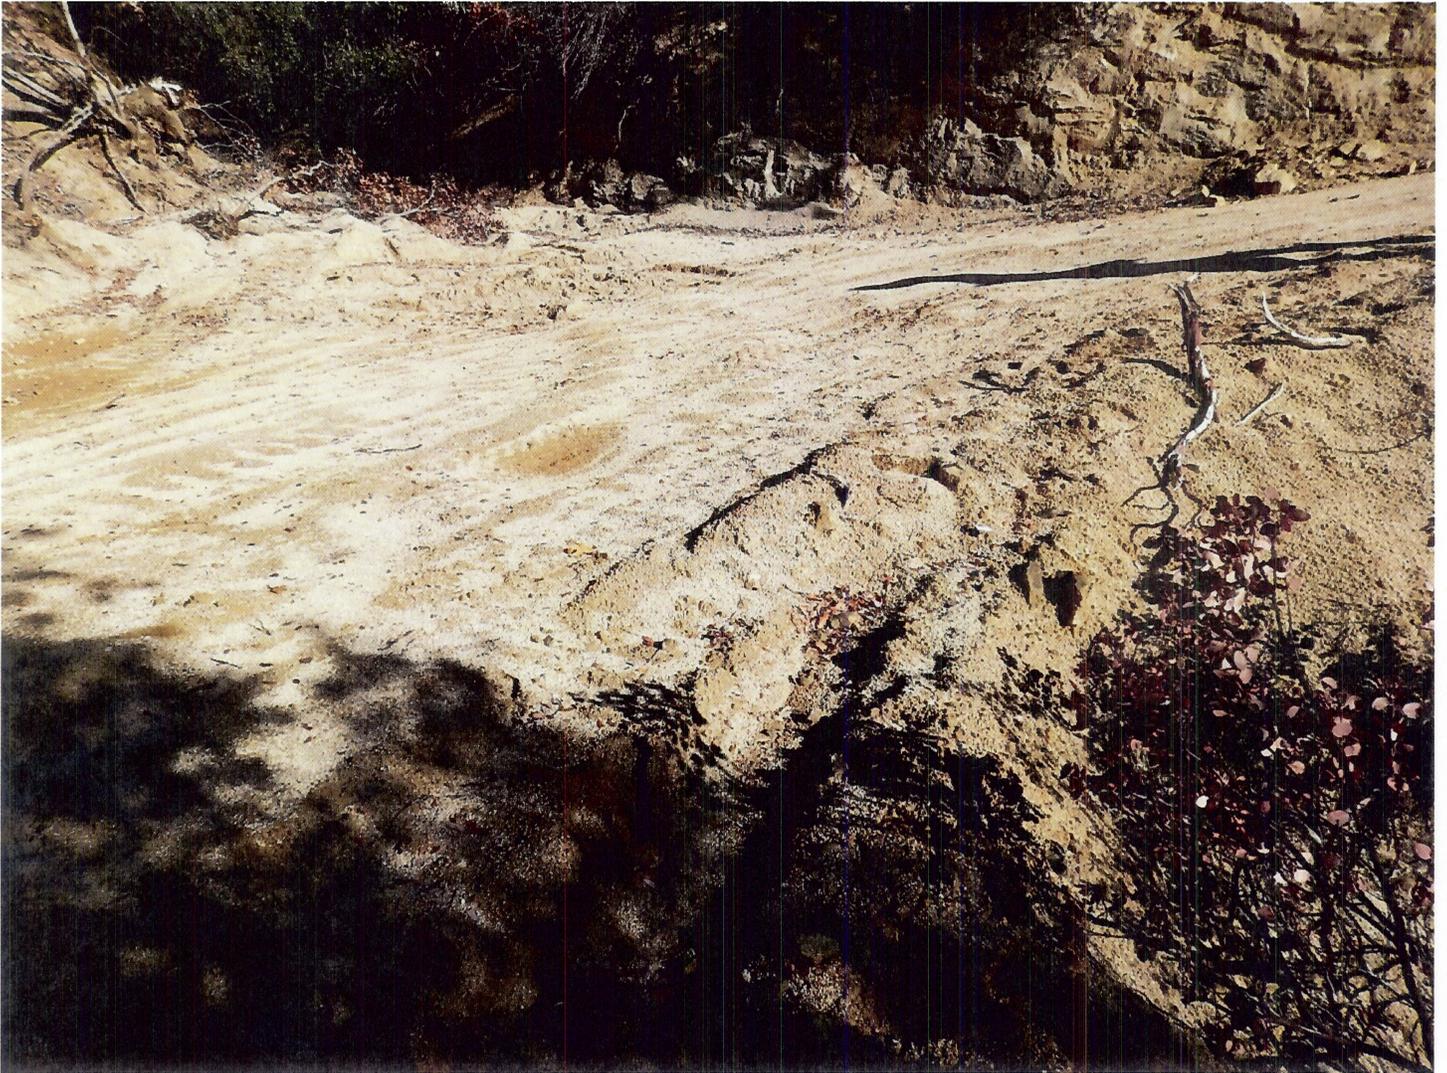
Staff discovered a previously unknown and recently constructed section of road that started from the north side of the upper terrace and traveled west ("New Road"). Staff investigated a section of the New Road discovering areas with fresh tracks from heavy equipment and identifying several areas where sediment had been discharged directly to a watercourse (Way Point 115). Staff also discovered a watercourse that had been diverted by the road construction (Way Point 116), and an un-culverted, non-armored watercourse crossing that used more than 3840 ft³ of fine grained fill material (Way Point 117, Photograph #12). Above this crossing the watercourse had a more stable substrate with very little, if any, of the sand that formed the substrate of the watercourse below this crossing and the terraces.

Photograph #12. Way Point 117 – Un-culverted, non-armored watercourse crossing with native soil used for fill.

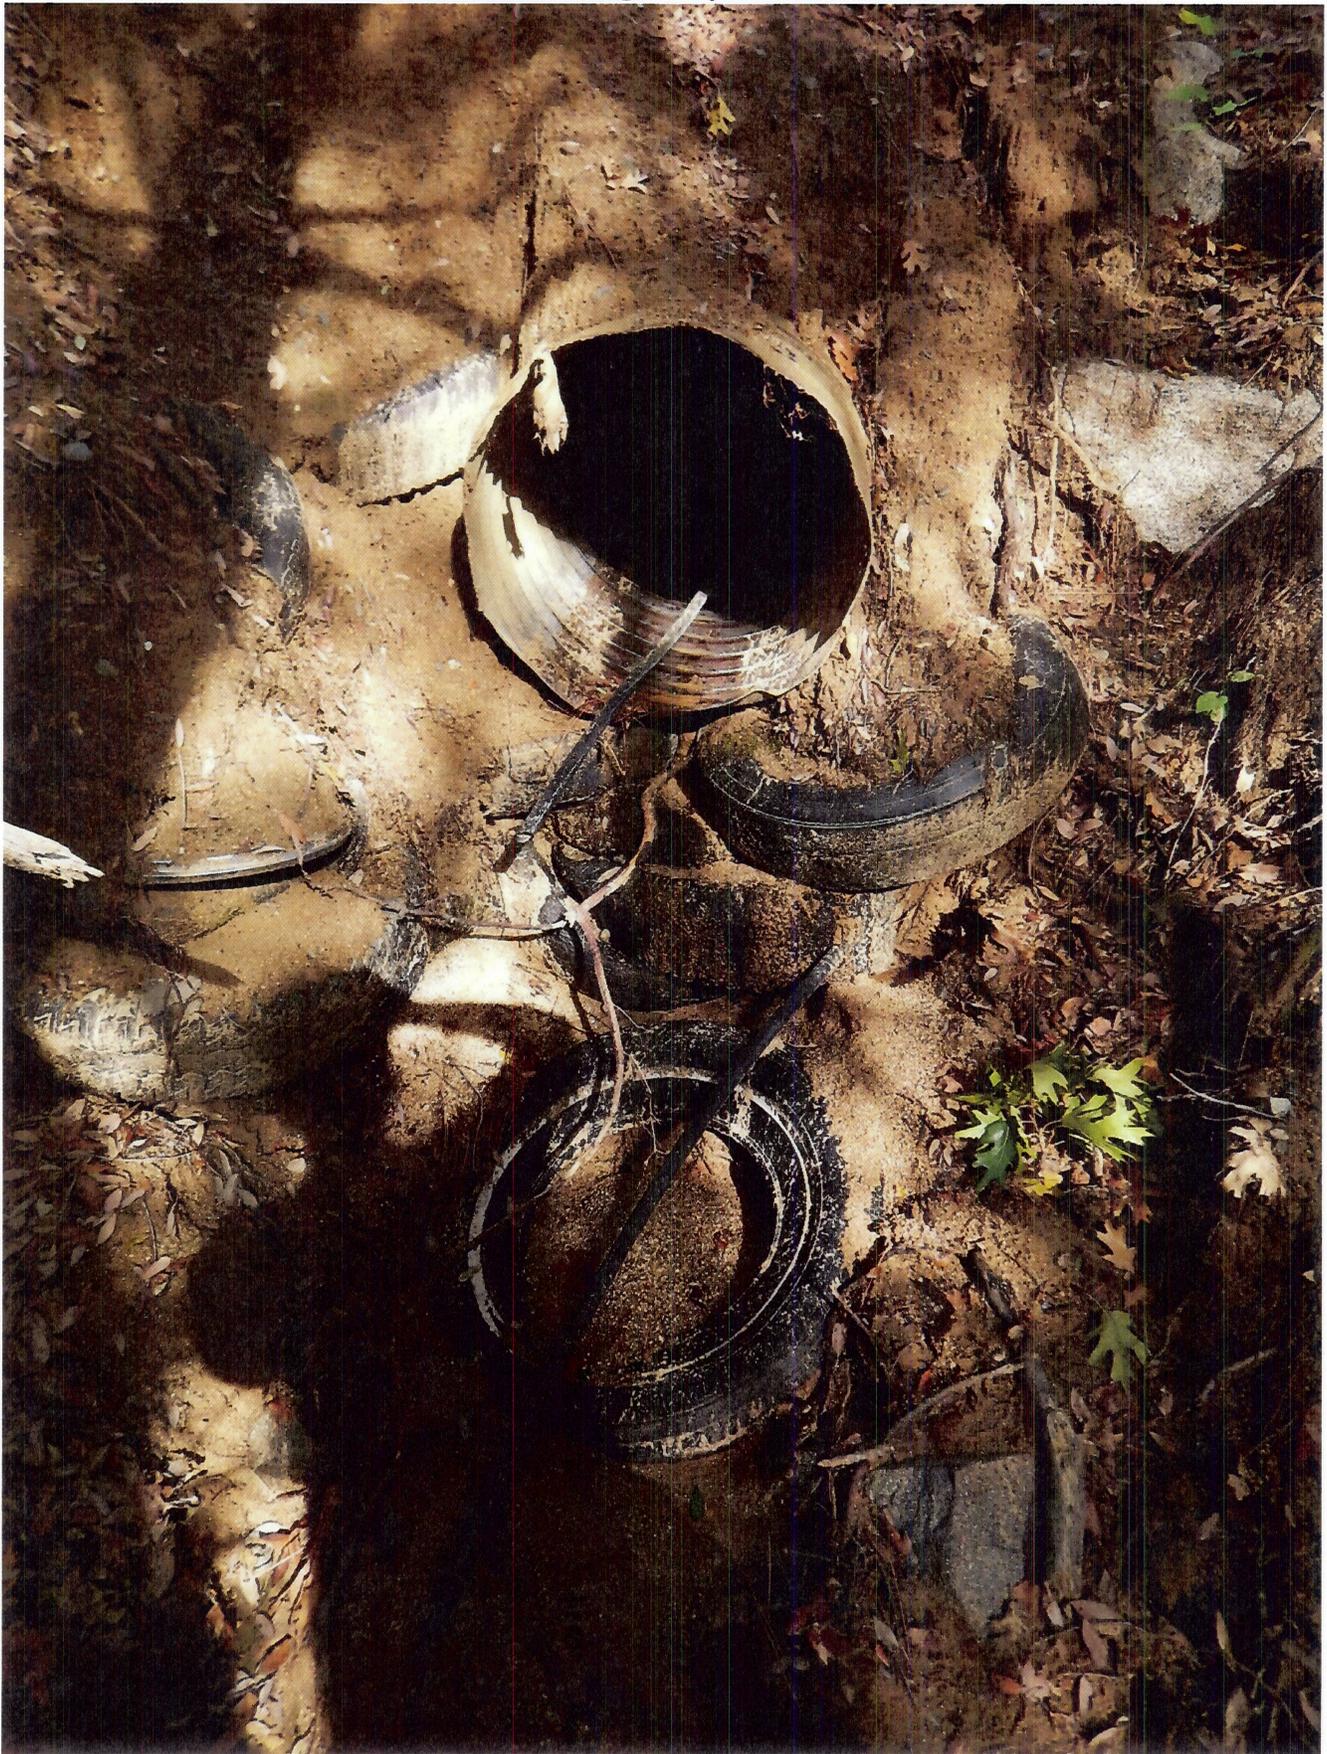
Finally, Staff stopped to inspect a watercourse crossing located at the entrance to the property (Way Point 118). The crossing was composed of a 24" metal culvert with tires and native soil used as fill (Photograph #13). The native soil surfaced road between the lower terrace and the watercourse crossing was in-sloped with no outlets. All storm water runoff from that section of road discharges directly to the watercourse on the upstream side of this watercourse crossing. The culvert was more than 50% plugged and Staff found areas along the banks of this watercourse, where sediment from the road had discharged to the watercourse. Staff found a layer of sediment within the watercourse from the road, 34 inches thick, directly below the storm water discharge of the road. (Photograph #14)

Photograph #13. Way Point 118 – Culverted watercourse crossing with tires and native soil used as fill.
