CLEANUP AND ABATEMENT ORDER NO. R5-2015-0701

Attachment C – 28 October 2014 Baker Ridge Inspection Report

INSPECTION REPORT

28 OCTOBER 2014 BAKER RIDGE INSPECTION REPORT

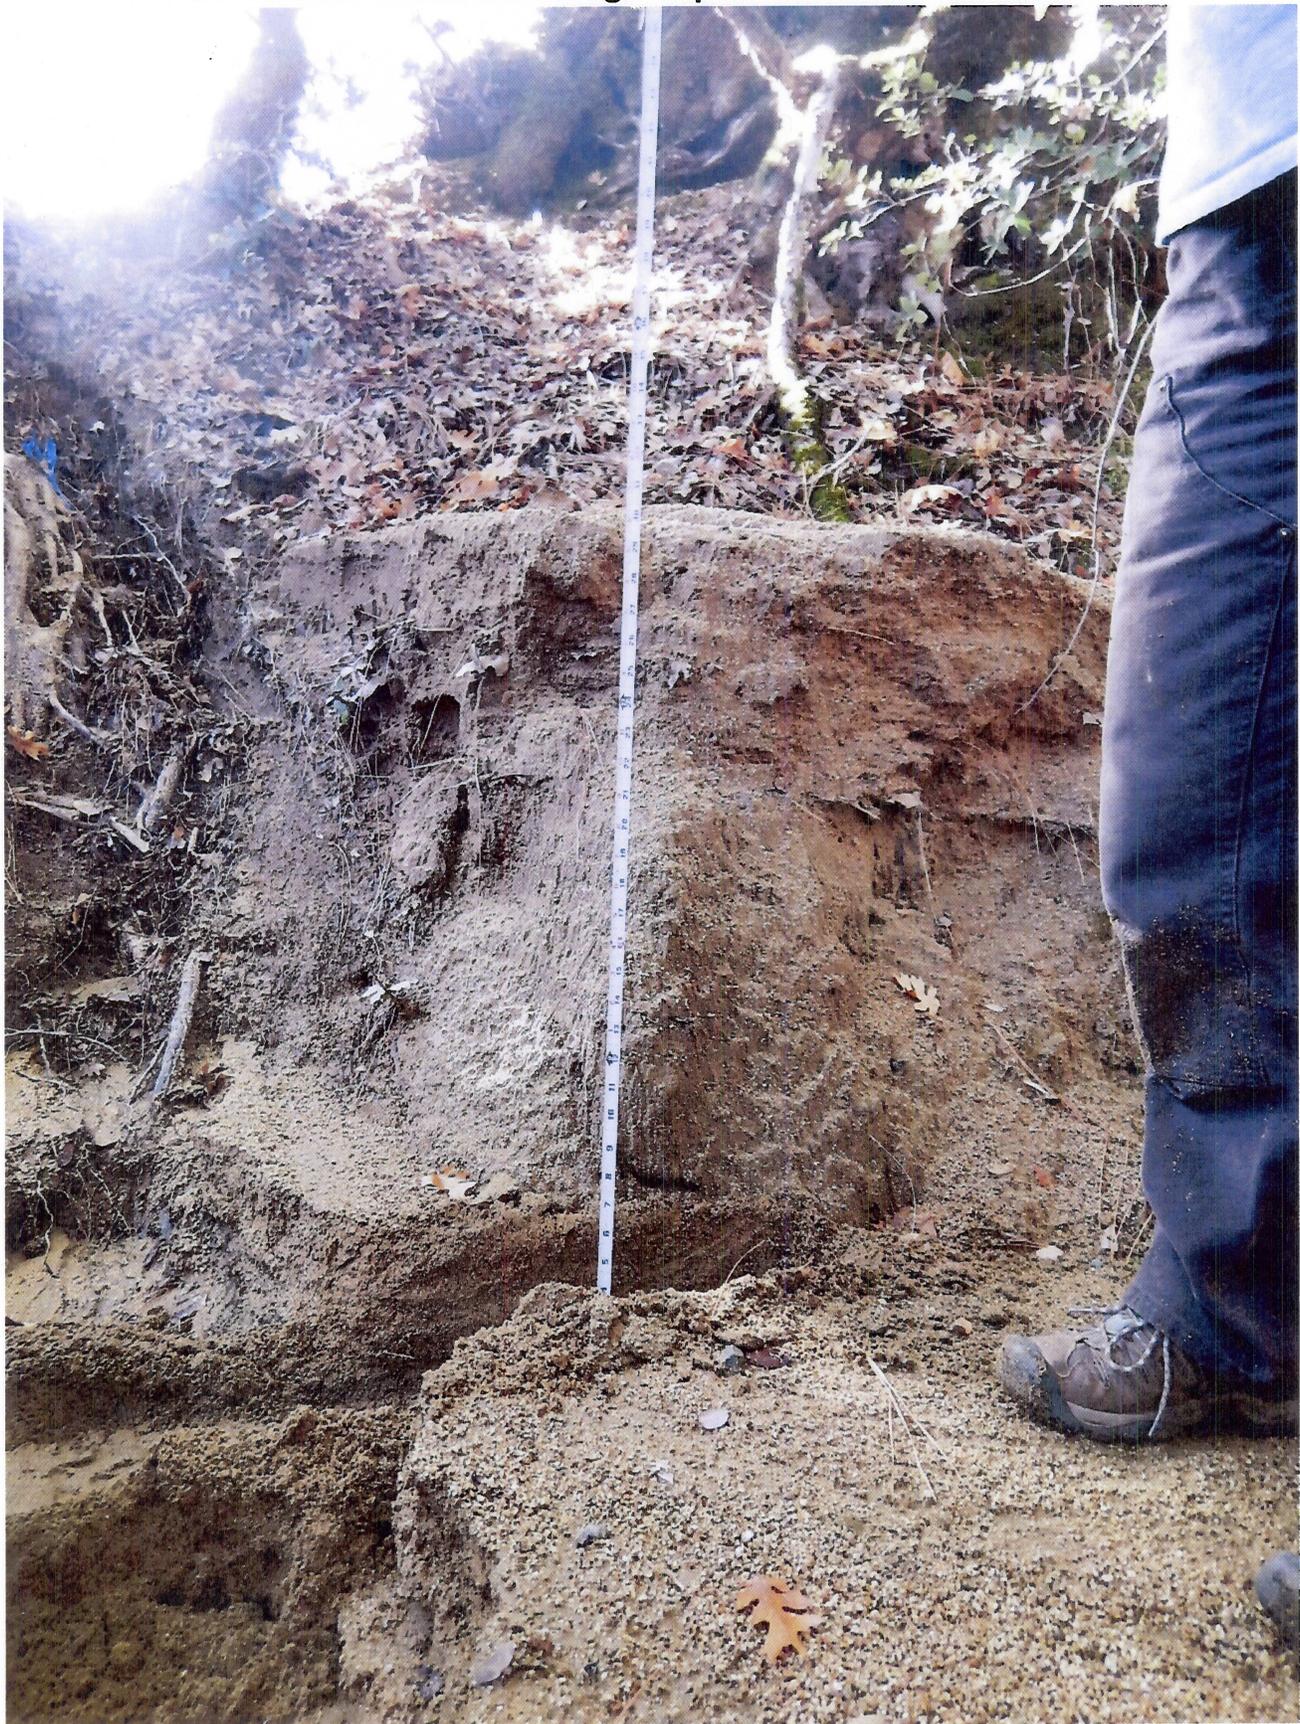
Photograph #14. Way Point 118 – Sediment from road surface stacked as high as 34" along banks of watercourse.
