Nursery Products, LLC.  
12277 Apple Valley Road, Suite 131  
Apple Valley, California 92308

**FINAL CONSTRUCTION  
QUALITY ASSURANCE REPORT  
EAST WASTE PILE COMPOSTING PAD and  
SURFACE IMPOUNDMENT A and B**

**HAWES COMPOSTING FACILITY**

May 2012

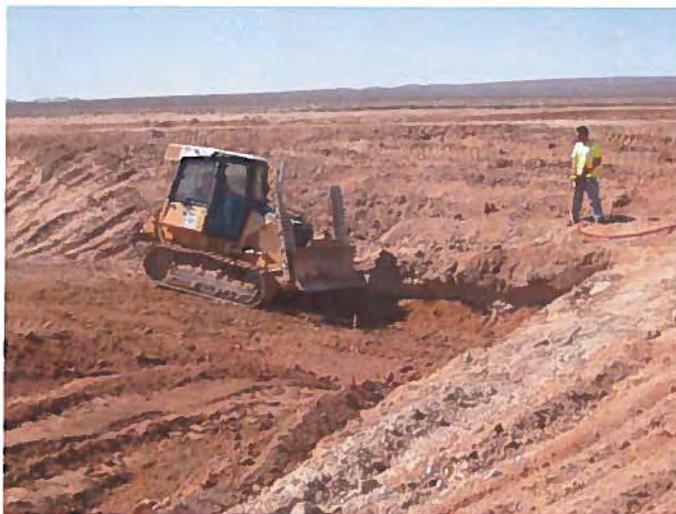
**Replacing and compacting soil in Lysimeter sump in pond B**

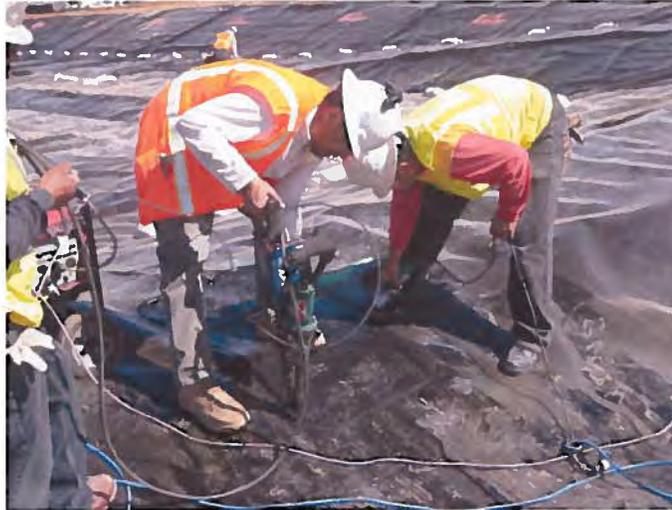
**Extrusion welding repair made to HDPE liner in pond B**

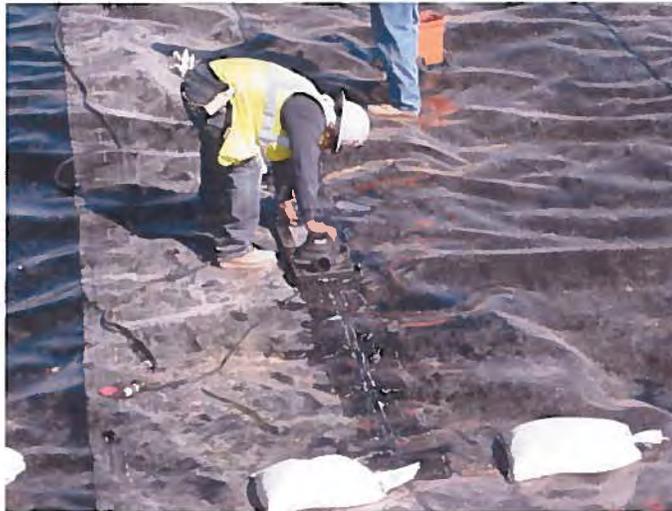
**Vacuum box testing extrusion weld on cap of anchor trench in pond B**

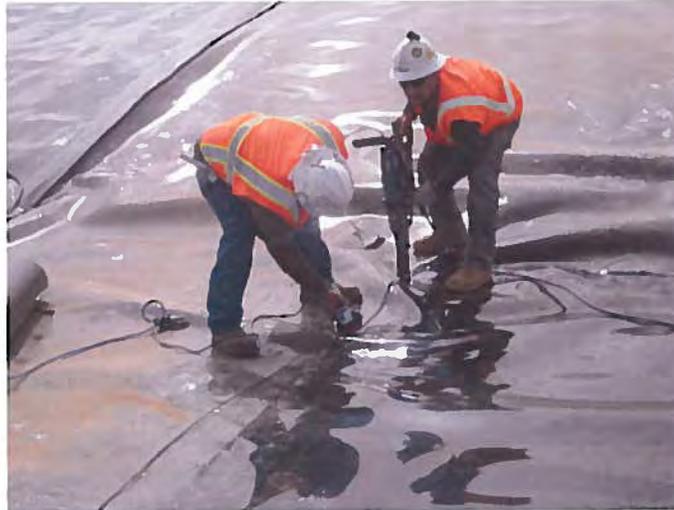
**Extrusion welding repair made to HDPE liner in pond B**

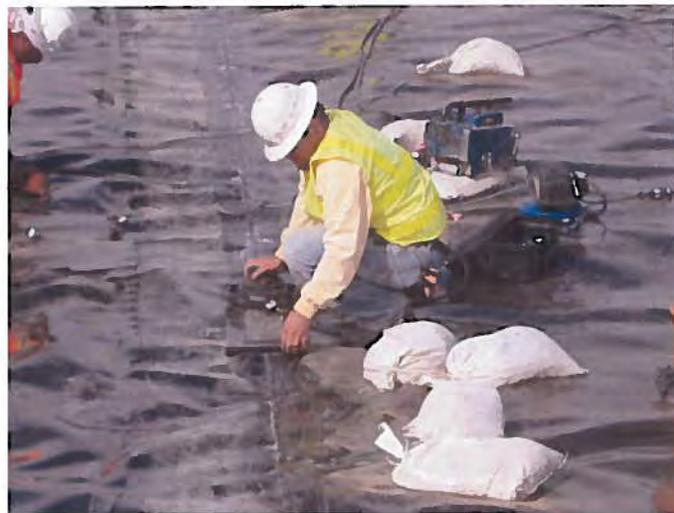
**Vacuum box testing extrusion weld on cap of anchor trench in pond B**

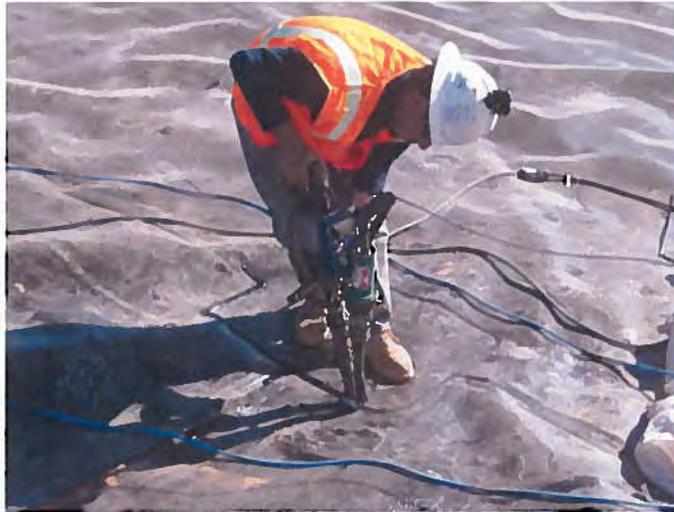
**Extrusion welding repair made to HDPE liner in pond B**

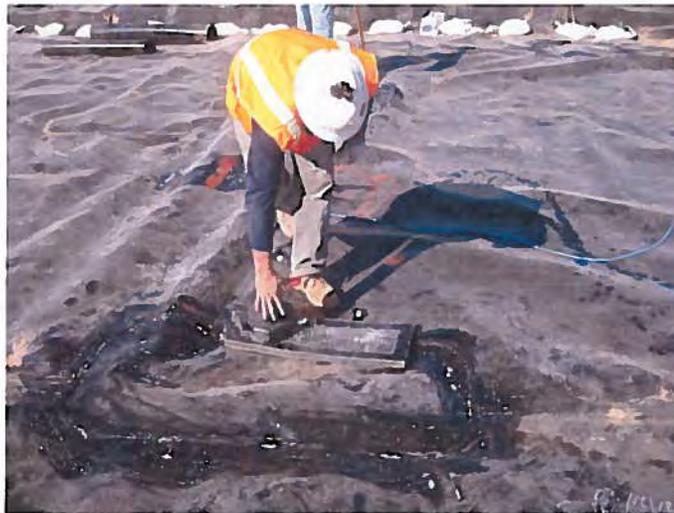
**Vacuum box testing extrusion weld on repair in pond B**

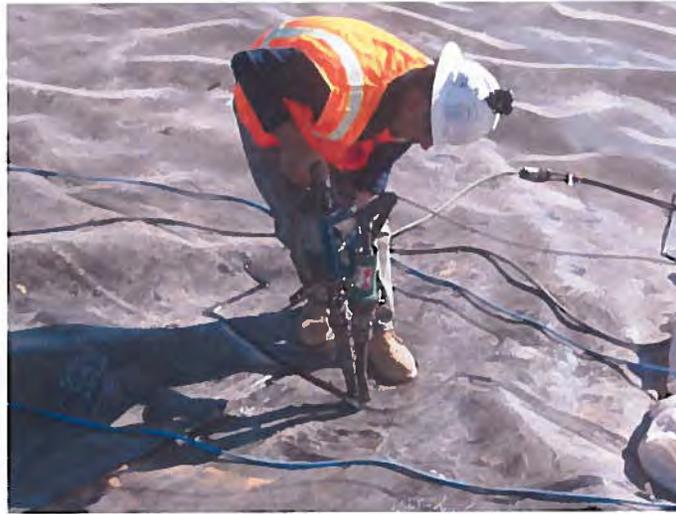
**Extrusion welding repair made to HDPE liner in pond B**

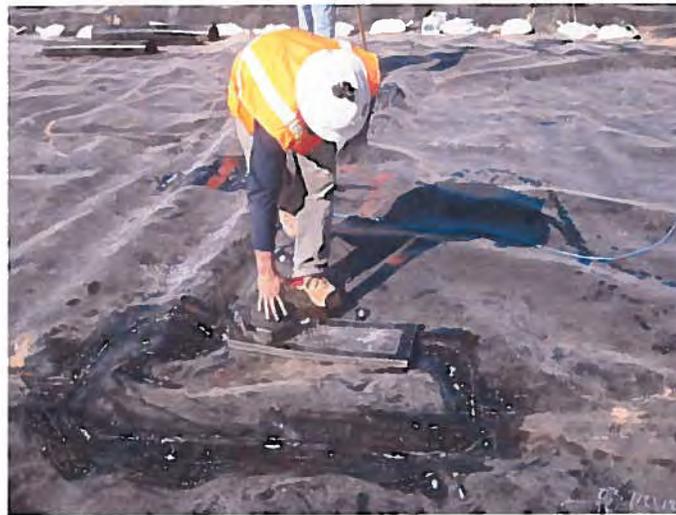
**Vacuum box testing extrusion weld on repair in pond B**

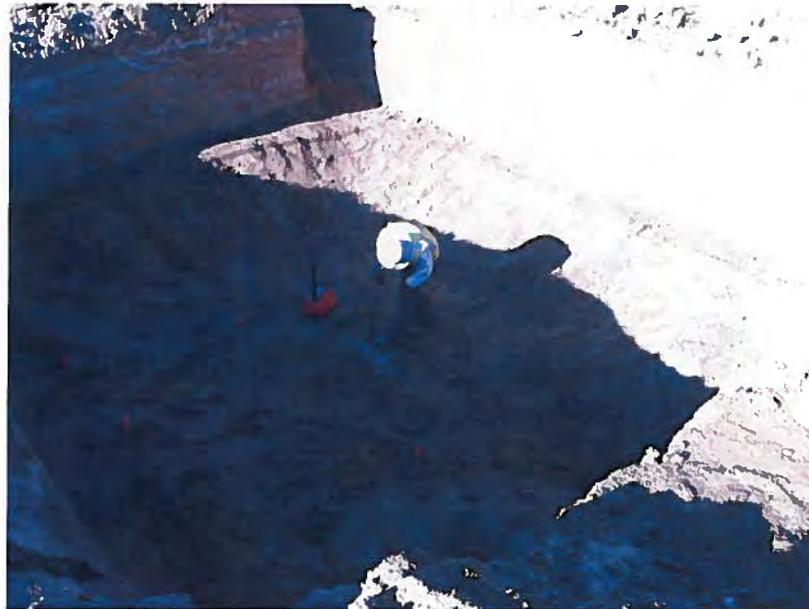
**Lysimeter Excavation subgrade moisture/density test**

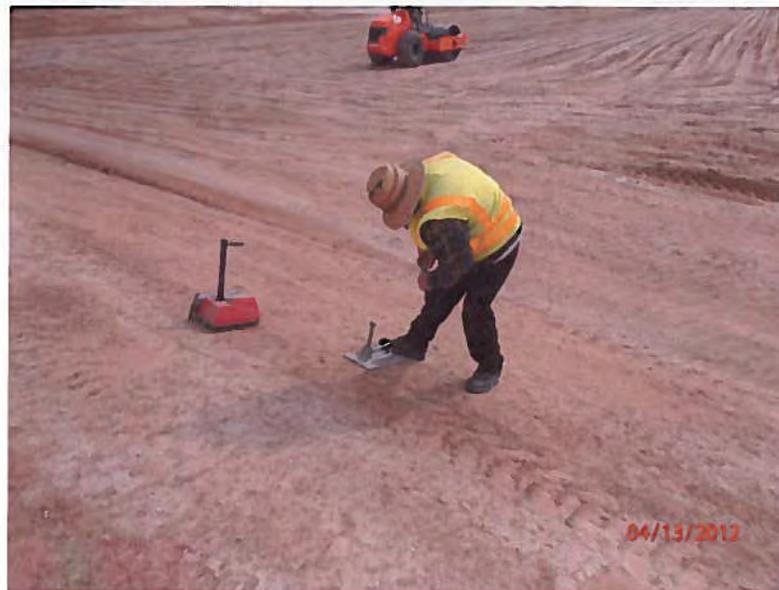
**Pond A Moisture/Density Test Side-slopes**

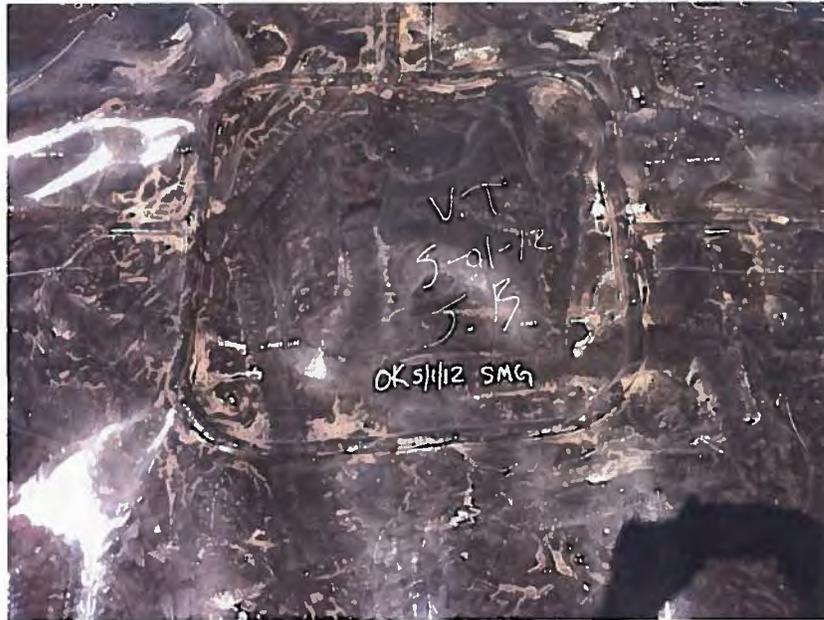
**Pond A Quality Control Documentation Repair**

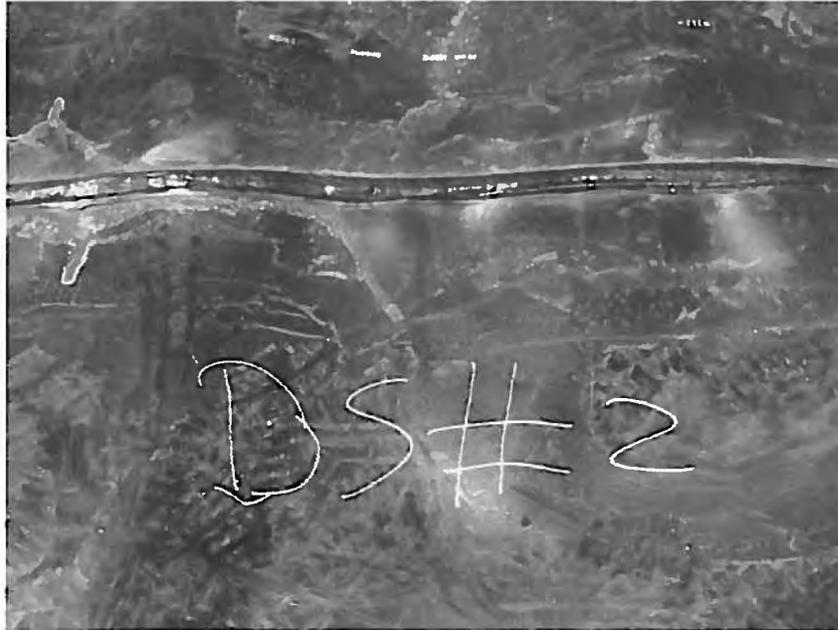
**Pond A HDPE Liner Seam Destruct #2 Location and Repair**
