Lahontan Regional Water Quality Control Board

ADMINISTRATIVE CIVIL LIABILITY COMPLAINT NO. R6T-2012-0010 FOR NORTH TAHOE PUBLIC UTILITY DISTRICT – PLACER COUNTY, WQID NO. 6SSO11110

EXHIBIT - DECEMBER 19, 2010 SEWER SPILL

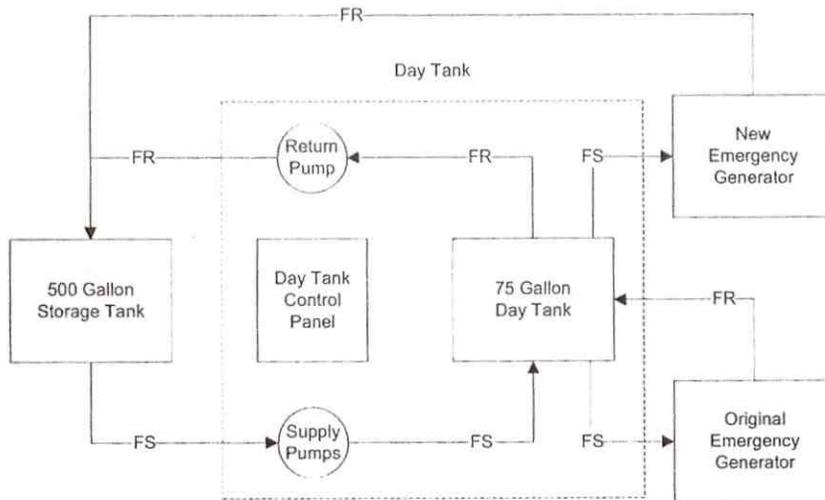
Figure 2: Schematic Diagram of Emergency Generator Fuel System

The terminology used in Figure 2 is: FS refers to fuel supply piping and FR refers to fuel return piping.

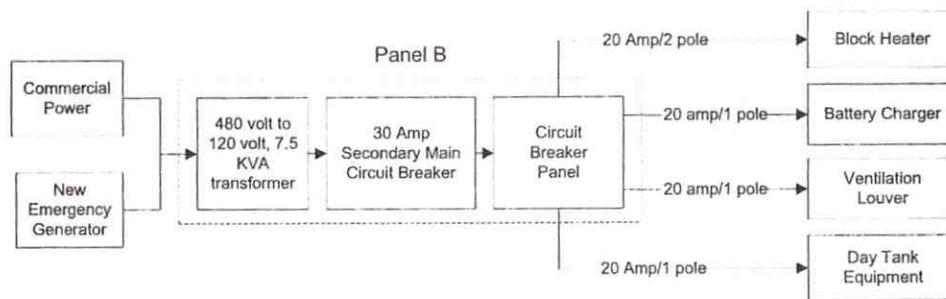
Figure 3: Schematic Diagram of “As Constructed” Generator Fuel System Electrical Supply

The power to the new emergency generator support systems (block heater, battery charger, ventilation louvers, and fuel system day tank equipment) is provided through Panel B (see Appendix D for electrical drawings), which consists of a transformer and a circuit breaker panel combined into one unit. The electrical supply to the new emergency generator support systems is shown on Figure 3 in the “as constructed” configuration that existed on December 19, 2010. In this configuration, the circuit breaker panel capacity is 30 amps and a single 20 amp circuit provides electric power to the fuel system day tank equipment

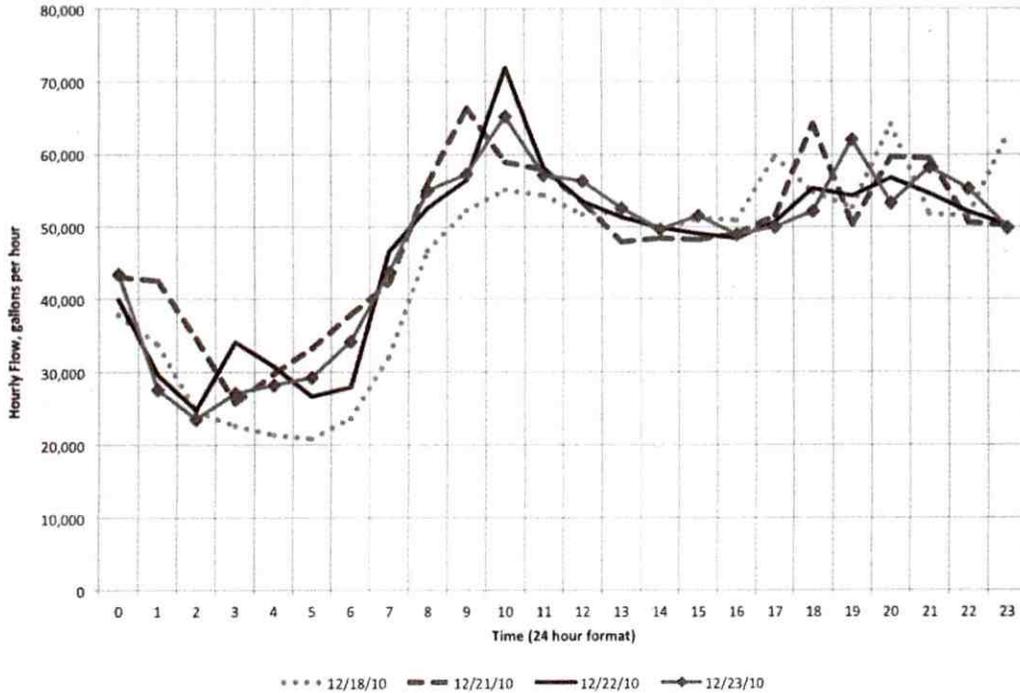
Figure 4: Dollar PS Hourly Flowrate for December 18 and 21-23, 2010

The hourly flows from the NTPUD SCADA for December 18-23, 2010 are shown on Figure 4. The SCADA system failed after the December 19 spill event had ended due to damage sustained as the result of voltage fluctuations associated with the commercial power failures that occurred on the evening of December 19. SCADA operation was restored by mid-day on December 20.

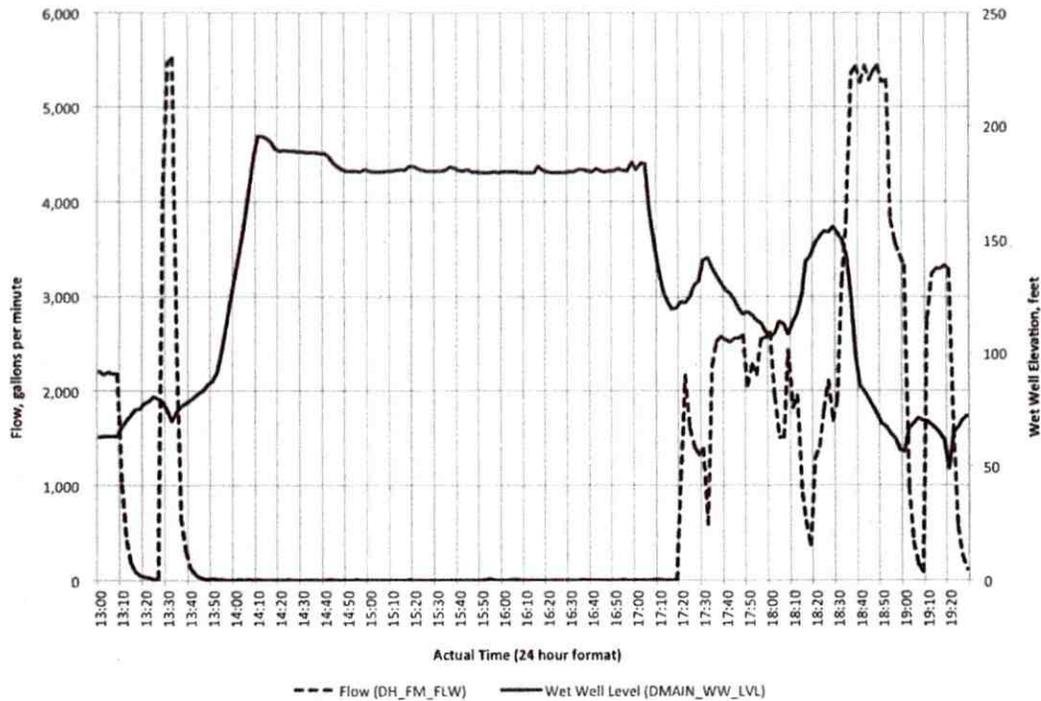
Figure 5: Dollar Hill Flow Meter and Dollar Hill PS Wet Well Level Data for December 19, 2010 (13:00 to 19:30)

19:28	SCADA data ends due to voltage surge associated with ongoing commercial power outages
Note: The time shown has been corrected because the SCADA clock is six minutes fast.

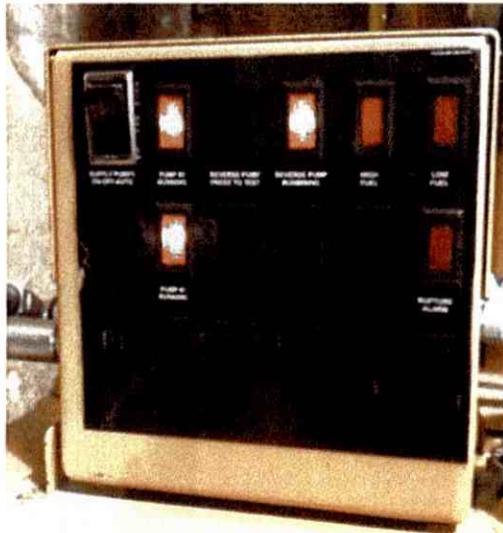
Figure 6: Day Tank Control Panel in Manual Mode with Three Fuel Pumps Operating

- Additional electrical loads were added to the fuel system day tank equipment feed circuit in order to evaluate the operation of the original circuit breakers.
 - The 20 amp breaker tripped after five minutes at 26.1 amps. This performance was within the design time-current envelop for this circuit breaker.
- No problems were observed during the internal inspection of the fuel system day tank.

It is apparent from the testing that Stantec's design underestimated the electrical loads associated with the emergency generator support systems: the electrical load on Phase B at 30 amp secondary main breaker was 27.5 amps and the electrical load at the 20 amp fuel system day tank equipment circuit breaker was 20.1 amps. It is the opinion of the authors that proper design of circuits supporting critical equipment such as the emergency generator support systems would be to provide a circuit with 20% greater current capacity than the total connected load. In this case, installing a 30 amp circuit breaker panel to feed the emergency generator support systems did not meet the design standard of care for this critical equipment. In addition, providing a 20 amp circuit to feed the fuel system day tank equipment did not meet the design standard of care for this critical equipment.

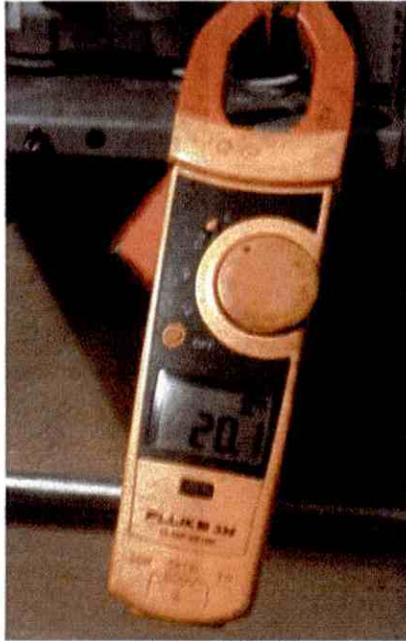
Figure 7: Fuel System Day Tank Equipment Current (amps) with Three Fuel Pumps Operating

While the testing that was conducted on February 17, 2010 was not able to demonstrate the tripping of the circuit breakers that caused the loss of power to the generator fuel system, it was conducted under stable commercial power conditions. Voltage conditions which may have existed in June 2010 and definitely existed on December 19, 2010 (based on NTPUD staff observations) reasonably explain the intermittent tripping of the two marginally sized circuit breakers (the secondary main circuit breaker feeding Panel B and the circuit breaker feeding the fuel system day tank equipment).
