Lahontan Regional Water Quality Control Board

WITHDRAWAL OF SETTLEMENT OFFER R6T-2016-0047 FOR SIERRA BOAT COMPANY MARINA, CARNELIAN BAY, PLACER COUNTY

COMPLIANCE INSPECTION REPORT

FACILITY NAME: Sierra Boat Company

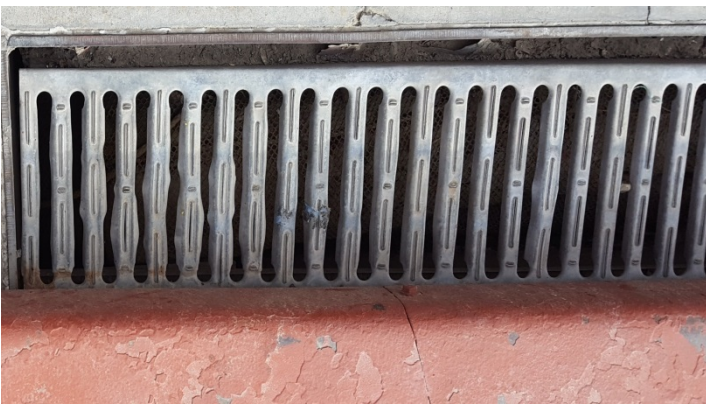
The pre-treatment vault located at Hydrographic Area B was inspected and several concerns were expressed to Sierra Boat staff. Anthony stated that the Facility's vault is serviced by a vacuum truck regularly. Boat washing was actively taking place. With an incoming forecasted storm, Water Board staff expressed concerns regarding the oily sheen and dirty water in the post-treatment compartment, which is directly connected to the outlet pipe draining to surface waters of Lake Tahoe. Anthony began to vacuum out the dirty water from the post-treatment compartment, revealing multiple feet of sludge at the bottom. The trench drain that conveys stormwater to Hydrographic Area B appeared to contain excessive debris.

Photo No. 1 Sierra Boat Company: Hydrographic Area B, accumulated sediment and dirt in trench drain that leads directly to pre-treatment vault.

Sediment and dust accumulation observed at Hydrographic Area B. Vegetation observed at Hydrographic Area A. Please see Photos No. 1 and 2.

- 1) Please provide oil water separator manufacturer’s pumping recommendation with regards to sludge depth and frequency with which sludge depth is tested. Provide documentation of oil water separator maintenance by **December 9, 2016**.
- 2) Provide documentation of corrective action taken to resolve violations listed above by **December 9, 2016**.

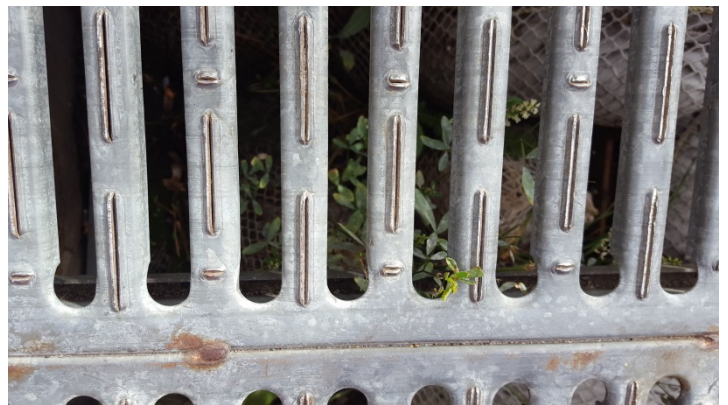
The stormwater inlet in Hydrographic Area A had vegetation growing in it that exceeded six inches in height. This is a clear indication that the inlet is not regularly maintained.

Photo No. 2 Sierra Boat Company: Hydrographic Area A, weeds growing out of stormwater inlet.

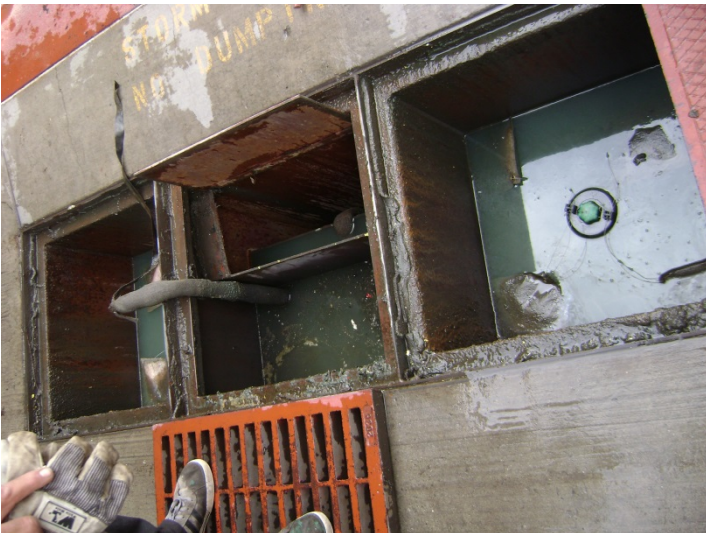
Photo No. 3 Sierra Boat Company: Hydrographic Area B, pre-treatment vault filled with water from boat washing activities.

Pre-treatment vault at Hydrographic Area B showed collection of wash water that comingles with stormwater. Please see Photos No. 3 and 4.

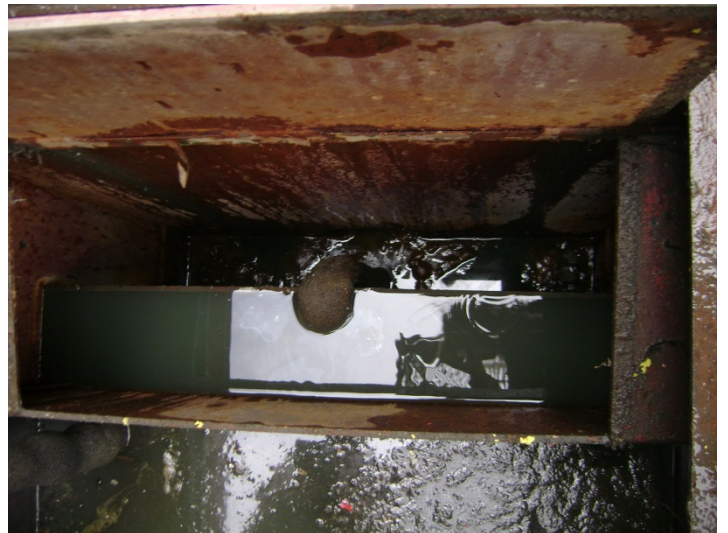
Photo No. 4 Sierra Boat Company: Hydrographic Area B, pre-treatment vault with sludge adjacent to the outlet to surface waters.
