**Los Angeles Regional Water Quality Control Board**

**INSPECTION REPORT**

**DATE OF INSPECTION:** October 17, 2016

APNs 2821-002-023; 2821-009-030; 2821-002-024; 2821-002-025; 2821-009-029; 2821-009-031; 2821-009-023

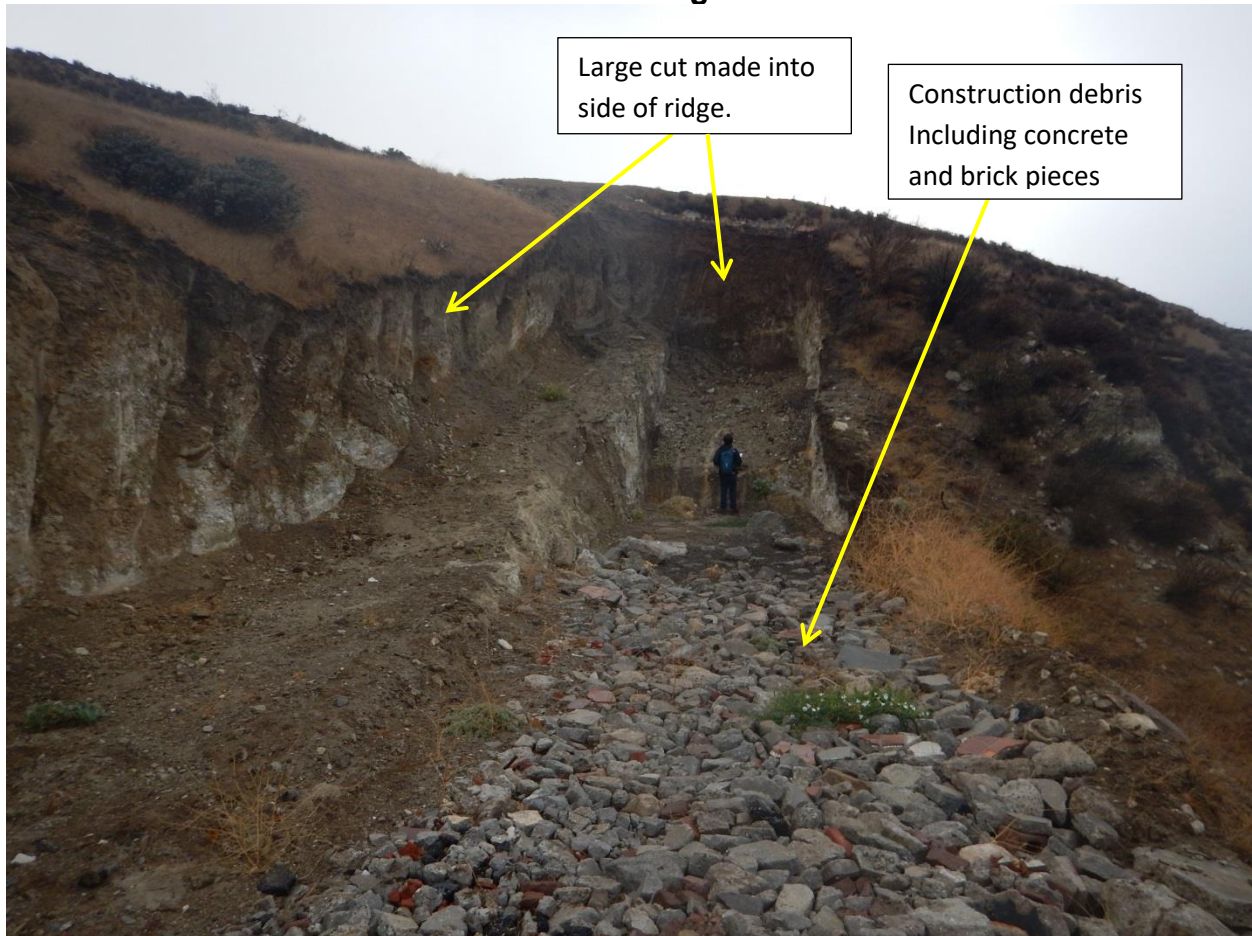
- **Grading activity on the ridge on the western side of the parcel** - Construction debris consisting of broken pieces of concrete and bricks were observed in a cut graded into a ridge along the west portion of the parcel. There were no erosion and/or sediment control Best Management Practices (BMPs) in place to prevent the sides of the cut from eroding and releasing sediment into Devil's Creek during a rain event (Photo 1). This cut was a recent development as it was not noted in the September 2015 inspection report.

**Photo 1.** This photo shows a cut made into the side of a ridge. Concrete and brick debris has been deposited in the cut. The sides of the cut have exposed, unstabilized sediment at risk of eroding. This photo was taken in Parcel 2821-002-025, at latitude and longitude 34 18.653, -118 37.263.

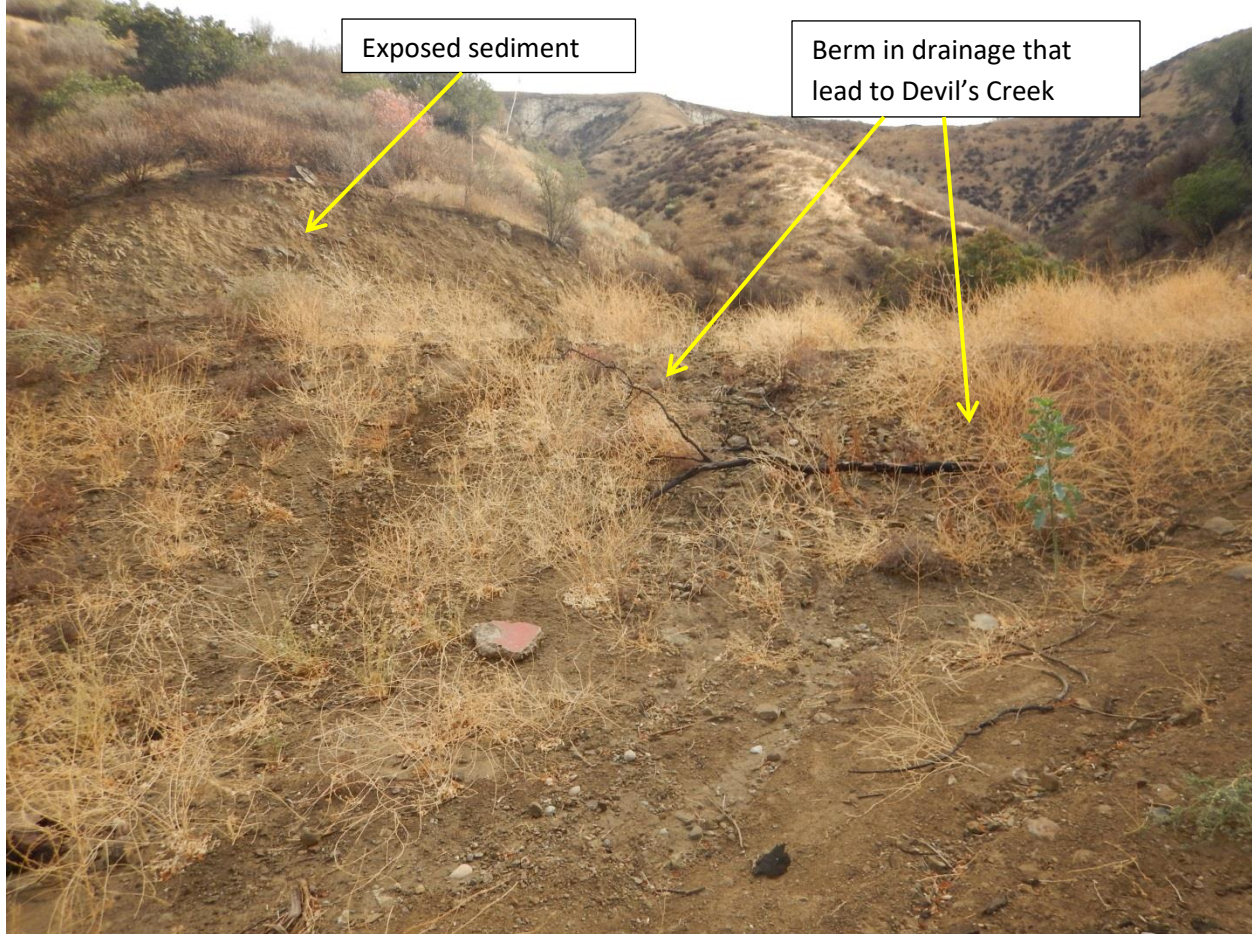
**Photo 2.** This photo shows a berm in a drainage that leads to Devil's Creek. This photo was taken in Parcel 2821-002-025 at latitude and longitude of 34 18.729, -118 37.356.

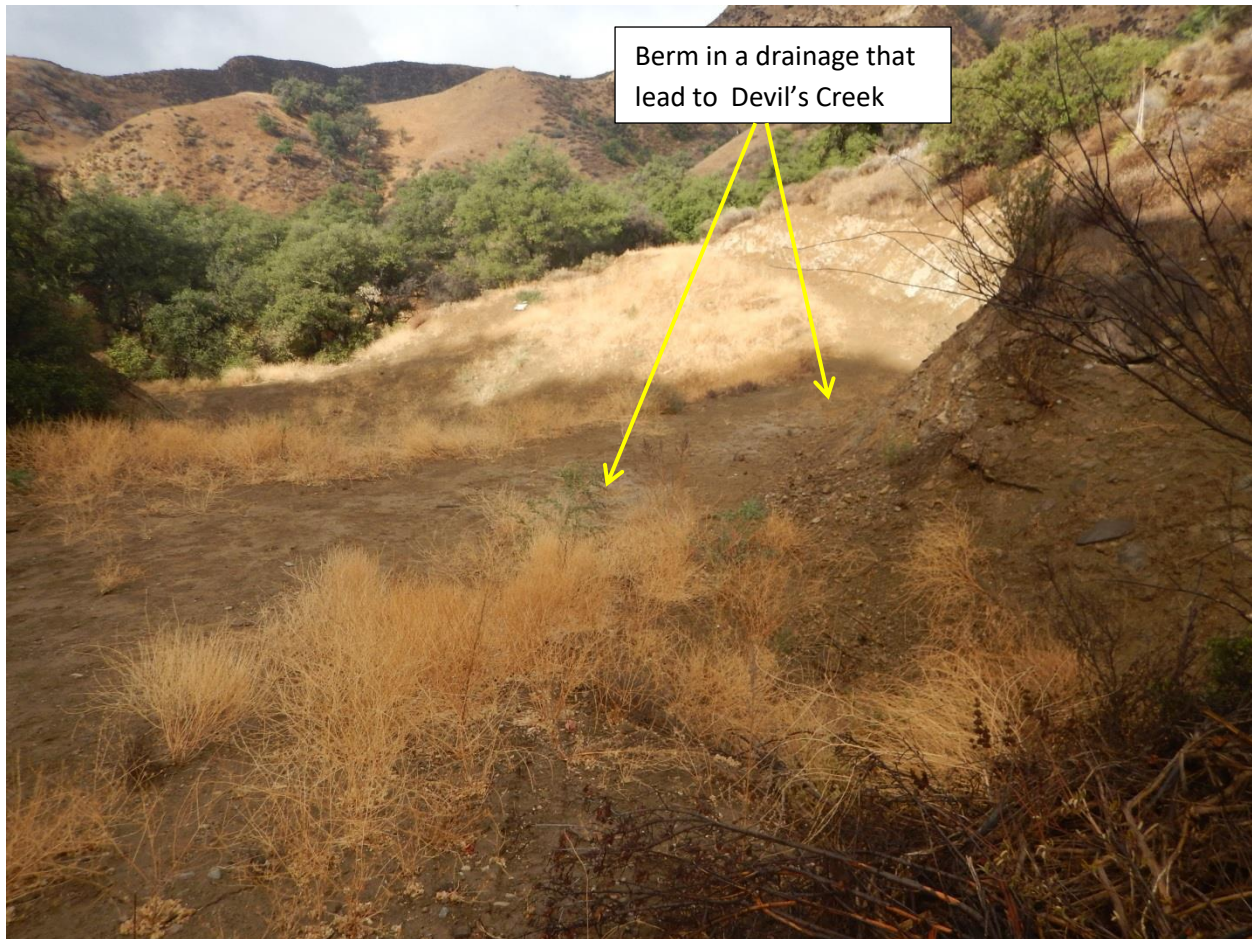
**Photo 3.** This photo shows another view of the berm in drainage that lead to Devil's Creek that was also shown in Photo 2. This photo was taken in Parcel 2821-002-025 at latitude: 34 18.729 and longitude: -118 37.367.

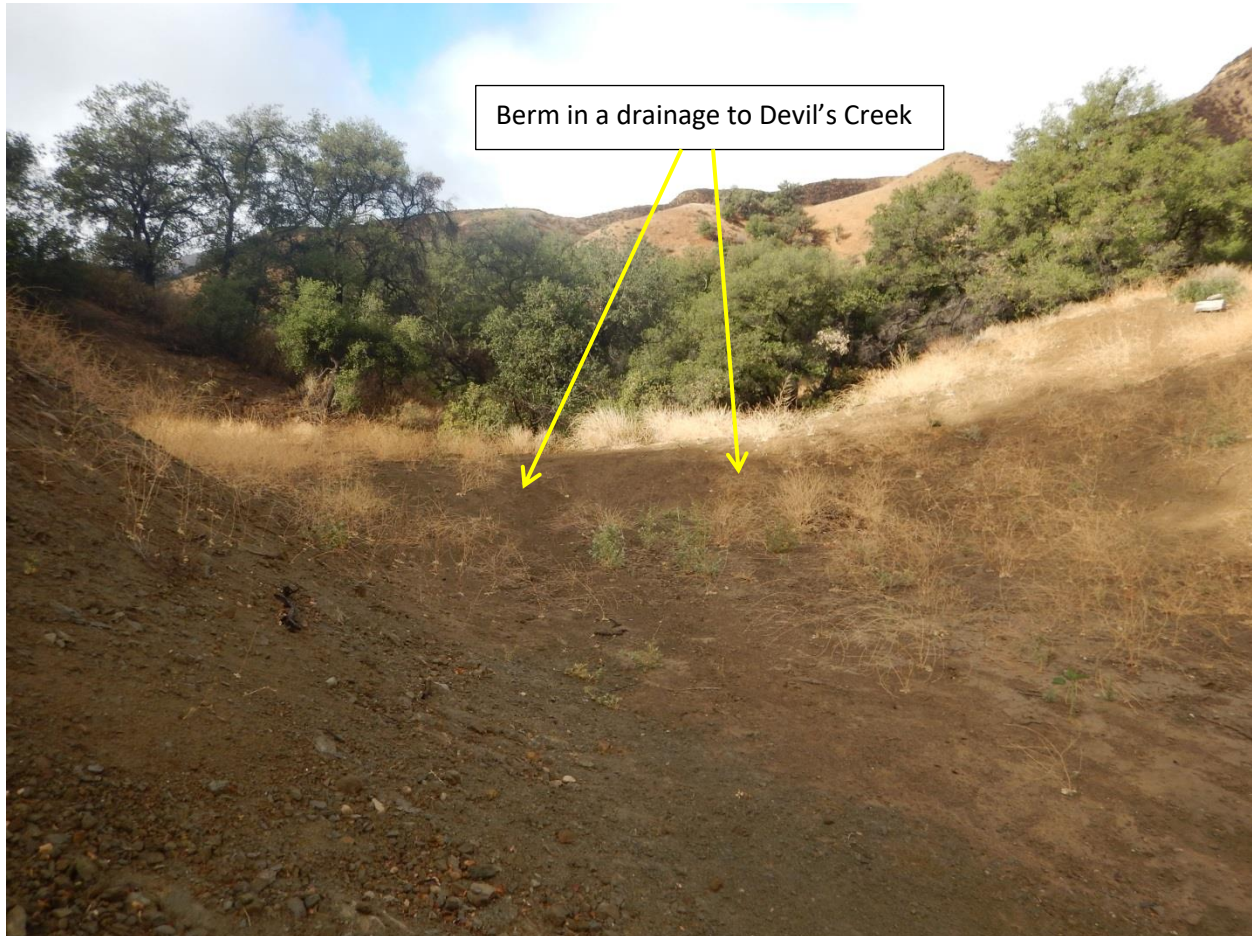
**Photo 4.** This photo shows a berm in a drainage that lead to Devil's Creek and is the same as shown in Photos 2 and 3. This photo was taken in Parcel 2821-002-025, latitude: 34 18.717 and longitude: -118 37.365.

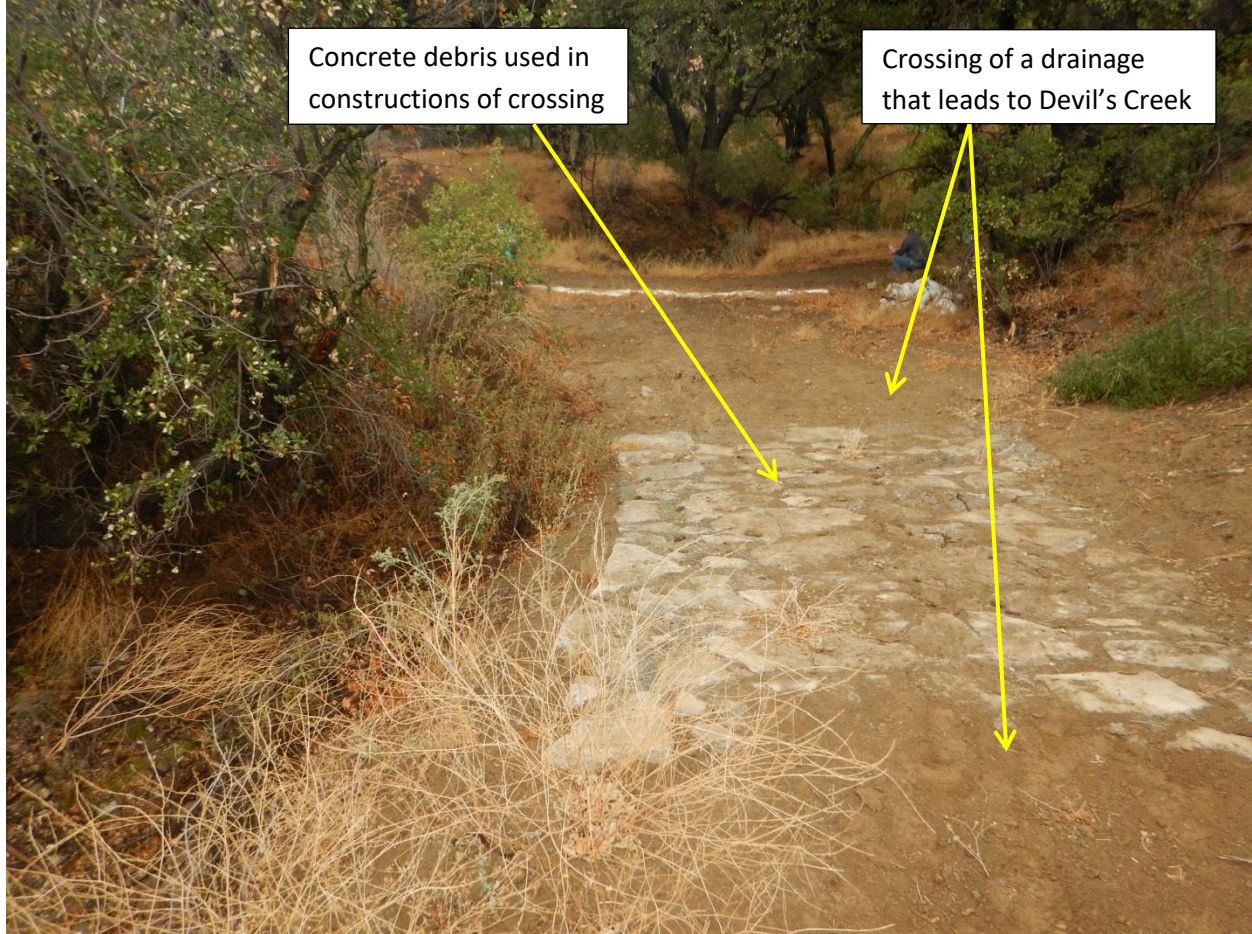
**Photo 5.** This photo shows a suspected crossing of drainage of Devil's Creek made of concrete debris. Ultimately, the stream on the left side of the photo discharges to Devil's Creek on the other side of the trail at the top of the photo. This tributary is the same tributary shown in Photos 2, 3, and 4. This photo was taken on Parcel 2821-002-025 at latitude: 34 18.714 and longitude: -118 37.393.

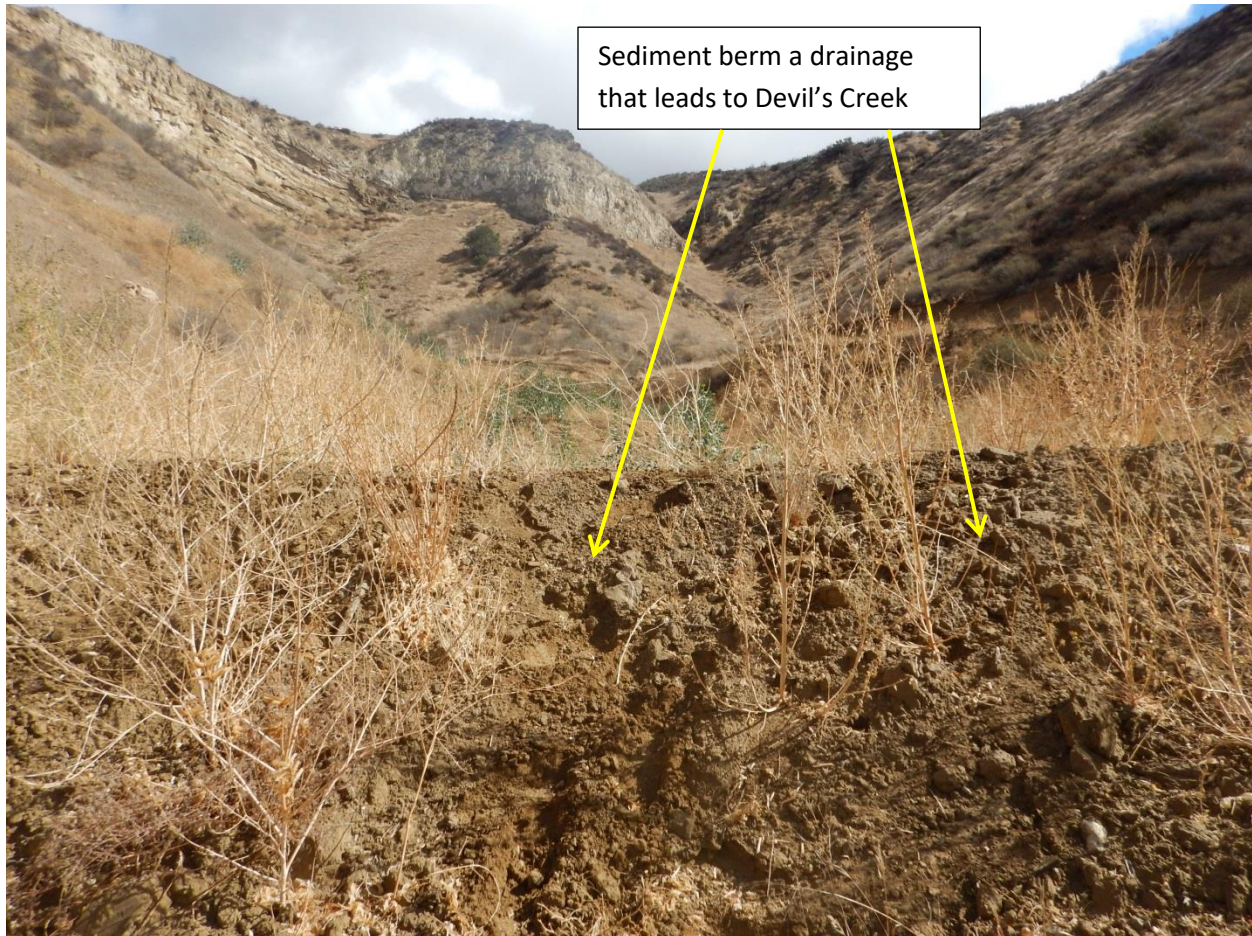
**Photo 6.** This photo shows a sediment berm in a drainage to Devil's Creek. This photo was taken on Parcel 2821-002-025 at latitude: 34 18.586 and longitude:-118 37.344.

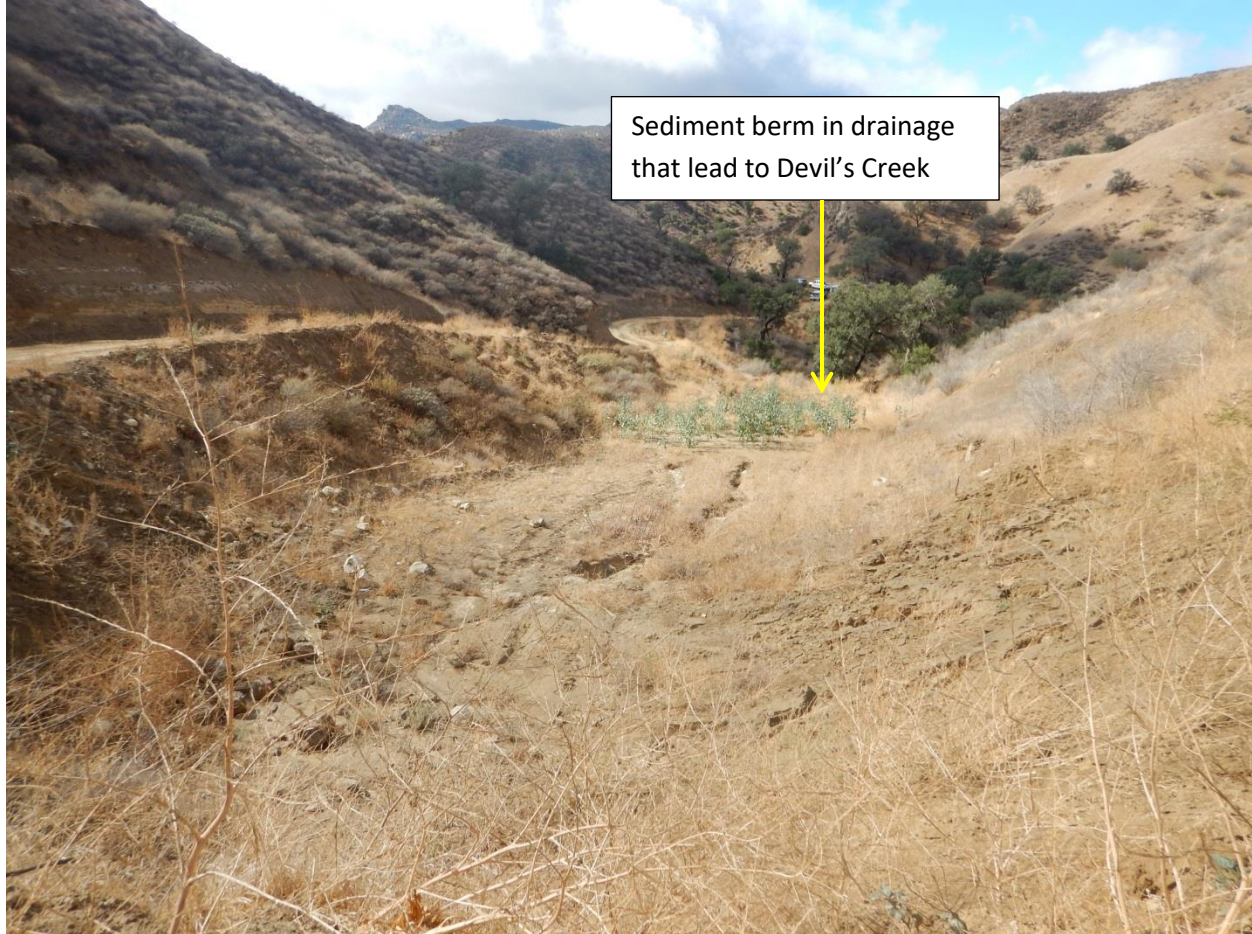
**Photo 7.** This photo shows a drainage that leads to Devil's Creek. This is another view of the sediment berm from Photo 6. This photo was taken on Parcel 2821-002-025, at latitude: 34 18.603 and longitude:-118 37.304.

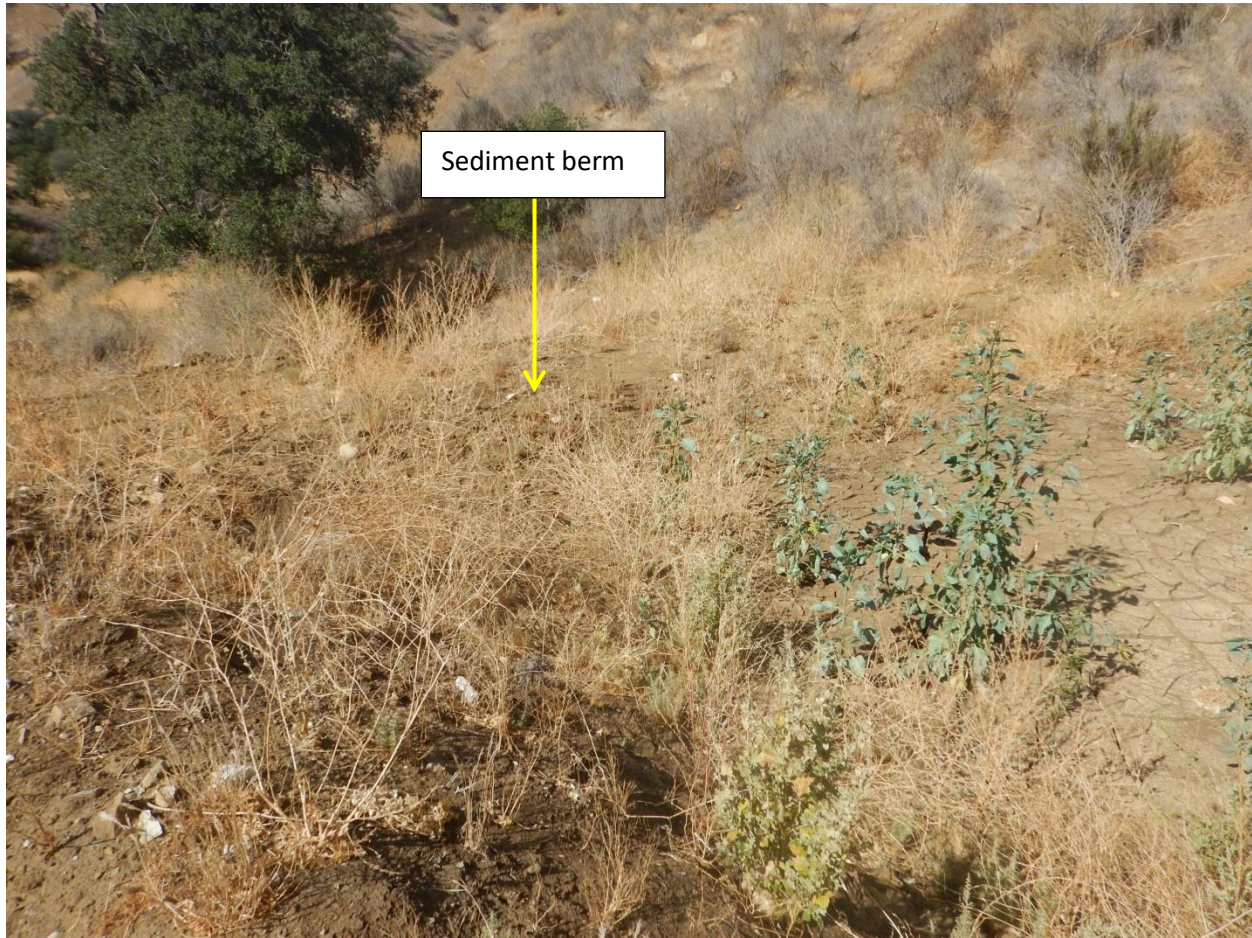
**Photo 8.** Showing another sediment berm in a drainage that leads to Devil's Creek. This photo was taken on Parcel 2821-002-025 at latitude: 34 18.583 and longitude: -118 37.344.

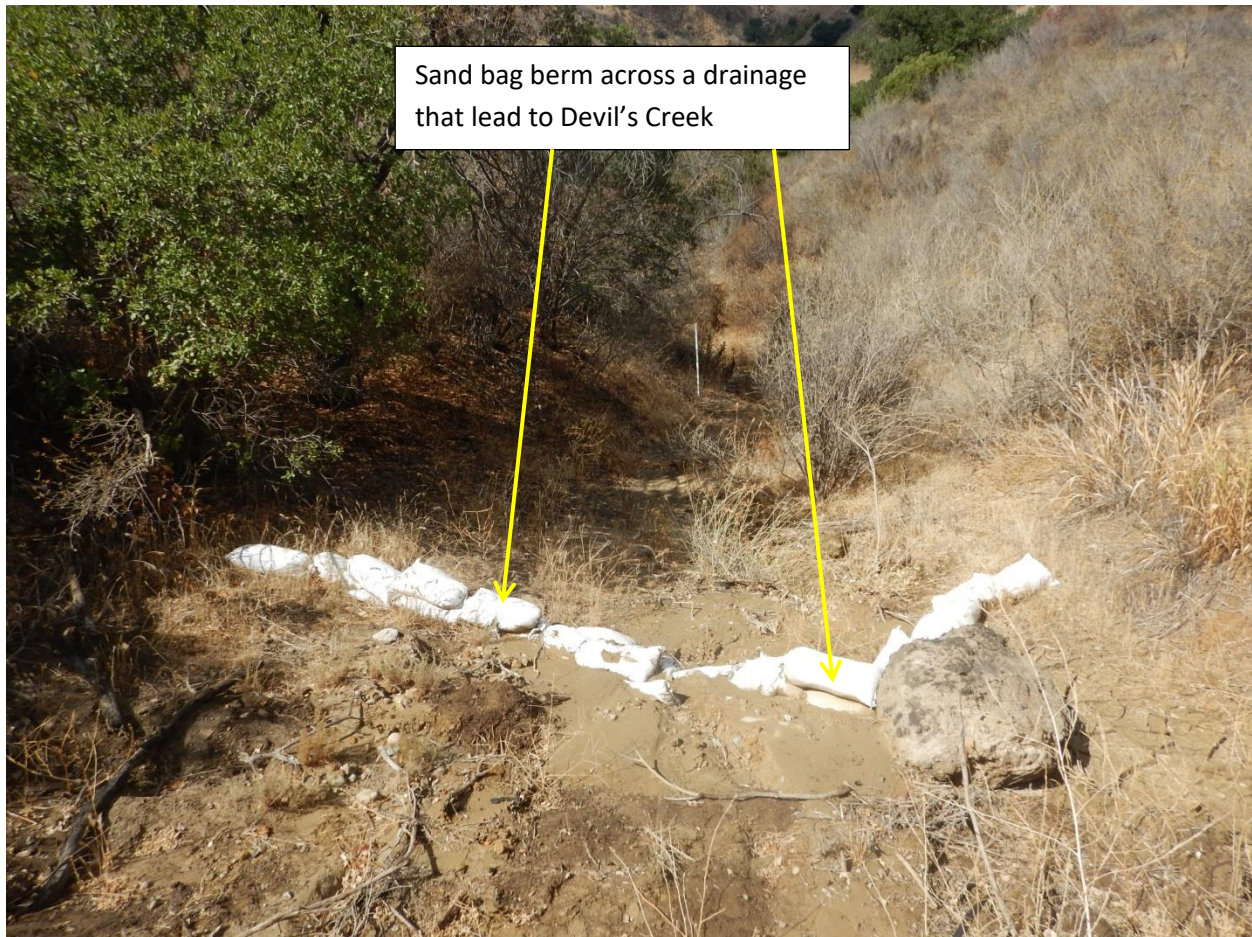
- **Sand bag berm** – A berm constructed across the unnamed tributary with sand bags was observed in the same area where the soil berms referenced above and in Photos 6, 7, 8 were found (Photos 9 and 10). This sand bag berm was a recent disturbance as it was not noted in the in the September 2015 inspection report.

**Photo 9.** This photo shows a sand bag berm located in drainage that leads to Devil's Creek. This photo was taken on parcel 2821-002-025, at latitude: 34 18.568 and longitude: -118 37.358. This area lacked erosion control best management practices, and there was loose sediment accumulated behind the berm.

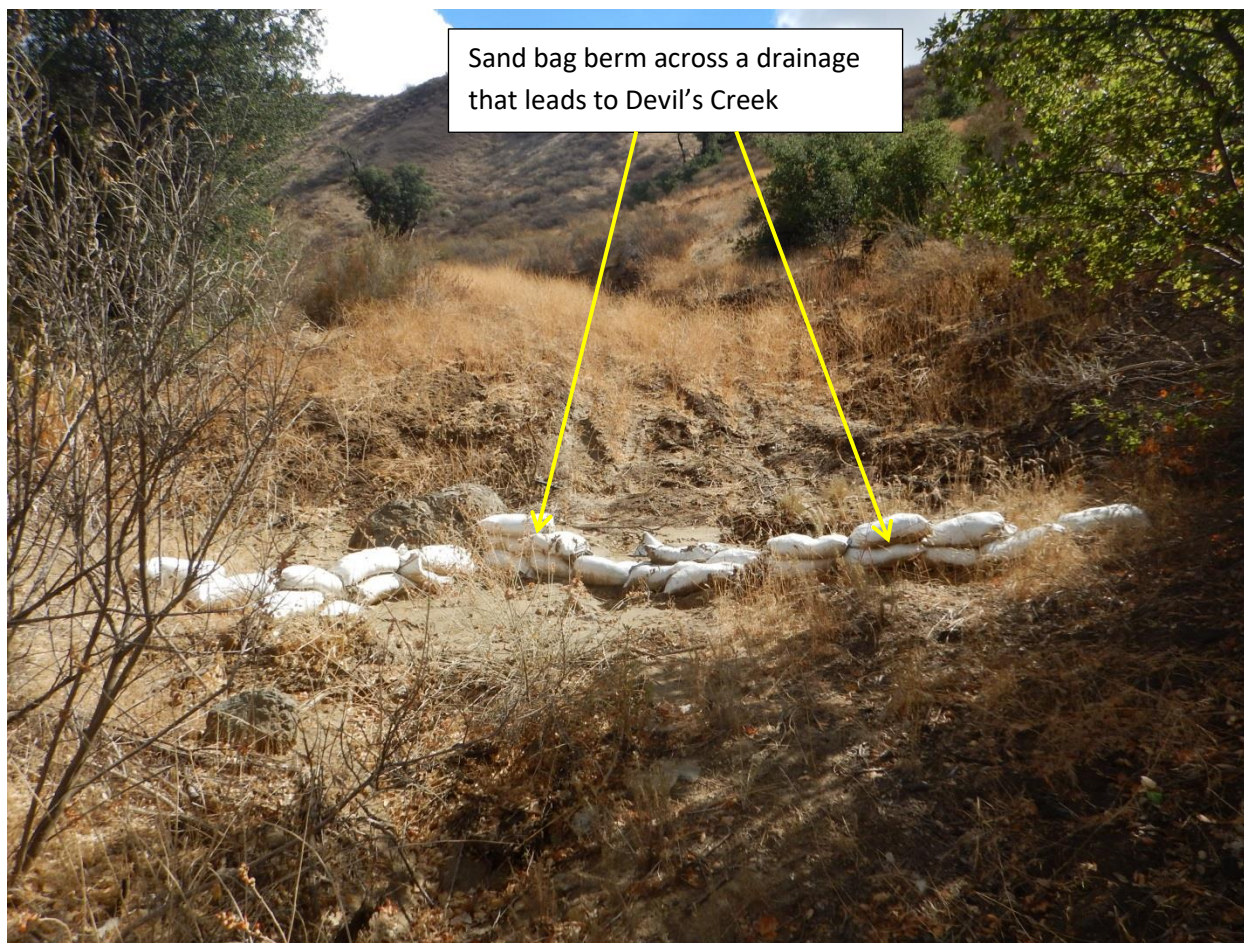
**Photo 10.** This photo shows another view of the sand bag berm located in a drainage that leads to of Devil's Creek. The sand bag berm shown is the same sand bag berm shown in Photo 8. This photo was taken on Parcel 2821-002-025, at latitude: 34 18.568 and longitude: -118 37.418.

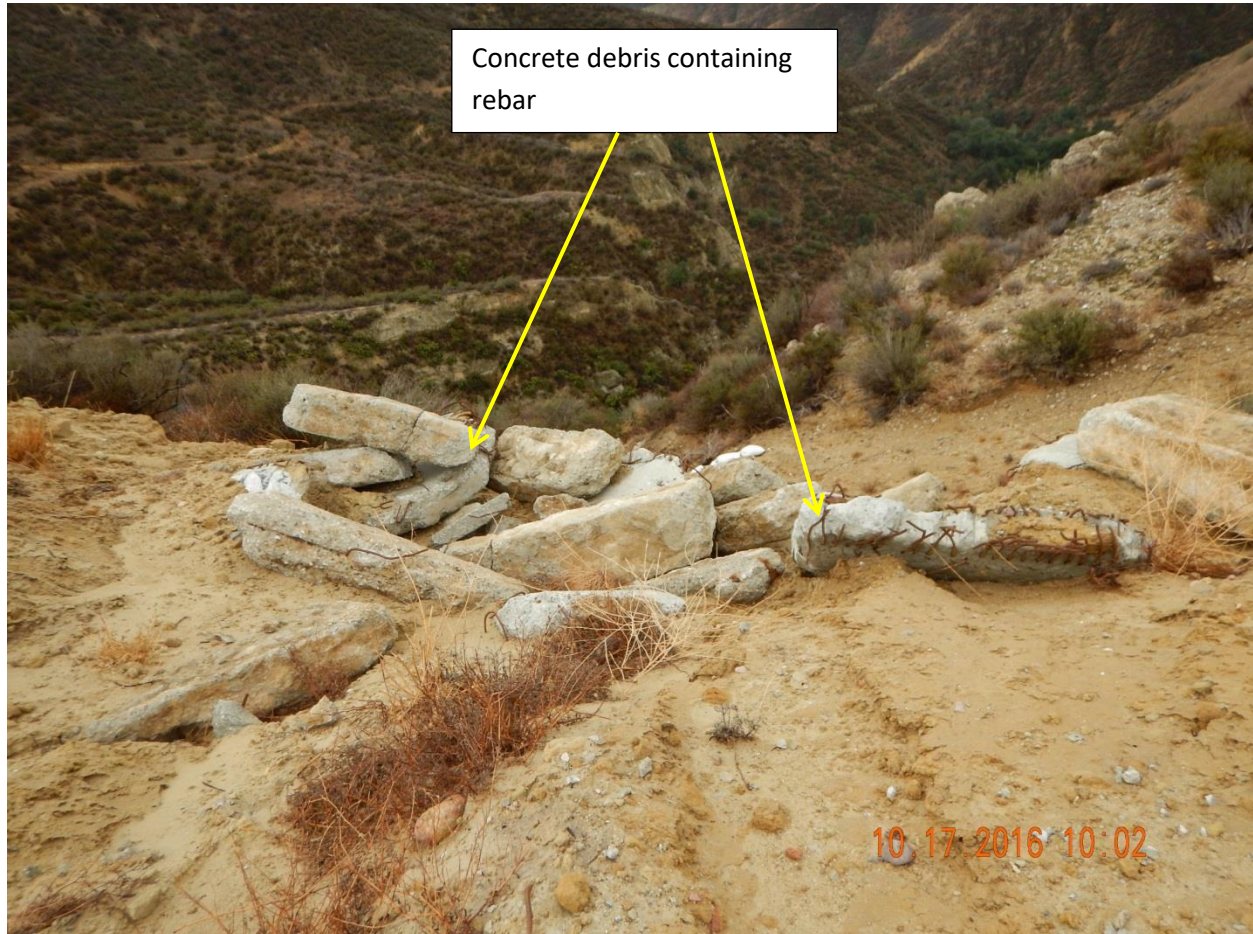
- **Stockpiled concrete debris** – Concrete debris was observed stockpiled throughout the parcel. Concrete debris was also seen partially buried at different locations within the parcel (Photo 11 and Photo 14).

**Photo 11.** This photo shows concrete debris partially buried in Parcel 2821-002-025 from sediment build up. The pieces of concrete debris contained rebar. This photo was taken near latitude: 34 18.574 and longitude: -118 37.078.

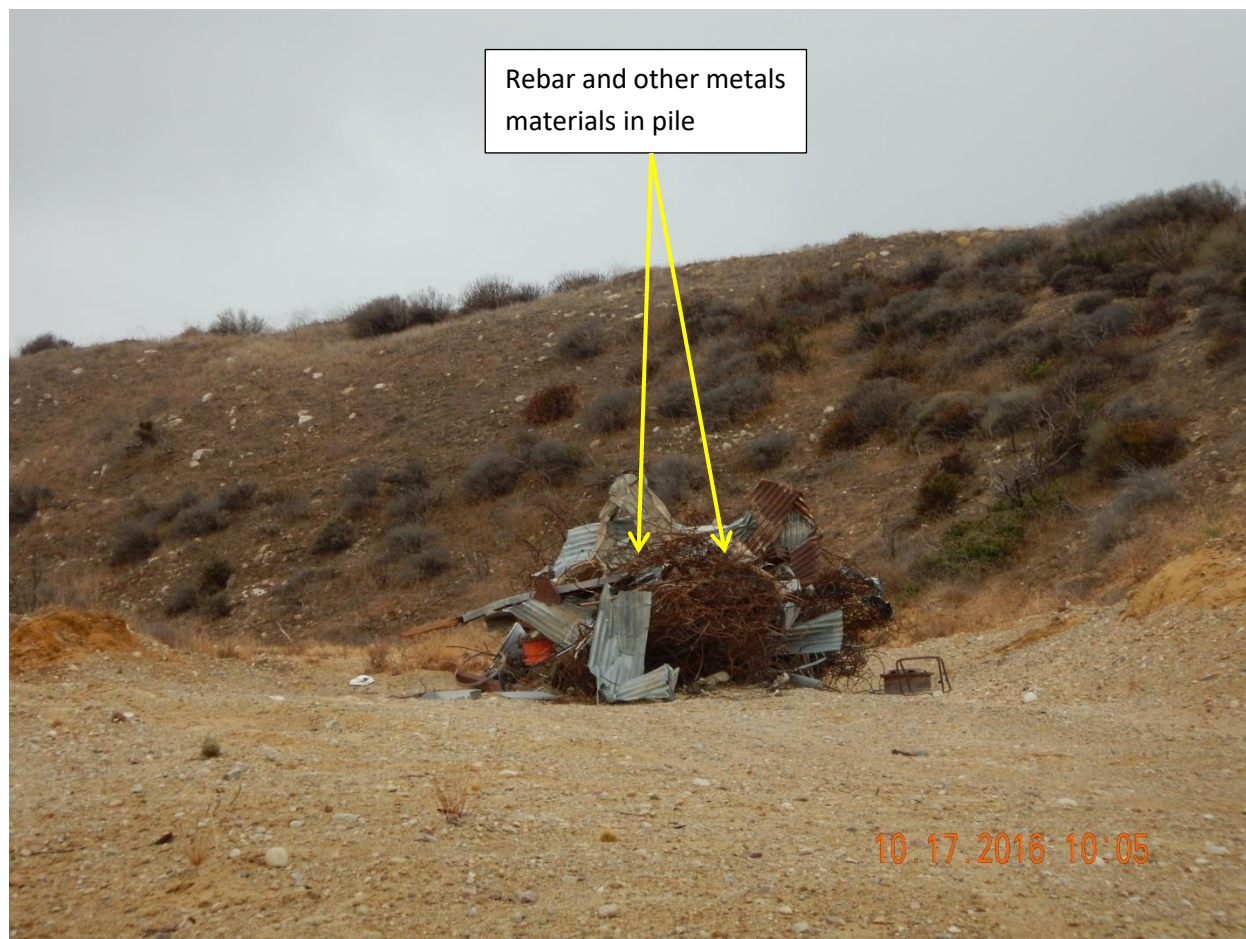
- **Rebar and metal stockpiles** – A stockpile of rebar and other miscellaneous metal was observed in a graded area located on the eastern side of the parcel. There were no BMPs in place to keep rust from the metals from discharging into Ybarra Creek and Devil's Creek (Photo 12). This stockpile rebar was not previously noted in the September 2015 inspection report.

**Photo 12.** This photo shows a stockpile of rebar and other miscellaneous metals found in Parcel 2821-002-025. This photo was taken near latitude: 34 18.594 and longitude: -118 37.078.

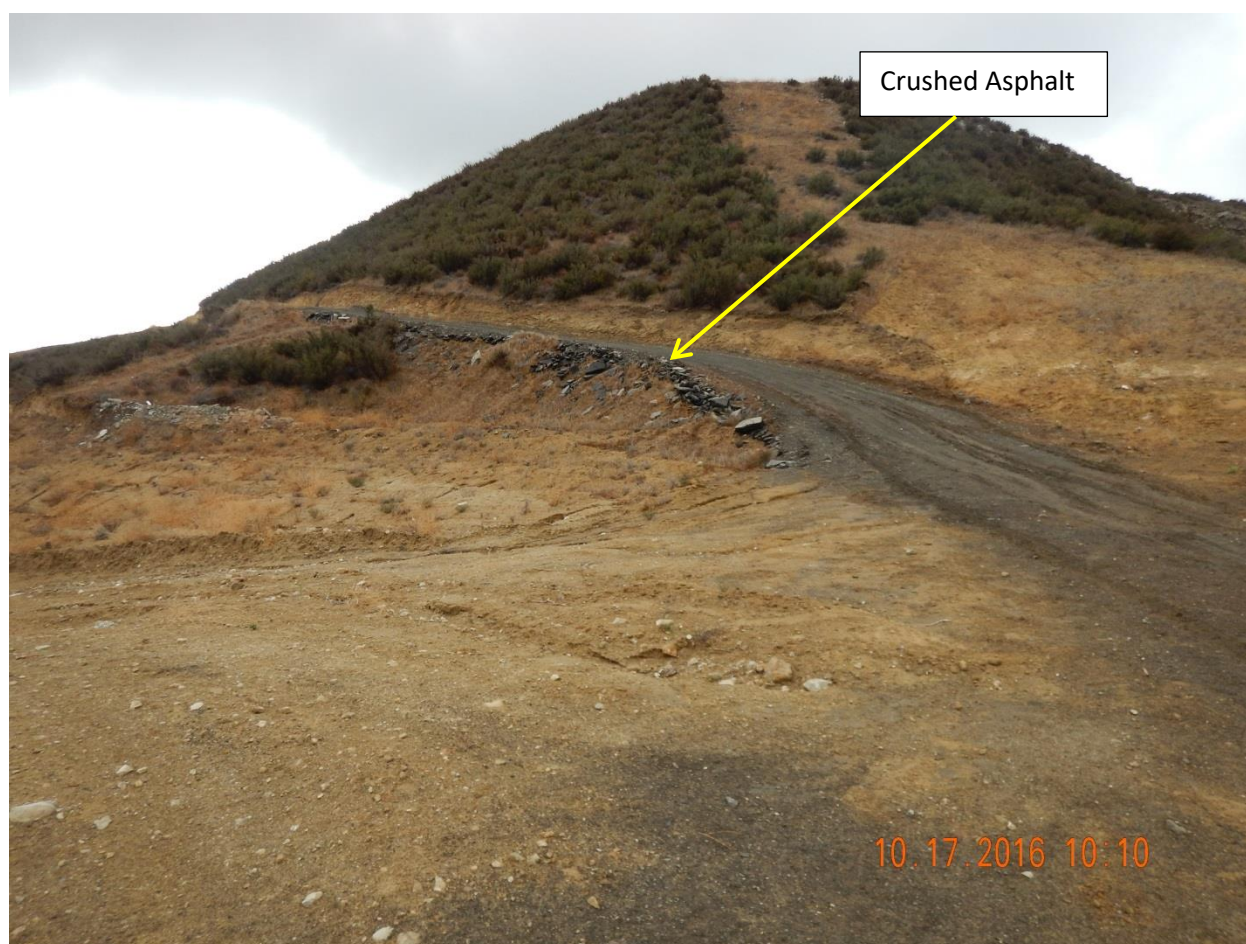
**Photo 13.** This photo shows crushed asphalt that was used to build the road. This photo was taken near latitude: 34 18.574 and longitude: -118 37.078 in Parcel 2821-002-025.

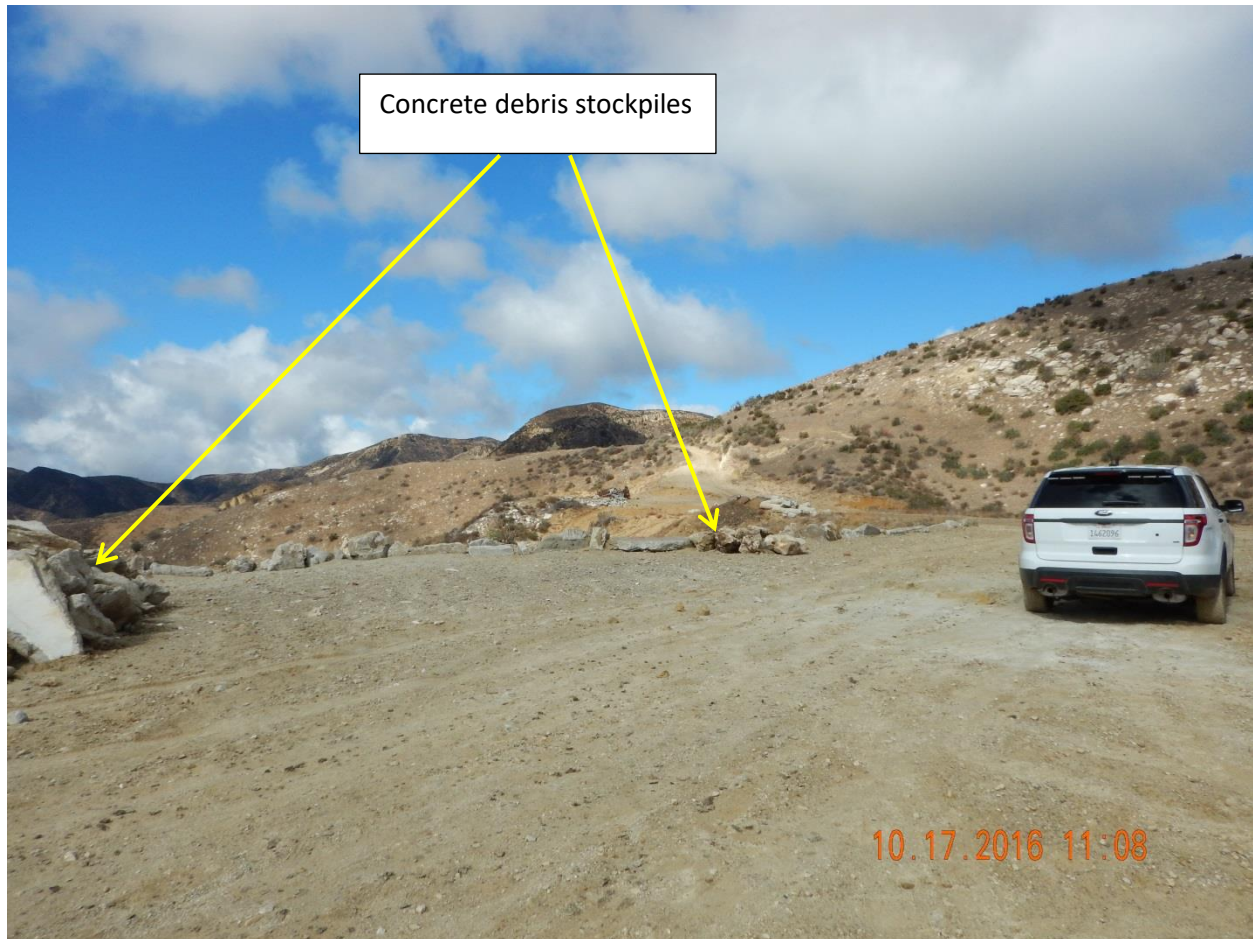
- **Large graded areas** – Areas within the parcel have been graded. Some of these graded areas contain stockpiles of construction debris. These large graded areas can erode and release sediment and other fill materials into creek waters (Photo 14). At least three separate areas within the parcel had been graded flat. These three areas had not been noted in the September 2015 inspection report and are likely new disturbances.

**Photo 14.** This photo shows a large graded area in Parcel 2821-002-025. This area contains stockpiles of concrete. This area lacked erosion control best management practices (BMPs), or sediment control BMPs. This photo was taken near latitude: 34 18.574 and longitude: -118 37.078.

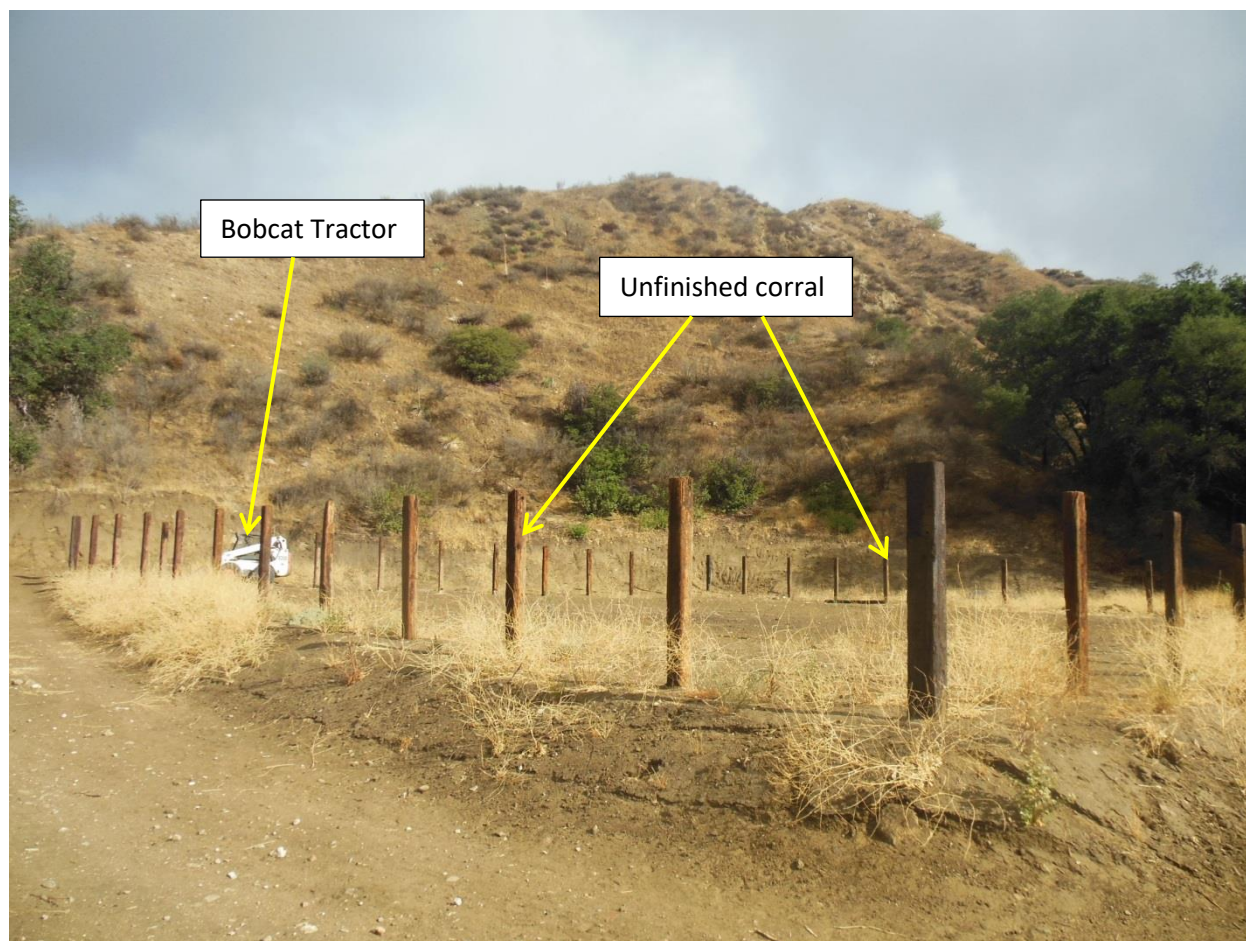
**Photo 15.** This photo shows a Bobcat tractor and an unfinished corral found in Parcel 2821-009-029.

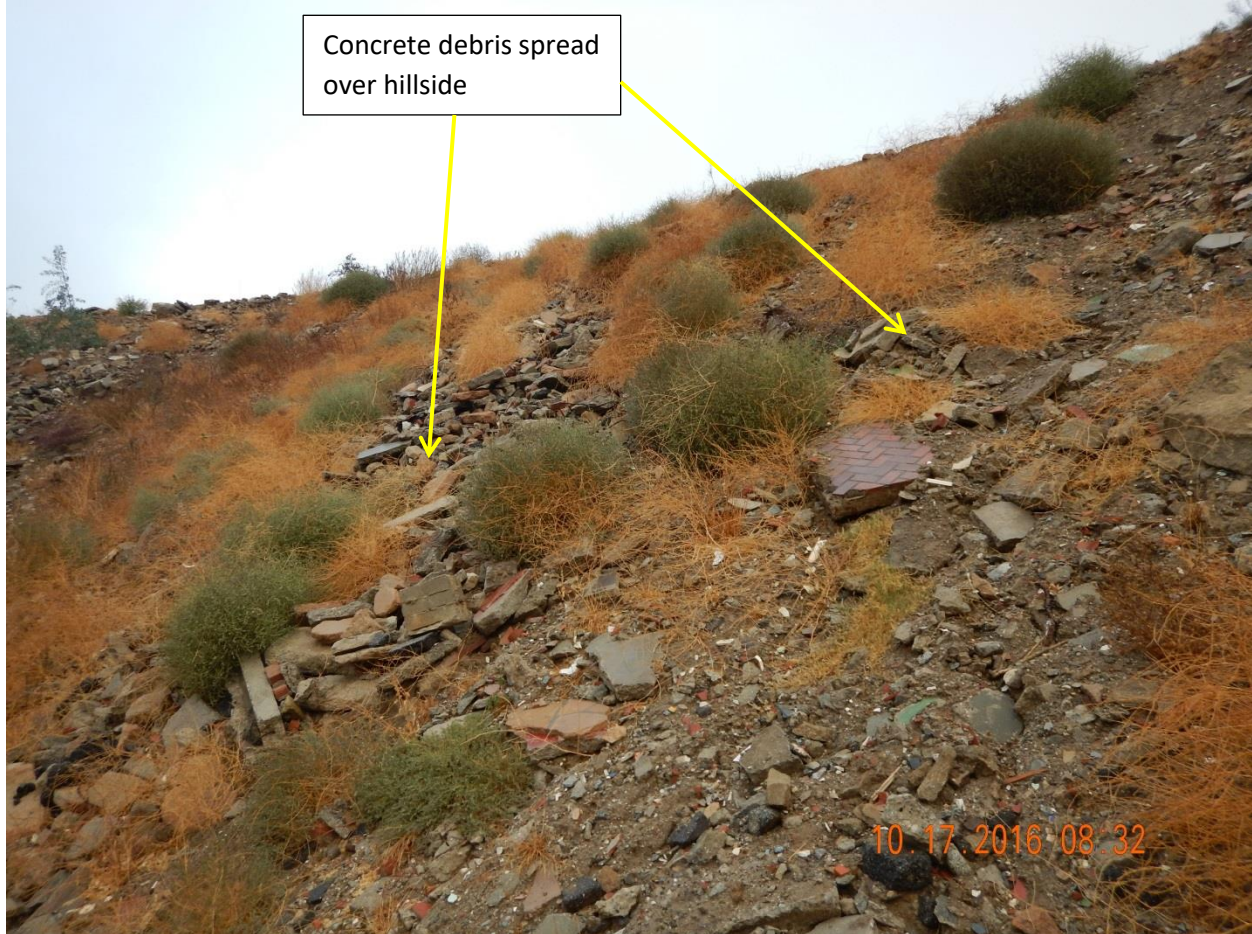
**Photo 17.** This photo shows construction debris piles found in the northeast section of Parcel 2821-002-023, near latitude: 34 18.622 and longitude: -118 36.766.

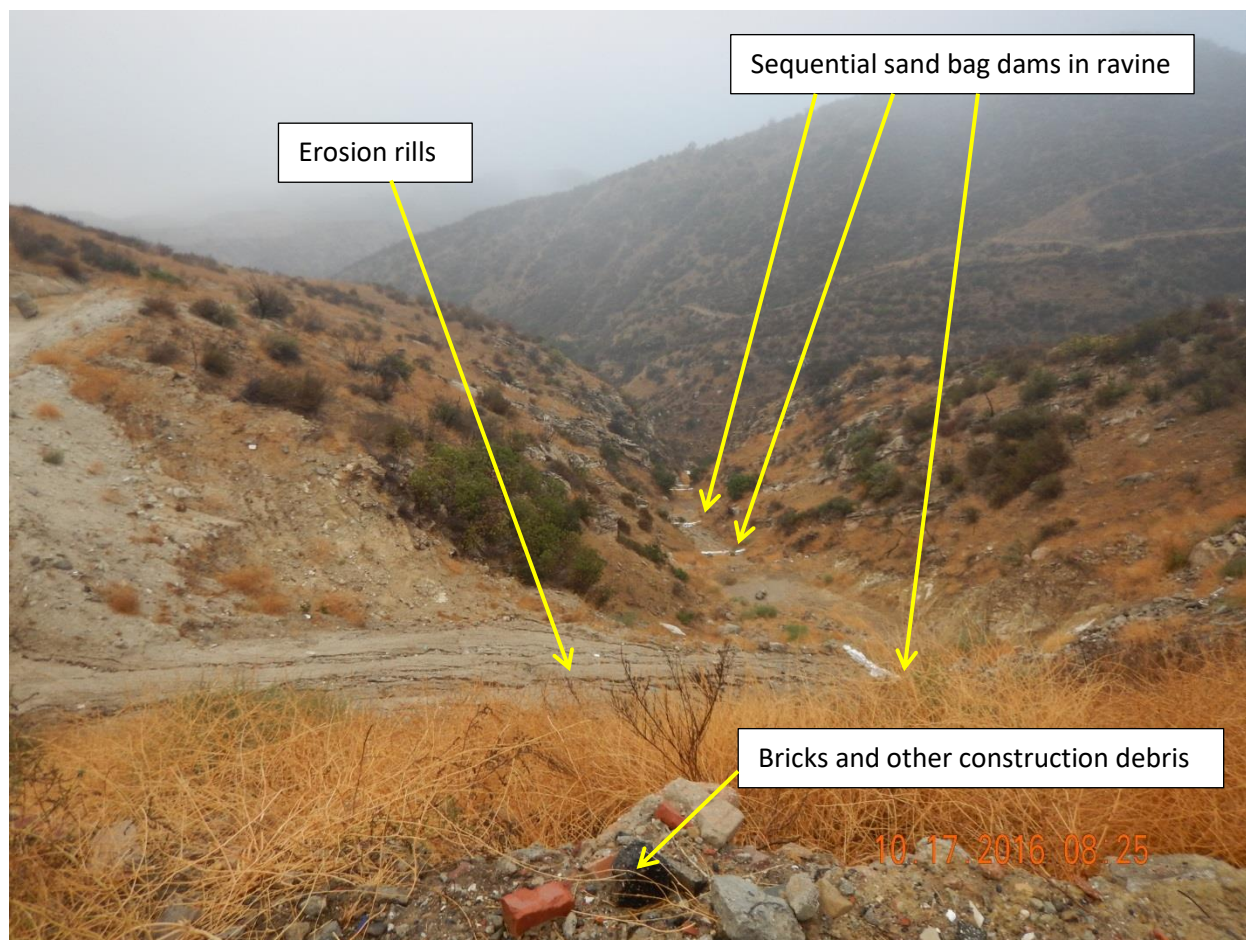
**Photo 18.** This photo shows sequentially placed sand bag dams on a steep ravine. The steep ravine leads to Ybarra Creek. This photo was taken on Parcel 2821-002-023 near latitude: 34 18.600 and longitude: -118 36.755.

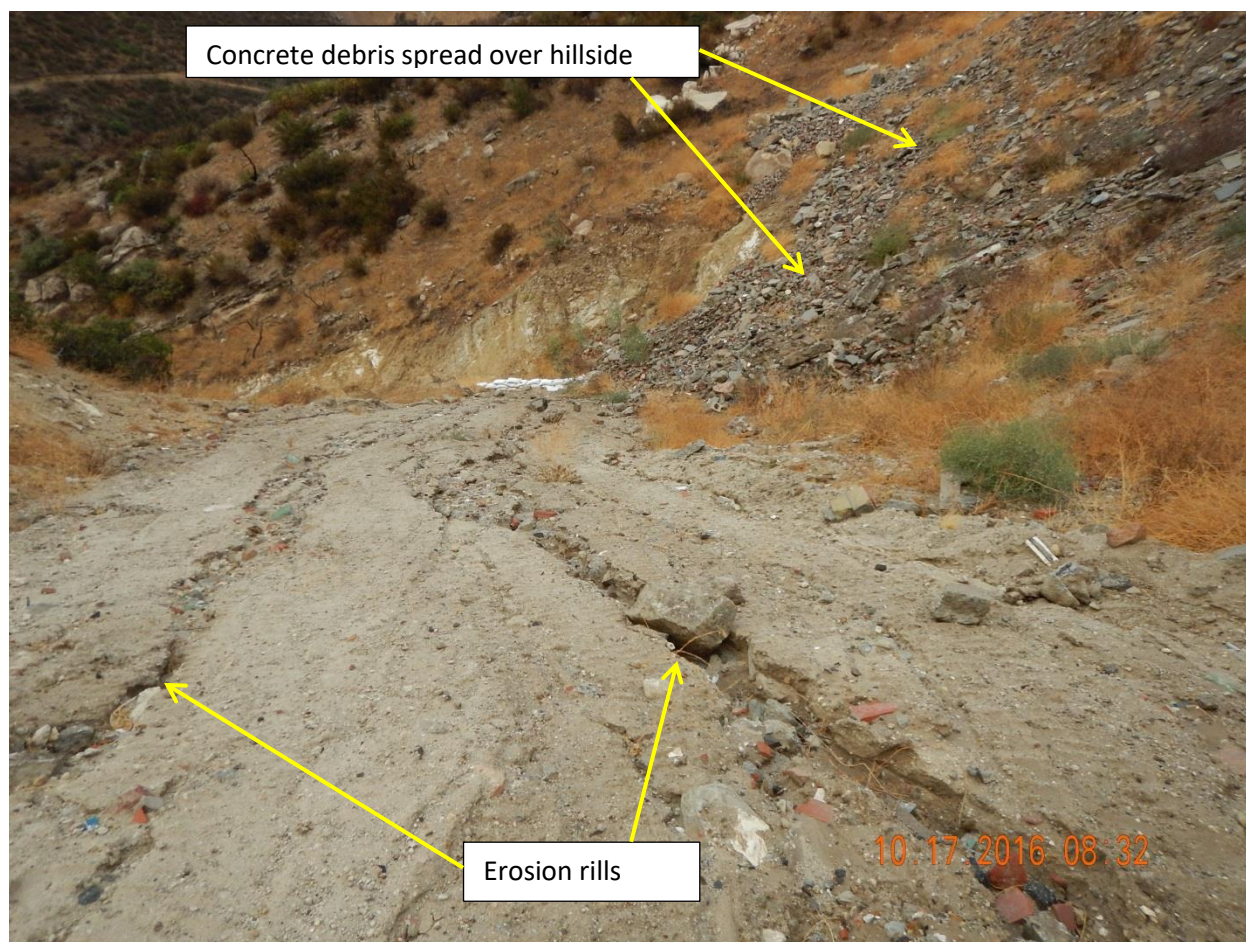
**Photo 19.** This photo shows erosion occurring on the road in Parcel 2821-002-023 above the sand bag dams. This photo was taken near latitude: 34 18.626 and longitude -118 36.767.
