**Los Angeles Regional Water Quality Control Board**

**INSPECTION REPORT**

**DATE OF INSPECTION:** October 17, 2016

APNs 2821-002-023; 2821-009-030; 2821-002-024; 2821-002-025; 2821-009-029; 2821-009-031; 2821-009-023

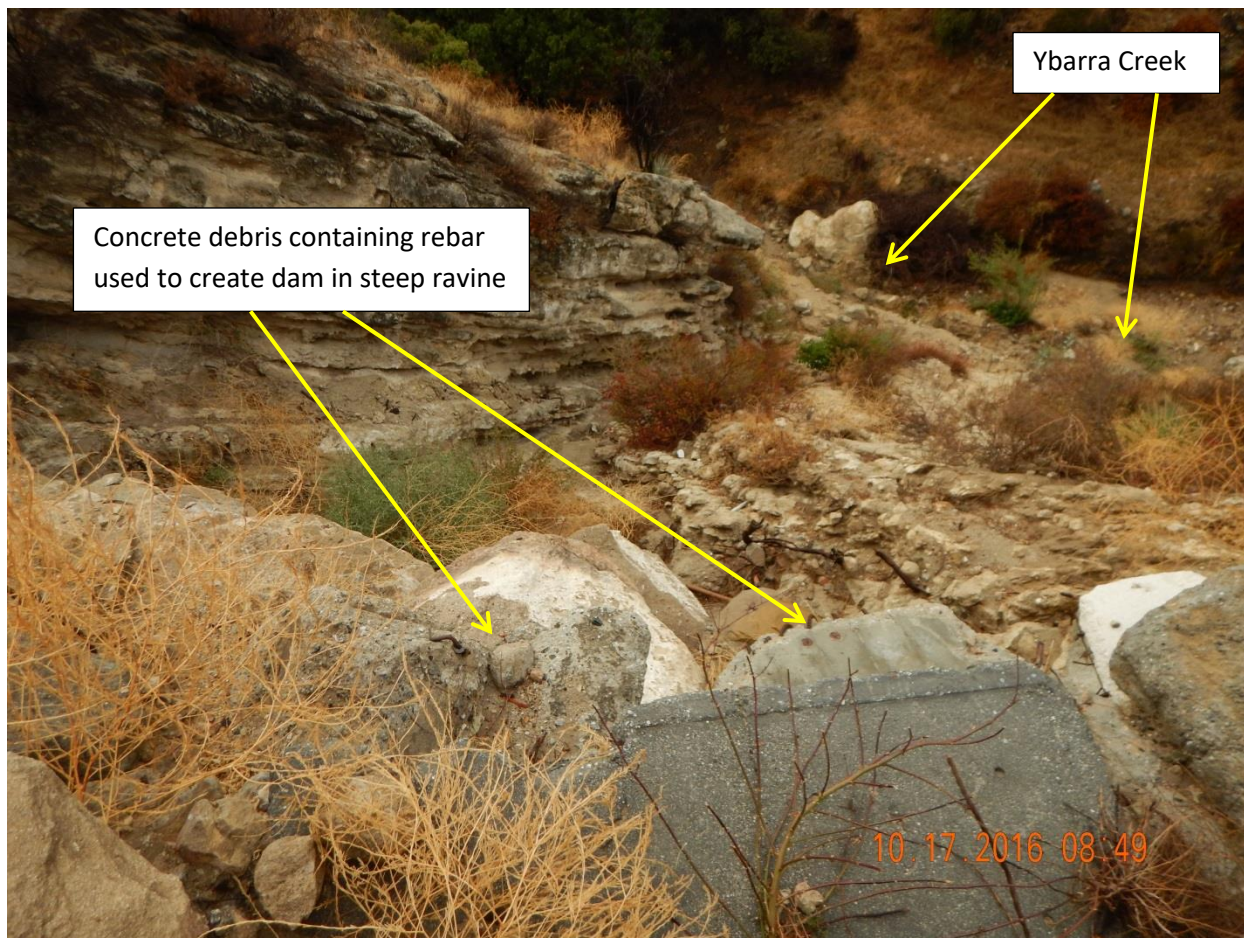
- **Concrete rubble dam** – The final dam on steep ravine above Ybarra Creek was constructed with broken concrete containing exposed and rusty rebar (Photo 20).

**Photo 20.** This photo shows a dam in a steep ravine. The dam was made of broken pieces of concrete that contained rebar. This photo was taken on parcel 2821-002-023 above Ybarra Creek near latitude: 34 18.547 and longitude: -118 36.769.

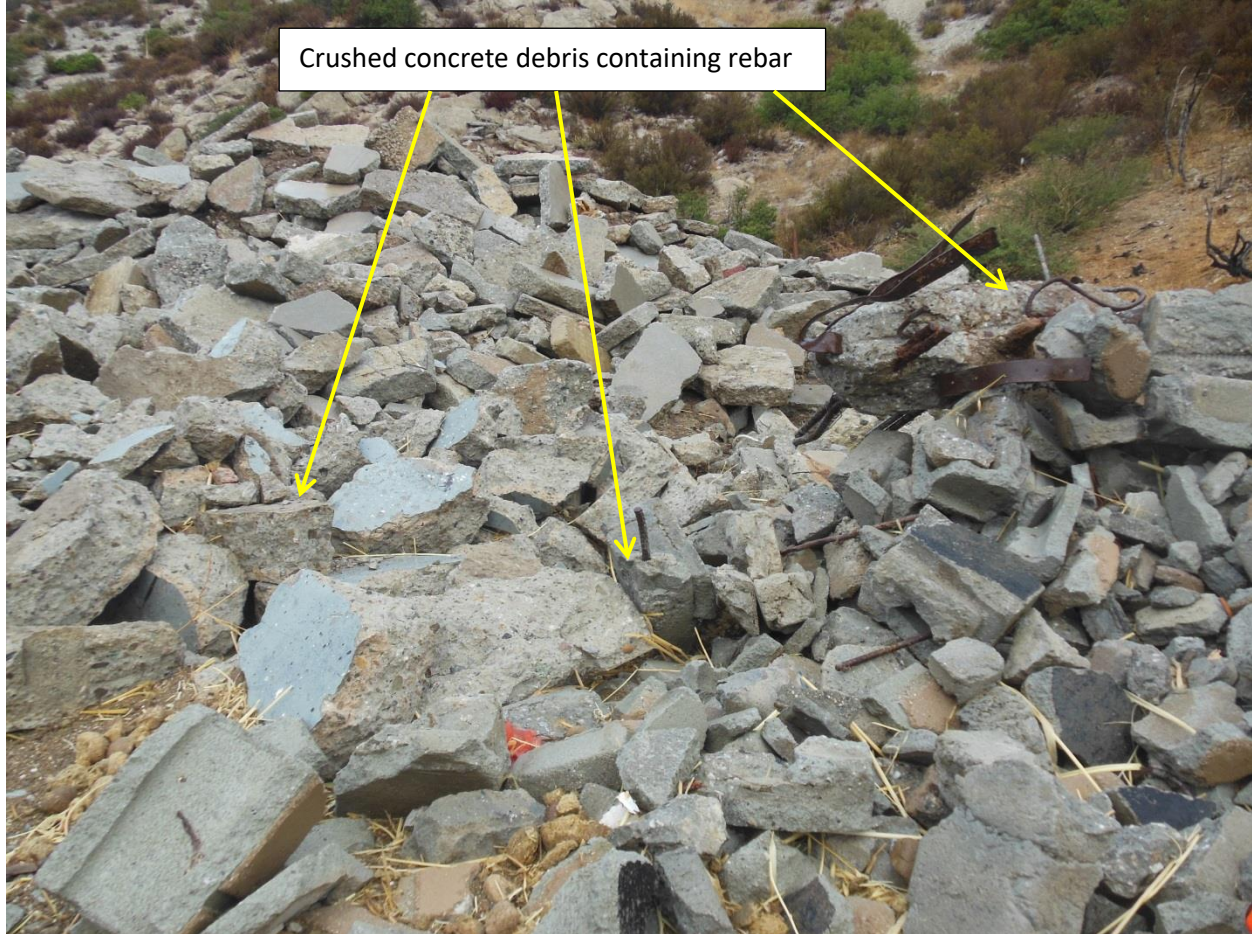
- **Crushed concrete stockpiles** – Crushed piles of concrete were found throughout the parcel. The crushed concrete contained exposed and rusty metal rebar (Photo 21).
- **Construction material stockpiling** – Construction materials that included brick, tile, stones, and wood were stockpiled in a large graded area (Photo 22).

**Photo 21.** This photo shows piles of crushed concrete. The crushed pieces of concrete have rebar in them. This photo was taken in Parcel 2821-009-030 near latitude: 34 18.338 and longitude: -118 36.687. While reviewing photos of the inspection it was found that the camera used by Team 1 had the incorrect date. The camera had the date of October 16, 2016, when it should have had the correct date of October 17, 2016.

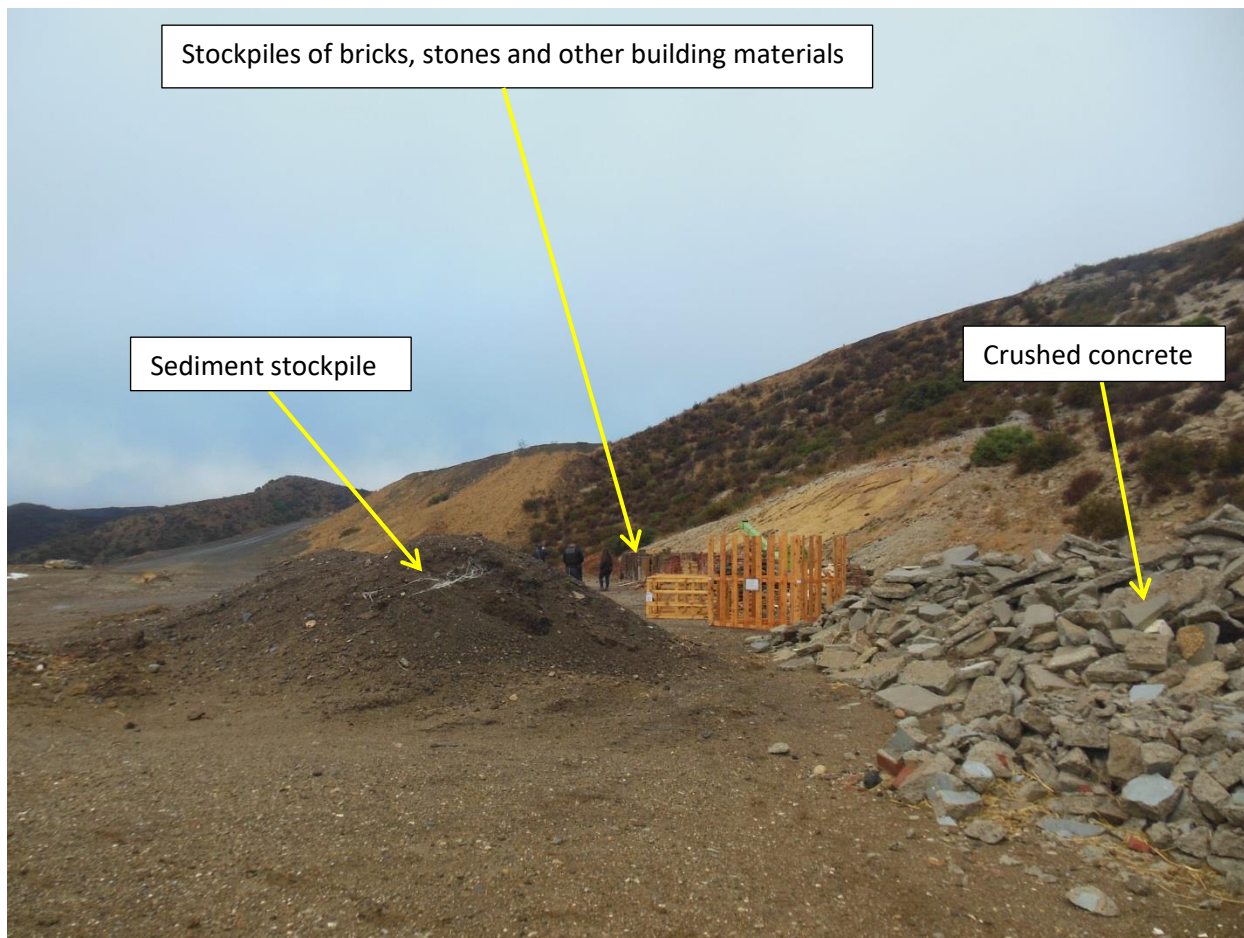
- **Sediment Stockpiling** – Stockpiles of sediment were found on the parcel at various locations. These stockpiles were not covered; BMPs were not implemented to prevent sediment from being released into Ybarra Creek. (Photo 22)

**Photo 22.** This photo shows stockpiles of sediment, crushed concrete debris, and construction materials. This area lacked erosion or sediment control BMPs. This photo was taken in Parcel 2821-009-030 near latitude: 34 18.338 and longitude: -118 36.687.

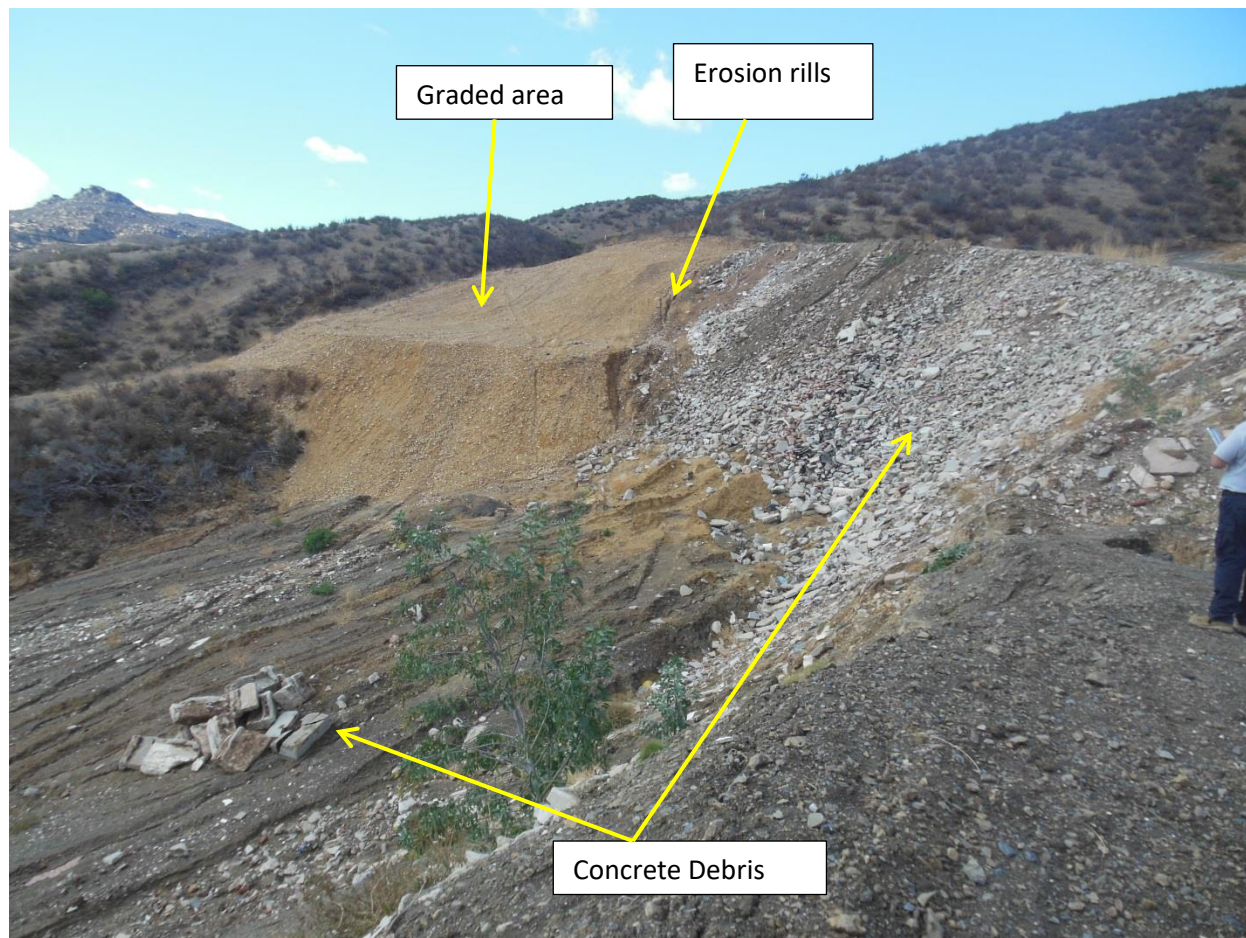
- **Ravine with concrete debris fill** – Crushed concrete debris partially filled a ravine within the southern section of the parcel. There were no BMPs present to prevent concrete debris and other fill material from being released into Ybarra Creek. (Photos 23 and 24) The ravine filled with concrete debris was not noted in the September 2015 inspection report.

**Photo 23.** This photo shows graded slopes and crushed concrete being used to fill a ravine. This photo was taken in Parcel 2821-009-030 near latitude: 34 18.260 and longitude: -118 36.831.

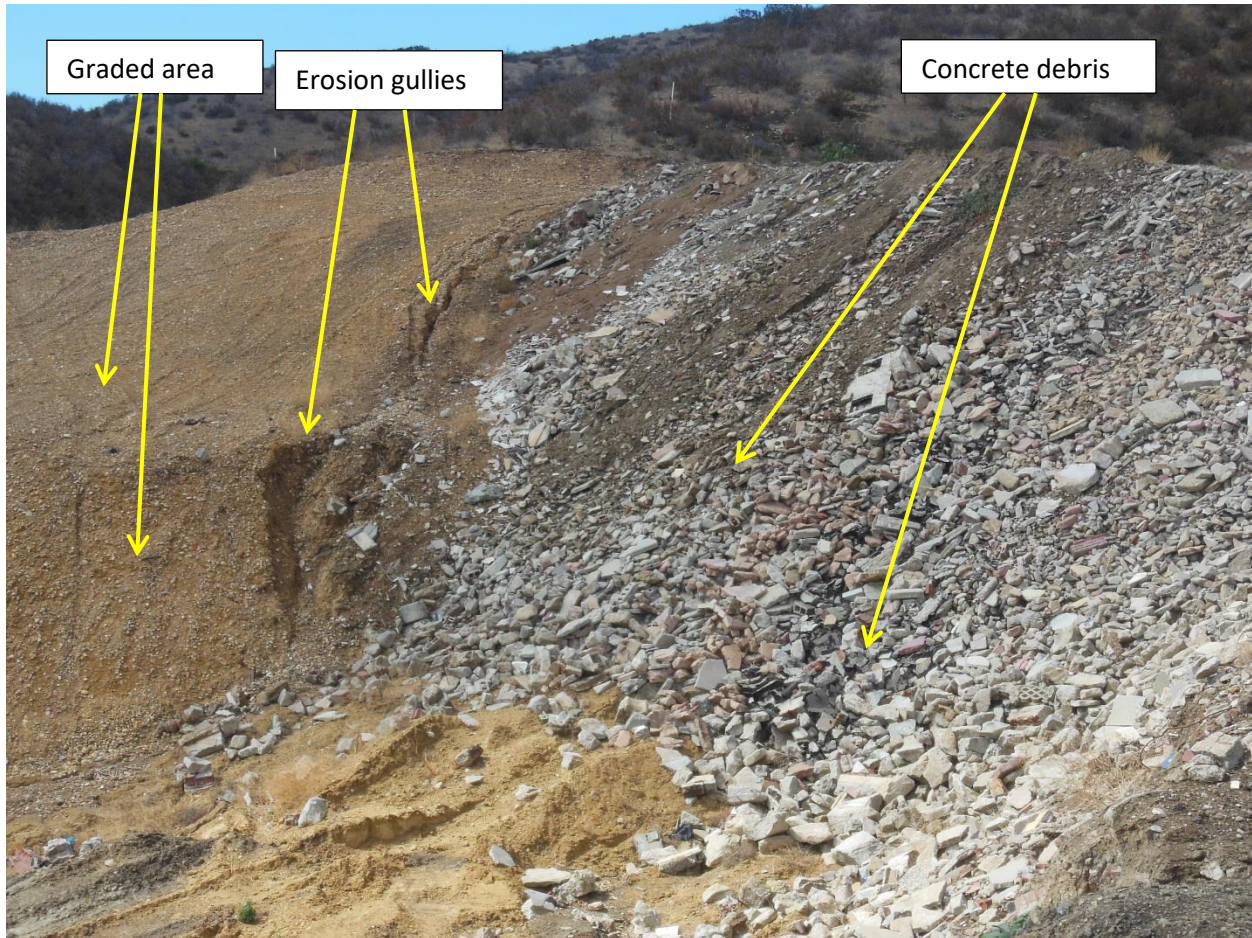
- **Erosion of large graded areas** – Areas within the parcel have been graded. Erosion gullies were observed on these graded areas. There were no BMPs in place to prevent sediment and other materials from being released into Ybarra Creek. (Photos 23 and 25) The September 17 and 18, 2015, inspection report describes these areas as having been recently graded and that no evidence of erosion was present.

**Photo 24.** This photo shows graded slopes and crushed concrete being used to fill a ravine. Erosion gullies are visible on the graded slopes. This photo was taken in Parcel 2821-009-030 near latitude: 34 18.260 and longitude: -118 36.831.

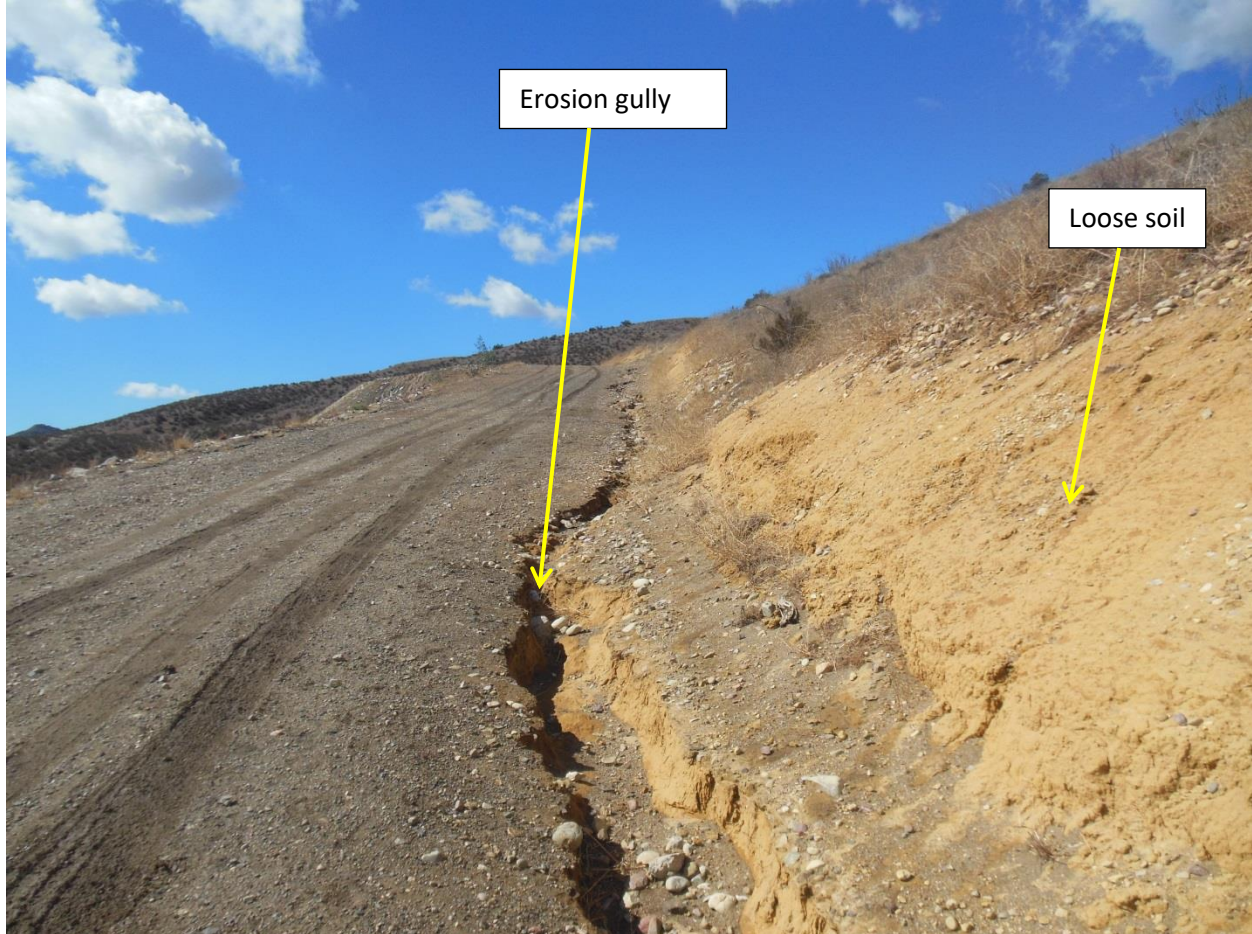
- **Dirt roads** – Graded dirt roads are found within the parcel. These roads split off of each other and met back up which formed a road network. Erosion gullies were found on these dirt roads. There were no BMPs in place to prevent sediment from being released into Ybarra Creek (Photo 25).

**Photo 25.** This photo shows a dirt road with an erosion gully running along its edge. This photo was taken in Parcel 2821-009-030 near latitude: 34 18.260 and longitude: -118 36.831. This area lacked erosion control BMPs.

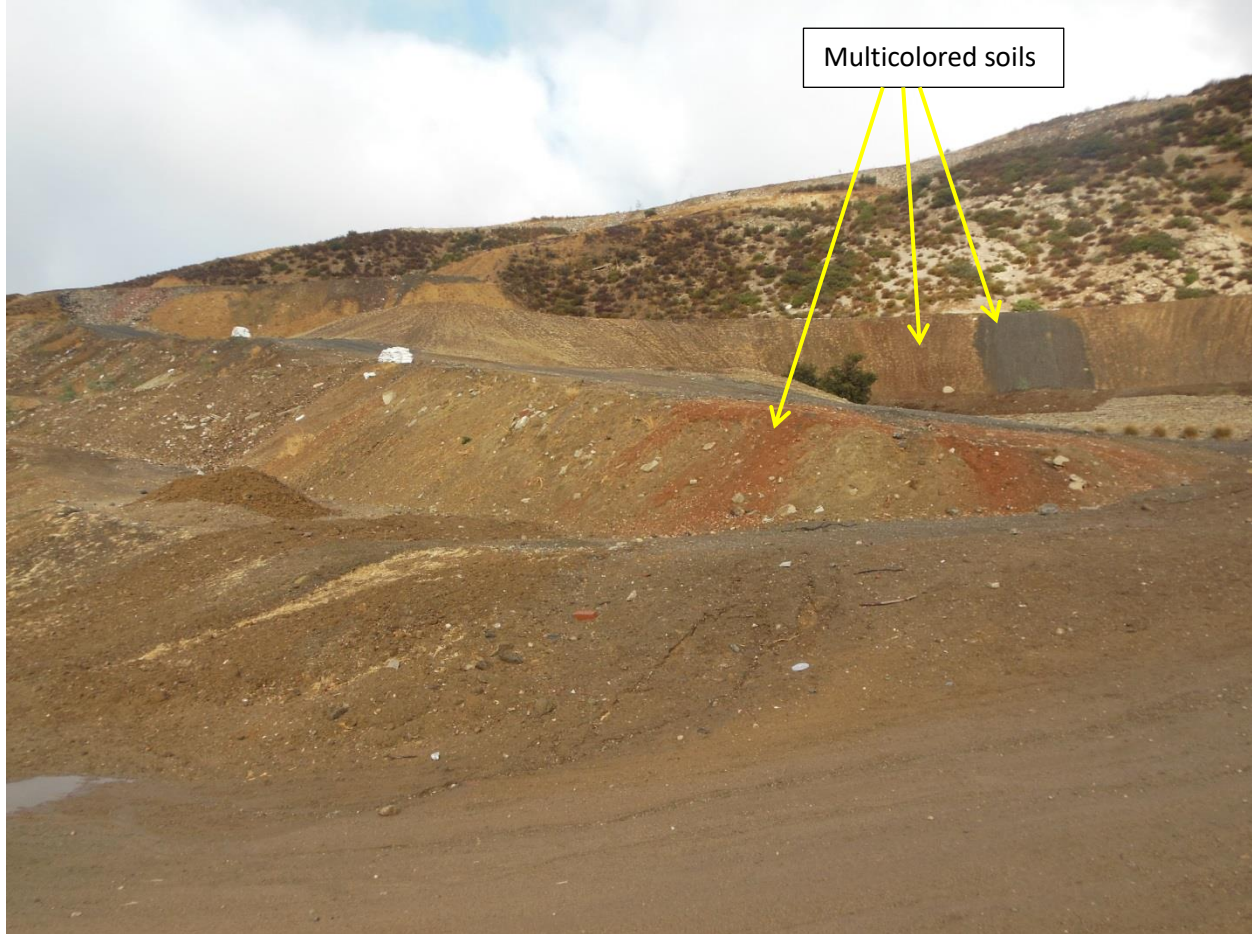
- **Slopes constructed with fill** – Slopes in this parcel contained multicolored imported fill material. There were no BMPs in place to prevent the release of sediment into Ybarra Creek (Photo 26).
- **Damaged sand bag berms at the top of a graded slope** – Sand bag berms were placed at the top of a slope in the general vicinity of latitude 34 18.264 and longitude -118 36.644 next to an area that had been graded flat. BMPs consisting of the sand bags were ineffective as the bags were damaged and were releasing sediment. Some of the sand bags had rolled down the slope (Photo 27).

**Photo 26.** This photo shows terraced multicolored soil in Parcel 2821-009-031. The multicolored soils indicate that non-native soils and potentially crushed construction debris may have deposited in the area. This area lacked erosion and sediment control BMPs. This photo was taken near latitude: 34 18.264 and longitude -118 36.644.

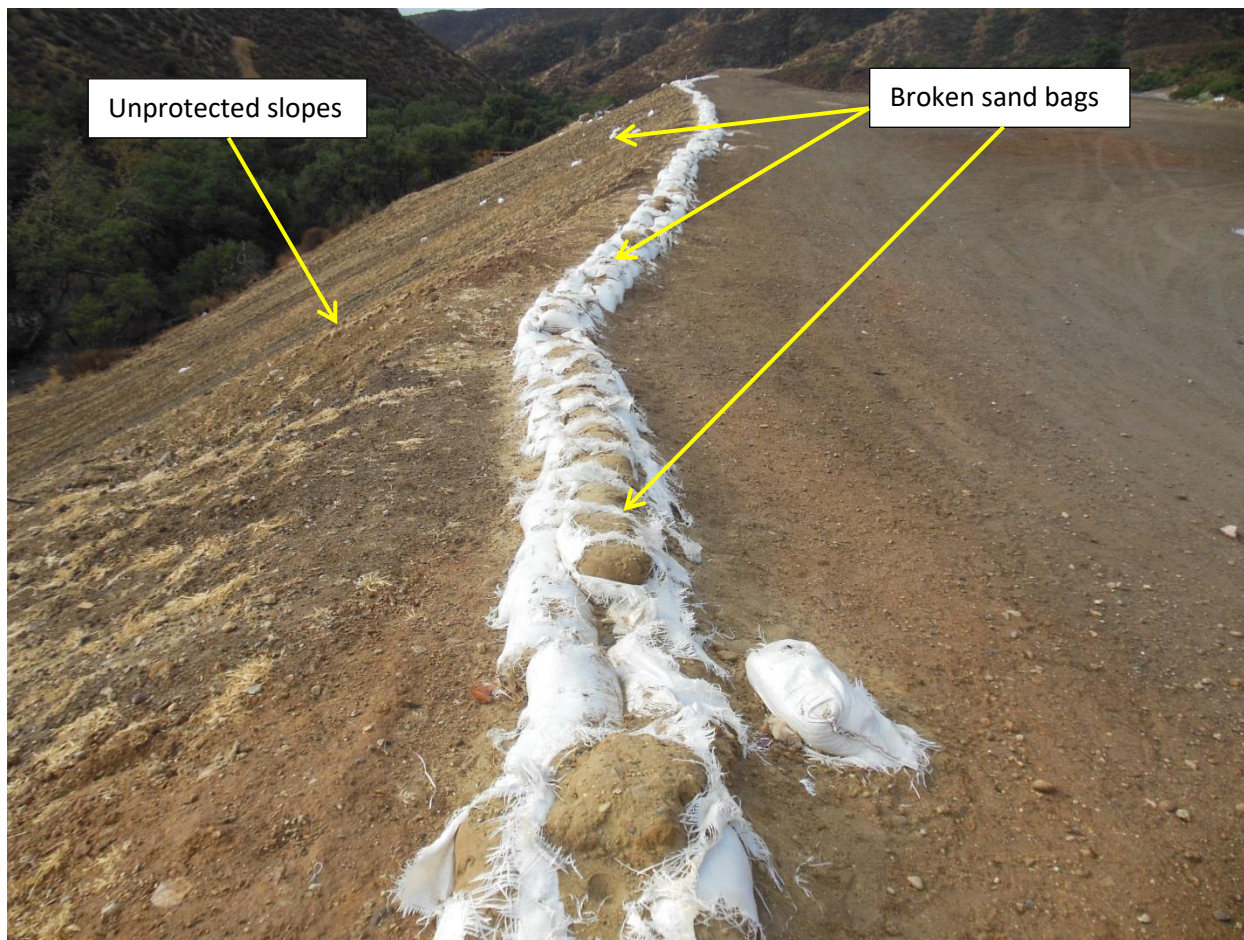
**Photo 27.** This photo shows a damaged sand bag berm placed at top of slope at the edge of an area that was graded flat. This photo was taken in Parcel 2821-009-031 near latitude: 34 18.264 and longitude: -118 36.644.

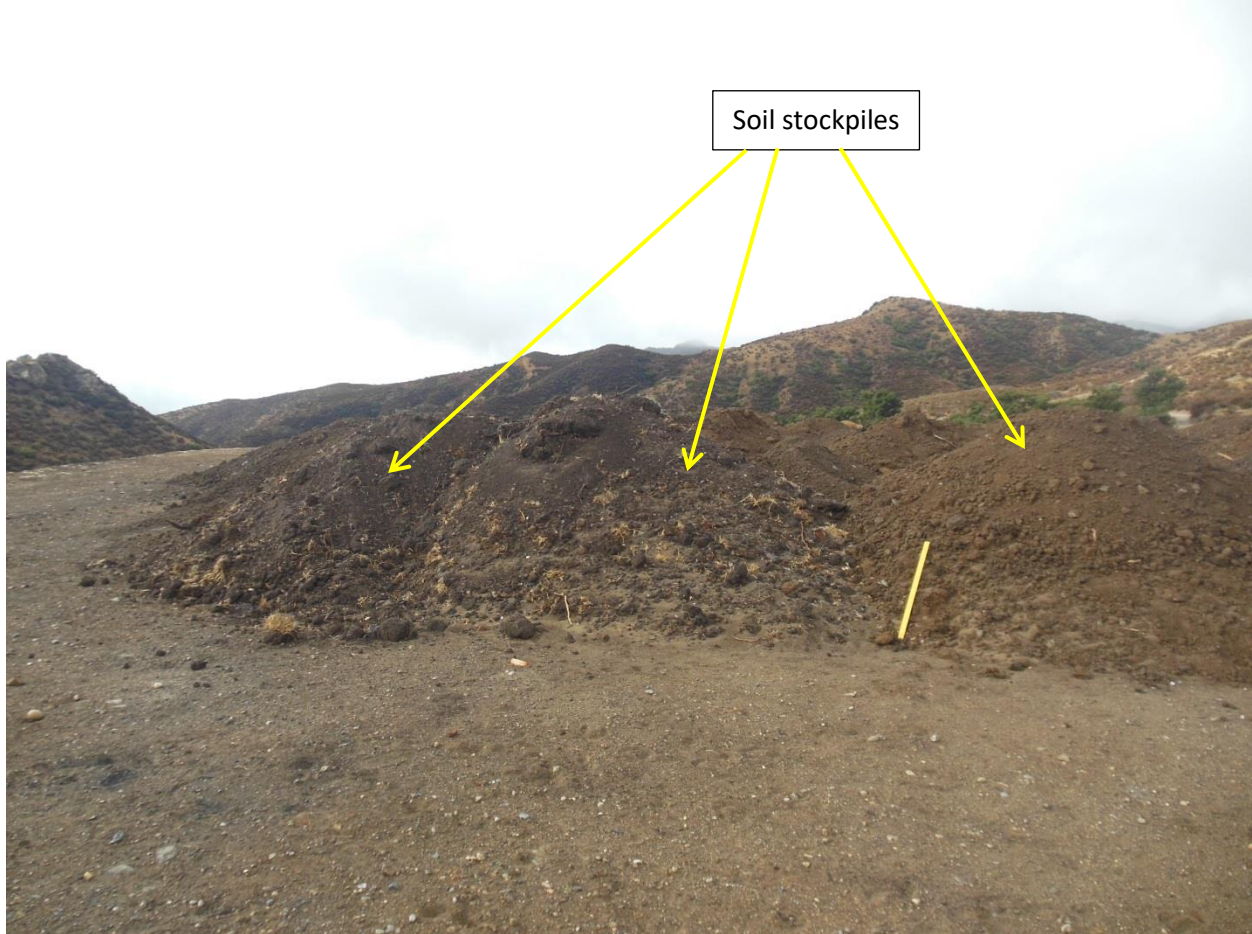
- **Sediment stockpiles** – Sediment stockpiles were found on the parcel at various locations. BMPs were not implemented to prevent sediment from being released into Ybarra Creek (Photo 28).

**Photo 28.** This photo shows stockpiles of soil found in Parcel 2821-009-031. This area lacked erosion or sediment control BMPs. This photo was taken near latitude: 34 18.264 and longitude -118 36.644.

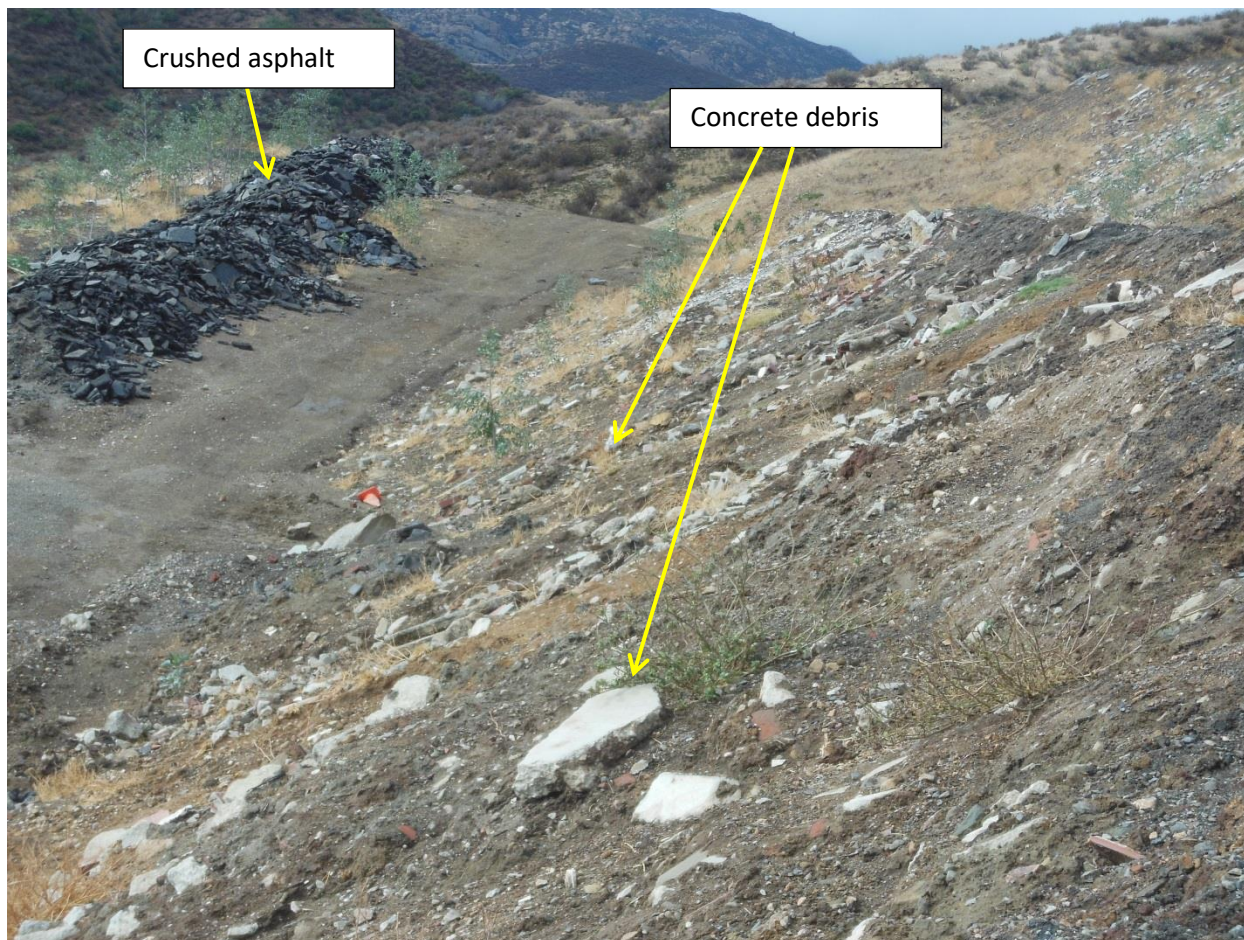
- **Buried and stockpiled construction debris** – Construction debris that had been deposited in graded terraces is visible at different areas within the parcel. Construction debris consisted of crushed asphalt, concrete and bricks. BMPs were not implemented to prevent these materials from eroding and discharging into Ybarra Creek (Photos 29 and 30). The buried and stockpiled construction debris was noted during the September 2015 inspection.

**Photo 29.** This photo shows crushed piles of asphalt and concrete in Parcel 2821-009-031 near latitude: 34 18.271 and longitude: -118 36.713.

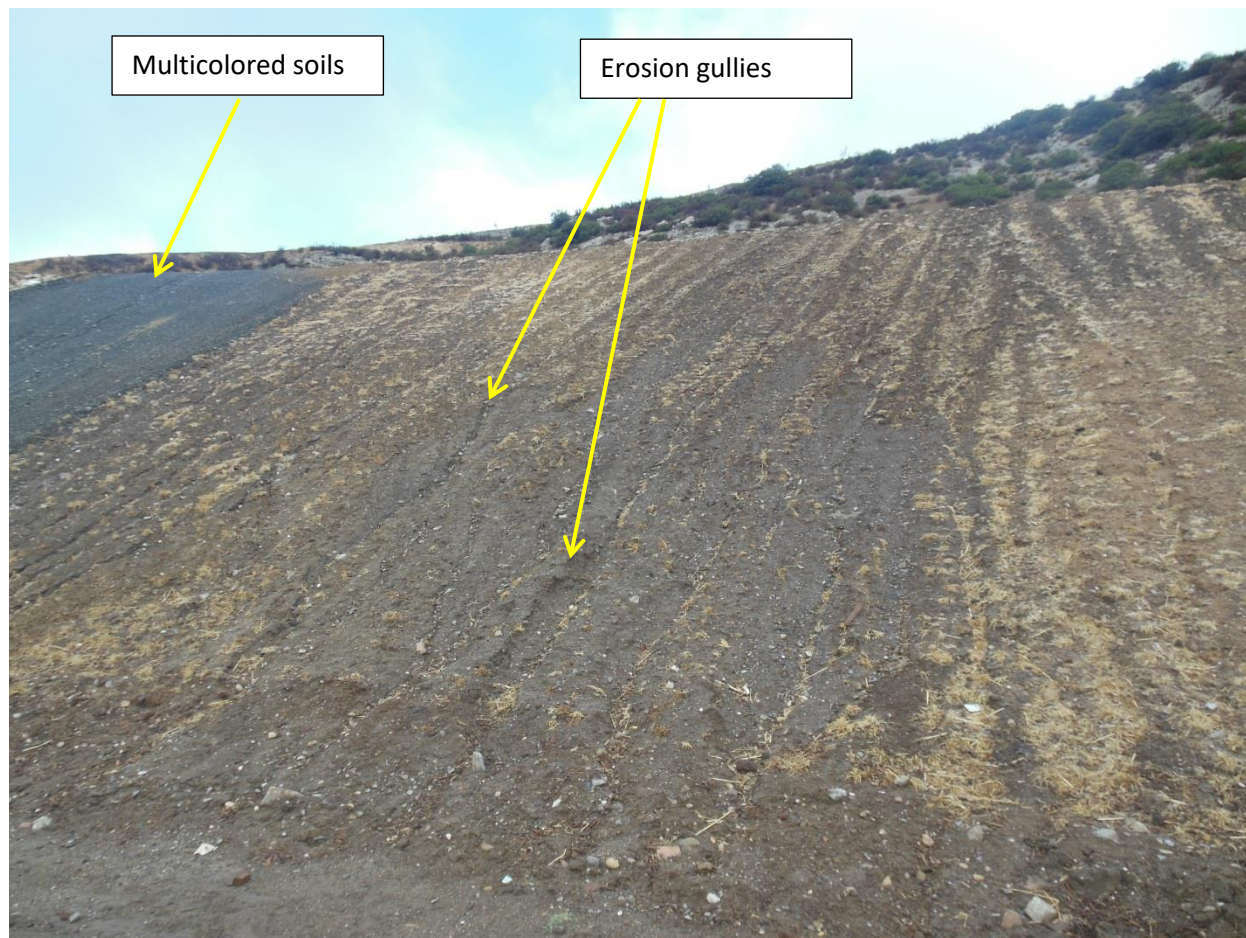
- **Evidence of erosion** – Erosion rills were found on graded slopes located between two areas that had been graded flat in the northeastern part of the parcel (Photo 30). The deposited sediment will slowly erode and eventually discharged into Ybarra Creek. These erosion rills on the graded slopes have developed since the September 2015 inspection.

**Photo 30.** This photo shows erosion rills on a graded slope located between two terraced areas. There are multi colored soils on the slopes. This photo was taken in Parcel 2821-009-031 near latitude: 34 18.308 and longitude: -118 36.671.

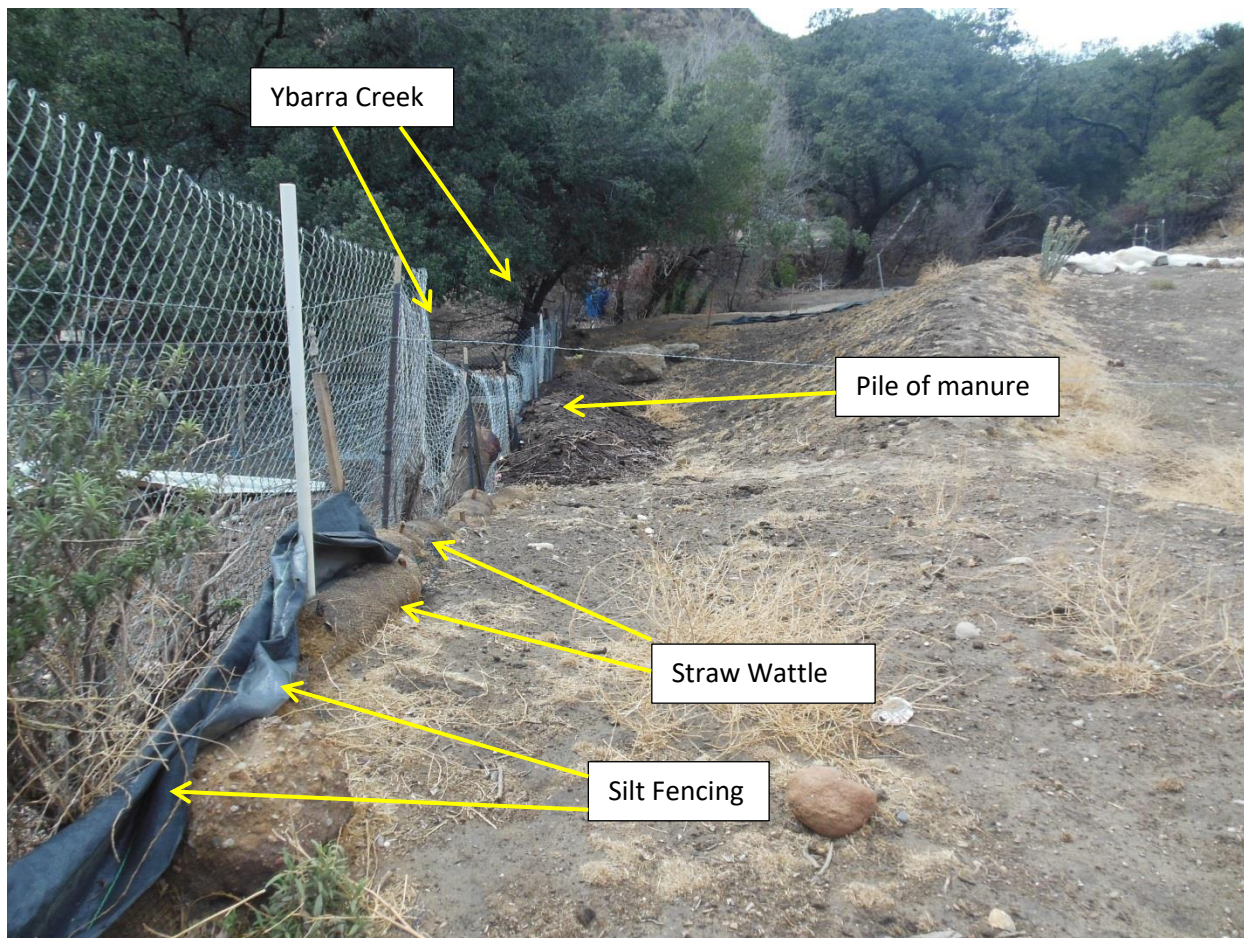
- **Silt fence and straw wattle BMPs in poor condition** – Sediment control BMPs including a silt fence and straw wattle were placed along the fence line adjacent to Ybarra Creek. However, the BMPs were in poor condition. The straw wattle was ripped and releasing straw (Photo 31).

- **Manure stockpile** – A pile of manure was placed against the fence line that was adjacent to Ybarra Creek. There were no BMPs in place to prevent the stockpile of manure from being discharged into the creek (Photo 31). The pile of manure was sixty (60) feet from Ybarra Creek. The manure stockpile was not noted in during the September 2015, inspection.

**Photo 31.** This photo shows sediment control BMPs placed along the fence line including a straw wattle and parts of silt fencing. A pile of manure is also along the edge of the fence line. This area lacked erosion control BMPs. This photo was taken in Parcel 2821-009-031 near latitude: 34 18.248 and longitude: -118 36.630. Ybarra Creek is on the other side of the chain-linked fence.

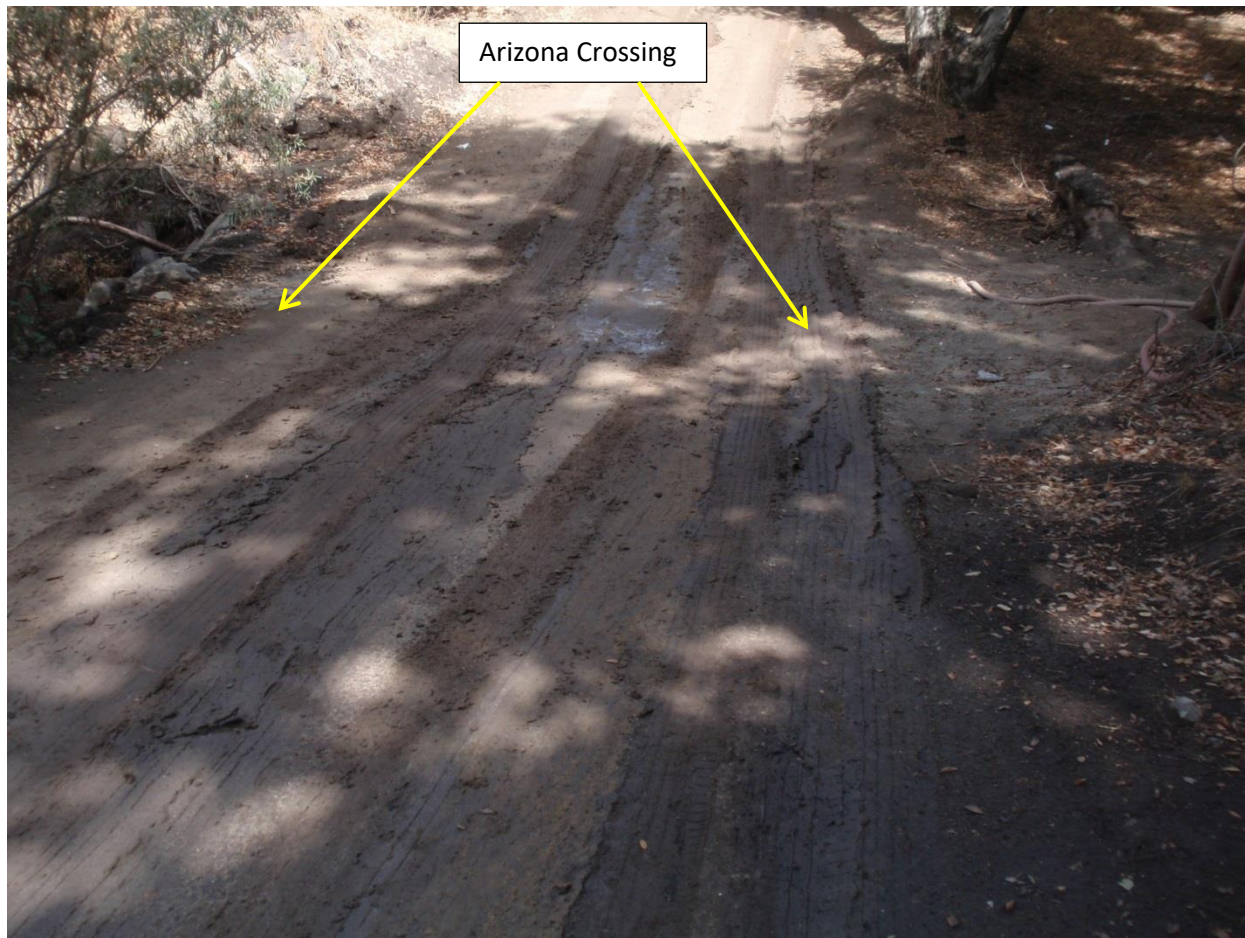
- **Arizona Crossing** – In this parcel, Regional Board staff found an Arizona crossing in Ybarra Creek. The Arizona crossing consisted of rip rap made of crushed concrete debris. The Arizona crossing is an unpermitted discharge of sediment and concrete material to Ybarra Creek (Photo 32 and 33).

- An Arizona crossing constructed across Ybarra Creek was found in Parcel 2821-009-023. This parcel is owned by Sacred Oaks Ranch, LLC. The Arizona Crossing was constructed using sediment and concrete debris. Two berms were also constructed within Ybarra Creek, and were used to pool water in Ybarra Creek.

**Photo 32.** This photo shows an Arizona crossing in Ybarra Creek in Parcel 2821-009-023. This photo was taken near latitude: 34 18.158 and longitude:-118 36.665.

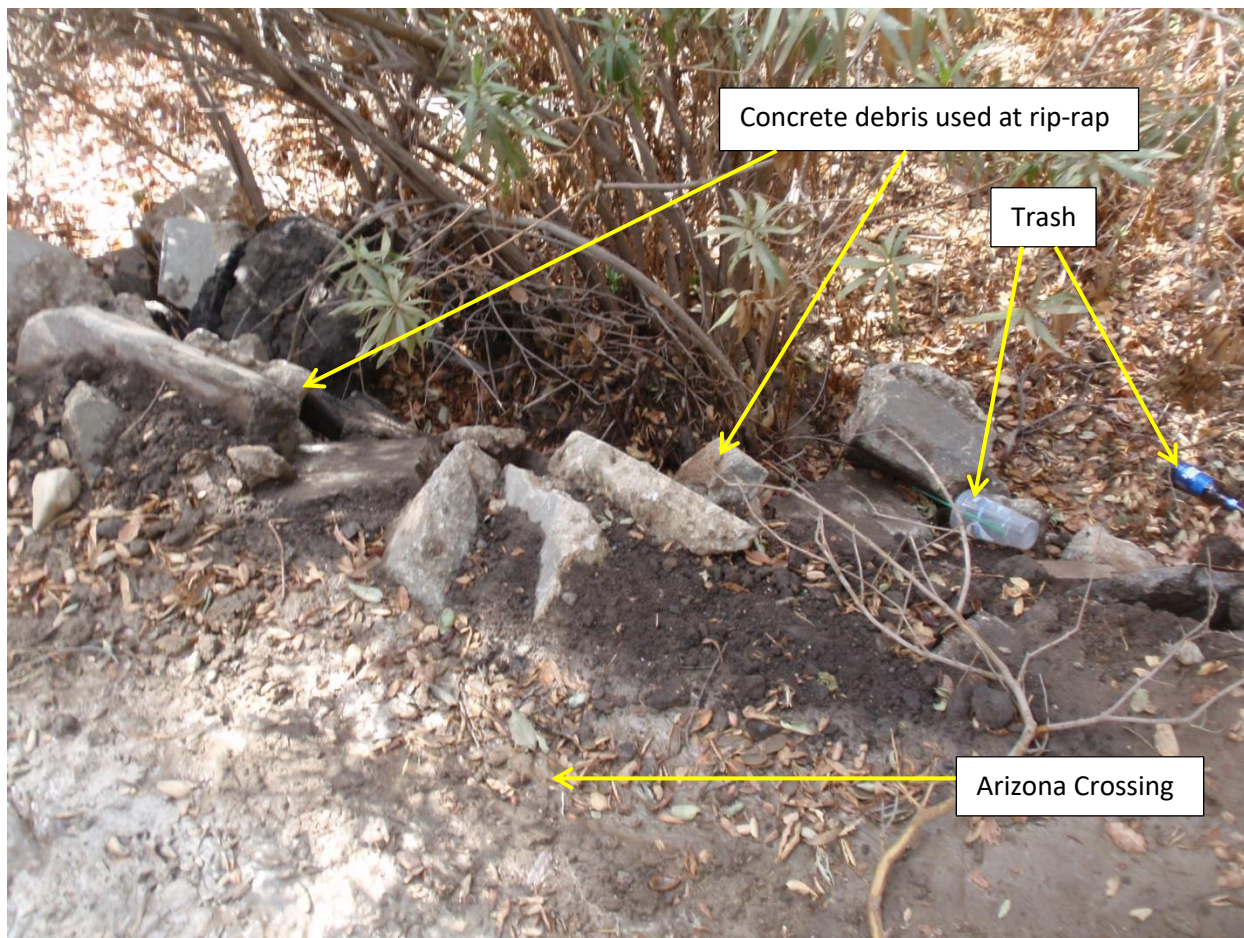
**Photo 33.** This photo shows crushed concrete used to create the Arizona crossing in Parcel 2821-009-023 near latitude: 34 18.158 and longitude:-118 36.665.

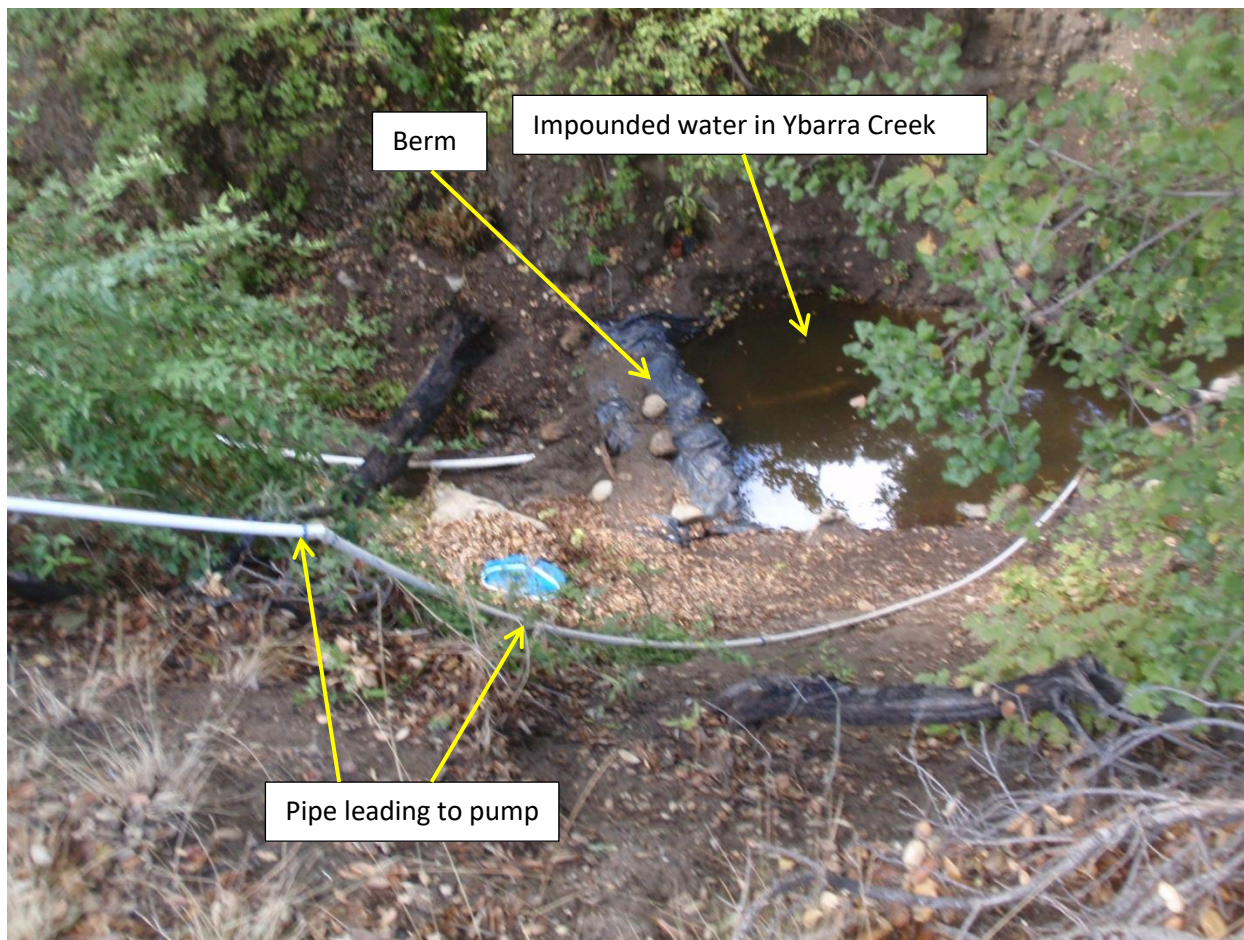
- **Berms in Ybarra Creek** – Two berms were found in the creek that caused in-stream diversion and impoundment of water (Photo 34). The berms consisted of sediment and plastic sheeting. Pipes were found coming from these pooled areas, and one set of these pipes lead to a pump and spigot (Photo 35). Any water removed from the parcel and not used for riparian uses is likely an unauthorized water diversion. Therefore, on December 16, 2016, Regional Board staff contacted Jeffrey Yeazell from the State Water Resources Control Board's Department of Water Rights to determine if a water rights permit had been filed for parcel 2821-009-023. Mr. Yeazell stated that according to their GIS database, there was no water rights permit for parcel 2821-009-023.

- Two in-stream diversions were found in Ybarra Creek that consisted of sediment and plastic sheeting. These berms pooled water in the creek and PVC piping connected the pooled water a water pump and spigot.

**Photo 34.** This photo shows an in-stream diversion and water impoundment in Ybarra Creek that was created with plastic sheeting and sediment. Pipes leading to a pump were observed coming from the pooled water behind the sediment berm. The pump was not operational during the inspection. This photo was taken in parcel 2821-009-023 near latitude: 34 18.158 and longitude:-118 36.665.

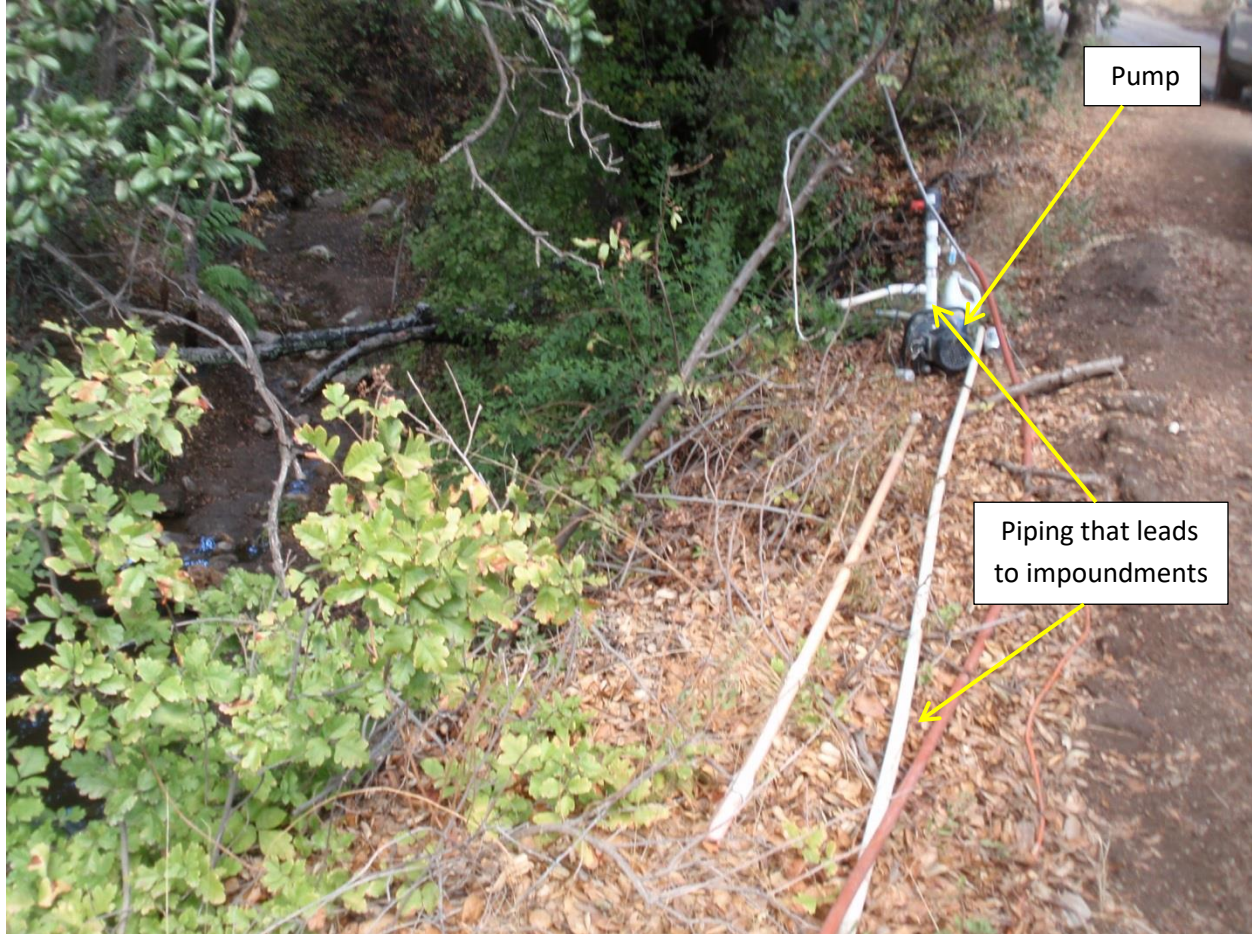
**Photo 35.** This photo shows the pipes in Photo 34 were connected to a pump. The pump was not in operation at the time of the inspection. This photo was taken in Parcel 2821-009-023 near latitude: 34 18.158 and longitude:-118 36.665.

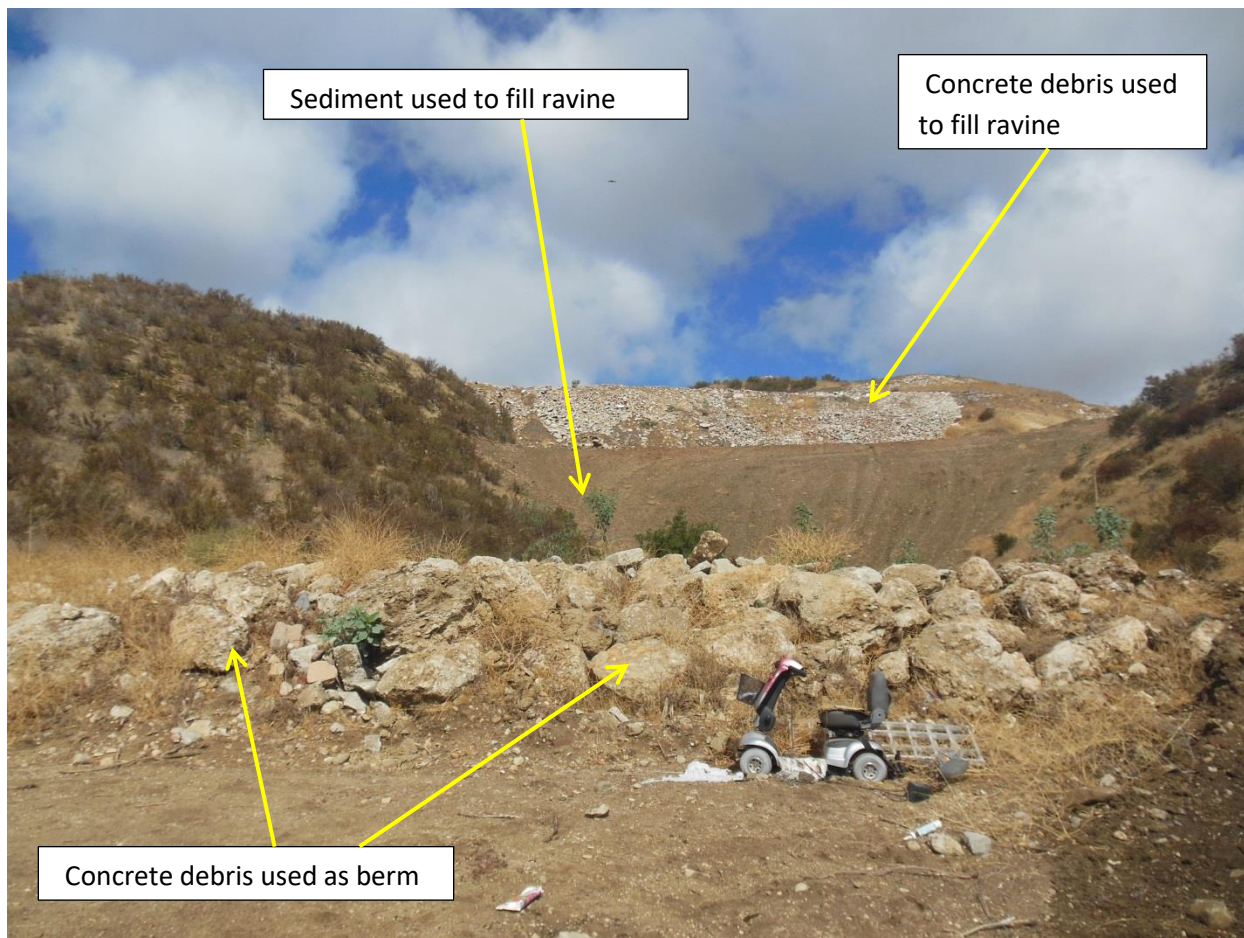
- **Sediment and construction debris in ravine** – Large amount of sediment and broken concrete were deposited in a ravine. The deposited debris appears to have been graded and terraced. Construction debris was also deposited throughout the parcel. This deposited construction debris threatens to discharge into Ybarra Creek (Photo 36).

**Photo 36.** This photo shows a ravine filled with sediment and crushed concrete debris. This area lacked erosion control BMPs. This photo was taken in Parcel 2821-009-023 near latitude: 34 18.184 and longitude: -118 36.812.
