Harwood CAO R1-2009-0128 Attachment

The following pictures and captions depict onsite conditions during the Regional Board 11/03 inspection.

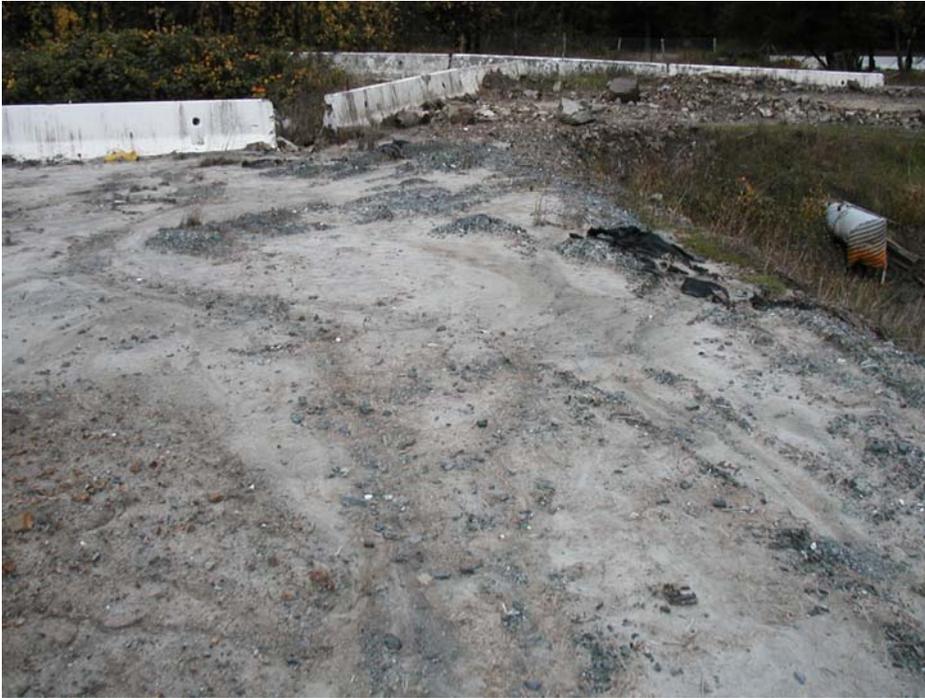
Bare dirt in vicinity of settling ponds

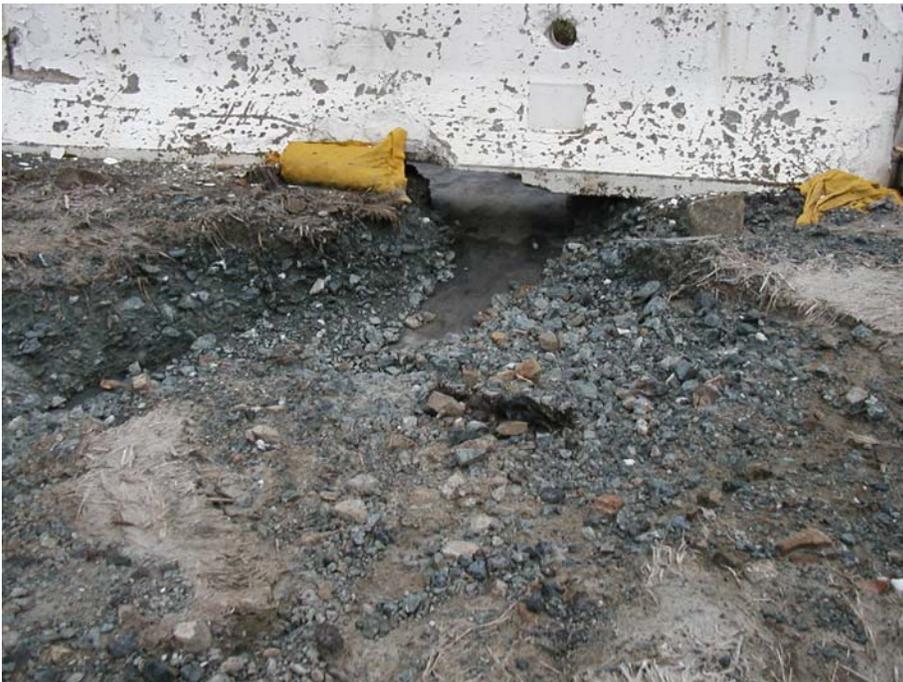
Unimpeded flow of sediments from finished lumber storage yard into settling ponds

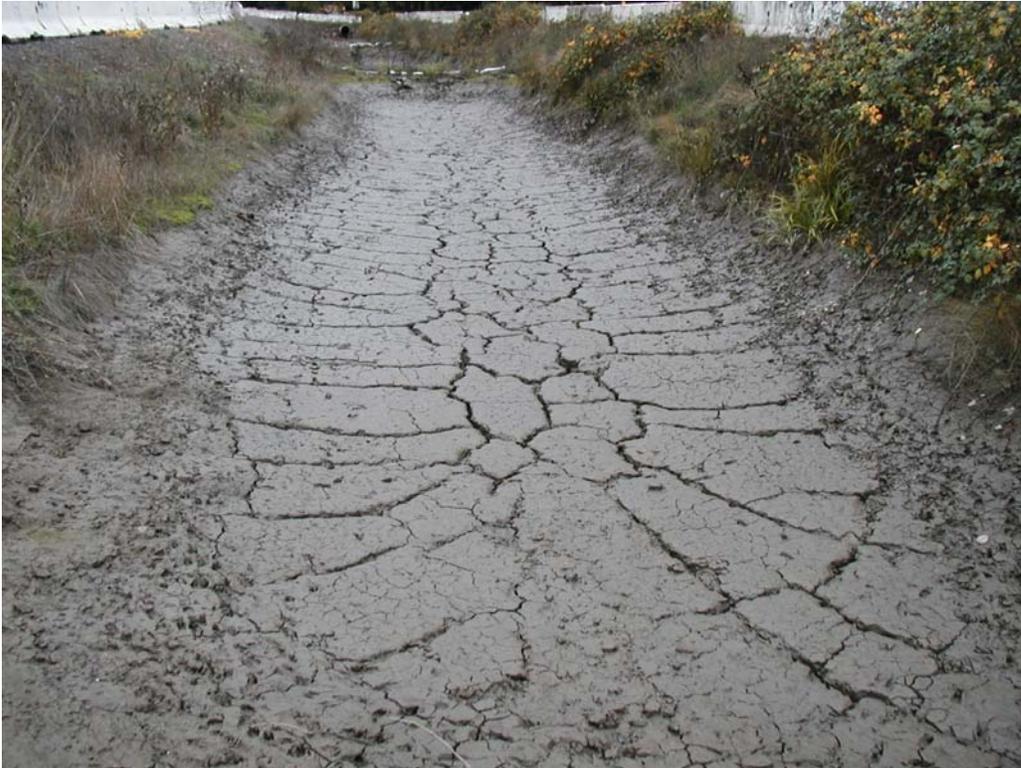
Settling ponds full of sediment

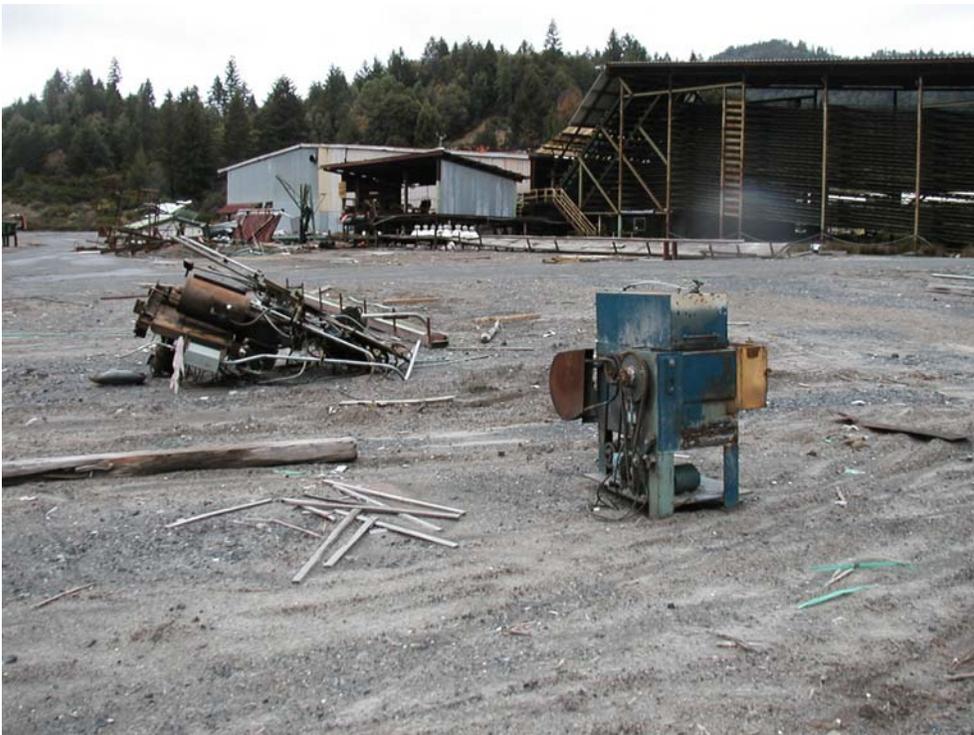
Equipment strewn throughout yard, some leaking oil

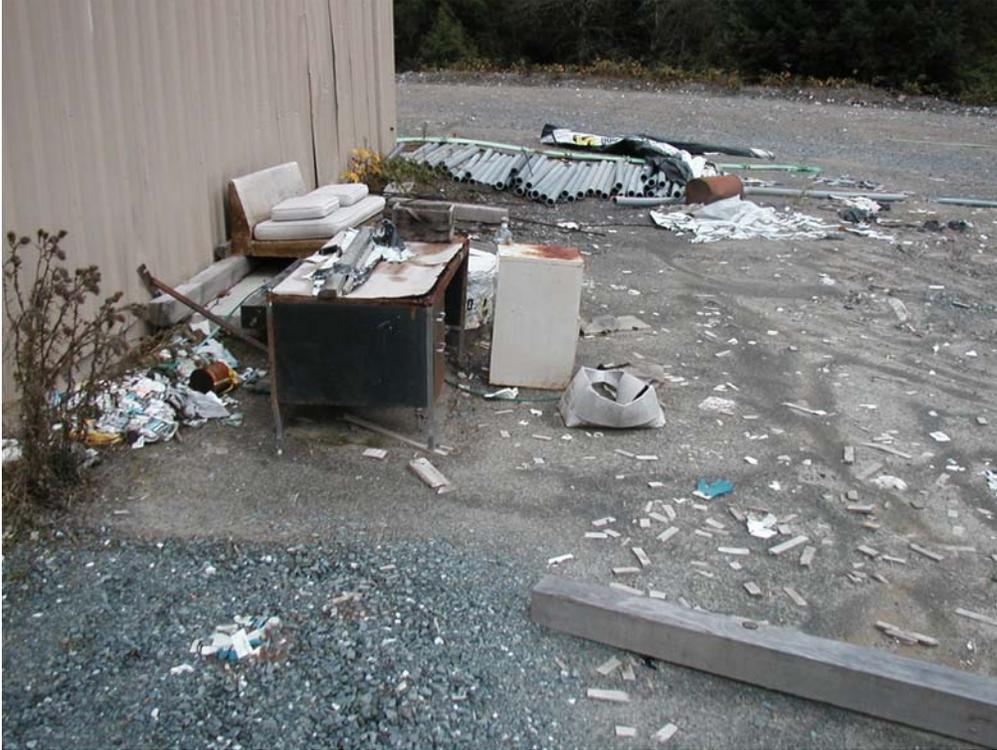
Poor housekeeping

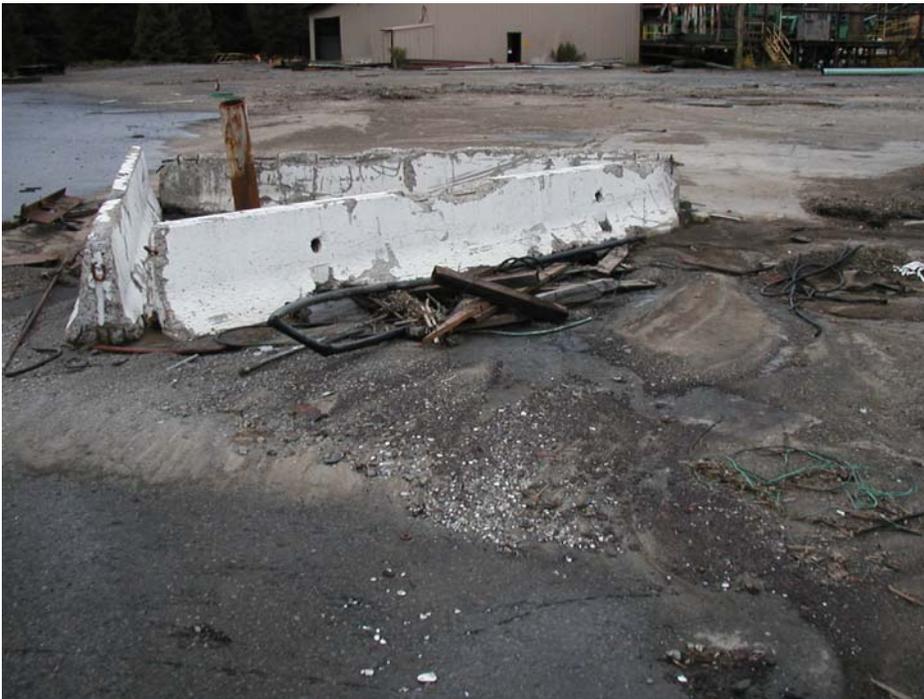
Sediments and hydrocarbons discharging unimpeded into open drop inlets throughout site.

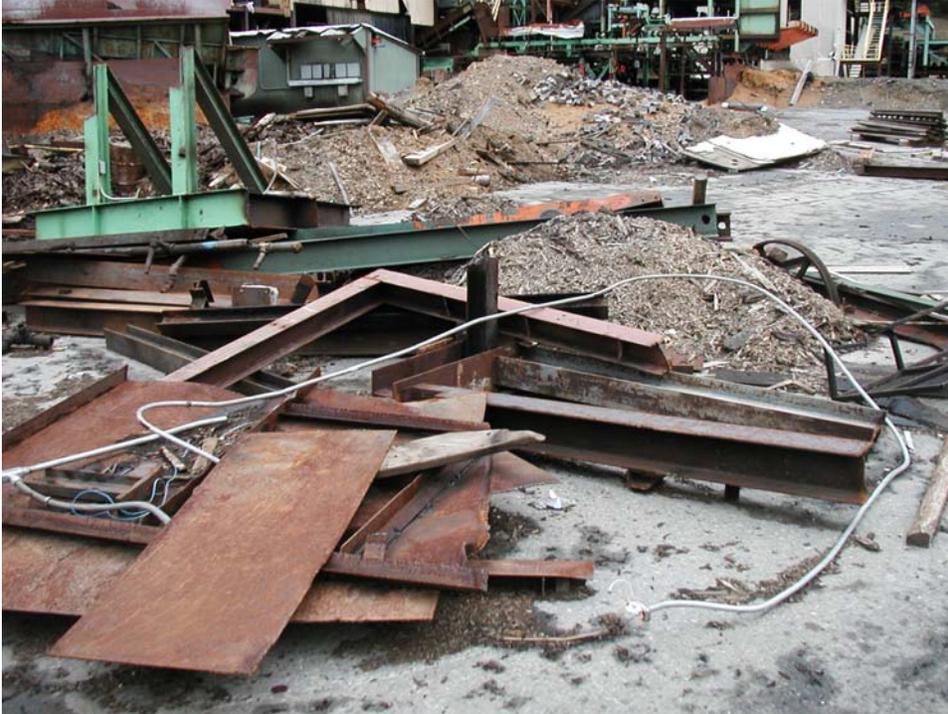
Scrap metal and rotting wood chip piles

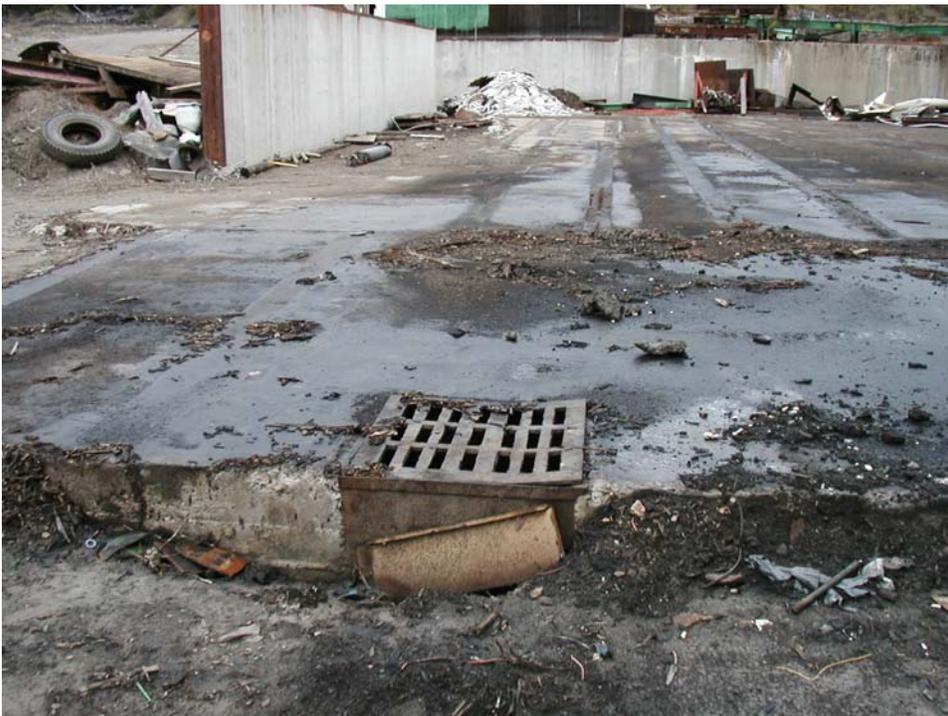
Formerly interior drains now exposed due to fires

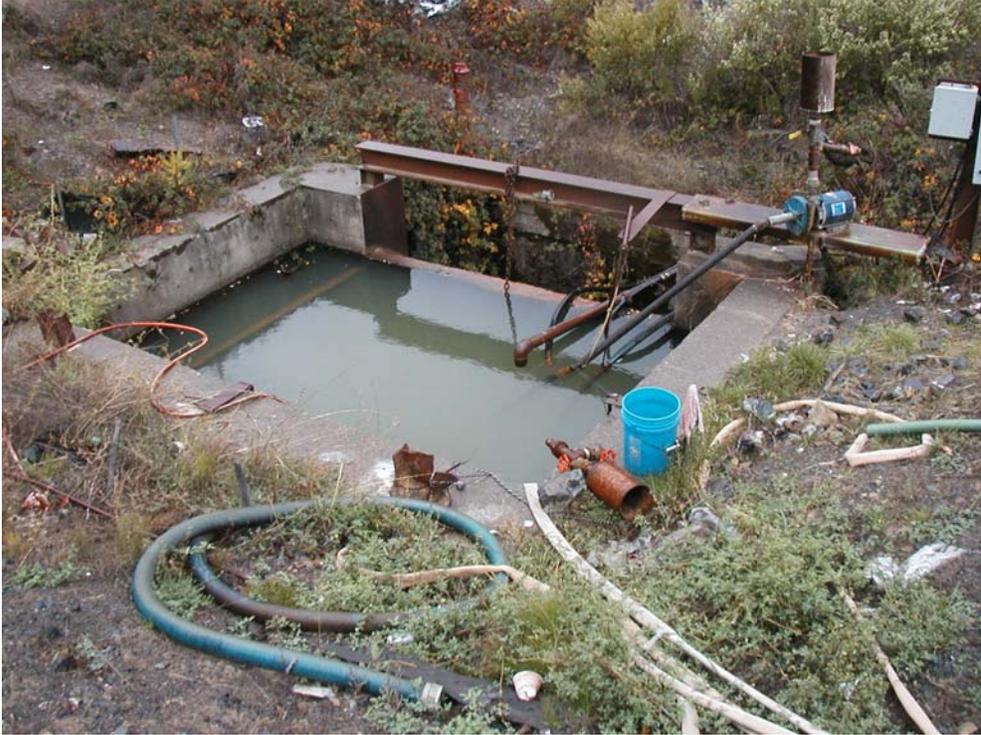
Buck Creek, tributary to Eel River, which bisects Harwood site

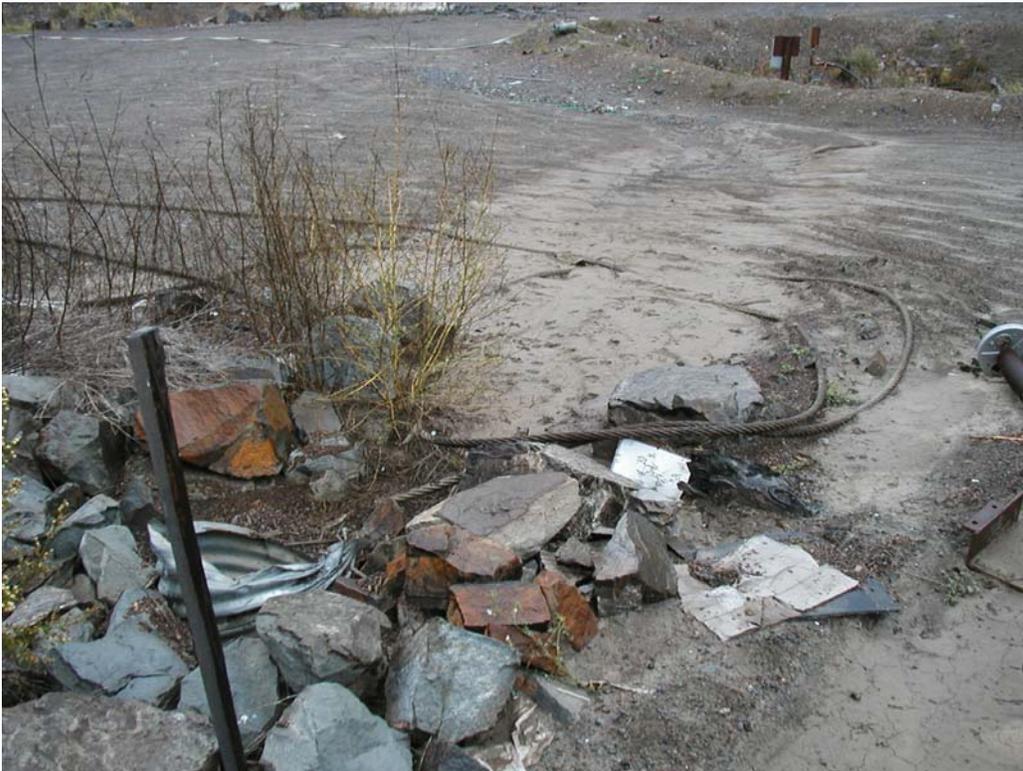
Sediment discharges into drop inlets in various locations onsite

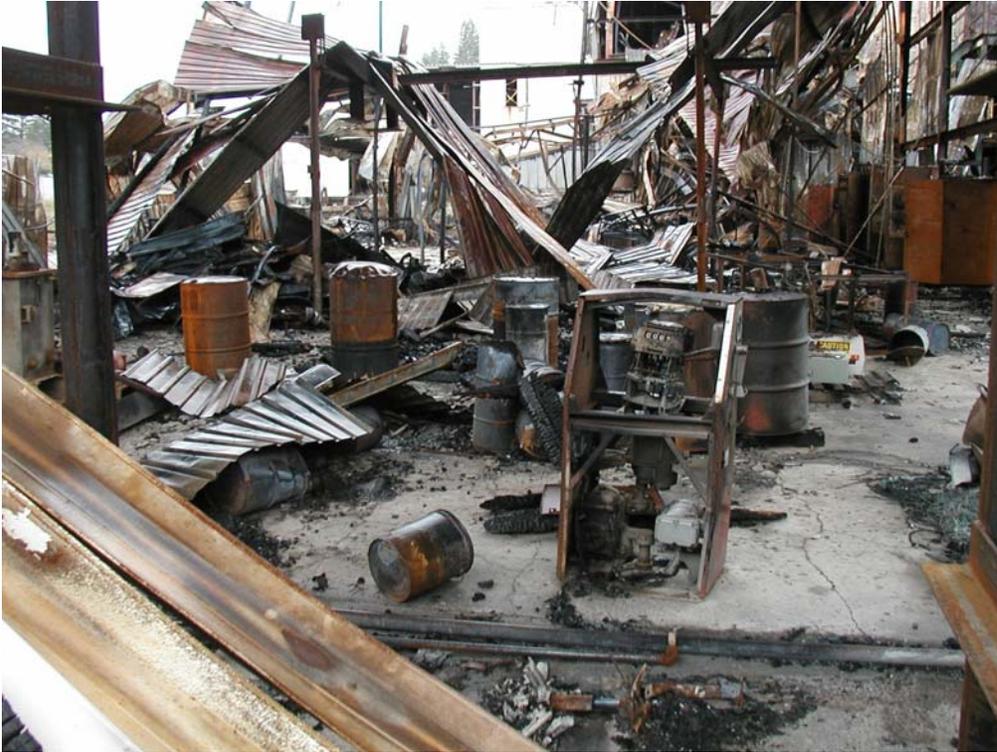
Fire debris – All discharge either directly to Buck Creek or to settling ponds

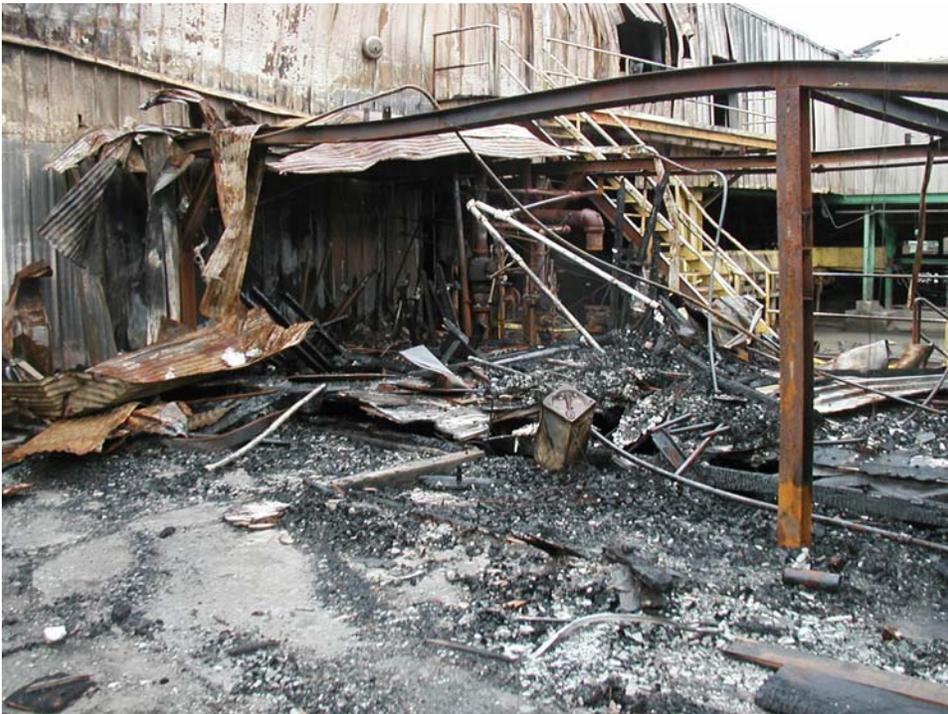
Potential dioxin contamination due to fire

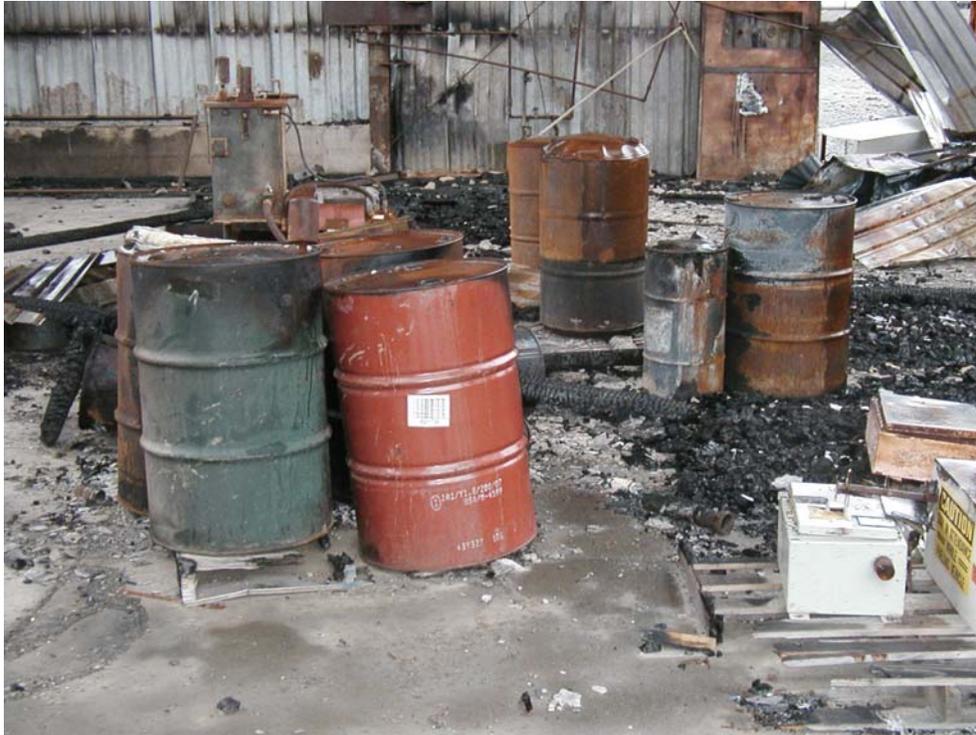
Drums containing unknown substances

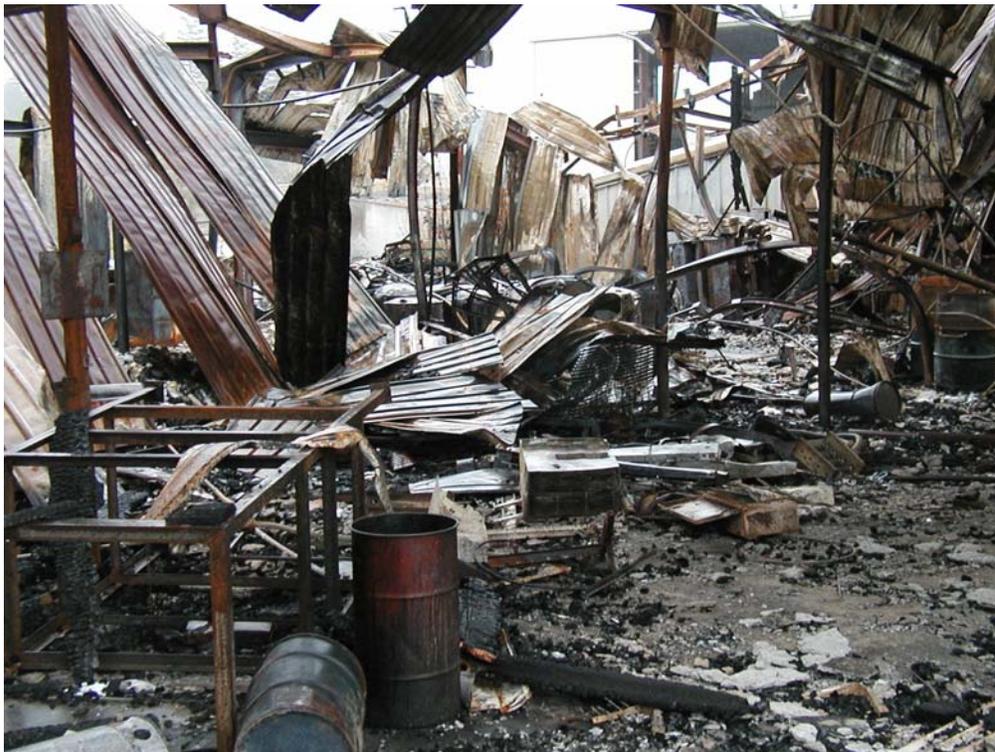
Fire debris

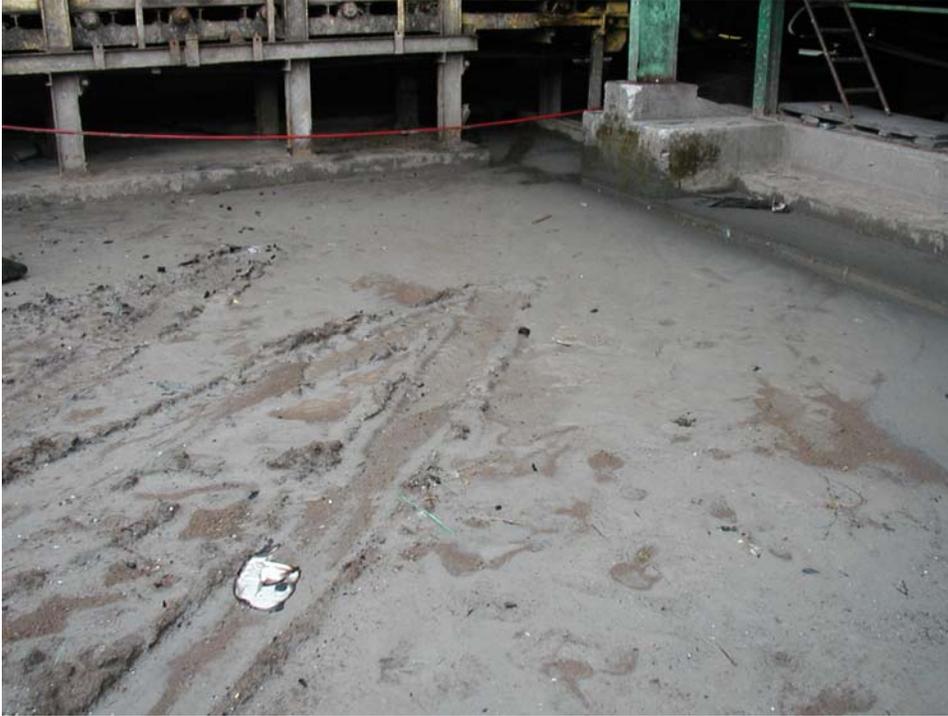
Sediments discharging to culvert under sawmill
