**California Regional Water Quality Control Board  
North Coast Region**

**Complaint Inspection Report  
Rector Frocteau Property  
25820 Comptche-Ukiah Rd. Comptche**

Subject: Complaint inspection of Rector/Frocteau Property

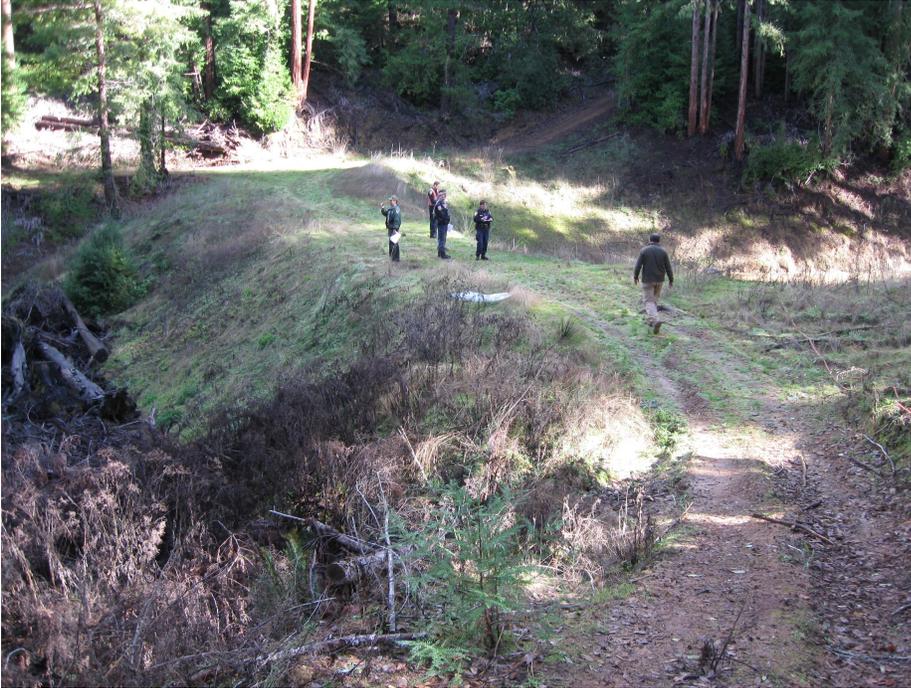
1/14/2010 Rector/Frocteau Property earthen impoundment approach and surface.

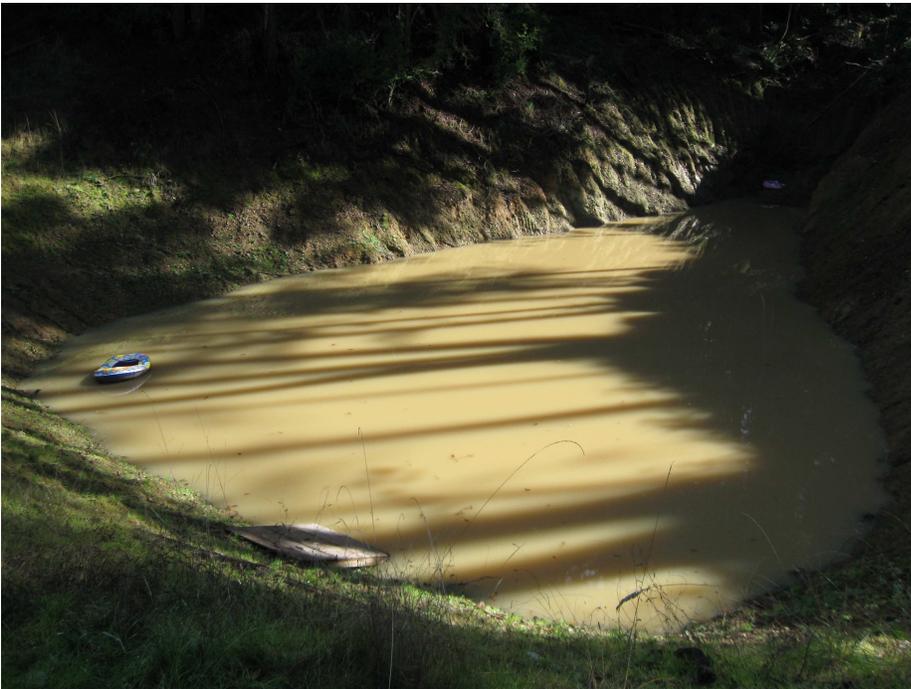
The impoundment was estimated at half capacity with the water line about 12 feet (slope distance) from the bottom of the spill way outlet. The previous year's high water mark appeared to be about 4 feet above the existing location. The impoundment did not appear to have ever reached full capacity. The downstream side of the dam surface evidenced tension cracks. The tension cracks did not appear to be recent; this is based upon spider webs observed in the interior of the cracks.

1/14/2010 Rector/Frocteau Property in-stream impoundment.

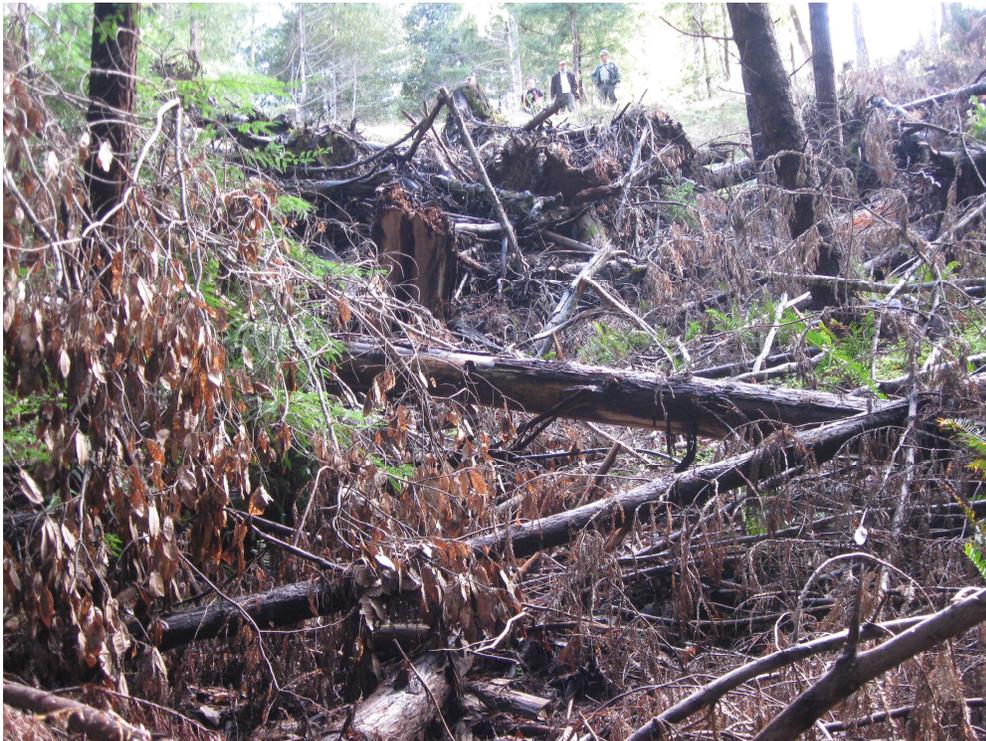
1/14/2010 Rector/Frocteau Property impoundment- The photo is from the base of the fill and woody debris looking up to the top of the impoundment, a slope distance that is estimated at approximately 35-40+ feet.
