**Complaint Inspection Report  
Erik Windschitl Burnt Ranch Property**

Date: December 9, 2010

Subject: Complaint Inspection of Erik Windschitl Property

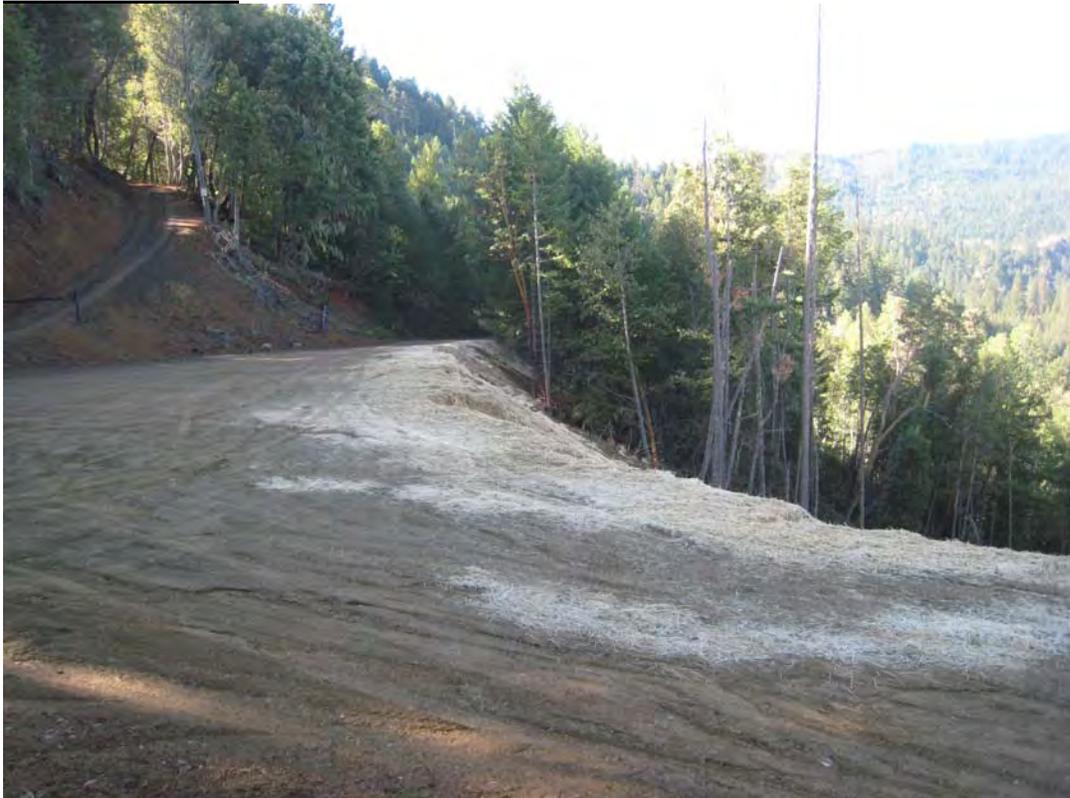
November 3, 2010 Photograph of Forest Service Road FSNO9 at the driveway to the Windschitl property where earthen materials appear to have been recently side cast over the edge of the road.

Side cast earthen materials off of roads that are near a surface stream or defined swale should be pulled back and stabilized in a location where adequate compaction can be achieved and there is no potential for delivery to surface waters. After compaction these excess materials should be treated with standard erosion control management practices.

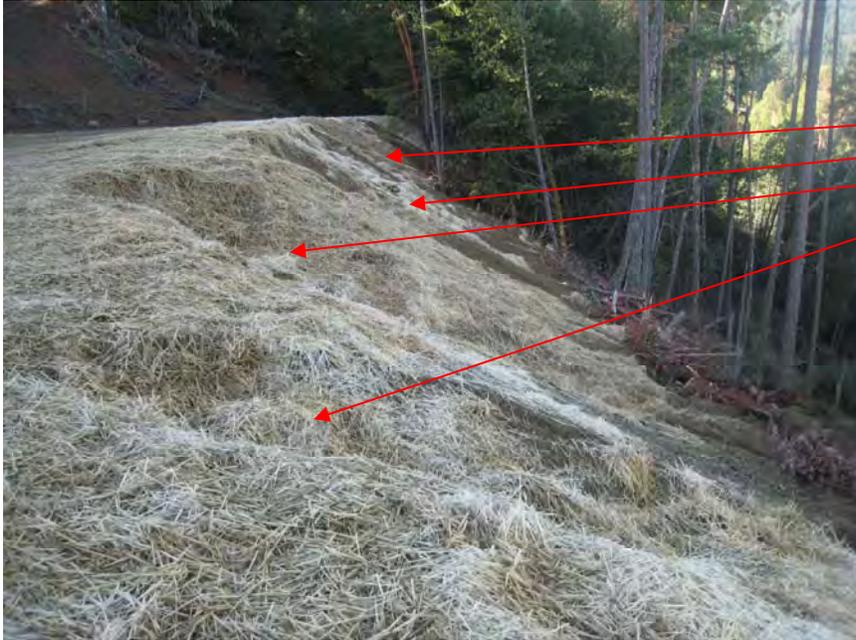
Fill failures

November 3, 2010 photograph a closer view of the side cast earthen material at the base of Windschitl property driveway. Here earthen materials were pushed over the edge of Forest Road NO9. Straw mulch was applied as the earthen materials had apparently failed during the first rains.

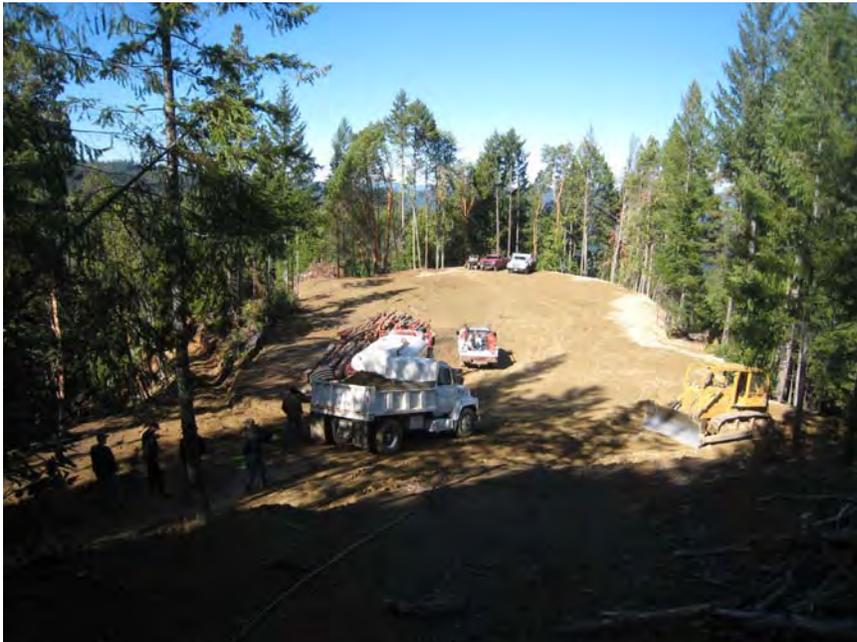
November 3, 2010 Pad #1 approximately an acre in size.

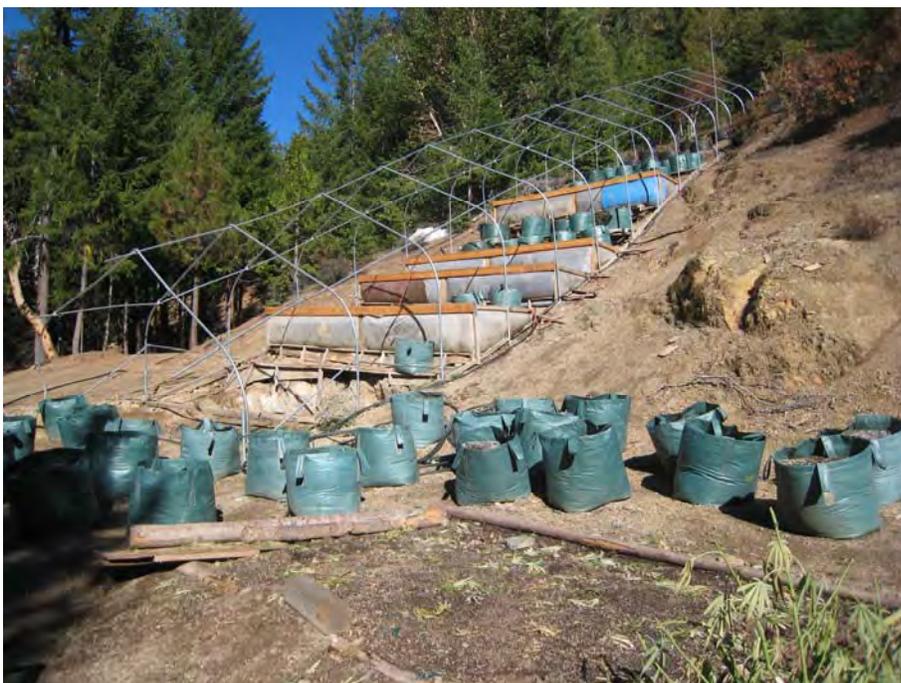
November 3, 2010-Grow site cut into slope near Pond 2.

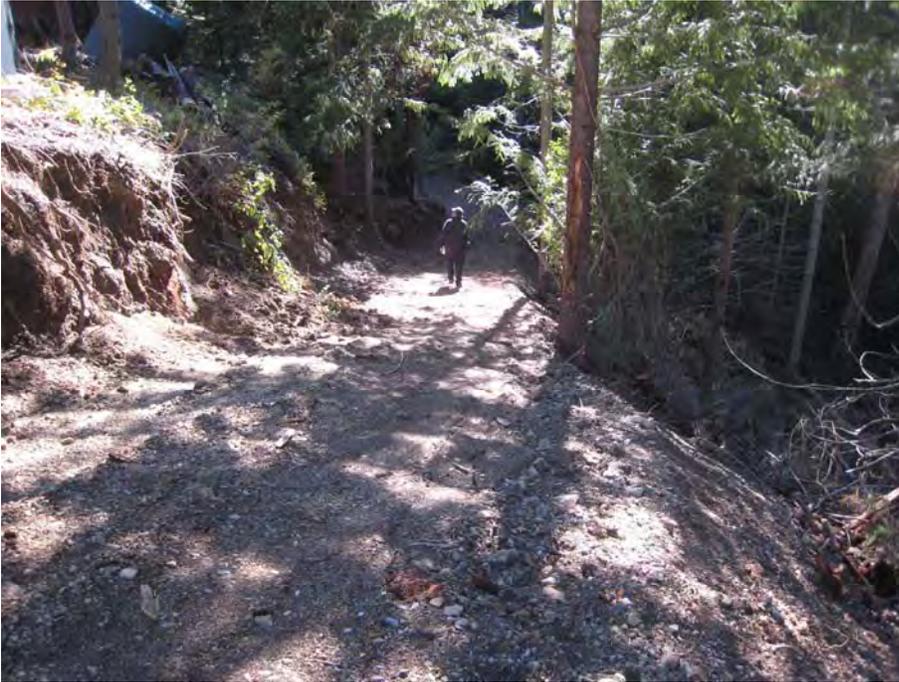
November 3, 2010-New road construction down to Class II stream and site of Pond 2 construction.

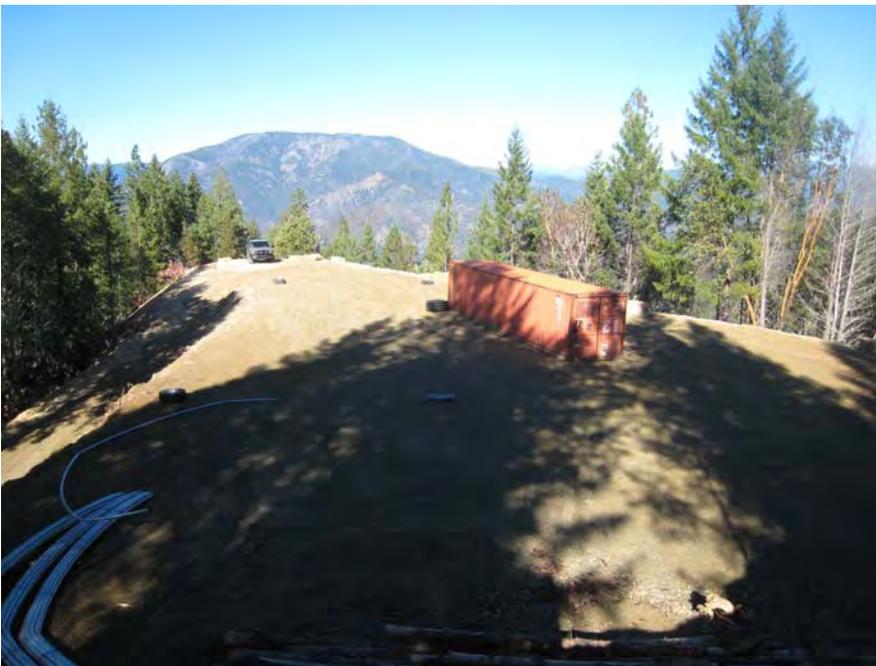
November 3, 2010 Pad 2 this is the pad that failed and delivered sediment down and across FS Road NO9.

To reduce the potential for catastrophic failure and sediment delivery to streams in an impaired watershed I would recommend that all perched fill material on the pads be pulled back and compacted back into the excavated areas in a manner to mimic natural surface contours that facilitate dispersed surface drainage from precipitation or snowmelt. It is likely that excess spoils will be generated. Excess spoils should be end hauled to a stable location where there is no threat of delivery to surface waters, compacted and treated with standard erosion control management practices.

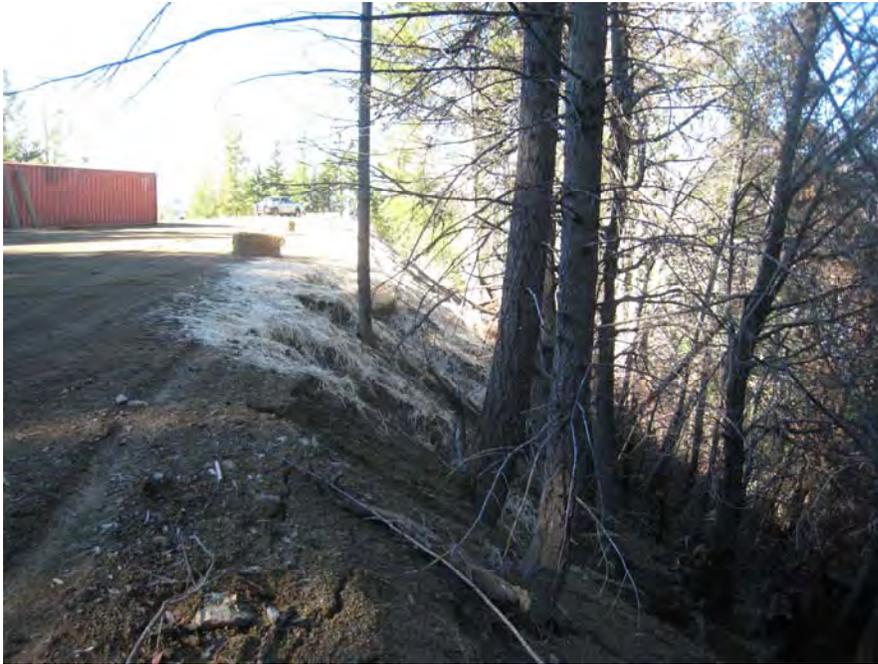
November 3, 2010 Pad 2 note the failing fill slope partially treated with hay and the fill burial around the trees.

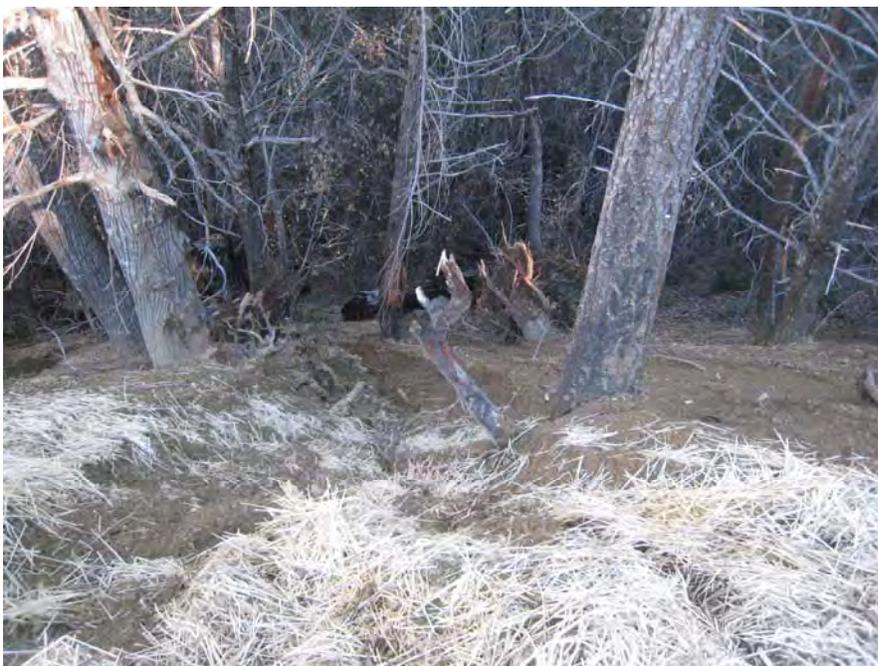
November 3, 2010 pad 2 photo of debris slide gully and trees buried within earthen fills.

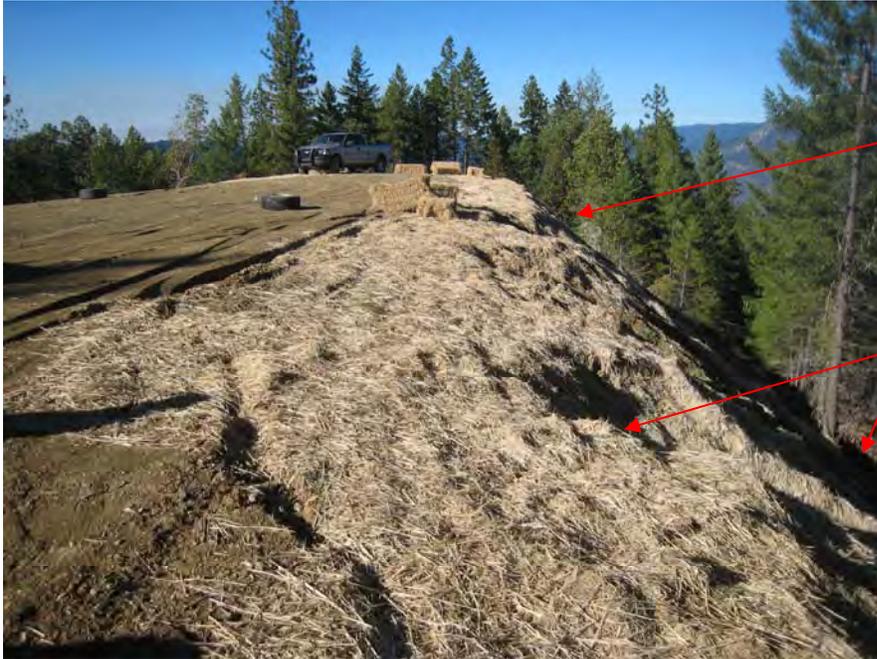
Long fill slope

Earthen fill failure

November 3, 2010 pad 2 edge of pad failing from first rains (note the long fill slope and material depth).

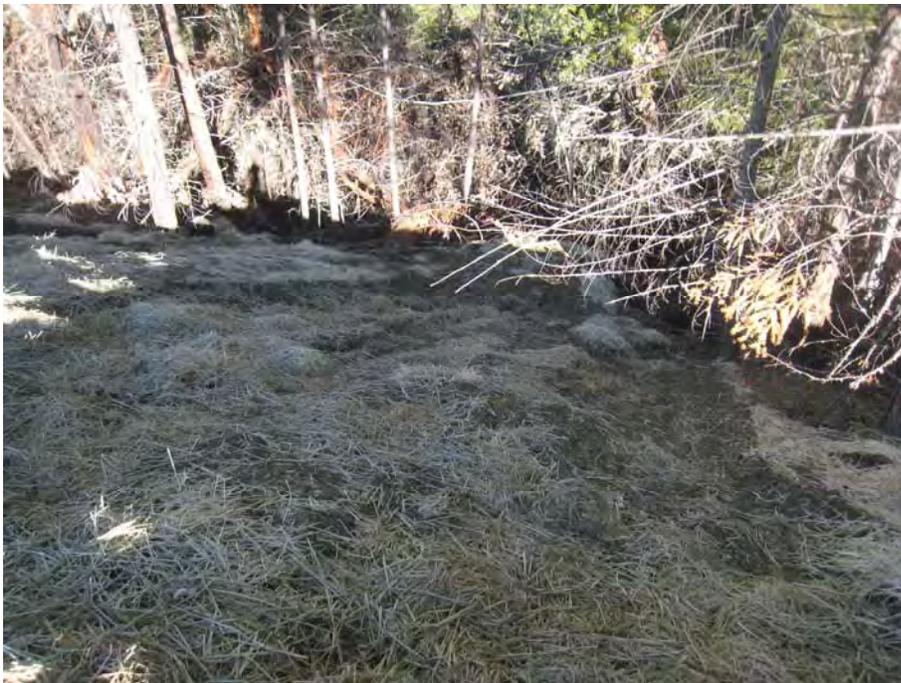
November 3, 2010 pad 2 fill slope failing after first rains

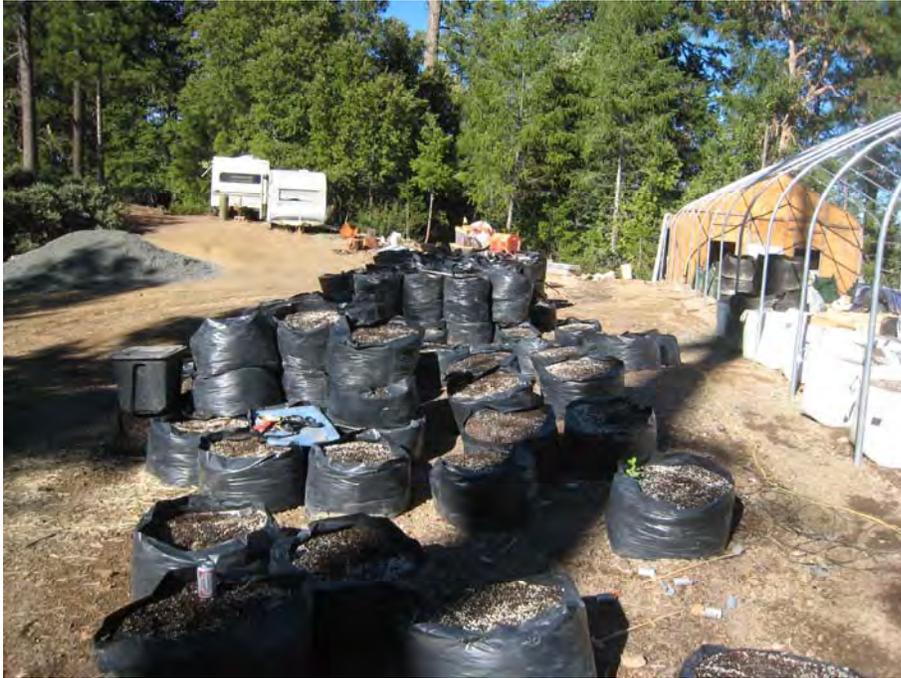
November 3, 2010 Pad 3 home site and possible grow site

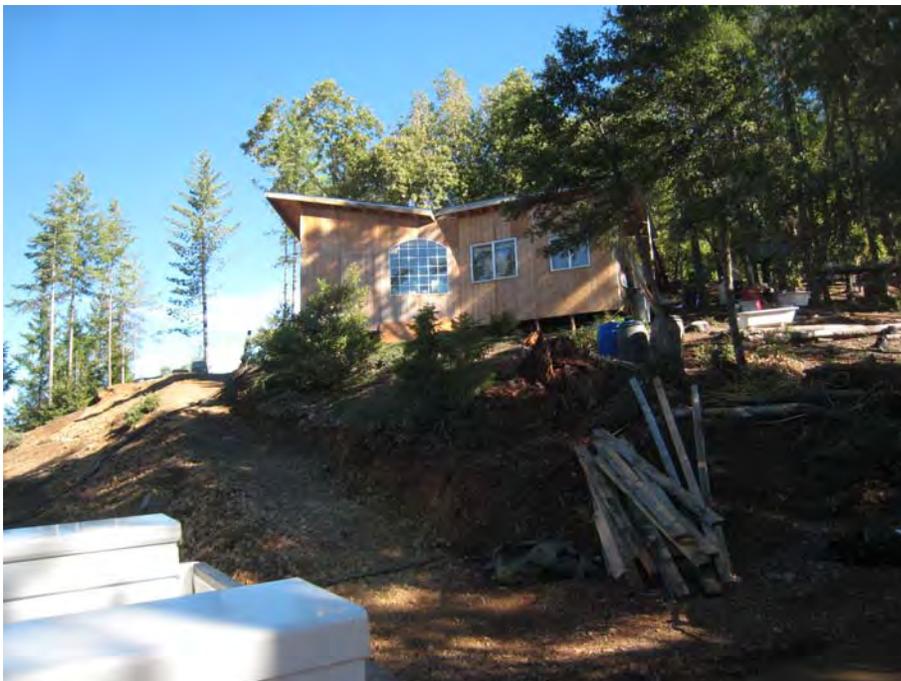
November 3, 2010 Pad 3 home site above previous photo

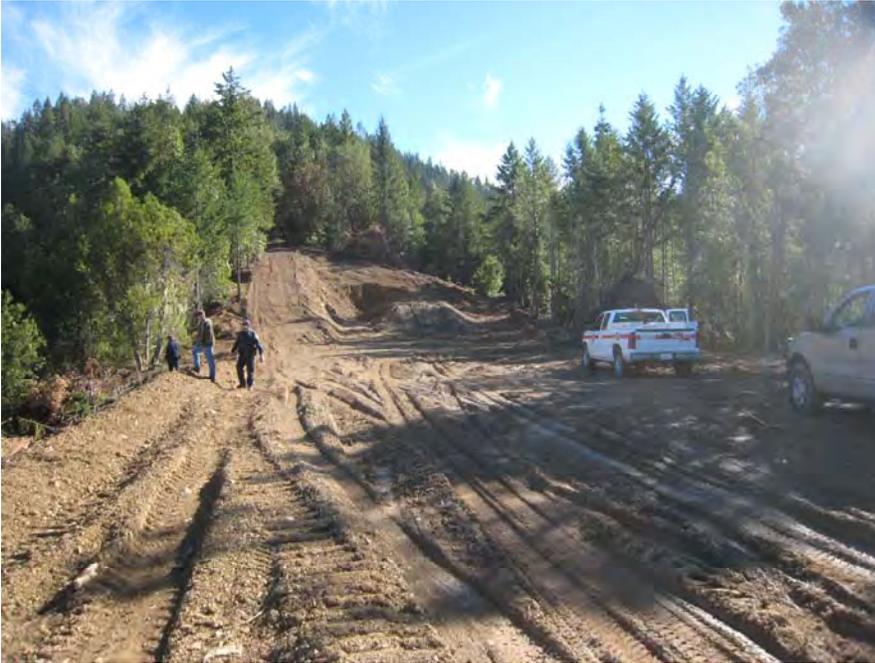
November 3, 2010 pad 4 recently constructed earthen pad of unconsolidated fill material.

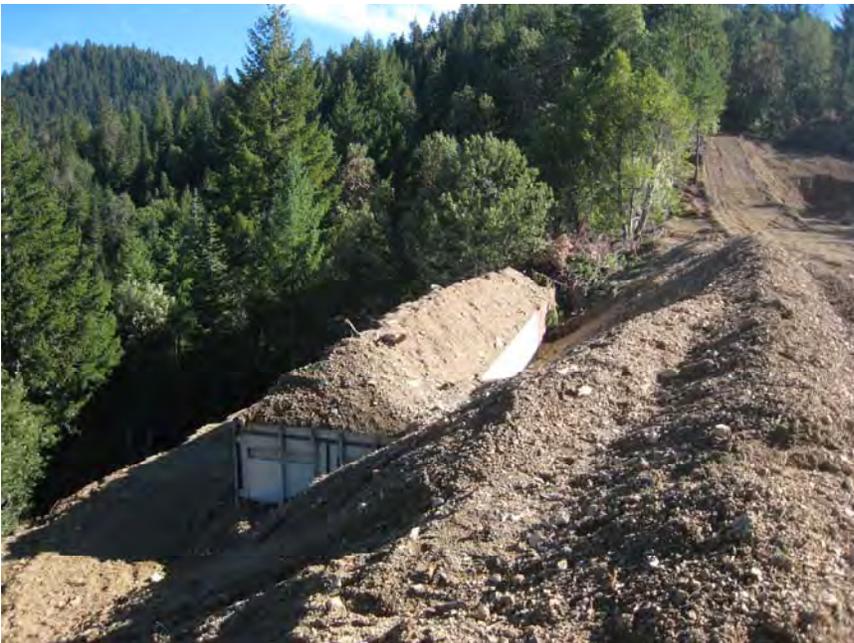
November 3, 2010 about 80 feet of a container partially buried on the North edge of pad 4 (note the unconsolidated nature of earthen fill materials)

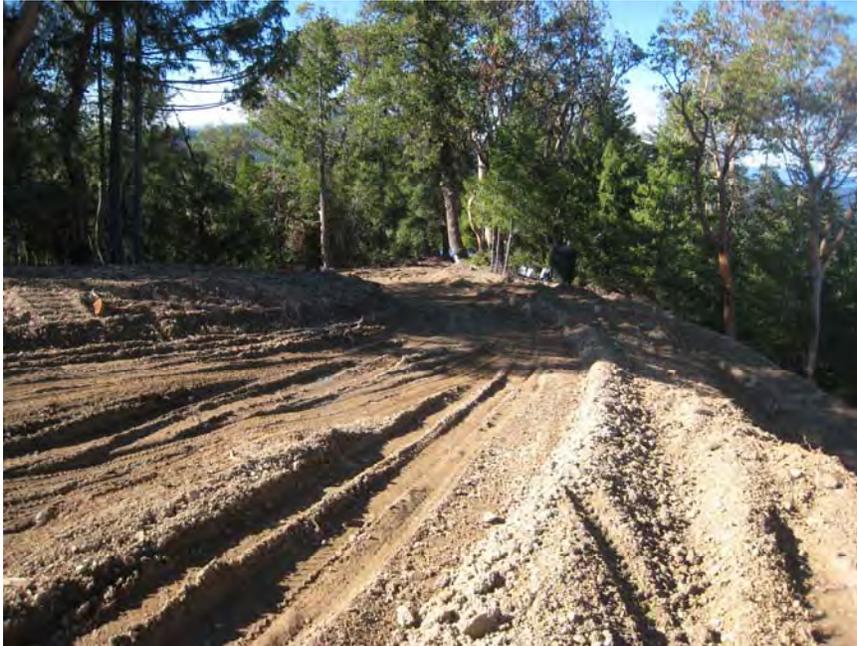
November 3, 2010 access road up to Pad 4 (note the rutting from pick up trucks in the loose earthen fill materials)

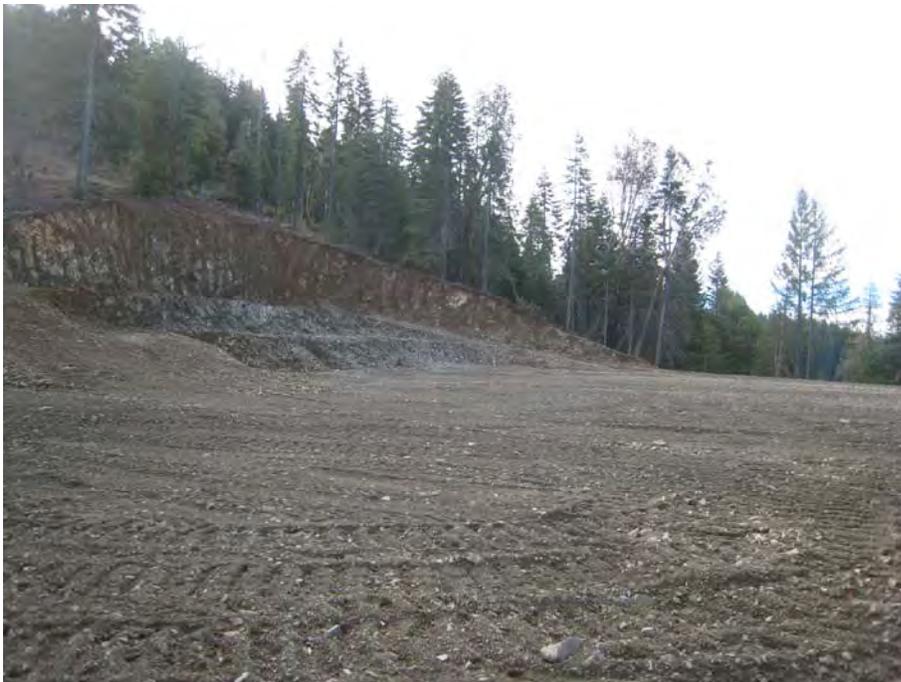
November 3, 2010 pad 5 at top of property

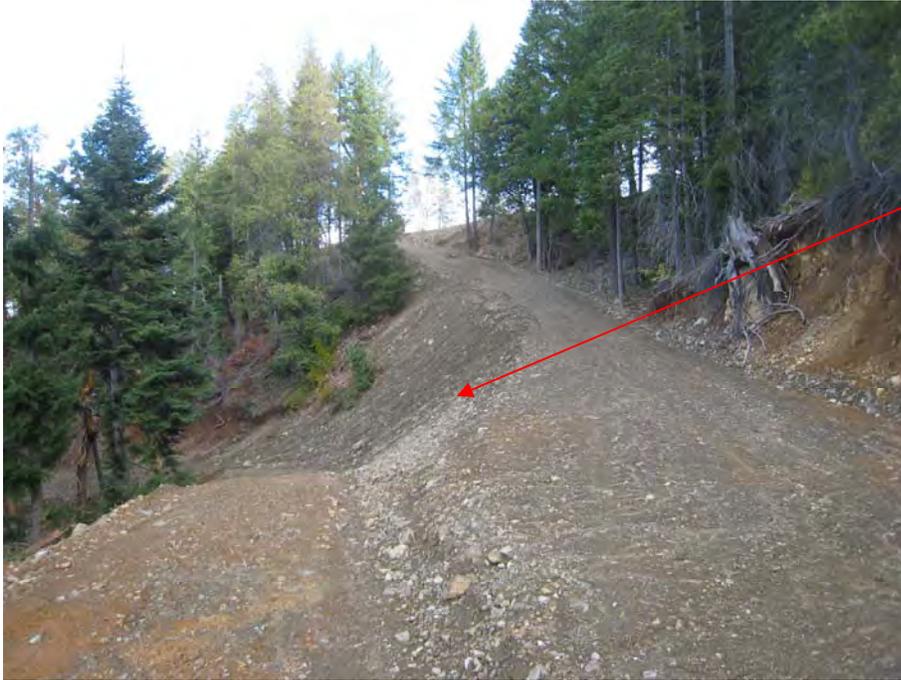
Failing side  
cast

November 3, 2010 access road to pad 5 (note the failing side cast off the road edge)

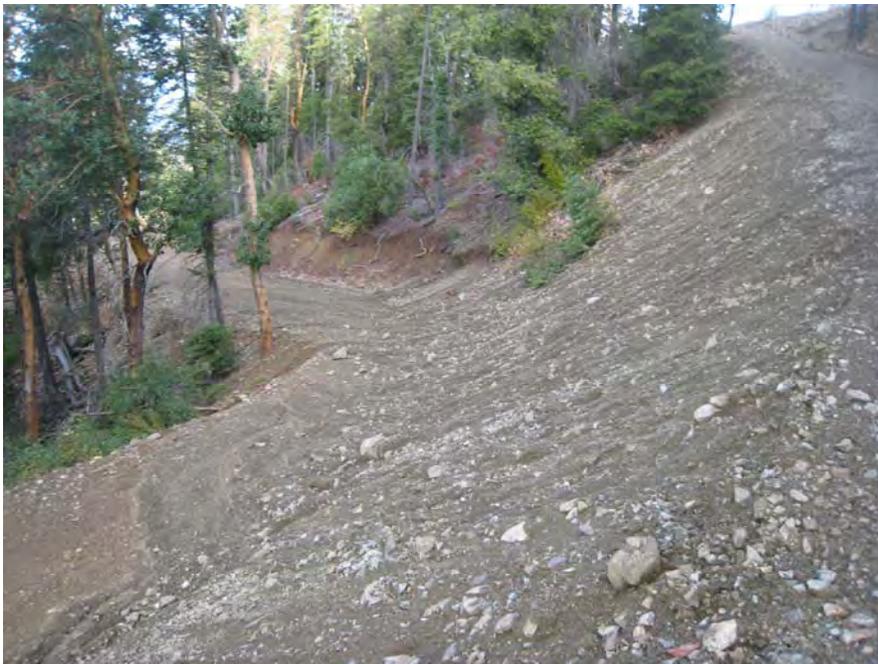
November 3, 2010 close up of failing side cast materials on road accessing pad 5 (note how these failing earthen materials are partially obscuring the lower road)

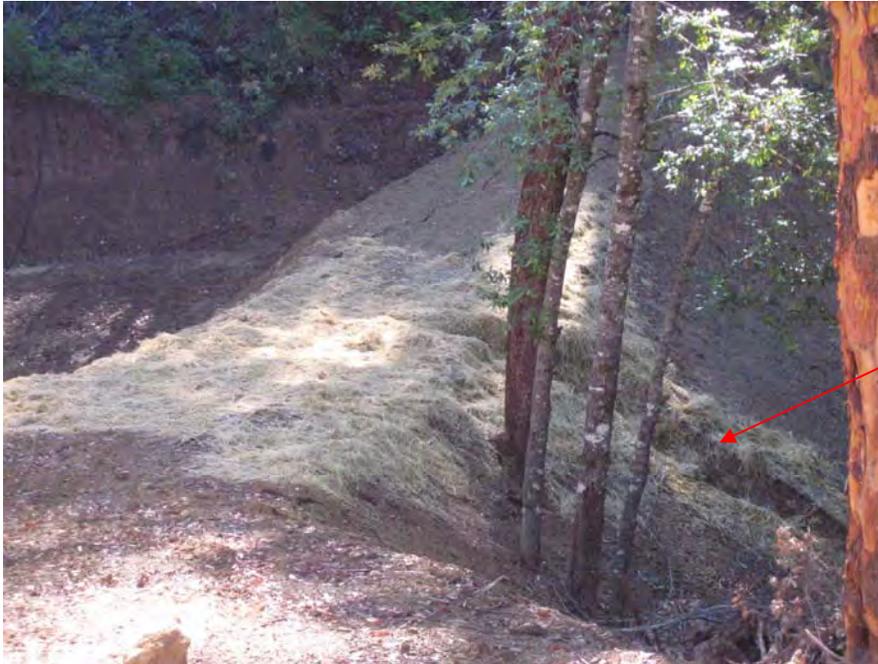
The lower pond identified on the attached map was constructed in what appears to be an ephemeral channel that during past logging was used as a skid trail. The skid pattern was still in evidence in the swale/stream bottom and is likely obscuring the original drainage pattern. The earthen dam was already failing from the first rains; erosion was clearly evident in the downstream fill slope.

Fill failure

November 3, 2010 lower pond earthen dam

Based upon the observations described in this report, the dams should be removed to reduce the potential for catastrophic failure of earthen fill materials. The areas of excavation should be restored by compacting earthen fill in engineered lifts assuring maximum compaction and shaping to mimic natural surface drainage patterns of dispersed flows. This work should be followed by a full re-planting of native vegetation to ensure surface stabilization and remediation success. It is likely that excess spoils will be generated. Excess spoils should be end hauled to a stable location where there is no threat of delivery to surface waters, and then compacted and treated with standard erosion control management practices.

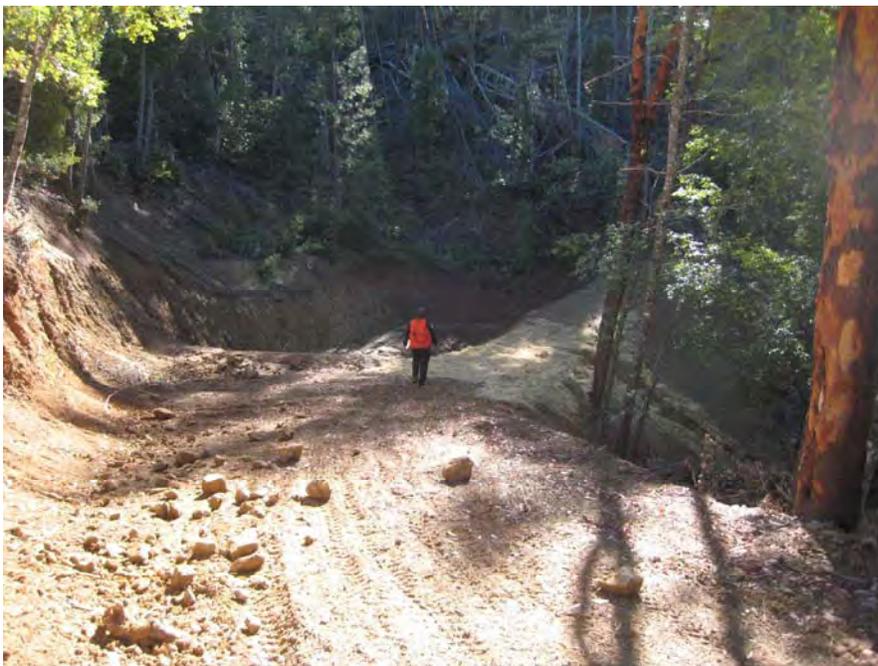
November 3, 2010 overview of lower pond

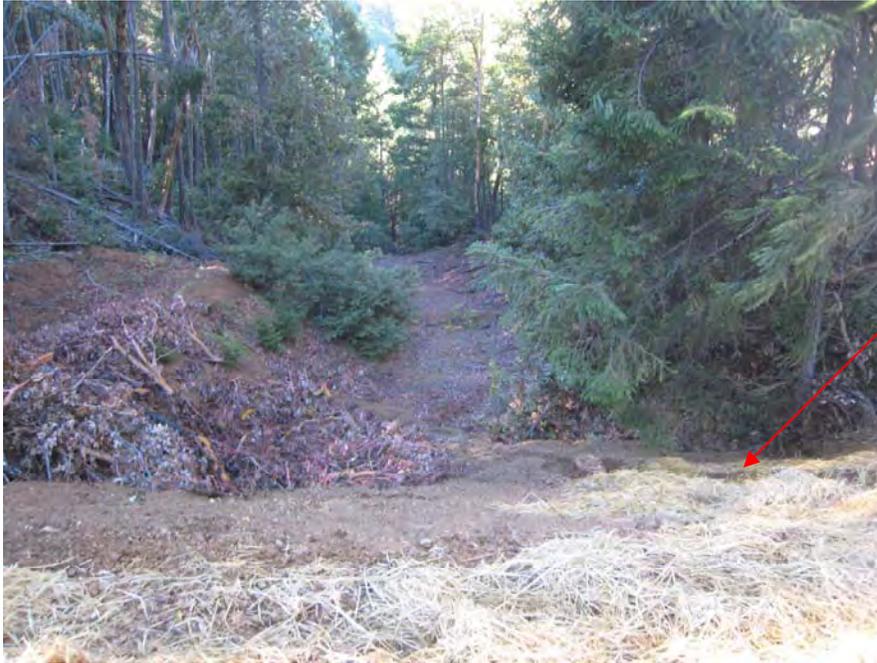
Fill failure

November 3, 2010 view from off lower pond earthen dam looking down at the old skid trails and truck road that appear to have been developed in the center of a drainage. The fill failure is also visible along the right side of the photo.

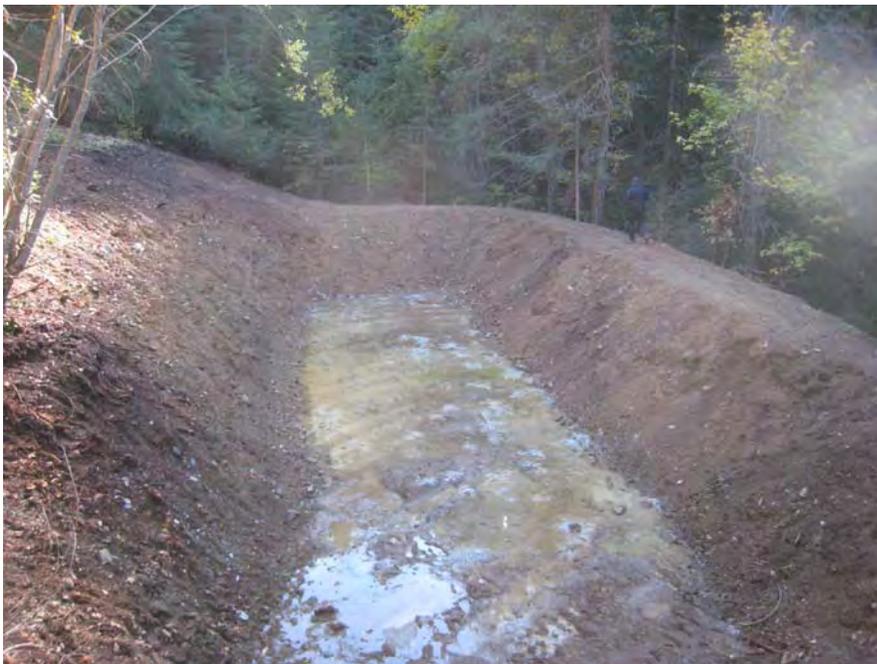
November 3, 2010- Upper pond is an off stream pond constructed directly adjacent to a Class II Stream

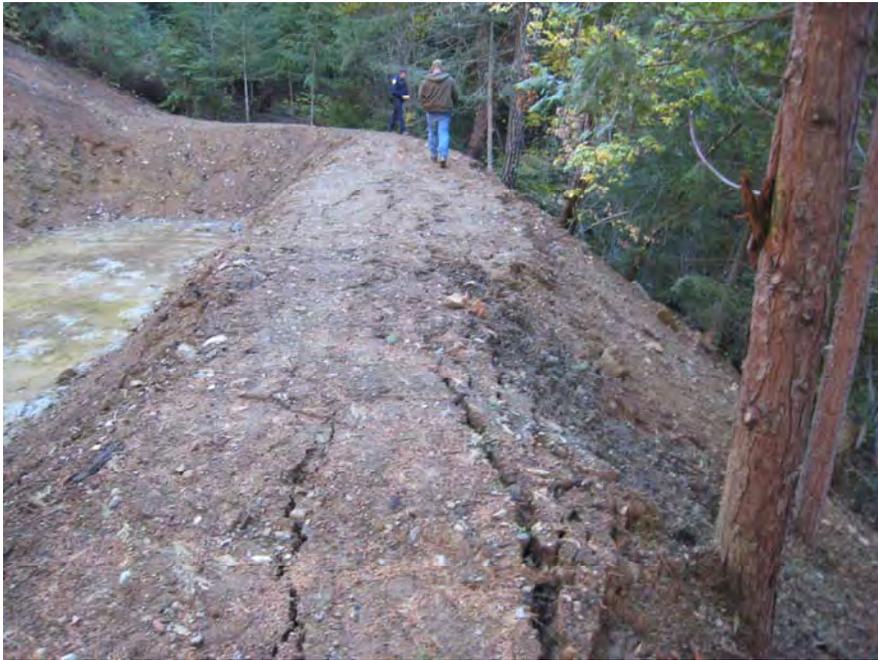
The Upper pond identified on the attached map is constructed adjacent to a Class II<sup>1</sup> stream channel. The earthen berm damming this impoundment appears to be constructed of unconsolidated earthen materials, which were failing, apparently from the first rains. The downstream fill face of the berm evidenced erosion that was delivering approximately 2-3 cubic yards of sediment to within approximately 25 feet of the Class II stream channel. This erosion is likely to progress through the winter and to result in substantial delivery of sediment to downstream receiving waters. In addition a pad of apparently unconsolidated earthen material was constructed directly below this impoundment within 10-12 feet of the stream.

November 3, 2010 Upper pond earthen fill berm/dam (Note the cracks forming in the fill that may indicate poor compaction and soil cohesion)

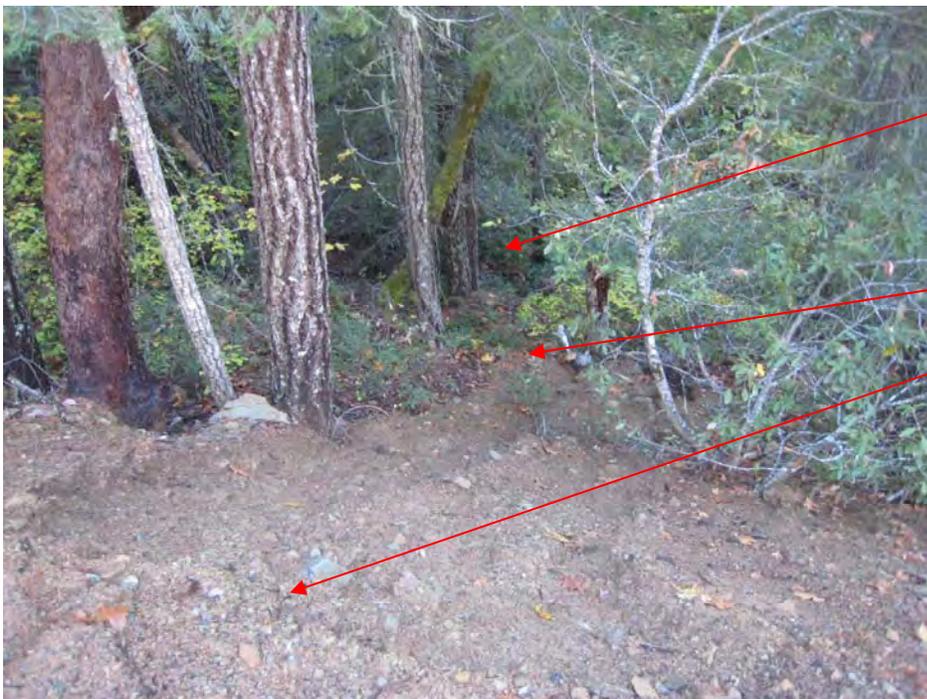
Stream channel

Fill failure plane

November 3, 2010 Upper pond fill failure down towards Class II stream.
