Complaint Inspection Report Yi Joung Min Properties Inspection Report WDID# 1B1110532CNME

Subject: July 8, 2011 Inspection of Yi Joung Min properties

Physical Site: 29980 HWY 101 North and 30010 HWY 101 North
County: Mendocino

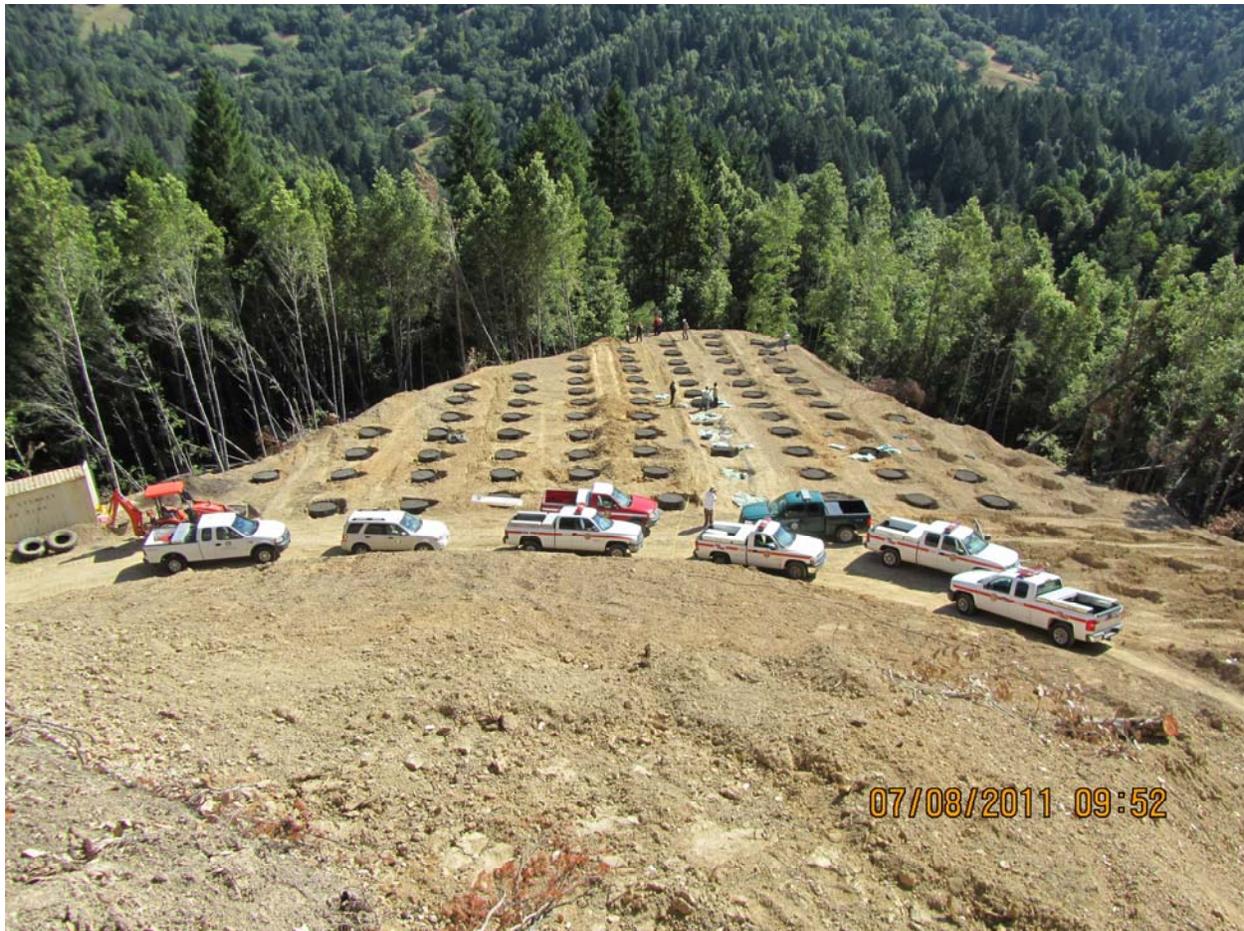
The inspection team started the inspection on Parcel 1. Parcel 1 contains a large earthen pad (top surface area approximately 1.8 acres) prepared for marijuana cultivation by excavation of multiple holes (approximately 99) and filling the holes with soil amendment. Two workers were adding amendment to the holes during the inspection.

Photo #1- Parcel 1 earthen pad overview

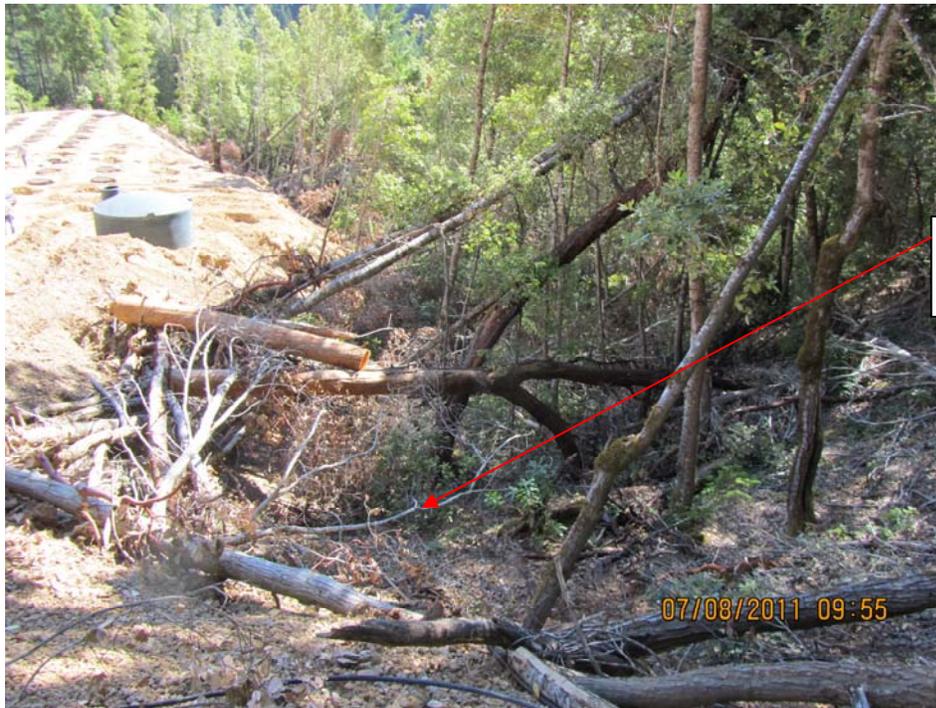
Watercourse

Based on my observations, it appears that construction of this pad resulted in the discharge of organic and earthen material into or where it could pass into waters of the State and United States. I observed woody material in the westerly portion of the Class III channel on the south side of the fill pad, and earthen materials perched within the woody materials less than 50 feet from the adjacent watercourse at the southwest corner of the fill, and within 150 feet of the watercourse at the southeast corner of the fill. I expect that with winter rainfall, much of the unconsolidated earthen fill material will slide down the steep slopes and deliver to the stream described above. In addition, the CGS Memo indicates that there appears to be a significant potential that if the fills used in the pad construction become saturated, the fill slopes will fail, likely impacting not only downslope watercourses, but the downslope house pad, site driveway, and Highway 101; saturation of the uncompacted fills could occur from irrigation of vegetation of plants on the pad and/or from winter rains.

Photo#2: Parcel 1 - woody and earthen materials in and perched adjacent to watercourse at top (west side of earthen pad)

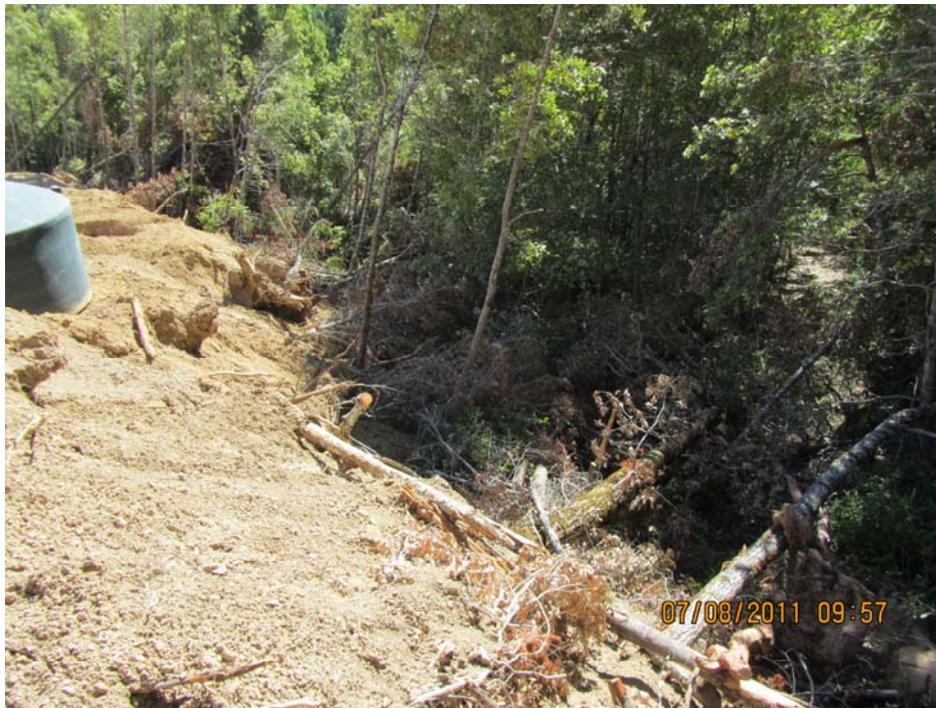
Photo #3: Parcel 1 - side cast earthen materials on top of trees and brush above watercourse channel

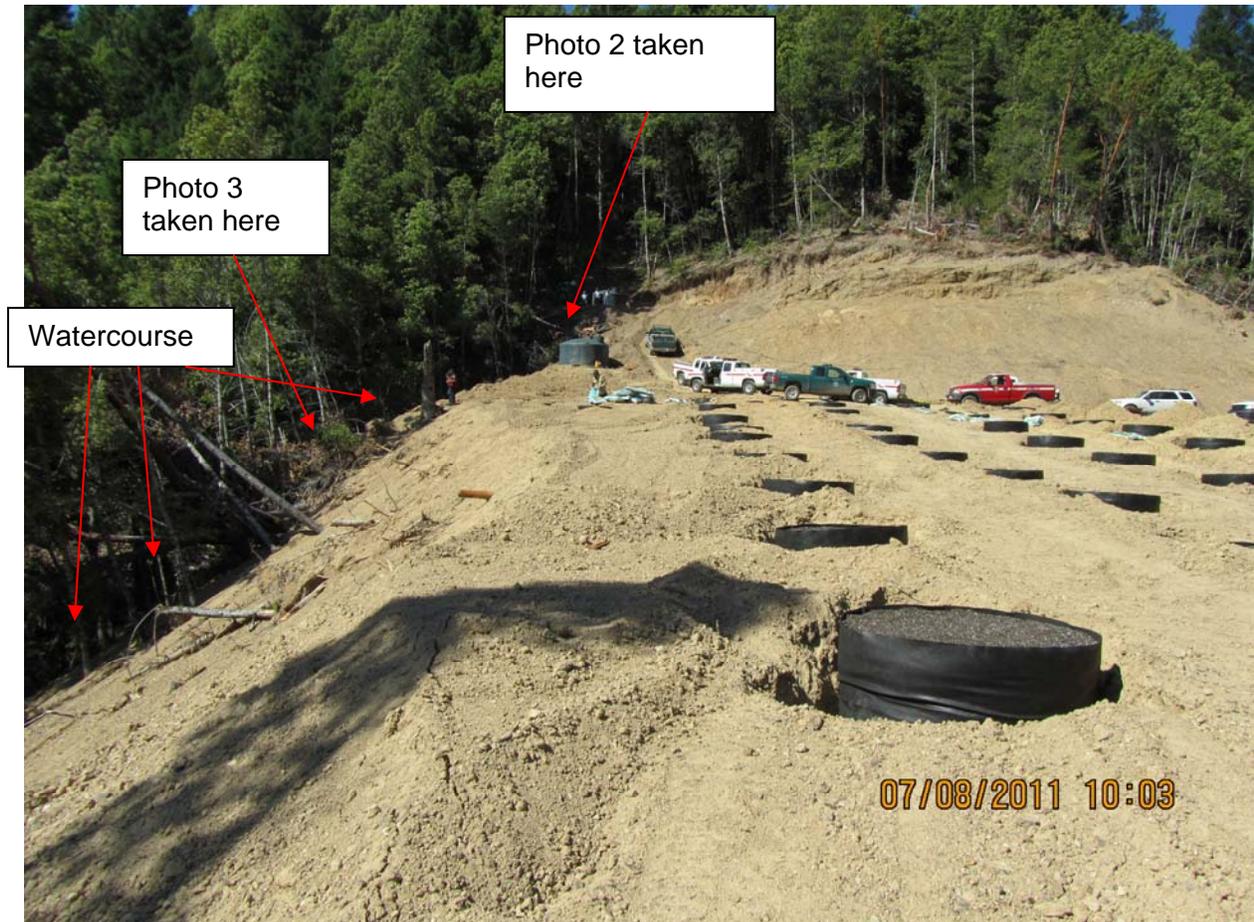
Photo #4: Parcel 1 - East end looking toward the west end.

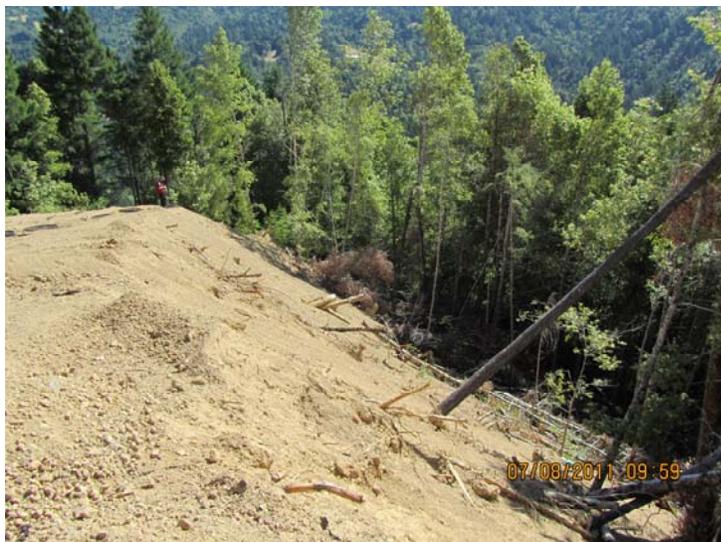
The Parcel 1 earthen pad appears to be underlain, and in some areas supported, by large and small woody debris and material. A Class III watercourse borders Parcel 1 on the southern edge; the watercourse flows to the east. There is a house pad located immediately below and northeast of the earthen pad (refer to the CGS Memo⁵ for detail).

Photo #5: Parcel 1 - looking west down south side (note the woody material sticking out of the earthen fills and depth of fills)

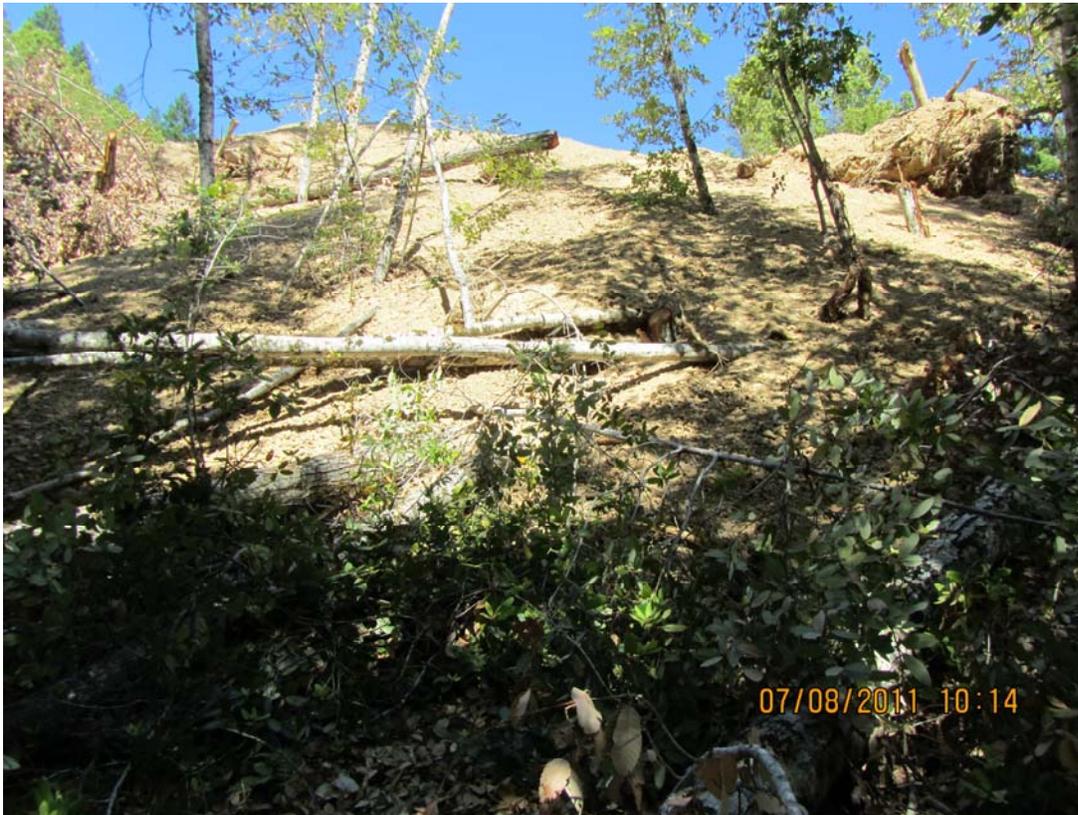
The Parcel 1 earthen pad appears to have been constructed on terrain with natural slopes in excess of 80%. I measured the slope leading to the watercourse on the South Side of Site 1 with a clinometer and found that along the lower southeast side, the side slopes leading to the watercourse range from 68-75% and as the slope leads up to the west along this southern edge, native slopes increase to 90-94%. The earthen fill materials piled on top of the woody debris have side slopes ranging from 60-80%. The majority of the fill material side slopes are around 65-70%. The fill side slopes were loose and unconsolidated. There is no visible evidence to suggest that the earthen materials were compacted during construction. Dave Longstreth's inspection memo (referenced herein as the CGS Memo), indicates that the fill pad is estimated to be a maximum of about 20 to 25 feet thick and is estimated to be on the order of about 15,000 cubic yards of material. The earthen pad is located approximately 1,300 feet from Highway 101, as estimated from a USGS Topographic Map (Willits 7.5 minute Quadrangle).

Photograph #6: Parcel 1 - looking up at fill slope from about 50 feet above the watercourse

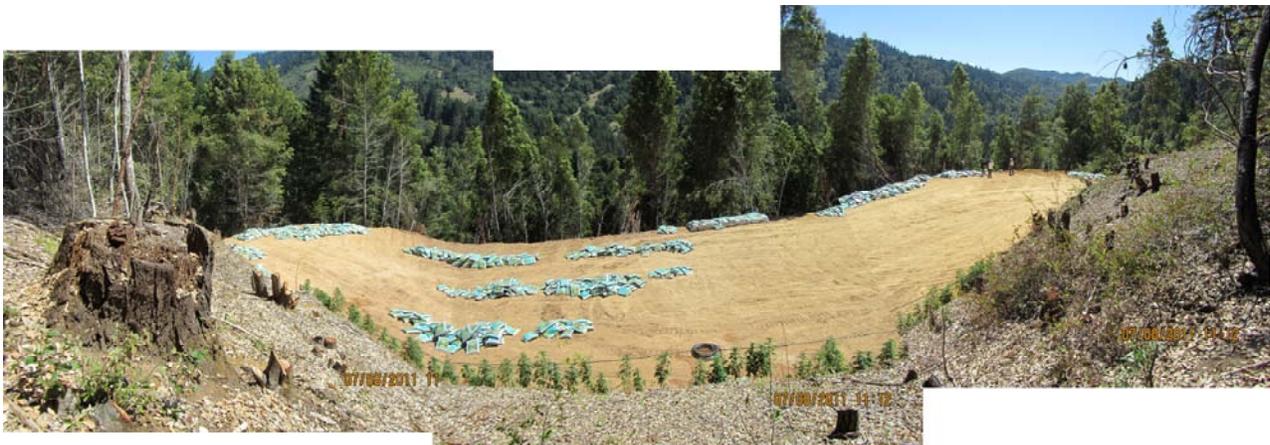
Parcel 2 contains a constructed earthen pad, approximately 0.7 acres in size, constructed in similar manner as the pad located on Parcel 1, though this pad appears to have been constructed by enlarging upon an existing landing, which likely indicates that the volume of earthen material excavated was not as extensive as that excavated to construct the pad on Parcel 1. The Parcel 2 pad does not appear to pose an immediate threat to water quality. The east edge of the unconsolidated earthen fill materials is perched on top of an 80% slope directly above, and about 800 feet from Highway 101. Similar to the earthen pad observed on Parcel 1, the perched earthen materials in the fill prism on Parcel 2 include large and small woody materials, and the earthen fill does not appear to have been compacted during construction. The CGS Memo indicates that the volume of fill materials involved in this prism is about 2,500 cubic yards.

Photograph #7: Parcel 2 earthen pad overview, photo merge slightly skews the shape of Site 2, as it is relatively linear along the down slope edge. This photo series is taken from above the pad looking to the east.

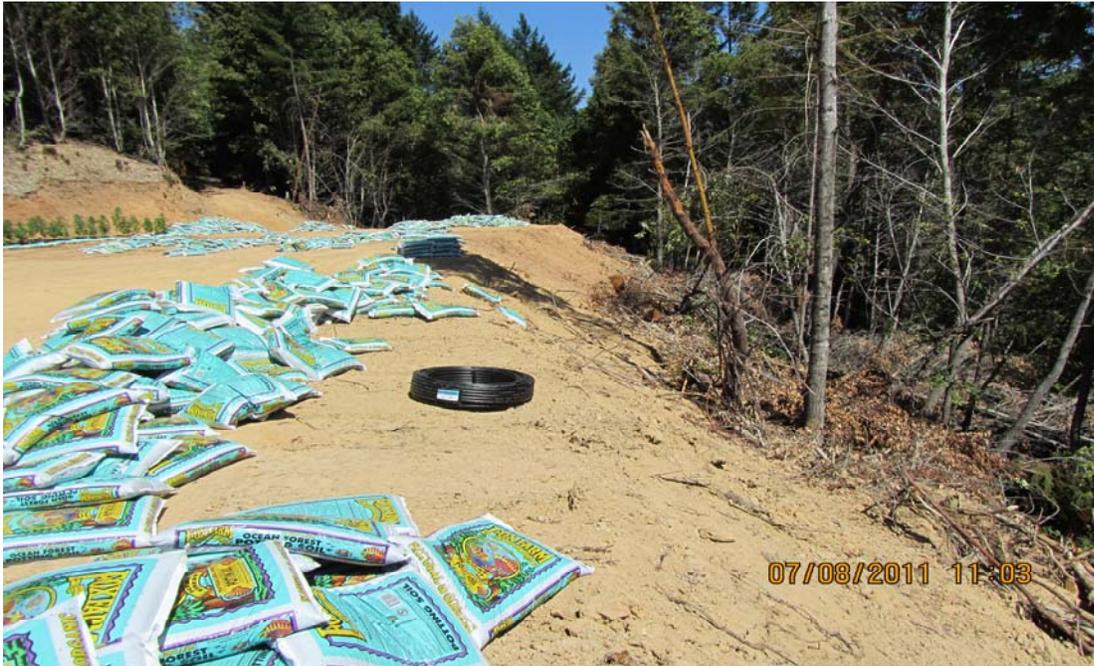
Photograph #8: Parcel 2 - East side of pad looking North

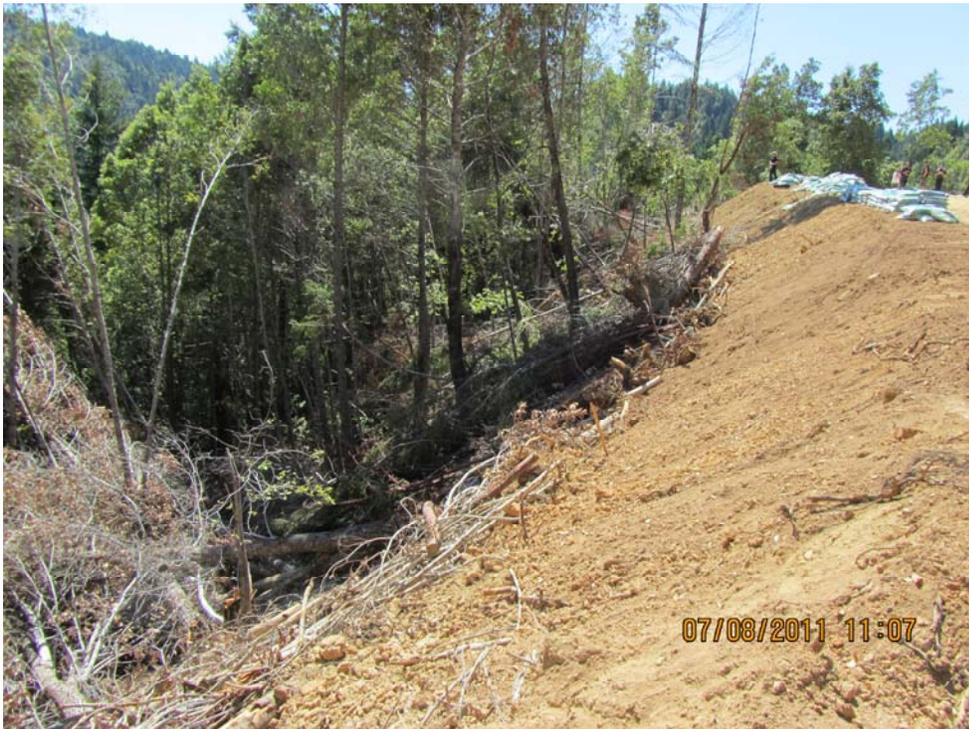
Photograph #9: Parcel 2 - East side of pad looking south (note the loose earthen fills and the buried woody materials at the fill base)

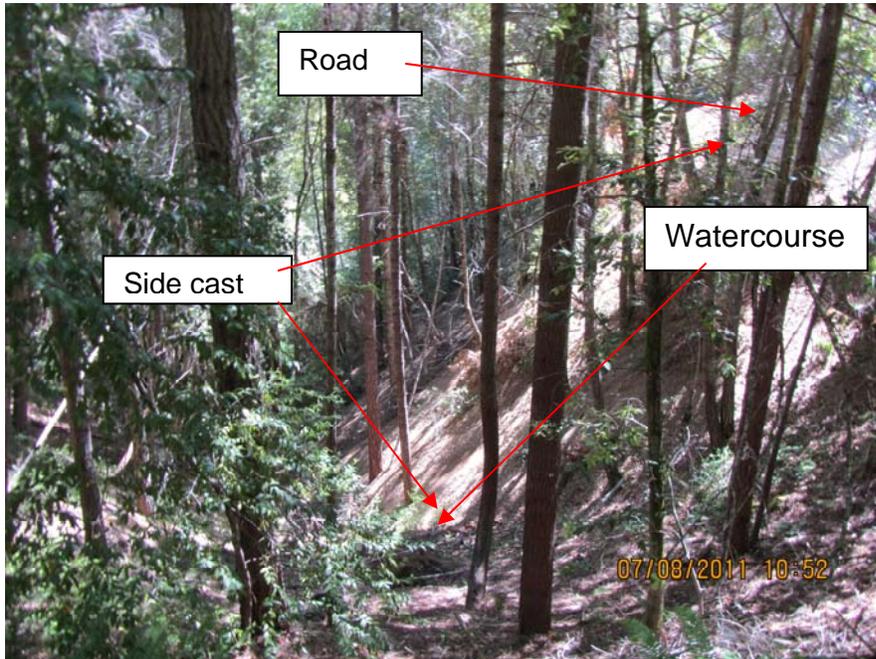
At the location where the access road branches to the roads leading to Parcels 1 and 2, there is approximately 300-400⁶ cubic yards of earthen material sidecast off the outboard edge of the road. The sidecast material extends approximately 100 feet down the slope, reaching the watercourse channel below. This particular watercourse flows to and under Highway 101, passing under the Highway through the 42-inch culvert mentioned in the section above. As noted above, the culvert is already nearly half filled with deposited sediment; the sediment observed in the stream channel upstream of the culvert and sidecast material on the slope above the watercourse threatens to further fill and ultimately compromise the integrity of this culvert, and represents a discharge and threatened discharge to waters of the State and United States.

Photo #10: Access road – Side cast earthen materials extending approximately 100 feet down the slope from the road to the watercourse

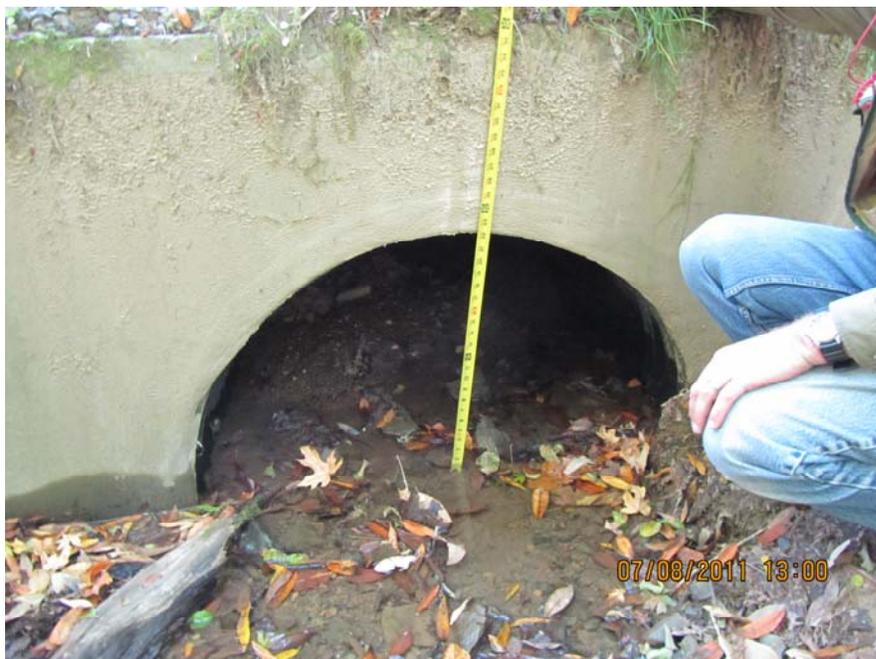
The stream below Parcel 2 to the southeast appears prone to side slope failures and sediment delivery from both mass wasting events (debris slides) and the driveway and access road described in the next subsection. These existing conditions increase the risk of sediment delivery from Parcel 2, which will further compromise the integrity of the 42-inch culvert that passes the stream under Highway 101; the culvert is currently not functioning properly, as in-stream sediment deposition occludes half of the culvert capacity.

Photo #11: - 42-inch culvert passing under Highway 101 (note the sediment deposits in stream occluding full flow through the culvert).
