Willits Bypass Project April 9, 2013 Inspection Findings
Inspected by Brendan Thompson
Time of inspection: ~ 11:30 a.m.-1 p.m., clear weather
Caltrans EA No.: 01-262004, Risk Level 3, WDID No. 1B12045WNME

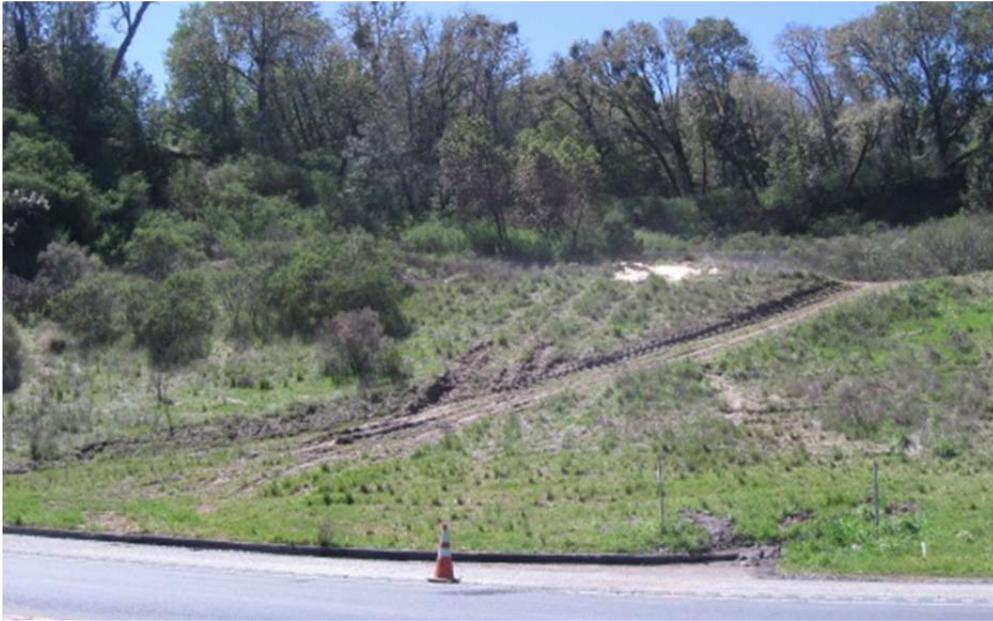
Photo 1: Unstabilized area at southern end of project site adjacent southbound 101, directly across from Haehl Creek construction access road (see Photo 2).

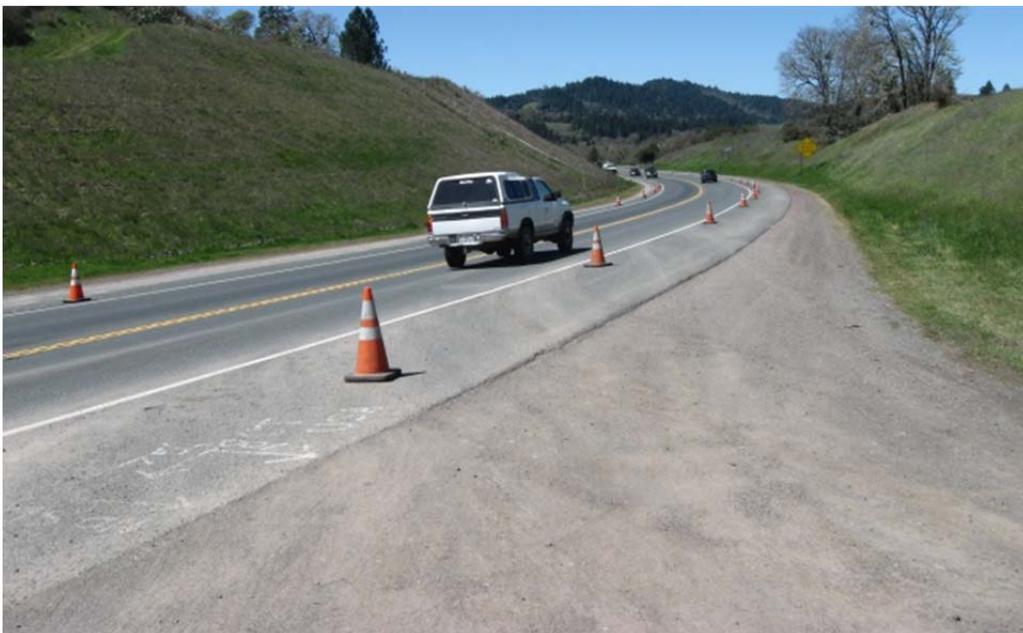
Photo 2: Unstabilized construction entrance at southern-most construction access location. Contractor and Caltrans staff noted it was unstabilized to allow access for California Highway Patrol vehicles.

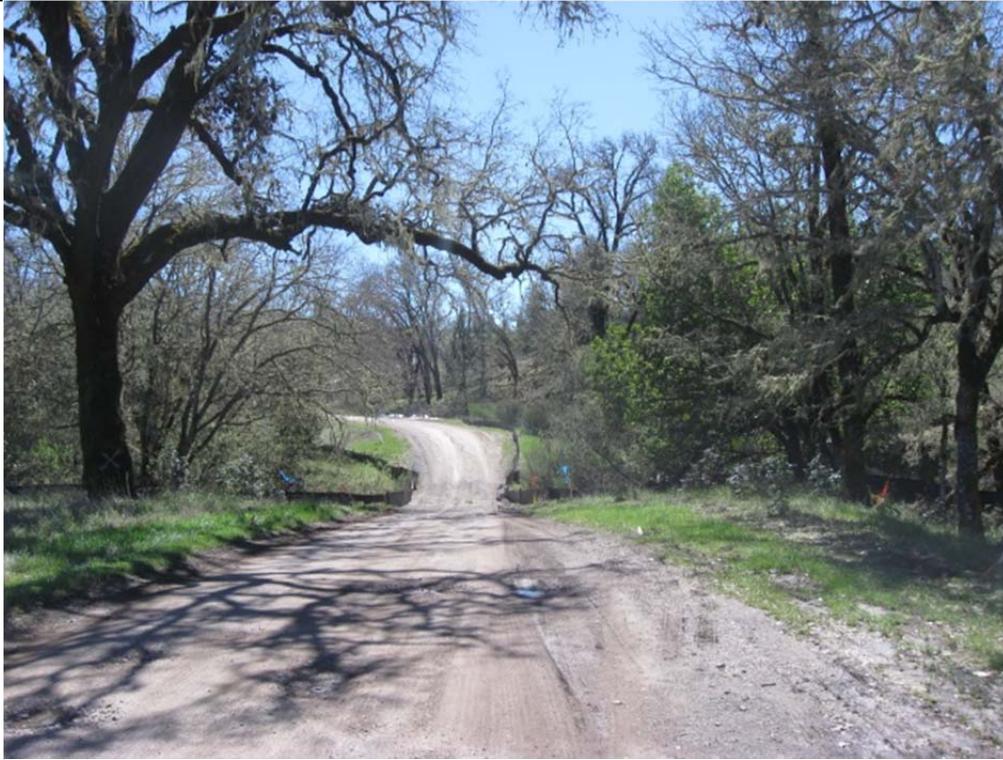
Photo 3: Looking south at road crossing over Haehl Creek, north of the construction entrance shown in photo 2.

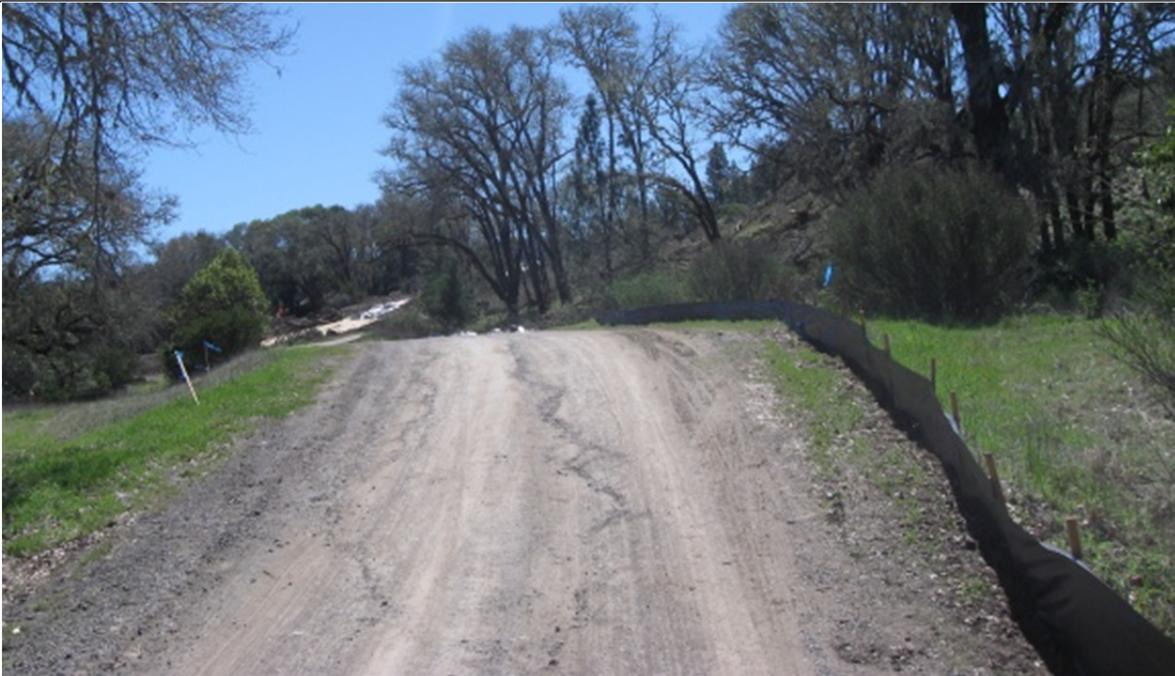
Photo 4: A closer look at the slope shown in the Photo 3: I was told that erosion had developed after a recent rain event. Stormwater had pooled at the low point in the roadway above the Haehl Creek culvert (see low point in photo 3). According to Caltrans and the contractor, the silt fence helped contain the stormwater, thereby allowing crews to pump the water and discharge to land. There was no evidence of sediment discharge on the outward side of the silt fence.

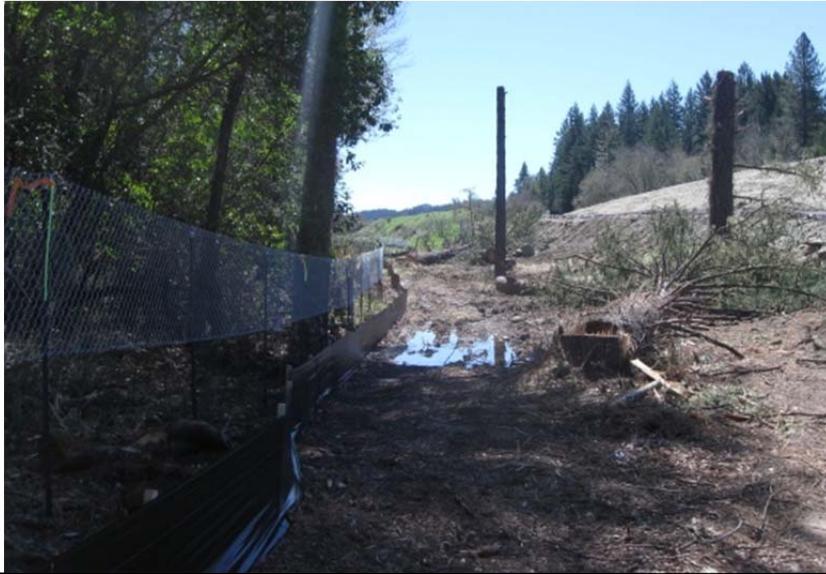
Photo 5: Looking south, approximately 0.25 miles north of Haehl Creek--disturbed soil area less than 50 feet west of a tributary to Davis Creek.

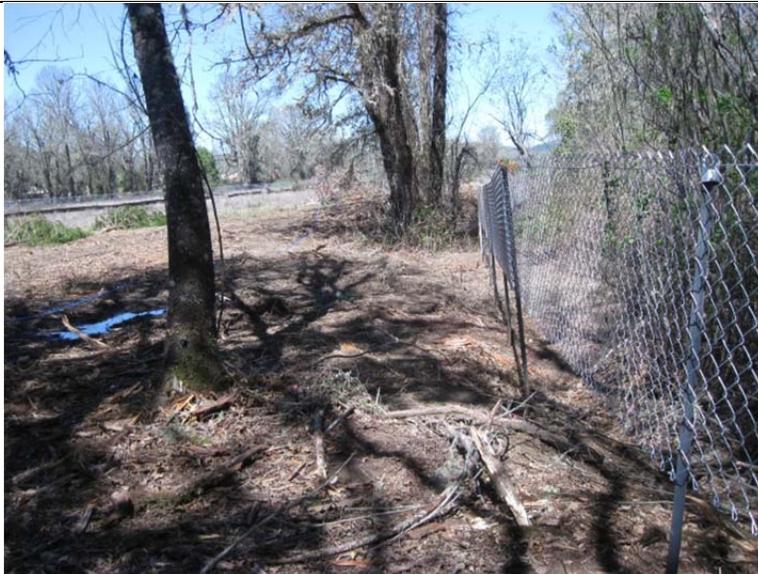
Photo 6: Looking to the north; north of the photo 5 location. Cleared vegetation, disturbed soil, and no perimeter control, less than 50 feet from a tributary to Davis Creek. The tributary had flowing water and was a short distance to the east of this cyclone fence (see photo 7). Perimeter control was installed north and south of this discrete area. I was told by the contractor that crews were ordered to stop installing silt fence at this location by Caltrans biological monitors. Perimeter control was not installed further to the east to avoid the riparian area. Blue tape had been placed on the ground approximately 50 feet away from and parallel to the creek.

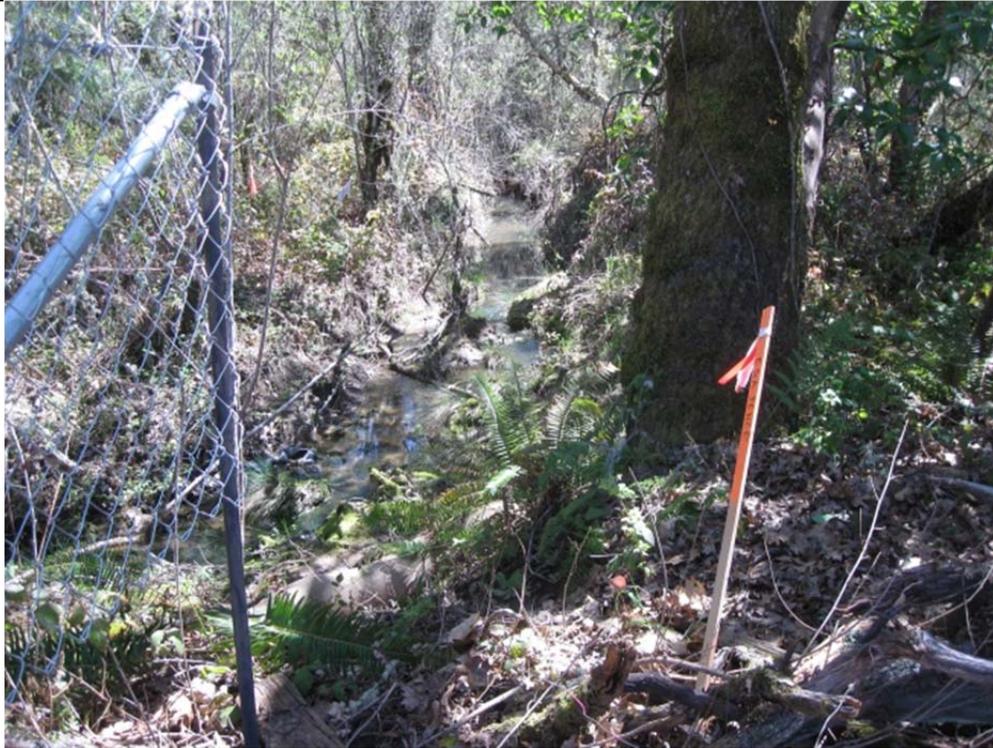
Photo 7: Tributary to Davis Creek, looking southeast. This photo was taken about 180 degrees and ~15 feet south from where photo 6 was taken

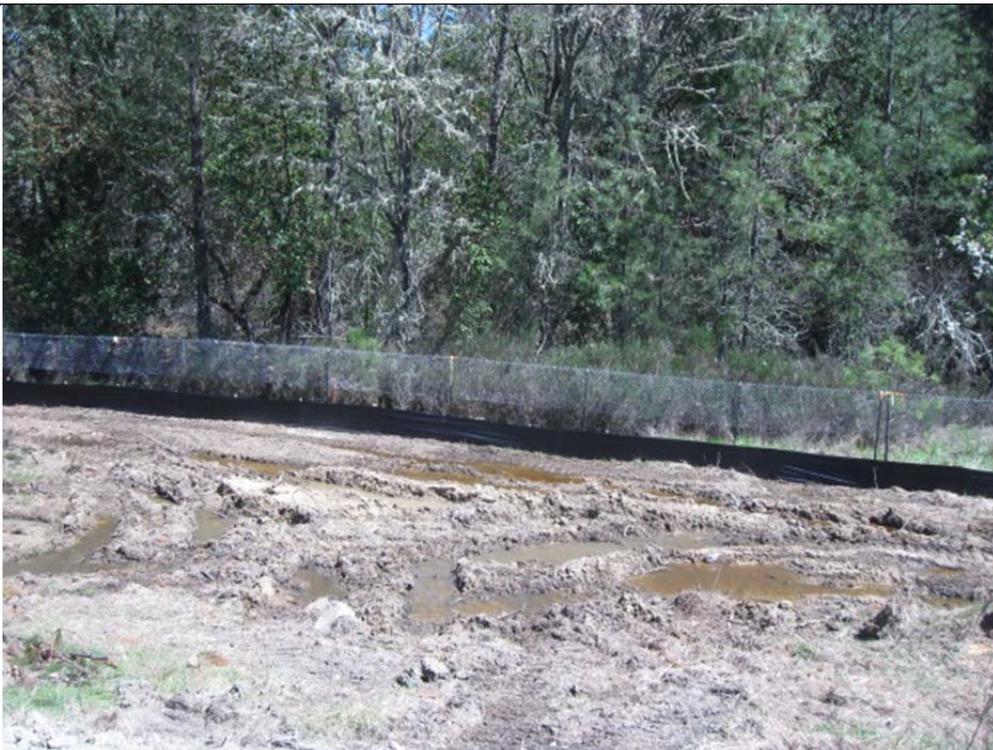
Photo 8: Looking east, north of photos 6 and 7. Disturbed soil within 50 feet of the tributary to Davis Creek.
