North Coast Regional Water Quality Control Board

Subject: Notice of Violation of Order No. R1-2013-0005, General Waste Discharge Requirements for Discharges for Timber Operations on Non-Industrial Timber Management Plans (NTMP) in the North Coast Region

File: Nonindustrial Timber Management Plan 1-95NTMP-018 MEN, "Galliani NTMP"

July 15, 2015 Site inspection

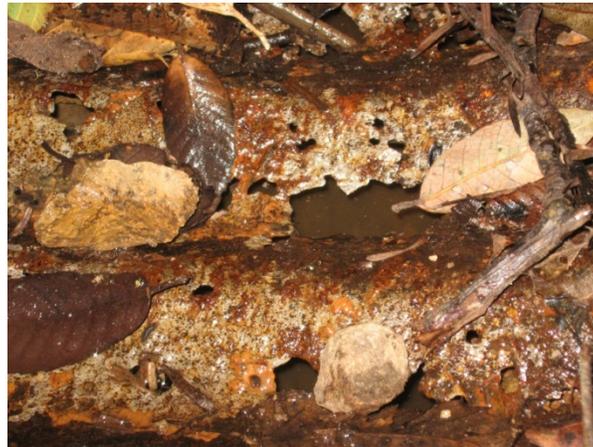
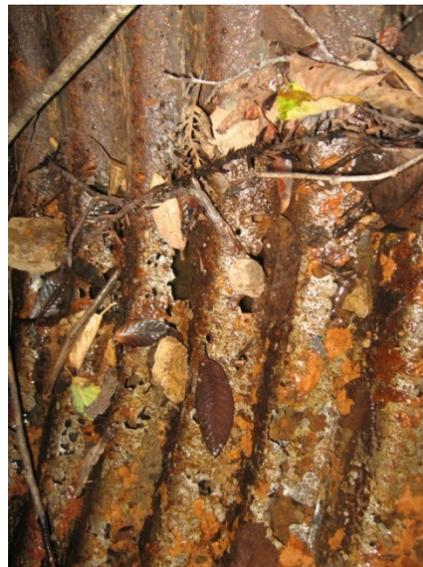
On July 15, 2015, Regional Water Board staff Ryan Bey inspected NTO #11. Also present during the inspection were Lee Susan, Registered Professional Forester (RPF) and Ken Margiott of the California Department of Forestry and Fire Protection (CAL FIRE). NTO #11 includes approximately 145 acres to be harvested using selection silviculture. Cable yarders and tractors will be used for yarding. During the inspection, Regional Water Board staff inspected the condition of numerous watercourse crossings. At an un-numbered site located north of watercourse crossing number 6 (Logging Area 2015 map/Galliani NTMP Yarding Systems map, attached as map 1), Regional Water Board staff observed a 48"-diameter corrugated metal culvert with a rusted bottom in which there were a number of holes (Images 1 and 2). Water flowing out of the holes in the culvert may saturate underlying and surrounding fill material, increasing the potential that the crossing and associated fill will fail during a large storm event. As such, the culvert is no longer functioning as designed and must be replaced.

Figure 1 and 2: rust and rust holes. Note water draining out of holes, saturating surrounding fill soil

On August 10, 2015, Regional Water Board staff Jonathan Warmerdam spoke with RPF Lee Susan about the culvert. Following that discussion, Mr. Susan submitted a description of the existing site conditions to the Water Board with a proposed corrective action plan. We appreciated the timely response. However, the plan did not include design, installation and material specifications. Please submit to the Regional Water Board, by October 15, 2015, a revised proposed corrective action plan for this site to prevent or minimize sediment discharge. Please address the following in the plan:

- The length, diameter and material of the new culvert necessary to ensure that it will accommodate the estimated 100-year flood flow, including debris and sediment loads;
- Specifics about the removal of the existing culvert and installation of the new culvert; and
- Specific prescriptions to hydrologically disconnect the road approaches to the crossing, including proposed road surface materials and incorporation and location of rolling dip(s) or other drainage structures, as warranted.

Implementation of the corrective action must occur no later than October 15, 2016. Following implementation of corrective action at the site, you must contact Regional Water Board staff to schedule a subsequent inspection so that we may evaluate whether the corrective action has been sufficiently implemented and confirm that the violation has been adequately corrected.
