# Kawana Meadows Subdivision

Subject: Kawana Meadows Development / Farmers Lane Extension 1/15/2016 site Clean Water Act section 401 Water Quality Certification inspection memo

<b>Name and Location of Facility Inspected</b> Kawana Meadows Development, Santa Rosa, Sonoma County	<b>Facility Permit</b> CGP WDID No.1 49C374058	<b>Inspection Date</b> January 27, 2016	<b>Inspection Time</b> 1100
<b>Names &amp; Titles of On-Site Representatives and Consenting Parties</b>	<b>Consent Provided?</b>	<b>Contact Information</b>	Notified of Inspection?
Will Oswald, CEO, CMservices	<input checked="" type="checkbox"/> Yes	Phone: 415-828-0224 Email: CMservices@aol.com	<input checked="" type="checkbox"/> No
<b>Property Owner(s)</b>		<b>Address:</b> Petaluma Hill Road and Yolanda Road, Santa Rosa	
Kawana Meadows Development Corporation		2 Fifer Avenue, Corte Madera, CA 94925	
<b>WQ Inspector Name(s) &amp; Title(s)</b> Paul Keiran, Water Resource Control Engineer (WRCE), Regional Water Board (WQ)			
<b>California SMARTS Inspection</b>			
<b>Weather Conditions at the Time of the Inspection:</b> Partly cloudy	<b>Facility Receiving Water Names:</b> Todd Creek, Laguna de Santa Rosa

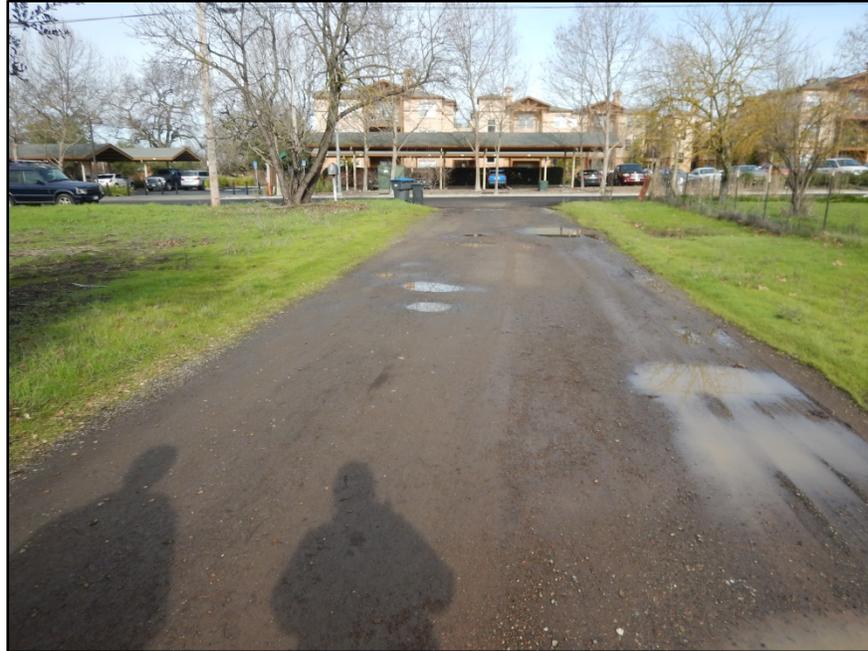
**Photo 1.** Unstabilized construction entrance/exit of the Project's access road, located at the intersection of Kawana Terrace and Franz Kafka Avenue. Photo taken by Devon Jorgenson on 01/15/2016 at approximately 12:36. Photo facing north.

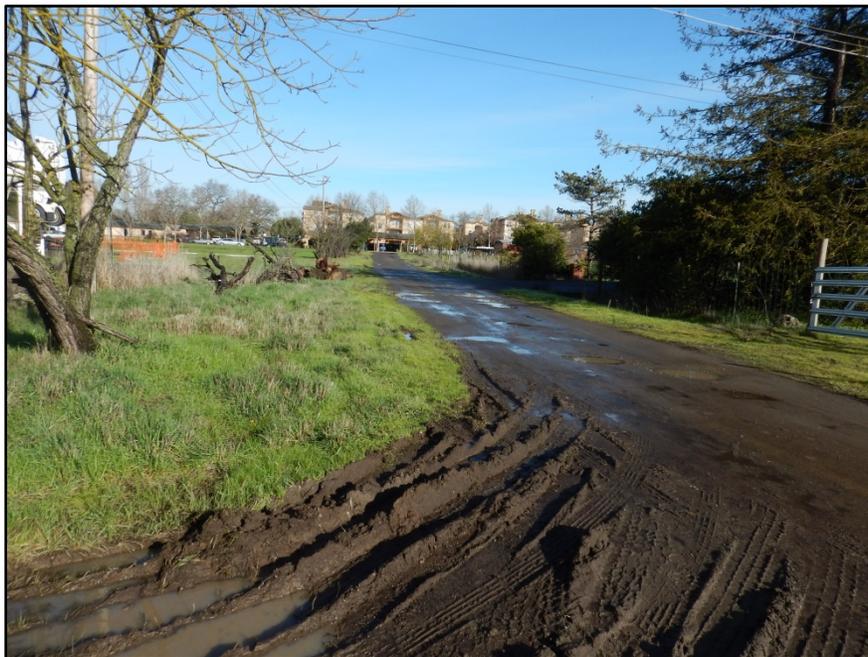
**Photo 2.** Unstabilized entrance/exit located at Franz Kafka Avenue and the Project entrance. Photo taken by Devon Jorgenson on 01/15/2016 at approximately 11:11. Photo facing northeast.

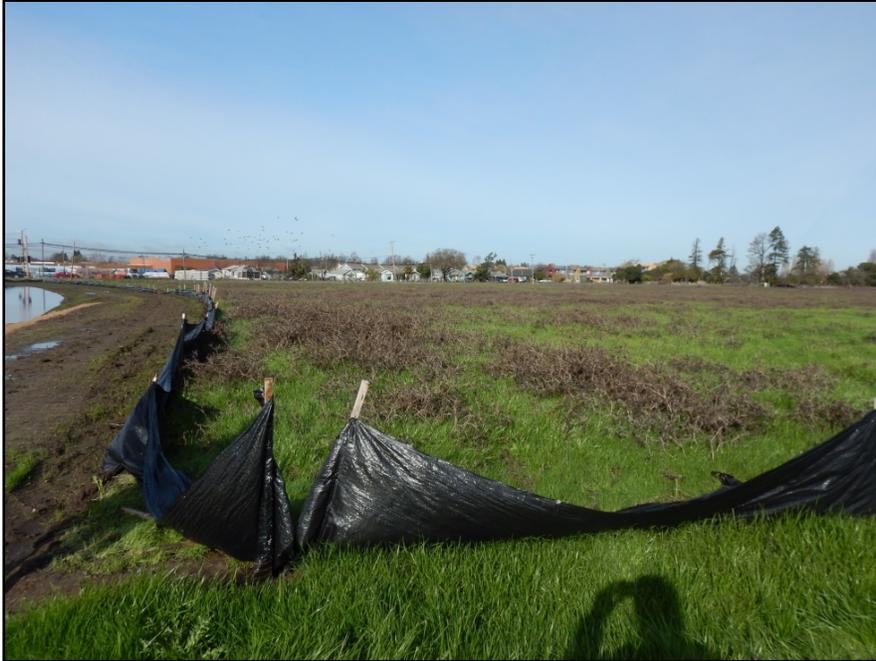
**Photo 3.** Silt fence serving as perimeter control in poor condition along the western boundary of the Site. Photo taken by Devon Jorgenson on 01/15/2016 at approximately 11:35. Photo facing northwest.

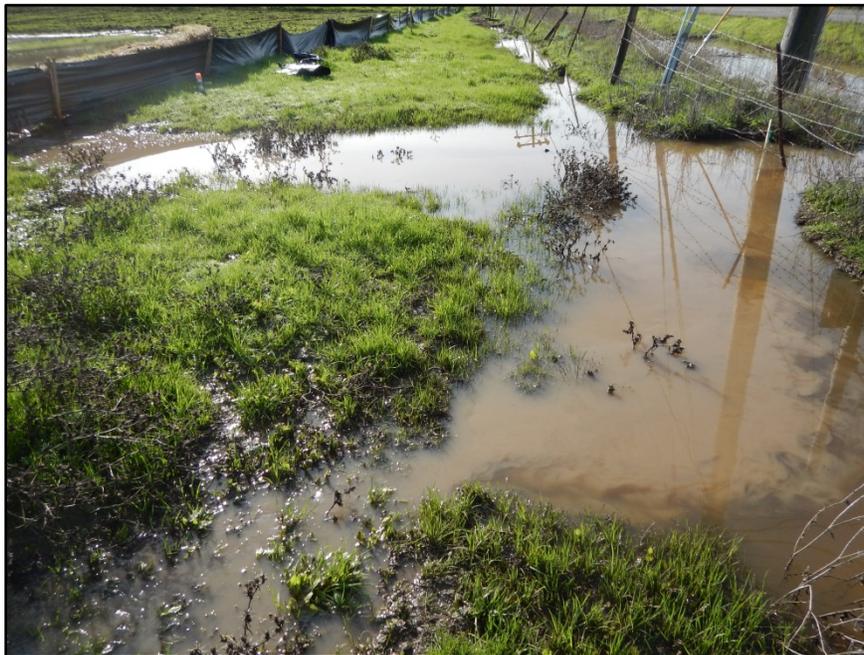
**Photo 4.** The failure of the silt fence perimeter control (top left corner of photo; see Photo 5 for a magnified view) resulted in a sediment discharge to an unnamed tributary to Todd Creek, thence to Bellview/Wilfred Channel, thence to Laguna de Santa Rosa, thence to Mark West Creek, thence to the Russian River. Note the sediment plume and visible change in turbidity from background in the lower right as a result of Site discharge. Photo taken by Devon Jorgenson on 01/15/2016 at approximately 11:39. Photo facing south.

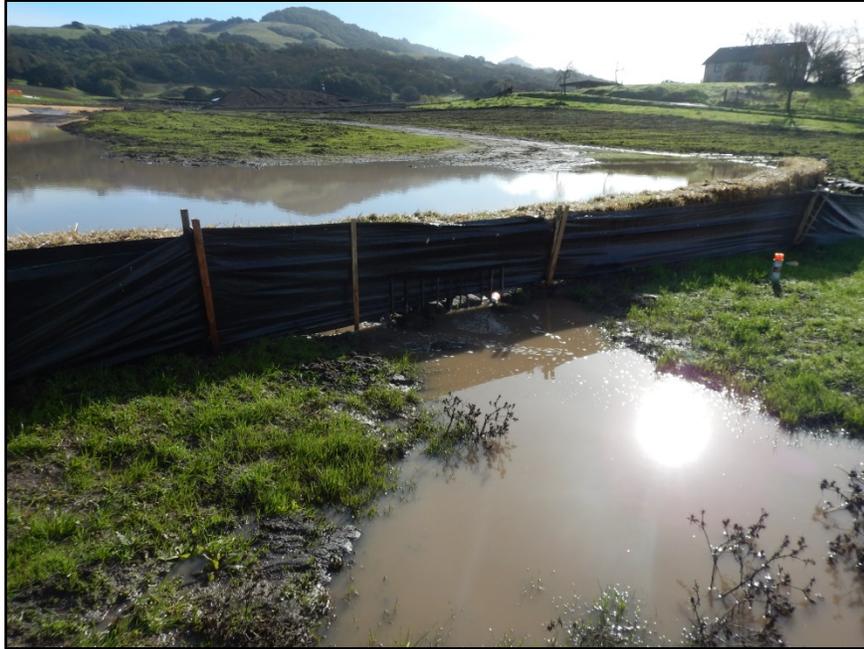
**Photo 5.** Silt fence perimeter control as seen in Photo 4. Note the improper installation and maintenance that is allowing sediment-laden water to flow through the fence and to an unnamed tributary to Todd Creek, thence to Bellview/Wilfred Channel, thence to Laguna de Santa Rosa, thence to Mark West Creek, thence to the Russian River. Photo taken by Devon Jorgenson on 01/15/2016 at approximately 11:40. Photo facing southeast.

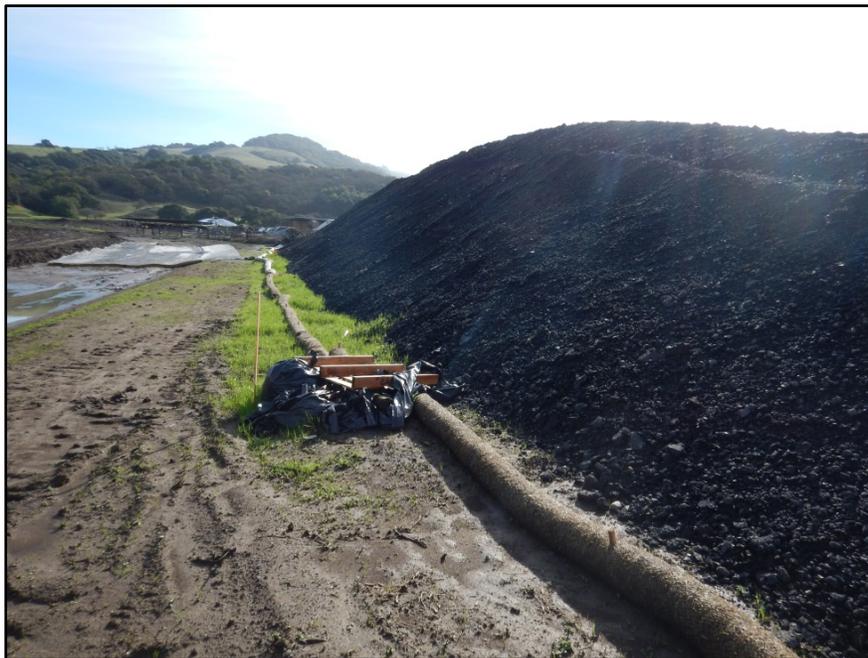
**Photo 6.** Exposed stockpile on southern boundary of project. Photo taken by Devon Jorgenson on 01/15/2016 at approximately 11:45. Photo facing southeast.

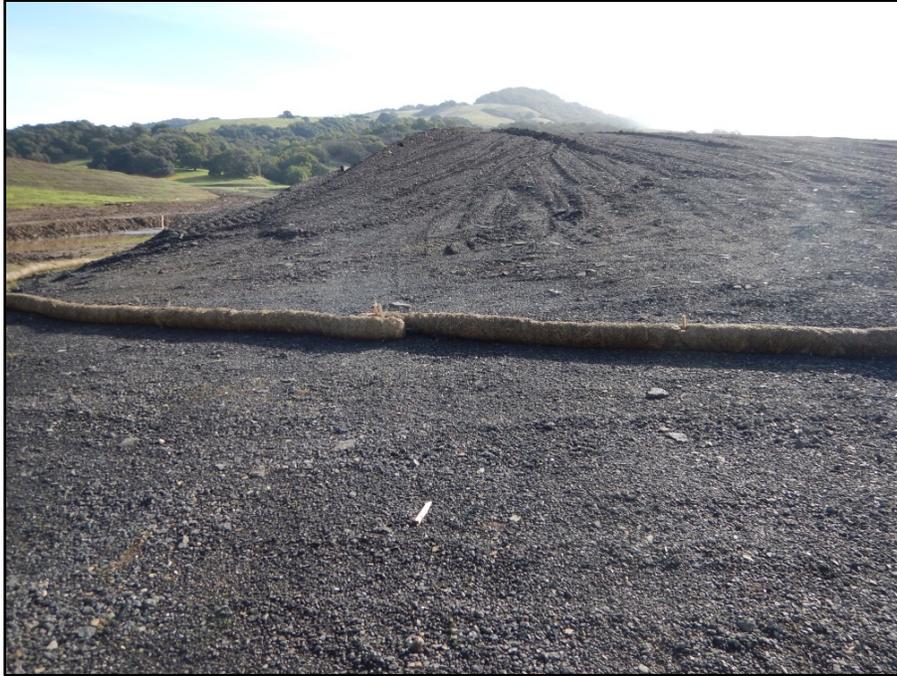
**Photo 7.** Improper placement of wattles for the use of the stockpile berm. Wattles cut across the stockpile rather than at the base. Photo taken by Devon Jorgenson on 01/15/2016 at approximately 11:45. Photo facing southeast.

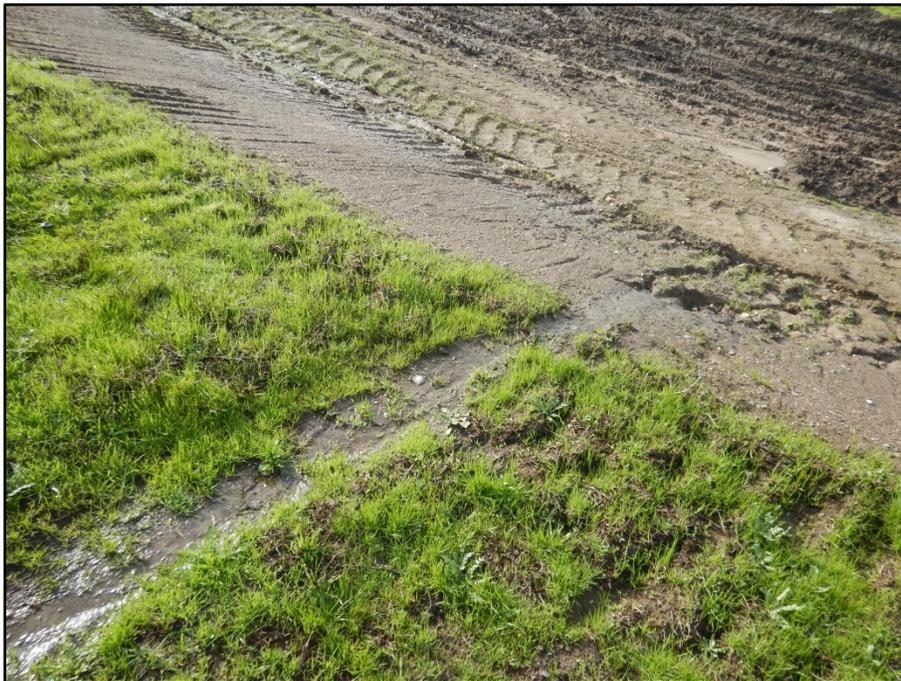
**Photo 8.** Run-on from upslope of the Site (undisturbed area in the photo) contributing to erosion on site. Note the run-on appearing in the lower left corner traveling to the upper right, and the rilling that has developed downslope of the flow. Photo taken by Devon Jorgenson on 01/15/2016 at approximately 12:02.

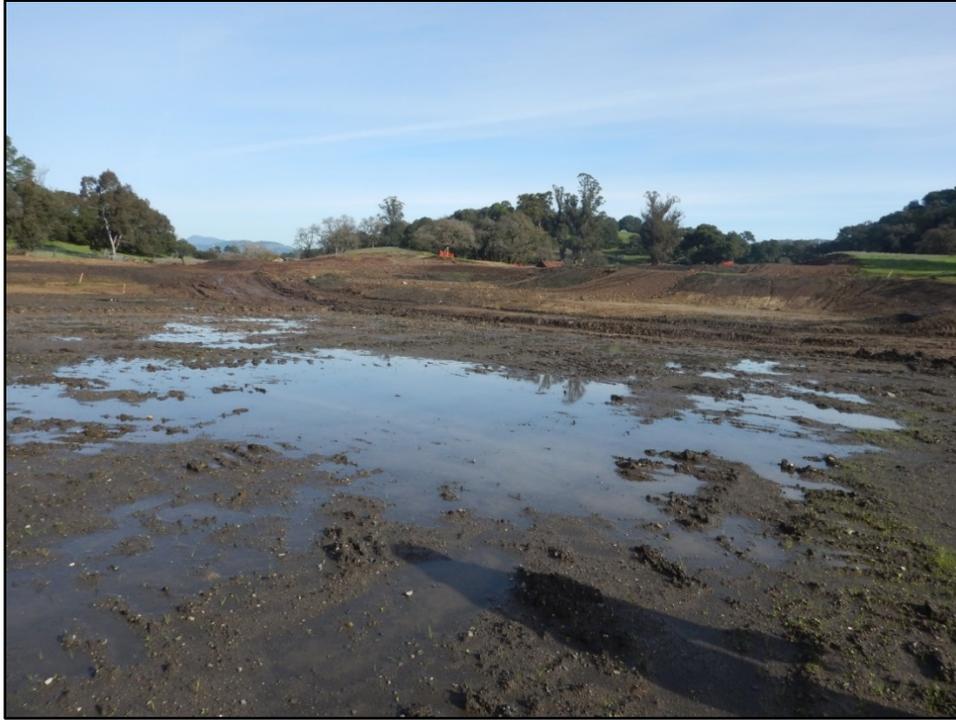
**Photo 9.** Lack of soil cover on inactive area. As a result, runoff contacting the exposed soil entrained and transported sediment, adding to the overall sediment discharges from the site to waters of the state. Photo taken by Devon Jorgenson on 01/15/2016 at approximately 12:00. Photo facing northeast.

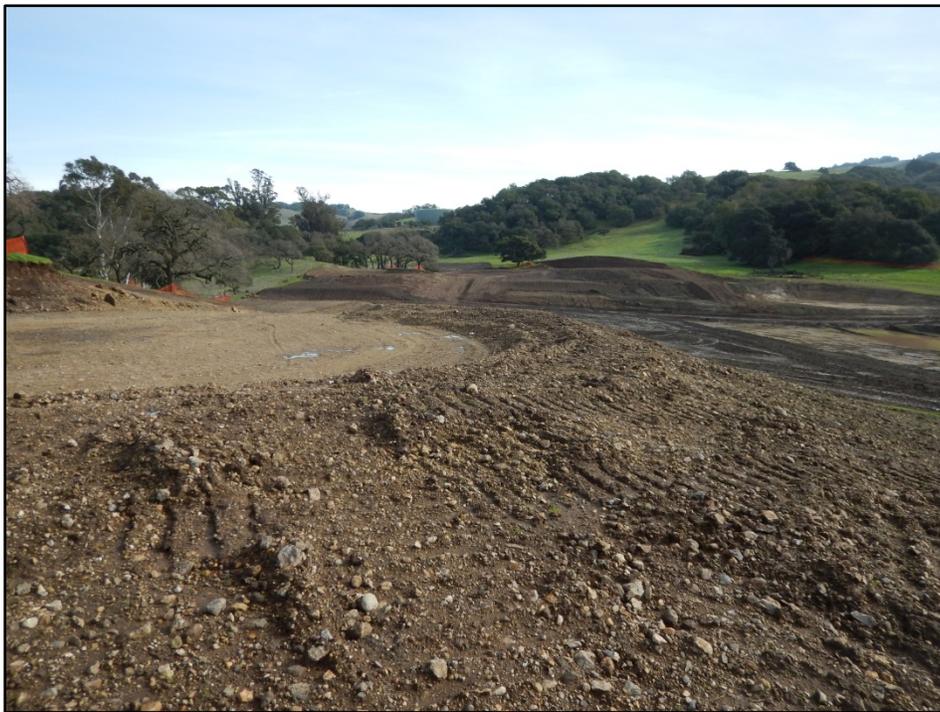
**Photo 10.** Lack of soil on inactive areas. As a result, runoff contacting the exposed soil entrained and transported sediment, adding to the overall sediment discharges from the site to waters of the state. Photo taken by Devon Jorgenson on 01/15/2016 at approximately 12:25. Photo facing east.

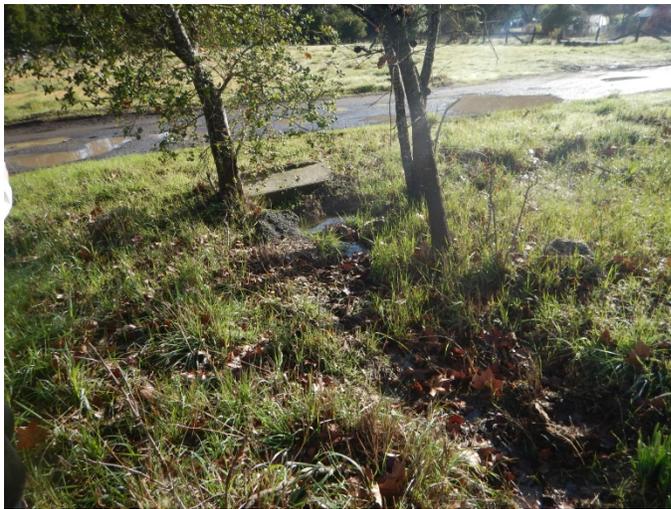
**Impact site 1:** South of the contractor trailer there was a culvert with drainage flowing onto the property into vegetated swale (likely jurisdictional waters of the United States or State) that was excavated or graded that contained ponded water.

Site 1: culvert and swale conveying water onto property

4. Restoration of impacted waters at Site 1 and Site 4 should be attempted after May 15th to restore functions.
5. Mitigation for temporal loss of function and permanent loss of function should be provided by the land owner where necessary.

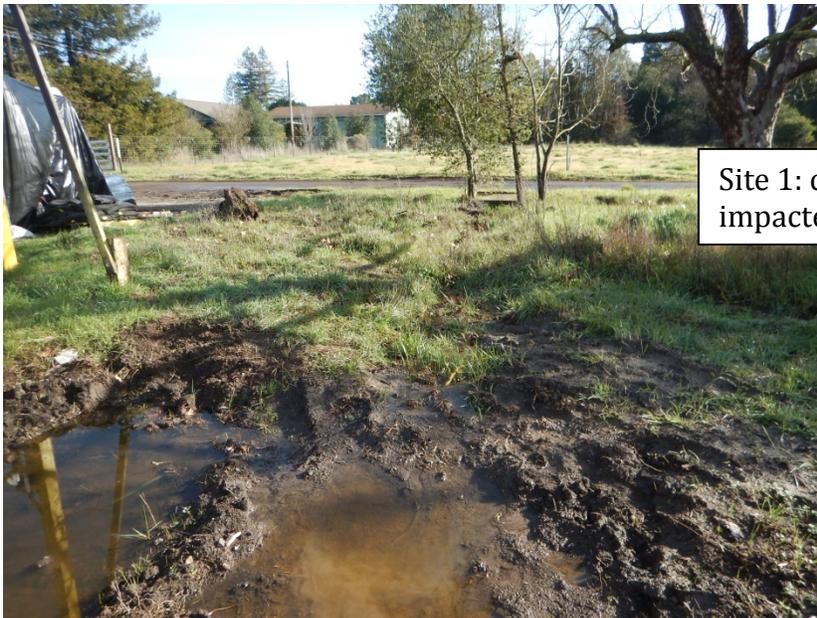
Site 1: culvert and swale and impacted area possible wetland

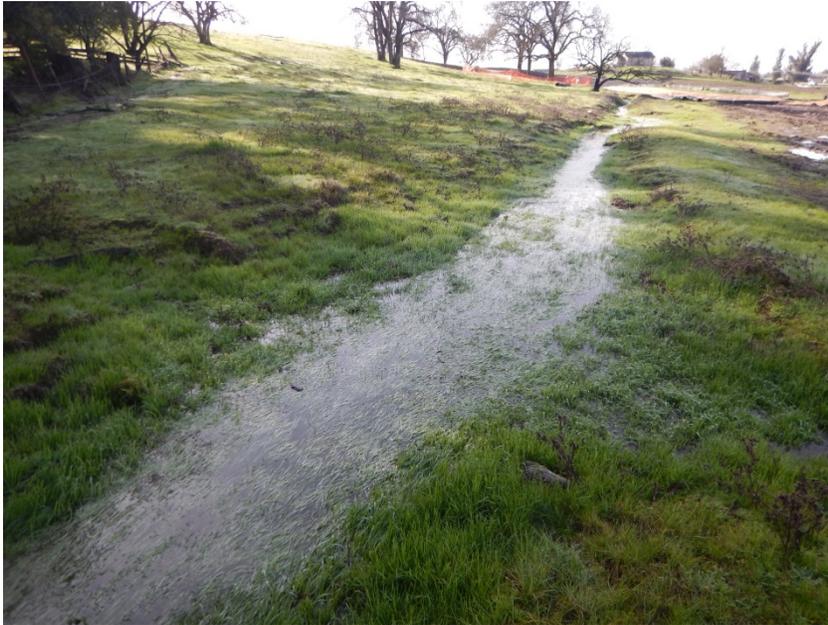
**Site 2:** A construction roadway excavated or graded through an unnamed linear watercourse running onto, through and off of the property (jurisdictional waters of the United States or State). The impact to the watercourse was **approximately 60 linear feet** of grading of the channel. Due to the recent excavation water flowing across Site 2 was diverted into a temporary culvert in an attempt to dewater this section of the watercourse.

Site 2: defined channel flowing toward impact site 2

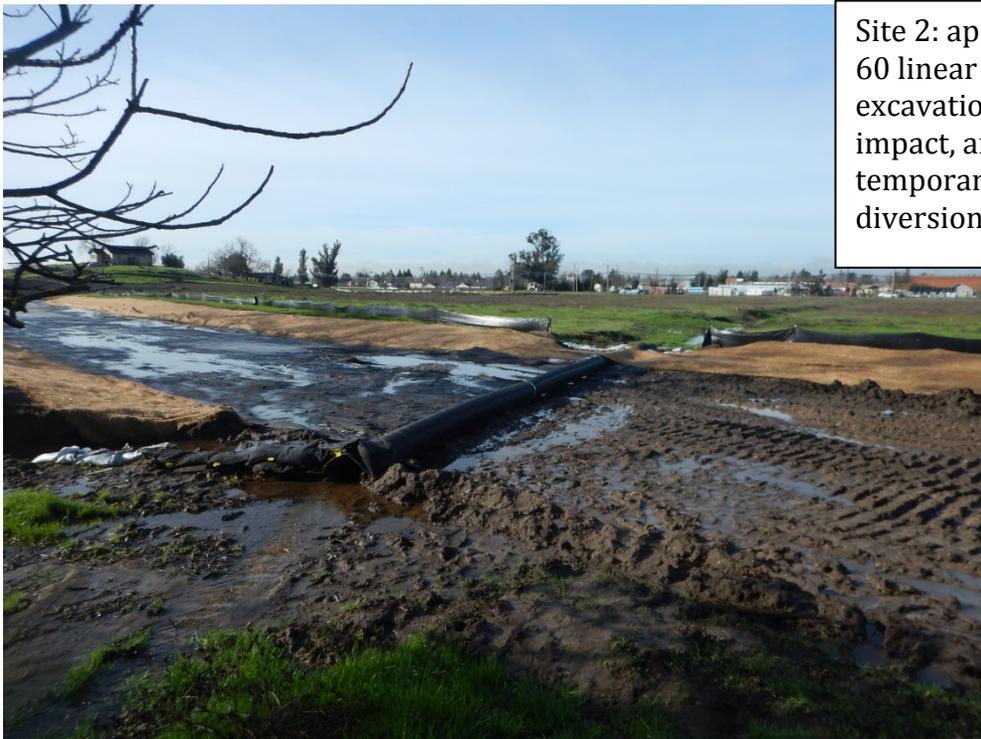
Site 2: approx. 60 linear feet of excavation impact, and temporary diversion

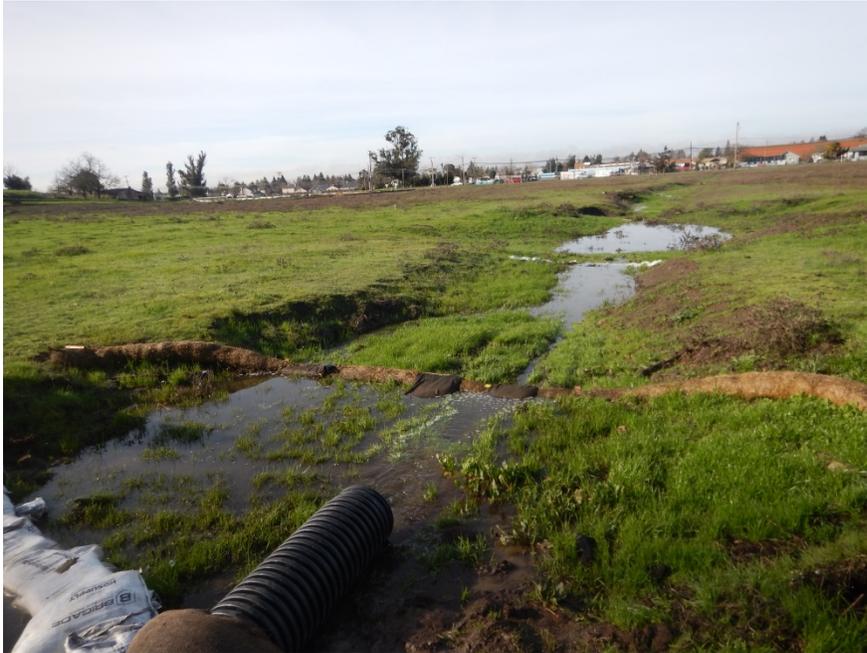
Site 2: diversion outlet, fiber roll check dams placed in water course (additional impacts)

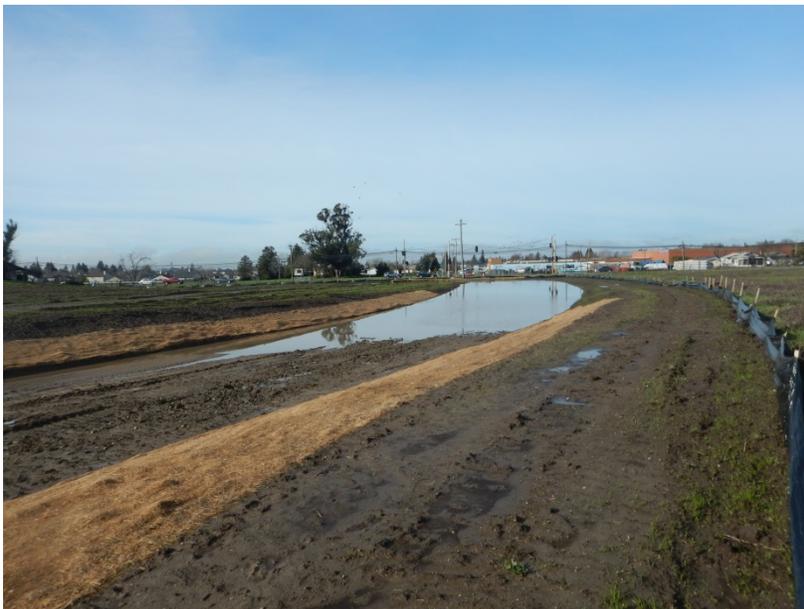
**Site 3:** Farmers Lane extension meets Yolanda Rd. This site had a previously delineated United States Army Corps of Engineers (USACE) jurisdictional wetland **approximately 0.036 acres** (Monk & Associates wetland delineation verified by USACE June 6, 2006). This previous delineation did not include the entire area at Site 3 so the size of the impacted wetland may be greater. The area at Site 3 had been excavated and was completely inundated with no evidence of wetland plants, complete loss of area.

Site 3: Excavated, now ponded and completely inundated

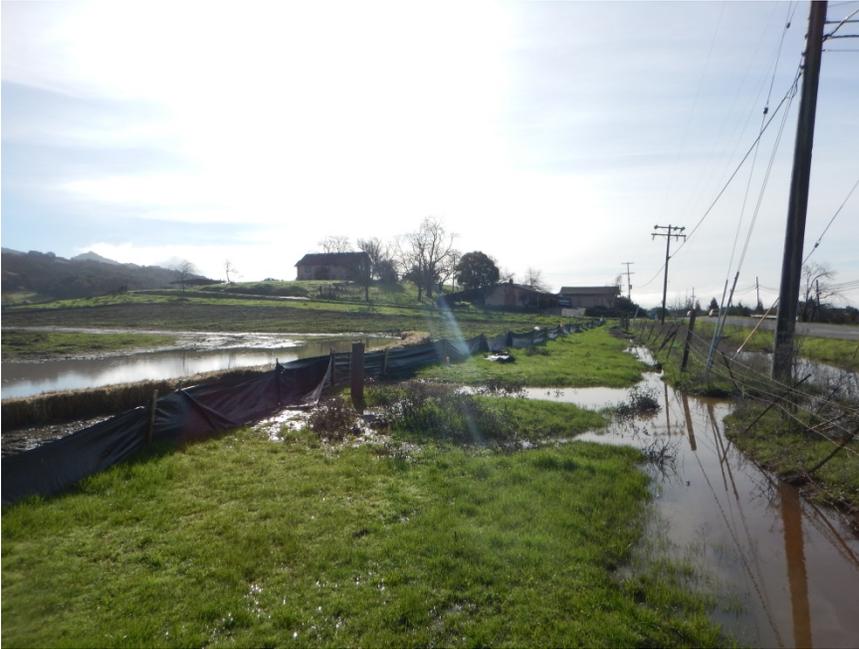
Site 3: straw bales and silt fence placed in wetland area to reduce sediment discharge to waters of the United States (channel on right side of photo)

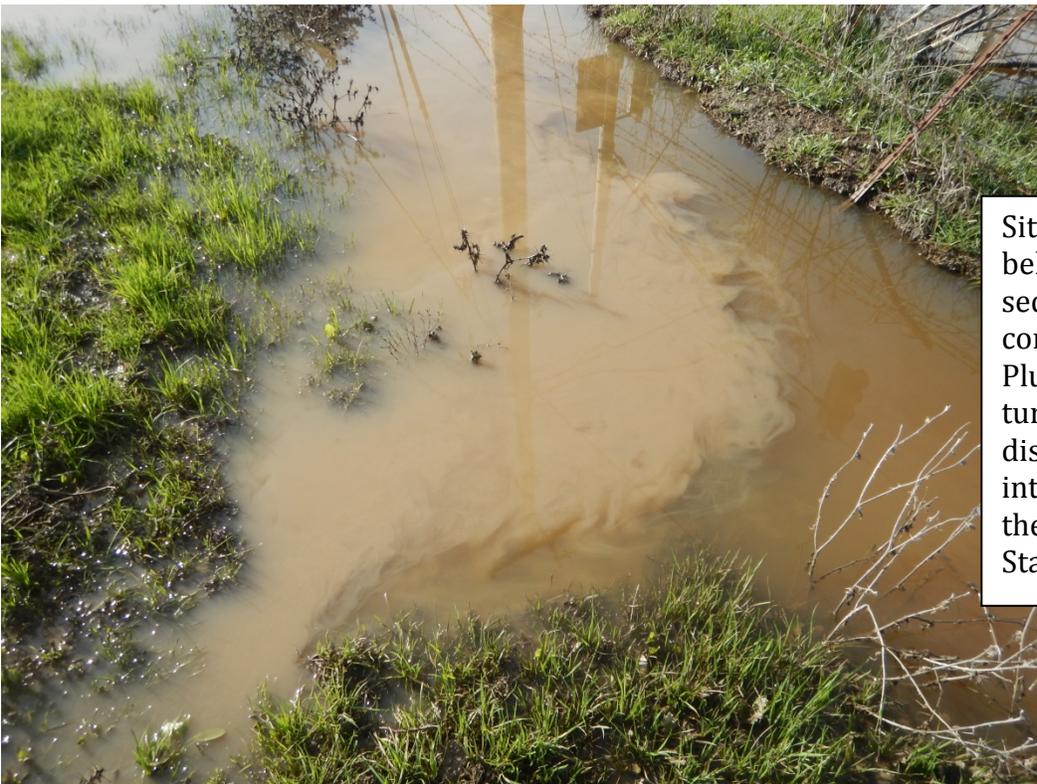
Site 3: just below sediment control. Plume of turbid water discharging into waters of the United States

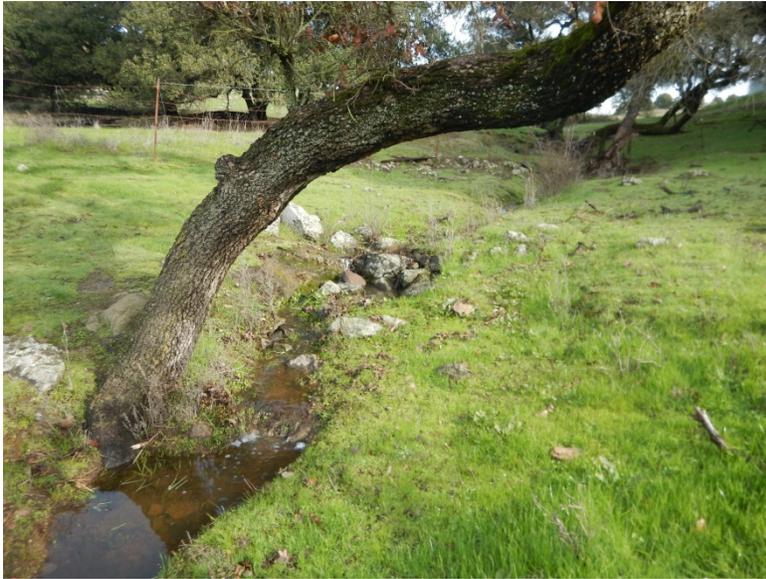
**Site 4:** Unnamed linear water course flowing onto the property was graded and possibly rerouted for **approximately 500 linear feet**. This linear water course likely was **approximately 2,700 feet long** where it exited the property at Petaluma Hill Road. Impacts at Site 4 were complete loss of ecological functions and active discharge of sediment off of the property.

Site 4: unnamed water course with defined bed and bank flowing onto property from Taylor Mountain Open Space Park Property

2. Diverting water from flowing onto the disturbed soil at Site 4 would reduce active discharge of sediment.
3. Develop a restoration and mitigation plan to address all unpermitted impacts to waters with the goal of restoration of functions first and secondly mitigation of lost area and or functions. This plan shall include monitoring and reporting as well as success criteria to ensure functions are restored and or mitigation for losses is successful.

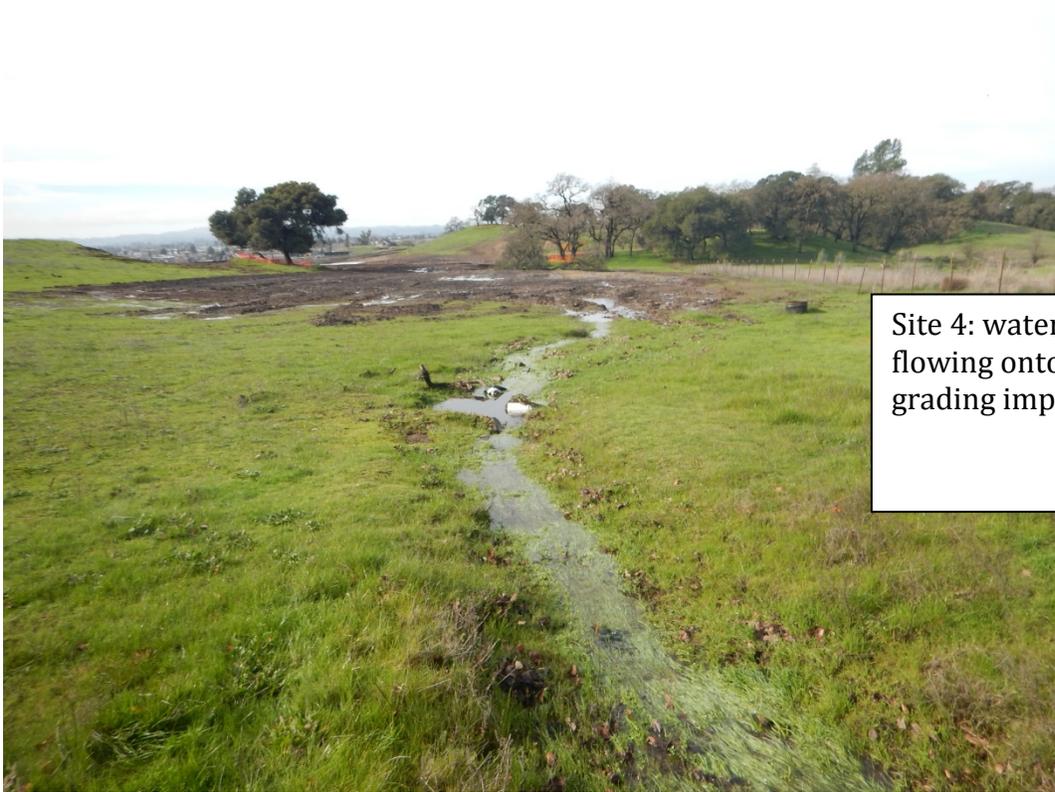
Site 4: water course  
flowing onto property,  
grading impacts evident

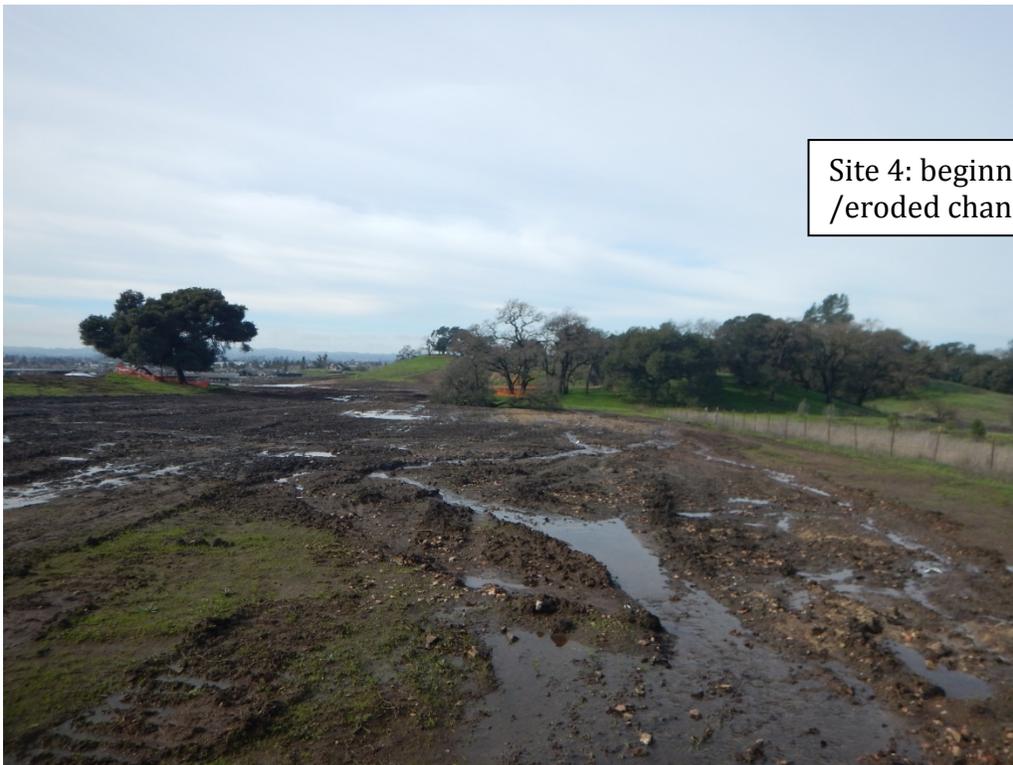
Site 4: beginning of graded  
/eroded channel

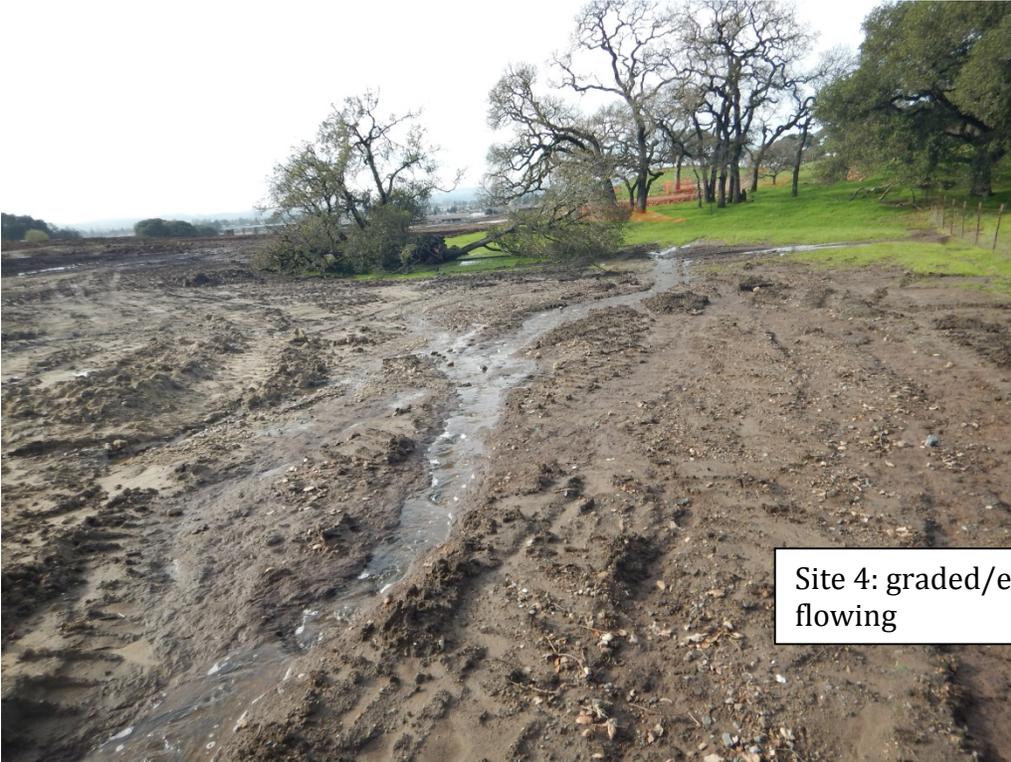
Site 4: graded/eroded channel flowing

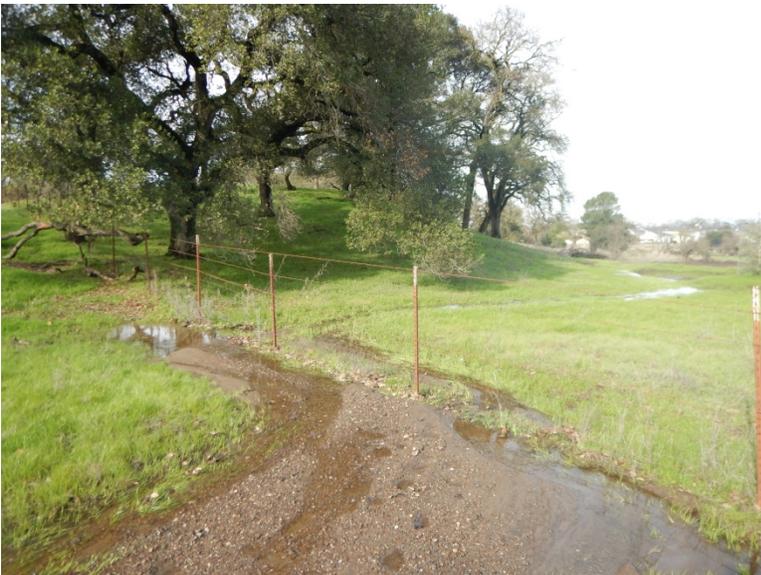
Site 4: graded/eroded channel (possibly rerouted) flowing off property to the north, delivering sediment

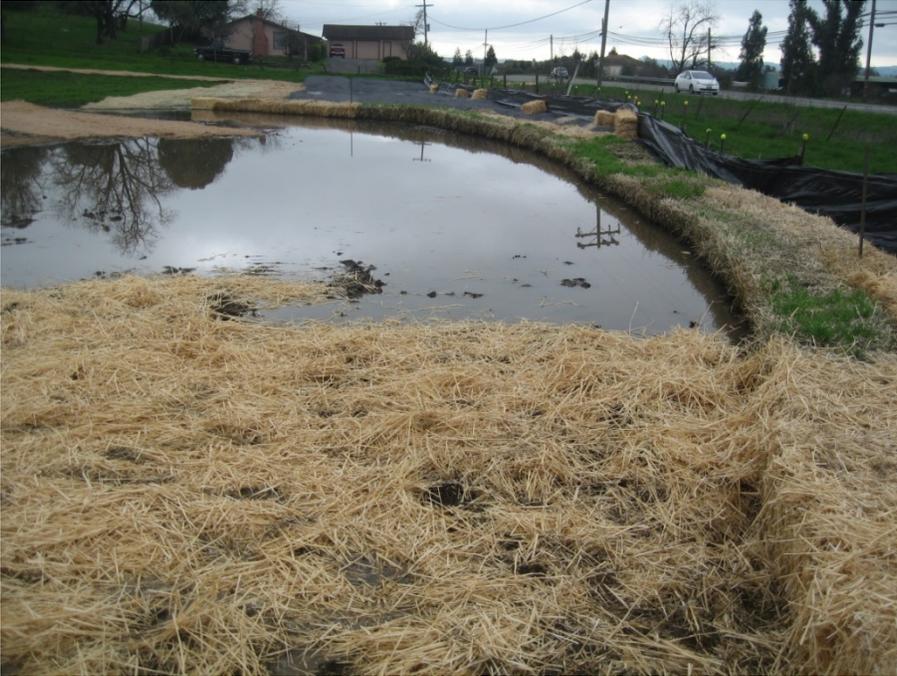
**Photograph 1. Lower detention pond with additional straw bales, wire fencing and gravel bags**

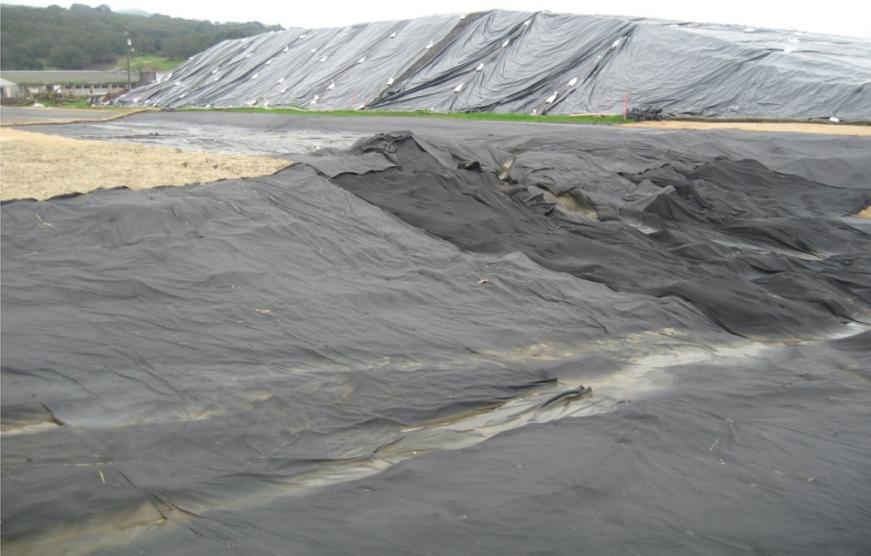
**Photograph 2. Lower section ground coverage**

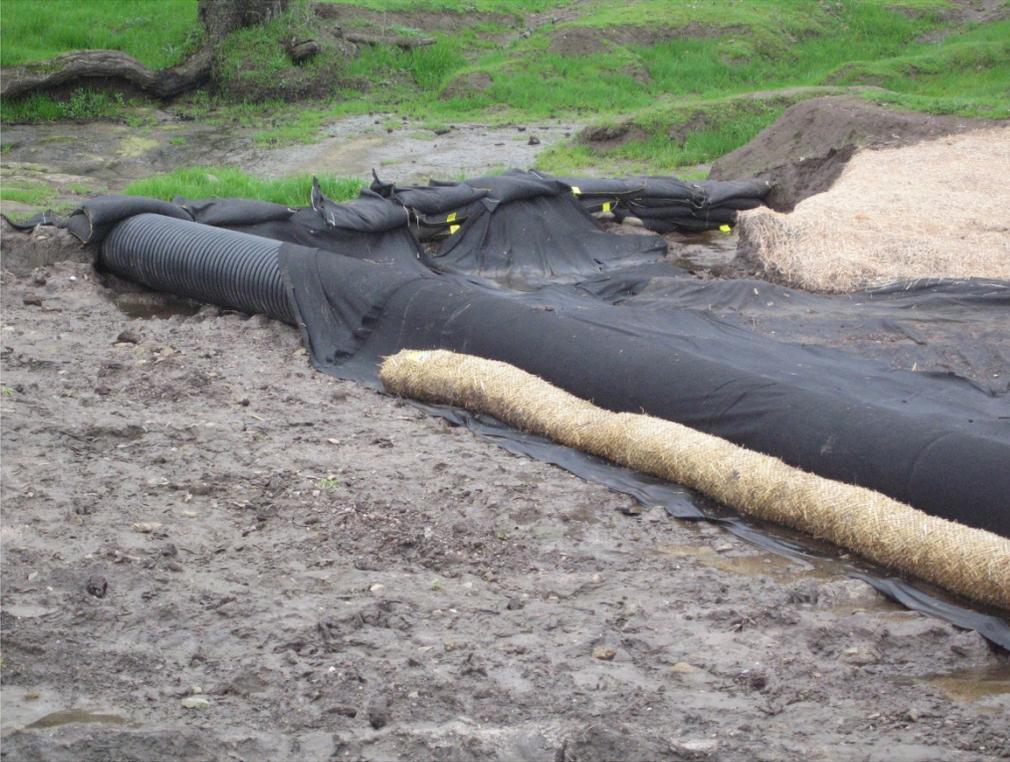
The upper section of the Site, approximately 8 acres, contains mostly exposed soils in need of immediate erosion control (see Photo 6). Staff observed several one-eighth of an acre self-created detention areas storing runoff several days after the last rain event (see Photo 7). Staff observed runoff discharging offsite onto an adjacent property through the drainage swale in the upper graded area (see Photo 8). The runoff was observed discharging into the small creek that is being piped across a lower graded roadway into adjacent property. This runoff was clear as seen discharging through the outfall of this above grade pipe conveyance (see Photo 3).

**Photograph 3. Creek above-grade crossing with additional BMPs**

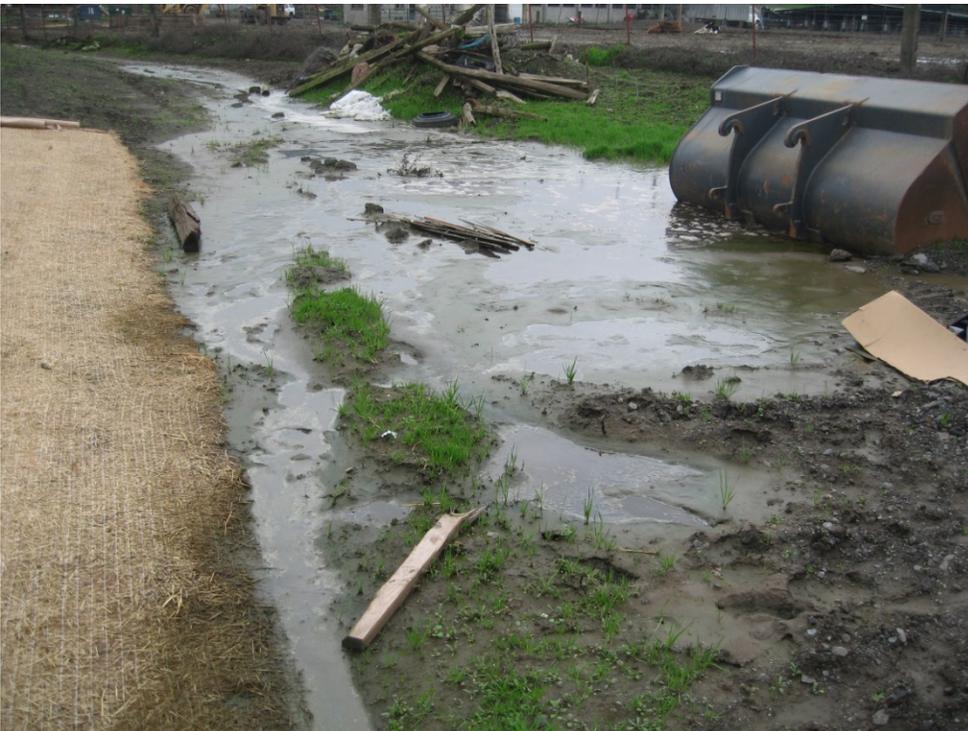
The bulk of BMPs in this portion of the Site relied on wattles within the road prism and straw, which staff observed being spread by workers on the side slopes during the inspection. Staff observed the discharge of waste from the adjacent dairy onto the Site. With the Site grading that occurred, staff observed dairy wastes flowing down gradient, into the construction graded areas and directly into the lower detention pond. Staff also observed dairy wastes comingling with Site runoff and discharging into a ditch along Petaluma Hill Road (see Photos 4 and 5). The ditch ultimately discharges into the headwaters of Todd Creek. Staff noted that the discharge into the ditch was highly turbid as evidenced by the murky brown color observed in the runoff. Prior ditch turbidity data collected during the January 15, 2016, inspection detected 634 NTUs in ditch runoff. Other observations in this area of grading included incorrect heavy equipment tracking on road cut slopes, with tracking parallel to runoff instead of perpendicular to the flow of runoff. This condition has created ever widening rills and small gullies and runoff has eroded these tracked channels, which continue to threaten to discharge sediment to Todd Creek during significant rain events. Please note that during prior inspections, staff observed discharge of sediment from the Site into Todd Creek.

**Photograph 4. Dairy waste discharges mingling with site runoff and entering ditch**

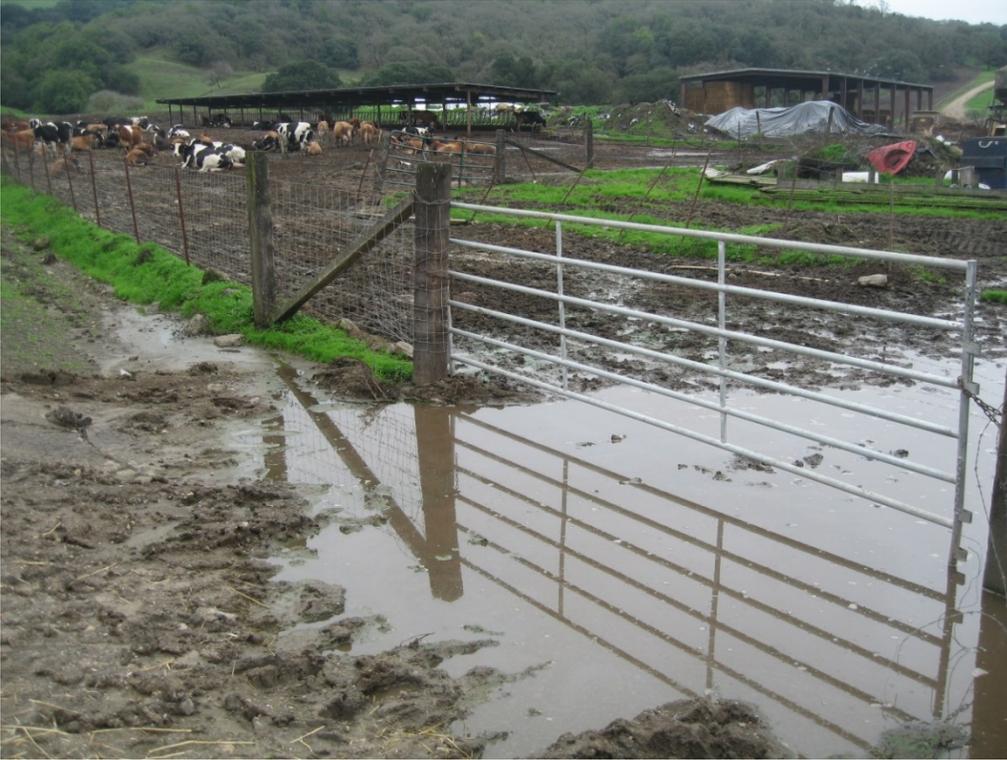
**Photograph 5. Cow loafing area discharging onto construction site**

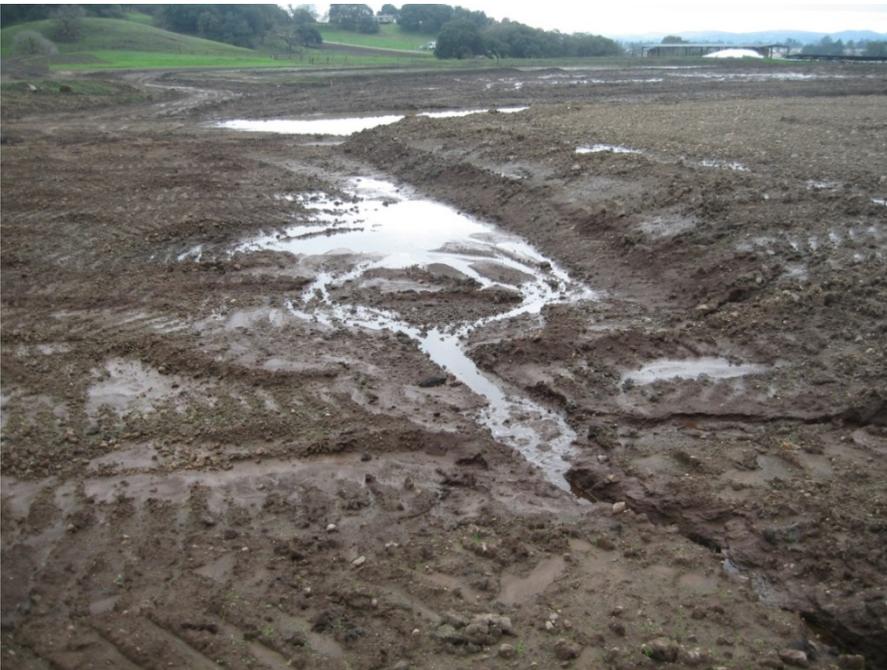
**Photograph 6. Upper section exposed soils**

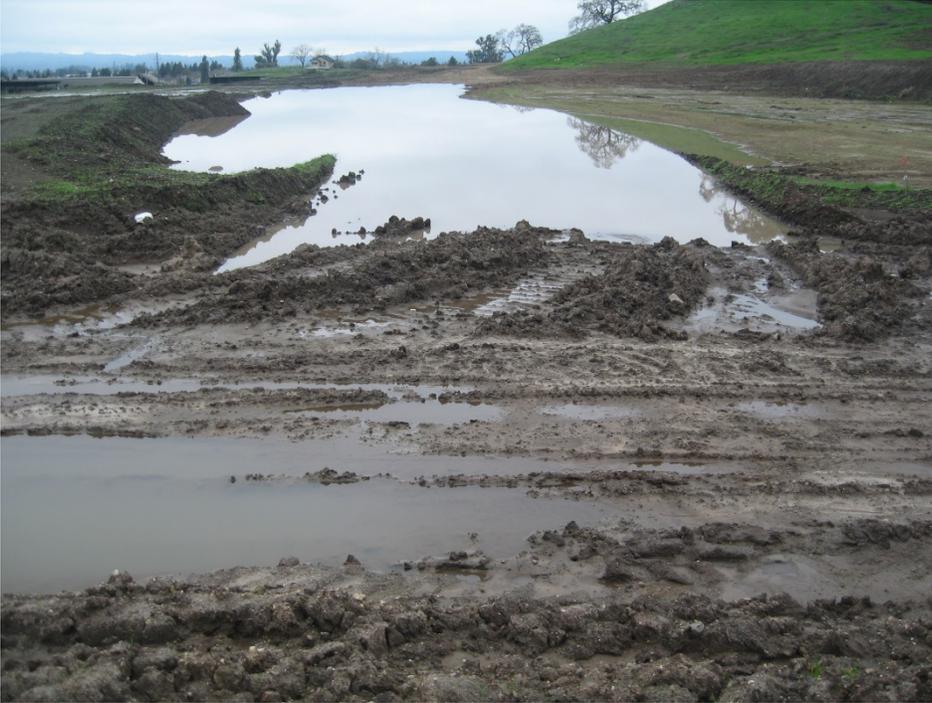
**Photograph 7. Upper section runoff detention areas**

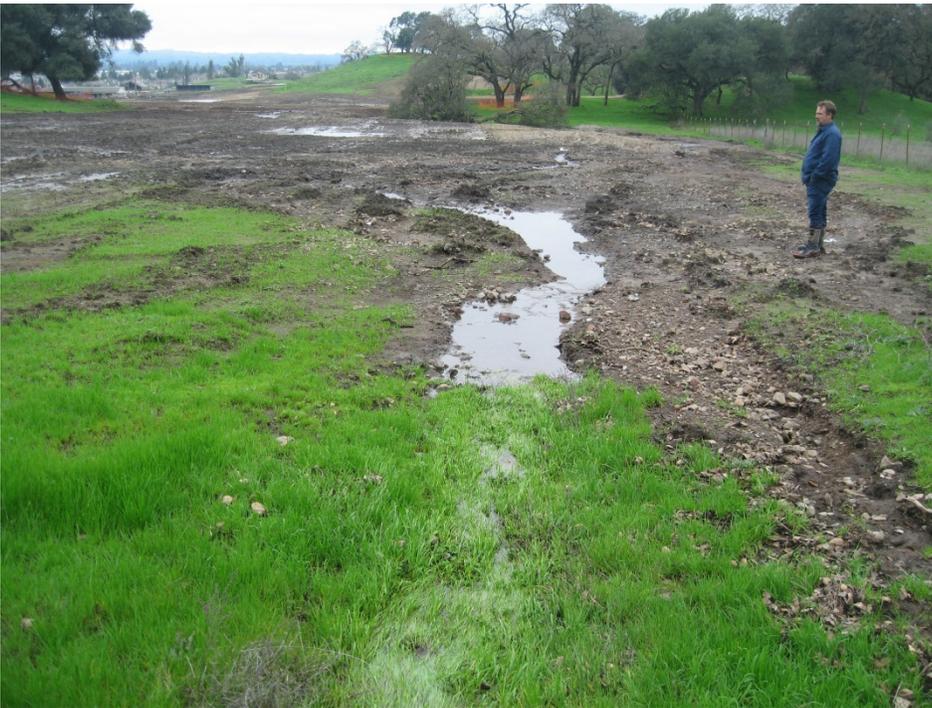
**Photograph 8. Looking at graded areas from linear watercourse**
