<b>Name and Location of Facility Inspected</b> McConnell Property APN 222-071-017 Garberville, CA	<b>Facility Permit</b> N/A	<b>Inspection Date</b> January 21, 2015	<b>Inspection Time</b> 10:59 a.m.
<b>Names &amp; Titles of On-Site Representatives</b>	<b>Contact Information</b>	<b>Notified of Inspection?</b>	
Ian McConnell, Co-Owner	(707) 267-6023	<input checked="" type="checkbox"/> <b>NO</b>	
Jacob Bullock, Co-owner	(760) 525-6675	<b>Consent<sup>1</sup> Provided? Administrative Warrant</b>	
Jeremy Bullock, Co-owner	(707) 223-4966		
<b>Property Owner(s)</b>	<b>Address</b>		
See above.	Ian McConnell P.O. Box 682 Garberville, CA 95542		
<b>Inspector Name &amp; Title<sup>2</sup></b> Erin Mustain, Senior Water Resource Control Engineer, SWRCB OE			
<b>Attending Agency Representatives</b> Melky Calderon, Water Resource Control Engineer, SWRCB OE Bryan Elder, Water Resource Control Engineer, SWRCB OE Michael Vella, Environmental Scientist, DIV Kevin Porzio, Water Resource Control Engineer, DIV Clare Golec, Environmental Scientist, DFW David Manthorne, Environmental Scientist, DFW Law enforcement personnel, DFW Wardens (Crowl, Gaske, Galwey) and Humboldt County Sherriff's Office

<b>Calif

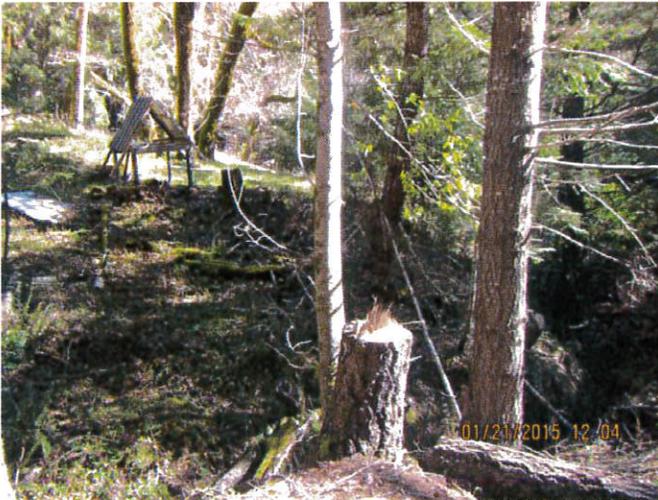
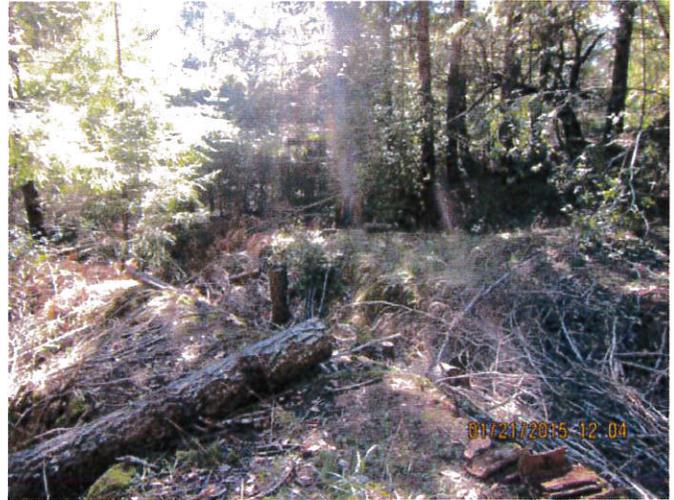
Water Quality staff walked from the main road towards the residence. To get to the residence, staff had to cross a drainage channel. There was evidence of recent vegetation removal in the riparian corridor (**photos 1 and 2**). Staff walked upslope to the residential structure and adjacent outdoor garden. Water Board staff noted that the residence was only a few feet from the drainage channel and that the septic tank was therefore immediately adjacent (**photos 3 and 4**). Mr. McConnell indicated that he had never had to do any maintenance on the septic tank. Water Board and CDWF staff noted fill in the drainage channel both upslope and downslope of a culvert located just in front of the residence (**photo 4**). The fill appeared to have been placed to stabilize the channel near the culvert. Mr. McConnell stated that he'd "fixed the runoff channel."

Photo 1 - Riparian Clearing

Photo 2 - Riparian Clearing

Adjacent to the McConnell residence, fill was placed directly into an unnamed tributary to Jones Creek, North Fork. Further downslope, trees were removed in the riparian corridor of the tributary to Jones Creek, North Fork (**photos 1 and 2**). This is likely to bring in sunlight for a new grow site and could increase the temperature of the unnamed tributary to Jones Creek, North Fork. At another location on the Jacob Bullock portion of the property a tree appeared to have been pushed by a bulldozer into the South Fork of the creek.

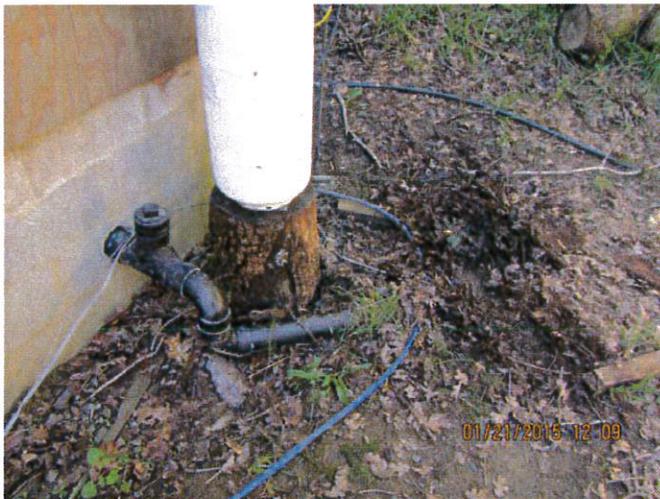
Photo 3 - Pipe to Septic Tank (east side of residence)

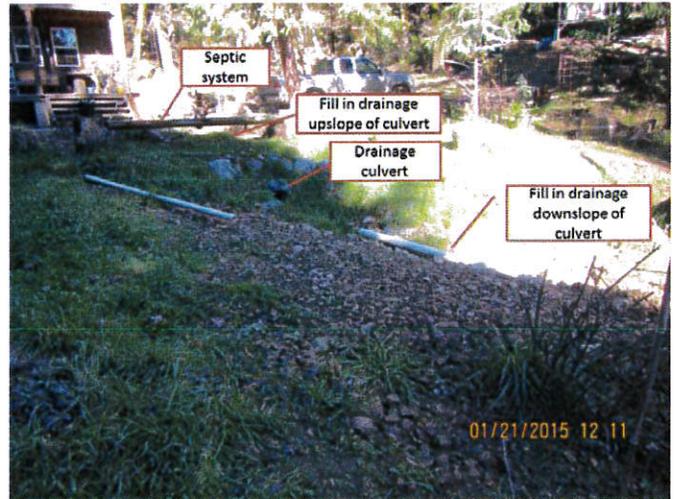
Photo 4 - Fill in Unnamed Tributary to North Fork of Jones Creek

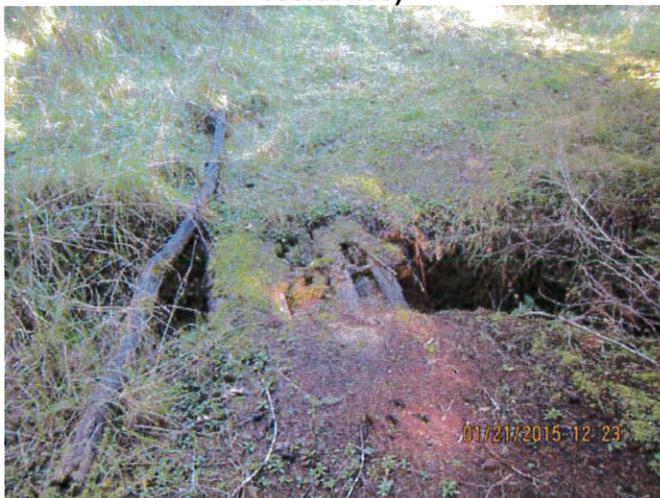
Staff continued to walk downslope of the residence and noted how the drainage split of into two channels. Flow in this channel is not atypical as evidenced by a stream crossing (**photo 5**) and from flowing water in the unnamed tributary (**photo 6**). Following the drainage channels led to an area with an above ground pool abutting a pond. Staff walked westerly along the road that lines the southern edge of the pond and noted a PVC pipe installed through the bank to the other side of the berm, possibly to keep the roadway free of water (**photos 7 through 10**).

Photo 5 - Crossing at Unnamed Tributary to North Fork of Jones Creek

The road running parallel to Jones Creek, South Fork runs through channels that are feeding the creek. The stream crossing on the tributary to the North Fork of Jones Creek, on the McConnell portion of the property was undersized and has created a nozzle effect on the channel forming a narrow channel with steep banks (**photo 5**). The stream crossing on the North Fork was clogged with vegetation, and showed signs of sediment transport from both sides (**photos 36 and 37**).

Recommendation 3: Inventory/assess roads and stream crossings, develop a workplan and schedule to hydrologically disconnect road from surface waters and to upgrade all stream crossings to pass flows from 100-year storm. This should include the installation of crossing for each channel along the road from Greenhouse 1 to the pad where the road veers north or the removal of the road and a restoration of the area. It also includes the replacement of the crossing at the North Fork of Jones Creek where sediment is being discharged from the road.

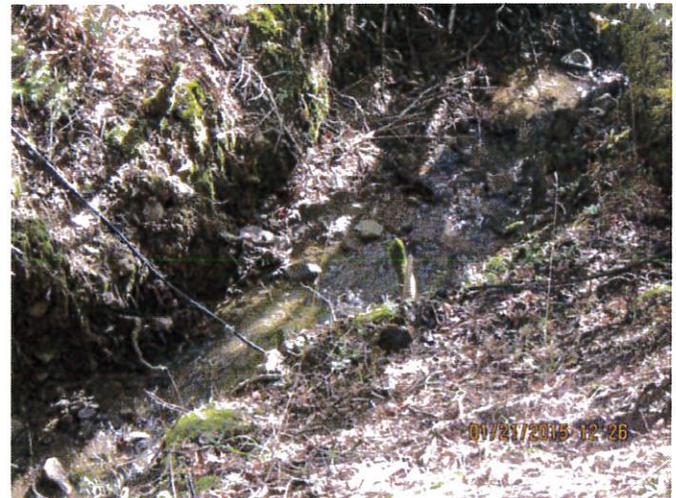
Photo 6 - Flow in Southern End of Unnamed Tributary to North Fork of Jones Creek (prior to)

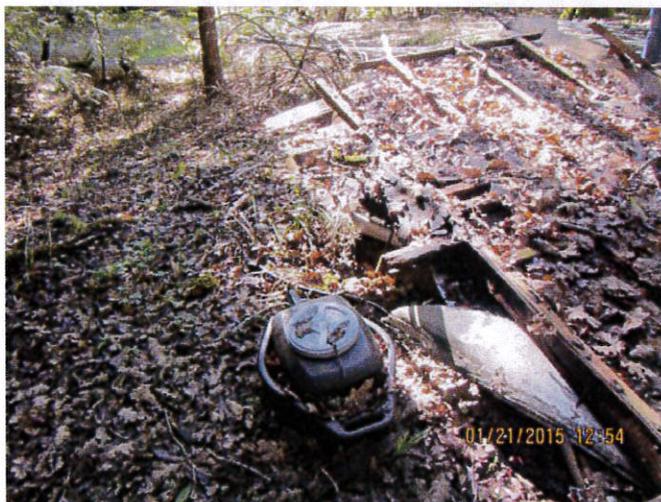
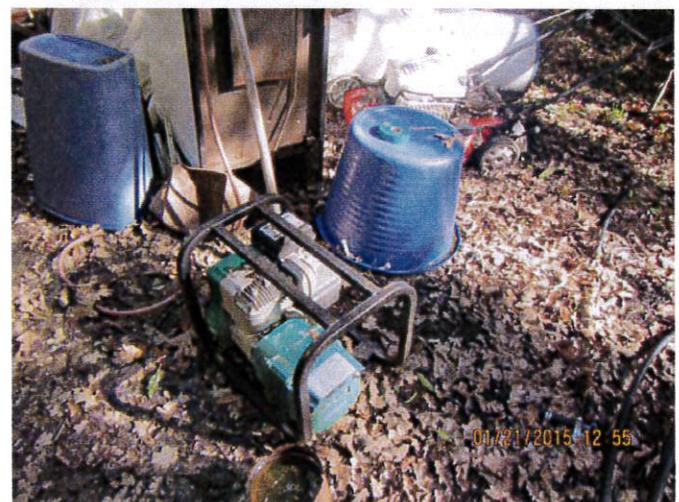
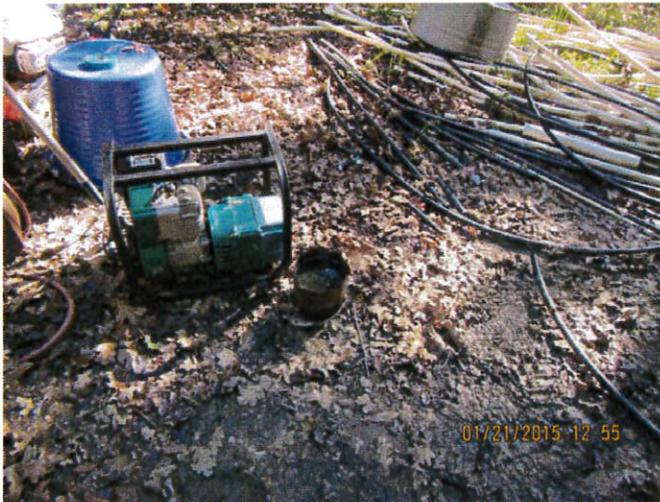
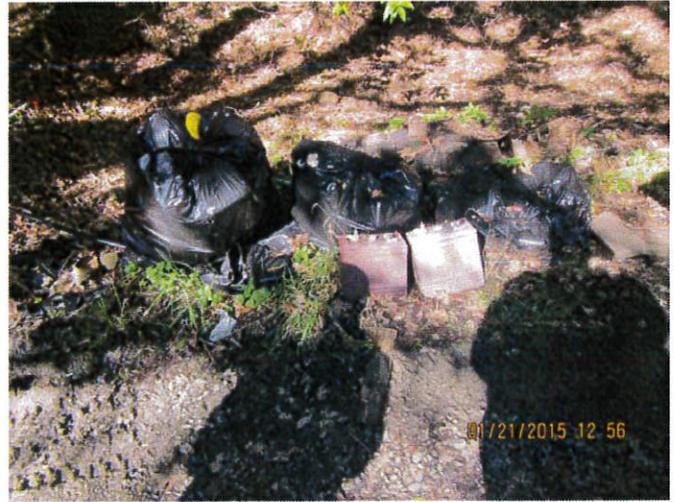
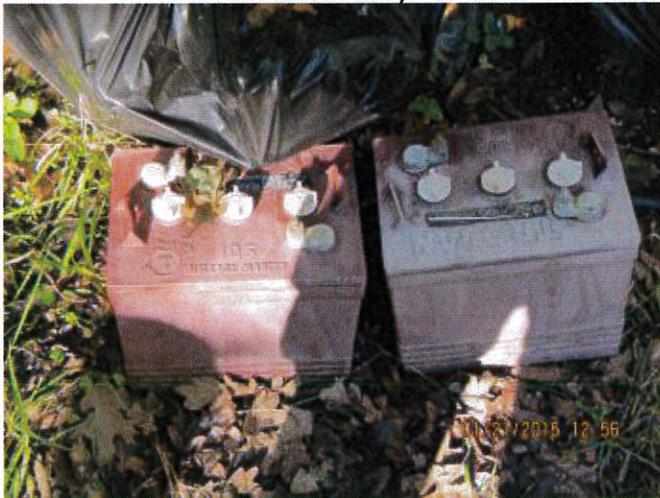
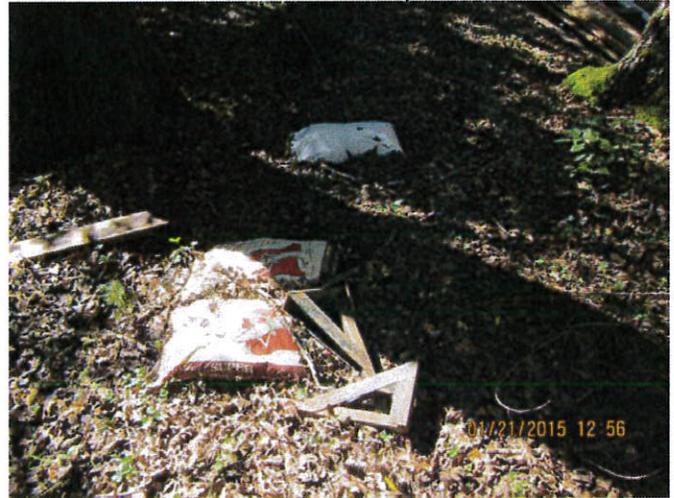
Staff continued to walk down the road towards the residence of Jacob Bullock. As staff neared the residence, they noted trash piles that included car batteries. The trash pile nearest the creek was 140 feet from the creek. There were numerous bags and containers of fertilizers strewn on the ground including: Mocha bat guano, chicken manure, and earthworm castings (**photos 11 through 16**). The residence had an outhouse (**photos 17 and 18**) on its porch alongside the drainage that flowed to Jones Creek and the gray water appeared to be typically discharged directly into the creek. However, because the pipe became disconnected, the sudsy, foamy water was on the side of the residence. Downslope from the current residence was a second greenhouse (Greenhouse 2). Upslope was a third greenhouse (Greenhouse 3) and the future residence of Mr. Jacob Bullock, currently under construction. Water Board staff walked up to

Staff observed trash at locations through the site, mostly on the Jacob Bullock portion of the property.

Recommendation 1: Relocate or dispose of fertilizers, spoils, and refuse so it cannot enter surface waters, and ensure that all spoils are properly stabilized.

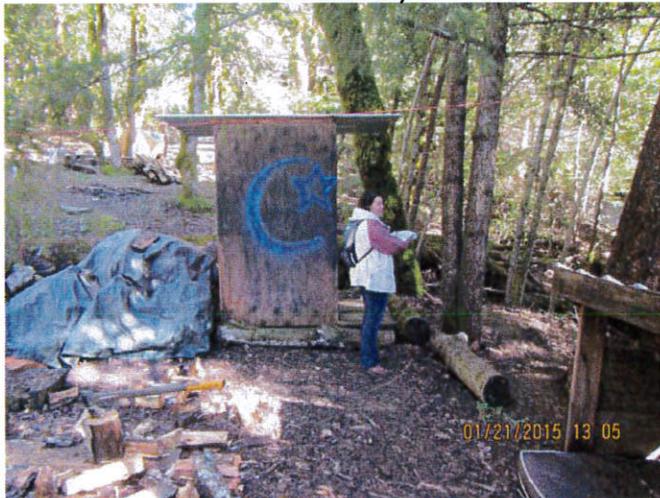
Photo 17 - West side of outhouse

The McConnell residence is poorly sited, immediately adjacent to a tributary; the drain field would therefore be under the channel. The current residence of Jacob Bullock had an outdoor pit toilet in close proximity to the South Fork of Jones Creek. The future residence of Jacob Bullock has a septic tank that doesn't appear to have been properly installed. It doesn't appear to be level. Additionally, there is standing water with a milky appearance. If this is due to a leak, it is a health hazard.

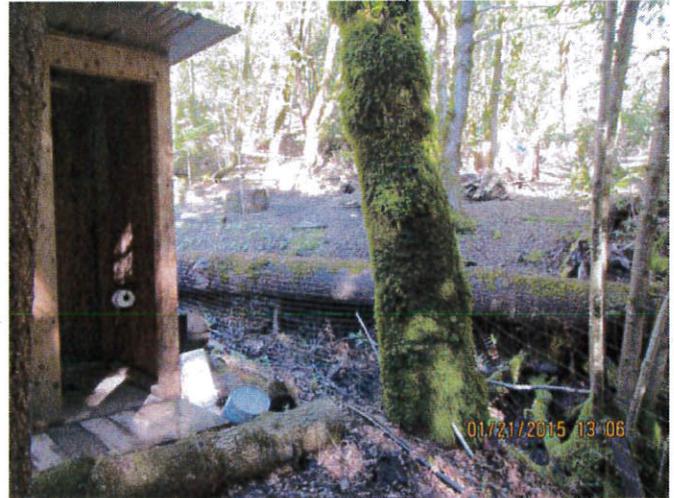
Photo 18 - South side of Outhouse (channel is between it and the log)

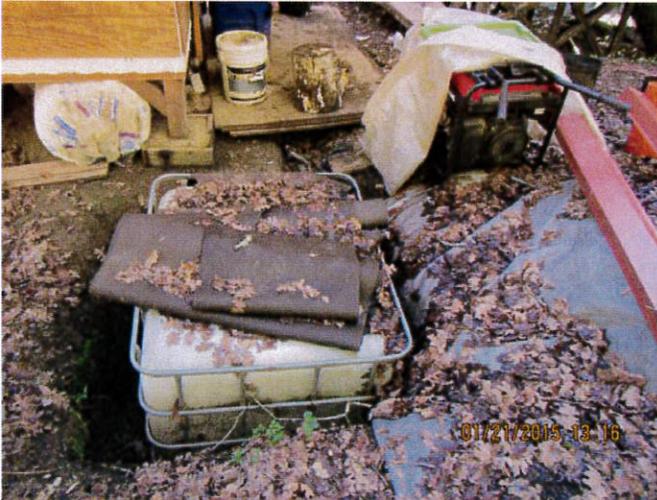
take a look at the structure and noted an excavated area in which a tote was placed. The tote had a pipe connected to it. Its purpose is unclear; it may be for collecting gray water (**photo 19**). Staff also noted the pit with the septic tank also had standing water (**photo 20**).

Photo 19 – Buried Tote

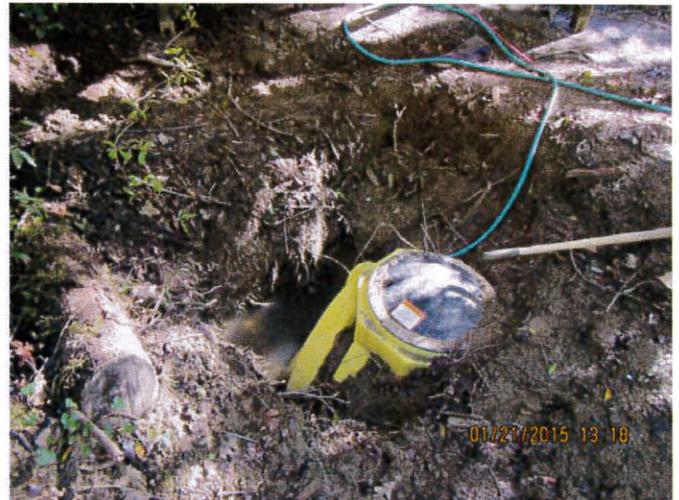
Photo 20 – Septic Tank

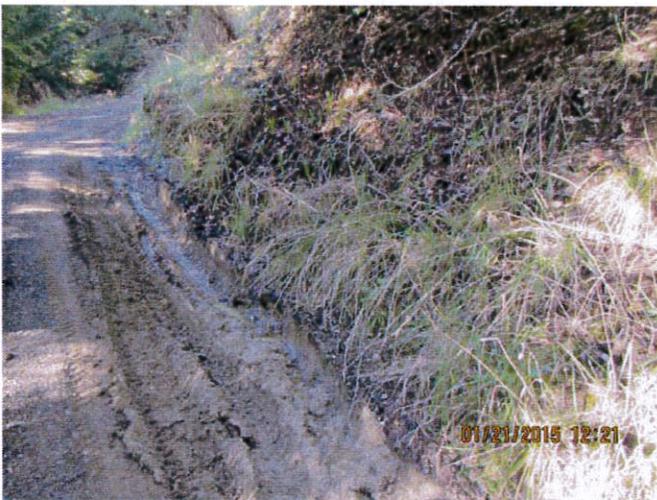
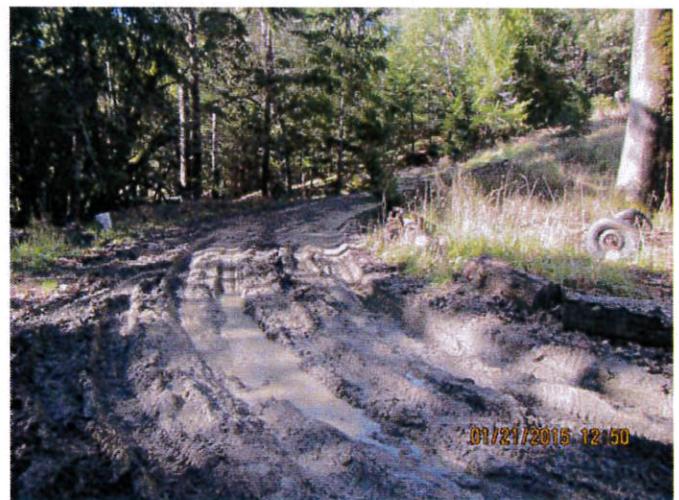
Photo 21 – Road Connecting Main Road to Jacob Bullock Residence

Photo 22 – Road just East of Jacob Bullock Residence

Many road segments throughout the site were muddy, showed evidence of erosion and sediment transport, and were delivering sediment to receiving waters. Evidence of rutting was observed and photographed (**photos 21 through 23**).

Recommendation 2: Improve the surface of the road throughout the parcel by consulting a professional to redesign the road and resurface areas of erosion, rutting, and soil failure. This will prevent high runoff velocities and the generation of loosened and muddy soil.

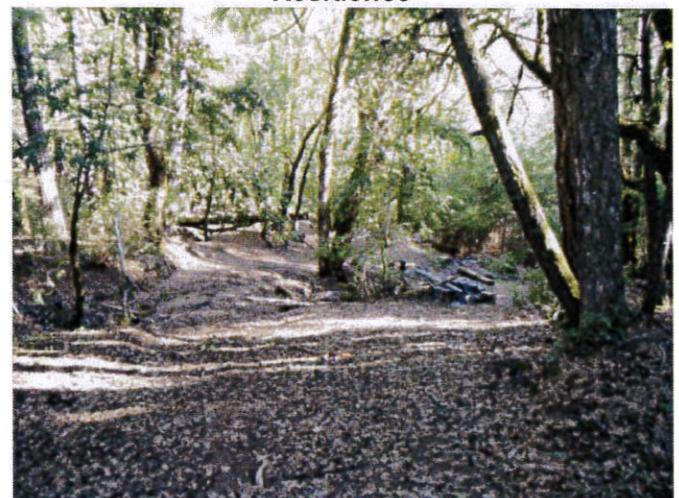
Photo 24 (Golec) – Channel Flowing across the road

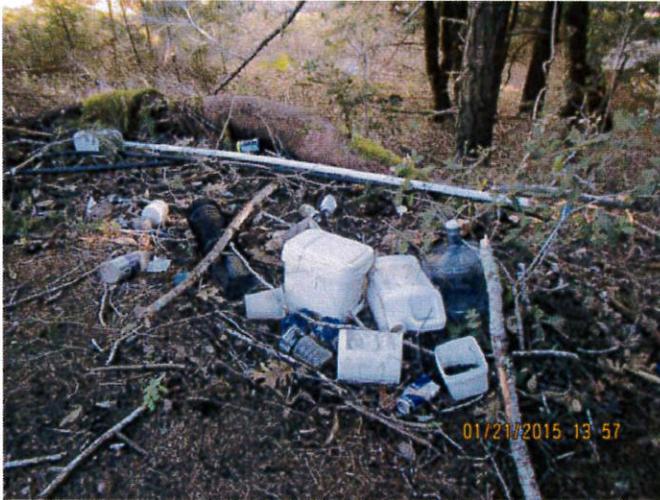
Mr. McConnell helped staff identify, and subsequently go to, an area of interest on the parcel map. This turned out to be a large pile of logs. Staff noted a channel running across the road and through the pile (**photo 23**). Mr. McConnell then escorted us to a short road leading down to clearing with a makeshift shed of covered pallets, where Mr. McConnell stated Mr. Jacob Bullock has stored equipment (**photo 27**). The shed was currently empty, with just pallets remaining. Adjacent was a filled earthen pad, stabilized by a log (**photos 28 through 30**). The pad had a gravel cover. Staff also found another trash pile upslope from this site (**photo 31**).

Photo 31 – Trash pile near Pad

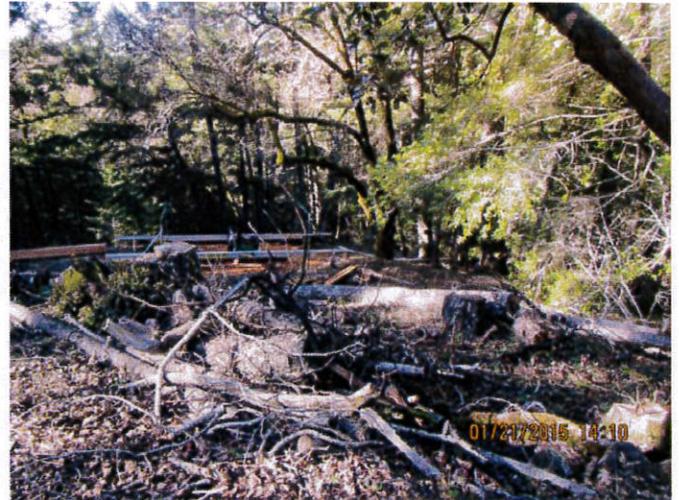
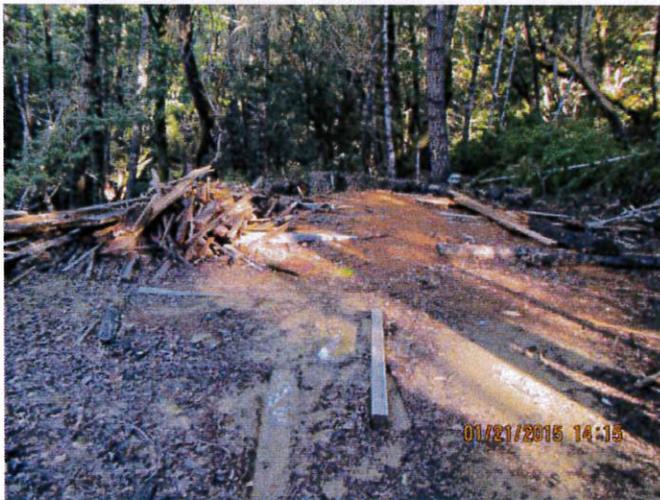
Mr. McConnell escorted us back up to the main road and to a multi-use greenhouse (greenhouse 6) on Mr. Jeremy Bullock's part of the parcel. Ms. Mustain introduced herself, gave Mr. Jeremy Bullock her business card, and handed him the warrant. From greenhouse 6 looking northwesterly toward Sproul creek, staff could see a pad with a machine for sawing and milling logs (**photos 32 and 33**).

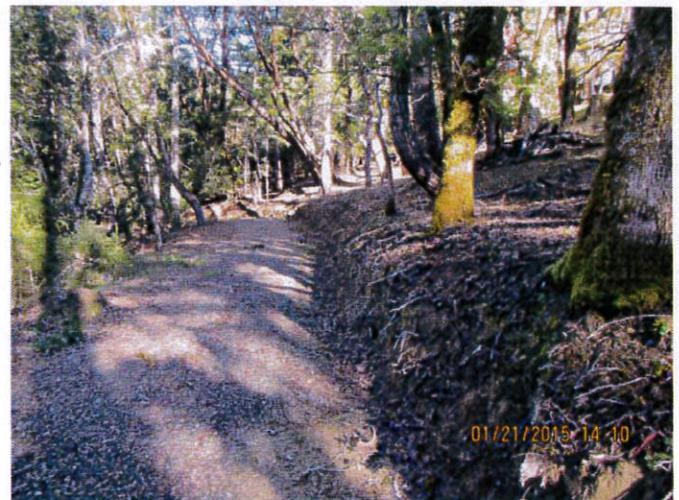
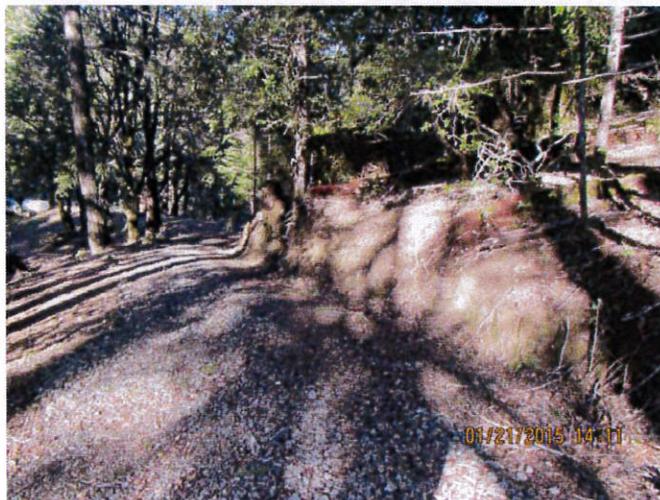
Water Board staff walked downslope to investigate the extent of the bulldozing (**photos 34 and 35**). It did not lead to any structure. Mr. Jeremy Bullock granted consent for Water Quality Staff to enter the greenhouse structure to Warden Steve Crowl. This greenhouse was used for more than just cannabis. Staff noted what appeared to be tomatoes and a citrus plant.

Photo 34 – Road from Greenhouse 6 towards Sproul Creek

Photo 35 – Road from Greenhouse 6 towards Sproul Creek

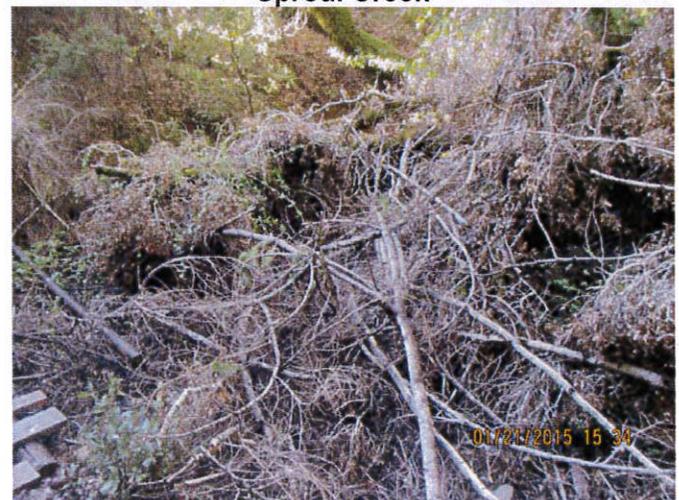
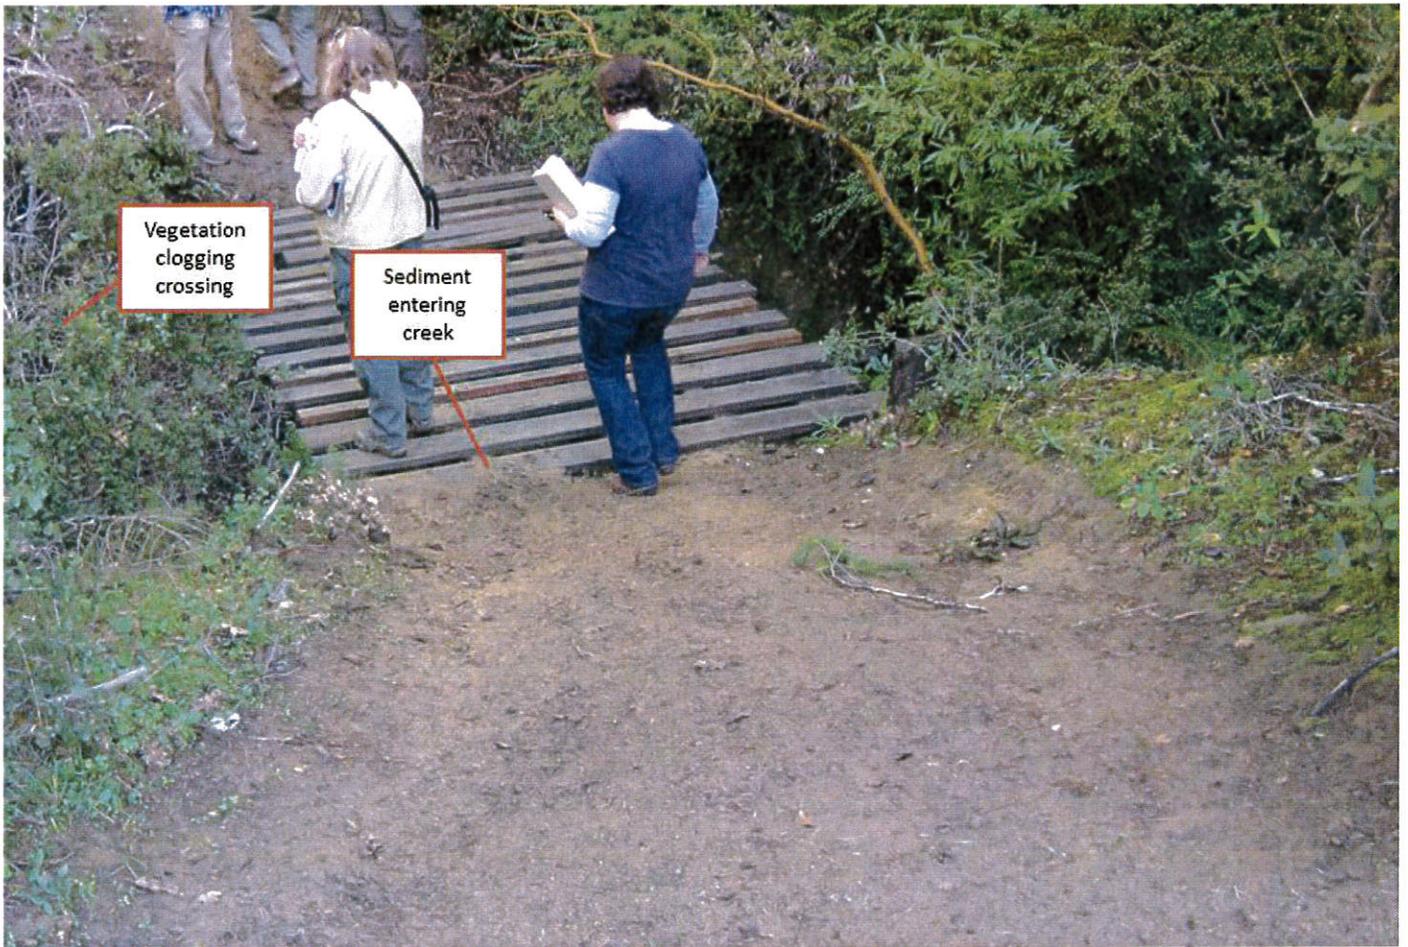
Lastly, Staff investigated some greenhouses at the northwest section of the property by cutting back through Mr. McConnell's part of the parcel and following a road to the unnamed creek. There was a makeshift crossing of several layers of boards across the North Fork of Jones Creek, with much debris and trees in the creek upstream of it (**photos 36 and 37**). Sediment was entering the creek from both sides of the crossing (**photo 37**).

Photo 36 – Slash Placed in Jones Creek

Photo 37 (Vella) – Crossing at Jones Creek, North Fork

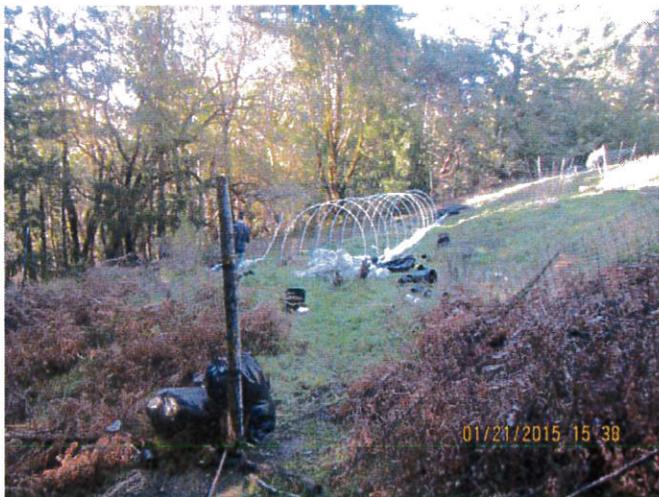
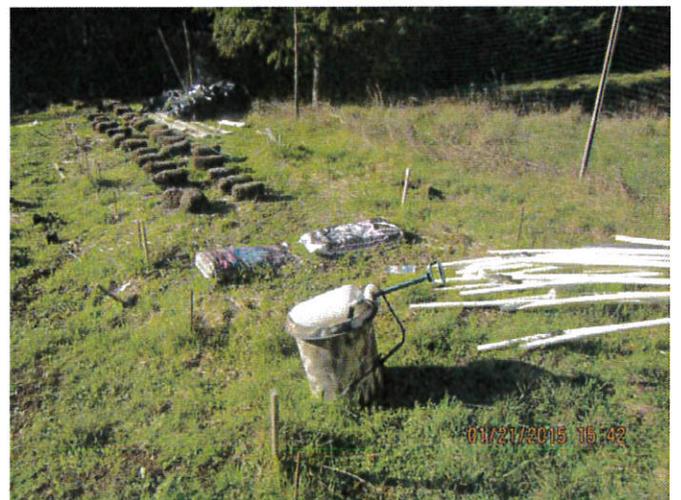
Then staff hiked up a steep slope to some more gardens (**photos 38 and 39**). Mr. McConnell stated that the neighbors had complained about the proximity to the property line and so these were not in use. However, potting soil, fertilizer, and miscellaneous debris remains on the site.

Photo 38 – Greenhouse 8 (Southeast Part of Property)

Photo 39 – Debris near Greenhouse 8
