North Coast Regional Water Quality Control Board

SUBJECT: CALTRANS UNPROTECTED STOCKPILE AREAS, STATE ROUTE 128,
BOONVILLE, MENDOCINO COUNTY

Appendix A: December 2, 2015, SR 128 Photo Log

Appendix B: December 2, 2015, SR 128 Photo Log—Post-Mile 44.3

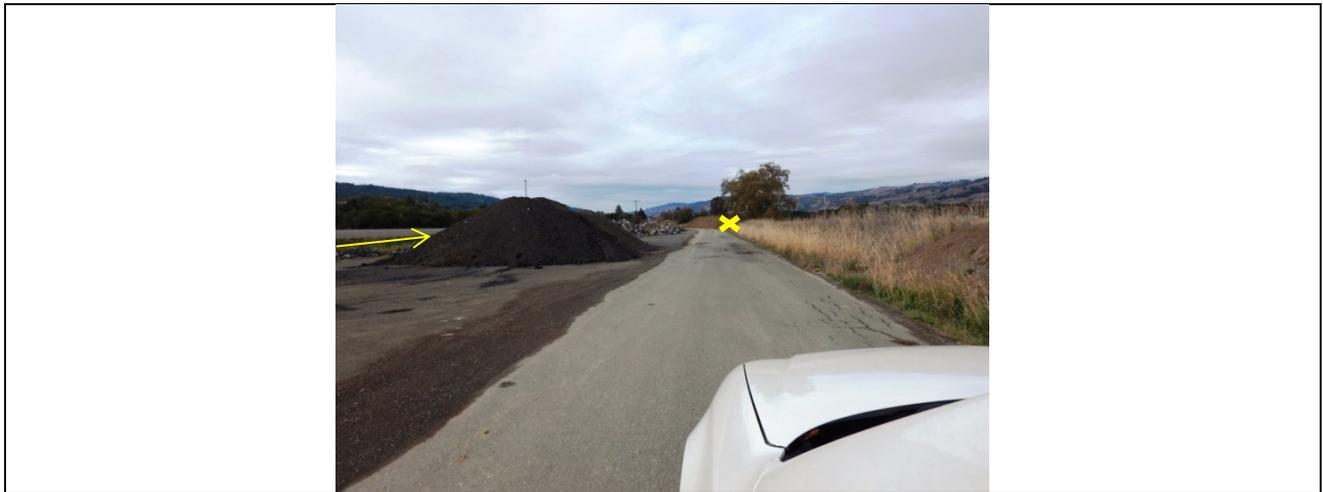
Photo 1: Looking NW towards Boonville. The stockpile area is linear and abuts SR 128. The entire site is sloped down to the NW and crowned; water running to the right would be directed down gradient by an earthen berm and collect at the bottom of the slope at the foot of the earthen stockpile at the location marked by the yellow "x"; water draining to the left would drain to a roadside drainage ditch. The pile in the foreground is asphalt concrete grindings. There was a drainage ditch on the other side of the berm.

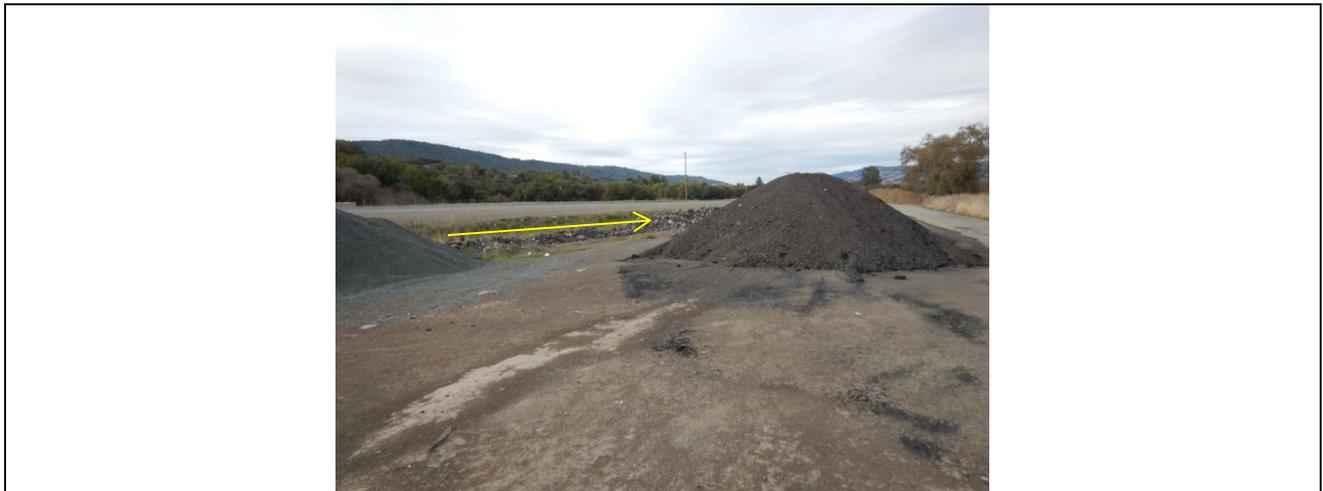
- A large pile of asphalt concrete grindings was left uncovered where runoff from the stockpile would discharge to jurisdictional waters;
- Pieces of yellow thermoplastic striping were visible within the pile of grindings. Caltrans typically separates this striping from asphalt and disposes of the material separately, due to the presence of lead and possibly other metals.

Photo 2: AC grinding stockpile shown in photo 1. Yellow thermoplastic pieces were evident within the pile. It appeared that runoff from the stockpile would drain both to the drainage ditch to the left and to the earthen berm on the right.

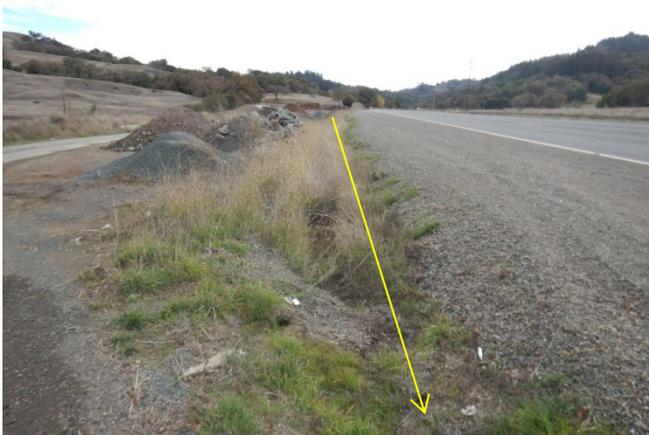
Photo 3. Looking southeast and upslope at the area show in photos 1 and 2. This drainage ditch would carry stormwater runoff from the stockpile area off-site. After passing through the stockpile area, this ditch would discharge to a creek approximately 750 feet down gradient.

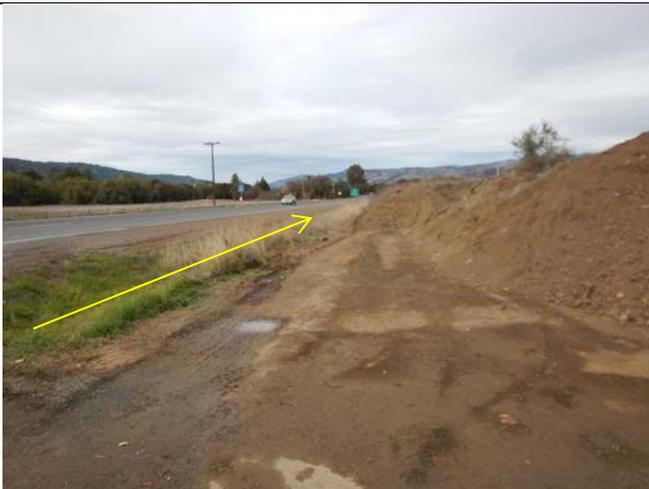
Photo 4: Taken from approximately the same position as Photo 3, except looking north east. Unprotected earthen stockpiles were placed immediately adjacent to the drainage ditch.

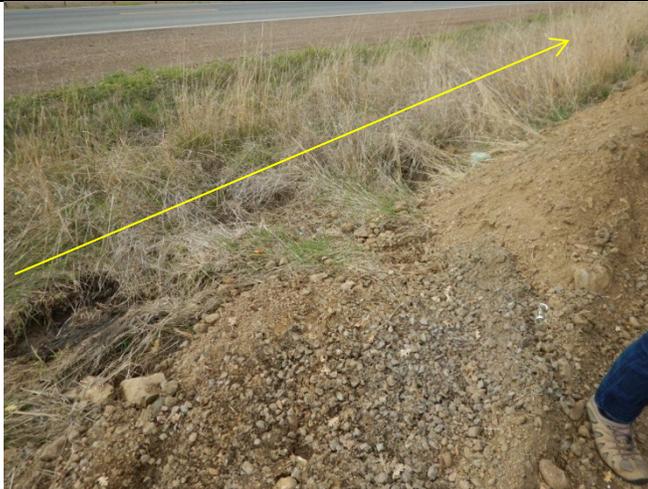
Photo 5: Dirt from the unprotected piles in Photo 4 were spilled into the roadside drainage ditch.

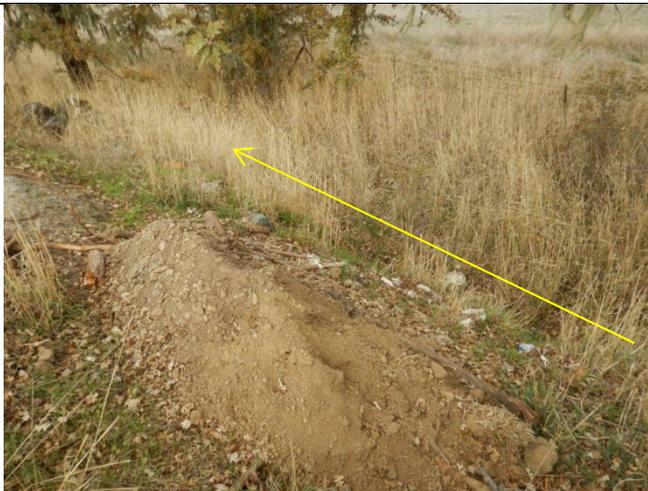
Photo 6: Looking onto and over the outside of the berm, immediately adjacent the area marked with the "x" in photo 1. This dirt spoil pile had been placed at the top and over the berm where it could be washed into the drainage ditch marked with the yellow arrow. This drainage ditch parallels the roadside drainage ditch and discharges into the same creek.

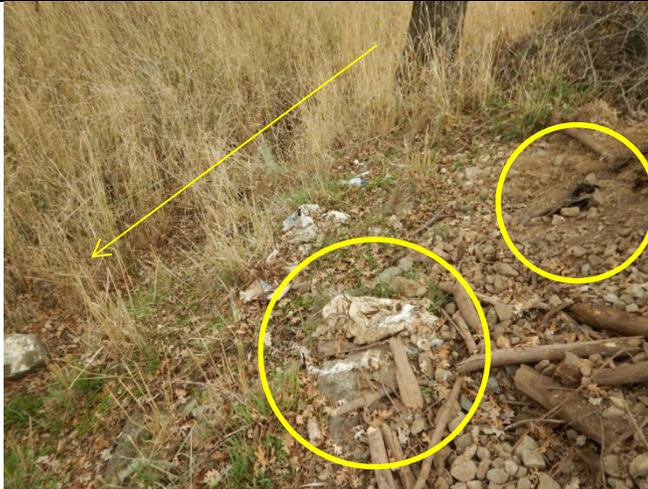
Photo 7: Another dirt/waste pile deposited immediately upgradient of the pile shown in Photo 6. 2 different decomposing animals were embedded in the pile. The pile was placed atop and down the side of the berm into the drainage ditch.

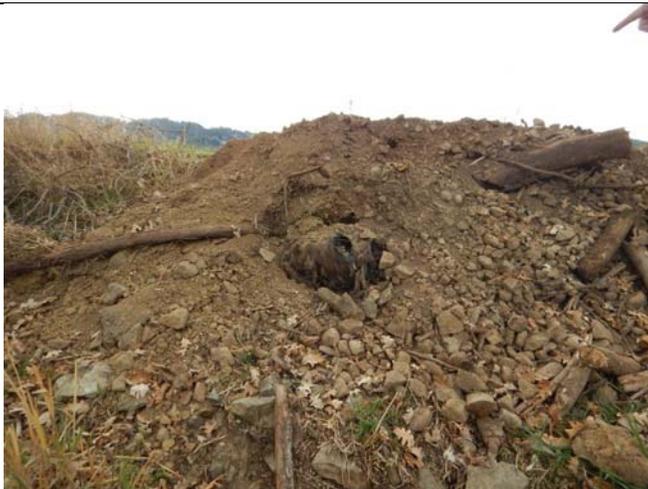
Photo 8: This is the same decomposing animal shown in the upper circle in Photo 7.

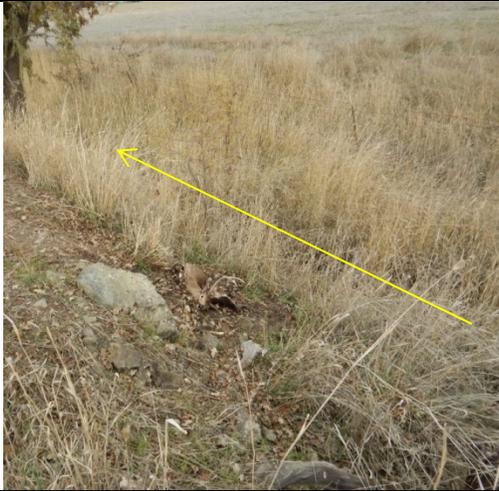
Photo 9: Deer carcass downstream of the areas in photos 6-8.

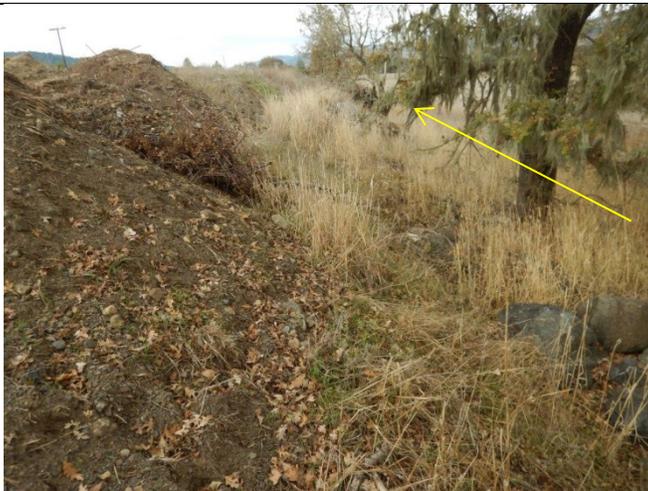
Photo 10: Dirt stockpiles placed on top of and pushed over the creek berm. Just downstream of the areas shown in Photos 6-9.

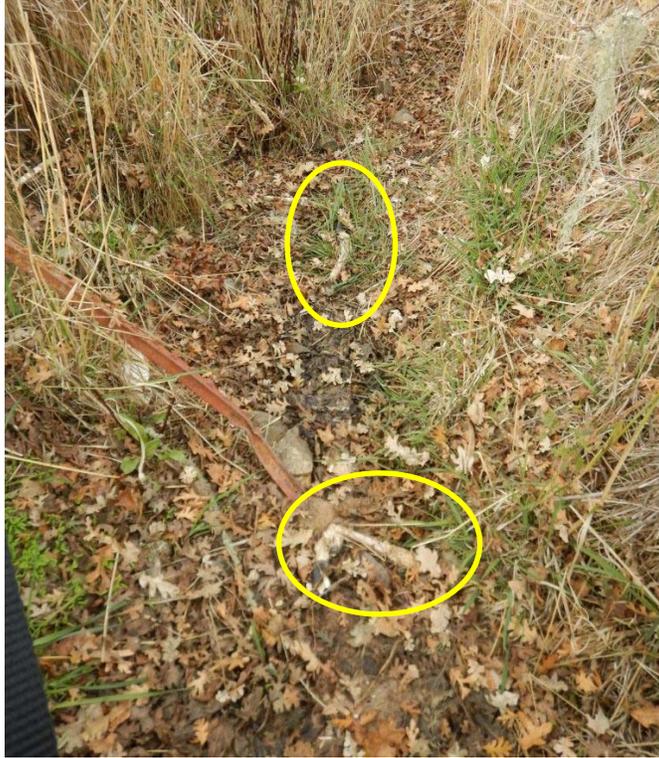
Photo 11: Deer parts placed into the drainage ditch channel adjacent the berm.

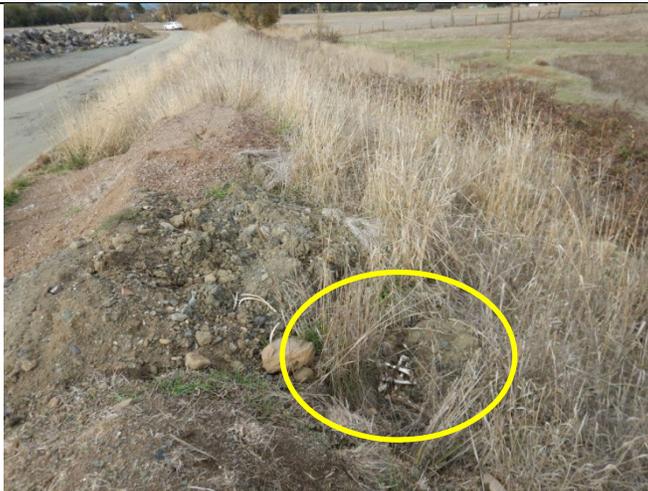
Photo 12: Animal bones several hundred feet upgradient of the areas shown in photos 6-11. Animal bones were present along the entire length of the berm.

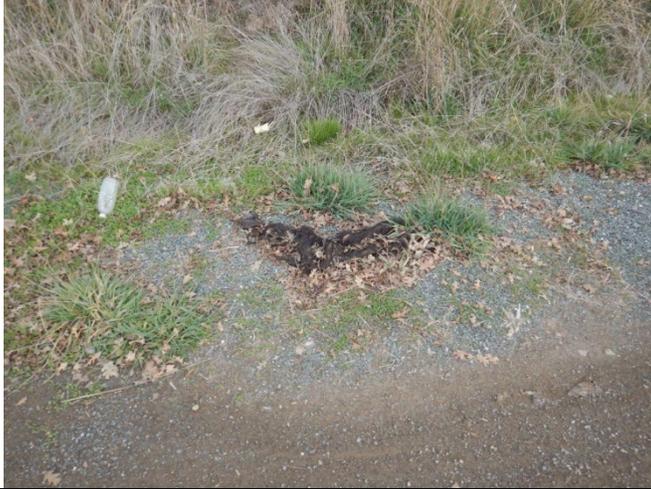
Photo 13: Decomposing animal at the foot of the inside of the berm.

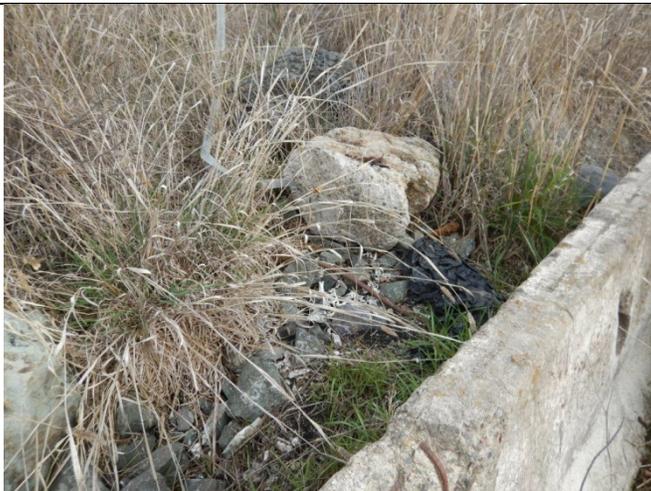
Photo 14: More animal bones placed on the berm.

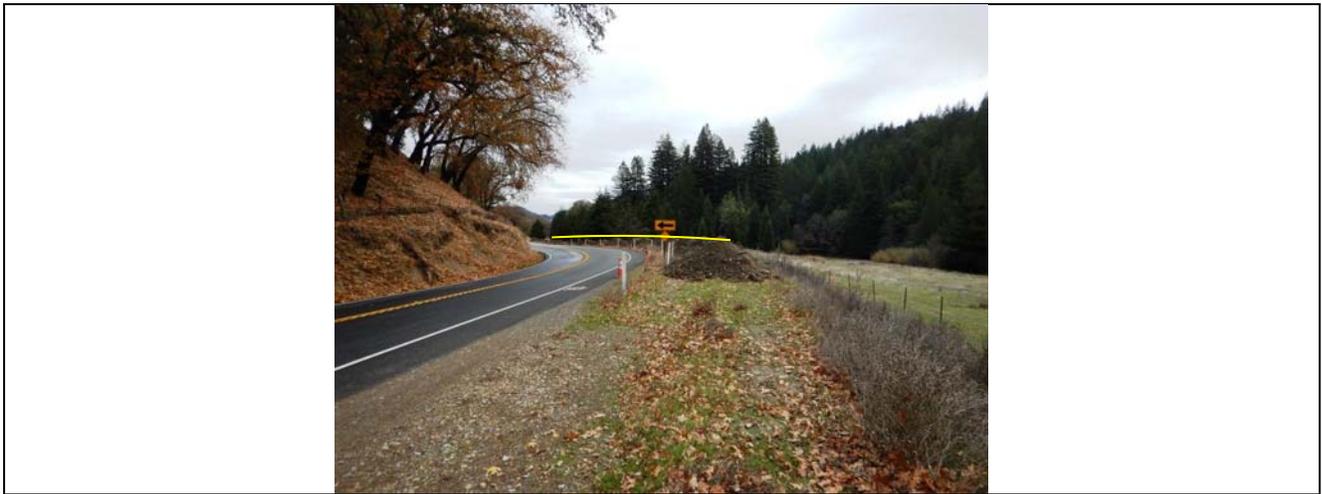
At this location, Caltrans stockpiled approximately 15 piles of dirt around the outside bend of a turn on the vegetated shoulder, approximately 200 feet from Rancheria Creek. The piles were without erosion and sediment control and rain was forecast for that evening and into the following day.

Photo 1: Looking eastbound. Approximately 18 piles of dirt were placed on the vegetated shoulder at the outside of this curve. There was no erosion controls present and rain was forecast for that evening and the next day. The yellow line indicates the extent of the piles.

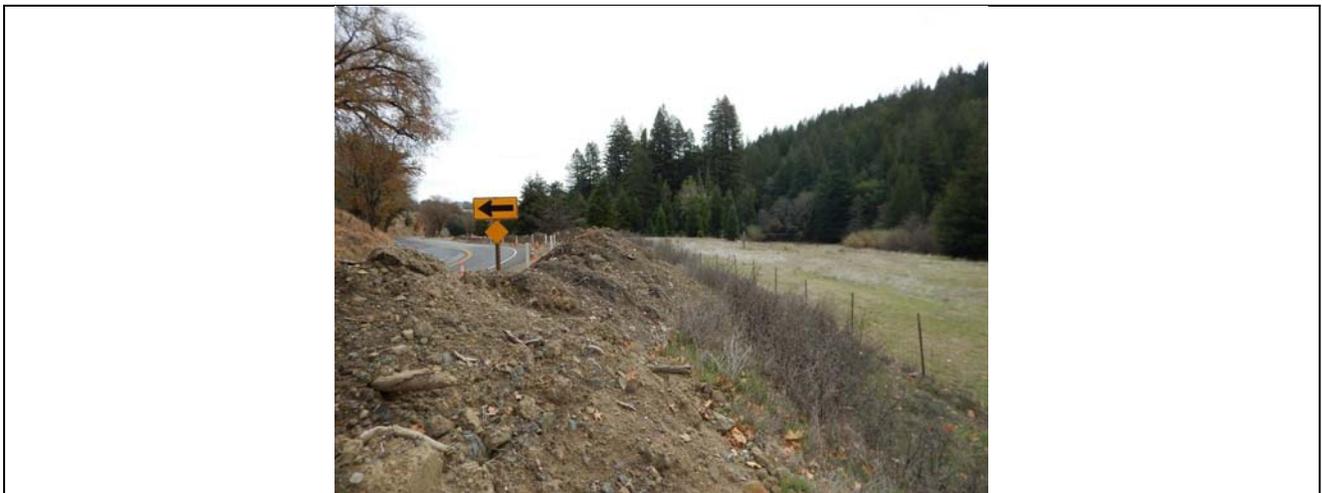
Photo 2: Looking eastbound at dirt piles. Rancheria Creek is approximately 200 feet to the right.

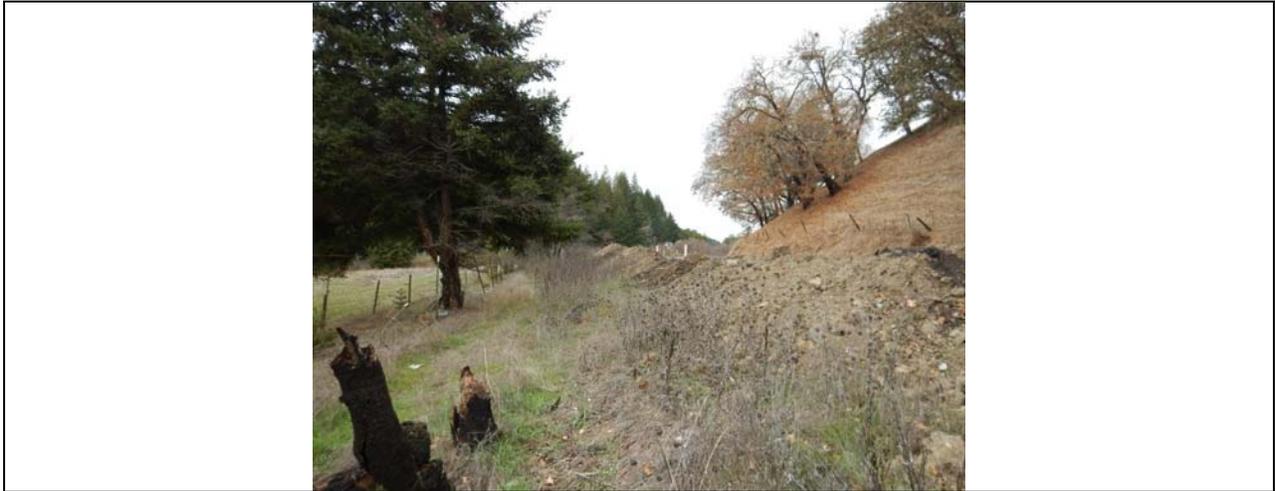
Photo 3: Looking westbound at unprotected dirt piles. There was not sediment control placed around the pile perimeter.
