Attachment A: Methodology

This technical analysis provides a summary of factual and analytical evidence that support the findings in Administrative Civil Liability Complaint No. R1-2020-0009 (Complaint) and the recommended assessment of administrative civil liability (ACL) in the amount of **\$6,425,680**. The Complaint alleges that Sonoma Luxury Resort LLC (Discharger) has failed to implement the requirements of State Water Resources Control Board (State Water Board) Order No. 2009-0009-DWQ, as amended by Order No. 2010-0014-DWQ and Order No. 2012-0006-DWQ, National Pollutant Discharge Elimination System (NPDES) General Permit for Storm Water Discharges Associated with Construction and Land Disturbance Activities (Construction General Permit or CGP) while conducting site development and construction work on the Saggio Hills Project, a 258-acre property located at 16840 Healdsburg Avenue, Healdsburg, in Sonoma County (Site). Additionally, the Complaint alleges that the Discharger has failed to meet the conditions of its December 5, 2008 (amended December 6, 2018), Clean Water Act section 401 Water Quality Certification (401 Certification) for work at the Site.

Figure 1. Saggio Hi

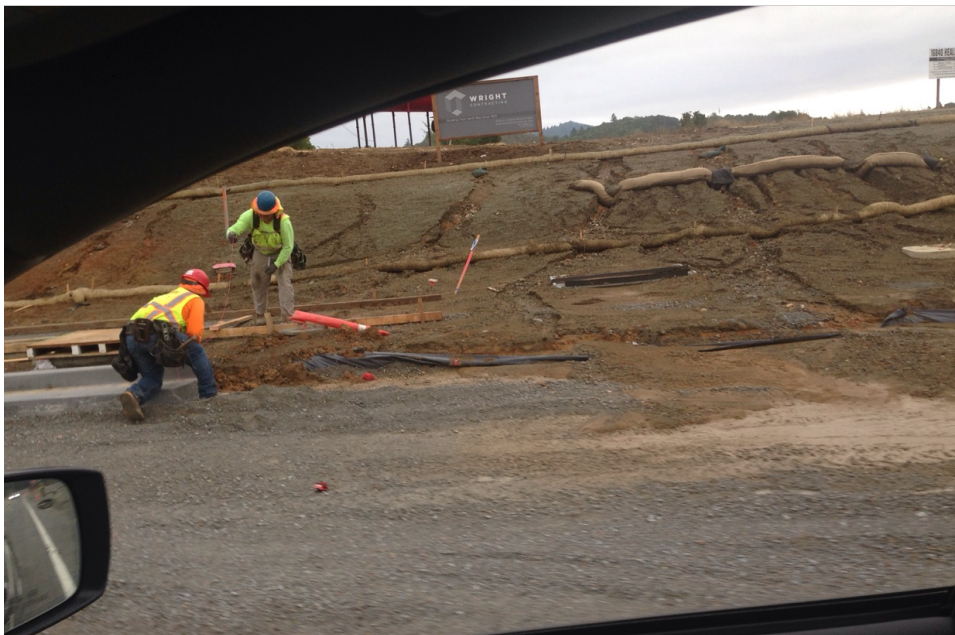
On October 3, 2018, Regional Water Board staff drove by the Site during a rainfall event and observed a portion of the Site from Healdsburg Avenue. Staff observed a bare, steep slope with several erosional rills or gullies (Violation 2: inadequate soil cover; D.2.) with intermittent wattles and silt fences that were undercut by erosion or overrun with sediment (Violation 1: BMPs not effectively reducing/preventing pollutants; B.5.e.). The slope did not have continuous or effective linear sediment controls at the base (Violation 4: inadequate linear sediment controls; E.4) showing evidence of drainage and sediment transport onto and across an adjacent active area (Violation 5: inadequate run-on/runoff control; F). Staff observed sediment that had been tracked from this area onto Healdsburg Avenue (Violation 3: inadequate perimeter control; E.1.). Collectively, this snapshot captured an overall failure to maintain adequate erosion, sediment, and turbidity control BMPs.

Figure 2. View of failed BMPs. Insufficient ground cover, and sediment in street (Healdsburg Avenue) after storm event. Photograph taken on October 3, 2018.

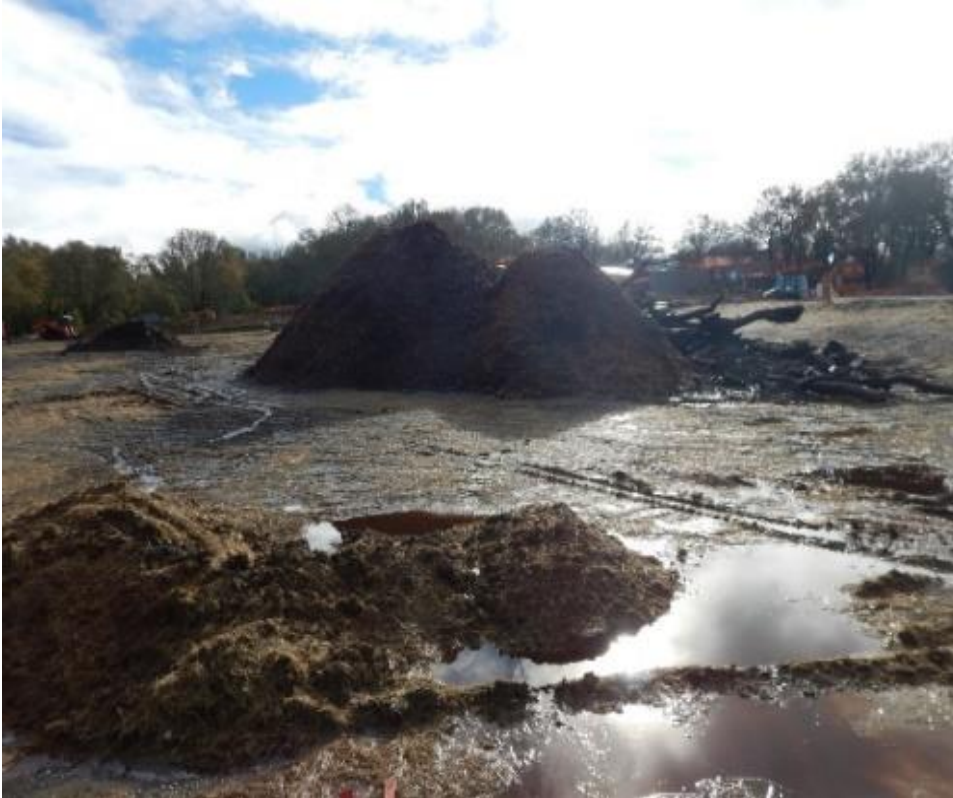
Staff observed two uncovered, uncontained stockpiles in the rain; one of wood waste with nearby puddles of discolored water (note image below), and one of gravel and fine-grained material adjacent to a drainage channel.

Figure 3. Uncovered, uncontained wood waste

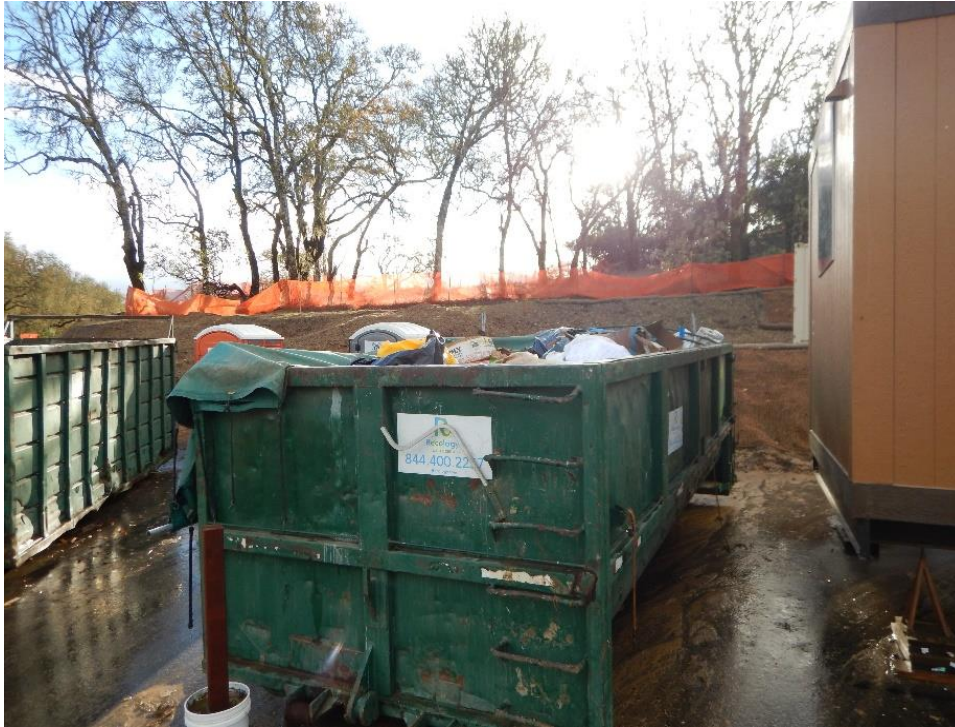
The circumstances of the violation indicate a substantial potential for harm given that the waste bin was uncovered during a rain event and the overall lack of adequate or effective pollution control BMPs on the Site at that time increases the likelihood that any waste, leachate, or contaminated rainwater could migrate or be transported into receiving waters and adversely impact water quality and beneficial uses. Accordingly, staff assigned a Potential for Harm of Moderate to this violation.

Figure 4. Uncovered waste disposal bin.

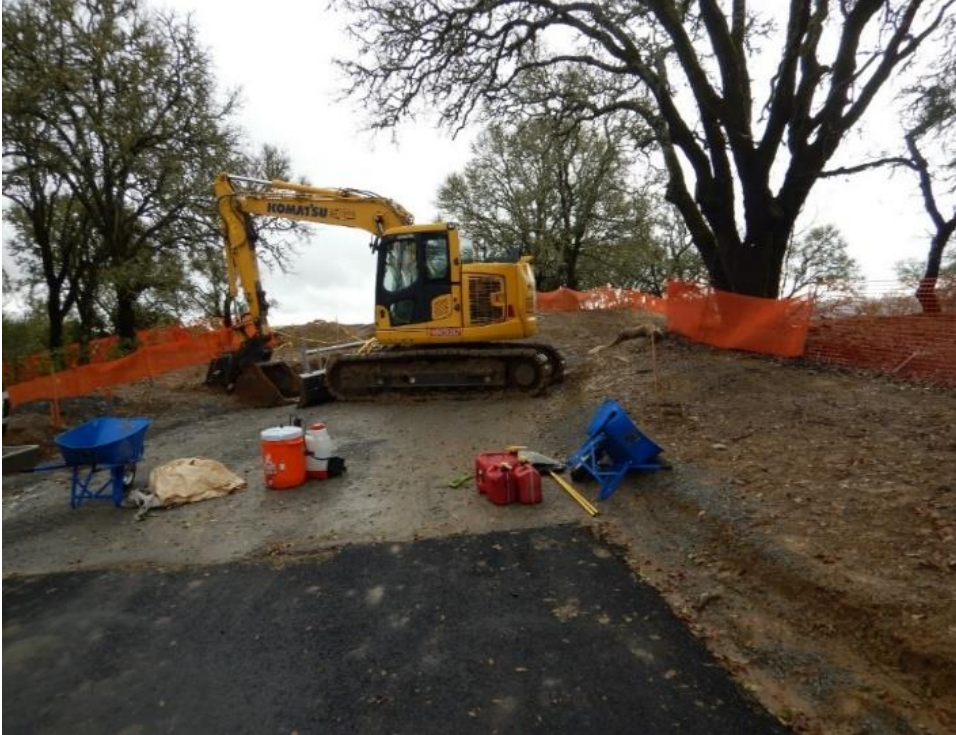
As seen in the picture below, gas cans were sitting on a sediment-covered road during a rain event. These circumstances, in addition to the conditions throughout the rest of the Site at the time, increase the likelihood that any chemicals spilled or leaked throughout the Site would come into contact with runoff and be transported into receiving waters, posing a substantial threat to water quality and beneficial uses. As a result, staff assigned a Potential for Harm factor of Moderate.

Figure 5. Gas cans on the ground in the rain.

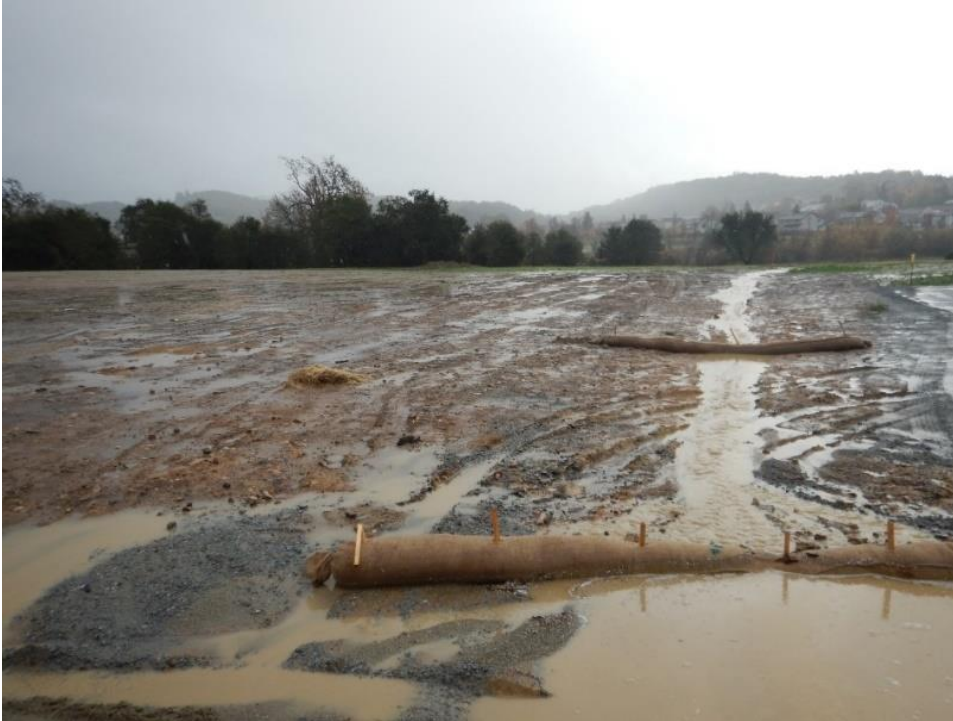
During the November 29 through December 4, 2018, inspections, staff observed 118 locations where BMPs were not effective in reducing or preventing pollutants in storm water discharges. In addition, storm water runoff samples collected by staff during the November 29, 2018, inspection showed turbidity levels as high as 896 NTU, well above the 250 NTU as a numeric action level (NAL) in the CGP that triggers additional pollution control requirements for Risk Level 3 sites.

Figure 6. Ineffective Sediment control BMPs resulting in turbid, sediment-laden storm water runoff.

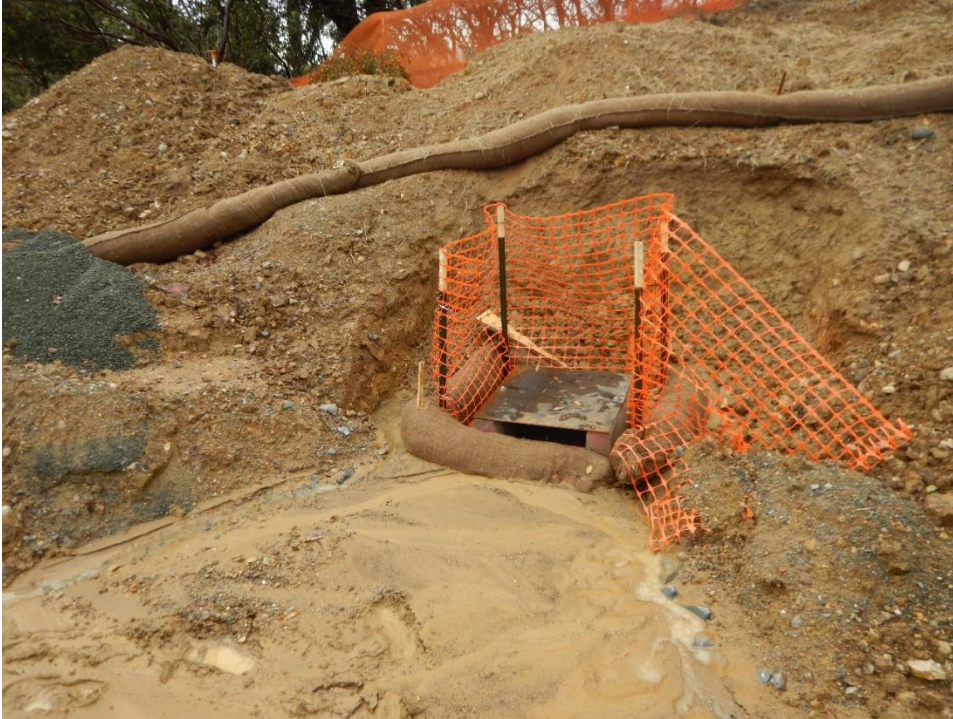
During the November 29 through December 4, 2018, inspections, staff observed 77 inactive areas with unprotected or ineffectively covered bare soil that was susceptible to erosion and exposed to the elements.

Figure 7. Sediment control BMPs inadequate to prevent erosion and overwhelmed by sediment deposition resulting from sediment-laden runoff.

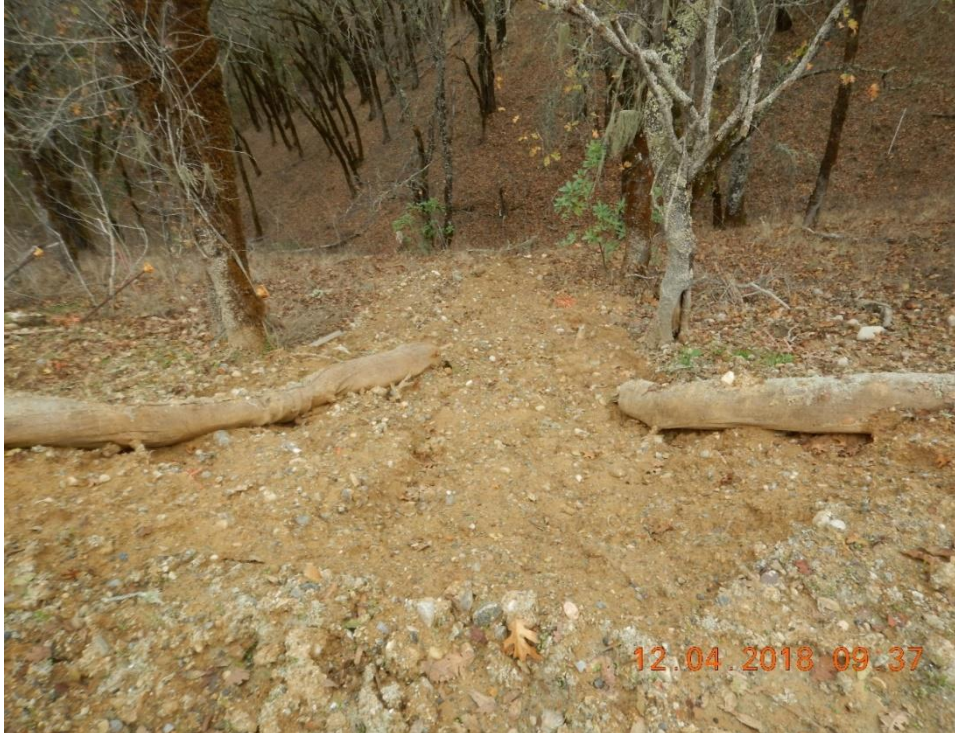
During the November 29 through December 4, 2018, inspections, staff observed 50 locations with inadequate perimeter controls, allowing pollutants to migrate or be transported off the Site.

Figure 8. Sediment from Road 5 has breached the single perimeter wattle and discharged to the hillslope below. An unnamed tributary to Foss Creek is located approximately 75 feet downslope.

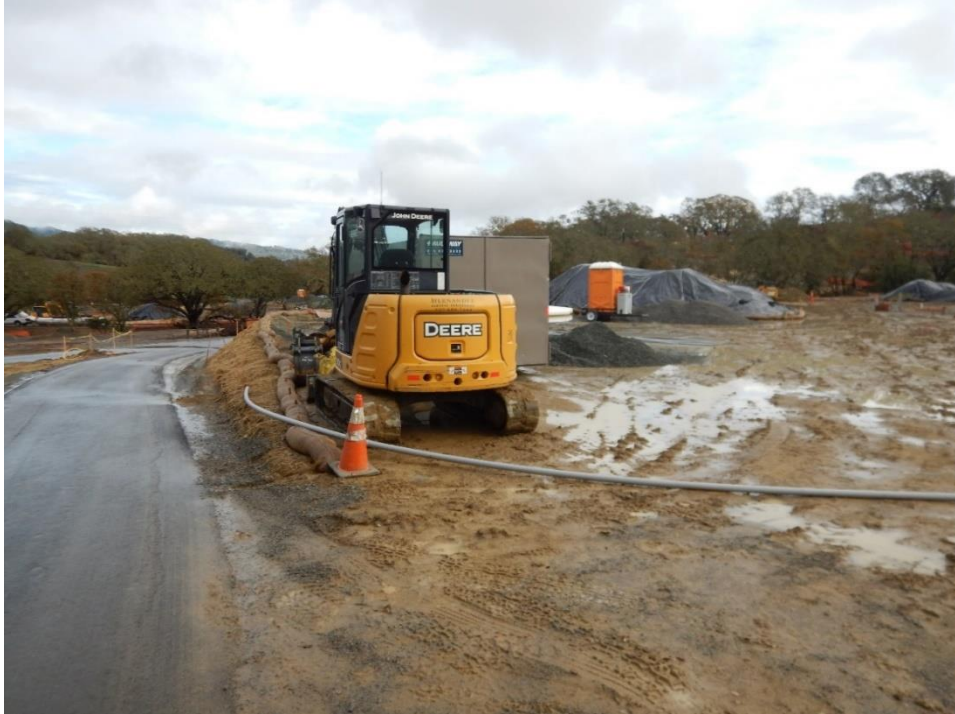
During the November 29 through December 4, 2018, inspections, staff observed 5 areas within the Site under active construction where erosion or sediment controls were non-existent or ineffective. Throughout the Site, staff observed bare, exposed, erodible, and eroding soil; turbid runoff; and sediment-laden runoff entering waterway. BMPs, where present, were either improperly installed, inadequate for the nature or scale of the discharges, rendered ineffective, or some combination thereof.

Figure 9. Disturbed soil where resort area was under active construction; lack of effective erosion or sediment control BMPs.

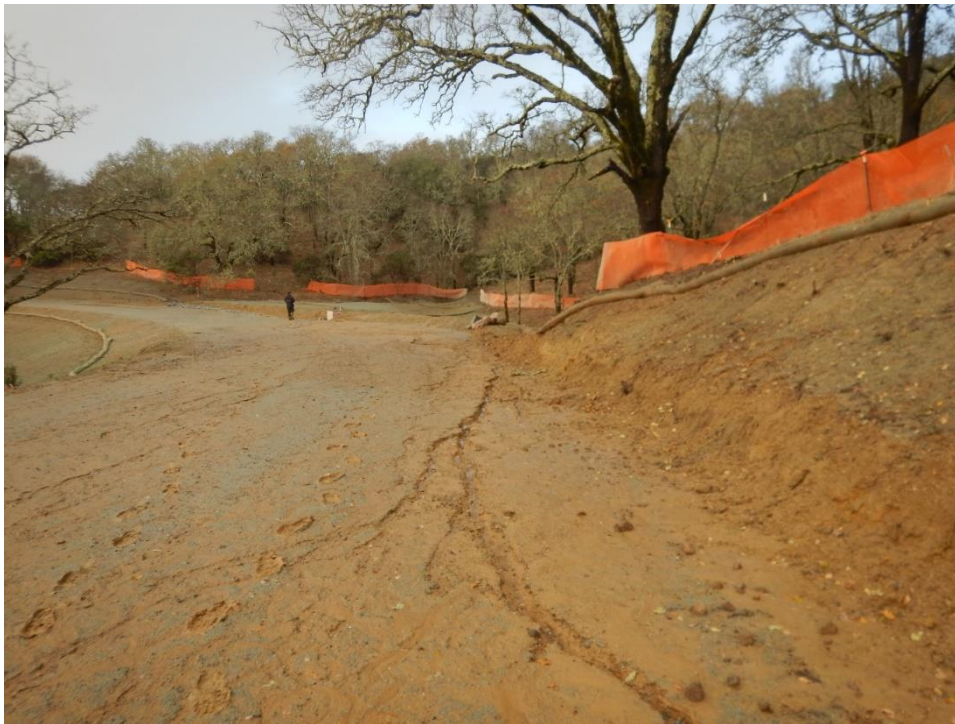
During the November 29 through December 4, 2018, inspections, staff observed 96 locations lacking adequate linear sediment controls at the toe or break in a slope. Erosion and drainage controls were non-existent or ineffective on slopes throughout the Site and were compounded by the lack of linear sediment controls. As a result, eroded sediment and large volumes of high-velocity runoff were free to travel across the Site, overwhelming ineffective BMPs and discharging into receiving waters.

Figure 10. No linear sediment controls along the base of this roadside slope. Signs of gullying on the road.

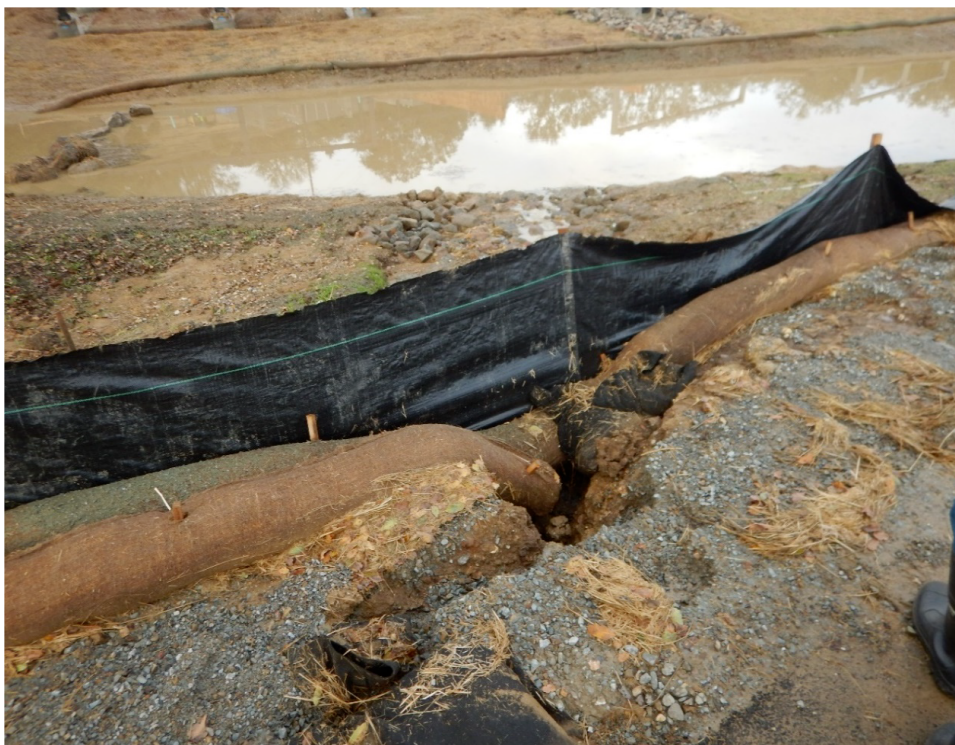
Figure 11. Erosional gully underneath wattle and silt fence; creek in the background.

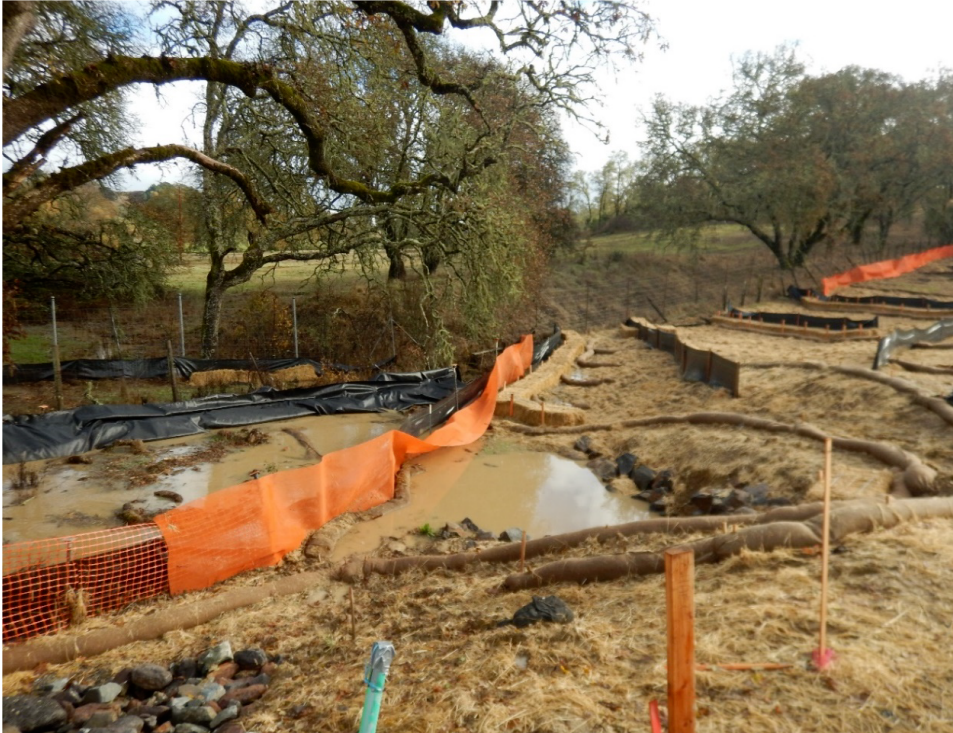
Figure 12. While several types of erosion and sediment controls are present at this location, the resort area lacked effective controls to prevent highly turbid runoff to the unnamed tributary (shown on left of photo) to Jordan Pond

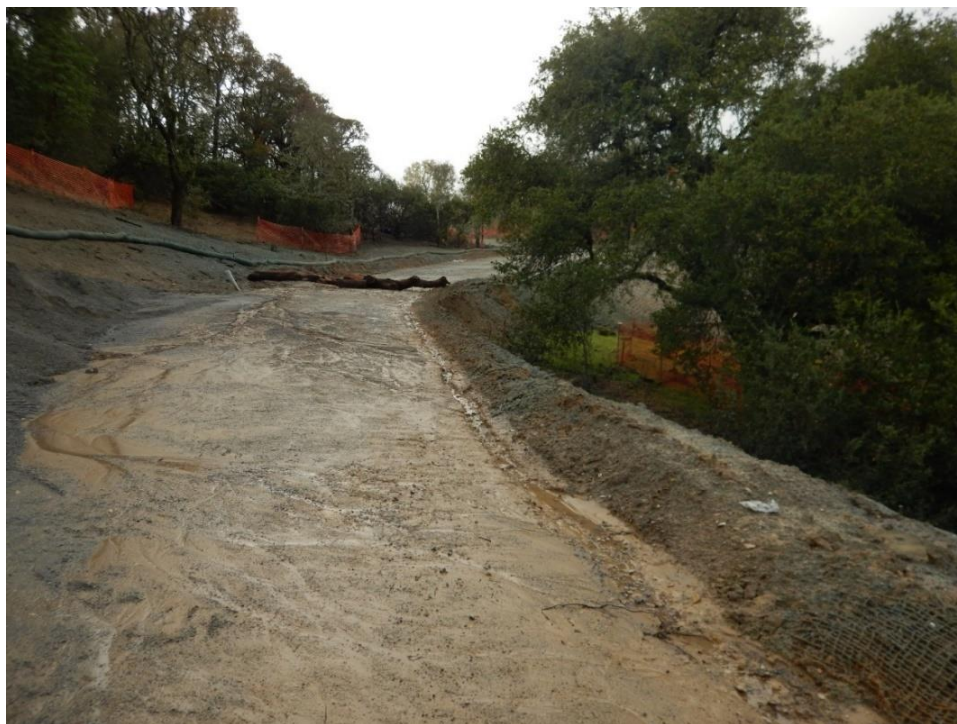
During the November 29 through December 4 inspections, staff observed 71 locations where run-on or runoff was not effectively controlled resulting in million gallons of sediment laden storm water discharging from the Site.

Figure 13. Road segment with adjacent unprotected slope and signs of uncontrolled runoff.

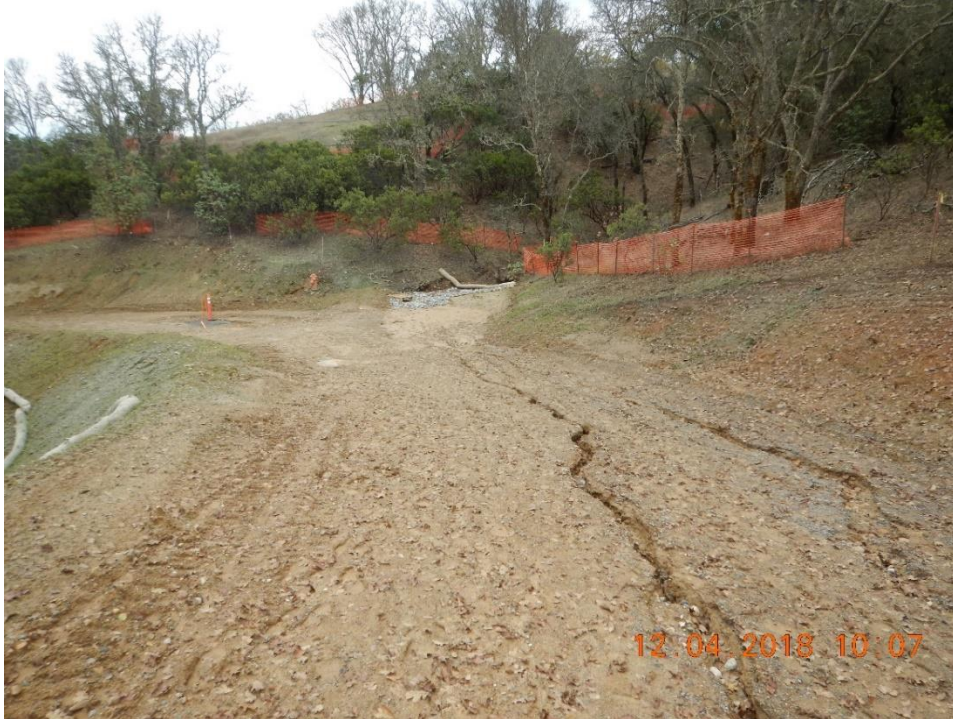
When effectively implemented, run-on and runoff controls can segregate clean or less polluted water from pollutants and more polluted water to control or minimize the amount of polluted storm water generated on a site and the amount of pollutants discharged from a site. With deficient run-on and runoff controls and widespread lack of effective pollution prevention BMPs throughout the Site, it is likely that most of the storm water that landed on or flowed across the disturbed portions of the Site became contaminated by sediment and other pollutants and discharged from the Site into receiving waters. The Potential for Harm associated with this violation is Major because the characteristics of the violation present an egregious threat to beneficial uses and the circumstances of the violation indicate a very high potential for harm.

Figure 14. Road segment with no erosion and sediment control BMPs. Signs of gullying on the road.

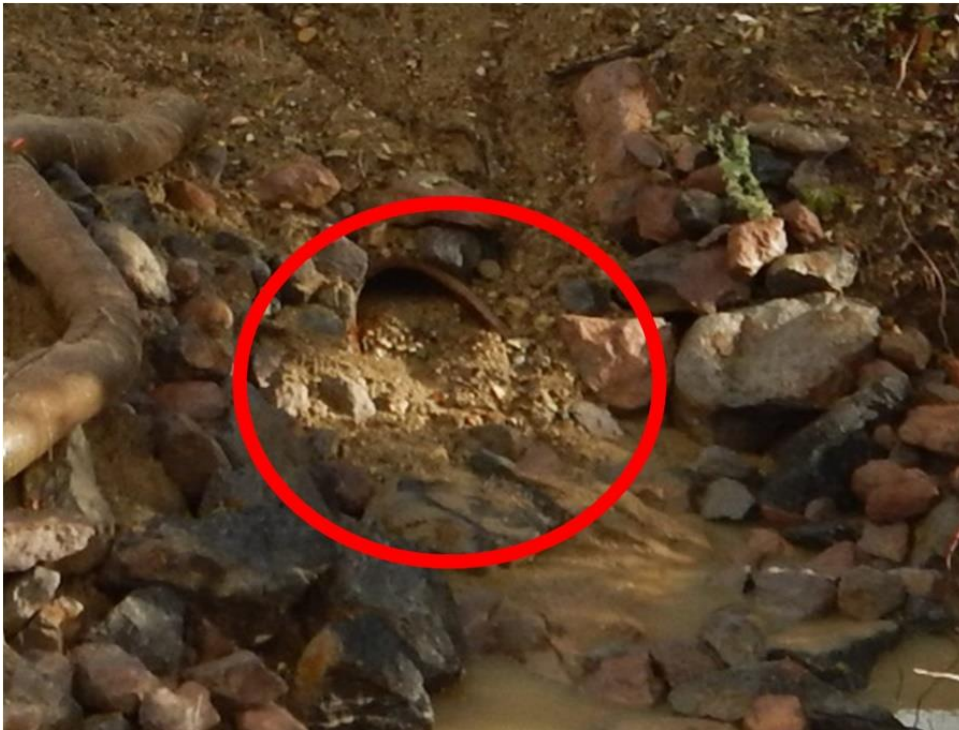
Figure 15. Significant sediment discharge at the culvert outfall that drains the upper resort area.

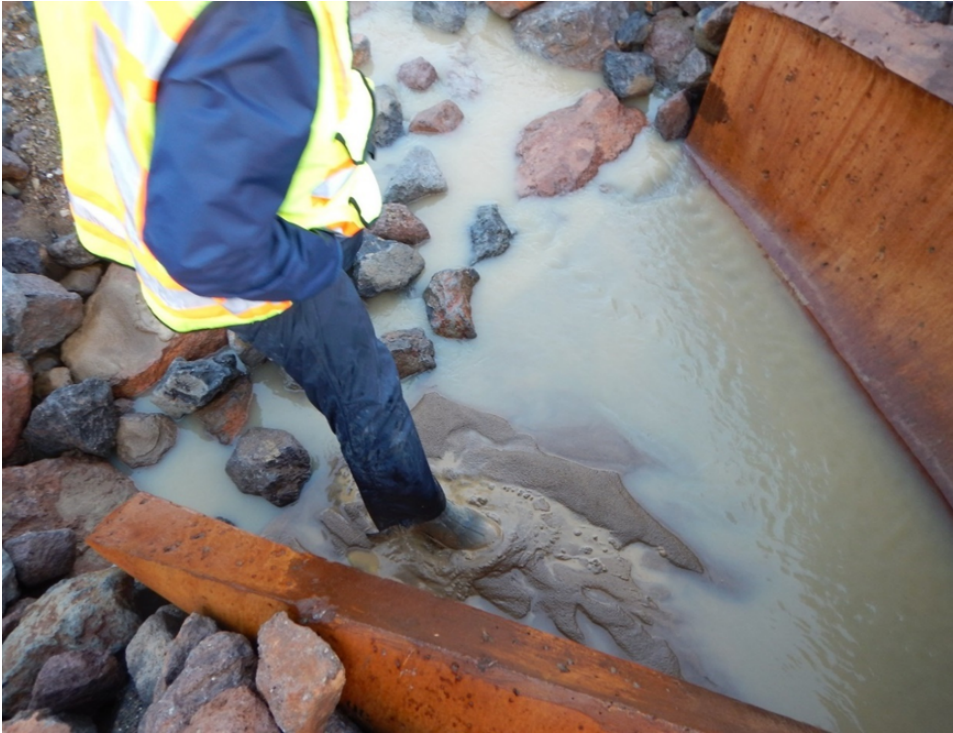
Figure 16. Significant sediment deposition within Foss Creek culvert inlet.

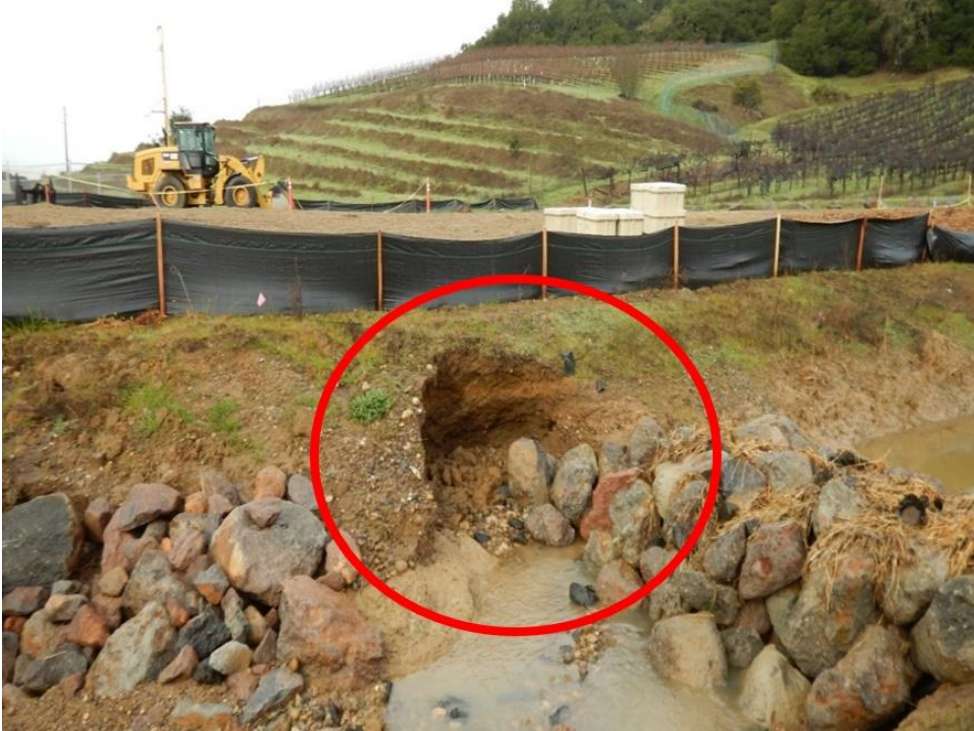
Violation 15 – Failure to implement BMPs that are effective in reducing or preventing pollutants in storm water discharges (CGP Att. E, section B.5.e)

Figure 17. Lack of erosion and sediment controls in this inactive area resulted in stream bank failure that led to sediment deposition within Foss Creek

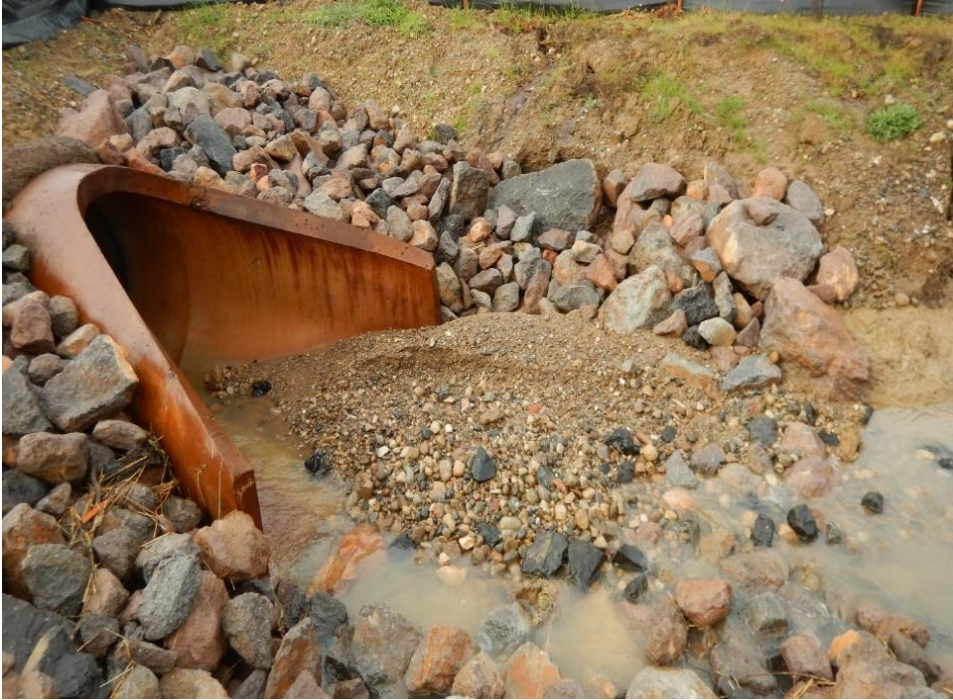
The BMPs staff observed on January 7, 2019 were not effectively reducing pollutants in storm water discharges as seen through the high turbidity measurements, resulting in significant adverse impacts to water quality and a continuing egregious threat to beneficial uses including habitat for endangered salmonids in sediment-impaired waters. The Potential for Harm for this violation is Major because the characteristics of the violation present an egregious threat to beneficial uses and the circumstances of the violation indicate a very high potential for harm.

Figure 18. Downstream from Figure 14, large sediment deposit within Foss Creek as a result of the slope failure along the creek bank.

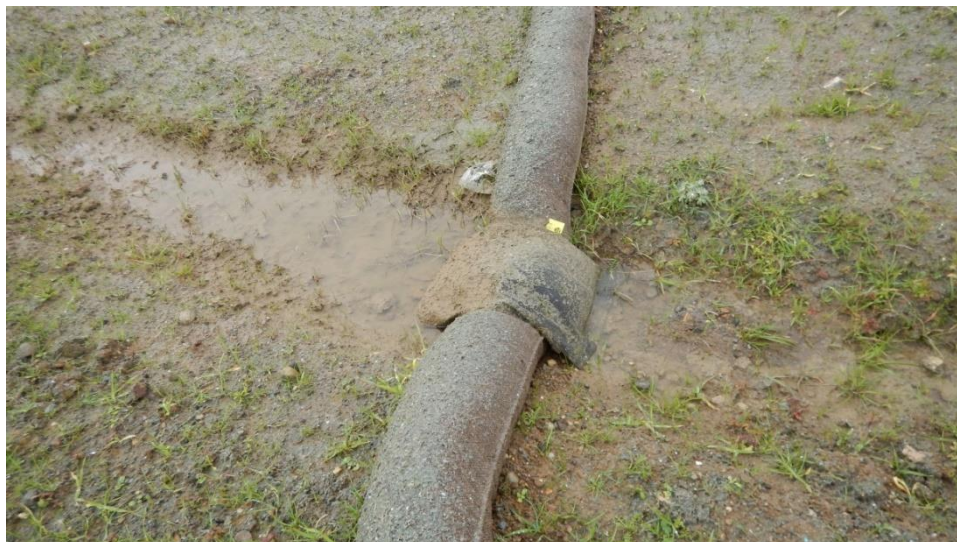
As noted above, staff observed only a limited portion of the Site on January 7, 2019 but observed inadequate erosion and sediment control BMPs and ineffective soil cover at two inactive areas along the lower portion of the Site and within Foss Creek. There were no erosion control blankets on the slopes that failed, resulting in the large sediment deposit shown in Figure 18, above. The applied hydroseed was not sufficiently established to effectively reduce soil erosion. Additionally, straw had not been uniformly applied in conjunction with the hydroseed, as described in the site-specific SWPPP.

Figure 19. Ineffective soil cover contributing to erosion. The combination of BMPs for erosion, sediment, and turbidity controls on the Site was not adequate to prevent erosion and sedimentation.

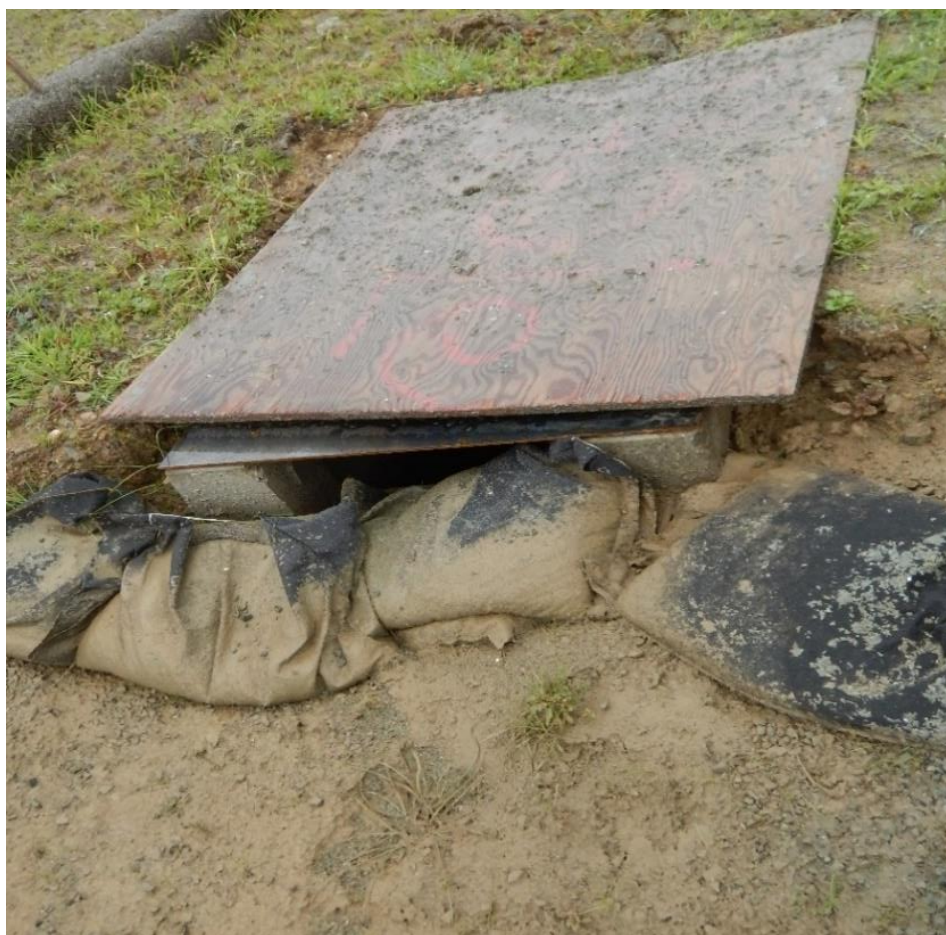
Figure 20. Farther downstream of Figure 19 above, the silt deposits show that sediment-laden water impounded sufficiently to overtop the center bag.

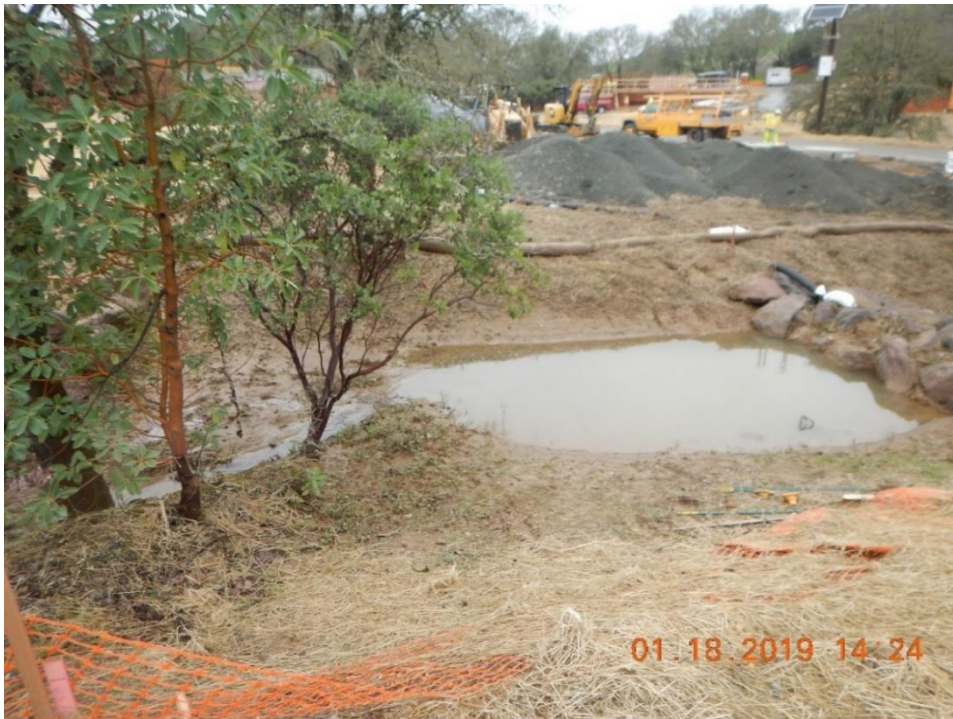
Though staff observed only two uncovered, uncontained construction material stockpiles during the January 18 inspection, both were exposed to the elements and showed signs of leaching of pollutants near receiving waters. Staff observed and photographed a pool of discolored water that had gathered under one of the stockpiles.

Figure 21. Uncovered stockpile near top of a stream/drainage channel bank. Creek in the foreground.

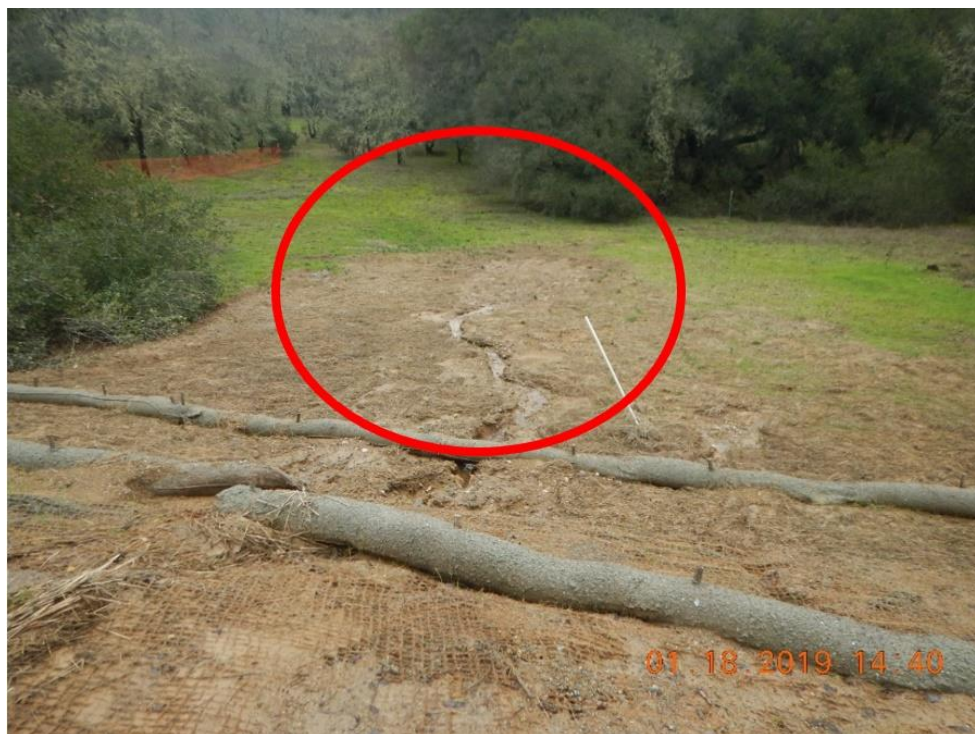
Staff observed four locations throughout Road 8 that had disturbed soil that had not been effectively covered and overwhelmed BMPs that needed maintenance on the January 18, 2019, inspection.

Figure 22. Sediment deposition beyond the undermined and overwhelmed BMPs; insufficient maintenance of erosion and sediment control BMPs.

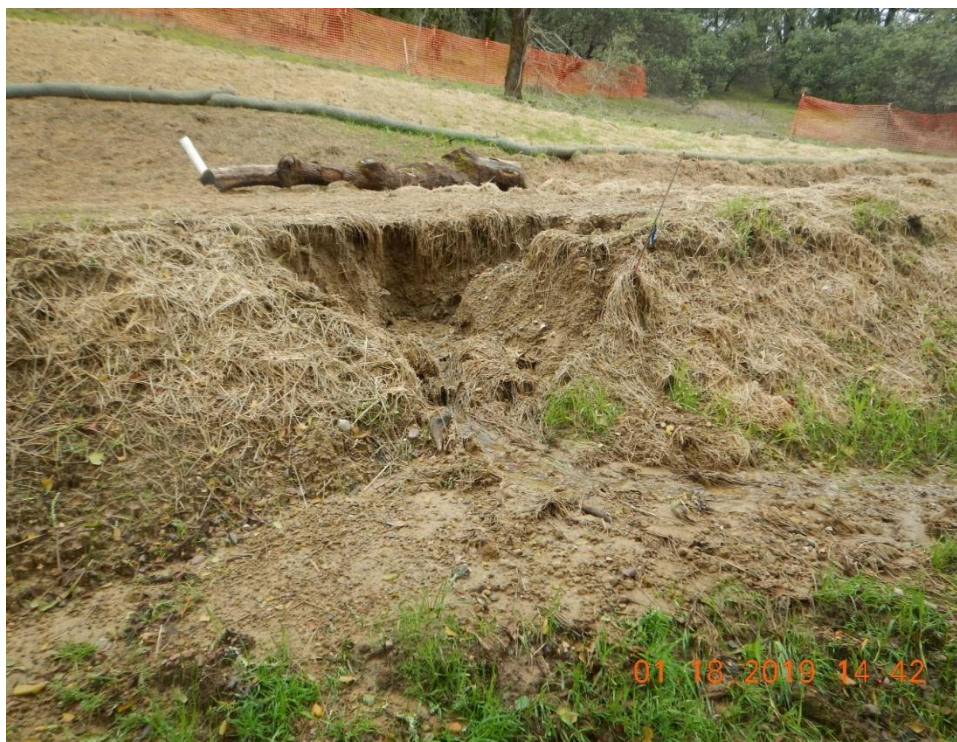
As mentioned above, there was extensive disturbed soil at the Site, requiring diligent maintenance over the continuing rainy season. Ineffective soil cover was observed at four locations along Road 8. Where disturbed soil was not effectively covered, and where BMPs were not maintained it was susceptible to erosion and transport to receiving waters, presenting an egregious threat to beneficial uses. The circumstances of the violation occurring during a continuing rainy season and the extensiveness of the disturbed soil indicate a very high potential for harm. Therefore, Potential for Harm for this violation was Major.

Figure 23. Ineffective erosion and sediment controls on slope resulting in bank failure and evidence of sediment transport in the foreground.

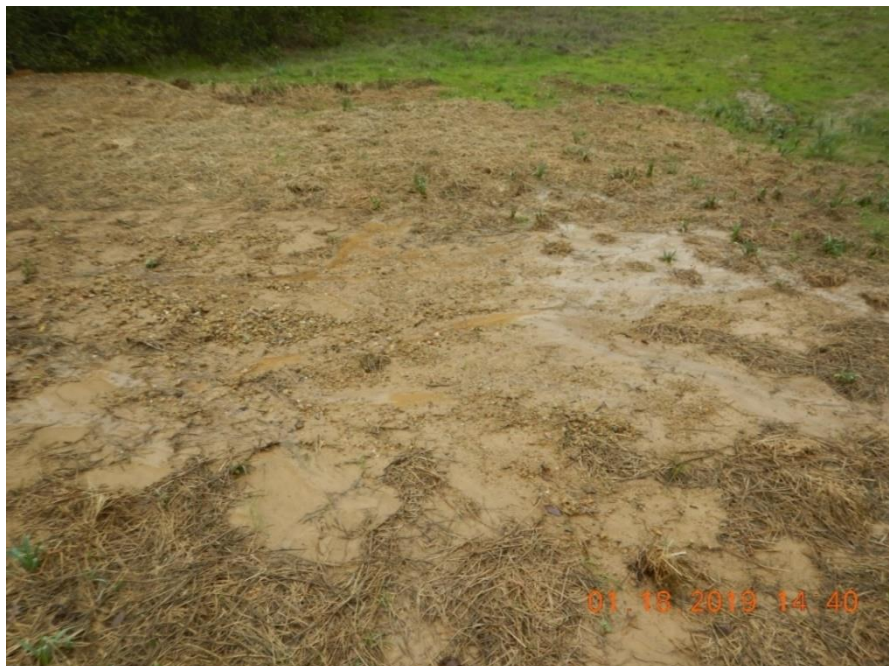
During the January 18 inspection, staff observed four areas lacking sufficient perimeter controls, allowing pollutants to migrate or be transported off the Site.

Figure 24. Lack of perimeter controls downhill from disturbed soil areas.

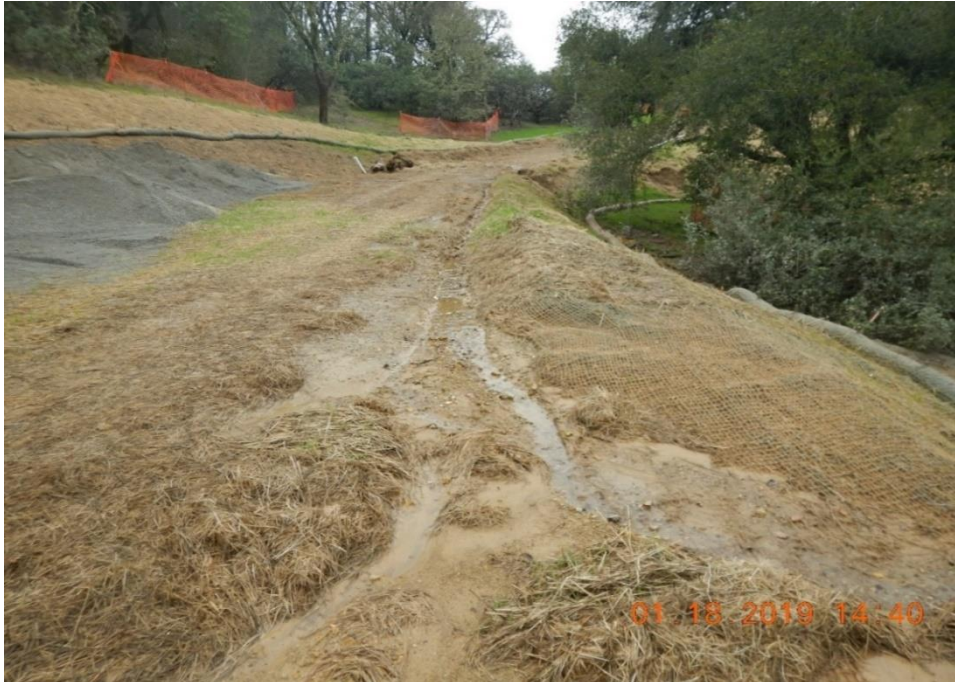
During the January 18, 2019 inspection, staff observed four locations lacking effective linear sediment controls at the toe or break in a slope. Erosion and drainage controls were non-existent or ineffective on slopes throughout the Site.

Figure 25. Lack of effective linear sediment controls at the toe or break in a slope.

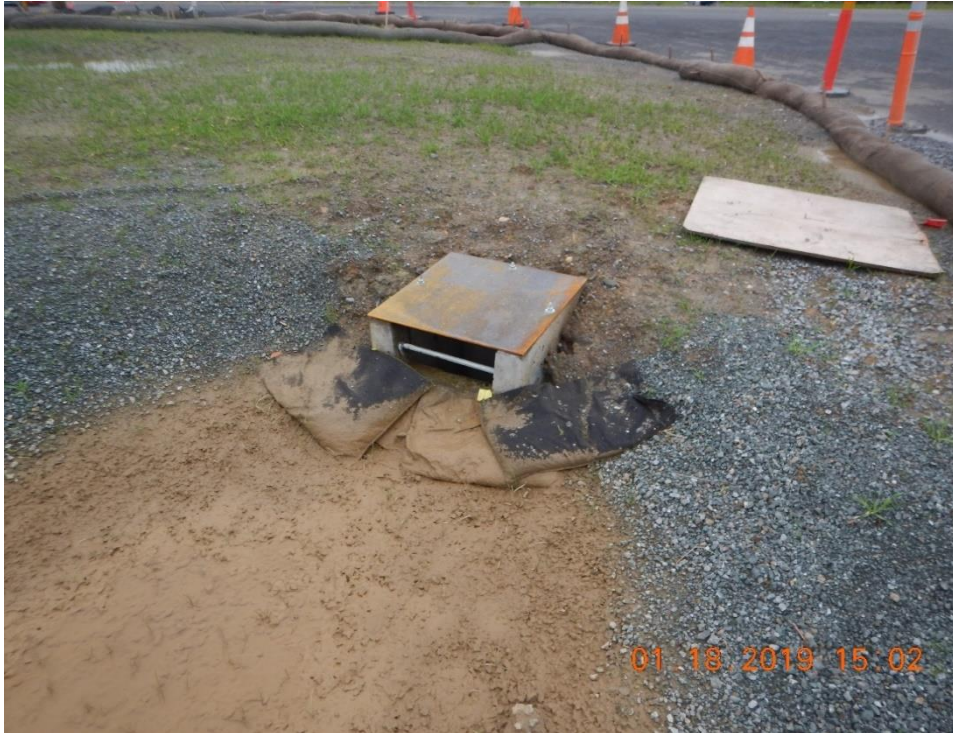
During the January 18, 2019 inspection, staff observed five locations where run-on or runoff was not effectively controlled.

Figure 26. The sediment trap is inadequate and needs maintenance; sediment has overtopped the gravel bags and discharged sediment-laden runoff to the storm drain system that discharges to Foss Creek

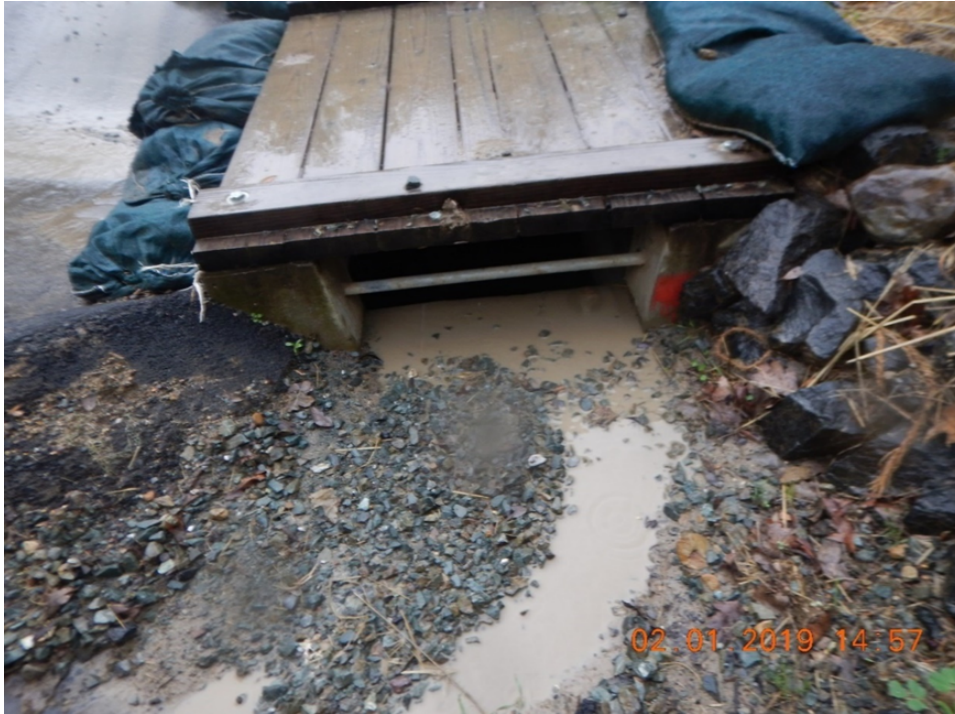
On February 1, 2019, staff mainly limited the inspection to the resort area. Rain occurred during the inspection and staff observed sediment-laden runoff discharging off the paved roadways and into the unnamed tributaries to Foss Creek and Jordan Pond, then to Lytton Creek. Staff observed mud tracking from construction vehicles on the roadways so extensive that the paved road system throughout the Site was covered in a layer of fine sediment. Staff noted that BMPs had been deployed on the Site, but that they were not sufficient to prevent runoff from construction activities into receiving waters. Staff also observed sediment-laden water entering receiving waters and a sediment-filled culvert leading to receiving waters. It was apparent that the Discharger was making little or no effort to inspect and maintain BMPs in general, and those BMPs deployed on the Site were continuing to deteriorate, fail, become damaged, or otherwise become less effective or functional.

Figure 27. Turbid storm water runoff entering drain inlet that discharges to Foss Creek

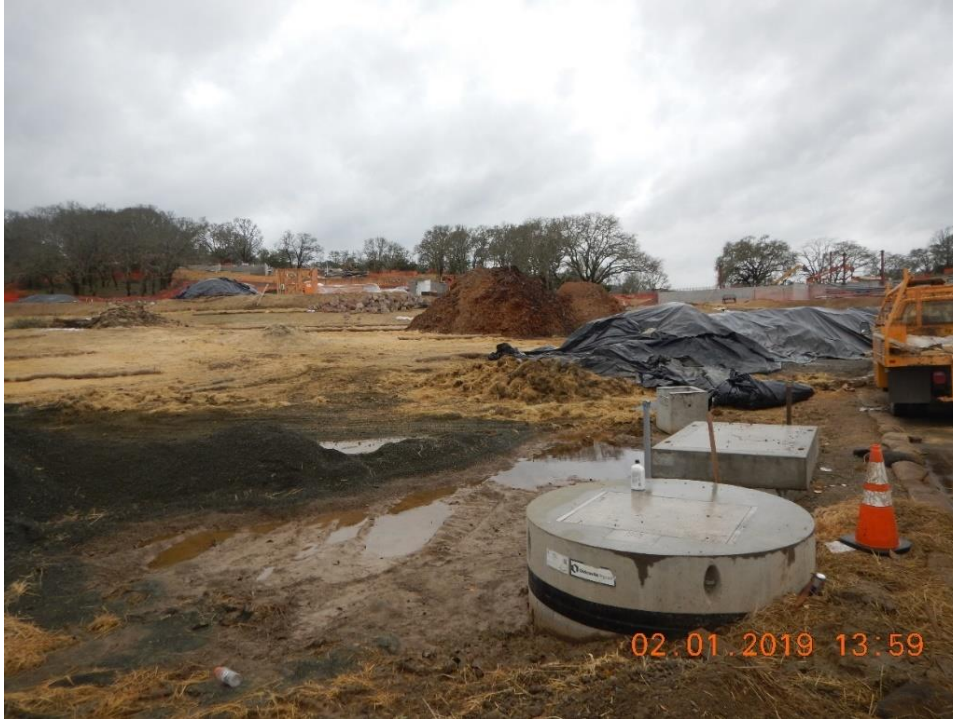
Figure 28. Stockpiles, some covered, some uncovered. Discolored water. Heavy equipment tracks in the mud.
