Attachment A: Methodology

This technical analysis provides a summary of factual and analytical evidence that support the findings in Administrative Civil Liability Complaint No. R1-2020-0009 (Complaint) and the recommended assessment of administrative civil liability (ACL) in the amount of **\$6,425,680**. The Complaint alleges that Sonoma Luxury Resort LLC (Discharger) has failed to implement the requirements of State Water Resources Control Board (State Water Board) Order No. 2009-0009-DWQ, as amended by Order No. 2010-0014-DWQ and Order No. 2012-0006-DWQ, National Pollutant Discharge Elimination System (NPDES) General Permit for Storm Water Discharges Associated with Construction and Land Disturbance Activities (Construction General Permit or CGP) while conducting site development and construction work on the Saggio Hills Project, a 258-acre property located at 16840 Healdsburg Avenue, Healdsburg, in Sonoma County (Site). Additionally, the Complaint alleges that the Discharger has failed to meet the conditions of its December 5, 2008 (amended December 6, 2018), Clean Water Act section 401 Water Quality Certification (401 Certification) for work at the Site.

Figure 1. Saggio Hi

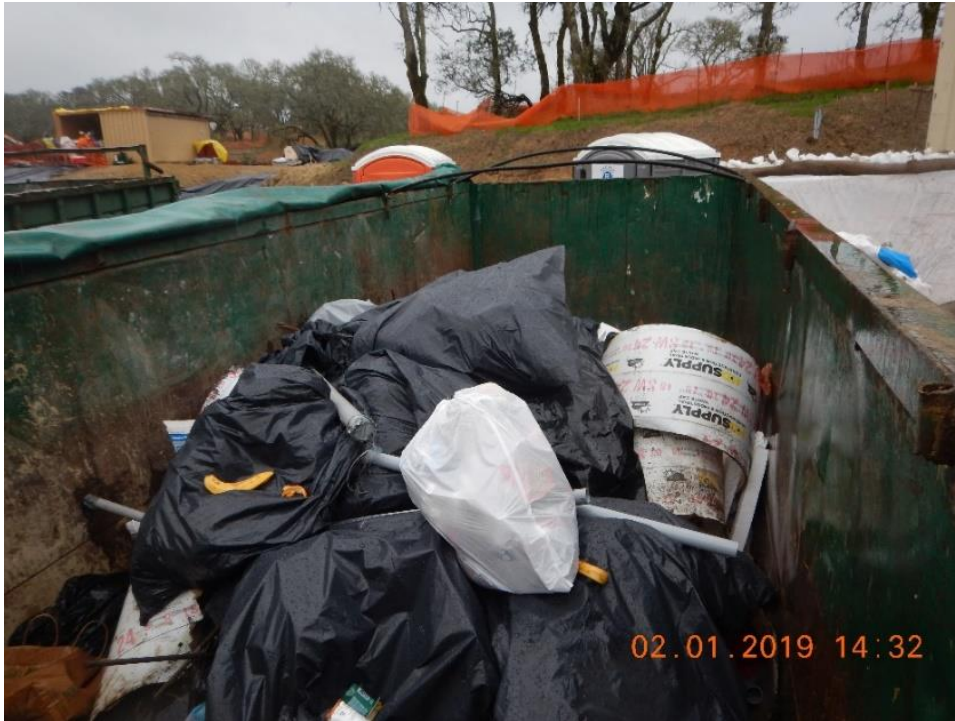
Staff observed one uncovered waste bin during the February 1 inspection, with accumulated trash bags and other garbage exposed to the rain.

Figure 29. Partially filled waste bin, uncovered, during rainfall.

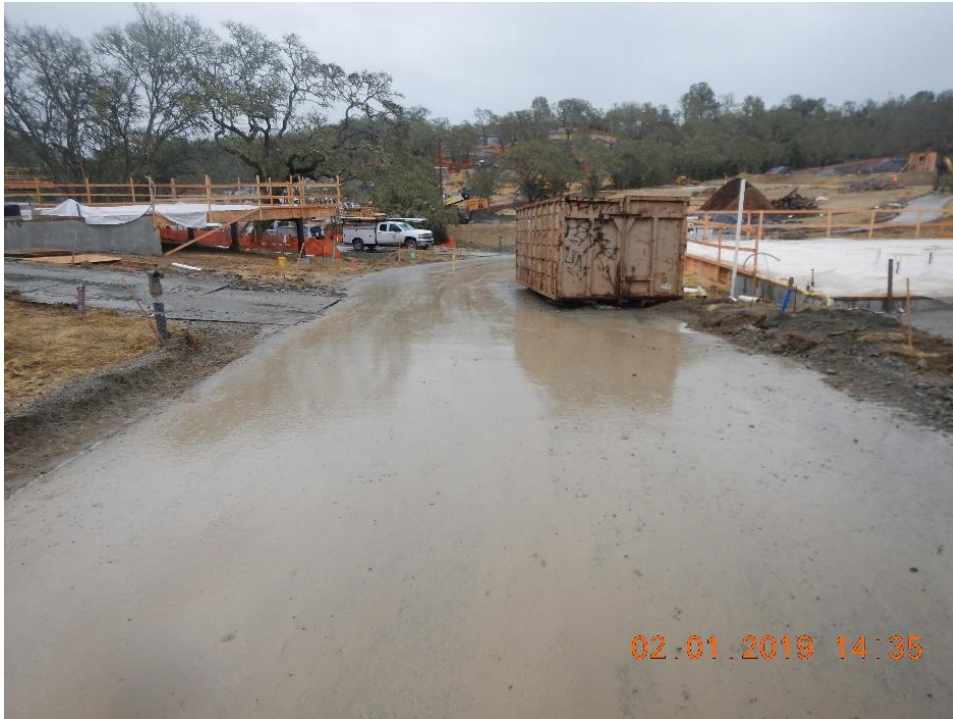
Figure 30. Mud on paved roads continues to result in discharges of sediment-laden runoff.

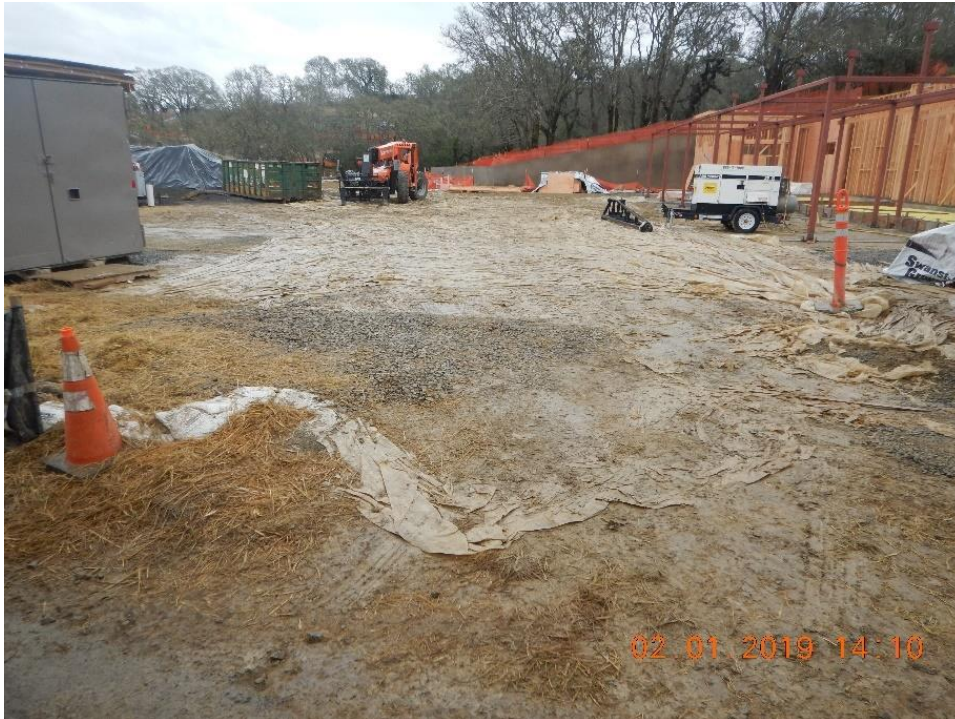
Figure 31. Ineffective erosion and lack of sediment controls in this inactive area.

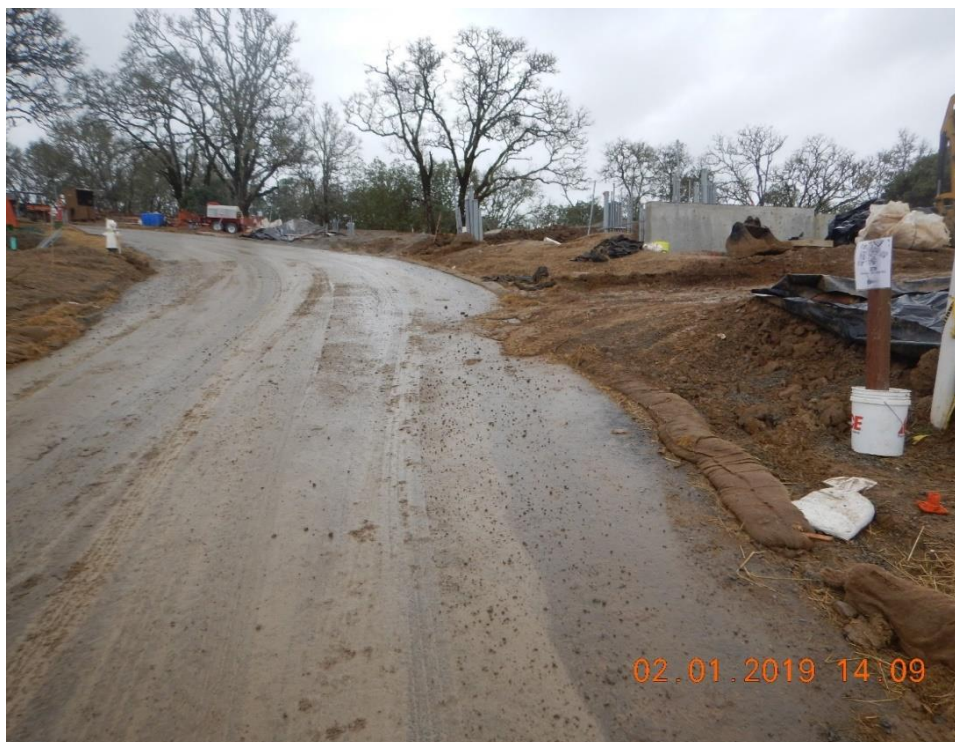
Figure 32. Sediment control BMPs observed do not effectively contain soil within the active construction area.

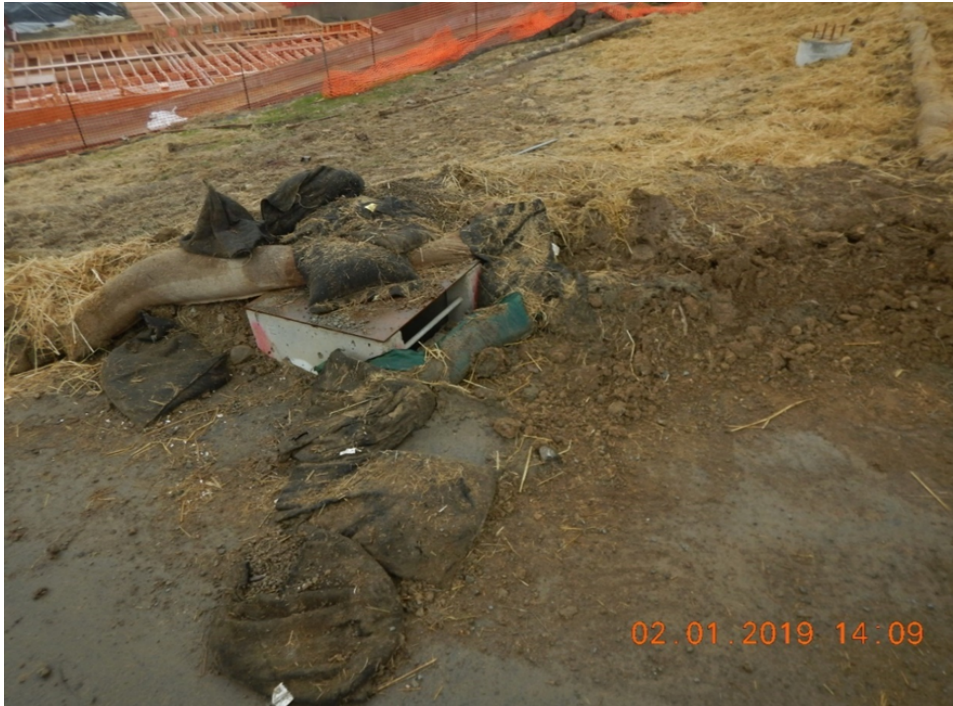
Figure 33. Sediment from the adjacent work area is overflowing onto the roadway and into the drain inlet.

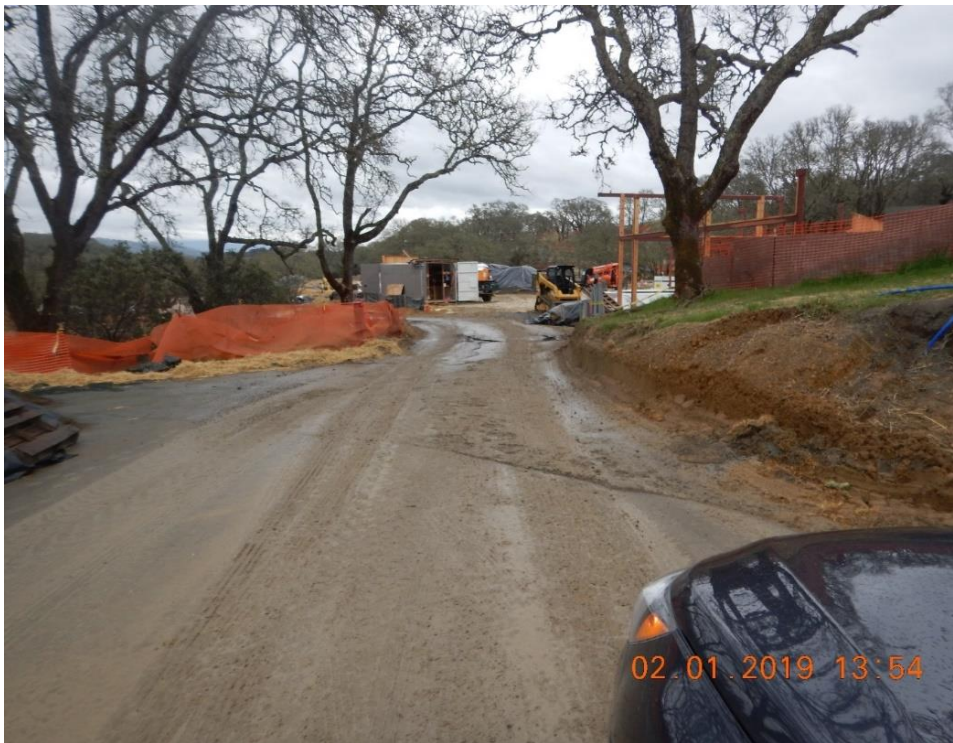
Figure 34. The cut slope adjacent to the roadway lacks erosion or sediment control measures either on the slope or at its toe.

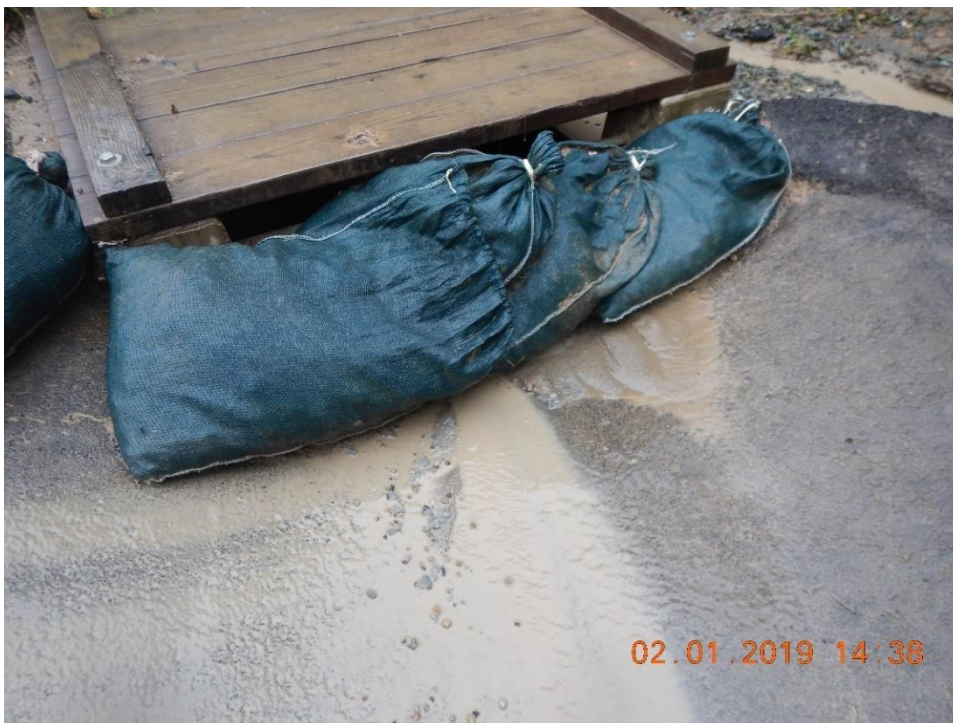
Figure 35. This check dam is not correctly positioned to effectively capture or remove pollutants from storm water runoff.

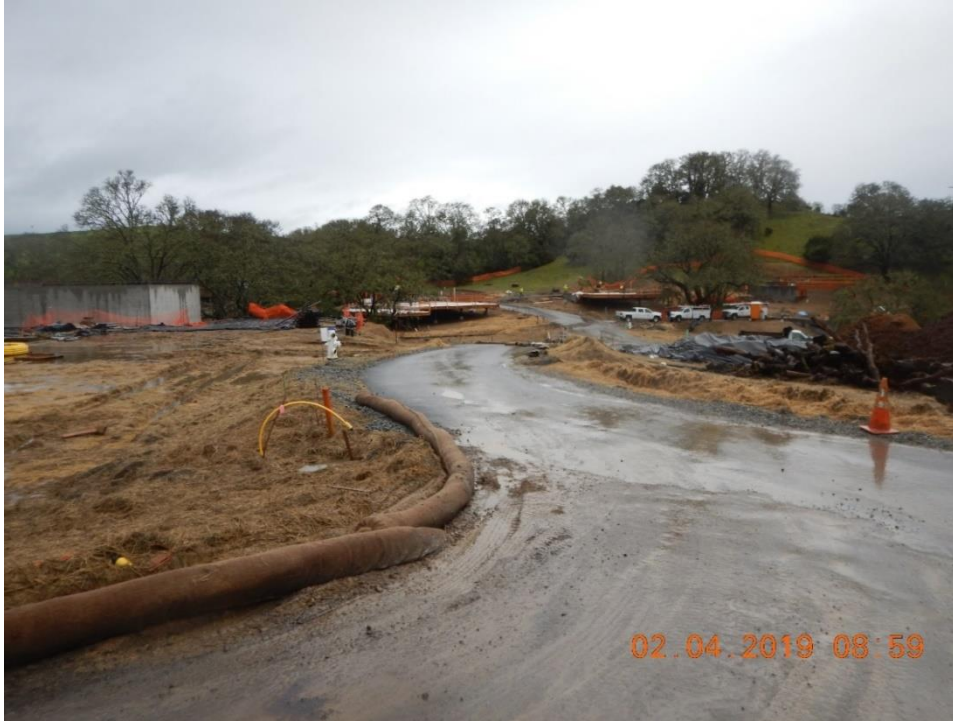
Figure 36. Poor maintenance of BMPs, and lack of BMPs to keep the paved roads clean continues to result in discharges of sediment-laden runoff to the drainage system.

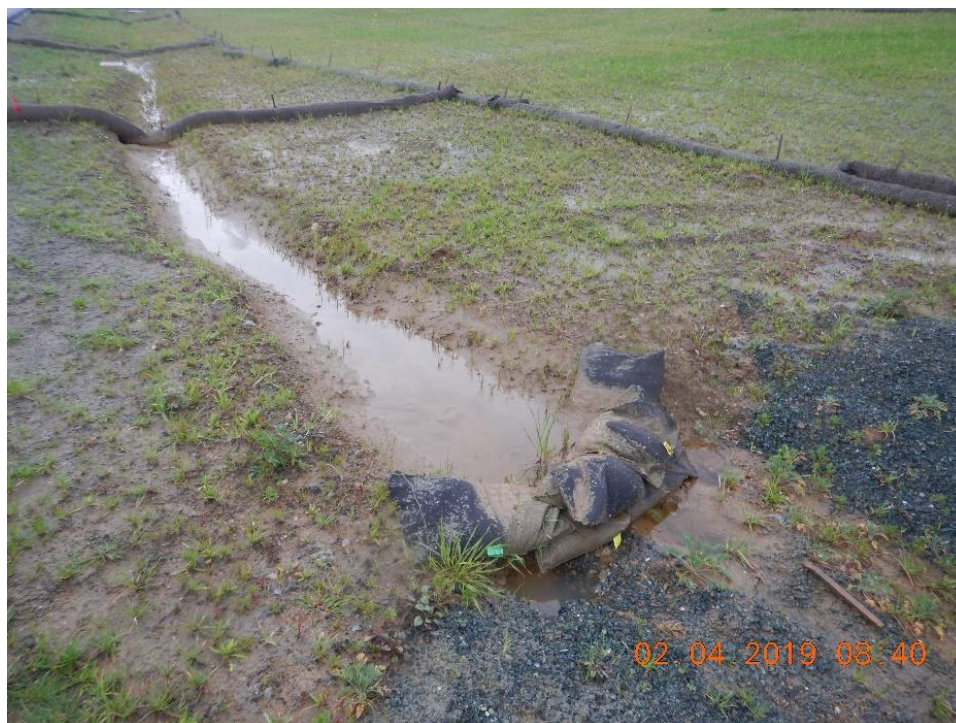
Figure 37. Erosion controls (hydroseed and straw soil cover) are not adequate or established enough to prevent sediment-laden runoff to the storm drain system that discharges to Foss Creek.

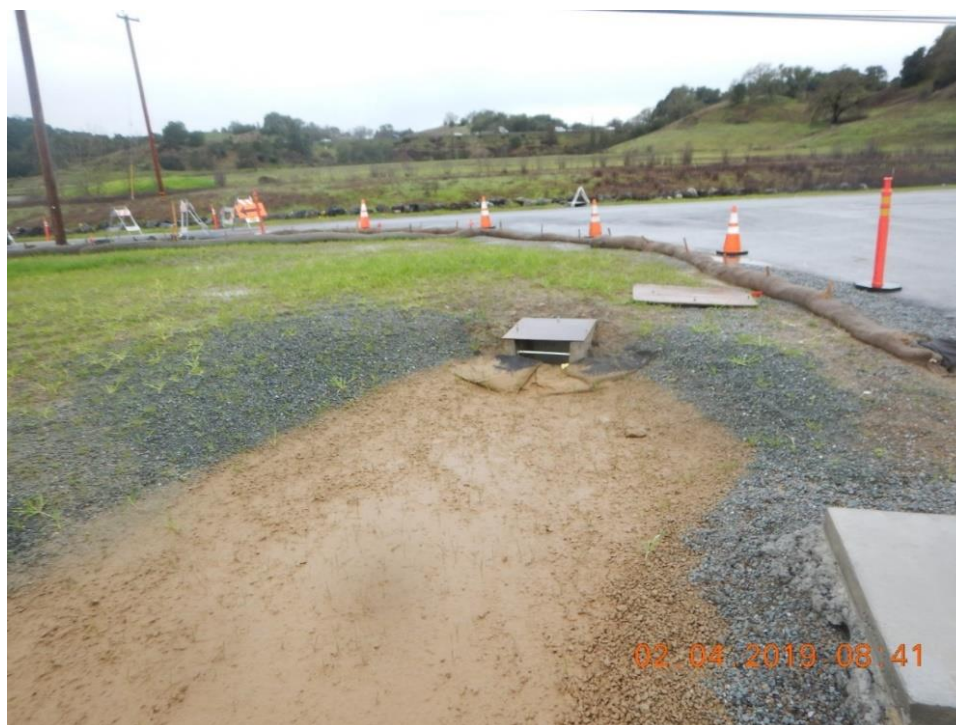
Figure 38. Downstream of Figure 37 above, sediment has overtopped the gravel bags and discharged sediment-laden runoff to the storm drain system that discharges to Foss Creek.

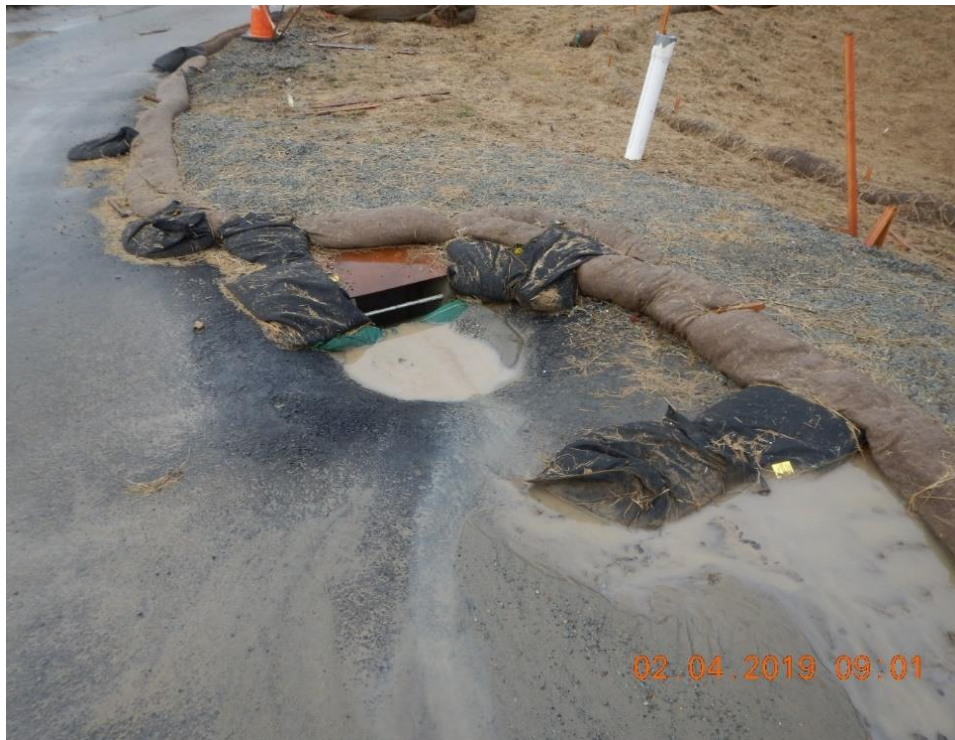
Figure 39. Sediment controls near the drainage inlet are not effectively reducing or preventing pollutants in storm water discharges.

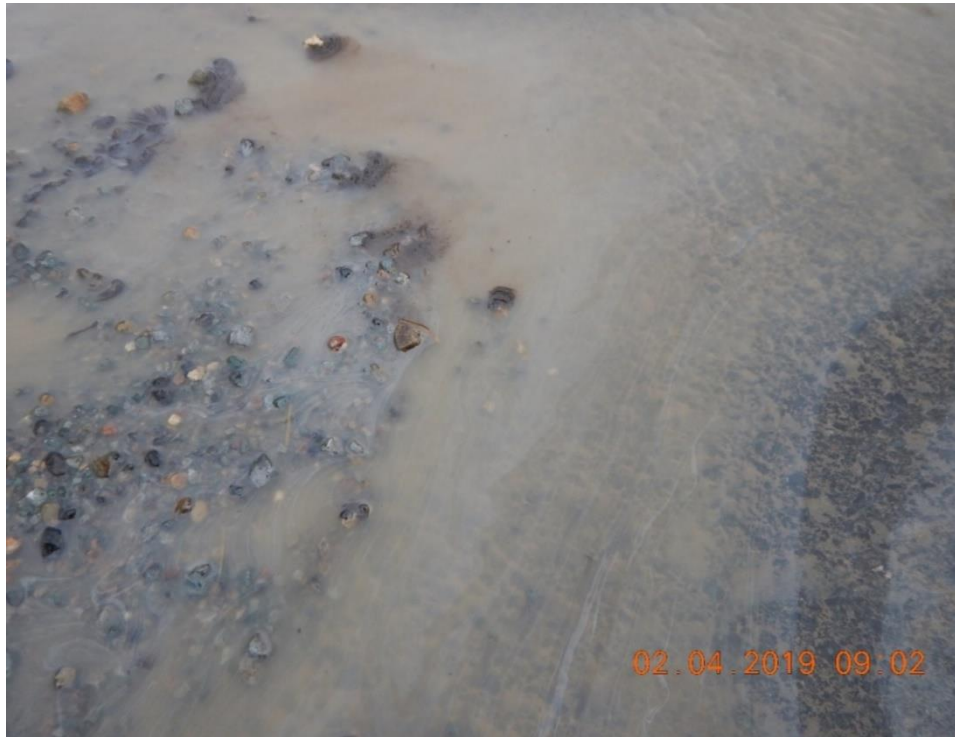
Figure 40. Oil sheen and turbid water on road surface in the resort area was observed flowing into the storm drain inlet in Figure 38.

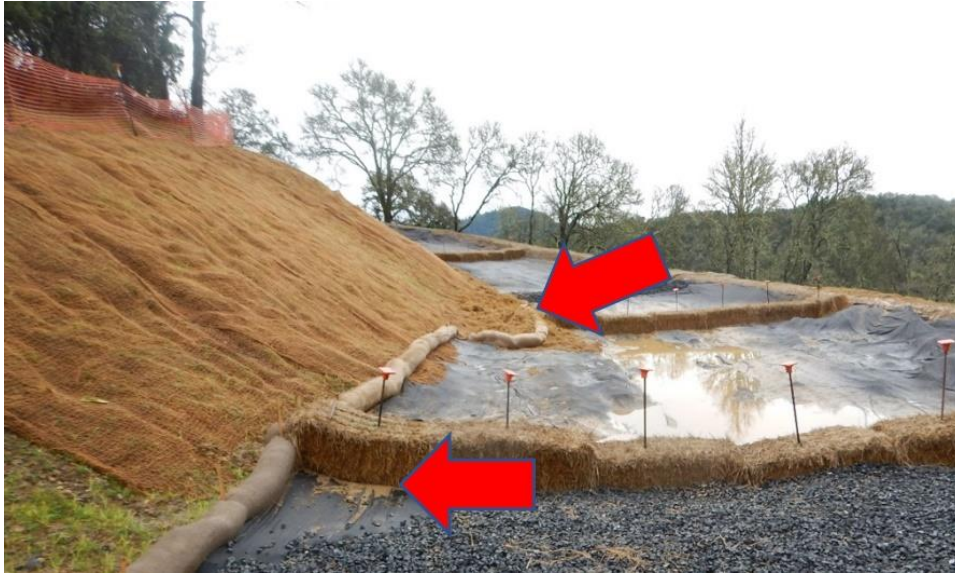
Figure 41. Note slumping slope on roadway. Turbid water is visible emerging from the left side of the first straw bale berm in the foreground. This turbid water eventually discharged to an unnamed tributary to Foss Creek.

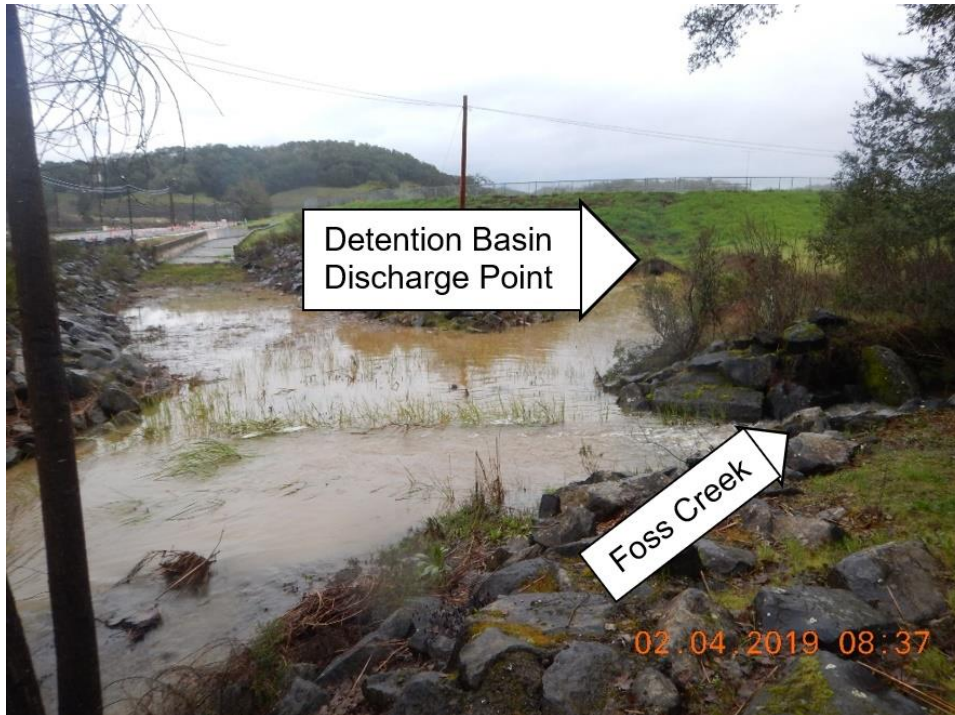
Figure 42. Discharge point from the City's detention basin which is receiving flow from the Site and delivering turbid water to Foss Creek.

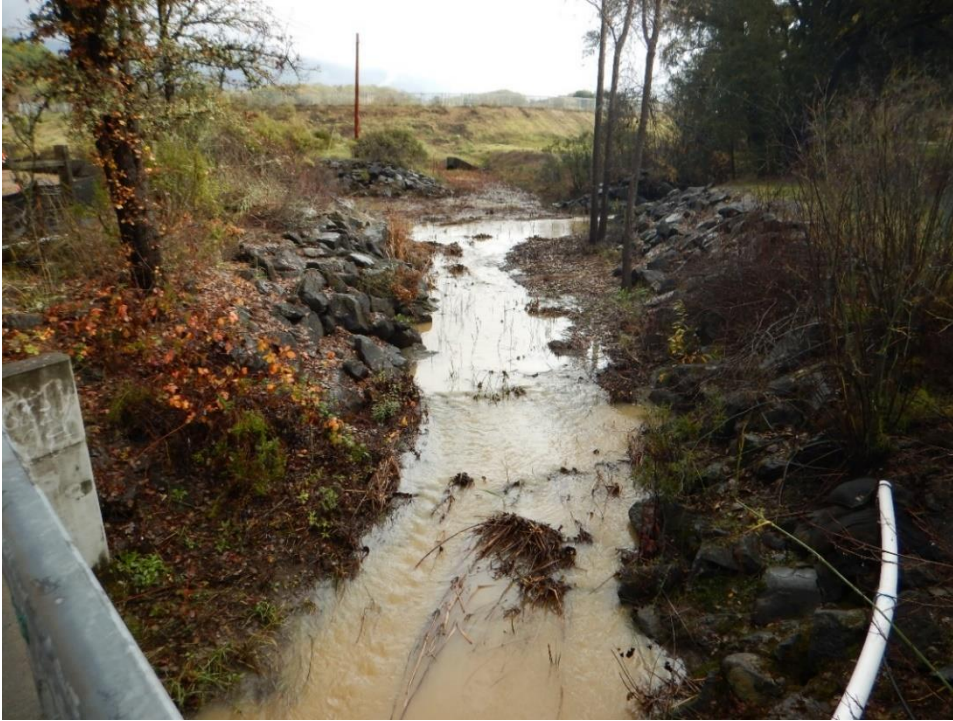
Figure 43. November 29, 2018. Foss Creek Bridge on Healdsburg Avenue downstream of Site. In route to the Site, staff noticed Foss Creek was highly turbid.

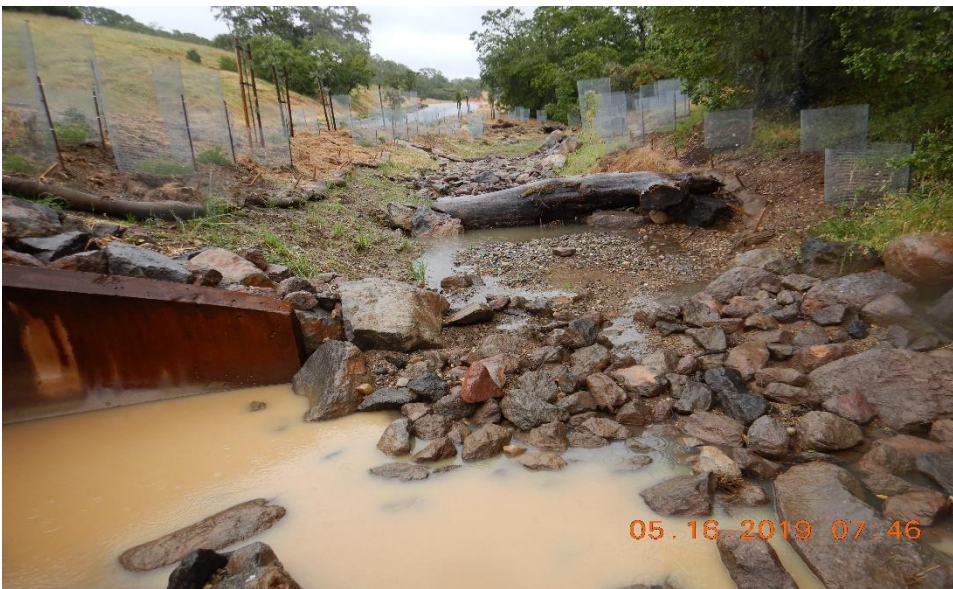
Figure 44. Foss Creek at the confluence of the tributaries affected by Site construction activities.

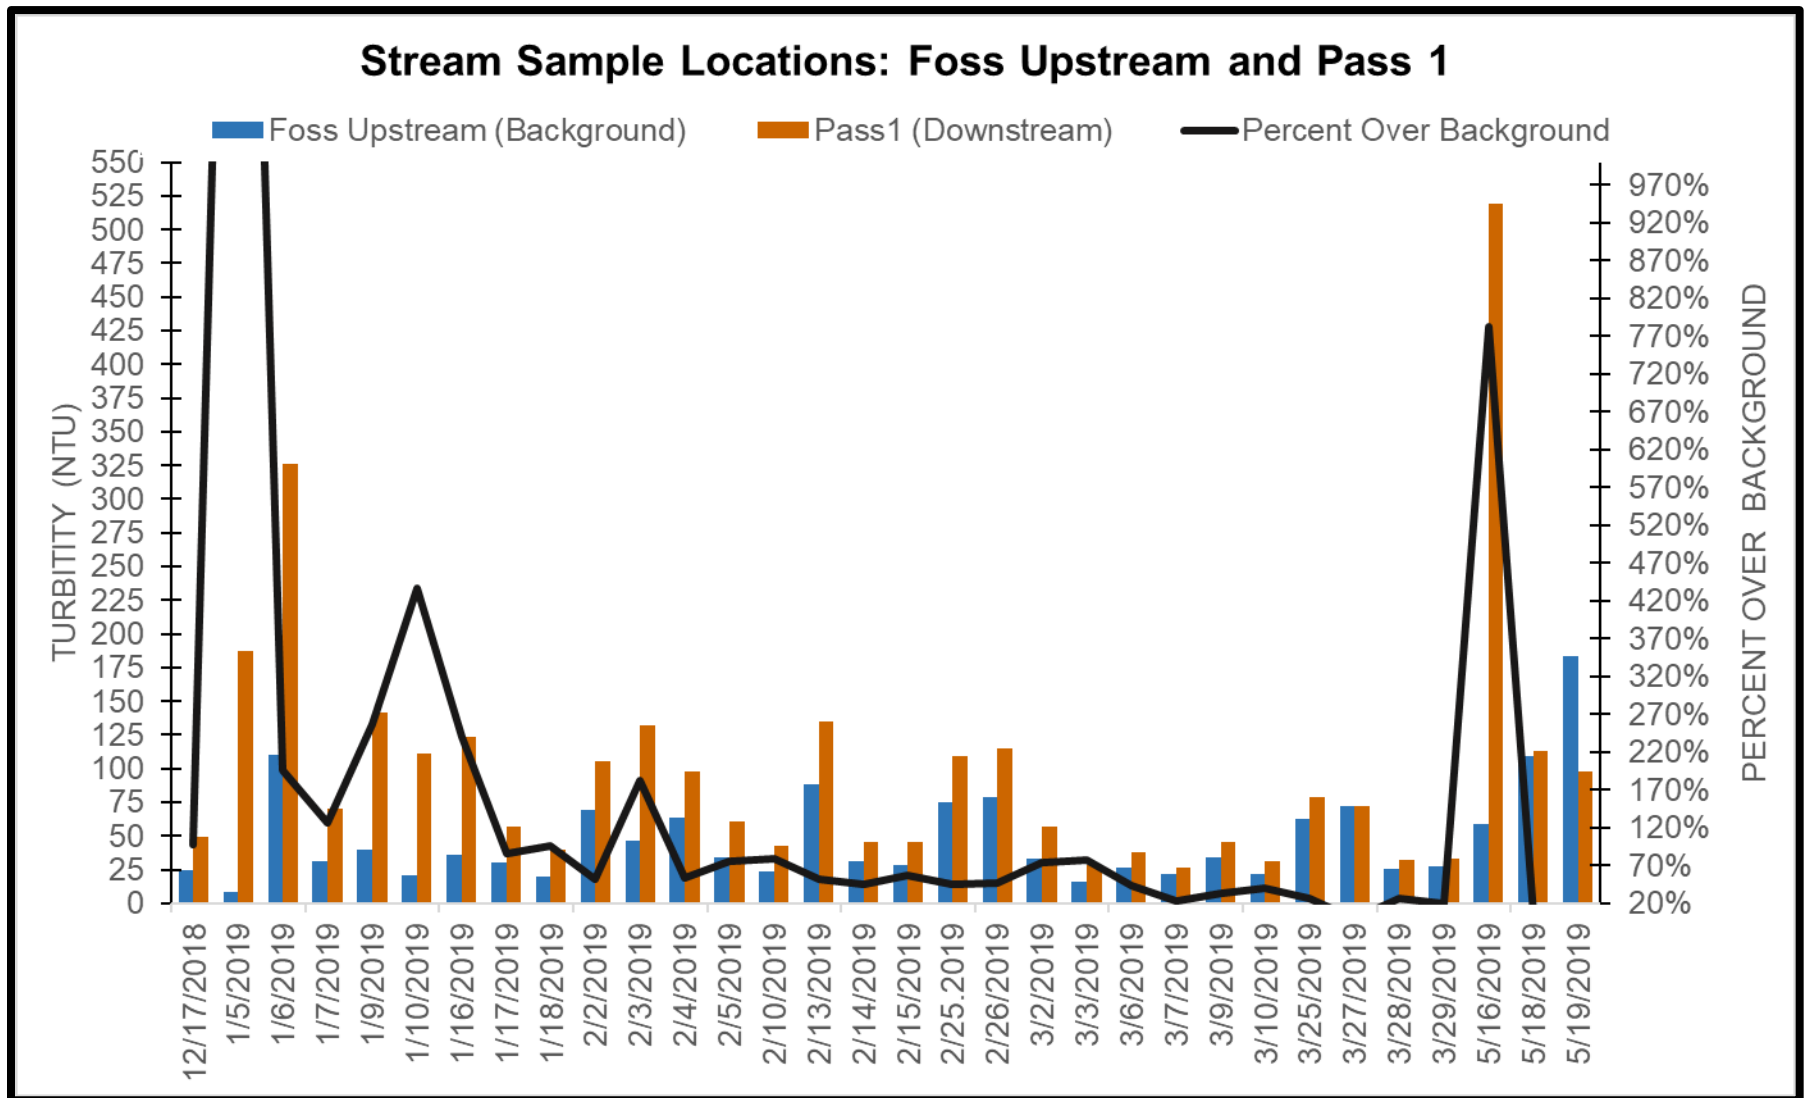
Figure 46. Saggio Hills receiving water monitoring program turbidity results for paired samples in Foss Creek; Foss Upstream (background) and Pass1 (downstream). Note: for viewing purposes the percent over background scale excludes the peak from the January 5, 2019 exceedance of 2,197 percent over background.

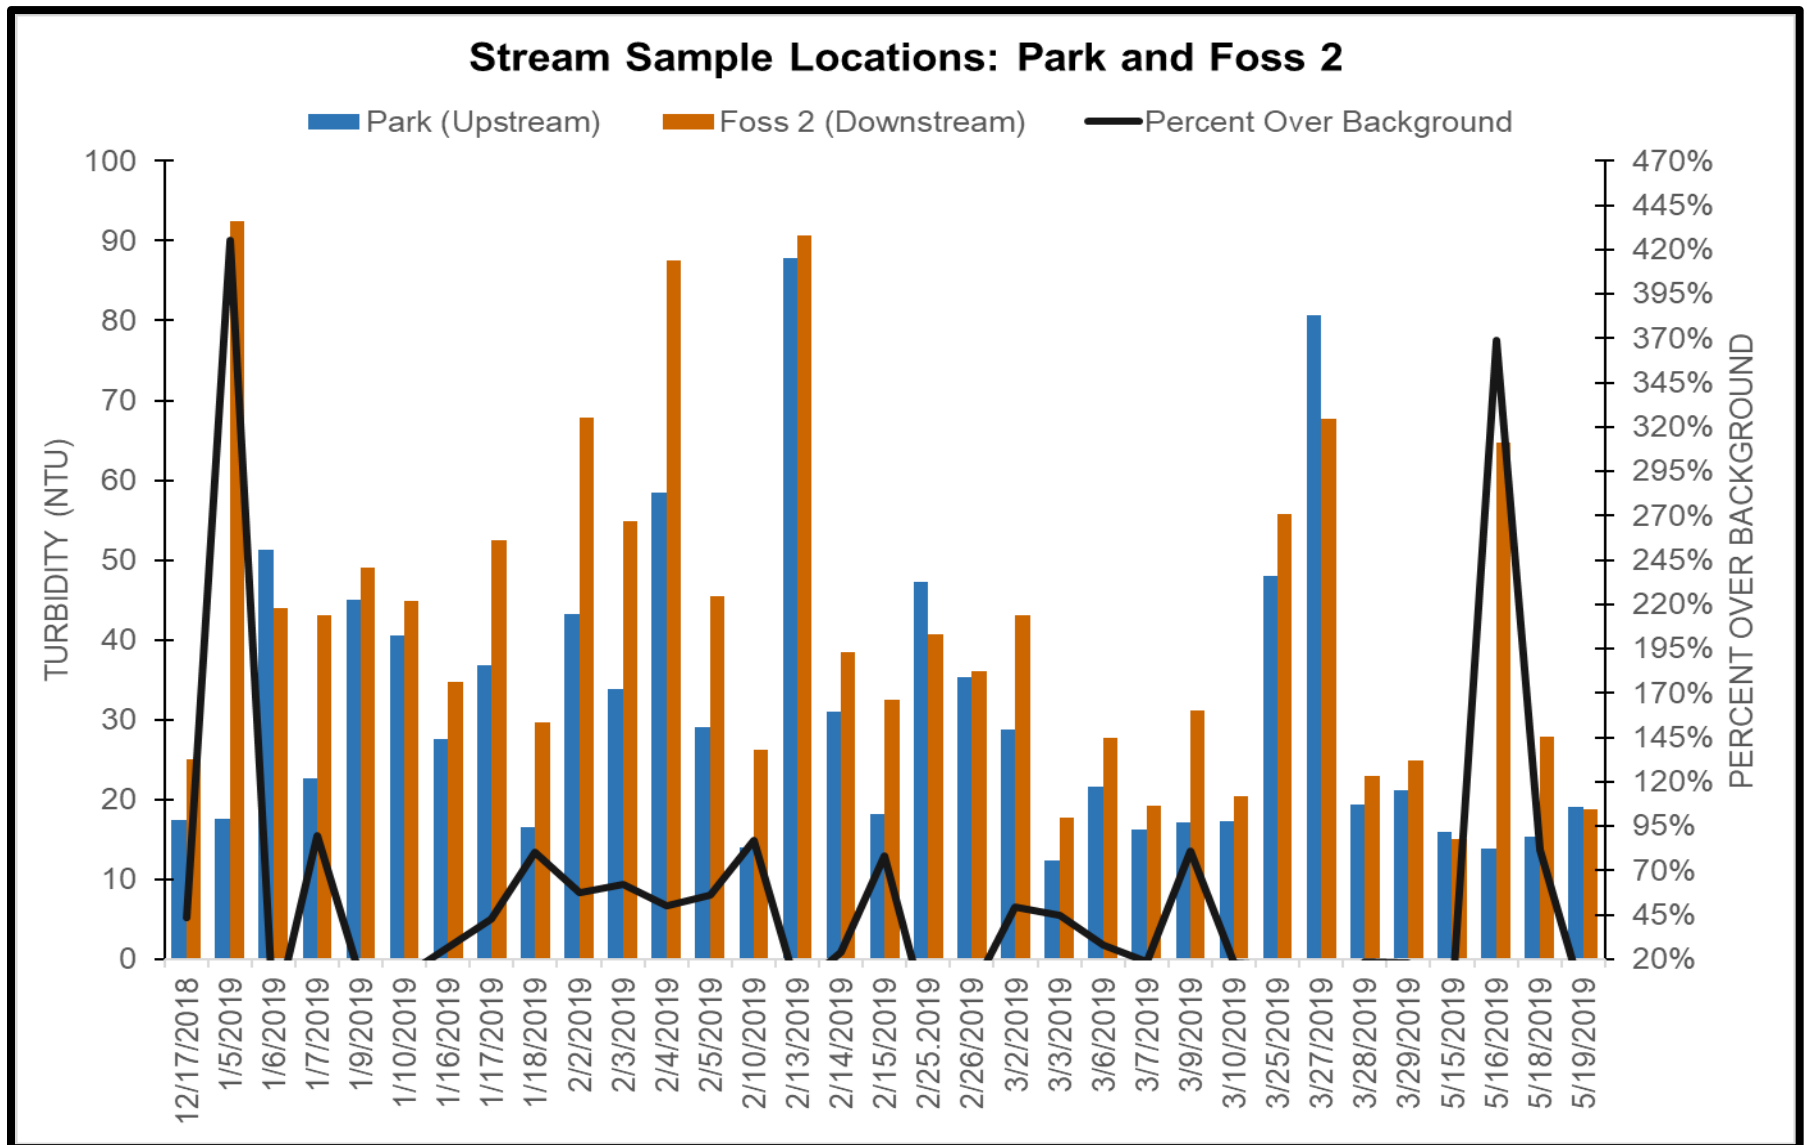
Figure 47. Saggio Hills receiving water monitoring program turbidity results for paired samples in Foss Creek; Park (background) and Foss 2 (downstream).

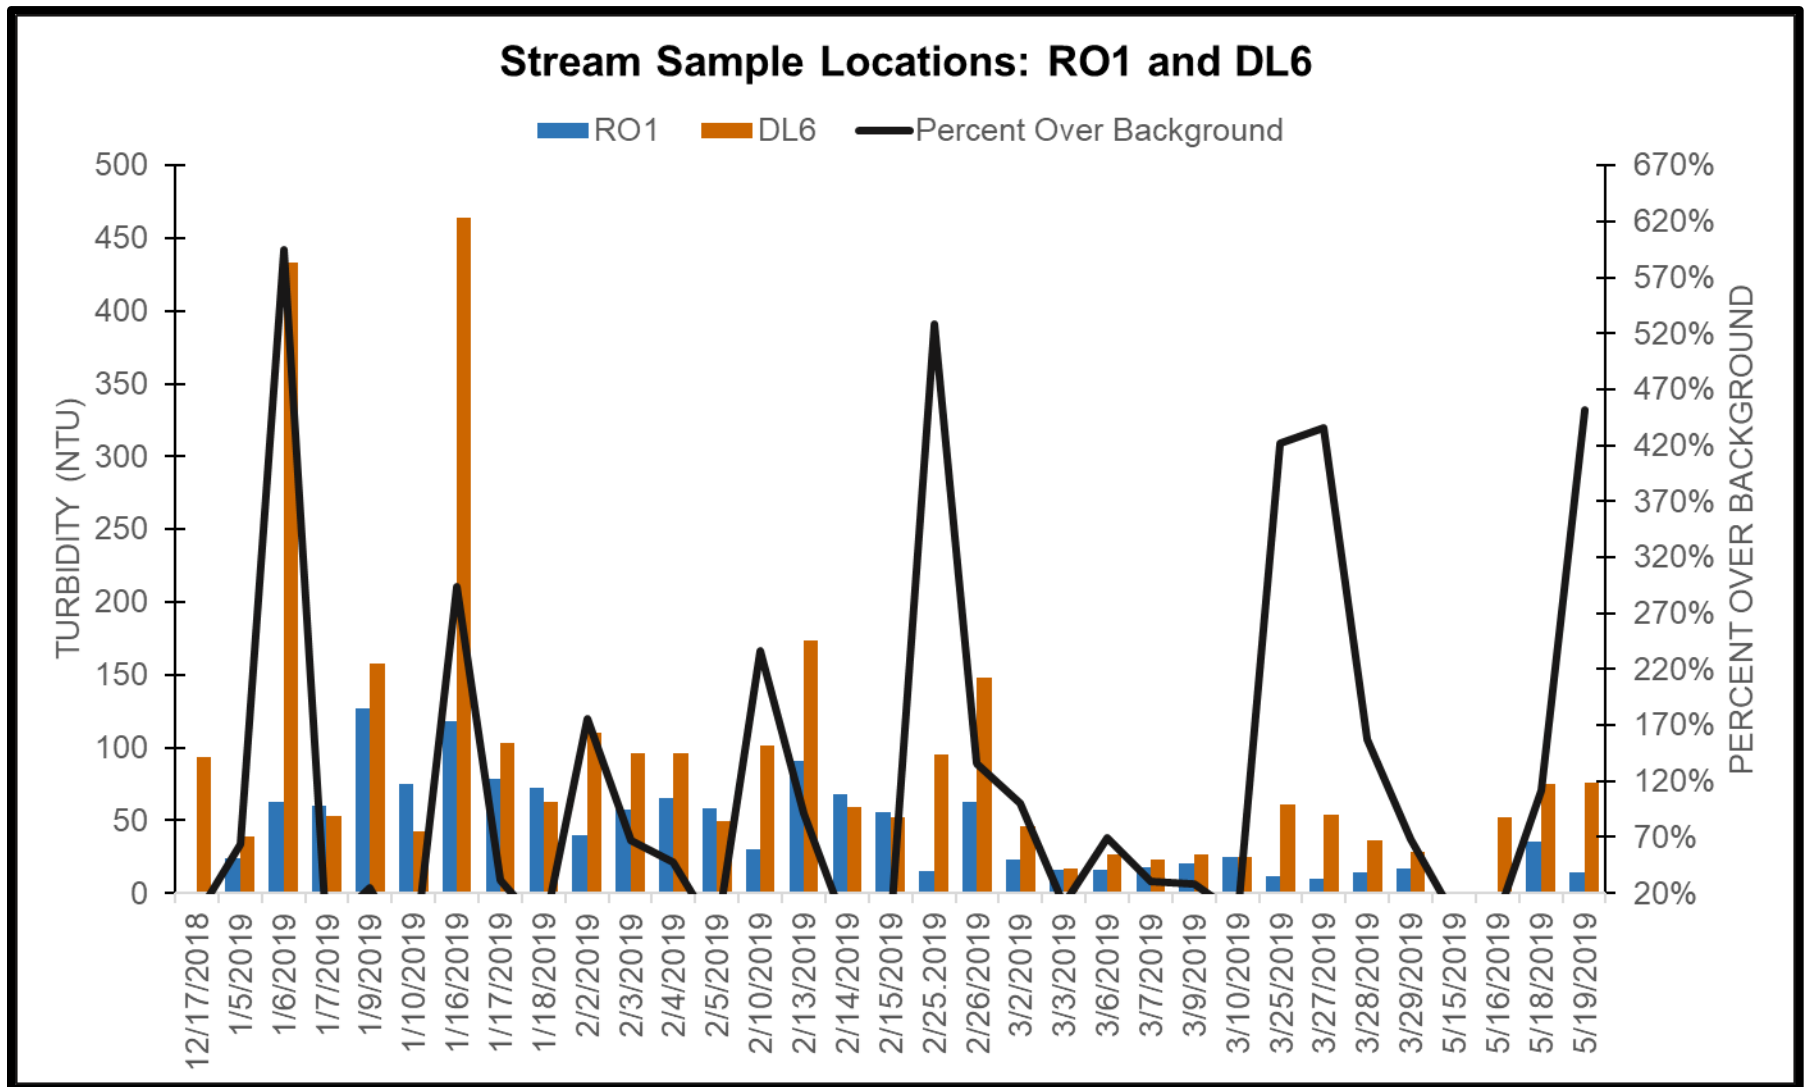
Figure 48. Saggio Hills receiving water monitoring program results for paired samples in tributary to Lytton Creek; R01 (upstream background) and DL6 (downstream).

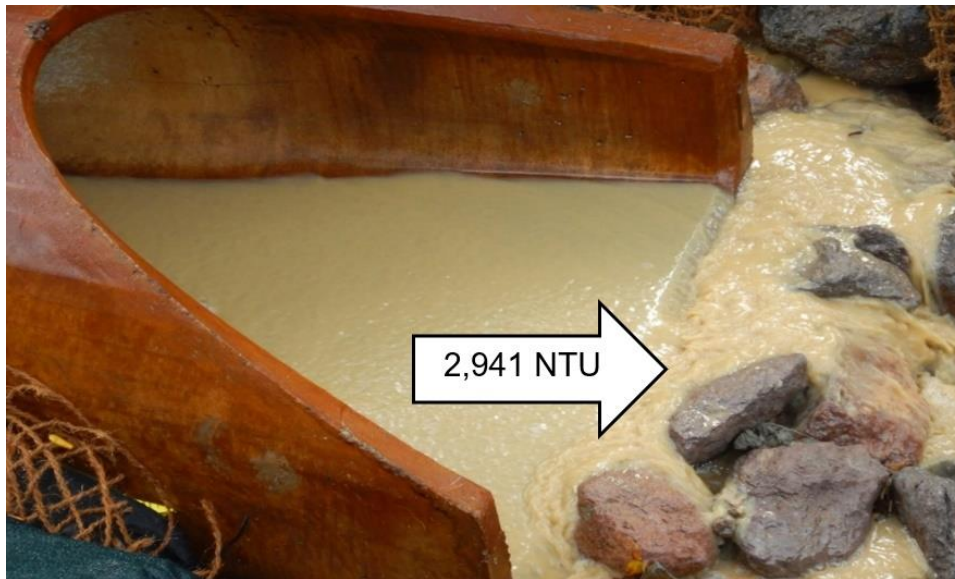
Figure 49. Highly turbid water (2,941 NTU) in stream due to failure by the Discharger to implement BMPs along Road 5. November 29, 2018.
