Draft Permit Attachment E:
U.S.EPA Inspection Report for Santa Rosa

**City of Santa Rosa
Municipal Separate Storm Sewer System (MS4)
Inspection Report**

**City of Santa Rosa - Municipal Separate Storm Sewer System (MS4)
(Order No. R1-2003-0062)**

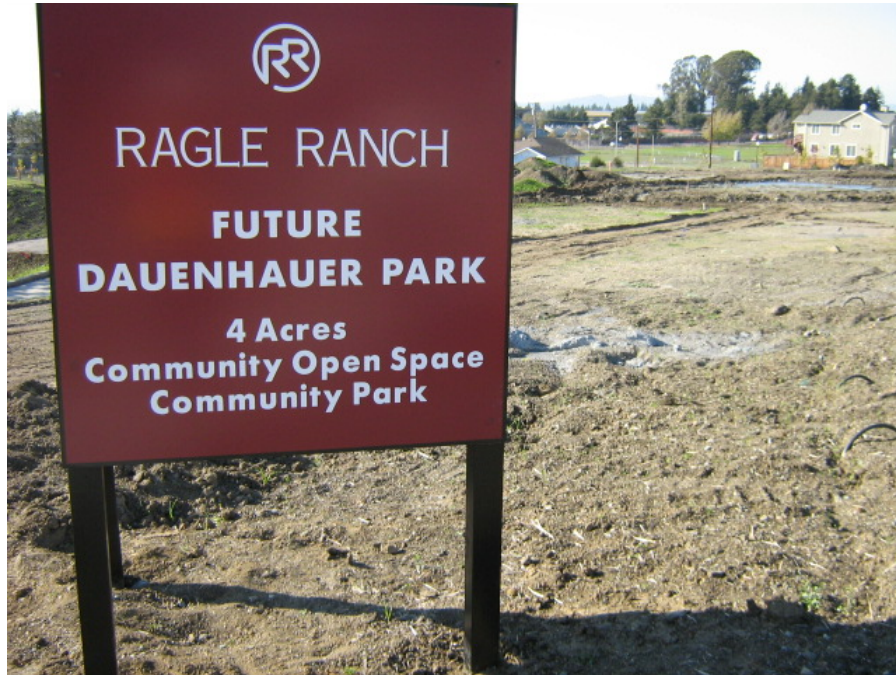
3. Regional Board Order No. R1-2003-0062, Provision 14.a.i. requires the City to ensure adequate source control and/or structural BMPs to control sediments generated at project sites. It was observed during the inspection that adequate BMPs were not implemented to prevent the discharge of sediment from a large expanse of disturbed soil exposed throughout the project site. The project site (see attached Photograph 1) was entirely unstabilized and temporary BMPs in the center portion of the site were limited to a series of sediment traps/basins (see attached Photograph 2). As provided by Douglas Williams (Civil Engineer Tech), the site had been idle in its current state for some time. In addition, well drilling fluids from recent drilling activity had been applied to the site, increasing the erosion potential and amount of unconsolidated material. As a result, the disturbed area had contributed sediment to the curb and gutter flow-line along an adjacent street (see attached Photograph 3). Furthermore, there was a potential for the discharge of sediment from the large expanse of disturbed soil to a down-gradient structural control (see attached Photograph 4). The City must ensure adequate source control and/or structural BMPs to control sediments generated at the Dauenhauer Ranch and Park project site.

Photograph 1: View of location and area of disturbed soils

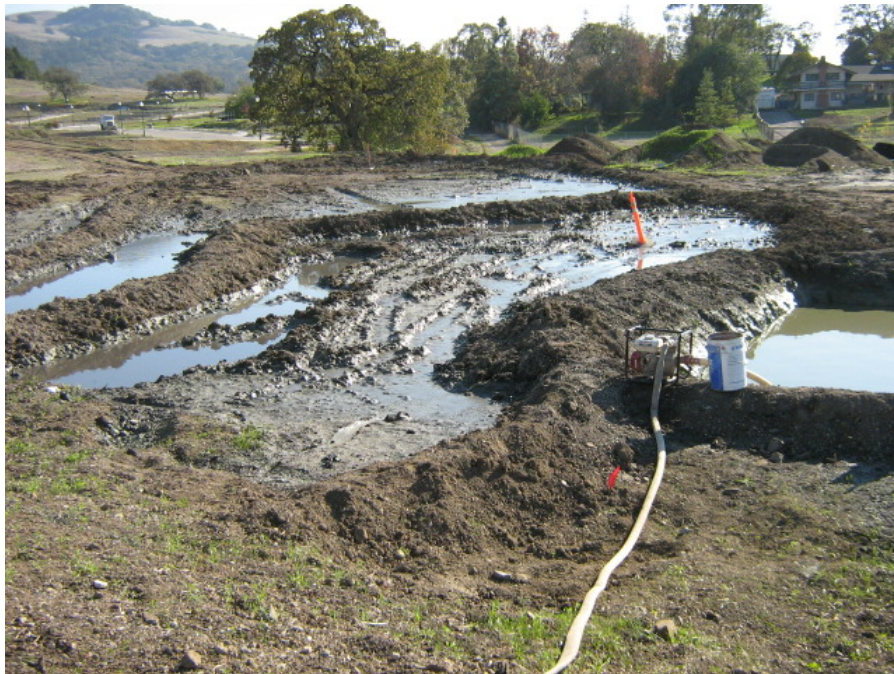
Photograph 2: Large expanse of unstabilized soil including the area where well drilling fluids had been applied

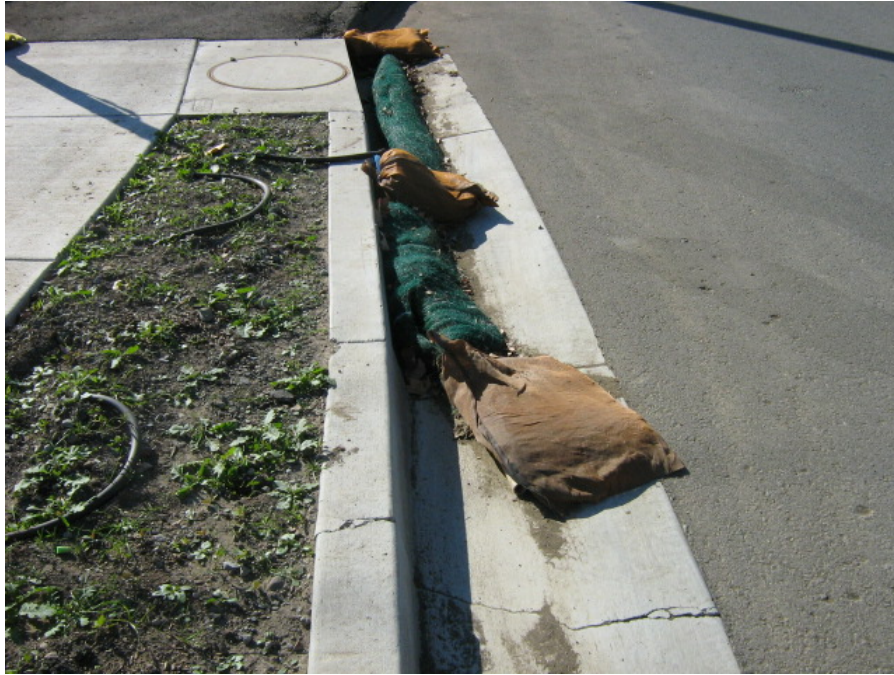
Photograph 3: Sediment transported to the curb and gutter flow-line

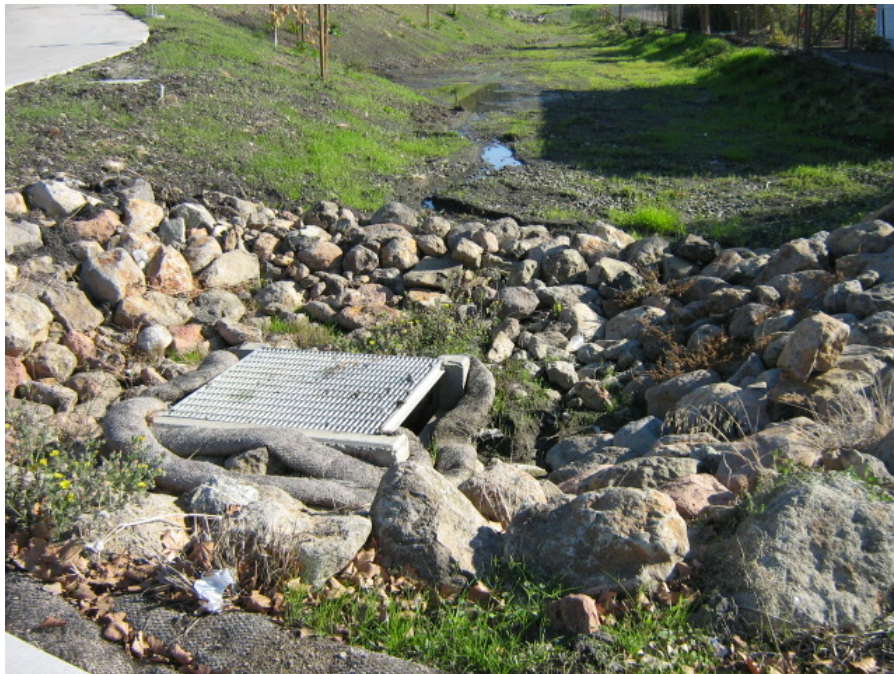
Photograph 4: Structural control located down-gradient from the site

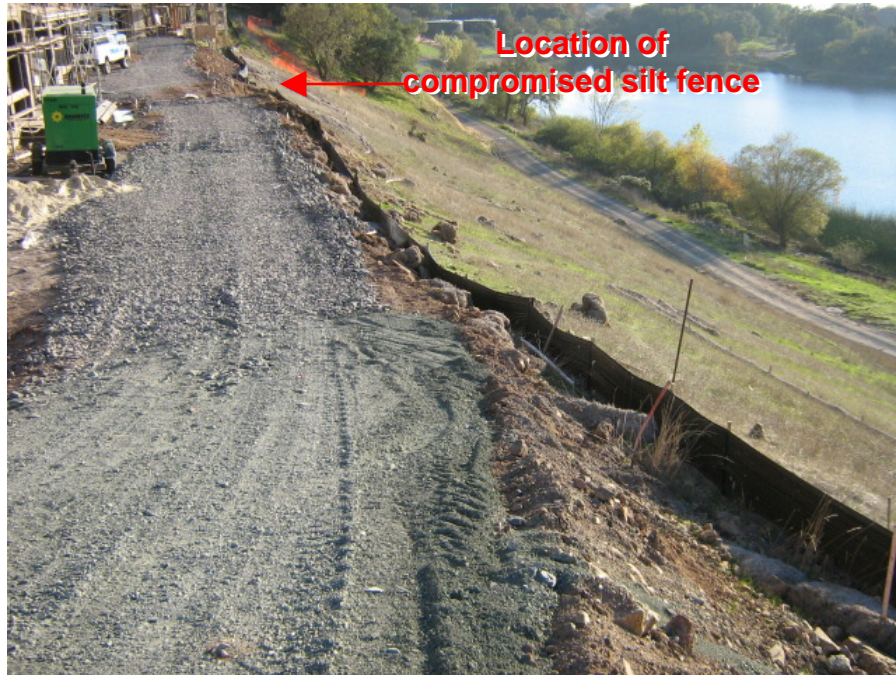
4. Regional Board Order No. R1-2003-0062, Provision 14.a.i. requires the City to ensure adequate source control and/or structural BMPs to control sediments generated at project sites. It was observed during the inspection that BMPs were not adequately maintained to prevent the discharge of sediment from disturbed areas of the project site undergoing building construction (see attached Photograph 5). Specifically, a length of silt fence had been run over or otherwise compromised by track equipment (see attached Photograph 6). As a result, there was a potential for the discharge of sediment from the active building construction site to a slope leading down-gradient toward a roadway and adjacent waterbody. The City must ensure adequate source control and/or structural BMPs to control sediments generated at the Varenna at Fountaingrove project site.

Photograph 5: View depicting location of compromised silt fence and down-gradient waterbody

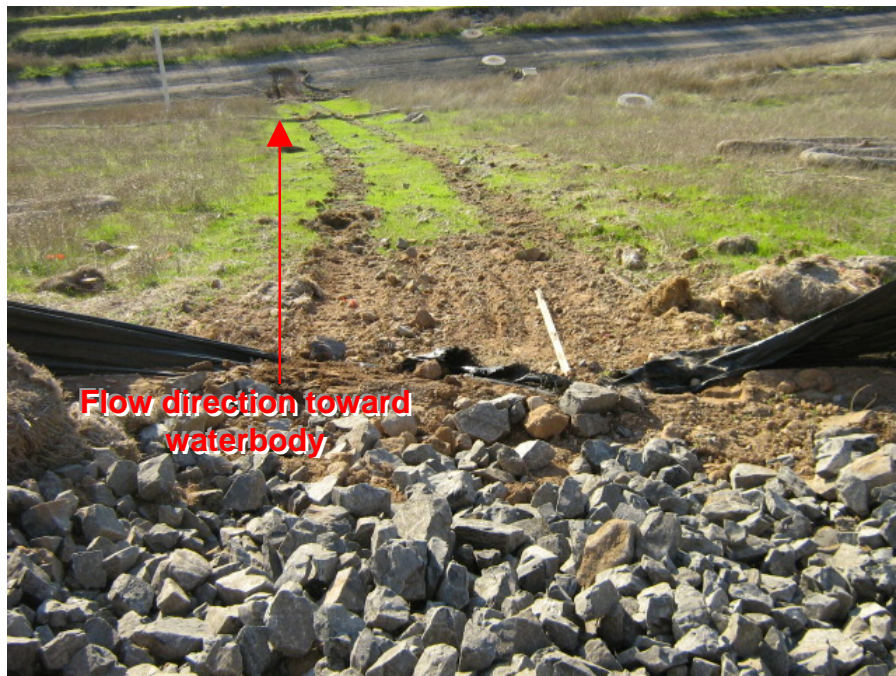
Photograph 6: Length of silt fence compromised by track equipment

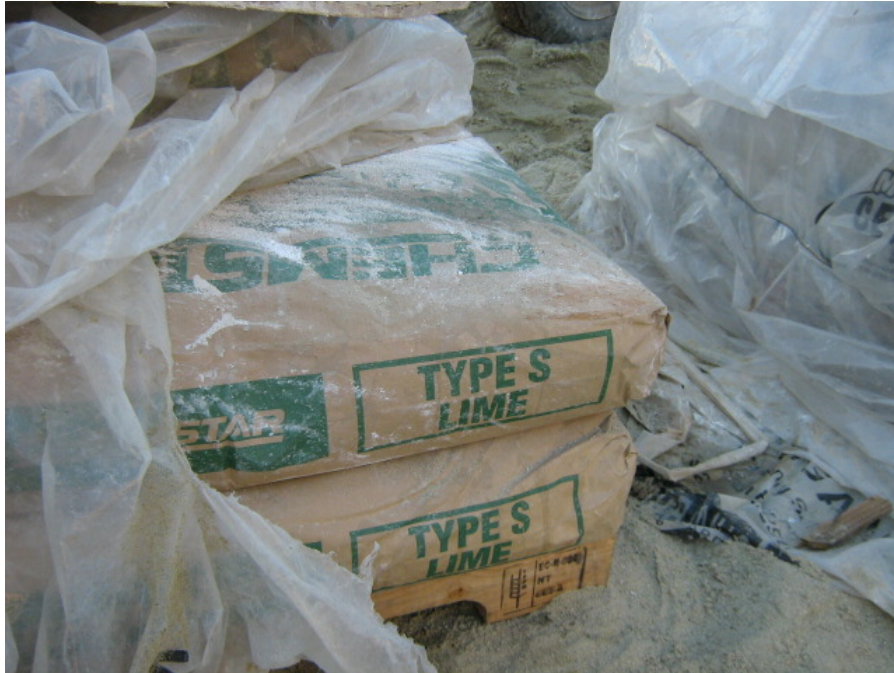
5. Regional Board Order No. R1-2003-0062, Provision 14.a.ii. requires the City to ensure adequate control of construction-related materials, wastes, spills, or residues at project sites. It was observed during the inspection that a pallet of lime (see attached Photograph 7) located adjacent to the active building construction area was stored without adequate protection to prevent and contain potential spills from contributing pollutants to storm water runoff. Specifically, several pounds of lime spillage were observed at this location (see attached Photograph 8). In addition, spillage of a grout or concrete material was observed where it could be exposed to storm water contact (see attached Photograph 9). As a result, there was a potential for contributing pollutants to storm water and overall housekeeping at the site was judged to be extremely poor. Adequate BMPs for pollution prevention, housekeeping, and spill prevention and response must be implemented to prevent any contribution of pollutants to storm water. Moreover, the City must ensure adequate control of construction-related materials, wastes, spills, or residues at the Varena at Fountaingrove project site.

Photograph 7: Close-up view showing type of stockpiled materials

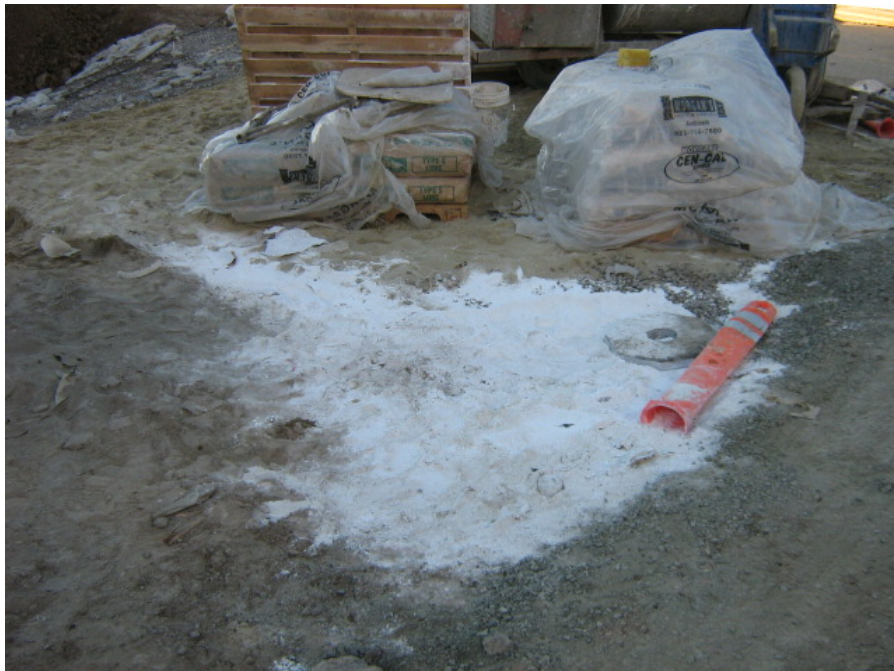
Photograph 8: Lime spillage was present where it could be exposed to storm water contact

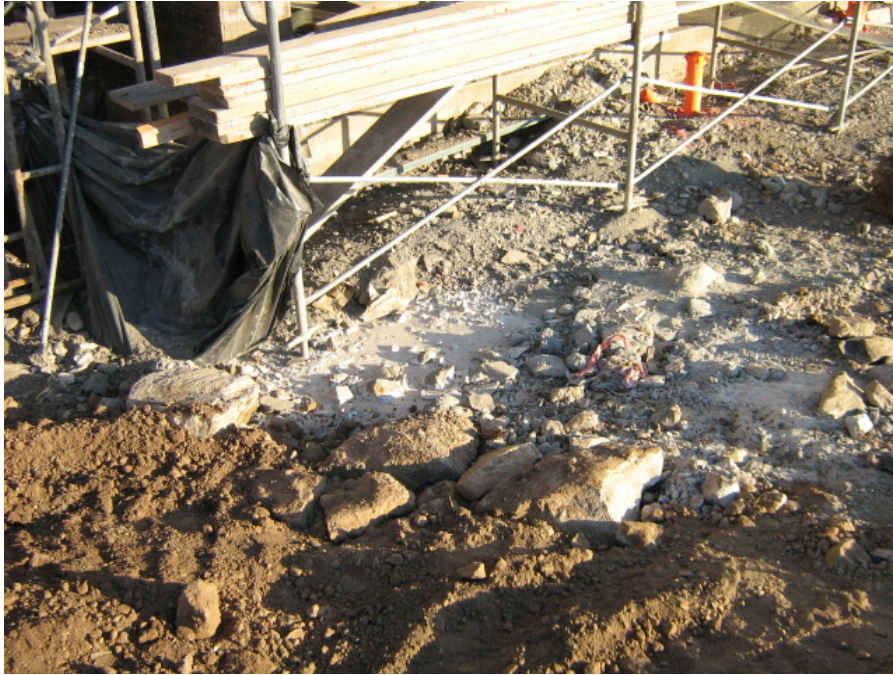
Photograph 9: Spillage of a grout or concrete material was observed in the active building construction area

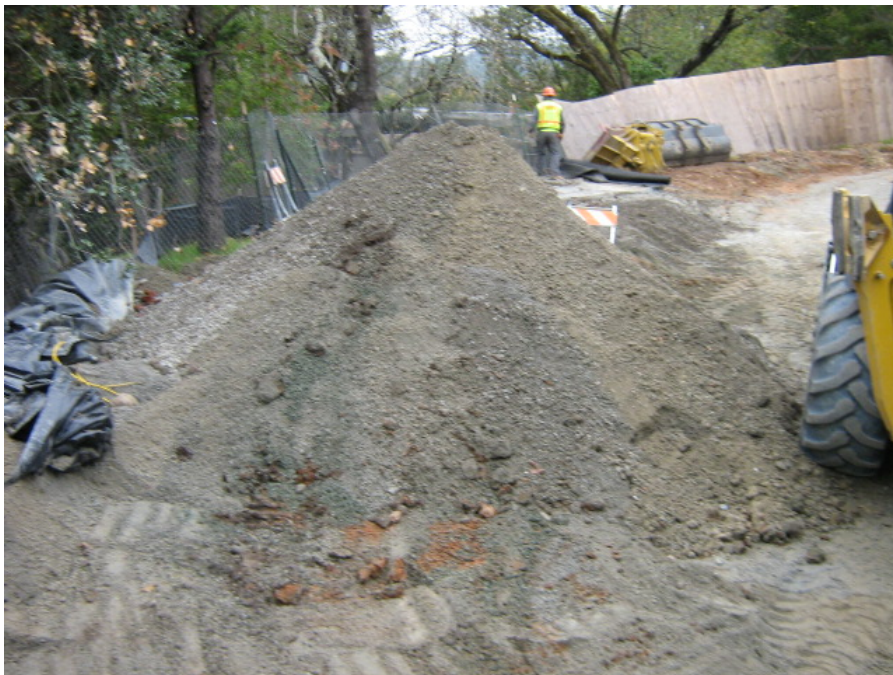
Photograph 10: Soil stockpile and area of unconsolidated material located on the down-gradient perimeter of the project site

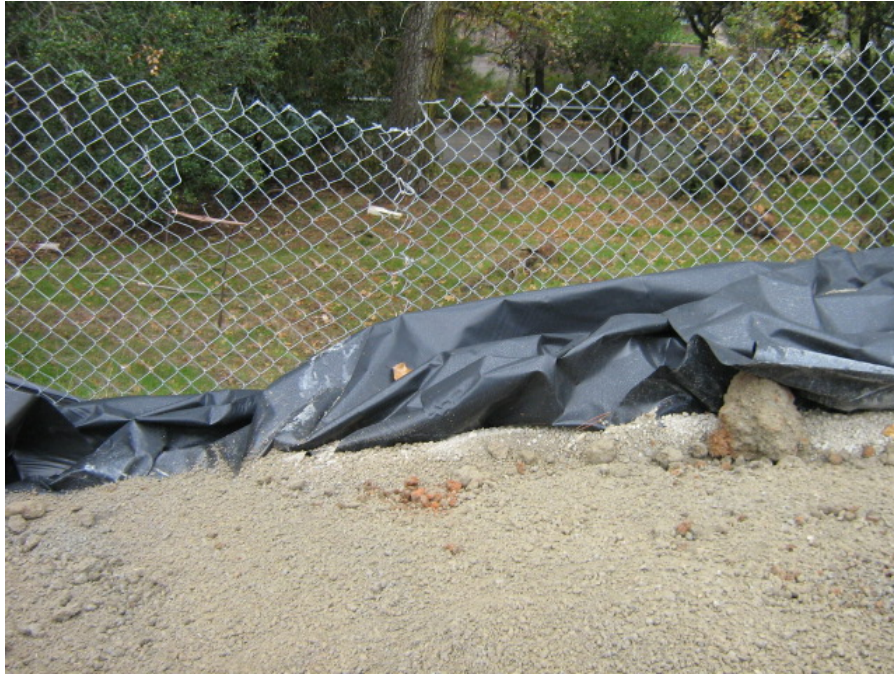
Photograph 11: View showing down-gradient area located offsite

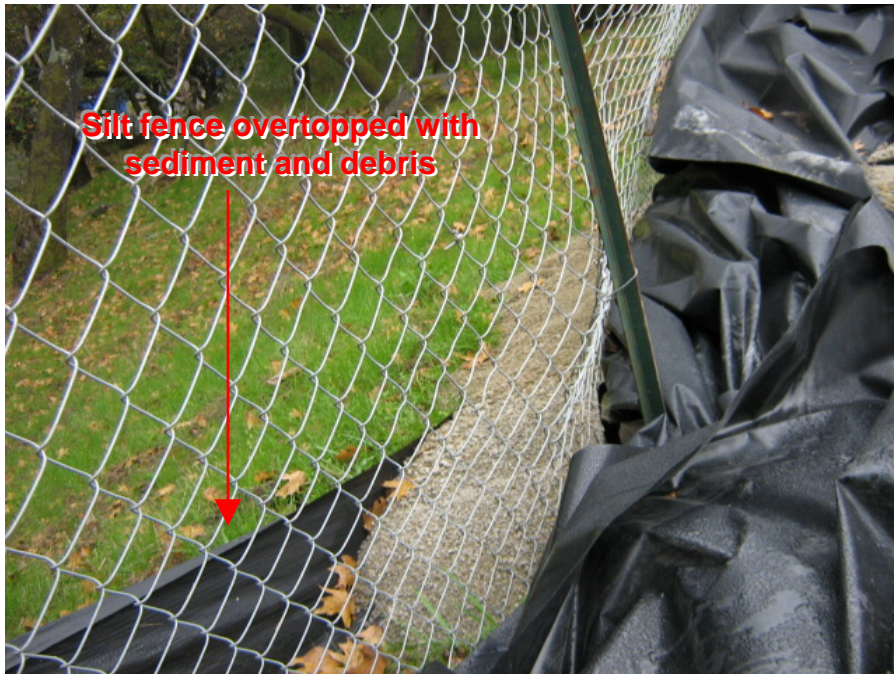
Photograph 12: Unconsolidated material had overtopped the perimeter control silt fence and had been pushed beyond the construction site boundary

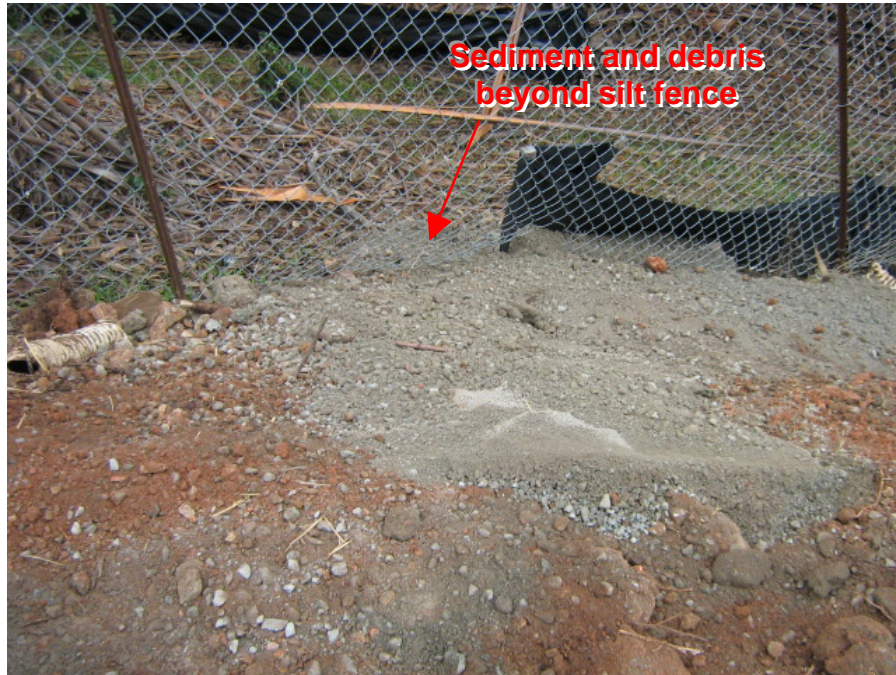
Photograph 13: Sediment transported beyond a section of silt fence located adjacent to the area shown in Photograph 12

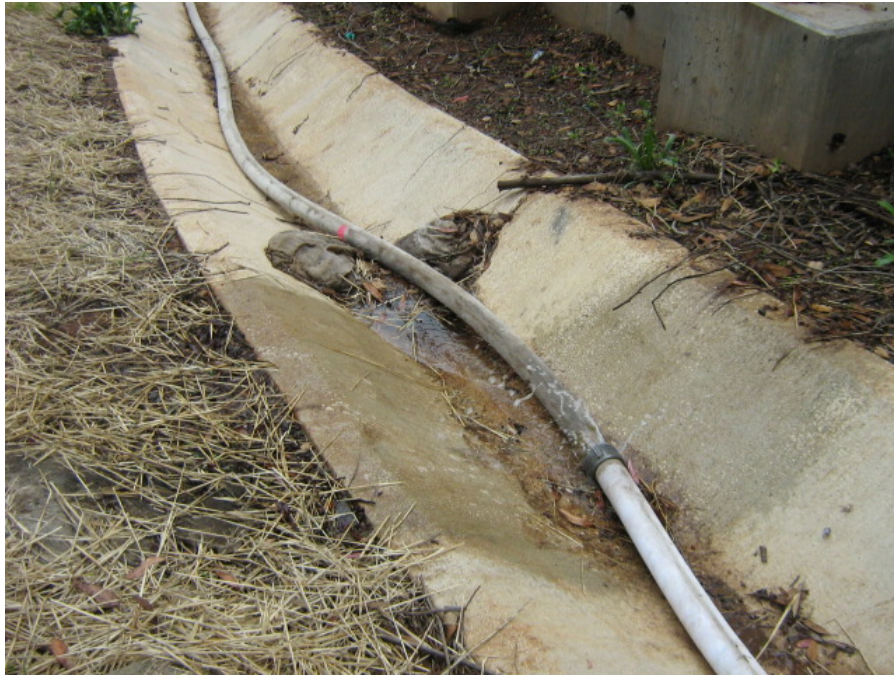
7. Regional Board Order No. R1-2003-0062, Provision 2.b., states that the City shall, at a minimum, pursue the implementation of reasonable BMPs for the elimination or reduction of pollutants from the categories of conditionally exempted discharges, which includes water line flushing. It was observed during the inspection that water line flushing activities were actively causing a non-storm water and sediment discharge to a drainage inlet located at the terminus of a concrete-lined brow ditch. An actively leaking fire hose, which was connected to a nearby fire hydrant, was placed in the concrete-lined brow ditch (see attached Photograph 15). It was unclear whether the leaking fire hose was carrying chlorinated or dechlorinated potable water. However, the flow originating from the leaking fire hose had conveyed sediment and debris from the brow ditch and associated sediment controls into the down-gradient drainage inlet (see attached Photographs 16 and 17). As a result, there was a non-storm water and sediment discharge to the drainage inlet. The City must ensure that reasonable BMPs are implemented for the elimination or reduction of pollutants from water line flushing and the additional categories of non-storm water discharges listed in Provision 2.b. of the Order.

Photograph 15: An actively leaking fire hose, which was connected to a nearby fire hydrant, was placed in the concrete-lined brow ditch

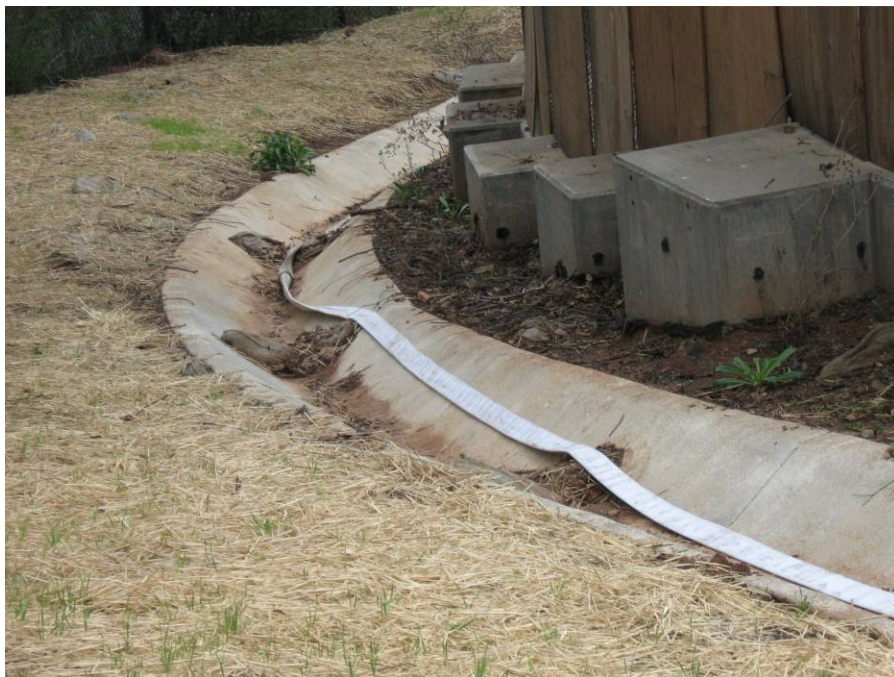
Photograph 16: View of sediment and debris in the brow ditch prior to the flow caused by the leaking fire hose

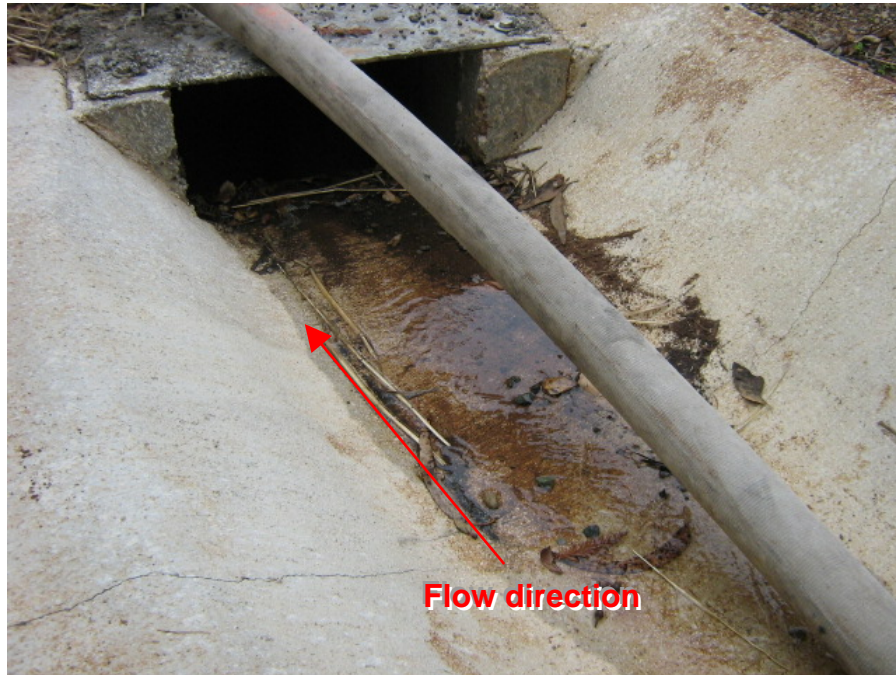
Photograph 17: Sediment and debris conveyed from the ditch and associated sediment controls into the down-gradient inlet

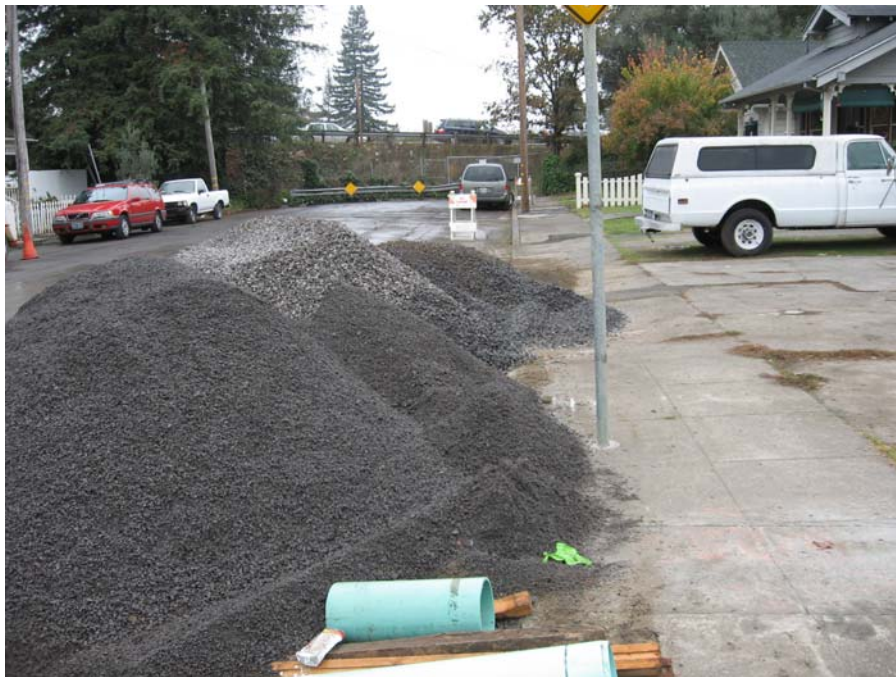
8. The City of Santa Rosa Management Plan, Section 4.1.3 states that “City construction inspectors are responsible to ensure that public improvement projects...are constructed in accordance with approved plans and specifications...the specifications and plans require the contractor to implement BMPs to protect water quality during construction activities.” It was observed during the inspection that adequate BMPs were not implemented to prevent the discharge of sediment from a number of material stockpiles at the project site. Specifically, placement of the stockpiles was inadequate as they were located in the curb and gutter flow-line, a primary drainage pathway (see attached Photograph 18). BMPs were not implemented to prevent erosion and transport of the stockpile materials, perimeter control BMPs were not installed, and the inlet protection installed at the receiving inlet was inadequate (see attached Photograph 19). As a result, there was a potential for the discharge of sediment to the street and subsequent storm drain system. The City must ensure that BMPs are adequately implemented at the McDonald Avenue Sewer and Water Improvements project site.

Photograph 18: Placement of material stockpiles in the curb and gutter flow-line and without BMPs

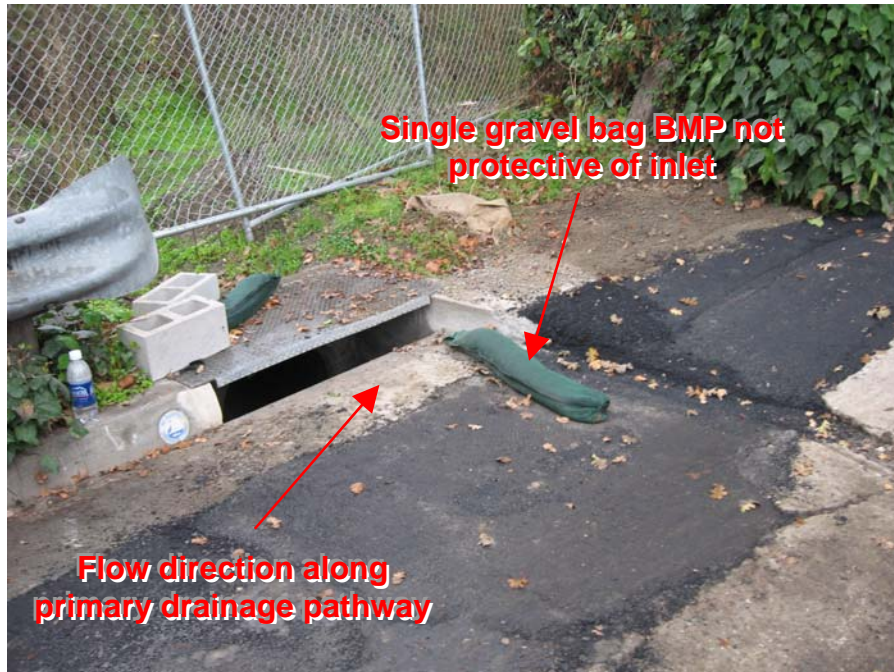
Photograph 19: Inlet protection BMPs were not adequately implemented at the receiving inlet located down-gradient of the material stockpiles shown in the previous photograph

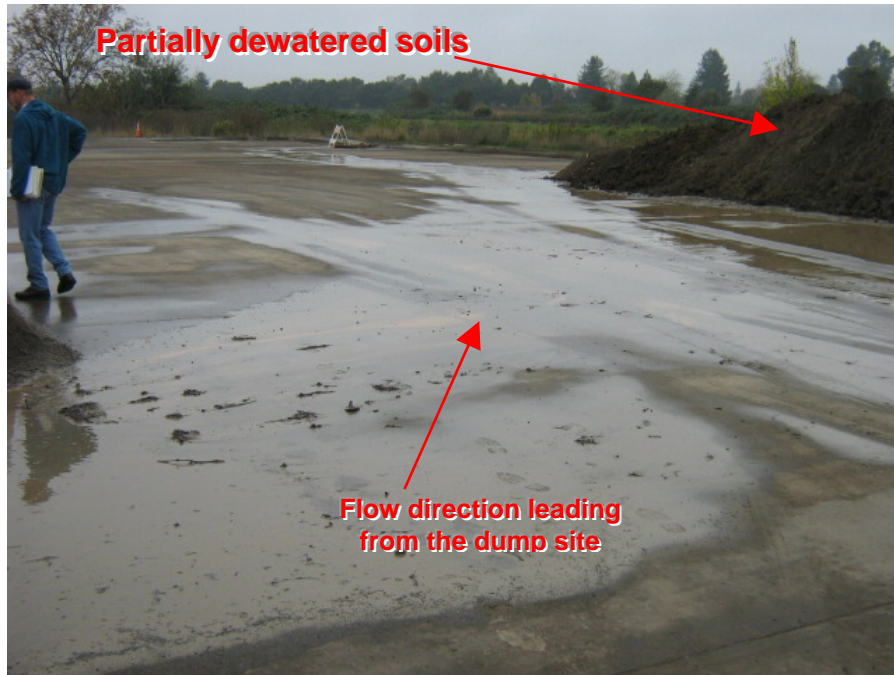
9. Regional Board Order No. R1-2003-0062, Provision 16.b.i. requires the City “to implement BMPs to minimize pollutant discharges in storm water” in association with corporation yards management. It was observed during the inspection that adequate BMPs were not implemented to prevent the discharge of sediment and other pollutants from a vector truck dump site located northwest of the main corporate yard. As provided by Mark Powell (Deputy Director), the City uses self contained hydro excavation trucks for a variety of excavation needs including sanitary sewer and water main breaks. The saturated soils resulting from hydro excavation, which may be contaminated with sanitary waste, are placed at the dump site (see attached Photograph 20). Flow was observed leading from the dump site and a stockpile of partially dewatered soils was placed in the flow-line (see attached Photographs 21 and 22). Furthermore, adequate BMPs were not implemented to prevent the discharge of potentially contaminated sediment from the dump site and adjacent stockpile to a nearby storm drain inlet. The inlet protection BMPs were clogged with potentially contaminated sediment (see attached Photograph 23) and turbid water was observed in the storm drain inlet (see attached Photograph 24). As provided by Mr. Powell, the inlet is connected to a detention basin located west of the dump site. As a result, there was a discharge of potentially contaminated sediment to the inlet and subsequent detention basin. The City must ensure that BMPs are adequately implemented to prevent the discharge of potentially contaminated sediment to the inlet and subsequent detention basin.

Photograph 21: Partially dewatered soils placed in the flow-line of the dump site

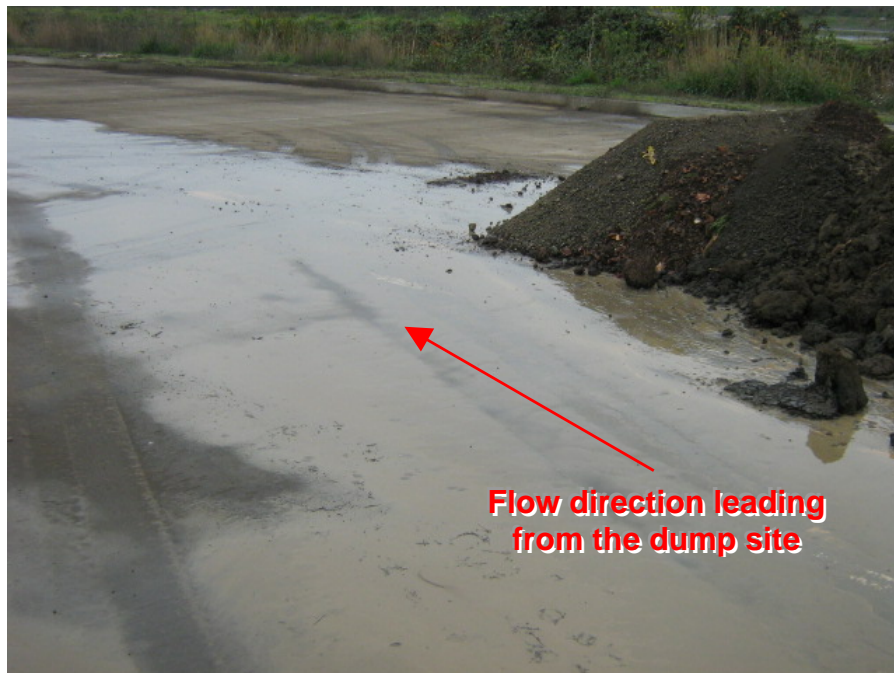
Photograph 22: Close-up view of turbid water flowing from the dump site and partially dewatered stockpile

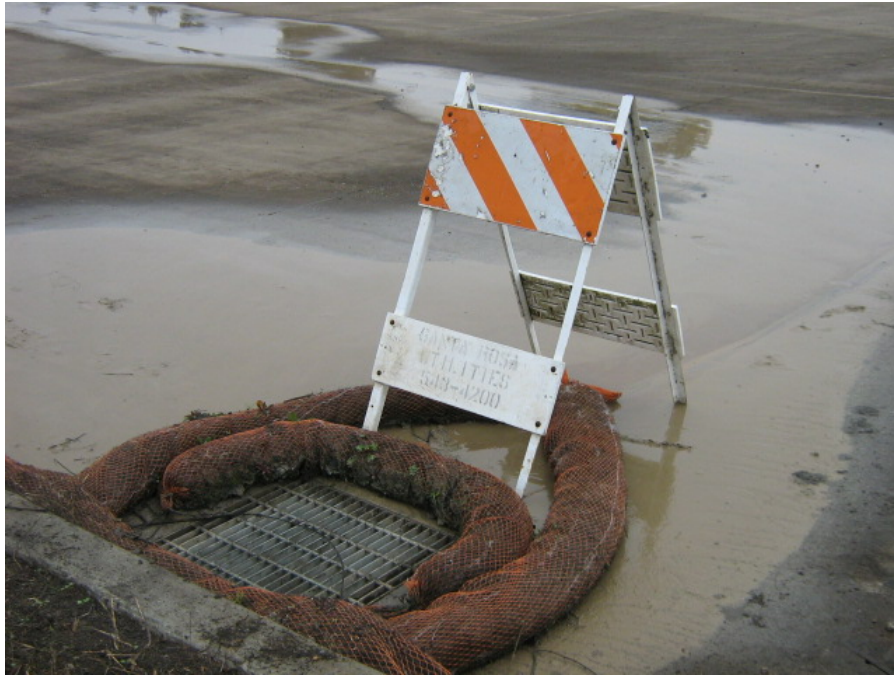
Photograph 23: Receiving inlet located down-gradient of the dump site and adjacent stockpile

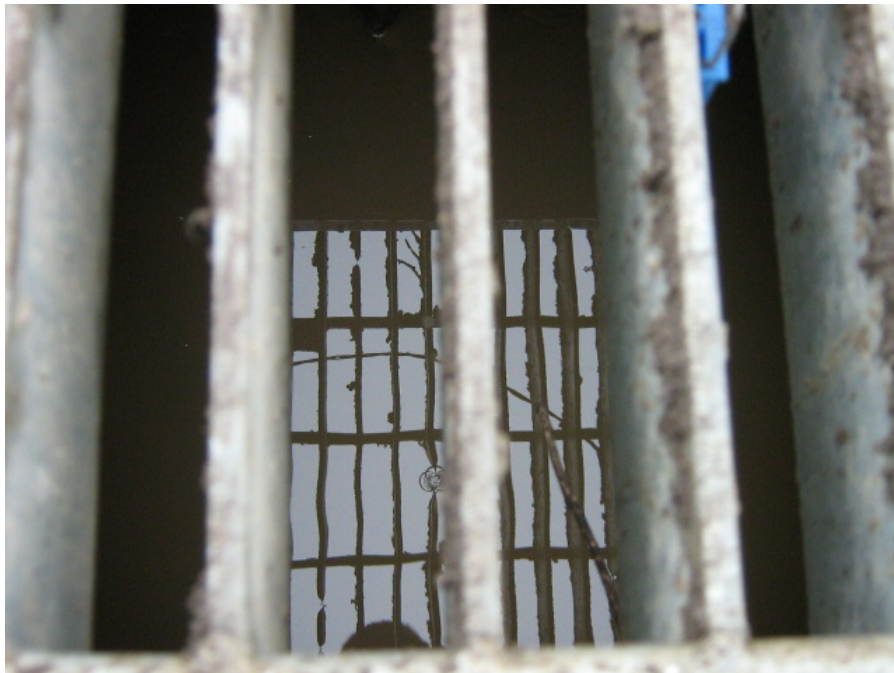
Photograph 24: Turbid water present in the storm drain inlet shown in the previous photograph
