### 3. EVIDENCE, STATUS, AND IMPACT OF WASTE DISCHARGES.

#### 3.1 Subsurface Investigations and Remediation at Clopay (Griffon) Site

REQUIRING GRIFFON CORPORATION, CLOPAY CORPORATION, LIGHTRON  
AND JOL ENTERPRISES  
TO CLEANUP AND ABATE  
CONDITIONS OF SOIL, SOIL GAS AND GROUND WATER POLLUTION  
CAUSED BY THE RELEASE OF VOLATILE ORGANIC COMPOUNDS  
AT 2930 EAST MARIA STREET  
RANCHO DOMINGUEZ, CALIFORNIA

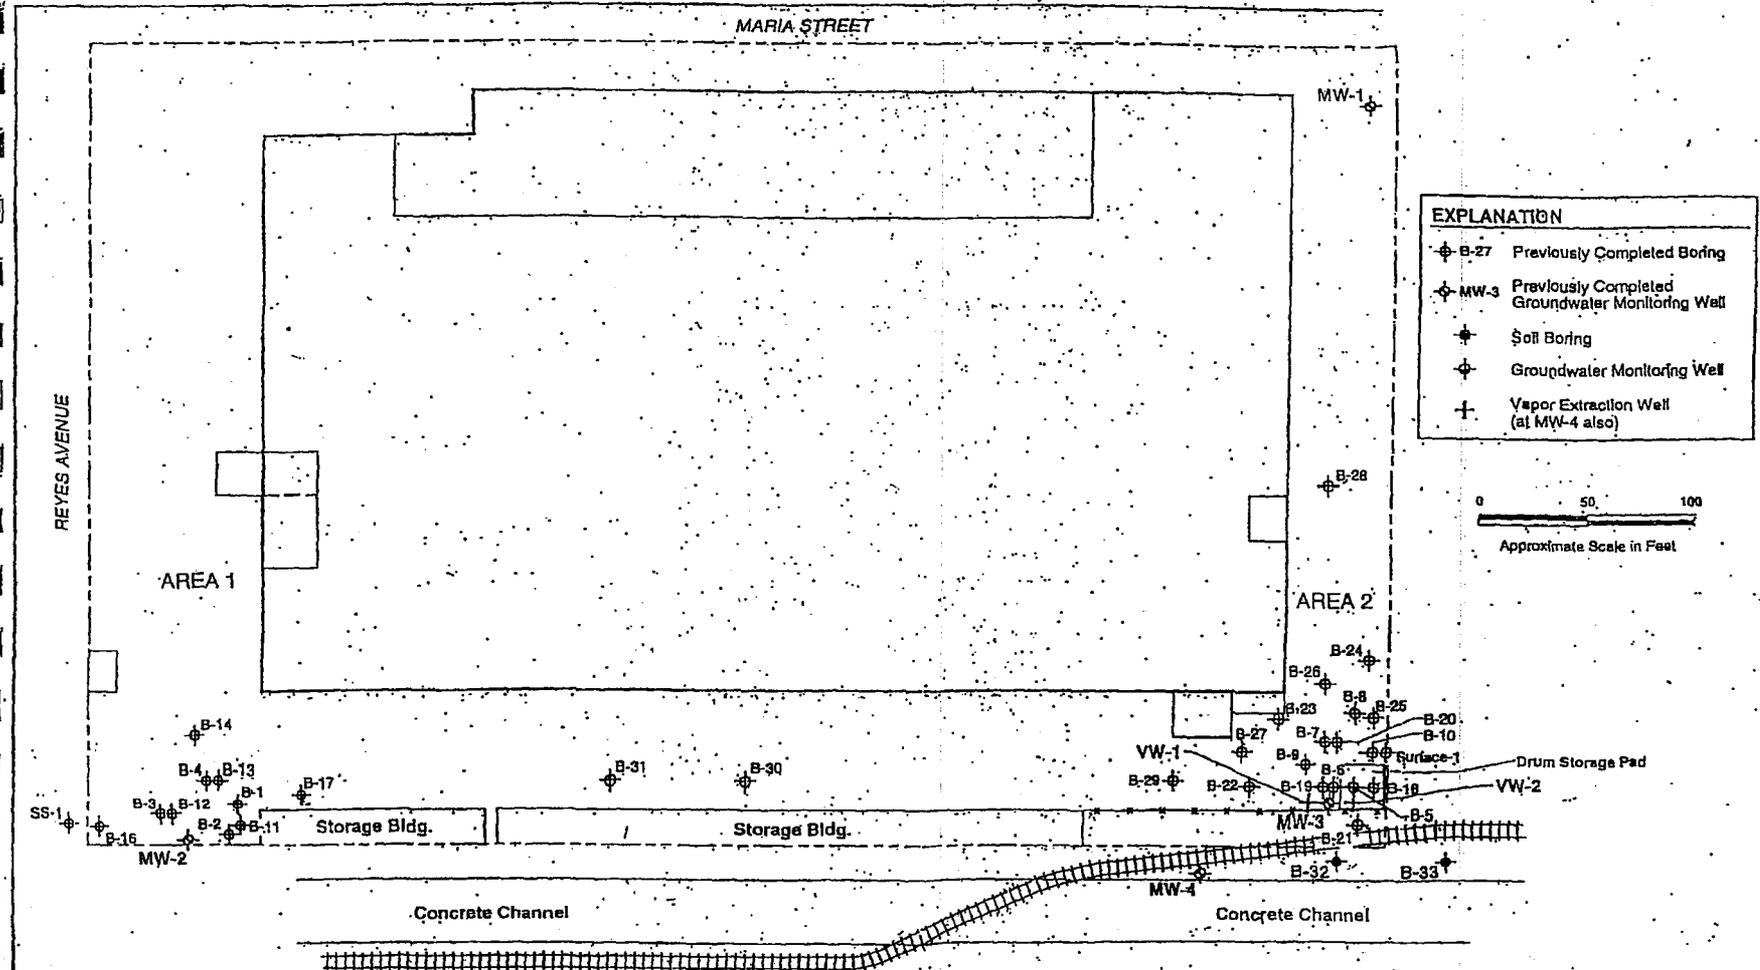
## BORING/WELL LOCATIONS

- Two areas of concern, referred as Area 1 and Area 2, are identified as impacted areas by VOCs in soil, soil gas, and groundwater. Area 1 is an isolated area of concern with VOCs in both soil and groundwater located in the southern portion of the Property. Area 2 is located in the southeastern portion of the Property, centered at former waste storage and disposal area (also referred as the drum storage pad) (see Figure 2).

- In Area 2, PCE was the principal detected contaminant, as in Area 1. The highest levels of contaminants were found directly beneath the drum storage pad (Boring B-5 and B-18) located at the southeast corner of the Property (see Figure 2). The highest PCE concentrations in soil at B-5 were detected at 2,800,000 ppb at 1 foot below ground surface (bgs), 11,000 ppb at 20 feet bgs, and 1,300 ppb at 30 bgs. PCE concentration in soil at B-18 was 54,158 ppb at 2.0 feet bgs.

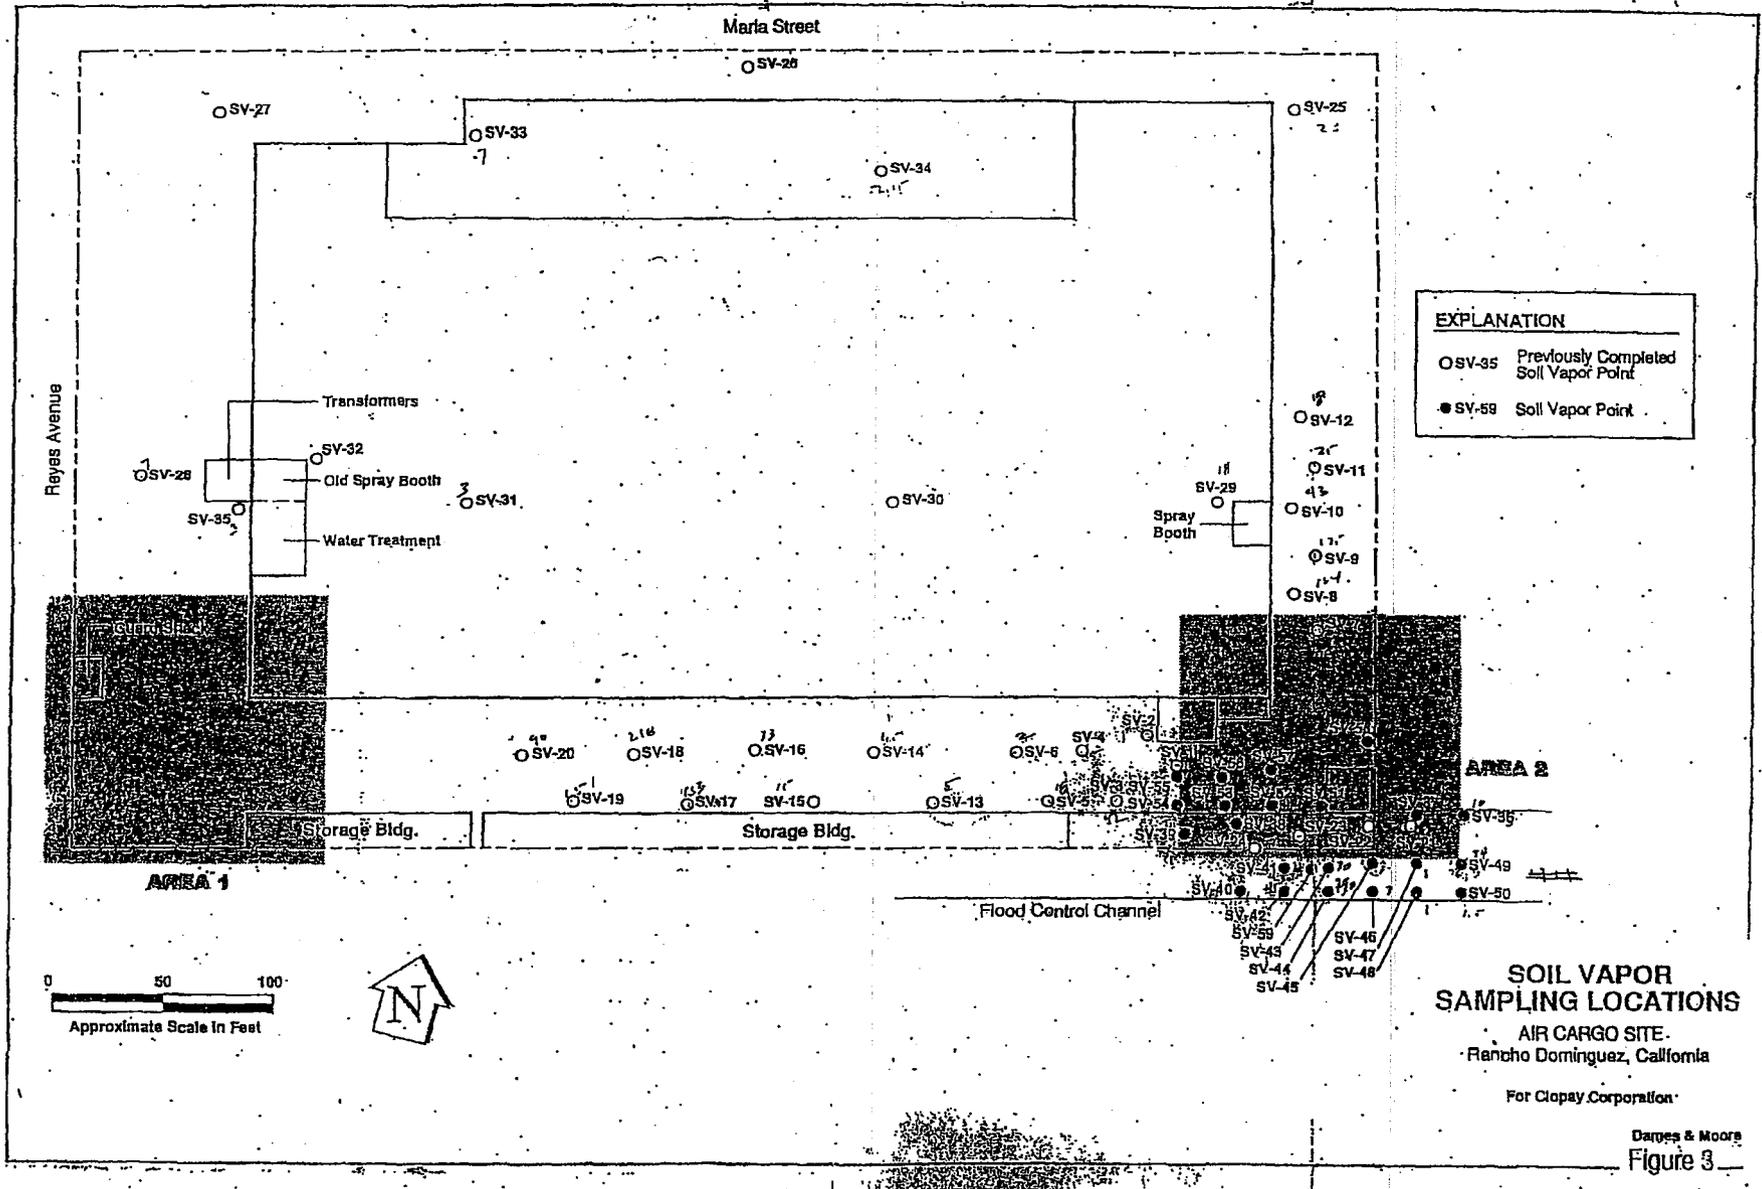
Darges & Moore  
 Figure 3

- An offsite groundwater monitoring well MW-4 was installed in May 1997 on the Flood Control Easement approximately 50 feet south of the former drum storage pad. PCE, TCE, and 1,1-DCE were detected at 10,000 ppb, 340 ppb, and 1,900 ppb, respectively.
- Fifty-nine soil vapor probes were installed on the Clopay site and along the rail spur and flood control channel access road near the former drum storage pad during the 1992 and 1994 investigations. Analytical results of the soil vapor samples indicated that PCE was the major compound detected. These test results demonstrated that the highest VOC concentrations are located south and southwest of the former drum storage pad (Figure 3).

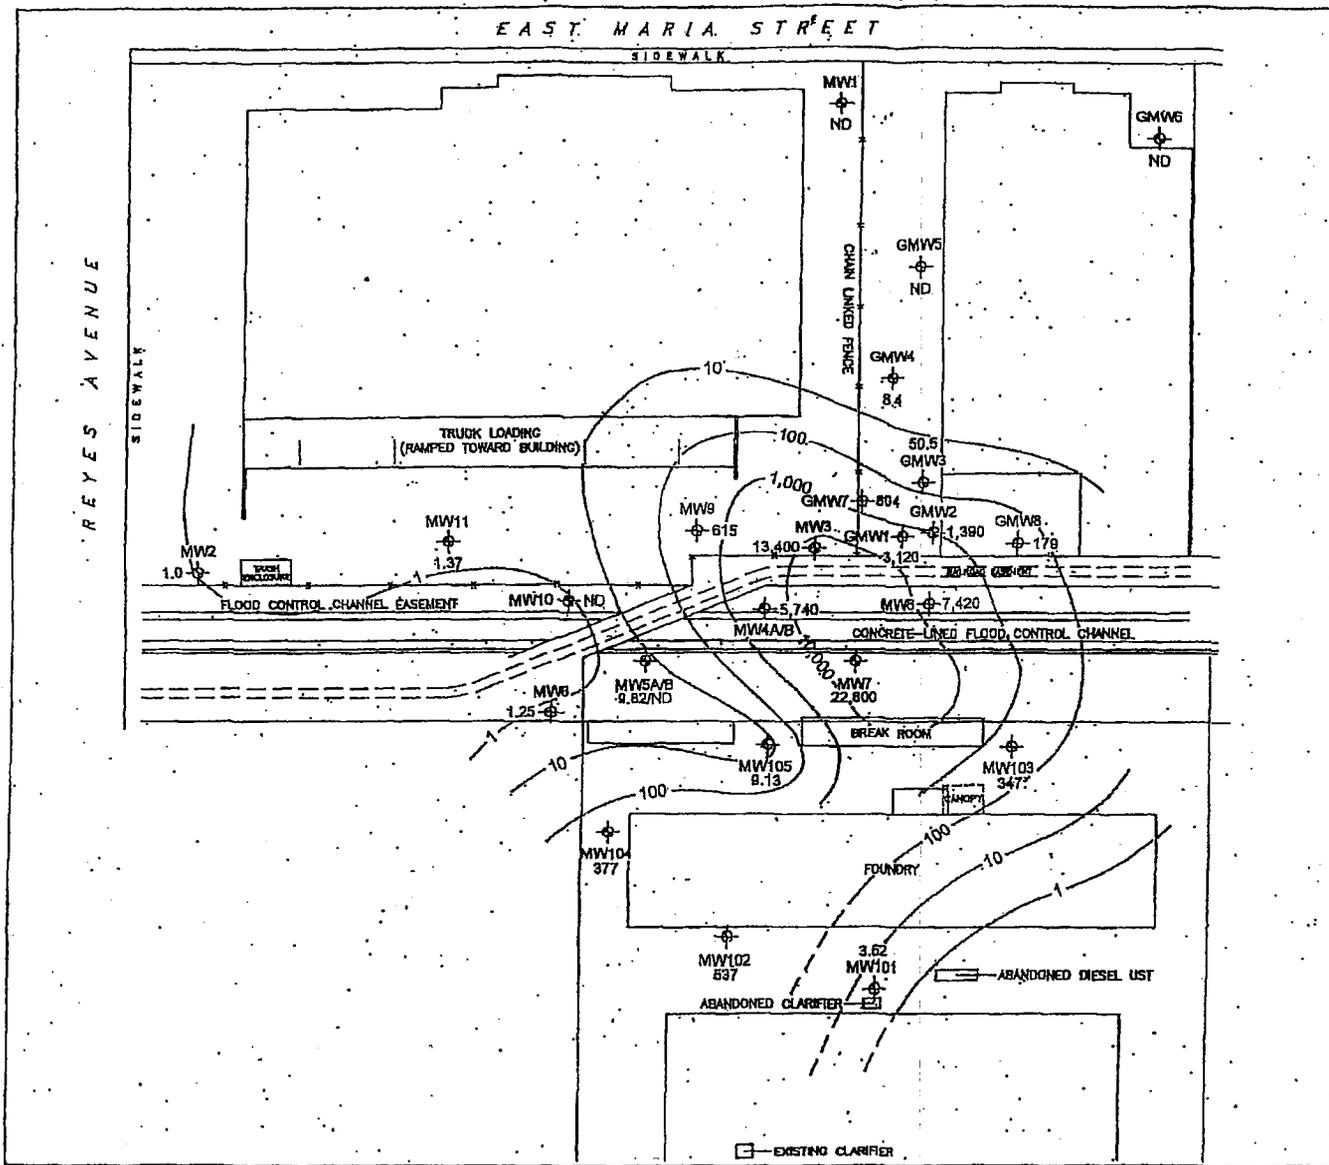
- The December 2008 groundwater sampling results indicate that PCE concentrations are 11,500 ppb in MW-3, an onsite monitoring well, and 7,920 ppb in MW-6 and 11,600 ppb in MW-7, two offsite monitoring wells south of the former drum storage pad (Figure 4).

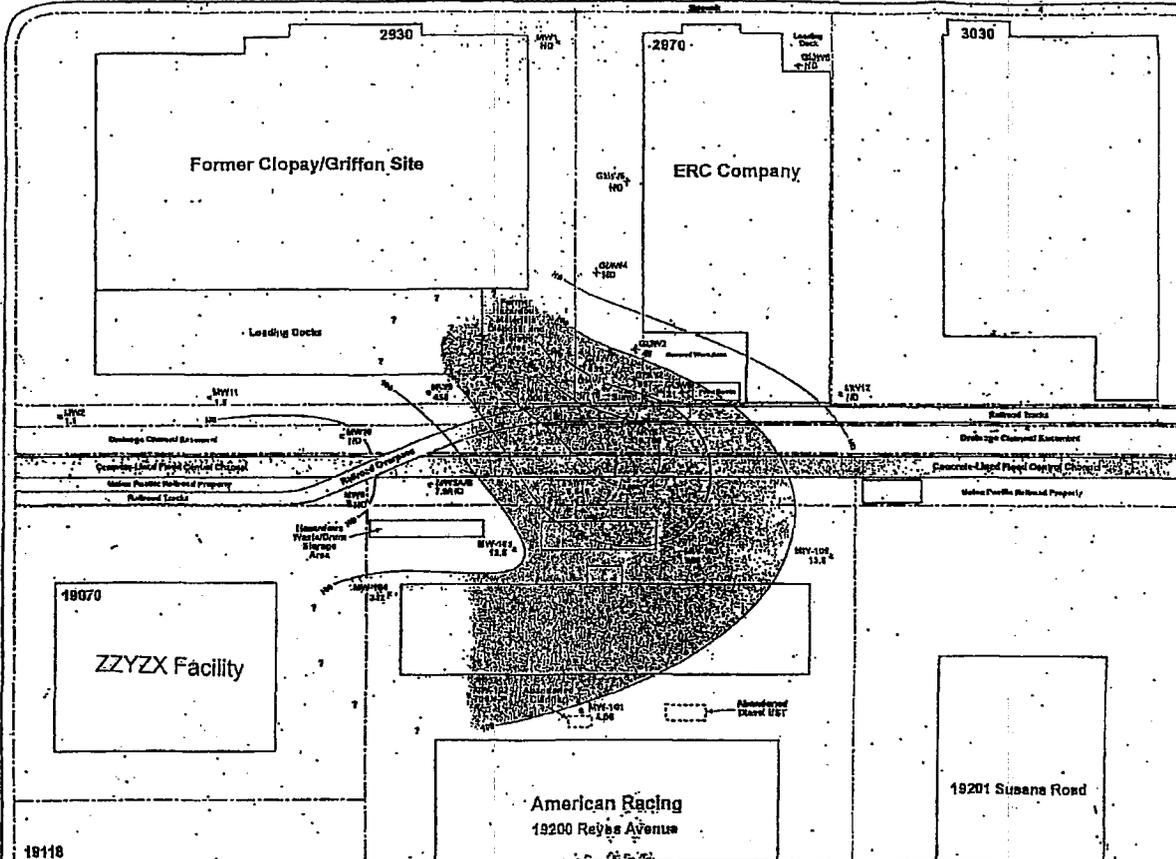
- Among eight onsite monitoring wells, elevated dissolved-phase PCE concentrations were detected in monitoring wells GMW-1, GMW-2, GMW-3, GMW7 and GMW8 located in the southwest corner of the ERC property (see Figure 5).
