San Francisco Bay Regional Water Quality Control Board

INSPECTION REPORT

December 13, 2016

Subject: Inspection of the Bremer Family Winery Vineyard, Napa County

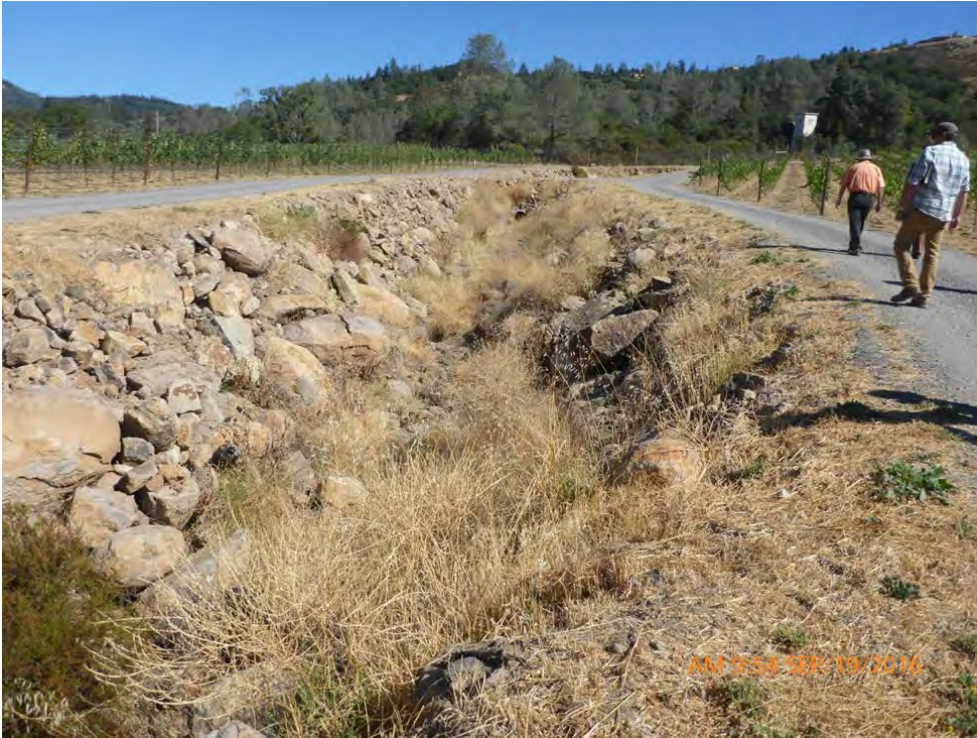
1. **An unnamed intermittent or ephemeral stream channel, that is hydrologically connected to the Napa River, was ditched and culverted during the current phase of vineyard development.** Vineyard blocks were developed directly adjacent to the channelized stream, with eight- to ten-foot-high rock walls now forming the banks of the stream. Prior to development, as evidenced by review of time-sequential aerial photographs available in Google Earth, there was a continuous physical connection between this unnamed stream and a named blue-line stream (Canon Creek), and wet-season flow was evident. Prior to development the stream alternated between single-thread and multiple-threaded reaches, cascade bedforms were common, and vegetation on the rocky floodplain for the channel was dominated by chapparral species.

Photo 1. Lower portion of unnamed intermittent stream that was channelized (looking upstream).

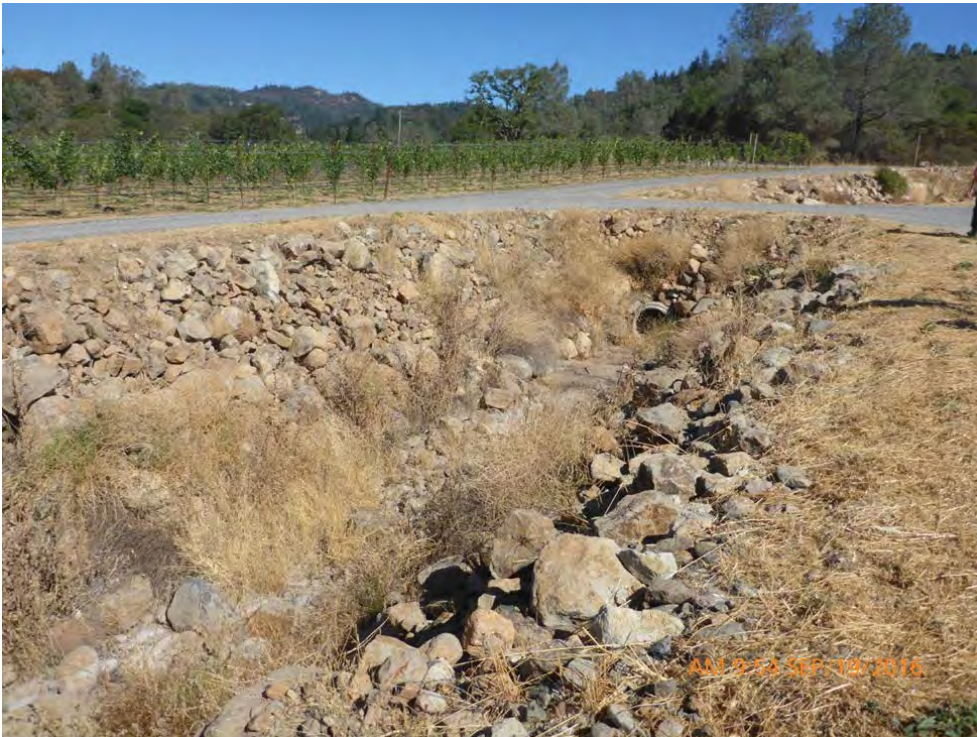
Photo 2. Lower portion of unnamed intermittent stream that was channelized (looking upstream).

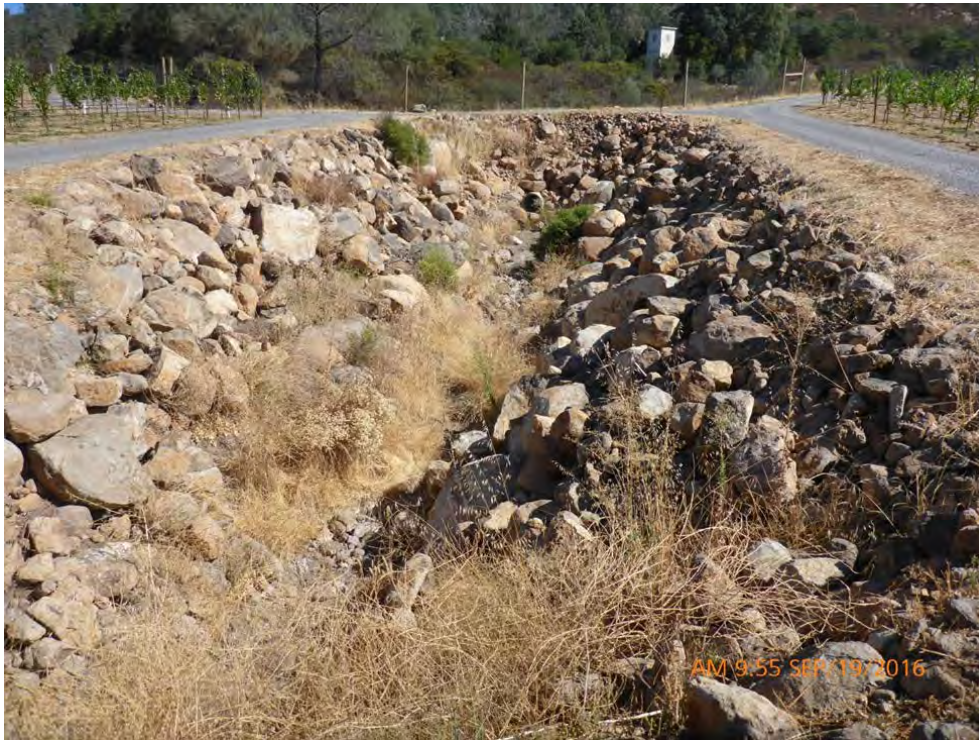
Photo 3. Upper portion of unnamed intermittent stream that was channelized (looking upstream).

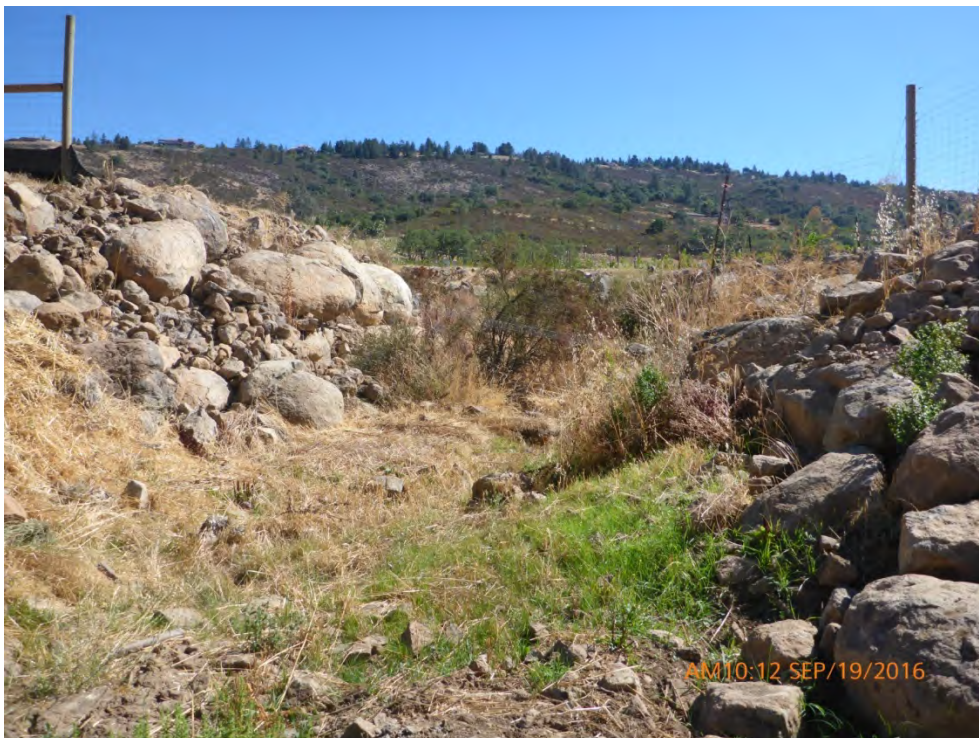
Photo 4. Confluence of channelized unnamed intermittent stream and Canon Creek (looking upstream).

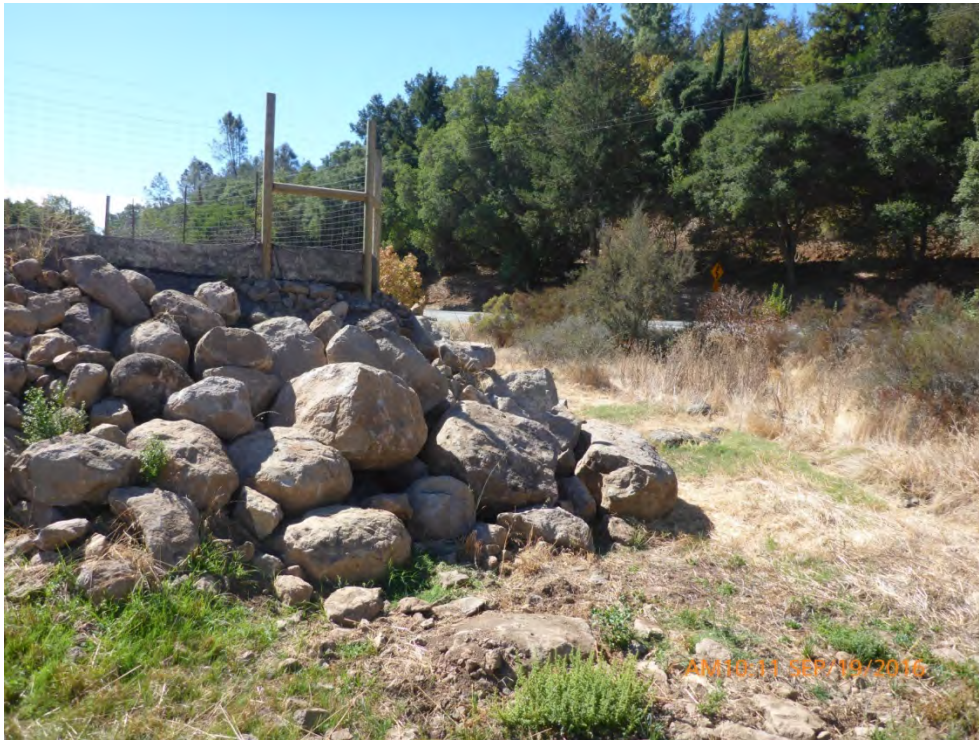
3. **No filter fabric was placed between the rock walls and fill, and the rock walls may be vulnerable to differential settlement and soil piping,** which has the potential to result in significant sediment discharge to Canon Creek. In our discussion with the project engineer, we learned that the fill is not keyed or benched except at the contact with the rock wall. There has been no engineering analysis performed to confirm that the rock walls will remain stable under expected loads. The rock walls should be subject to a design review by a qualified geotechnical engineer.

Photo 5. Example photograph of rock walls.

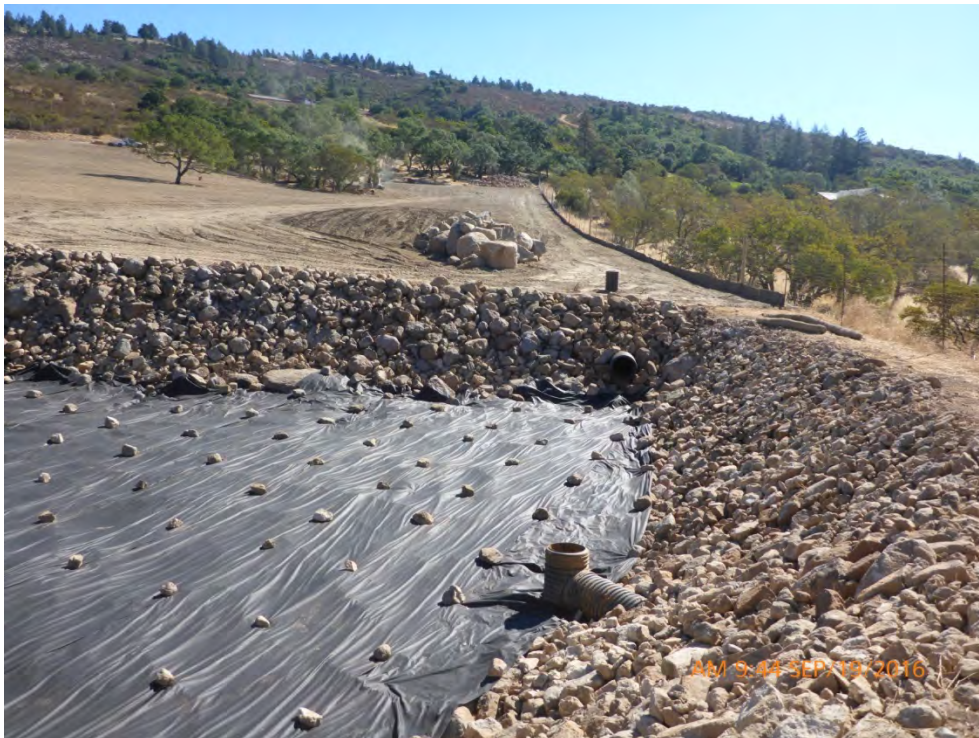
2. **Post-vineyard development increase in storm runoff peak does not appear to be fully attenuated.** Key assumptions in the original hydrologic model for the vineyard development project appear unreasonable or imprudent (e.g., a persistent improvement in soil infiltration capacity as a result of deep ripping; taking advantage of a recent fire over part of the property to assume reduced infiltration capacity under the pre-development condition; not accounting for decreases in time of concentration as a result of ditching and placement of subsurface drainage pipes, etc.). As a result, it is plausible that the constructed detention basin is significantly undersized.

Photo 6. Photograph of detention basin.

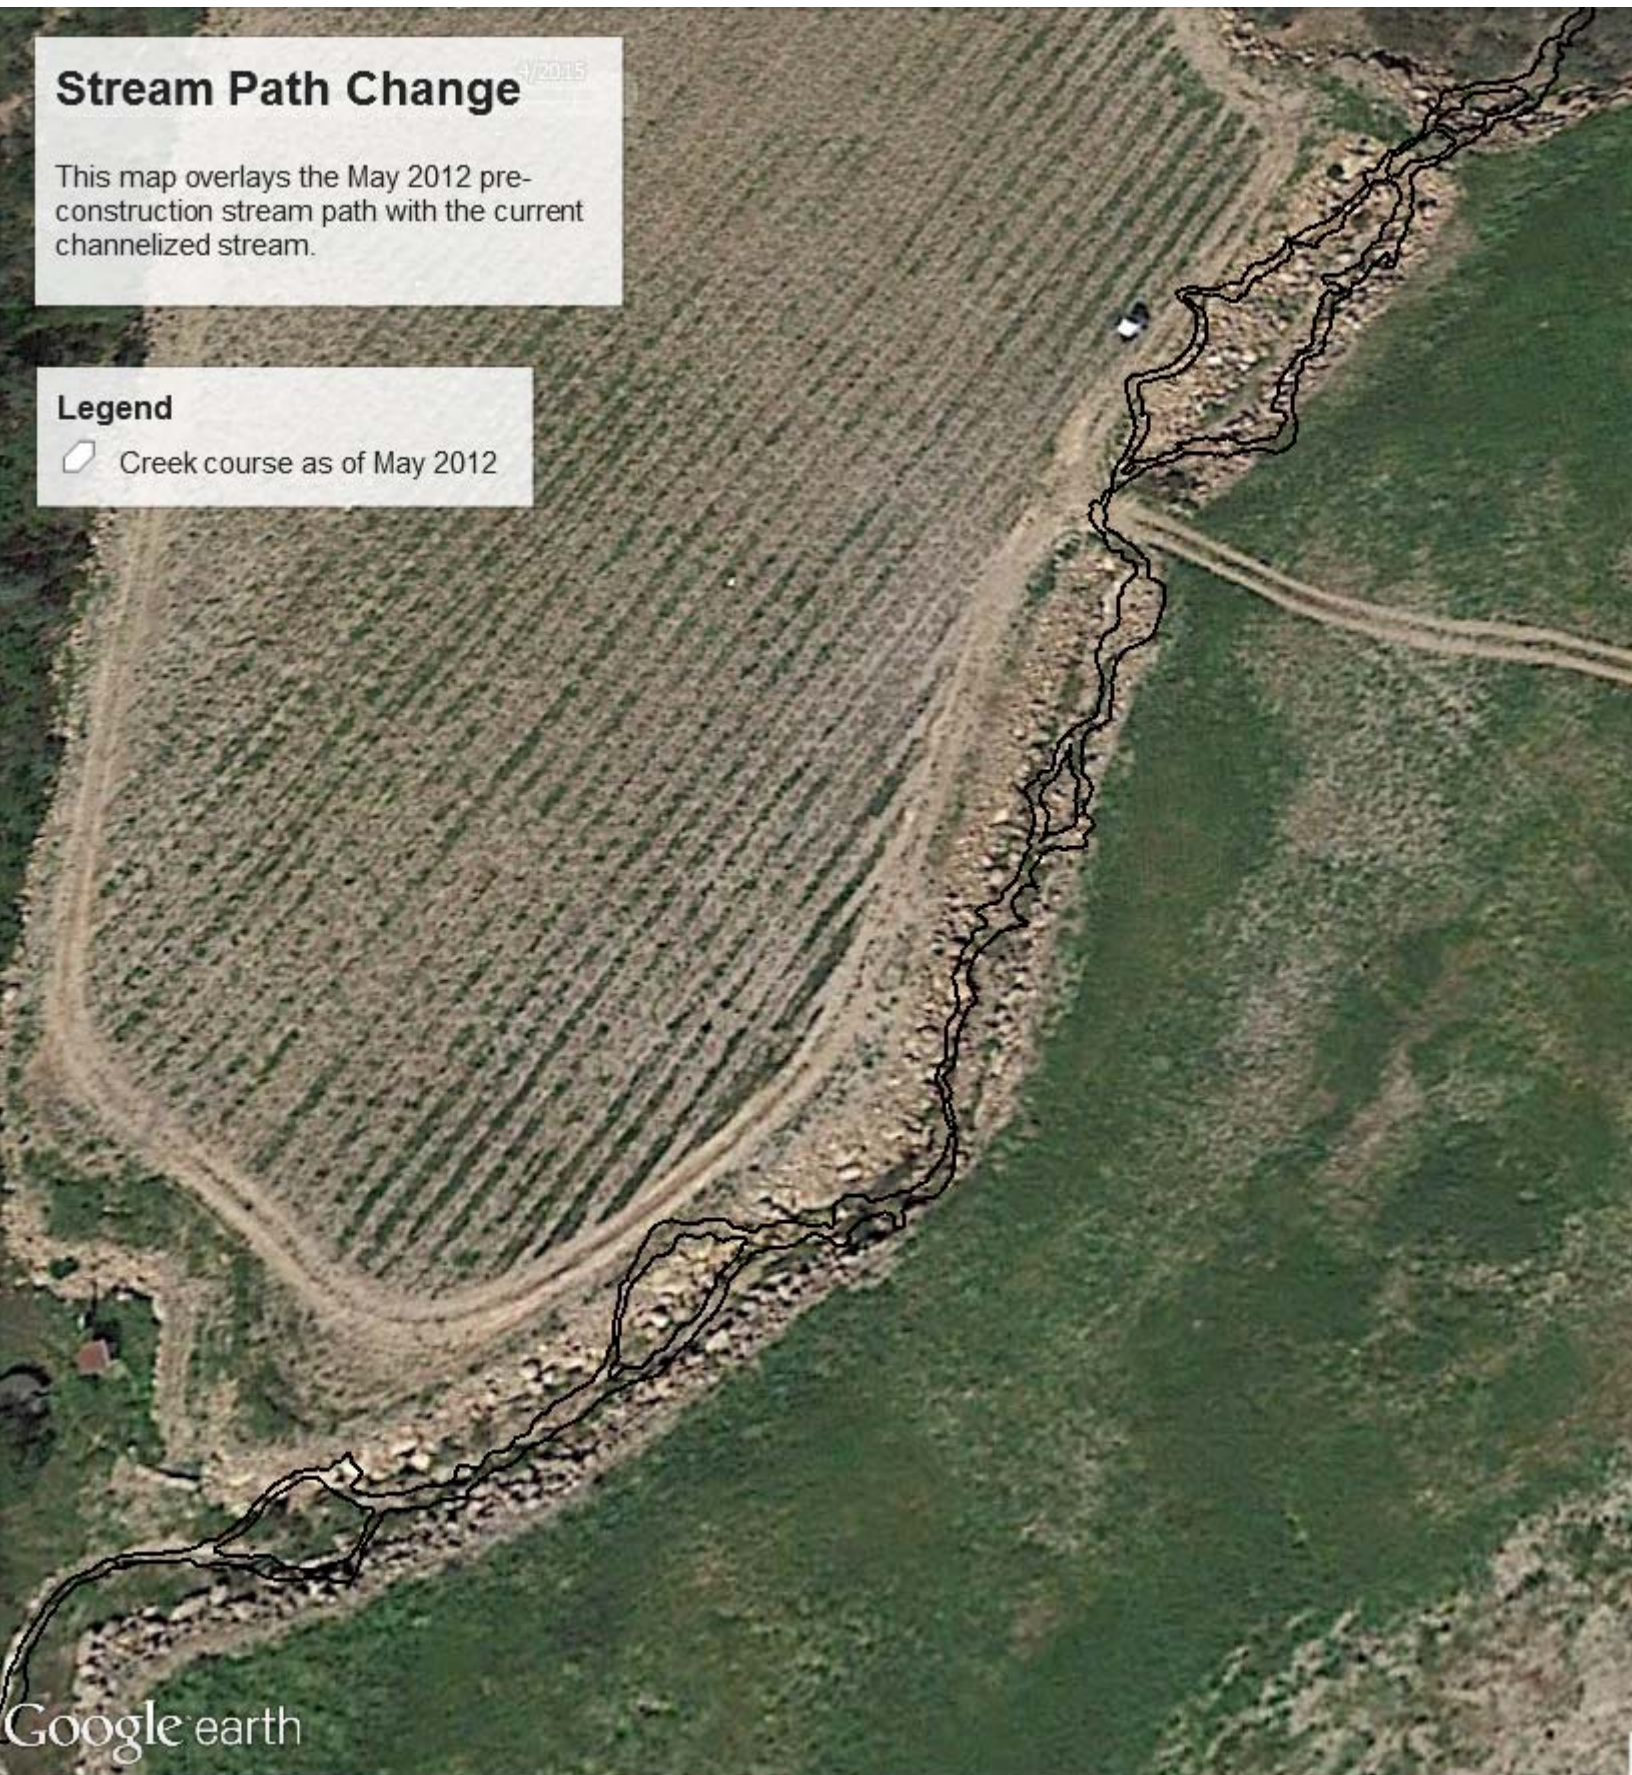
Stream Path Change 4/2015

This map overlays the May 2012 pre-construction stream path with the current channelized stream.
