Physical Setting Site SC#1: Soft and Intensively Deformed Franciscan Assemblage Mélange and Sheared Serpentinite terrain (Franciscan mélange); Deep-seated Landslides; 1995 vineyards and roads

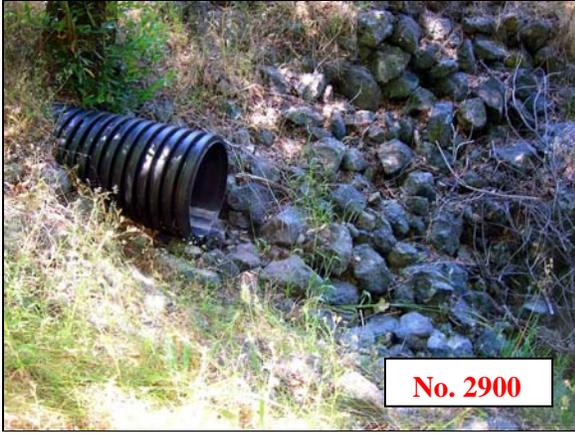
No. 2900

- 6) At another road-repair site, the creek was stabilized with the installment of new drainage pipes, which were built at the creek level, to prevent formation of scour pools (pics. nos. 2900, 2903);

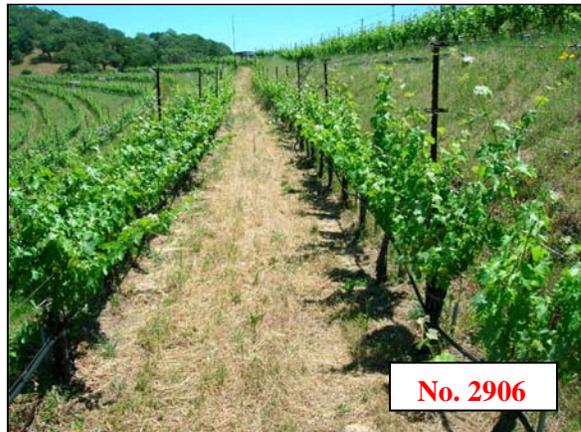
No. 2906

- 2) 95% of the vineyard is in a heavily engineered terrace;
- 3) Most of vineyard acreage (87ac) is replanted;
- 4) One of the blocks is located on a large and active rotational-translational landslide (pic. no. 2906). This landslide has been active since the late 1990s, when the vineyard was built, but it experienced an acceleration in March 2011. As a result, several slumps and cracks formed in the vineyard terraces on the upper slopes of the landslide (in the down-dropped hillside surface or in a fresh scarp) (pics. nos. 2897, 2904), and a large crack developed within the landslide toe (pic. no. 2896). A few trees were toppled due to the slumping of the toe. It is likely that the toe will collapse in less than 2 years, likely delivering 100-200m³ of sediment to the on-site creek. In the event of the re-activation of the entire landslide, an estimated 50,000m³ or more of sediment could be delivered, burying the creek at its toe;
