**AERIAL PHOTOGRAPHIC ANALYSIS
CASMALIA DISPOSAL SITE
CASMALIA, CALIFORNIA**

April 27, 2001

Prepared By: ERI

Contract No. 45791

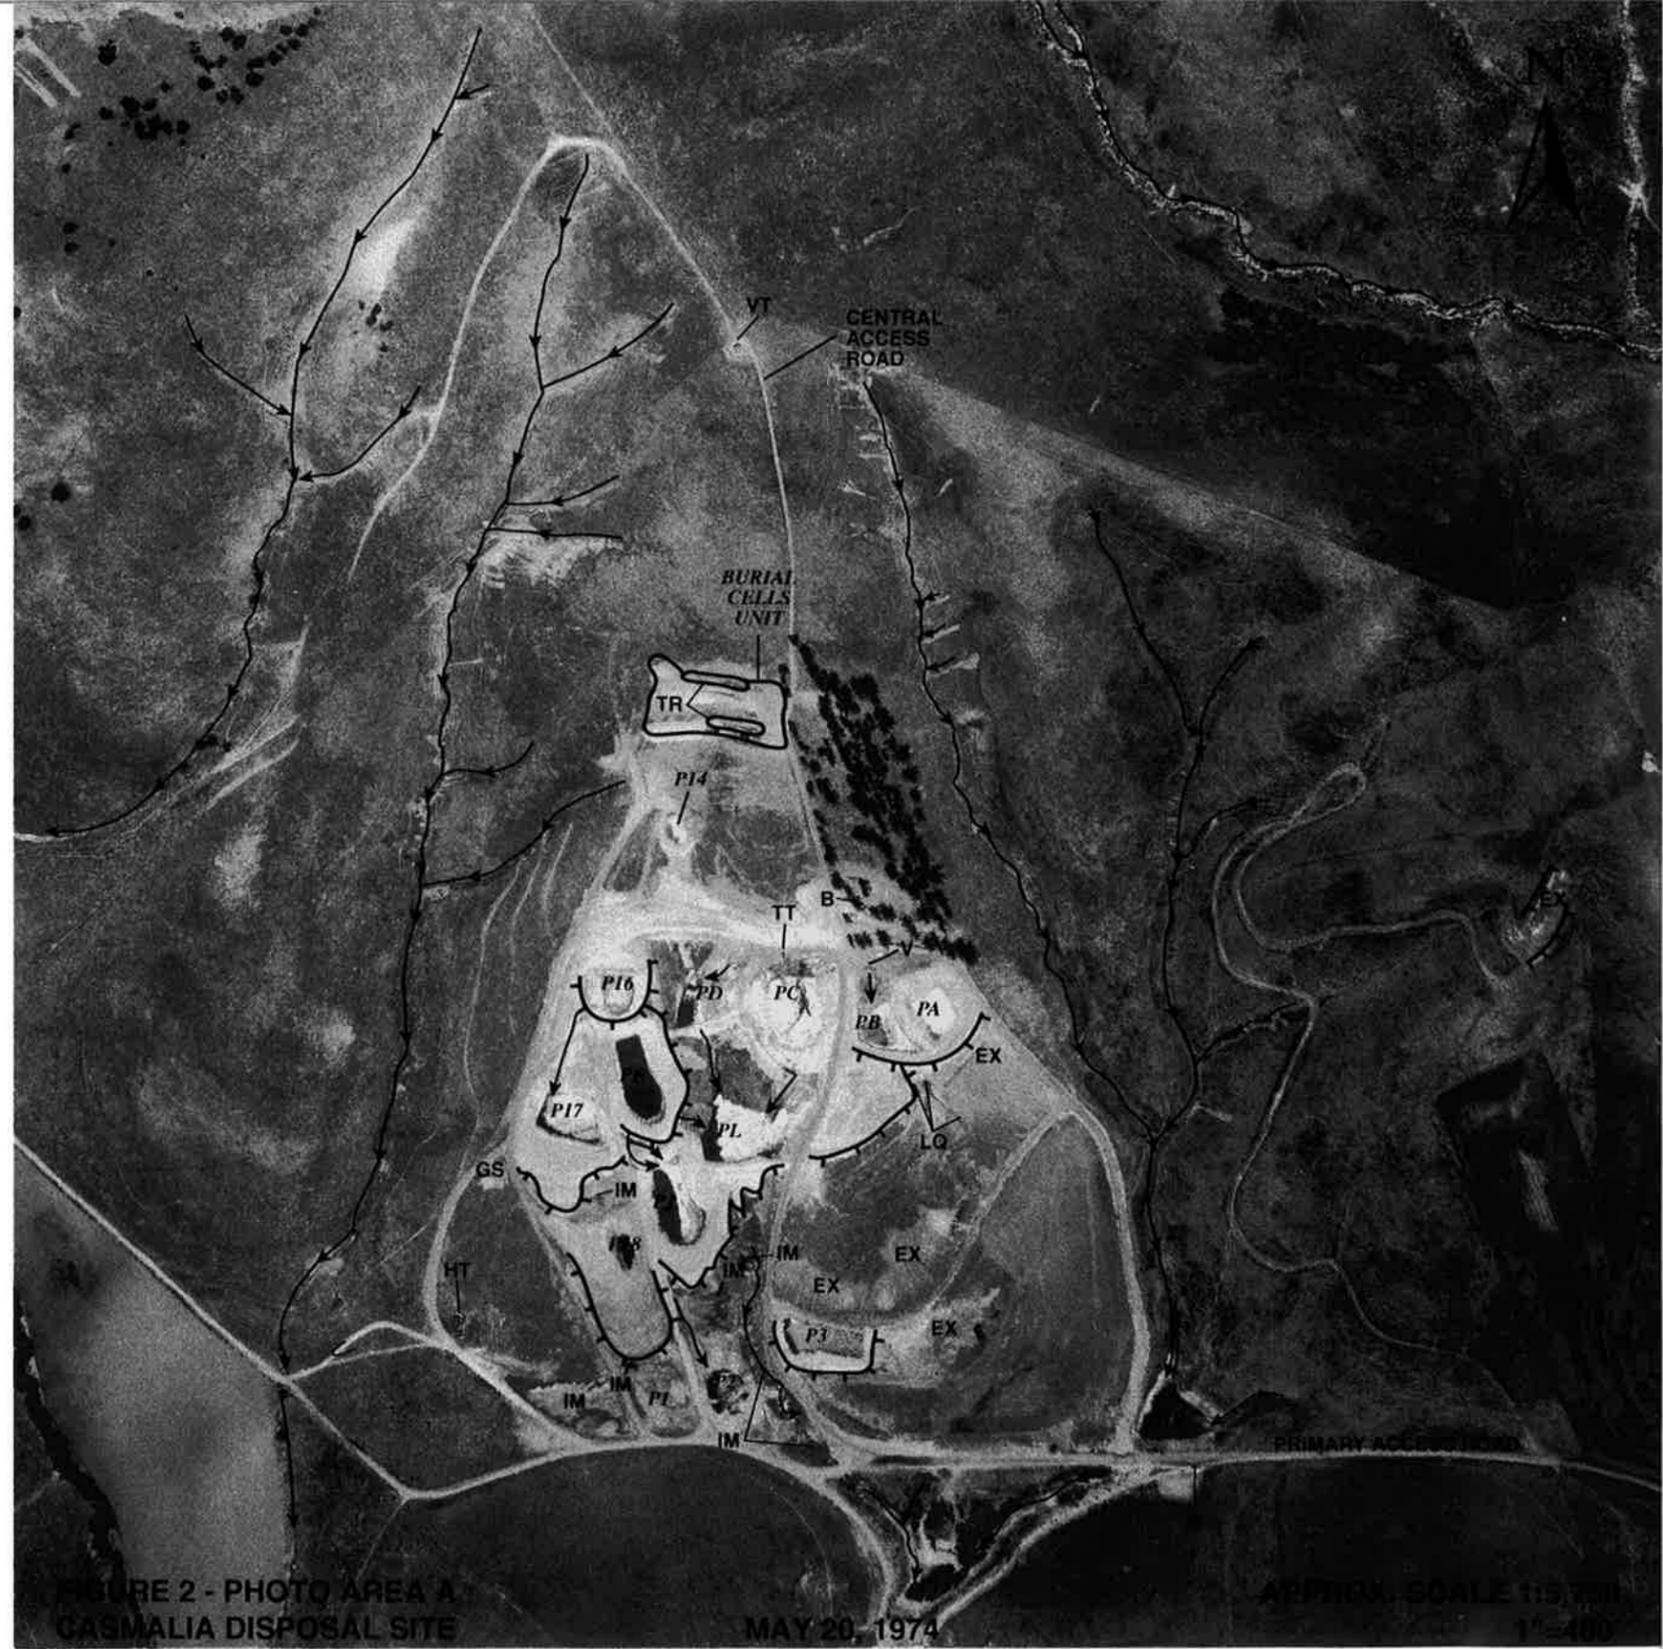
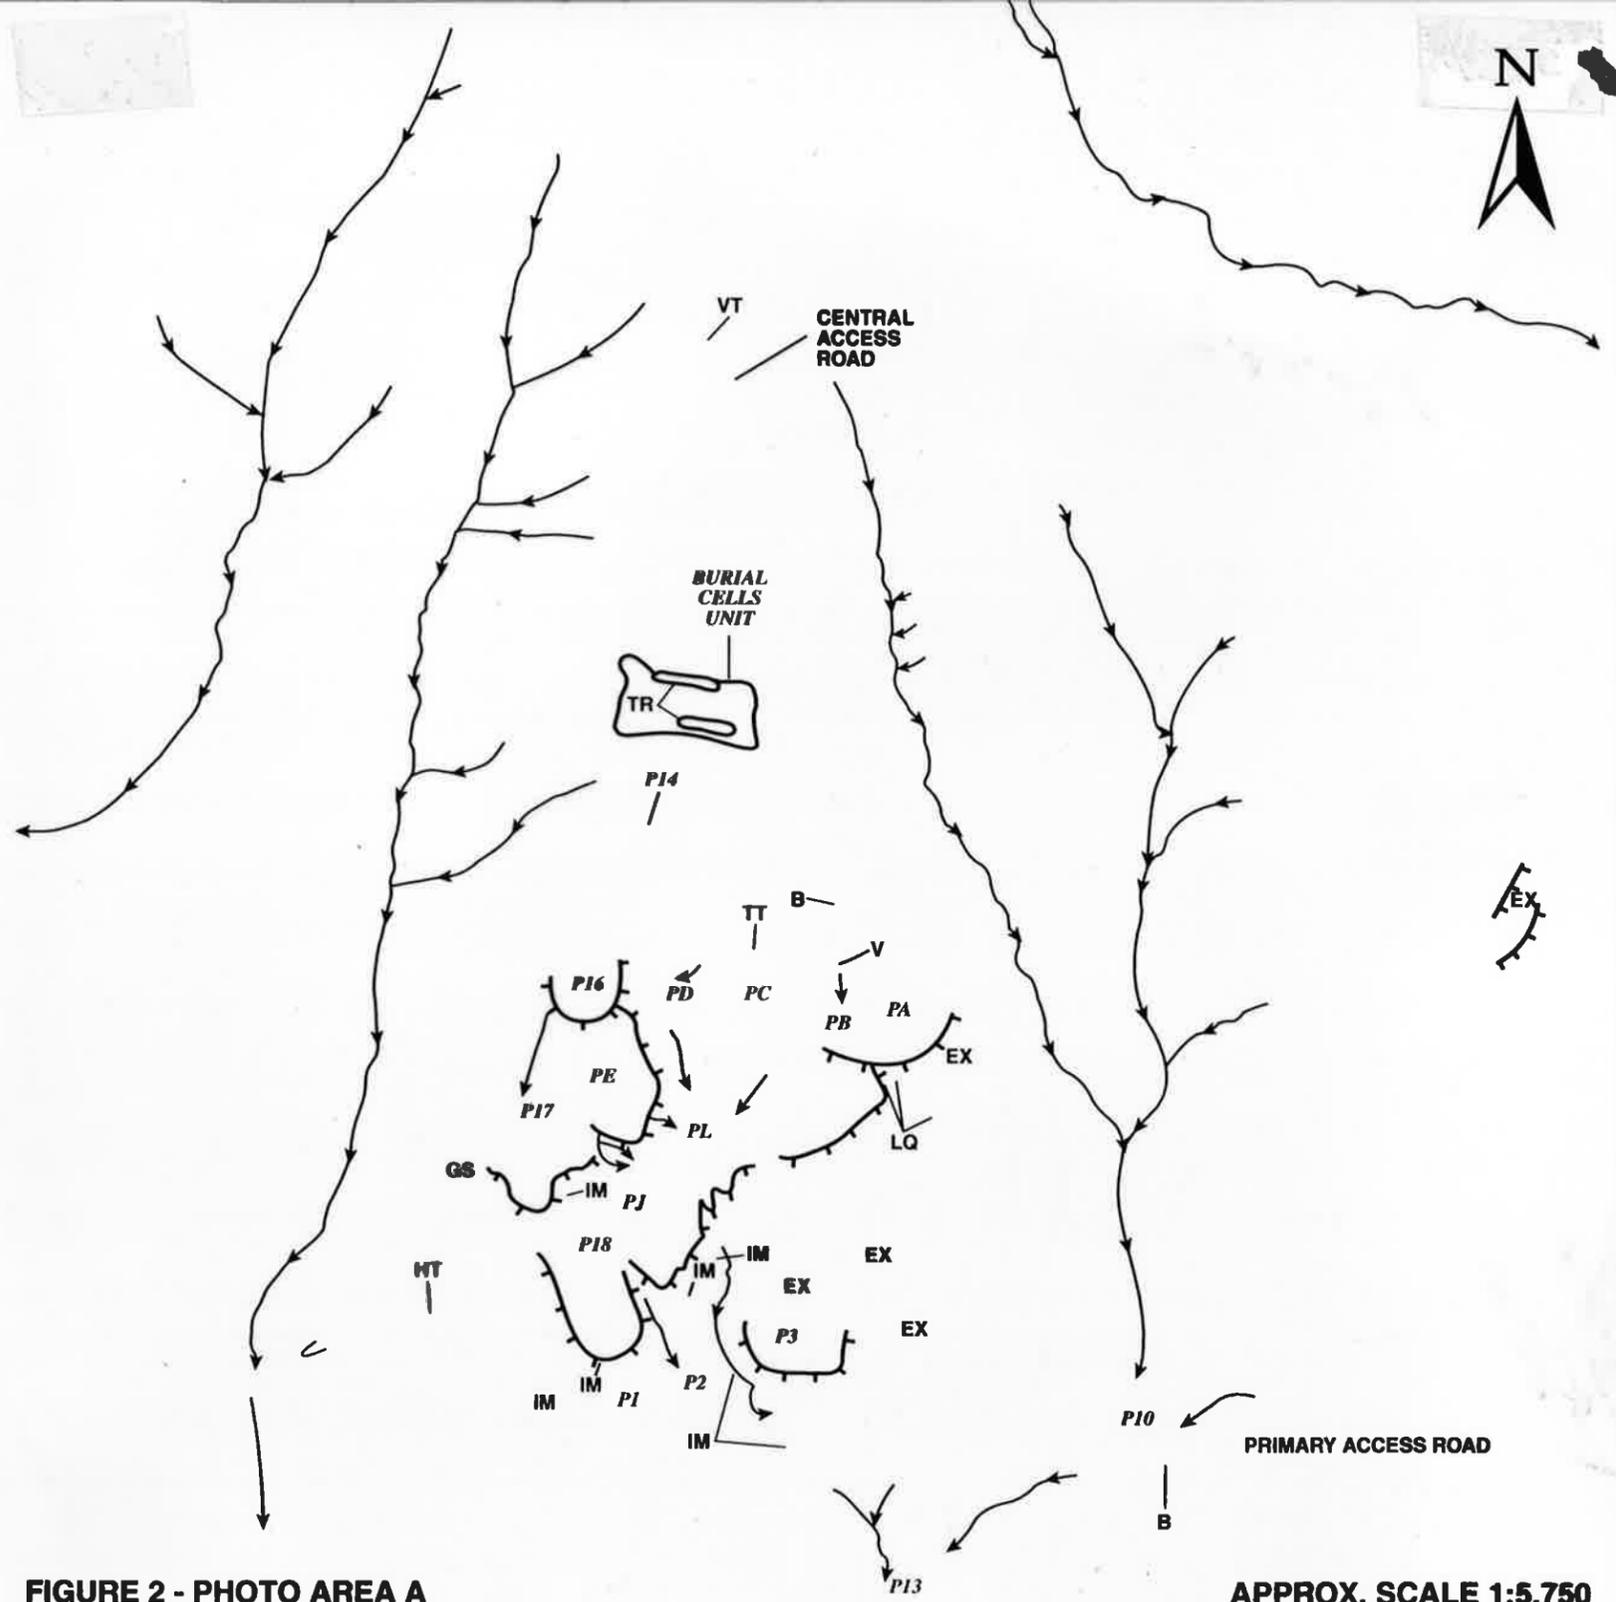
**FIGURE 2 - PHOTO AREA A
CASMALIA DISPOSAL SITE**

MAY 20, 1974 PHOTO AREA A (FIGURE 2)

The Casmalia Disposal Site is accessed by a road entering the southeastern edge of the site from Black Road (not annotated). This road will be referred to as the primary access road in this report.

Two buildings (B) are visible at the disposal site, one along the primary access road at the eastern entrance of the site, and one east of the central access road in the northern portion of the site.

A horizontal tank (HT) is seen in the southwestern portion of the site. An impoundment (IM) with light-toned material and liquid is seen southeast of the horizontal tank. North of the horizontal tank, a ground scar (GS) is visible along an access road. In the far northern portion of the site, a vertical tank (VT) is visible along the central access road. Several excavations (EX) are seen in the southeastern portion of the site. An excavated area is seen east of the disposal site along an access road. This excavation has created a leveled area.

Annotation	Description
<i>P1</i>	An excavation is visible. An impoundment is seen northwest of <i>P1</i> .
<i>P2</i>	Two ponds containing liquid are separated by a berm. A drainage channel containing liquid flows south into the northernmost pond. Liquid is impounded in a drainage channel, in three areas, in the eastern portion of <i>P2</i> . An impoundment is seen in a graded area north of <i>P2</i> .
<i>P3</i>	Liquid is visible in the pond.
<i>P10</i>	Liquid is visible in the pond. Drainage channels extend through <i>P10</i> from the north and exit to the southwest.

Annotation	Description
<i>P13</i>	Liquid is visible in the pond. Two drainage channels enter the pond from the north.
<i>P14</i>	The pond contains turbid liquid.
<i>P16</i>	The pond contains liquid and light-toned material.
<i>P17</i>	Liquid is visible in the pond. A drainage channel containing liquid extends from near <i>P16</i> to <i>P17</i> .
<i>P18</i>	Liquid is visible in an excavated area located within a larger graded area.
<i>PA</i>	Liquid is visible in the pond.
<i>PB</i>	The pond contains liquid along with light- and medium-toned material. Light- and medium-toned material is visible on a berm that forms the northern boundary of the pond. A vehicle (V), probably an earth-moving vehicle, is seen at the top of this berm. Liquid (LQ) is seen in drainage channels south of <i>PB</i> .
<i>PC</i>	A tanker truck (TT) is backed up to the berm that forms the northern boundary of the pond. Liquid is being released from a possible pipe on the top of the berm. Light- and medium-toned material, liquid, and staining are visible on the berm. Liquid, along with light- and medium-toned material, is visible in the pond.

<i>PD</i>	Liquid, as well as light- and medium-toned materials, are visible in the pond. The light-toned material appears to be partially graded.
<i>PE</i>	Liquid is visible in the pond.
<i>PJ</i>	The pond contains liquid. A drainage channel leads to the pond from the north. Light- and medium-toned material is visible in the eastern portion of the pond. This material probably enters the pond through a pipe visible in the northeastern corner of the pond.
<i>PL</i>	This pond appears to be receiving liquid via drainage channels that extend from <i>PC</i> and <i>PD</i> , and possibly from <i>PE</i> .
BURIAL CELLS UNIT	Two trenches (TR) are visible in this location. The southern trench contains liquid.

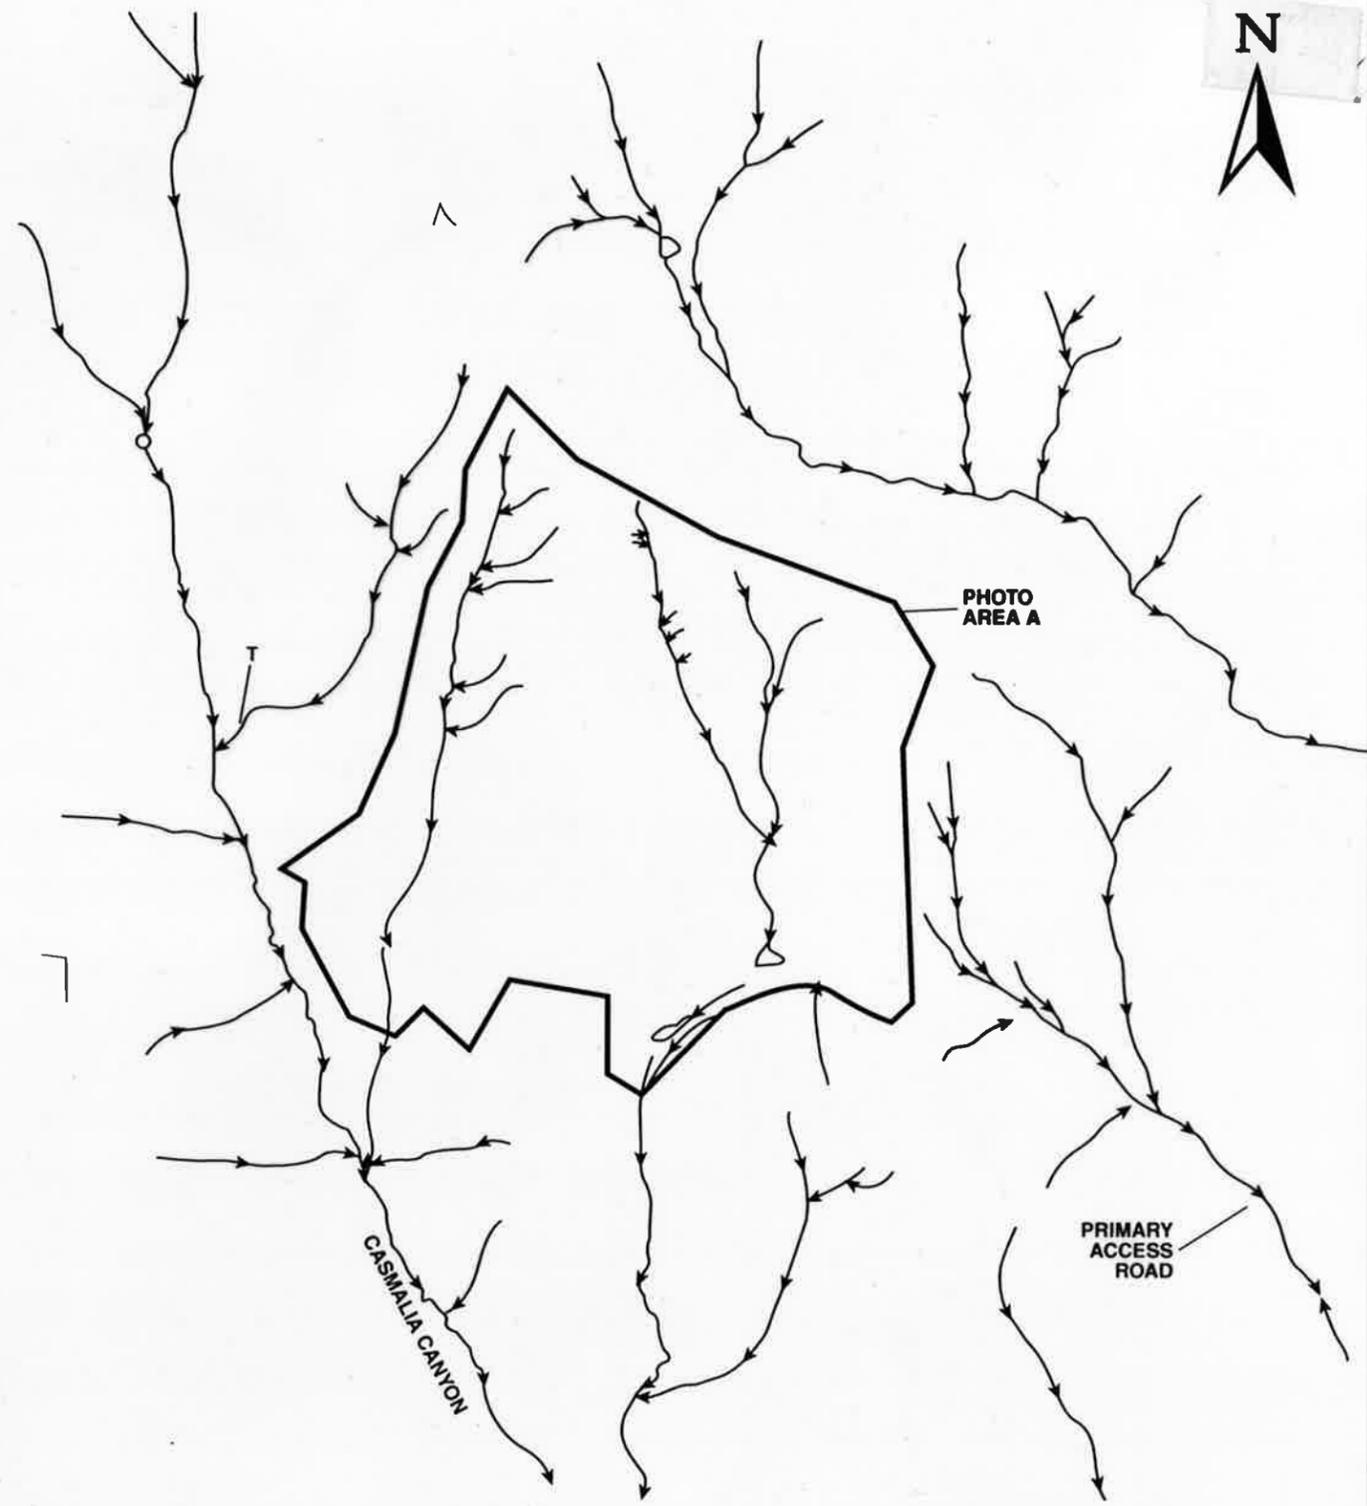
**FIGURE 3 - PHOTO AREA B
CASMALIA DISPOSAL SITE**

MAY 20, 1974 PHOTO AREA B (FIGURE 3)

The land in Photo Area B is primarily being used for livestock grazing. Agricultural fields are visible south of the disposal site (Photo Area A). A tank (T), possibly used for water storage, is visible west of the disposal area. Drainage from the disposal site flows to the south through Photo Area B. Drainage from Photo Area B flows into Casmalia Canyon, located to the west of the disposal site, and into Shuman Canyon (not seen), located to the south and east of the disposal site.

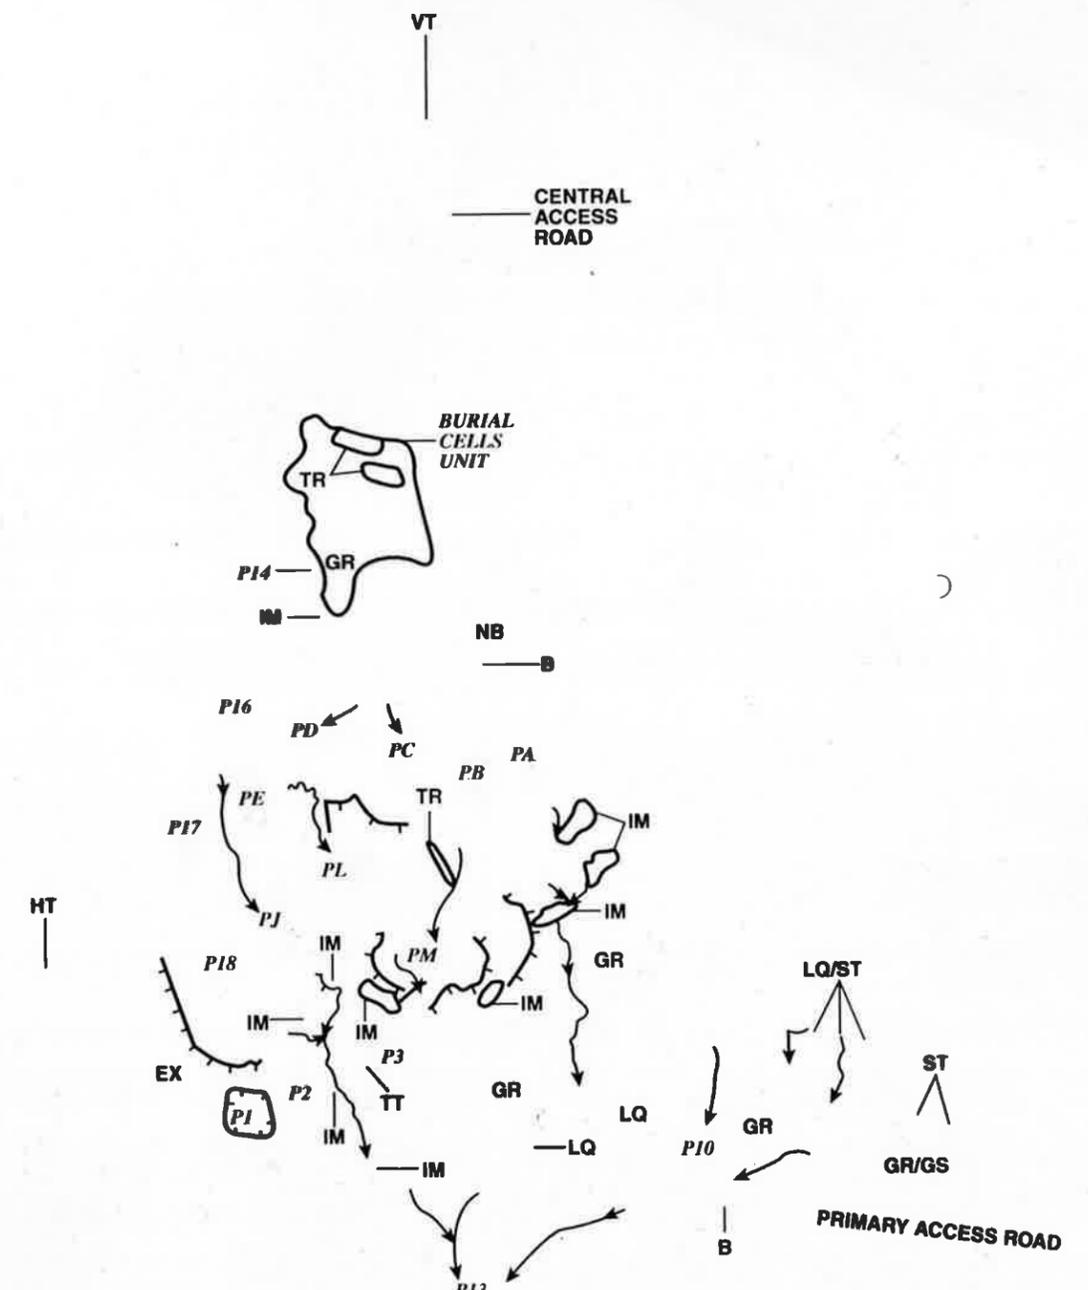
FIGURE 4 - PHOTO AREA A
CASMALIA DISPOSAL SITE

JUNE 18, 1975 PHOTO AREA A (FIGURE 4)

A horizontal tank remains visible in the southwestern portion of the site. An excavation is visible southeast of the horizontal tank along the primary access road. Liquid is visible in an impoundment south of *P14*. One new building (NB) is visible in the northern portion of the site, east of the central access road. Three impoundments with liquid and light- and medium colored material are seen south of *PA*. The impoundments are connected by drainage channels and descend in elevation to the south. A drainage channel enters the northernmost impoundment from a location near *PA*. A drainage channel extends south from the southernmost of these impoundments. Liquid has collected in several places in the southeastern portion of the site. To the east, liquid and staining (ST) are visible south of an access road. A linear area adjacent to this access road, and extending to the primary access road, is also stained. Grading (GR) and ground scars are visible south of the most concentrated area of staining.

Annotation	Description
<i>P1</i>	An excavation remains visible. An impoundment with liquid is seen northwest of <i>P1</i> .
<i>P2</i>	Two ponds containing liquid and separated by a berm remain visible. Turbid liquid is seen in the northern pond. Light-colored fill material and a small amount of liquid are seen in the southern pond. Liquid is impounded in a drainage channel in three areas in the eastern portion of the <i>P2</i> .
<i>P3</i>	The pond contains liquid. A tanker truck is seen backed up to the southwestern portion of the pond. Liquid emanating from the rear of the truck is discharging into the pond.
<i>P10</i>	Liquid is visible in the pond. Drainage channels extend through <i>P10</i> from the north and exit to the southeast.
<i>P13</i>	Liquid is visible in the pond. Drainage channels extend to the pond from the north.

Annotation	Description
<i>P14</i>	Liquid is visible in the pond.
<i>P16</i>	Light- and dark-colored material and liquid are visible in the pond. The northern berm is covered with light- and dark-colored material and staining.
<i>P18</i>	Liquid is visible in an excavated area located within a larger graded area.
<i>PA</i>	Liquid is visible in the pond. Light-colored mounded material is visible in the northwestern portion of the pond.
<i>PB</i>	Liquid is visible in the pond. Staining and dark-colored material are visible on the northern berm of the pond.
<i>PC</i>	Multi-colored material and liquid are visible in the pond. Dark-colored material and staining are visible on the northwestern berm of the pond.
<i>PD</i>	Liquid is visible in the pond. Dark-colored material and staining are visible on the northeastern berm of the pond. Dark-colored mounded material and staining are visible in the pond at the bottom of the berm.

<i>PE</i>	Liquid is visible in the pond.
<i>PJ</i>	Liquid is visible in the pond. A drainage channel extends to the pond from the north.
<i>PL</i>	Liquid is visible in the pond. A drainage channel extends to the pond from the northwest.
<i>PM</i>	A pond containing liquid is bermed and separated from a larger bermed area that contains liquid and multi-colored mounded material. A breach is present in the lower bermed area, allowing liquid to drain to an impoundment to the south. The area south of the pond also contains light-colored mounded material. An additional impoundment containing liquid is seen southeast of <i>PM</i> .
BURIAL CELLS UNIT	Two empty trenches and light-colored graded material are visible at the <i>Burial Cells Unit</i> .

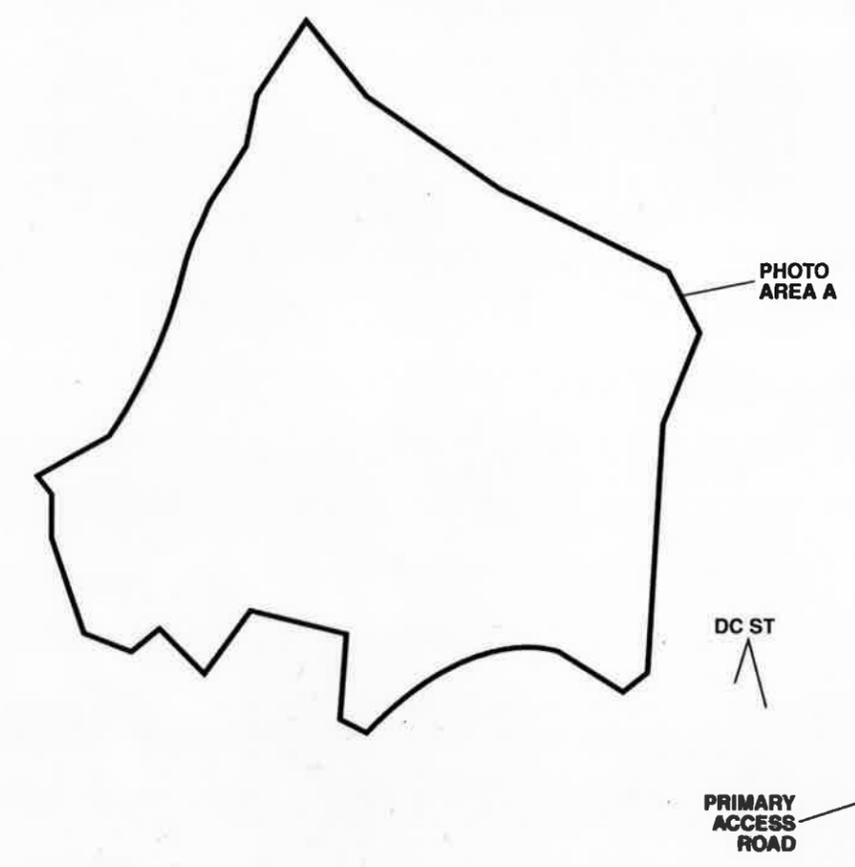
**FIGURE 5 - PHOTO AREA B
CASMALIA DISPOSAL SITE**

JUNE 18, 1975 PHOTO AREA B (FIGURE 5)

Dark-colored (DC) staining is visible on the eastern portion of the primary access road.

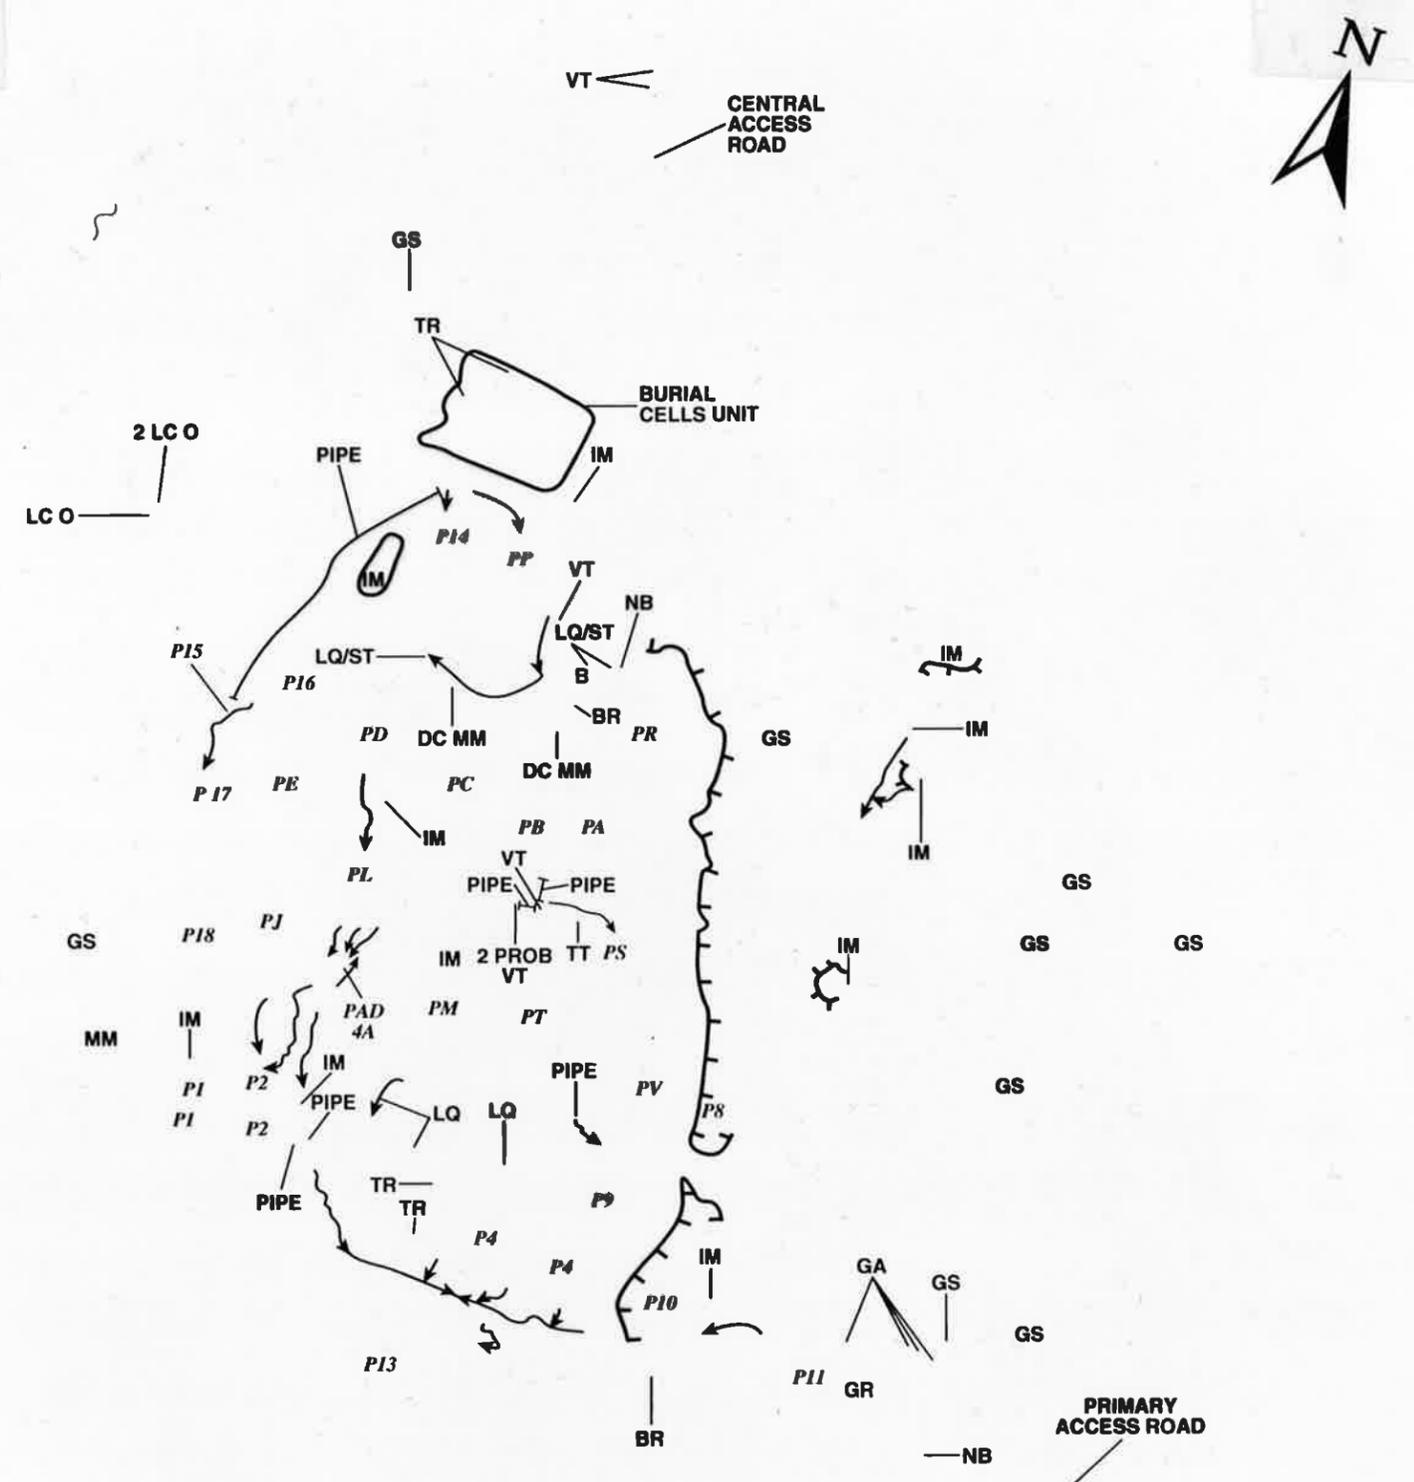
**FIGURE 6 - PHOTO AREA A
CASMALIA DISPOSAL SITE**

MARCH 14, 1978 PHOTO AREA A (FIGURE 6)

A ground scar is seen west of *P18*. Three light-colored (LC) objects (O) are seen west of the *Burial Cells Unit*. These objects are seen adjacent to a drainage channel and may be related to natural gas or petroleum extraction. North of the *Burial Cells Unit*, two vertical tanks are visible. A ground scar is visible northwest of the *Burial Cells Unit*. An impoundment with turbid brown liquid is visible southeast of the *Burial Cells Unit*. Further to the south, a vertical tank is seen. A new building is seen in the central portion of the site, north of *PR*. A building has also been removed (BR) from this vicinity. Liquid and staining are seen adjacent to a building south of the vertical tank. The liquid and staining are also visible on an access road that leads away from the building and around *PR*. An access road and ground scars are visible in a field east of *PR*. Several other ground scars are visible near this access road farther to the east of the disposal site. A drainage channel, impounded in four locations upstream, flows into *P8*. East of *P11*, graded dark-colored material is visible adjacent to the south side of an access road. Four graders (GA) are seen in this area. Dark-colored material has been graded and mounded near *P11*. An impoundment with turbid brown liquid is seen east of *P10*. In the south central portion of the site, north of *P13*, two trenches filled with liquid are visible. Orange liquid is seen in several areas north and east of the trenches.

Annotation	Description
<i>P1</i>	Two ponds and an impoundment adjacent to <i>P18</i> are visible. The northern pond contains liquid; the southern pond contains turbid liquid. The impoundment also contains liquid.
<i>P2</i>	Two ponds are visible in this location. Drainage channels flow into the northern pond. Drainage also flows into an impounded area on the eastern side of <i>P2</i> . Two pipes extending from the southern pond and a pipe extending from the impoundment discharge into nearby drainage channels. The drainage channels extend southeast from this point.

Annotation	Description
<i>P4</i>	Liquid is visible in two ponds.
<i>P8</i>	Liquid is visible in the pond. Drainage channels from the north extend into <i>P8</i> .
<i>P9</i>	Liquid is visible in the pond. Graded light-colored mounded material forms the southern berm of <i>P9</i> . A pipe extending from near <i>PV</i> discharges into a drainage channel that connects to <i>P9</i> .
<i>P10</i>	The pond contains liquid. <i>P10</i> is probably connected via a pipeline to <i>P8</i> that is located beneath a fill area constructed for an access road.
<i>P11</i>	Turbid dark-colored liquid is visible in the pond. Graded dark-colored material makes up the eastern berm of the pond. Graded medium-colored material makes up the western boundary of the pond.
<i>P13</i>	The pond contains liquid. Drainage channels, originating near pipes from <i>P2</i> , drain into <i>P13</i> . Drainage channels from <i>P4</i> , an impoundment near <i>P2</i> , and trenches east of <i>P4</i> also drain into <i>P13</i> .

<i>P14</i>	The pond contains liquid. Liquid is seen entering the northwestern corner of the pond via a pipe.
<i>P15</i>	The pond contains liquid along with light- and medium-colored material. The light-colored material is concentrated in the center of the pond near the end of a pipe extending from the northeastern corner of the pond. A drainage channel extends from <i>P15</i> to <i>P17</i> . Liquid, along with light- and dark-colored material, is visible in this drainage channel.
<i>P16</i>	The pond contains liquid mixed with light- and dark-colored mounded material. Staining is visible on the northern berm of the pond, in a location that serves as a discharge point to the pond.
<i>P17</i>	<i>P17</i> contains liquid and is connected to <i>P15</i> by a drainage channel. Liquid is also entering the pond through a possible pipe at the southeastern edge of the berm of the pond.
<i>P18</i>	The pond contains liquid.

Annotation	Description
<i>PAD 4A</i>	<i>Pad 4A</i> is mostly vegetated. Drainage channels extend south through this area and discharge into <i>P2</i> and an impoundment in the eastern portion of <i>P2</i> .
<i>PA</i>	Liquid is visible in the pond. Liquid, dark-colored material, and staining are visible on the northern berm of the pond.
<i>PB</i>	Liquid is visible in the pond. Dark-colored material and staining are visible on the northern berm of the pond. Light-colored material is seen on the surface of the southern portion of the pond (possibly floating).
<i>PC</i>	Liquid is visible in the pond. Dark-colored material and staining are visible on the northwestern berm of the pond. Light-colored material is seen on the surface of the southern portion of the pond (possibly floating).
<i>PD</i>	Turbid dark-colored liquid is visible in the pond. Multi-colored material is seen on the northeastern berm of the pond from a location used for discharging into the pond. The material is collected in a mound at the bottom of the berm.

<i>PE</i>	Liquid is visible in the pond. Liquid is seen entering the pond through a possible pipe on the eastern berm.
<i>PJ</i>	Liquid is visible in the pond. A pipe enters this site from the east.
<i>PL</i>	The pond contains liquid. A drainage channel extends from <i>PD</i> to this pond. Light-colored material has collected at the point where this drainage enters the pond. An impoundment containing liquid is visible north of the pond.
<i>PM</i>	Liquid is visible in the pond.
<i>PP</i>	The pond contains liquid. Liquid is also visible entering the pond in the northwestern corner from a probable pipe. The pipe extends westward to <i>PI4</i> and then southwestward to <i>P15</i> .
<i>PR</i>	The pond contains liquid, some of which is turbid. Medium-colored material is visible on the western berm. Dark-colored mounded material (MM) is seen west and south of the pond.

Annotation	Description
<i>PS</i>	Liquid is visible in the pond. A drainage channel is seen entering the pond from the northeast. This drainage channel extends from the vicinity of a vertical tank located to the west. The vertical tank is connected to a pipe that enters the ground just south of <i>PB</i> . A wider pipe connects this vertical tank to two more probable vertical tanks to the west. A light-blue tanker truck surrounded by liquid or staining is seen northwest of <i>PS</i> .
<i>PT</i>	Liquid is visible in the pond.
<i>PV</i>	Liquid is seen in the pond. A pipe is visible near the southwestern corner of this pond. The pipe connects to a drainage channel that is impounded prior to discharging into <i>P9</i> .
<i>BURIAL CELLS UNIT</i>	Two trenches are visible in the <i>Burial Cells Unit</i> . The trenches are partially backfilled and contain liquid.

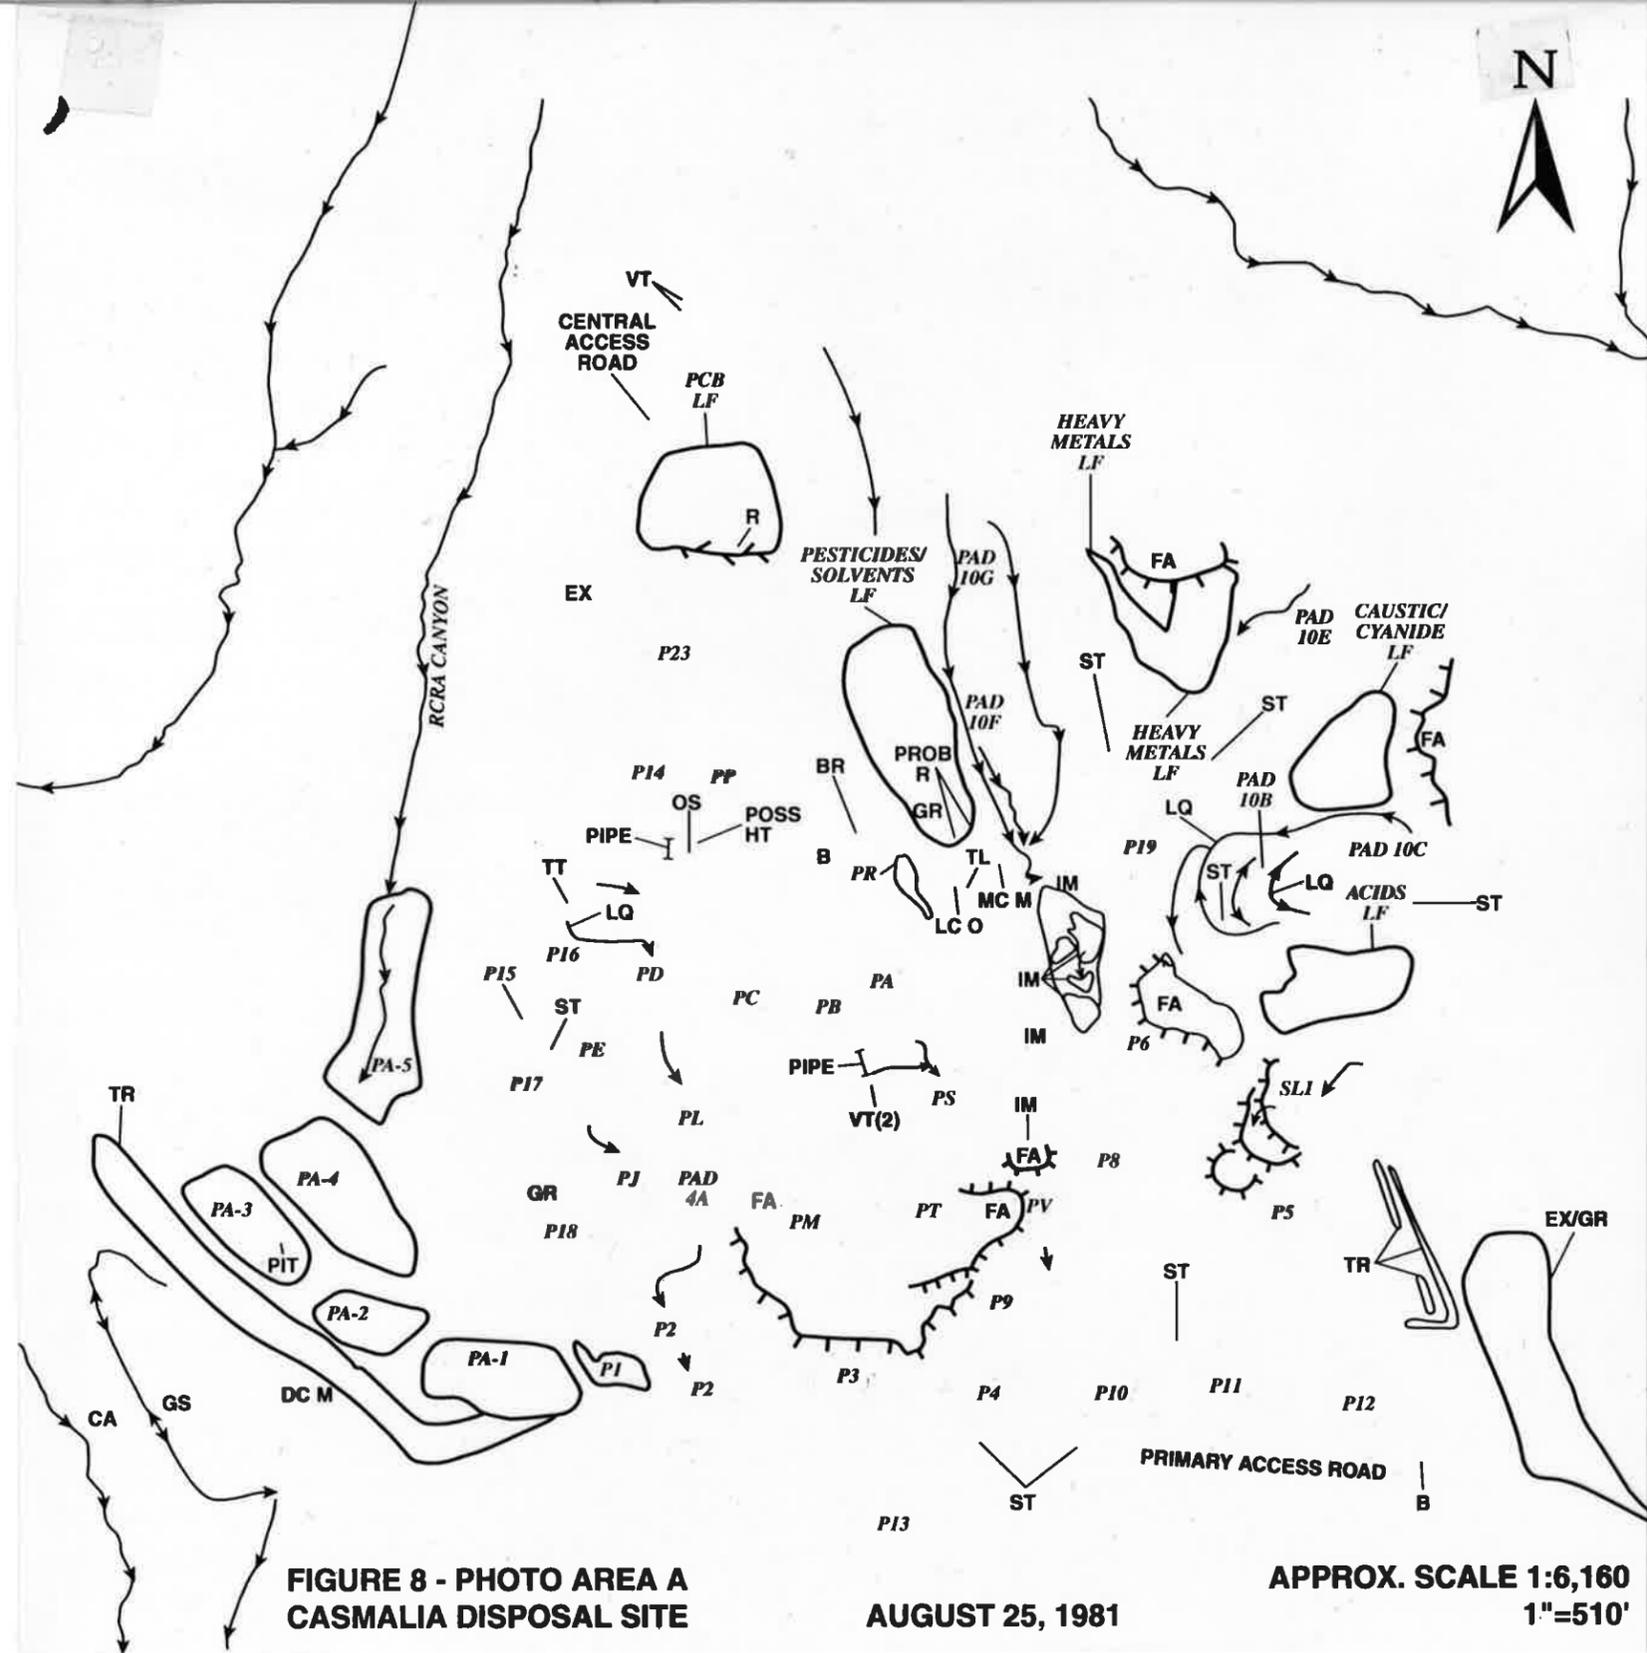
**FIGURE 8 - PHOTO AREA A
CASMALIA DISPOSAL SITE**

AUGUST 25, 1981 PHOTO AREA A (FIGURE 8)

In the southwestern corner of the site, a large trench is visible south of ponds *PA-1* through *PA-5*. Dark-colored material is visible on the surface of a graded fill area adjacent to the southwestern edge of the trench. Ground scars and a cleared area (CA) are also visible in this vicinity.

An excavation is visible west of *P23*. South of *P14*, open storage (OS) of possible pipes is visible. A probable horizontal tank is also visible in this area. To the east of the open storage area a building, seen in 1978, has been removed. East of *PR*, a trailer truck (TL) is backed up to a pad with three light-colored objects. A linear area of medium-colored (MC) material (M) is seen south of the *Pesticides and Solvents Landfill* (LF). Portions of an access road south of *Pad 10C* and surrounding *P19* are heavily stained. Staining is also visible on the primary access road and on an access road that branches from it between *P10* and *P11*. An impoundment containing liquid is visible north of *PV*. An additional impoundment is visible farther to the north. In the southeastern portion of the site, three empty trenches are visible. An excavated and graded area is visible east of the trenches.

Annotation	Description
<i>P1</i>	One empty pond is visible.
<i>P2</i>	The pond contains liquid. A drainage channel with liquid extends from <i>Pad 4A</i> into the northern end of <i>P2</i> . Both portions of <i>P2</i> are connected.
<i>P3</i>	Liquid is visible in the pond.
<i>P4</i>	Turbid liquid is visible in the pond.
<i>P5</i>	Liquid is visible in the pond.

Annotation	Description
<i>P6</i>	Turbid dark-colored liquid is visible in the pond. A fill area (FA) is visible northeast of the pond. West of the pond, an impoundment that contains light- and medium-colored mounded material is visible. Impounded areas of liquid are also visible interspersed with the material.
<i>P8</i>	Liquid is visible in the pond.
<i>P9</i>	The majority of the pond contains light-colored turbid liquid. A probable outfall from a pipe is visible in the eastern portion of the pond.
<i>P10</i>	Liquid is visible in the pond.
<i>P11</i>	Liquid is visible in the pond.
<i>P12</i>	Liquid is visible in the pond.
<i>P13</i>	Liquid is visible in the pond. An access road leads to the western edge of the pond.
<i>P14</i>	Slightly turbid liquid is visible in the pond.
<i>P15</i>	The pond contains a small amount of liquid. A probable pipe is visible in the eastern berm of the pond.
<i>P16</i>	The pond contains light-, medium-, and brown-colored sludge and a small amount of liquid. A tanker truck is backed up to the northern edge of the pond. A drainage channel extends from the back of the tanker truck through the material in <i>P16</i> and continues into <i>PD</i> .

<i>P17</i>	Liquid is visible in the pond.
<i>P18</i>	Light-colored graded material and a small area of liquid are visible in the pond.
<i>P19</i>	Liquid is visible in the pond.
<i>P23</i>	An excavation is visible in this location.
<i>PA-1</i>	A small amount of turbid liquid is visible in the pond.

Annotation	Description
<i>PA-2</i>	A graded area is visible in this location.
<i>PA-3</i>	A graded area and a pit are visible in this location.
<i>PA-4</i>	An empty pond is visible.
<i>PA-5</i>	A drainage channel, ground scars, and fill areas are visible within <i>PA-5</i> .
<i>PA</i>	Liquid is visible in the pond. Liquid is also being released onto the northern berm of the pond from a pipe. Liquid, dark-colored material, and staining are visible on the berm.
<i>PB</i>	Liquid is visible in the pond. Liquid is being released onto the northern berm of the pond from a pipe. Liquid, dark-colored material, and staining are visible on the berm. The berm between <i>PA</i> and <i>PB</i> is narrowed and stained at the southern end.
<i>PC</i>	Liquid is visible in the pond. Liquid is also being released onto the northern berm of the pond from a pipe. Liquid, dark-colored material, and staining are visible on the berm.

<i>PD</i>	Light-colored sludge is visible in the eastern portion of the pond and on the eastern berm of the pond. Liquid is visible in the western portion of the pond. A drainage channel containing liquid extends from <i>P16</i> into the western portion of <i>PD</i> .
<i>PE</i>	Liquid is visible in the pond.
<i>PJ</i>	Liquid is visible in the pond. A drainage channel enters the pond from the north.
<i>PL</i>	Liquid is visible in the pond. A drainage channel extends from <i>PD</i> to <i>PL</i> . Light-colored material is visible where the drainage channel enters <i>PL</i> .
<i>PM</i>	Turbid liquid with an oily sheen is visible in the pond. A graded fill area is seen along the western berm of the pond and extends into the pond.

Annotation	Description
<i>PP</i>	Liquid is visible in the pond.
<i>PR</i>	Liquid and dark colored material are visible in the pond.
<i>PS</i>	Liquid is visible in the pond. A drainage channel extends from an outfall, most likely originating from <i>PA</i> , and discharges into <i>PS</i> . Liquid and staining are visible around this outfall. Two vertical tanks are visible to the northwest. A pipe connects <i>PB</i> to one of the vertical tanks and to a nearby drainage channel. This drainage channel also extends into <i>P9</i> .
<i>PV</i>	Liquid is visible in the pond. A fill area with brown material extends into the western portion of the pond. A fill area with light-colored material extends into the northern portion of the pond. Liquid is visible in an impounded area, created by the aforementioned fill area.
<i>PAD 4A</i>	An impoundment containing dark-colored material and possible liquid is visible in this location.

<i>PAD 10B</i>	Drainage channels from <i>Pad 10C</i> are visible in this location.
<i>PAD 10C</i>	Liquid is visible on this spray area. Three drainage channels are visible in this vicinity. Liquid from the spray area has collected in two of these drainage channels.
<i>PAD 10E</i>	Liquid is visible in this spray area and within a drainage channel located to the west.
<i>PAD 10F</i>	Staining is visible in this spray area.
<i>PAD 10G</i>	Liquid and staining are visible in this spray area. Liquid is seen in drainage channels to the east and west.
<i>SLI</i>	Three impoundments are visible at descending elevations. Light-colored sludge is visible northeast of the impoundments at a probable discharge point. The two northernmost impoundments are visibly connected by an overflow drainage channel. All three impoundments contain light-colored slurry.

Annotation	Description
<i>PCB LF</i>	Refuse (R) is seen at a fill face in the southeastern portion of the landfill.
<i>PESTICIDES/ SOLVENTS LF</i>	Probable refuse is visible at a recently graded fill face in the southern portion of the landfill.
<i>HEAVY METALS LF</i>	A recently graded fill face is seen in the southern portion of the landfill. A fill area containing light-colored material is visible north of the landfill.
<i>CAUSTIC/ CYANIDE LF</i>	A fill area containing light-colored material is visible in the northern portion of the landfill. A fill area is also seen east of the landfill.
<i>ACIDS LF</i>	A recently graded fill face, containing light-colored material, is visible in the western portion of the landfill.

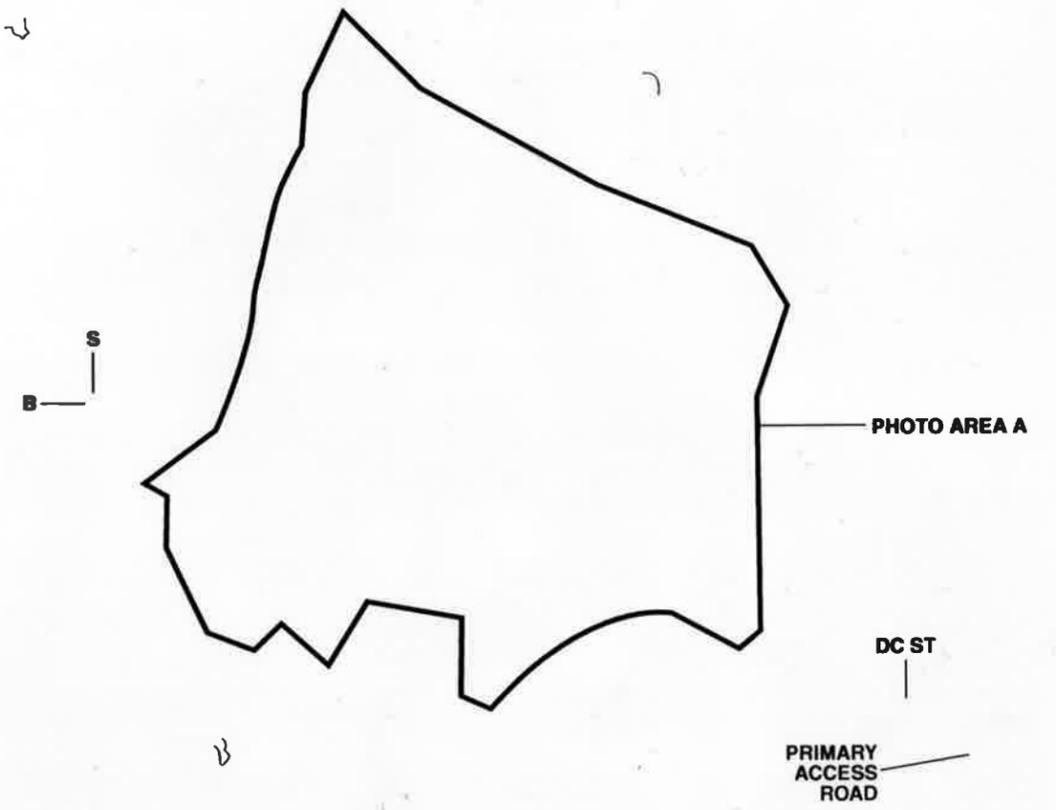
**FIGURE 9 - PHOTO AREA B
CASMALIA DISPOSAL SITE**

AUGUST 25, 1981 PHOTO AREA B (FIGURE 9)

A structure (S) and a building have been constructed adjacent to a dam (not annotated) west of the disposal site. Dark-colored staining is visible on the entire length of the primary access road.
