**AERIAL PHOTOGRAPHIC ANALYSIS
CASMALIA DISPOSAL SITE
CASMALIA, CALIFORNIA**

April 27, 2001

Prepared By: ERI

Contract No. 45791

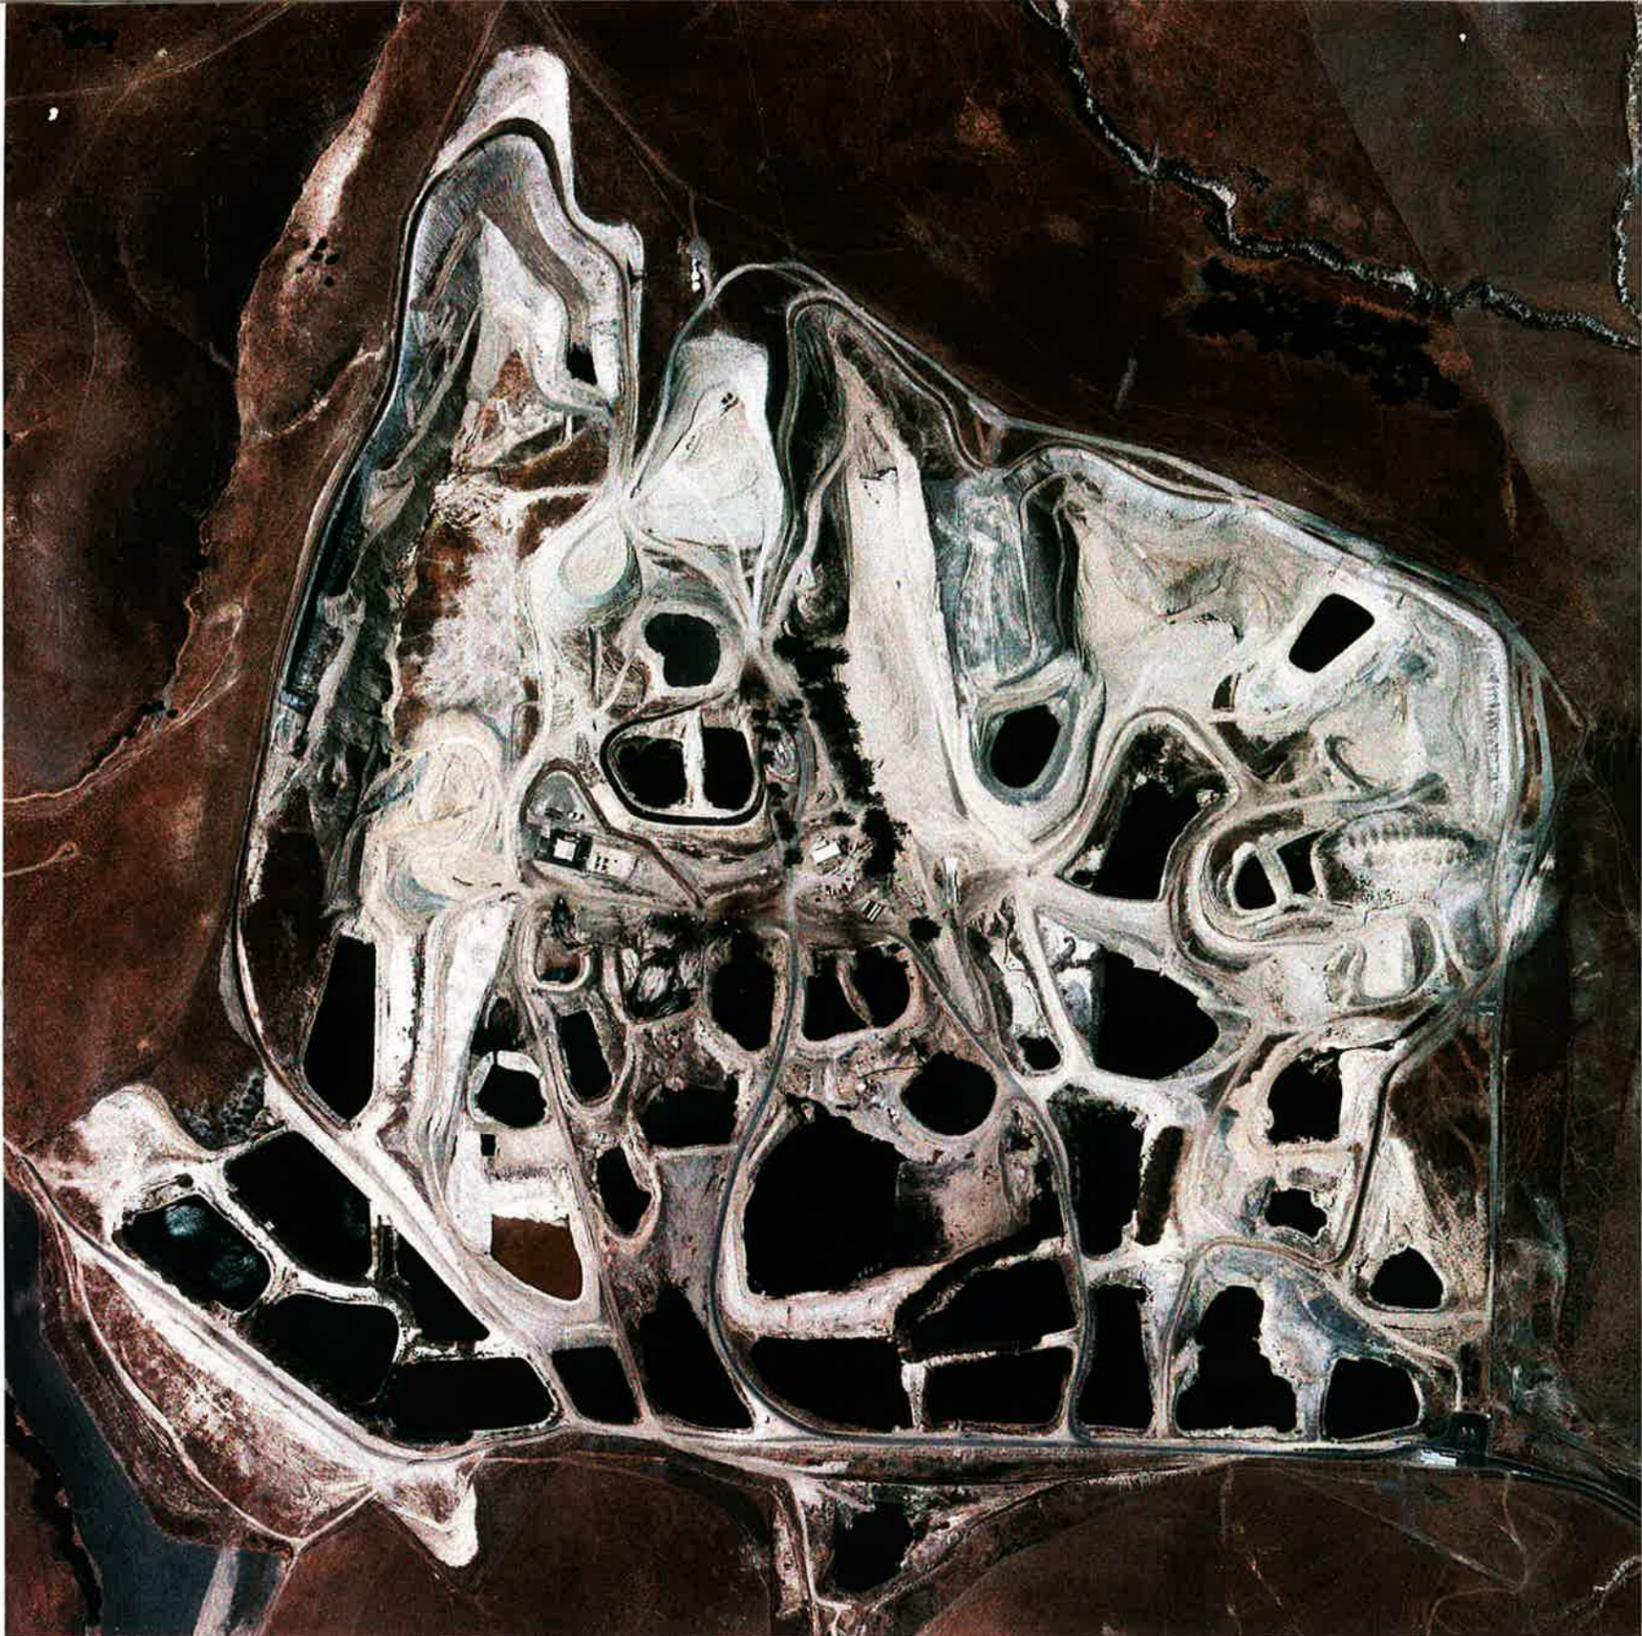
JULY 6, 1984 PHOTO AREA A (FIGURE 10)

Staining is visible surrounding six circular, evenly spaced areas north of *PA-4*. East of *RCRA Canyon*, a fill area is visible. An empty trench is seen to the south of the fill area. A vertical tank and a new building have been added where two vertical tanks were seen in the northwestern portion of the site in 1981. Southwest of *P14*, a new building and six vertical tanks are visible. Staining is visible east of a building near *PR*. Southeast of *PR*, an impoundment containing light-colored material and liquid is visible.

Annotation	Description
<i>P1</i>	Liquid is visible in the pond. A pipe connects this pond with <i>P18</i> .
<i>P2</i>	Liquid is visible in the pond.
<i>P3</i>	Liquid is visible in the pond. A drainage channel enters the pond from near <i>PM</i> .
<i>P4</i>	Liquid is visible in the pond.
<i>P5</i>	Liquid is visible in the pond.
<i>P6</i>	Liquid is visible in the pond. An impoundment located to the west contains light-colored material.
<i>P8</i>	Liquid is visible in the pond. Drainage from <i>Pad 7A</i> most likely enters this pond.
<i>P9</i>	Liquid is visible in the pond. Drainage channels extend south from <i>PV</i> and discharge into <i>P9</i> .
<i>P10</i>	Liquid is visible in the pond.
<i>P11</i>	Liquid is visible in the pond.
<i>P12</i>	Liquid is visible in the pond.
<i>P13</i>	Possible liquid is visible in the pond. An access road leads to the western edge of the pond from the northwest. A vehicle is seen at the terminus of the access road.

<i>P18</i>	Light-brown turbid liquid is visible in the pond. Three pipes are seen on the northern berm of <i>P18</i> . Light-colored mounded material is visible at the base of the northern berm. A pipe extending to the south connects this pond to <i>P1</i> .
<i>P19</i>	Liquid is visible in the pond.
<i>P20</i>	Liquid is visible in the pond.
<i>P22</i>	Liquid is visible in the pond. A drainage channel enters <i>P22</i> from <i>Pad 10F</i> and <i>Pad 10G</i> .
<i>P23</i>	Light-gray material is seen in the pond.
<i>PA-1</i>	Liquid is visible in the pond. Staining, visible on the western and southern berms of <i>PA-1</i> , indicates that discharges of liquid and material have likely occurred in these locations.
<i>PA-2</i>	Liquid is visible in the pond. Liquid is being sprayed into the pond adjacent to the southeastern and southwestern berms of <i>PA-2</i> .

Annotation	Description
<i>PA-3</i>	Liquid is visible in the pond. A pipe extends into the southern edge of the pond.
<i>PA-4</i>	Liquid is visible in the pond.
<i>PA-5</i>	Liquid is visible in the pond.
<i>PA-6</i>	Liquid is visible in the pond. A probable pipe or hose is visible along the southern berm of <i>PA-4</i> and <i>PA-6</i> .
<i>PA</i>	Liquid is visible in the pond. Dark-colored material, liquid, and staining are visible on the northern berm of this pond. The liquid appears to be emanating from a pipe in this location.
<i>PB</i>	Liquid is visible in the pond. Dark-colored material, liquid, and staining are visible on the northern berm of this pond. The liquid appears to emanate from a pipe in this location.
<i>PC</i>	Liquid and dark-colored mounded material are visible in the pond. Dark-colored material is seen inside the northern berm of the pond. A truck is backed up on top of the berm.

<i>PD</i>	Three trucks are seen backed up on top of the northern berm of <i>PD</i> . Liquid and staining, along with light- and dark-colored sludge, are seen on the top and the interior face of the berm.
<i>PE</i>	Turbid liquid is seen in the pond.
<i>PJ</i>	Liquid is visible in the pond. Probable light-colored material is seen adjacent to the northern berm of the pond beneath shallow liquid.
<i>PL</i>	Liquid is visible in the pond. A drainage channel extends from <i>PD</i> to <i>PL</i> . Light-colored material and sludge are visible in <i>PL</i> near the point of discharge of the drainage channel.
<i>PM</i>	Liquid is visible in the pond. Liquid is seen in a drainage channel entering at the northwestern corner of the pond.
<i>PP</i>	Liquid is visible in the pond.
<i>PR</i>	<i>PR</i> appears to be empty.

Annotation	Description
<i>PS</i>	Liquid is seen in the pond. Liquid and staining are visible in a drainage channel that extends to the northern portion of the pond from the vicinity of two vertical tanks to the west. A pipe possibly extends from one of these vertical tanks to <i>PB</i> . Orange liquid is seen on the southern berm of the pond.
<i>PT</i>	<i>PT</i> is currently under construction. Light-colored material is being graded to the west towards <i>PM</i> . Some of this material is inundated by liquid.
<i>PV</i>	Liquid is visible in the pond. An impoundment containing orange liquid is visible north of the pond. A drainage channel extends from this impoundment to <i>PV</i> .
<i>PAD 1A</i>	Staining is visible in this location adjacent to <i>PA-3</i> . This pad appears to drain into <i>PA-3</i> .
<i>PAD 4A</i>	A graded area is visible in this location.
<i>PAD 7A</i>	A spray area, currently in operation, drains into <i>P8</i> .

Annotation	Description
<i>PAD 18</i>	A fill area is visible in this location.
<i>SLI</i>	Liquid is visible in the pond. Sludge is visible at the terminus of a drainage channel extending into the pond from the northeast.
<i>RCRA LF</i>	An impoundment and a graded area are visible in the landfill.
<i>RCRA CANYON</i>	A linear stained area is located in the western side of the canyon. Flow-pattern staining leads from this area toward the bottom of the canyon. Three impoundments containing liquid are visible on the western side of the canyon. An additional impoundment containing liquid is visible on the canyon bottom just outside the <i>RCRA Canyon</i> boundary. A drainage channel extends to this impoundment from the north. An empty probable trench is visible east of the <i>RCRA Canyon</i> .
<i>PCB LF</i>	Approximately 30 drums (D) are visible at the northern fill face of the landfill. Probable liquid is visible north of the drums.

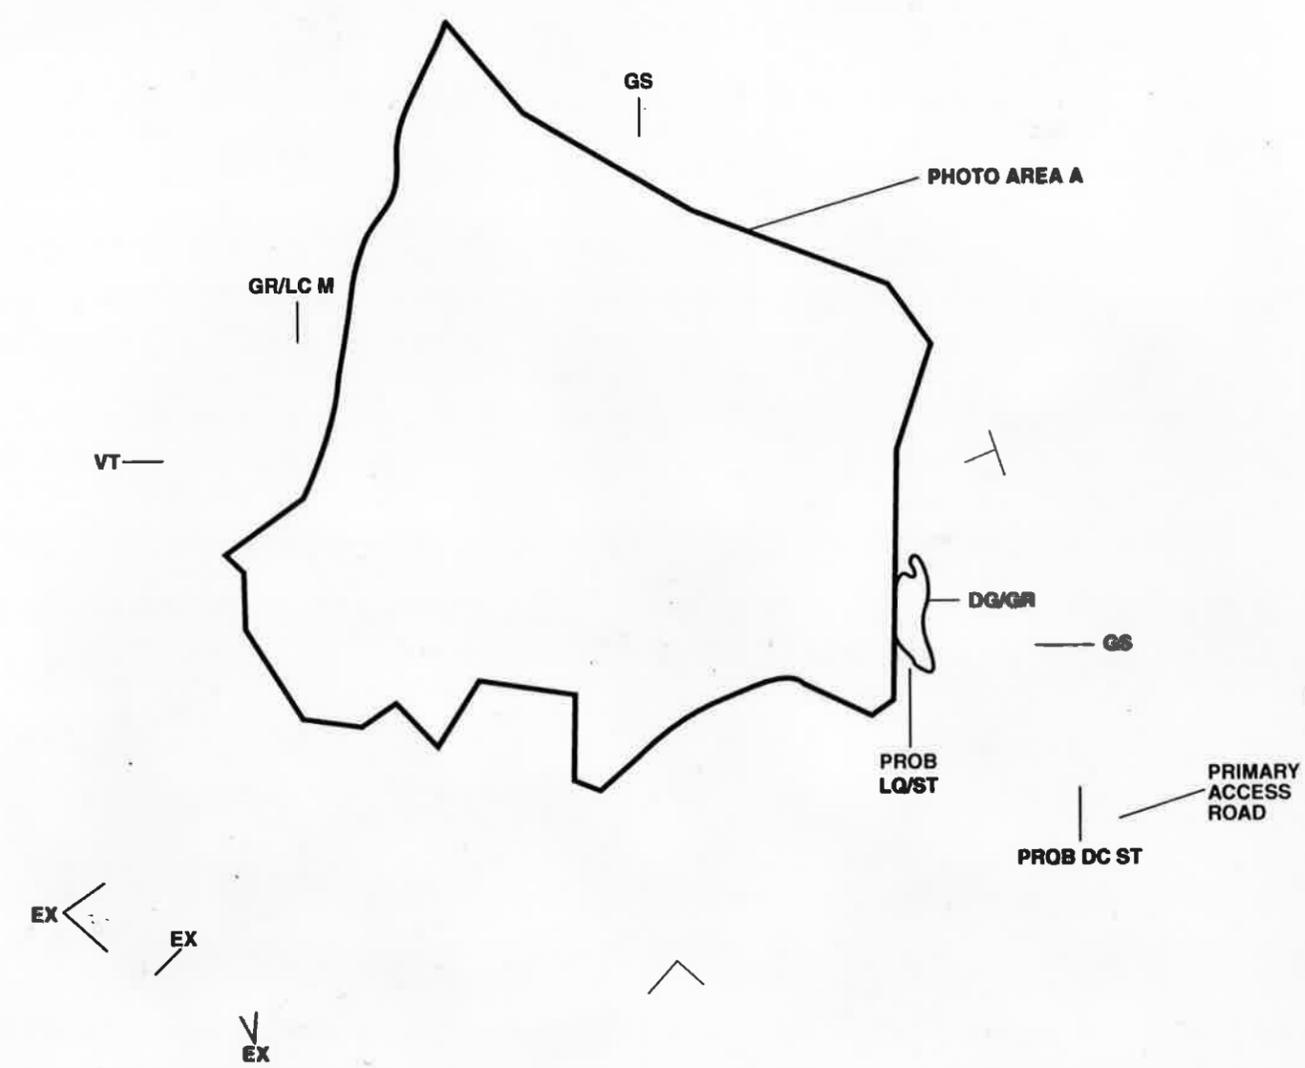
**FIGURE 11 - PHOTO AREA B
CASMALIA DISPOSAL SITE**

A vertical tank is visible west of the disposal site, where a building and structure were seen in 1981. A graded area with light-colored material is also visible west of the disposal site. A ground scar is located north of the disposal site. Probable liquid and/or staining are visible in the southern portion of a disturbed ground (DG) and graded area that extends from the eastern perimeter of the disposal site into Photo Area B. A ground scar is visible farther east of the disposal site. Probable dark-colored staining is visible on the entire length of the primary access road. Four excavations are seen southwest of the disposal site.

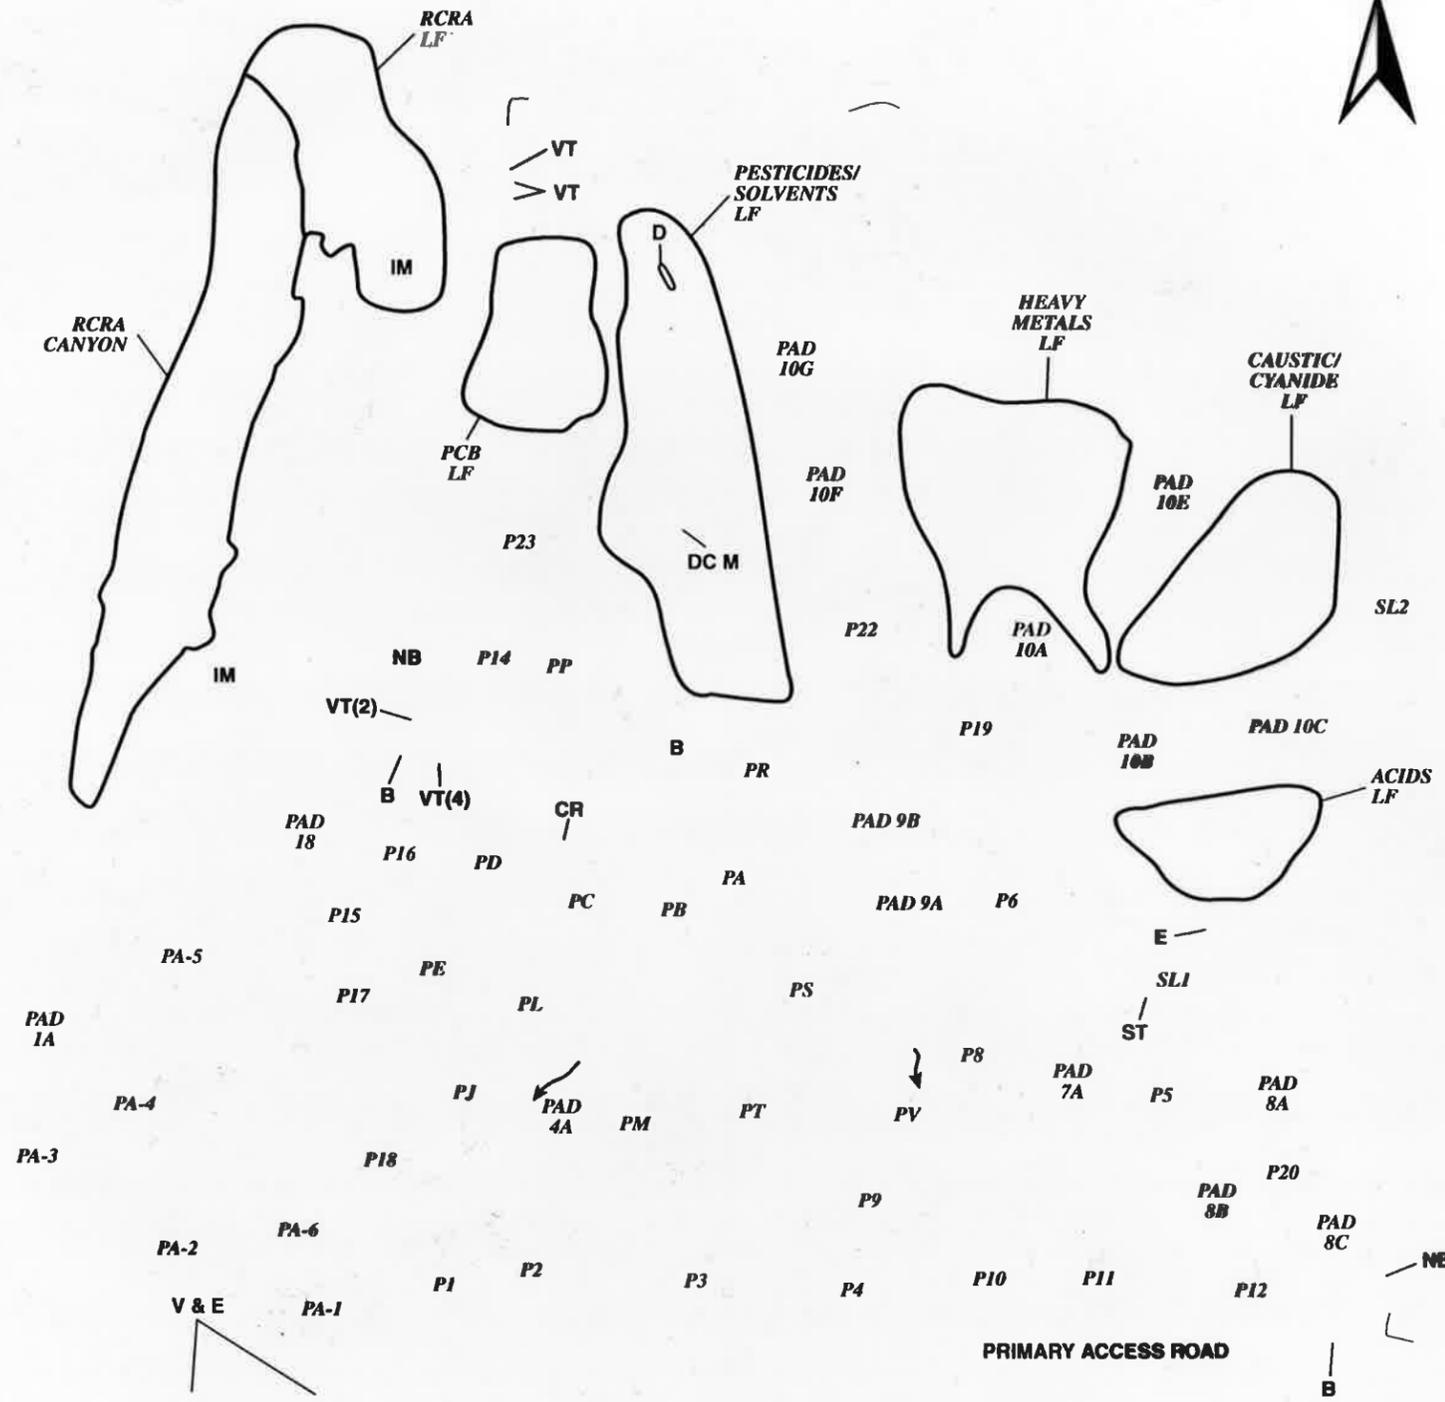
**FIGURE 12 - PHOTO AREA A
CASMALIA DISPOSAL SITE**

<i>PC</i>	Liquid is visible in the pond. Multi-colored material and staining are visible on the top and on the interior face of the northern berm. Dark-colored mounded material is also visible in the pond near the northern berm. A crane (CR) is visible on the edge of the berm.
<i>PD</i>	Light-colored sludge and a small amount of liquid are visible in the pond. A vehicle is seen at the northeastern berm near an area used for discharging into the pond.
<i>PE</i>	Liquid is visible in the pond. Light-colored material is visible in the northwestern portion of the pond.
<i>PJ</i>	Liquid is visible in the pond. Brown material mixed with liquid is visible in the northern portion of the pond.
<i>PL</i>	Light- and medium-colored sludge is visible in the pond.

<i>RCRA CANYON</i>	No activity is noted at this time.
<i>PCB LF</i>	Probable vegetation is visible on the surface of the <i>PCB Landfill</i> .
<i>PESTICIDES/ SOLVENTS LF</i>	Drums are visible near the fill face in the northern portion of the landfill. Dark-colored material is also visible near two trailer trucks in the southern portion of the landfill.
<i>HEAVY METALS LF</i>	A vehicle is visible at the landfill.
<i>CAUSTIC CYANIDE LF</i>	No activity is noted at this time.
<i>ACIDS LF</i>	No activity is noted at this time.

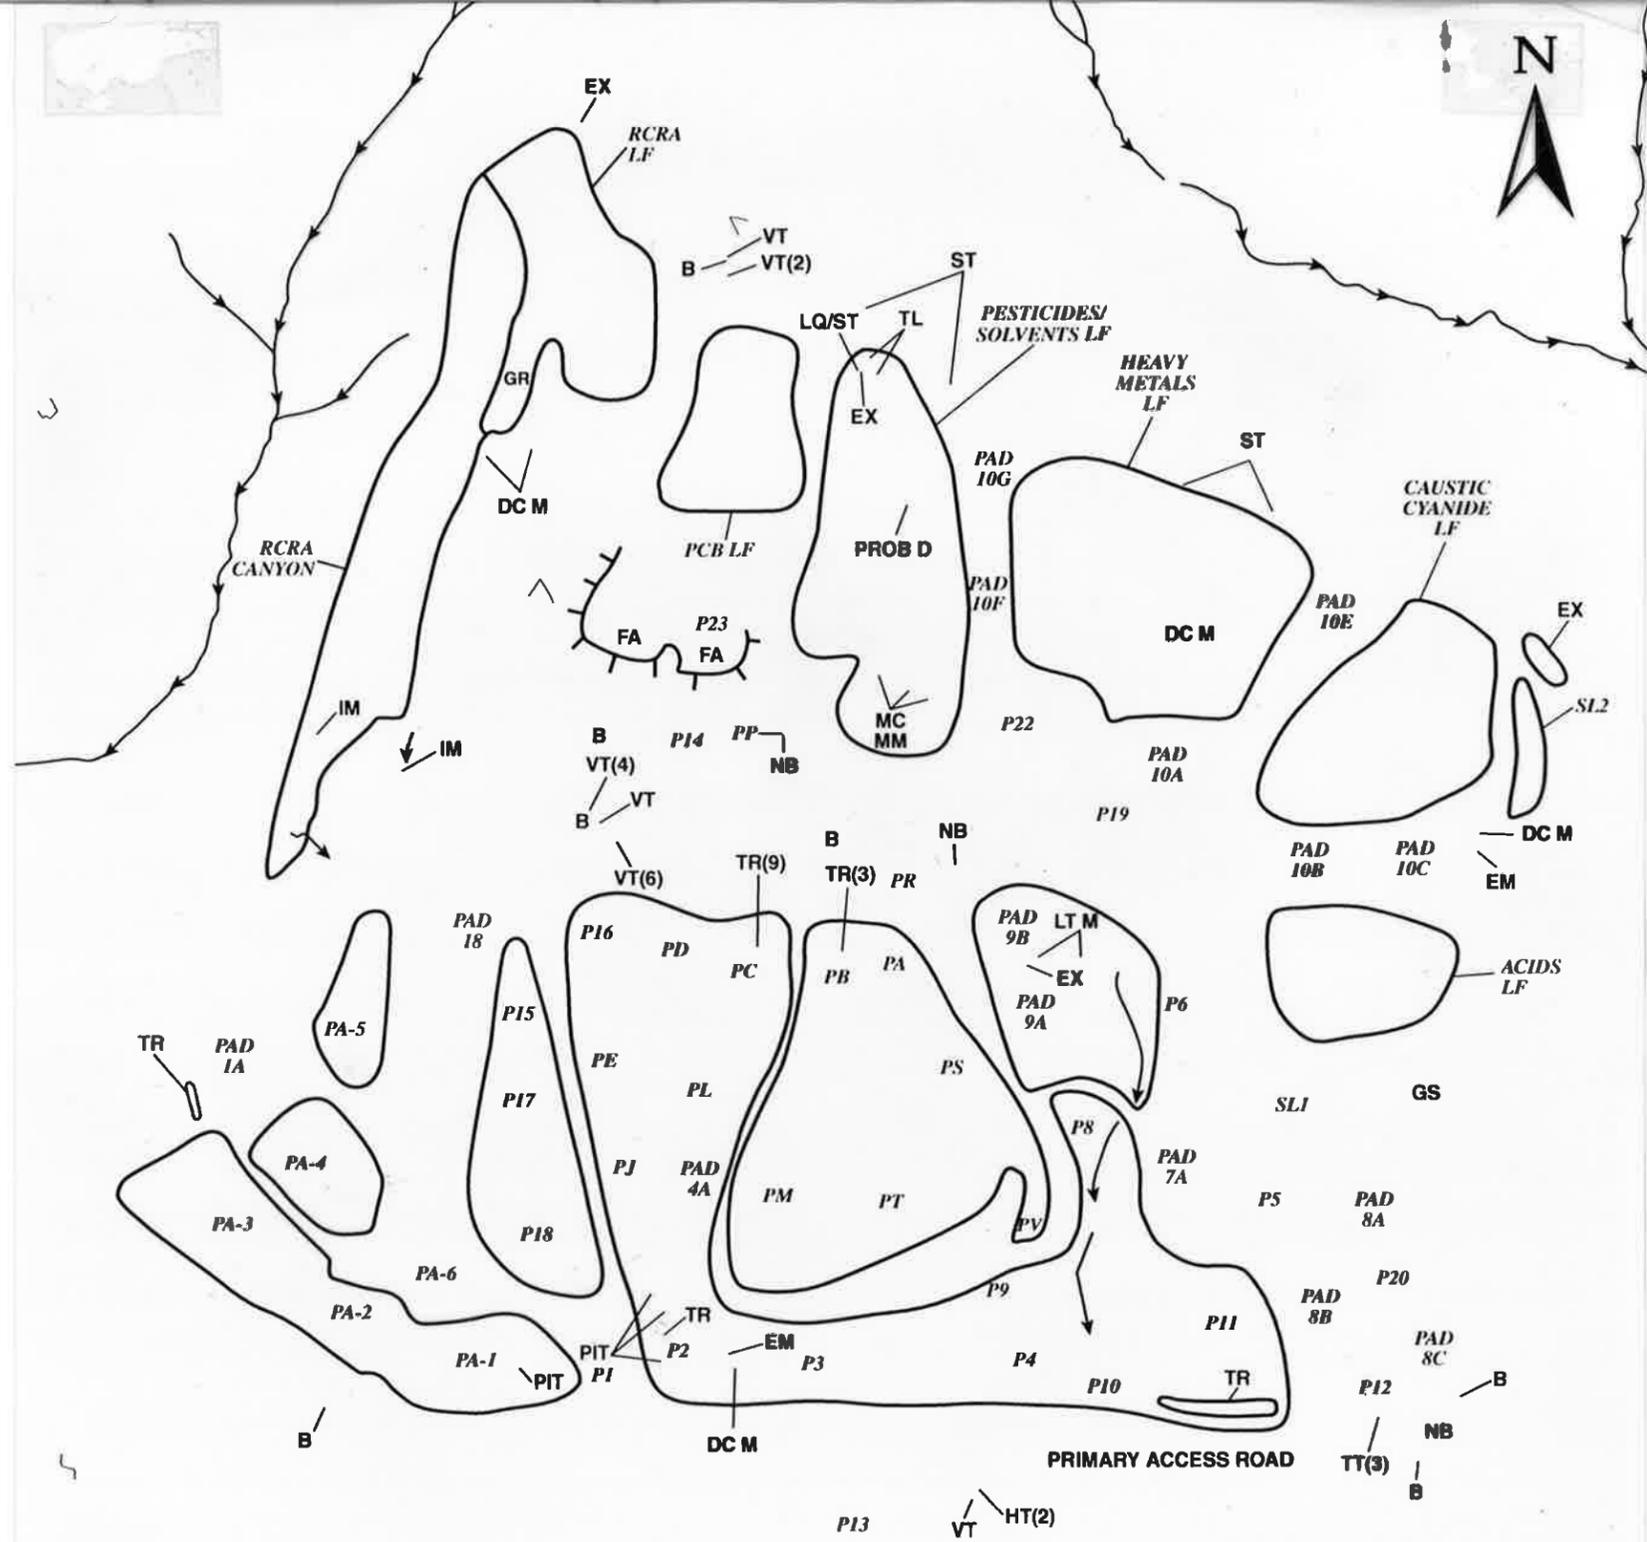
**FIGURE 14 - PHOTO AREA A
CASMALIA DISPOSAL SITE**

Remediation activity is observed throughout the disposal site on this date of photography. An empty trench is visible west of *Pad 1A*. An impoundment containing liquid remains visible east of the *RCRA Canyon*. Four vertical tanks remain visible north of the *PCB Landfill*. West and southwest of *P14*, one building remains visible. Two vertical tanks have been removed and seven have been added near the southernmost building. Six vertical tanks were visible in this location in 1987. A new building is visible east of *PP*, and a new building is visible east of *PR*. Staining is visible on an access road that connects to the primary access road near the southeastern entrance of the site. Staining is visible along most of the access road along the eastern and northern boundaries of the site. An empty excavation is seen north of *SL2*. A ground scar is visible east of the site near *SL1*. One new building has been constructed near *P12*, and two buildings remain.

Annotation	Description
<i>P11</i>	The contents and structure of the pond have been removed. Blue-gray material is visible in the graded material.
<i>P12</i>	<i>P12</i> has been filled. A heavily stained parking area containing three tank trucks and one trailer truck is visible in this location.
<i>P13</i>	The pond contains a small amount of liquid and/or staining.
<i>P14</i>	The contents and structure of the pond have been removed.
<i>P15</i>	The contents and structure of the pond have been removed.
<i>P16</i>	The contents and structure of the pond have been removed.
<i>P17</i>	The contents and structure of the pond have been removed.
<i>P18</i>	The contents and structure of the pond have been removed. A small amount of dark-colored mounded material is seen in the southern portion of the pond.
<i>P19</i>	The contents and structure of the pond have been removed.
<i>P20</i>	Vegetation is seen in the bottom of the pond.

Annotation	Description
<i>PAD 8B</i>	An access road is visible in this area.
<i>PAD 8C</i>	A heavily-stained parking lot is visible in this location.
<i>PAD 9A</i>	<i>Pad 9A</i> is graded.
<i>PAD 9B</i>	Three linear areas of light-colored mounded material are visible. These areas may cover pipes in this location. Light-colored material is visible surrounding the excavation. Objects covered with light-colored material are seen to the east of the excavated area.
<i>PAD 10A</i>	<i>Pad 10A</i> is graded.
<i>PAD 10B</i>	<i>Pad 10B</i> is graded.
<i>PAD 10C</i>	<i>Pad 10C</i> is graded. A small amount of blue-gray material is visible in the graded material. East of <i>Pad 10C</i> , graded dark-colored material is visible on a berm. An earth-moving (EM) vehicle is visible in this location.
<i>PAD 10E</i>	<i>Pad 10E</i> is graded.
<i>PAD 10F</i>	<i>Pad 10F</i> is graded. A small amount of blue-gray material is visible in the graded area.

Annotation	Description
<i>PESTICIDES/ SOLVENTS LF</i>	Probable drums are visible in the central portion of the landfill. An excavation is visible in the northern portion of the landfill. Two trailer trucks and two other vehicles are seen in this location. Liquid or staining is visible at the rear of one of the trucks and extends into the excavation. Multi-colored mounded material is visible in the southern portion of the fill area.
<i>HEAVY METALS LF</i>	The landfill has been graded with dark-colored material. Two graders, currently in operation, and a vehicle are visible on the surface of the landfill.
<i>CAUSTIC/ CYANIDE LF</i>	The surface of the landfill is graded.
<i>ACIDS LF</i>	The surface of the landfill is graded.

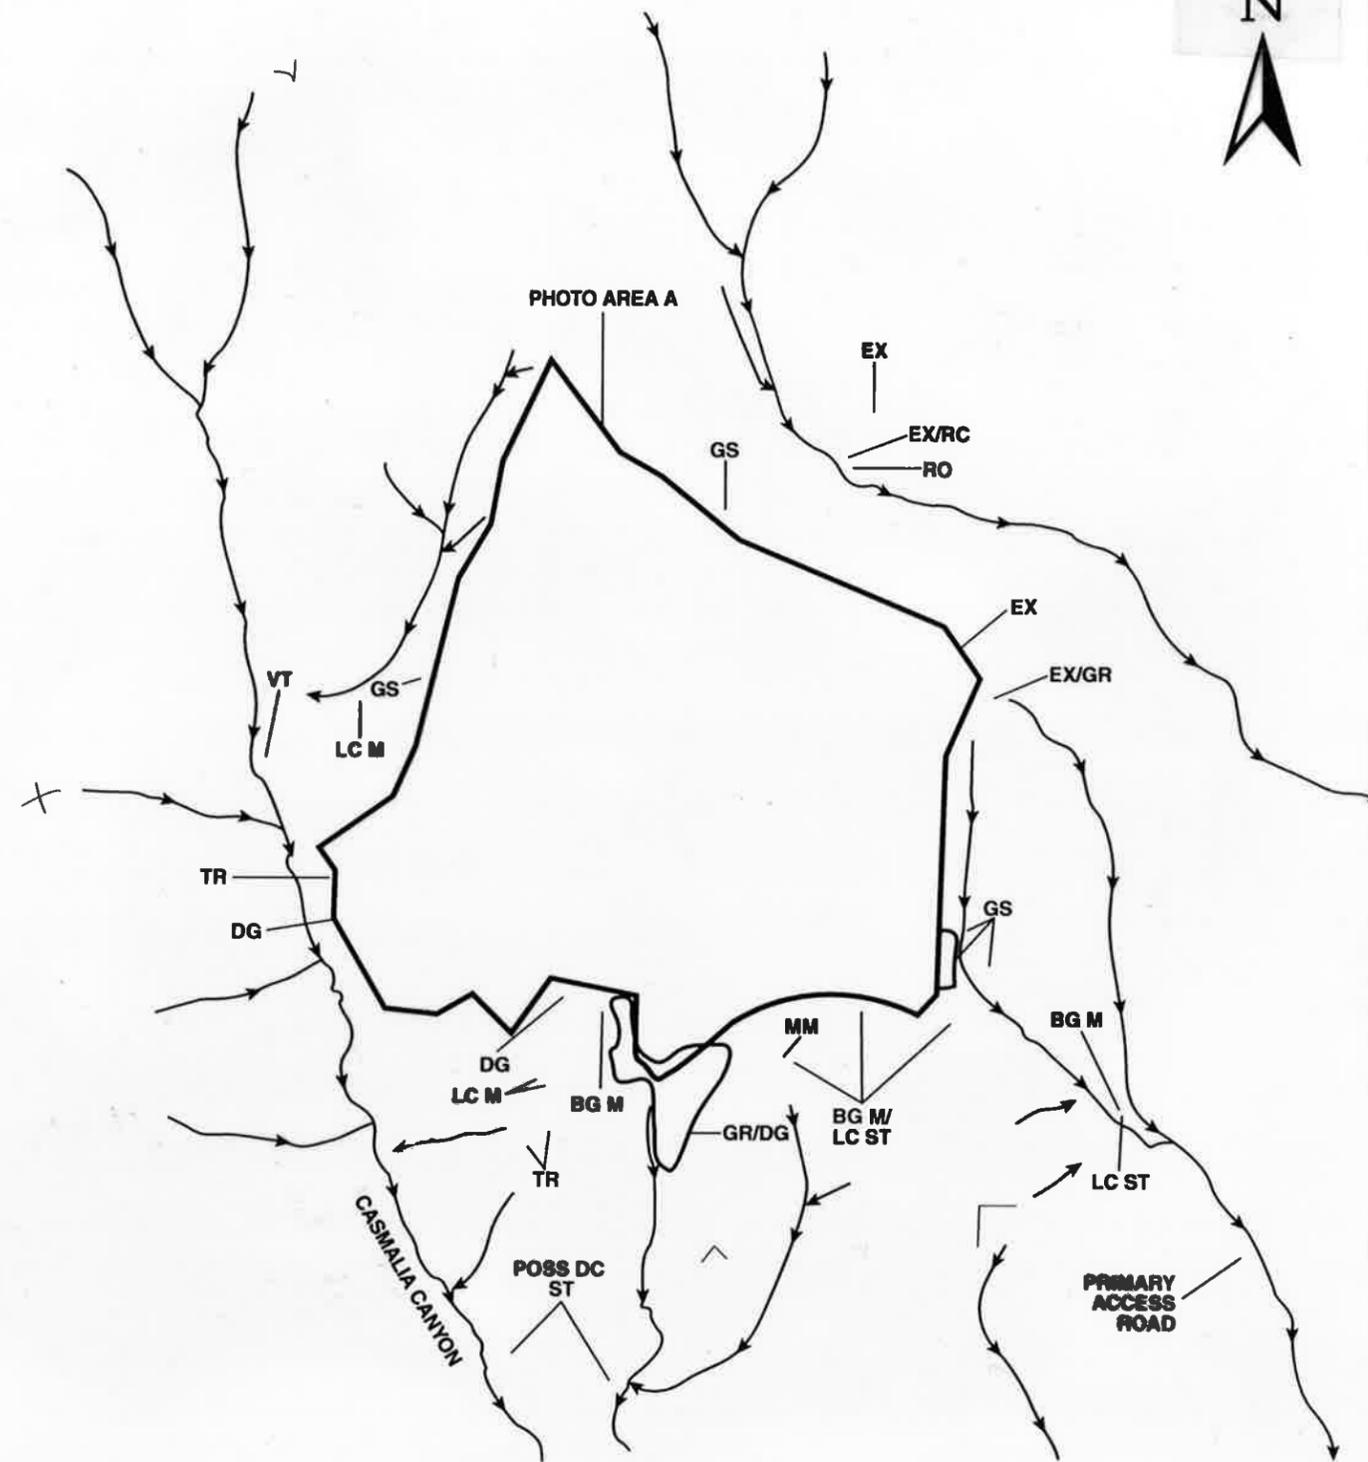
**FIGURE 15 - PHOTO AREA B
CASMALIA DISPOSAL SITE**

West of the disposal site, a trench, disturbed ground, light-colored material, and a ground scar are visible. Northeast of the disposal site, a ground scar, an excavation, and an excavation or road cut (RC) are visible. An erosion scar from liquid runoff (RO) extends south from the road cut. East of the disposal site, an excavation and an excavation and graded area are seen. Continued activity in the vicinity of the ground scars, seen east of the disposal site on the 1987 photography, has resulted in additional ground scars. Blue-gray (BG) material and light-colored staining are visible southeast of the disposal site. A graded area with disturbed ground extends from the southern portion of the disposal site into Photo Area B. Blue-gray material, light-colored staining, mounded material, disturbed ground, light-colored material, and two trenches are visible south of the disposal site. Possible dark-colored staining is visible on a road south of the disposal site.
