**AERIAL PHOTOGRAPHIC ANALYSIS
CASMALIA DISPOSAL SITE
CASMALIA, CALIFORNIA**

August 25, 2003

**Prepared for:
The Casmalia Resources Site
Steering Committee (CSC)**

**Prepared by:
Environmental Research, Inc.
5267 John Marshall Highway
Suite C
Linden, VA 22642**

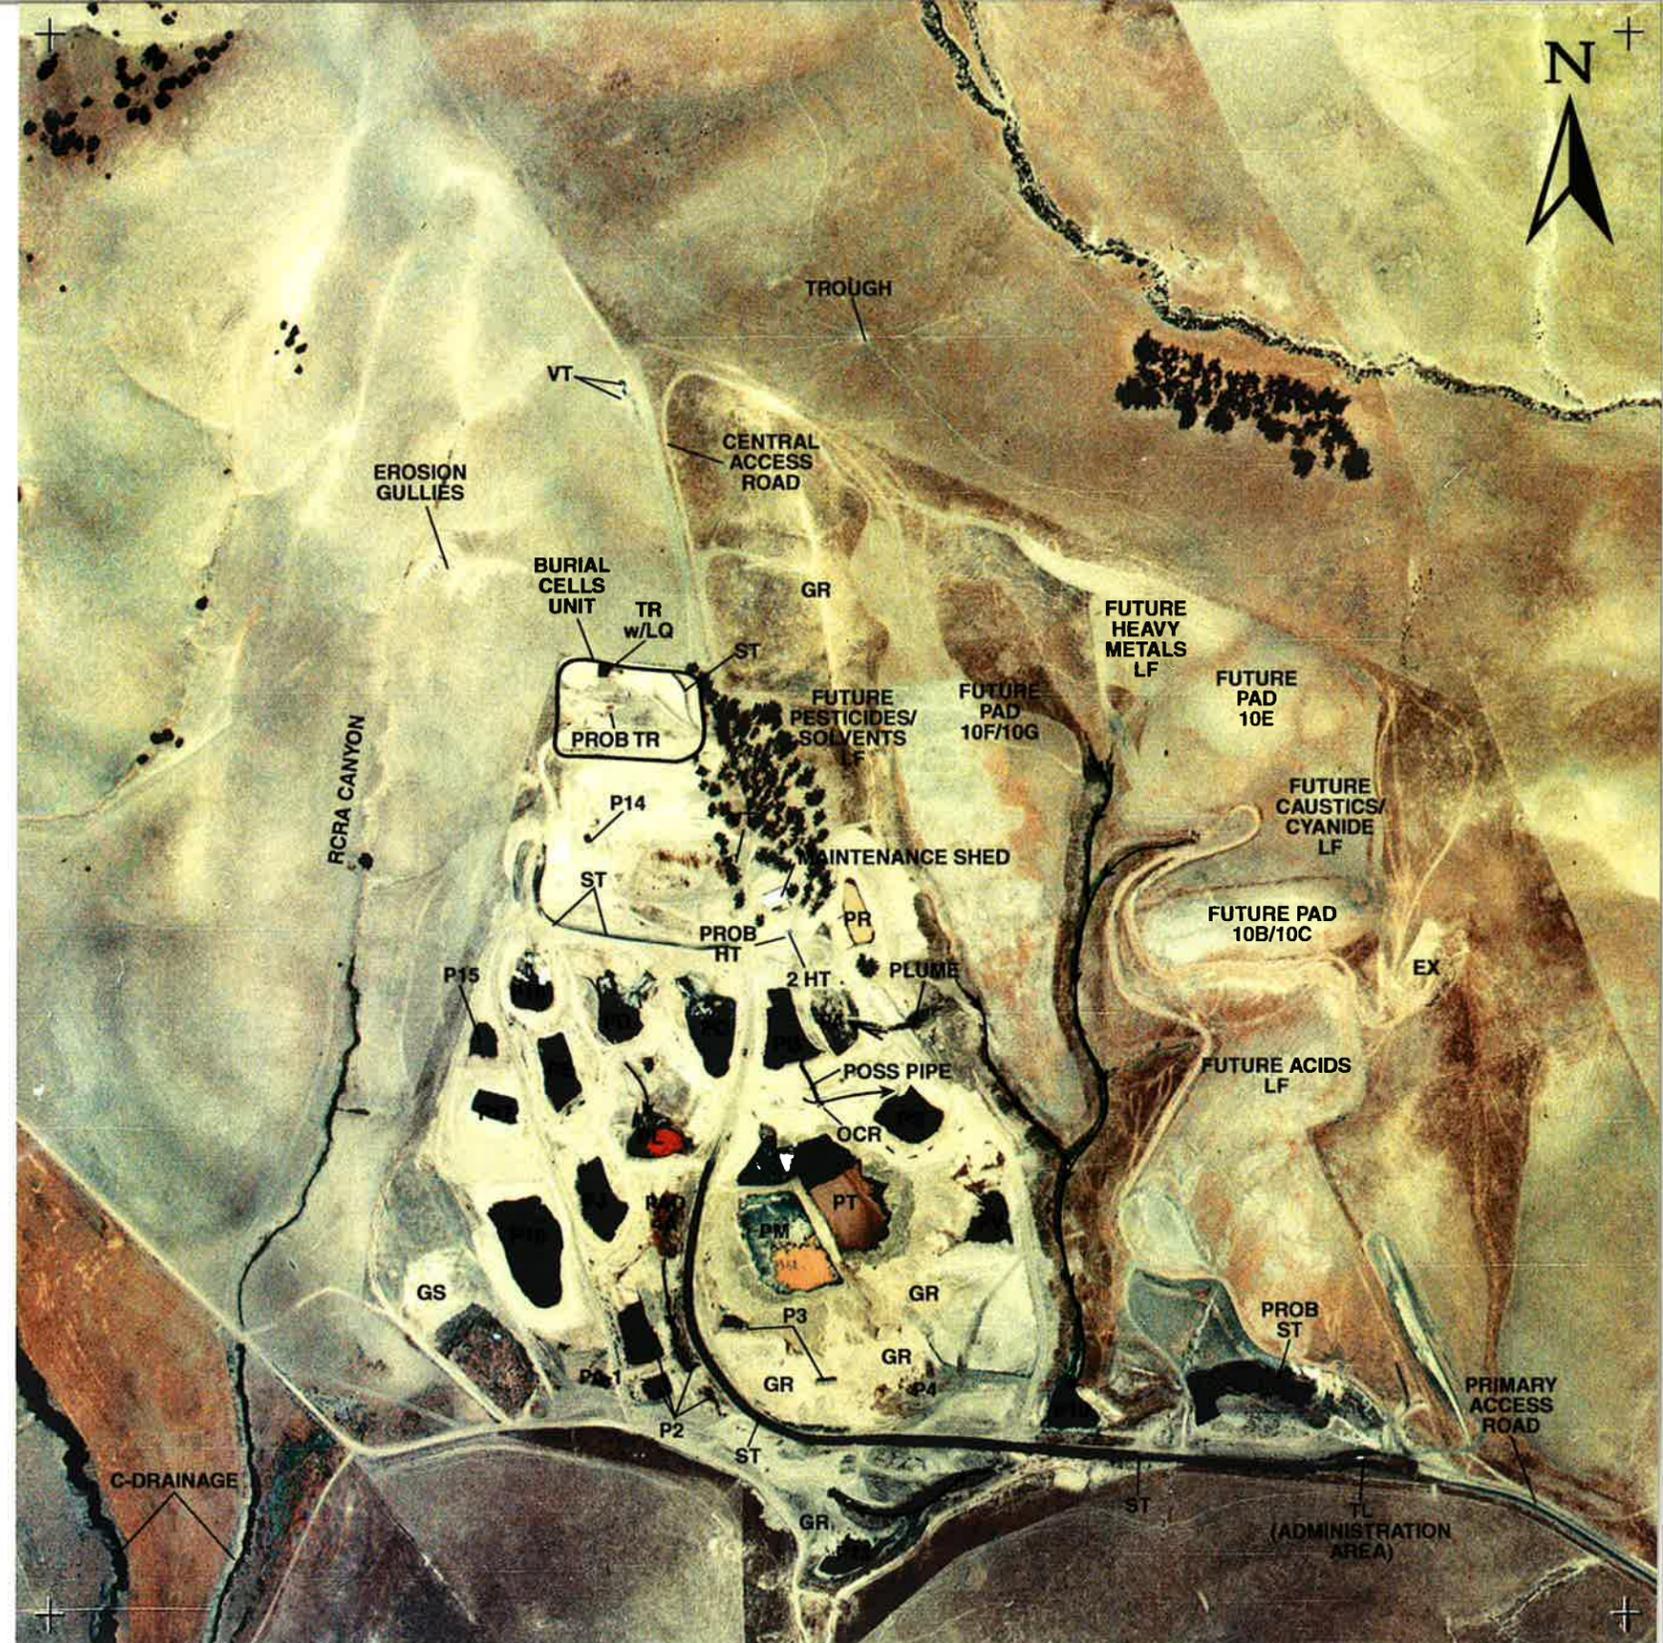
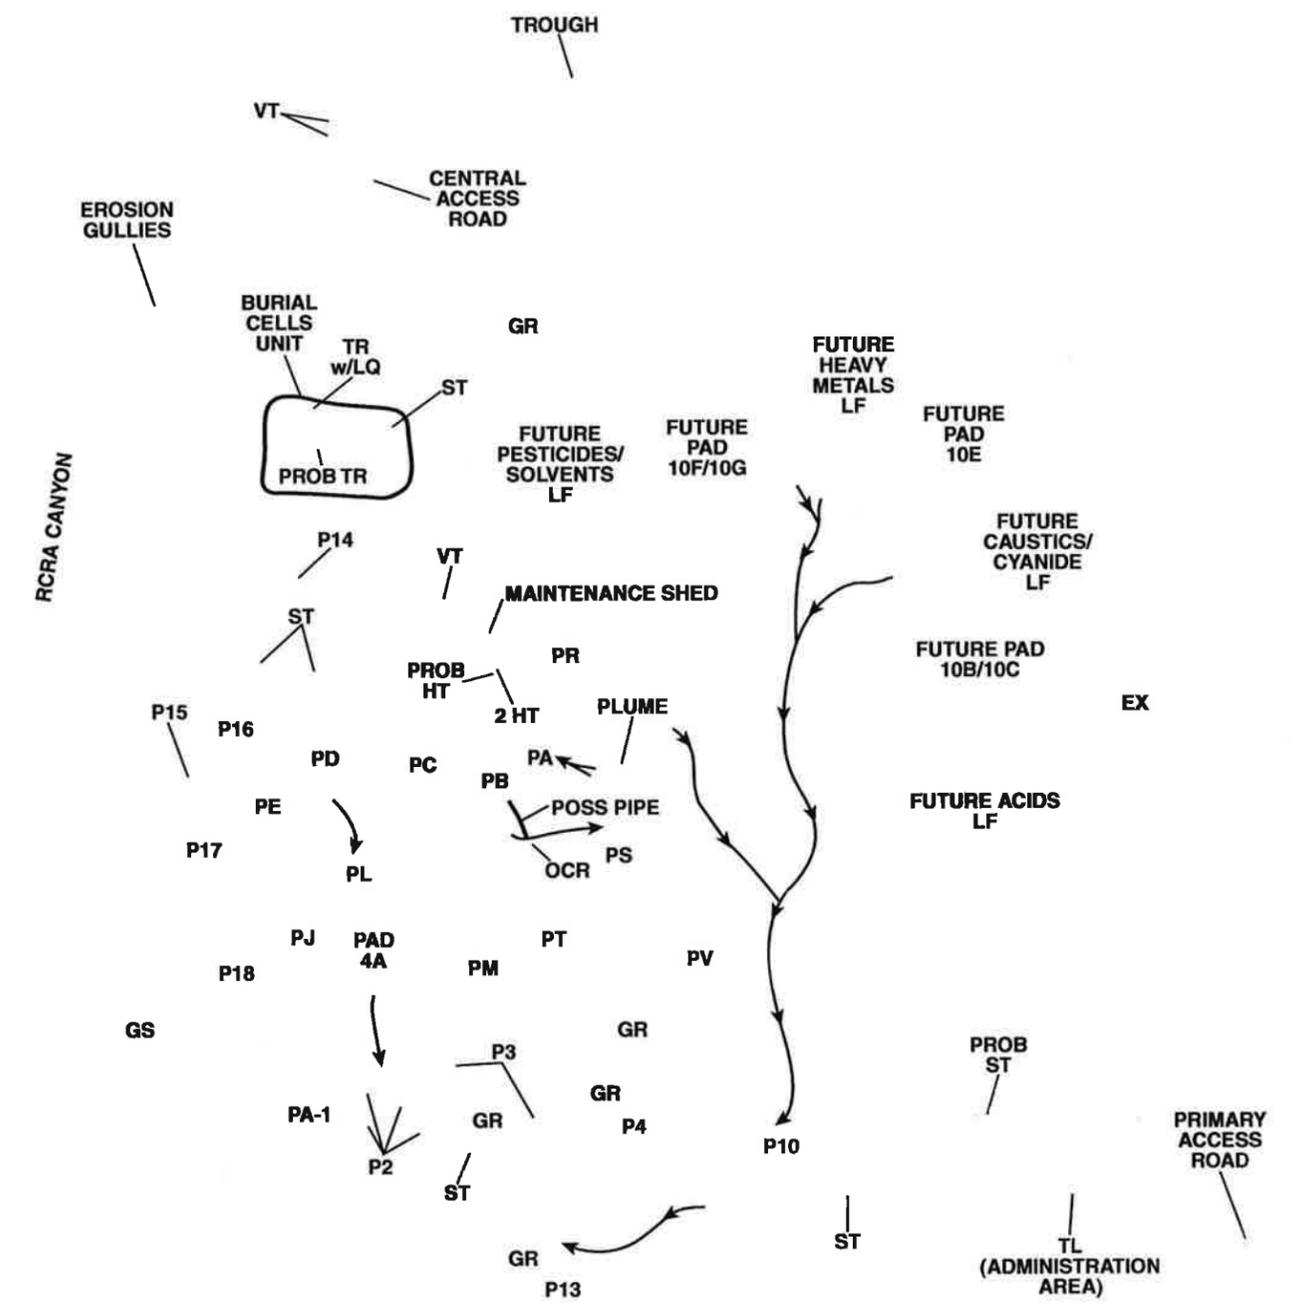
JULY 29, 1977
FRAME: 9

Dark-colored staining is seen on the primary access road. Probable staining is seen north of the primary access road in the southeastern portion of the site. Two vertical tanks are seen on a hill in the northwestern portion of the site.

Annotation	Description
P1	Probable liquid is visible in the pond.
P2	Four impounded areas are visible in the pond. A drainage pathway leads to the northern portion of the pond from Pad 4A.
P3	Two impoundments with liquid and grading (GR) is noted in this area.
P4	Grading is noted in this area.
P9	Grading is noted in this area.
P10	Liquid is visible in the pond. A drainage channel beginning in the northern portion of the site enters the northern portion of the pond.
P13	Liquid is seen in the pond. A drainage channel (probably under construction) is visible to the north. A graded area is visible in this vicinity.
P14	A small impoundment is observed in this vicinity.
P15	Liquid is seen in the pond.
P16	Liquid and light-colored material are visible in the pond.
P17	Rectangular area of liquid is seen in the pond.
P18	Liquid is seen in the pond.
PA-1	Grading is seen in the vicinity of the future pond.
PA-6	Grading is seen in the vicinity of the future pond.

PA	Light-colored material and liquid are seen in the pond. A drainage pathway emanating from near a plume near a possible pipe enters the pond from the east.
PB	Liquid is visible in the pond. A pipe leads from the southern part of the pond to the oil recovery unit (OCR). Liquid and staining are visible on the northern berm of the pond.
PC	Liquid is seen in the pond. Multi-colored material and staining are seen on the northern berm of the pond.
PD	Liquid is visible in the pond. Liquid and multi-colored material are visible on the northern berm of the pond.
PE	Liquid is visible in the pond.
PJ	Liquid is visible in the pond.

PL	Liquid is visible in the pond. Reddish/brown liquid is seen in the eastern portion. Drainage channels enter the impounded area from the direction of PD .
PM	Two impounded areas are seen in this area. The northern portion (which contains liquid) is joined with PT . The southern portion contains turbid liquid and light-colored material.
PP	Not visible.
PR	The pond contains turbid liquid. A probable dumping area is noted on the western berm of the pond.
PS	The pond contains liquid. A drainage channel leads to it from the west, beyond the oil recovery unit. Approximately five rectangular shaped probable impoundments (not annotated) surround the pond to the south.
PT	This pond is joined by two channels to PM . The northern portion contains liquid. The southern portion contains turbid liquid.
PV	Liquid and grading are seen in this vicinity.
WCCB	Not visible.
PAD 4A	The pad drains to the two northern impoundments that make up P2 and contains brown material and probable liquid.

PAD 10B	Surface grading is visible.
PAD 10C	Surface grading is visible.
PAD 10E	Surface grading is visible.
PAD 10F	Surface grading is visible.
PAD 10G	Surface grading is visible.
SL1	Grading is noted in this vicinity.
PCB LF	Not visible.
PESTICIDES/ SOLVENTS LF	Surface grading is visible.
HEAVY METALS LF	Surface grading is visible.
CAUSTIC/ CYANIDE LF	Surface grading is visible.
ACIDS LF	Surface grading is visible.
MAINTENANCE SHED AREA	Two horizontal tanks (HT) and one probable (PROB) horizontal tank are visible south of the Maintenance Shed. Staining is seen on a road to the southwest. A vertical tank is seen to the northwest.
BURIAL CELLS UNIT	A trench (TR) with liquid and a probable trench are visible in the burial cells unit. A probable injection well cap (not annotated) is also visible. Staining is visible on an access road in the eastern portion of this area.
RCRA CANYON AREA	Erosion gullies are seen in the northern portion of this area.

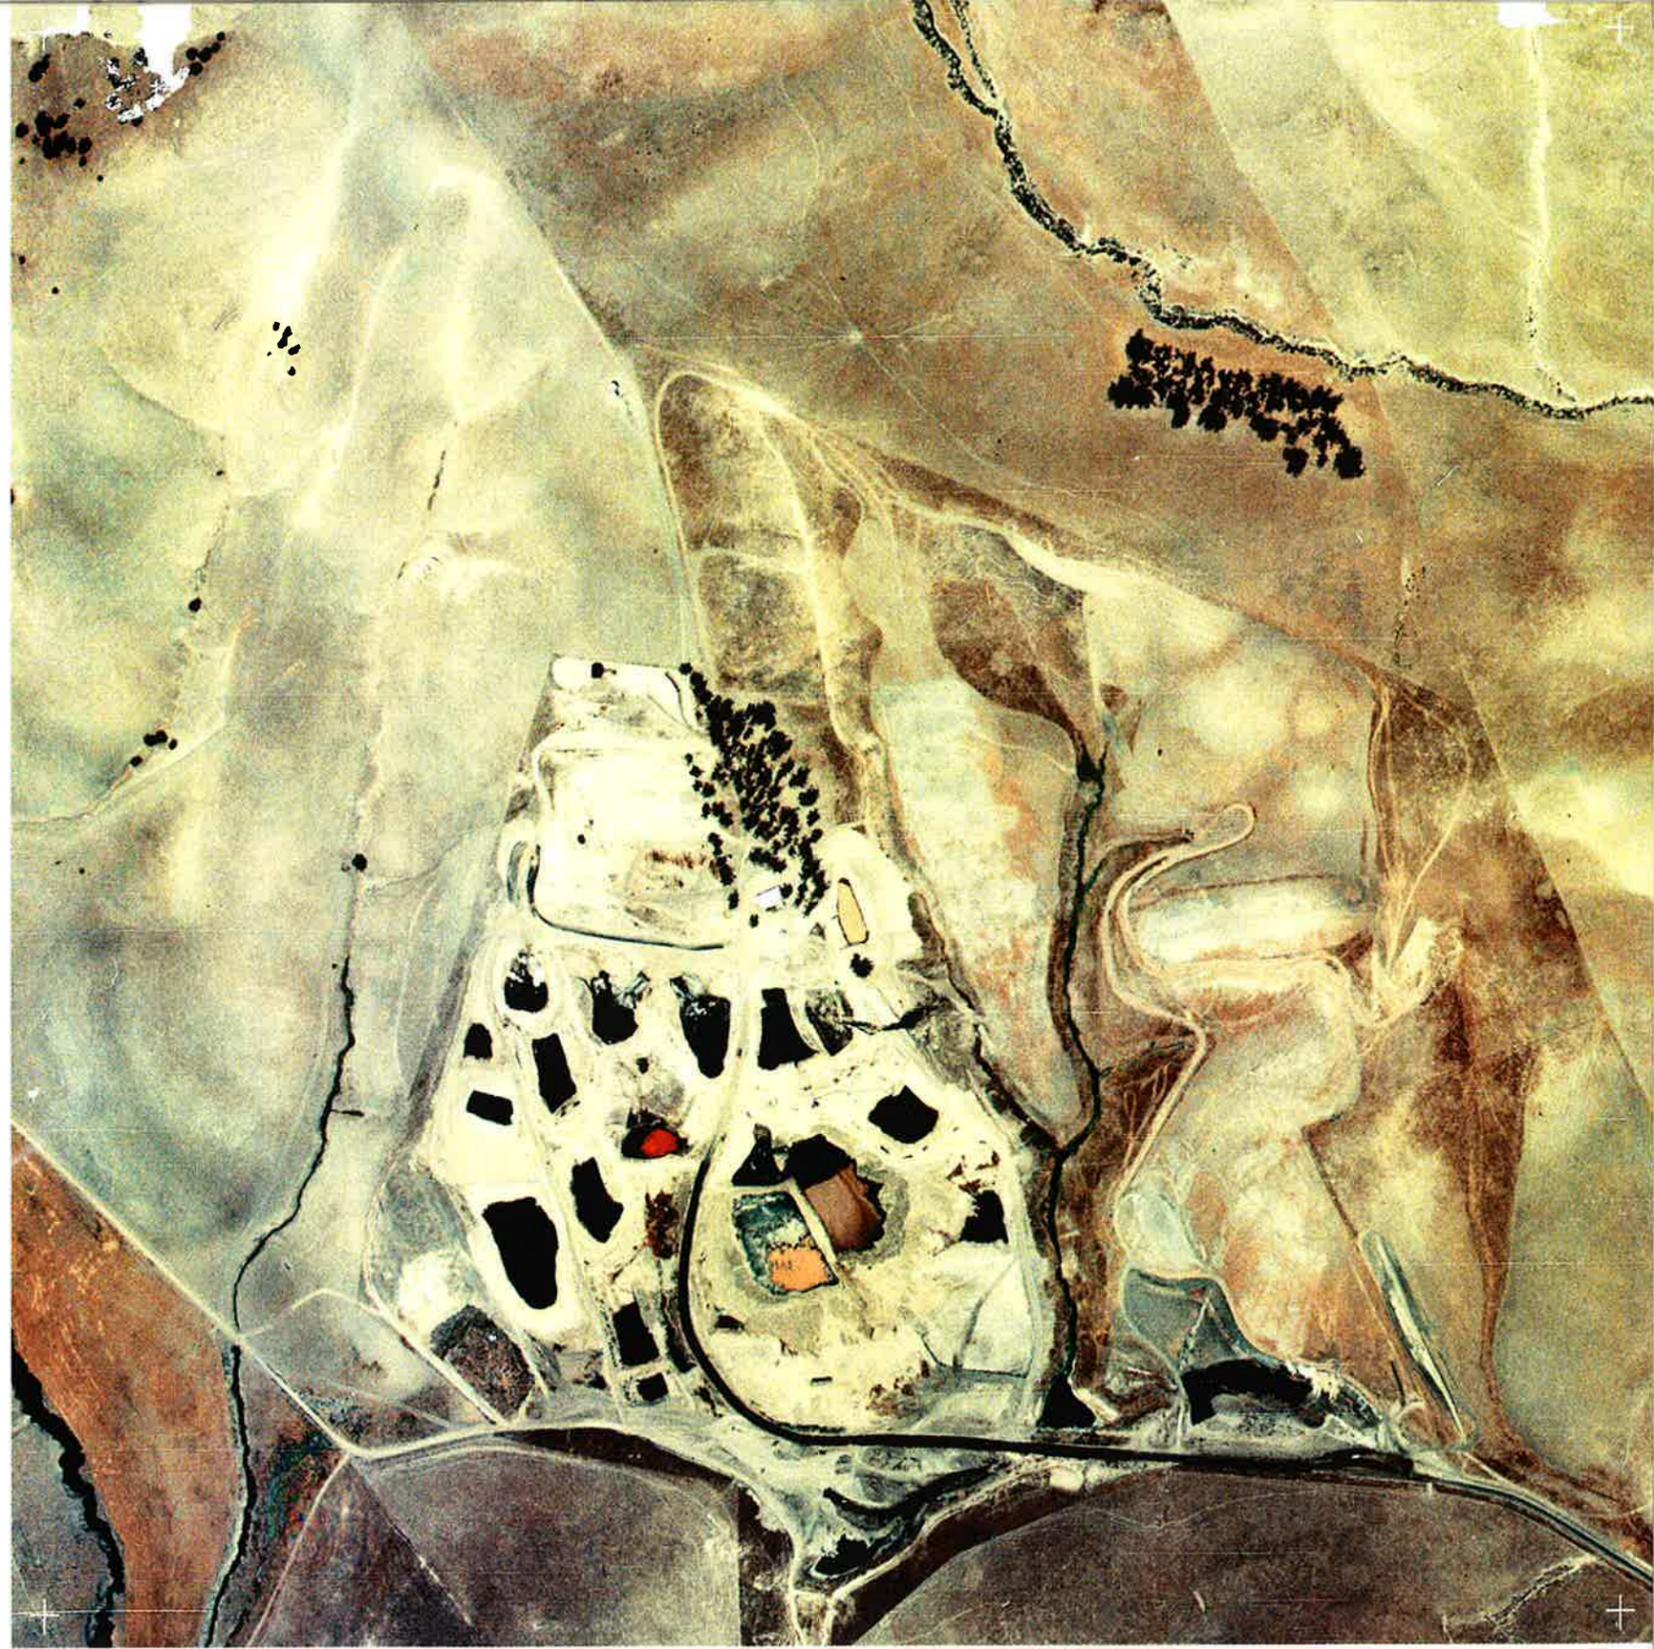
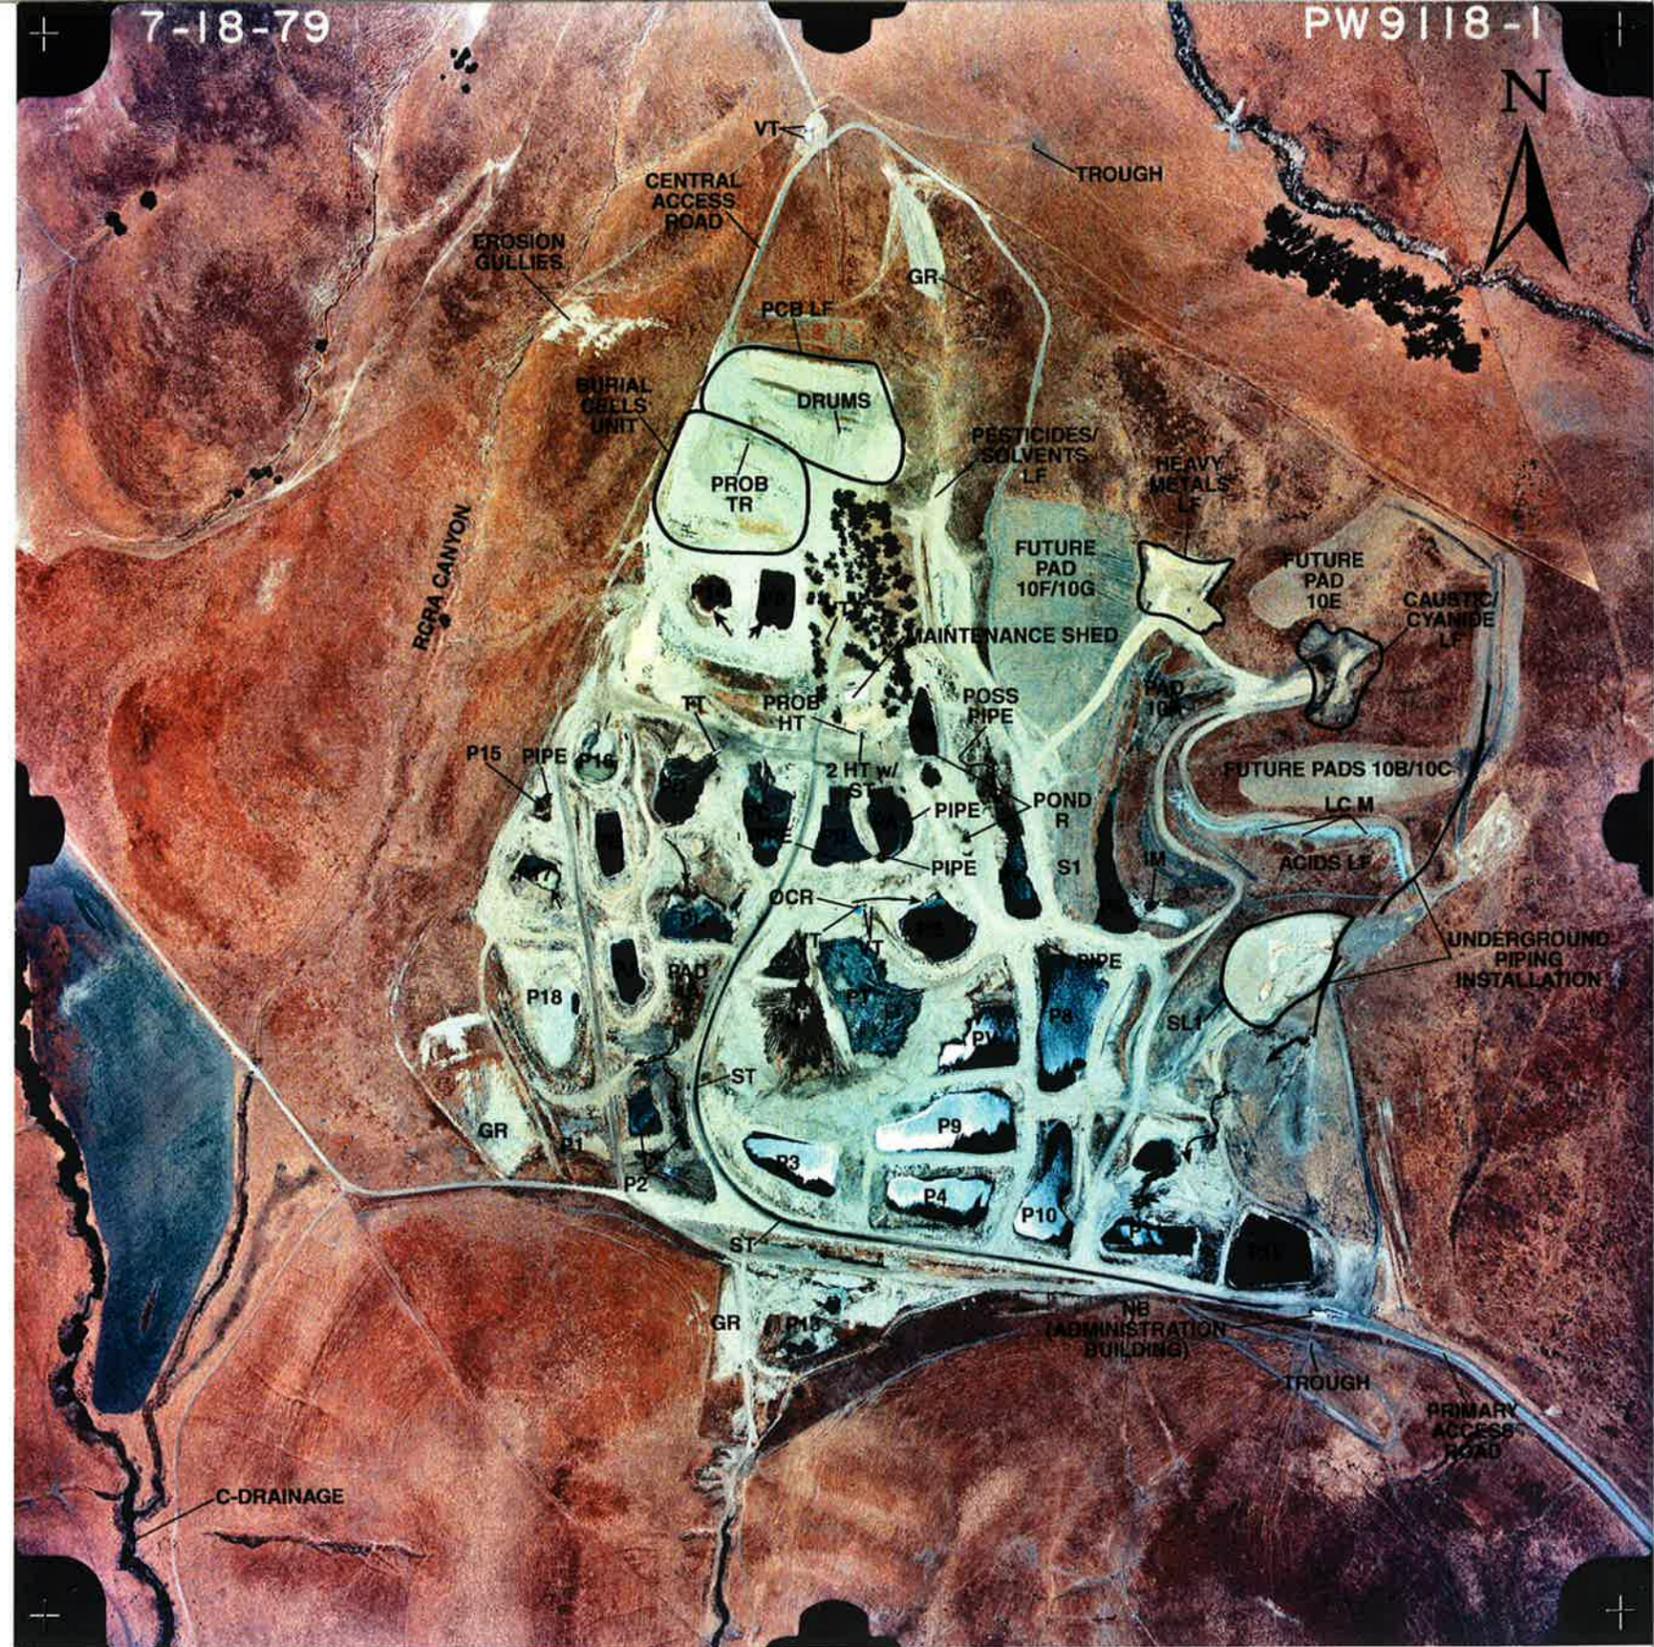
JULY 18, 1979
FRAME: 1

Annotation	Description
P1	Grading activity is noted in this vicinity.
P2	Four impounded areas containing liquid are visible. Drainage from Pad 4A leads to the northern portion of P2 .
P3	Liquid is visible in the pond.
P4	Liquid is visible in the pond.
P5	Pond is not visible.
P6	Liquid is seen in an impounded drainage. A smaller impounded area is seen nearby to the east. Gray material, liquid, and staining (not annotated) are seen to the northeast of this pond in a drainage that leads to it.
P7	Liquid is visible in the pond. Possible pipe is seen at head of drainage in northwest portion.
P8	Liquid is visible in the pond. Pond is probably connected by a pipe to P7 . A pipe is visible in the northwest corner of the pond.
P9	Liquid is visible in the pond.
P10	Liquid is visible in the pond.
P11	Liquid and a graded area are visible in the pond.
P12	Liquid is visible in the pond. A pipe (not annotated) is visible spanning from P11 to P12 .

PA-6	The graded area previously seen in this vicinity is now partially vegetated.
PA	Liquid (emanating from a probable pipe (not annotated)) and staining are observed on the northern berm of the pond. Turbid liquid is seen in the pond. Pipes are seen at the eastern and southern edges of the pond.
PB	Liquid (emanating from a pipe (not annotated)) and staining are observed on the northern berm of the pond. A pipe is seen near the southern edge of the pond. Turbid liquid is seen in the pond.
PC	Turbid liquid and gray material are seen in the pond and on its northwestern berm. Staining is also seen on the berm.
PD	Liquid and multi-colored material or sludge are visible in the pond. A tanker truck is backed up to the northeastern berm.
PE	Liquid is seen in the pond. A pipe (not annotated) is seen along the western perimeter of the pond. Another pipe (not annotated) extends south from the pond and then continues underground, possibly to PJ .

PJ	Liquid is seen in the pond. A pipe (not annotated) extends from the southern portion of the pond southward, and then continues underground, possibly to P2 .
PL	Liquid and white and gray material or sludge are seen in the pond. The pond probably receives drainage from PD .
PM	PM has two impounded areas. The northern portion, which contains liquid, is being moved and graded into the southern portion. The southern portion contains liquid and staining in the graded areas.
PP	Liquid is visible in the pond. A possible outfall pipe (not annotated) is visible in the southwestern corner.
PR	Pond contains liquid with reddish/brown material around the edges. A dumping area is seen on the western edge of the pond. An impoundment containing light-colored material and liquid is seen to the south. The impoundment is connected to PR by a drainage channel in the future.
PS	Pond contains liquid. A drainage pathway leads to it from the oil recovery unit.

PT	The pond contains liquid and gray material or sludge.
PV	The pond contains liquid.
PAD 4A	Contains probable liquid and drains toward P2 . Gray material is seen in the southwestern portion.
PAD 8A	Staining is visible.
PAD 10B	Surface grading is visible.
PAD 10C	Surface grading is visible.
PAD 10E	Surface grading is visible.
PAD 10F	Surface grading is visible.

PAD 10G	Surface grading is visible.
SL1	Contains graded light-toned material.
PCB LF	Contains approximately 90 drums in fill area.
PESTICIDES/ SOLVENTS LF	Graded areas are seen in northernmost and southernmost extent of the landfill.
HEAVY METALS LF	Active grading is observed.
CAUSTIC/ CYANIDE LF	Graded gray and dark-toned material seen.
ACIDS LF	Light-colored (LC) material (M) is spread in a flow pattern below the northern part of the perimeter road.
MAINTENANCE SHED AREA	A vertical tank remains to the northwest. Two horizontal tanks and one probable horizontal tank are visible southwest of the Maintenance Shed. Staining is seen adjacent to the eastern side of the horizontal tanks.
BURIAL CELLS UNIT	Four probable injection well caps (not annotated) are visible. One probable trench is visible.
S1	Grading is visible in this area.

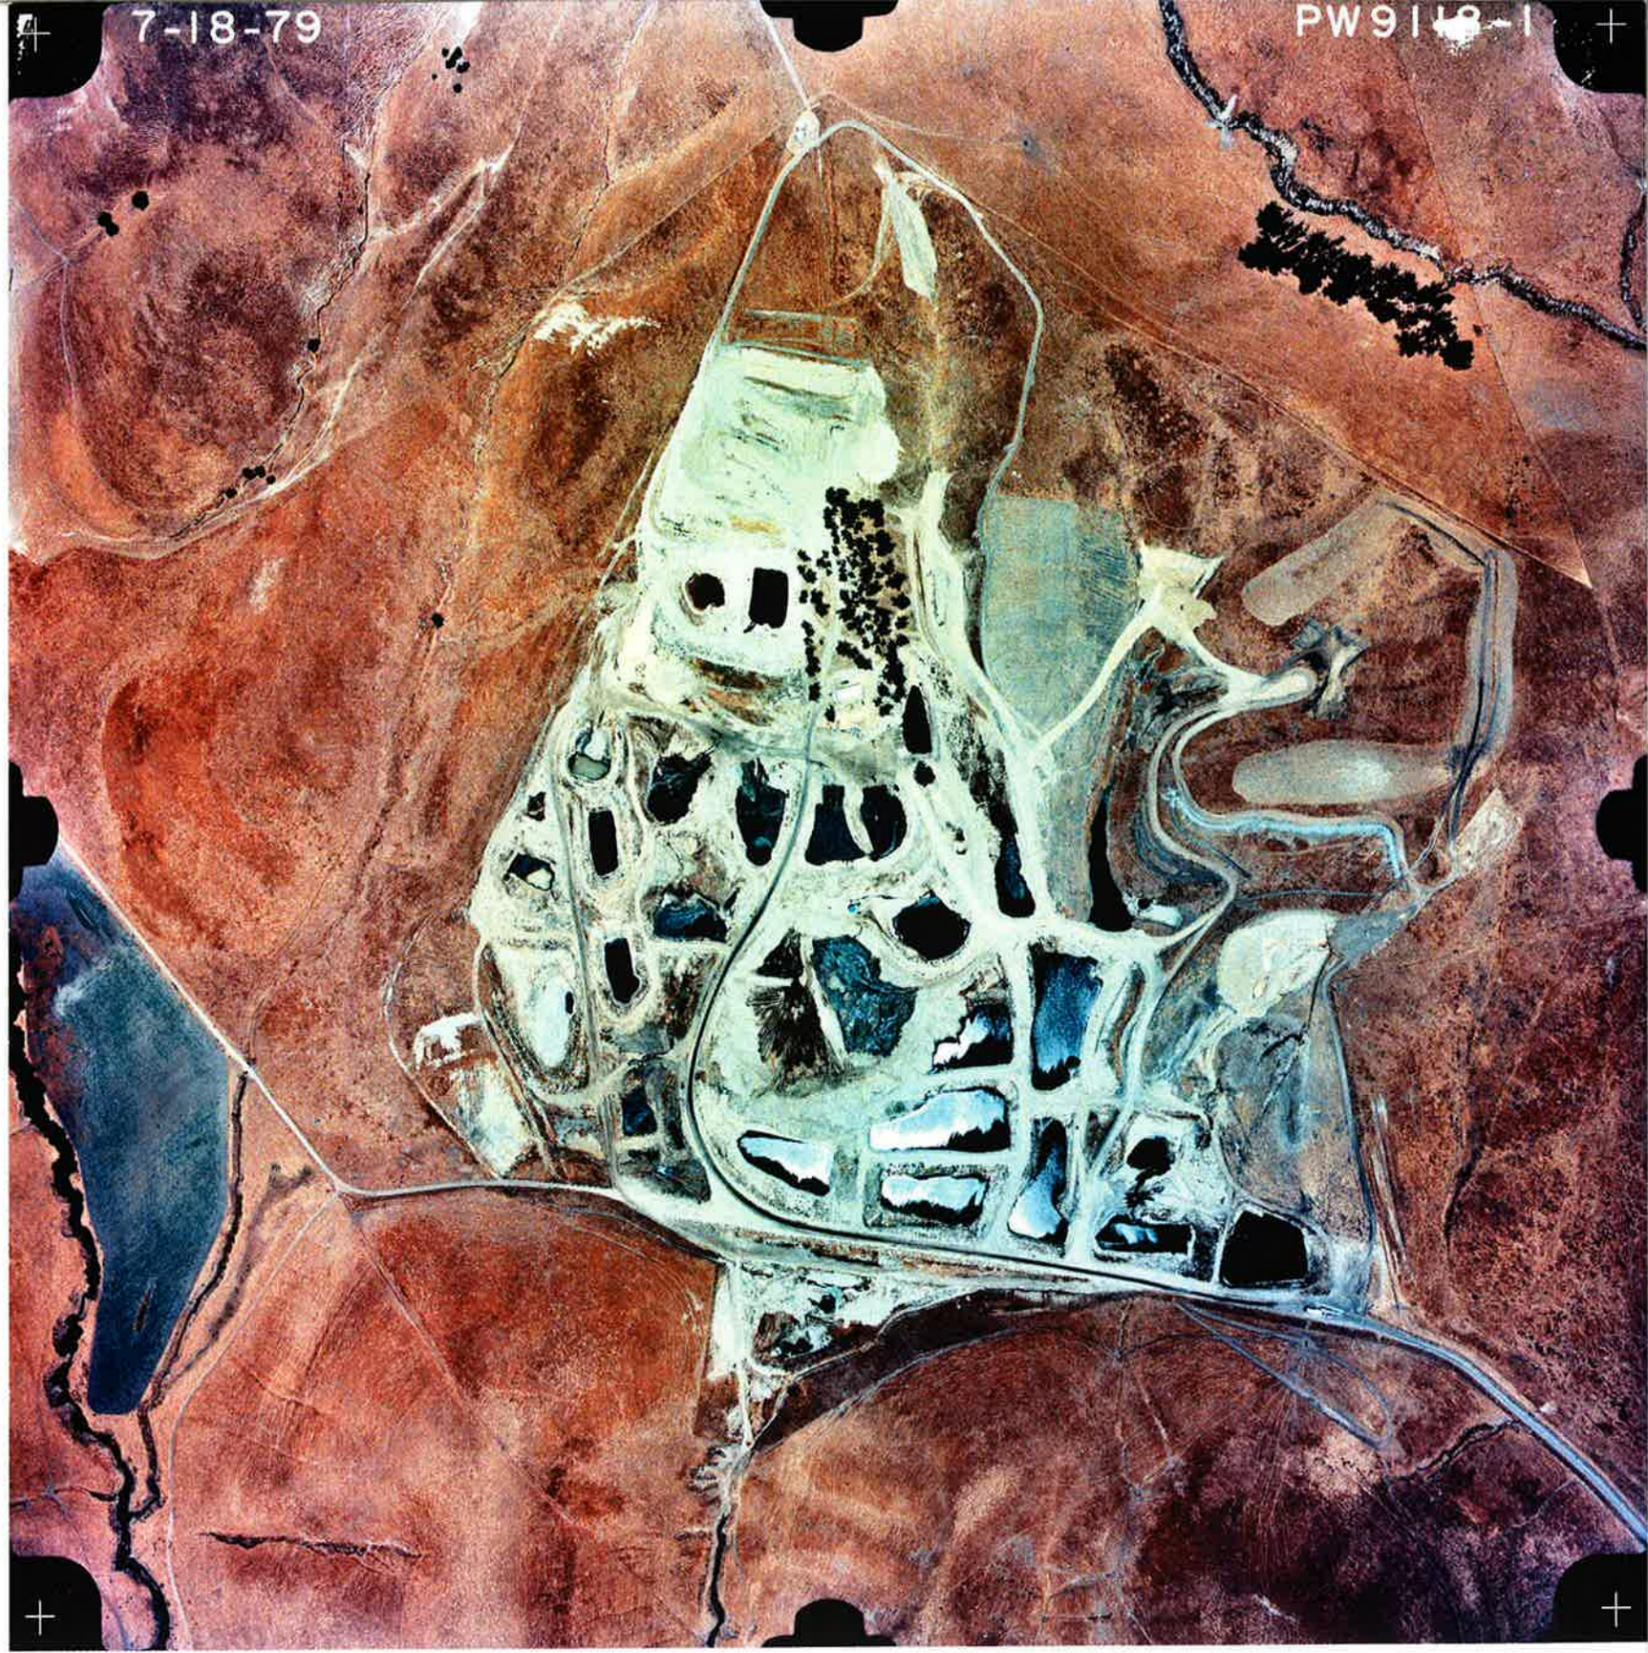
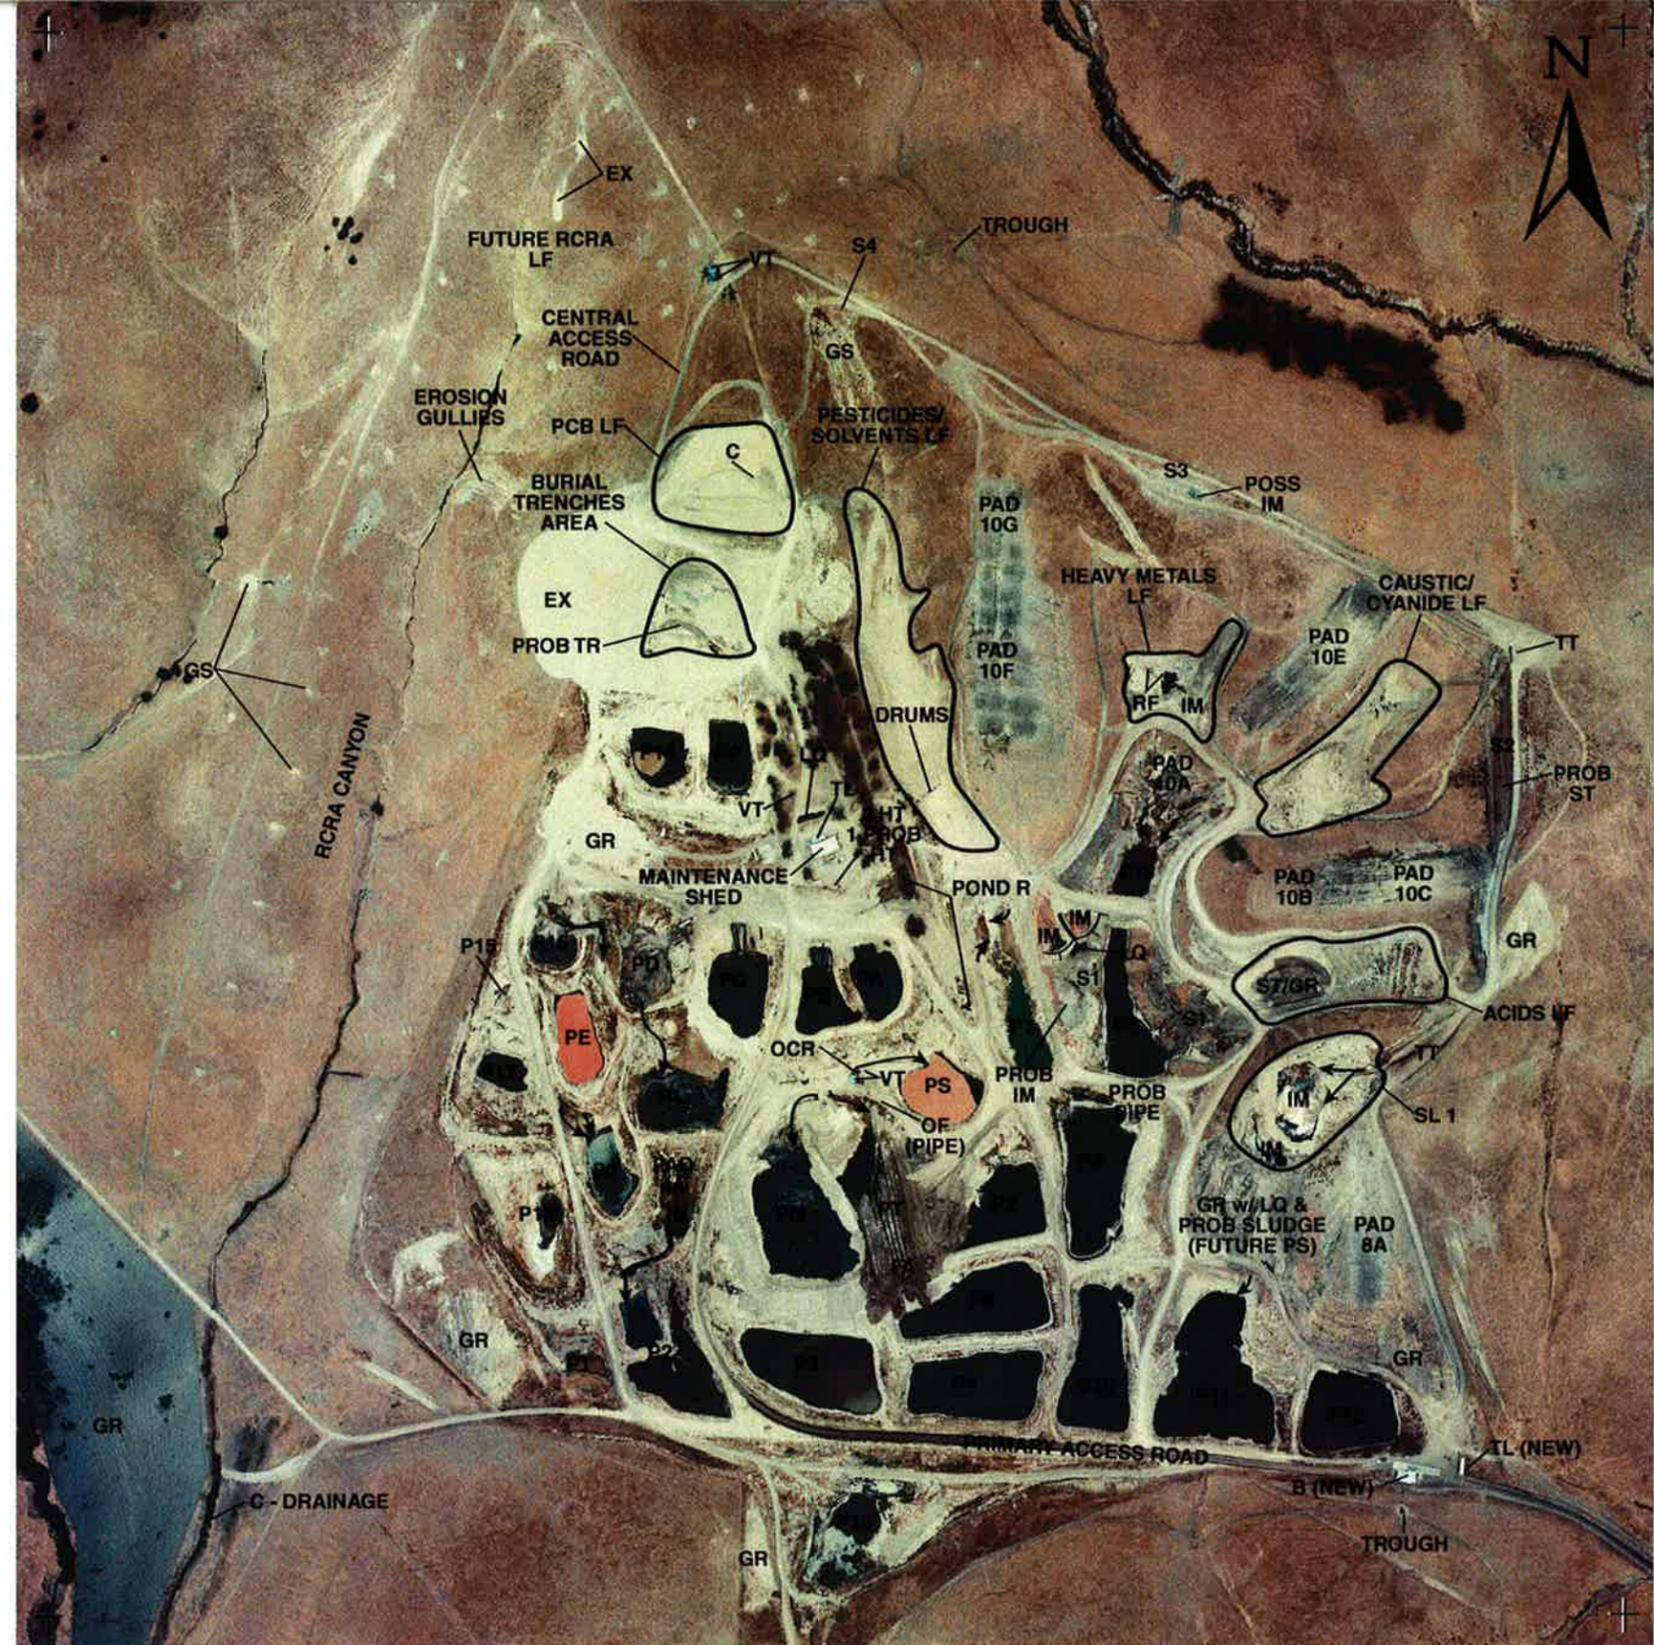
SEPTEMBER 15, 1980
FRAME: 1

P16	The pond contains light-colored material or sludge and liquid. A drainage pathway connects P16 to the vicinity of PD . Graders (not annotated) are seen north of the pond.
P17	Liquid is visible in the pond.
P18	Liquid is visible in the pond. Probable grading is seen in the northern portion of the pond.
P19	Liquid is visible in the pond. Drainage from Pad 10A joins the pond. Liquid or staining and white and gray material or sludge are visible in the northern portion of this area.
PA-1	Grading is visible in this vicinity.
PA-6	Grading is visible in this vicinity.
PA	Liquid is visible in the pond. Dark-toned liquid and staining or material are visible on the northern berm.
PB	Liquid is visible in the pond. Dark-toned liquid and staining or material are visible on the northern berm emanating from a pipe.
PC	Liquid is visible in the pond. Dark-toned liquid or material is visible on the northern berm. Brown material is seen in the northern portion of the pond.

PL	Liquid is visible in the pond. Light-toned material is visible in the northern portion. A drainage channel enters the pond from PD . Gray material is noted on the surface of the pond.
PM	Liquid is visible in the pond. Dark-toned liquid or staining is visible in the northern portion of the pond near the northern berm.
PP	Liquid is visible in the pond. A probable dumping area is seen on the east side of the northern berm.
PR	The pond contains liquid. Brown material is seen on the western berm near a dumping area. An impoundment is seen to the south. This impoundment is connected by a drainage channel to PR in future years.
PS	Liquid is visible in the pond. A drainage channel remains visible and extends from near the oil recovery unit into the northern portion of PS .
PT	A fill area with staining is visible. An outfall (OF) pipe is noted at the northern edge of the pond.
PV	Liquid is visible in the pond. Fill areas extend into the northern and western portions of the pond.

PAD 4A	An impoundment containing areas of dark-colored material or staining and possible liquid remains in this location. The pad drains to P2 .
PAD 8A	Staining and a pipe are visible on the pad.
PAD 8C	Grading is seen in this vicinity.
PAD 10B	A graded area is visible in this vicinity.
PAD 10C	A graded area is visible on the pad.
PAD 10E	A graded area and probable staining are visible on this pad.
PAD 10F	A graded area and probable staining are visible on this pad.
PAD 10G	A graded area and probable staining are visible on this pad.
SL1	Two impoundments are visible. White-colored sludge, brown material or sludge, and liquid are visible in the northern impounded area. The southwest impoundment contains liquid and light-colored material or sludge, and is probably connected to the northern impoundment by a drainage channel. A tanker truck is backed up to the northeastern berm of the impoundment.
MAINTENANCE SHED AREA	Two horizontal tanks and one probable horizontal tank remain visible to the south of the Maintenance Shed. A vertical tank remains visible to the northwest. A new trailer is seen adjacent to the maintenance shed.

ACIDS LF	Probable staining is noted on a graded area seen in this vicinity.
BURIAL CELLS UNIT	A probable trench is visible in this area. Seven probable injection well caps (not annotated) are visible in this area.
RCRA CANYON	Two excavations are seen in the northern portion of this area. Several ground scars (three of which are annotated) are visible throughout the entire RCRA Canyon area.
S1	Two impoundments and one probable impoundment are seen here. The northwestern impoundment contains liquid, light-colored material, and brown material. The northeastern impoundment contains brown material. Liquid (LQ) is seen south of the two northern impoundments. Gray and white colored material with possible staining is seen in and around the probable impoundment.
S2	A tanker truck is seen in this area at the top of a hill. Probable gray and brown material is seen on the hill below the truck.
S3	A possible impoundment with liquid or staining is visible.

S4	A ground scar with possible staining is visible.
S5	Not visible.
S6	Not visible.
