**AERIAL PHOTOGRAPHIC ANALYSIS
CASMALIA DISPOSAL SITE
CASMALIA, CALIFORNIA**

August 25, 2003

**Prepared for:
The Casmalia Resources Site
Steering Committee (CSC)**

**Prepared by:
Environmental Research, Inc.
5267 John Marshall Highway
Suite C
Linden, VA 22642**

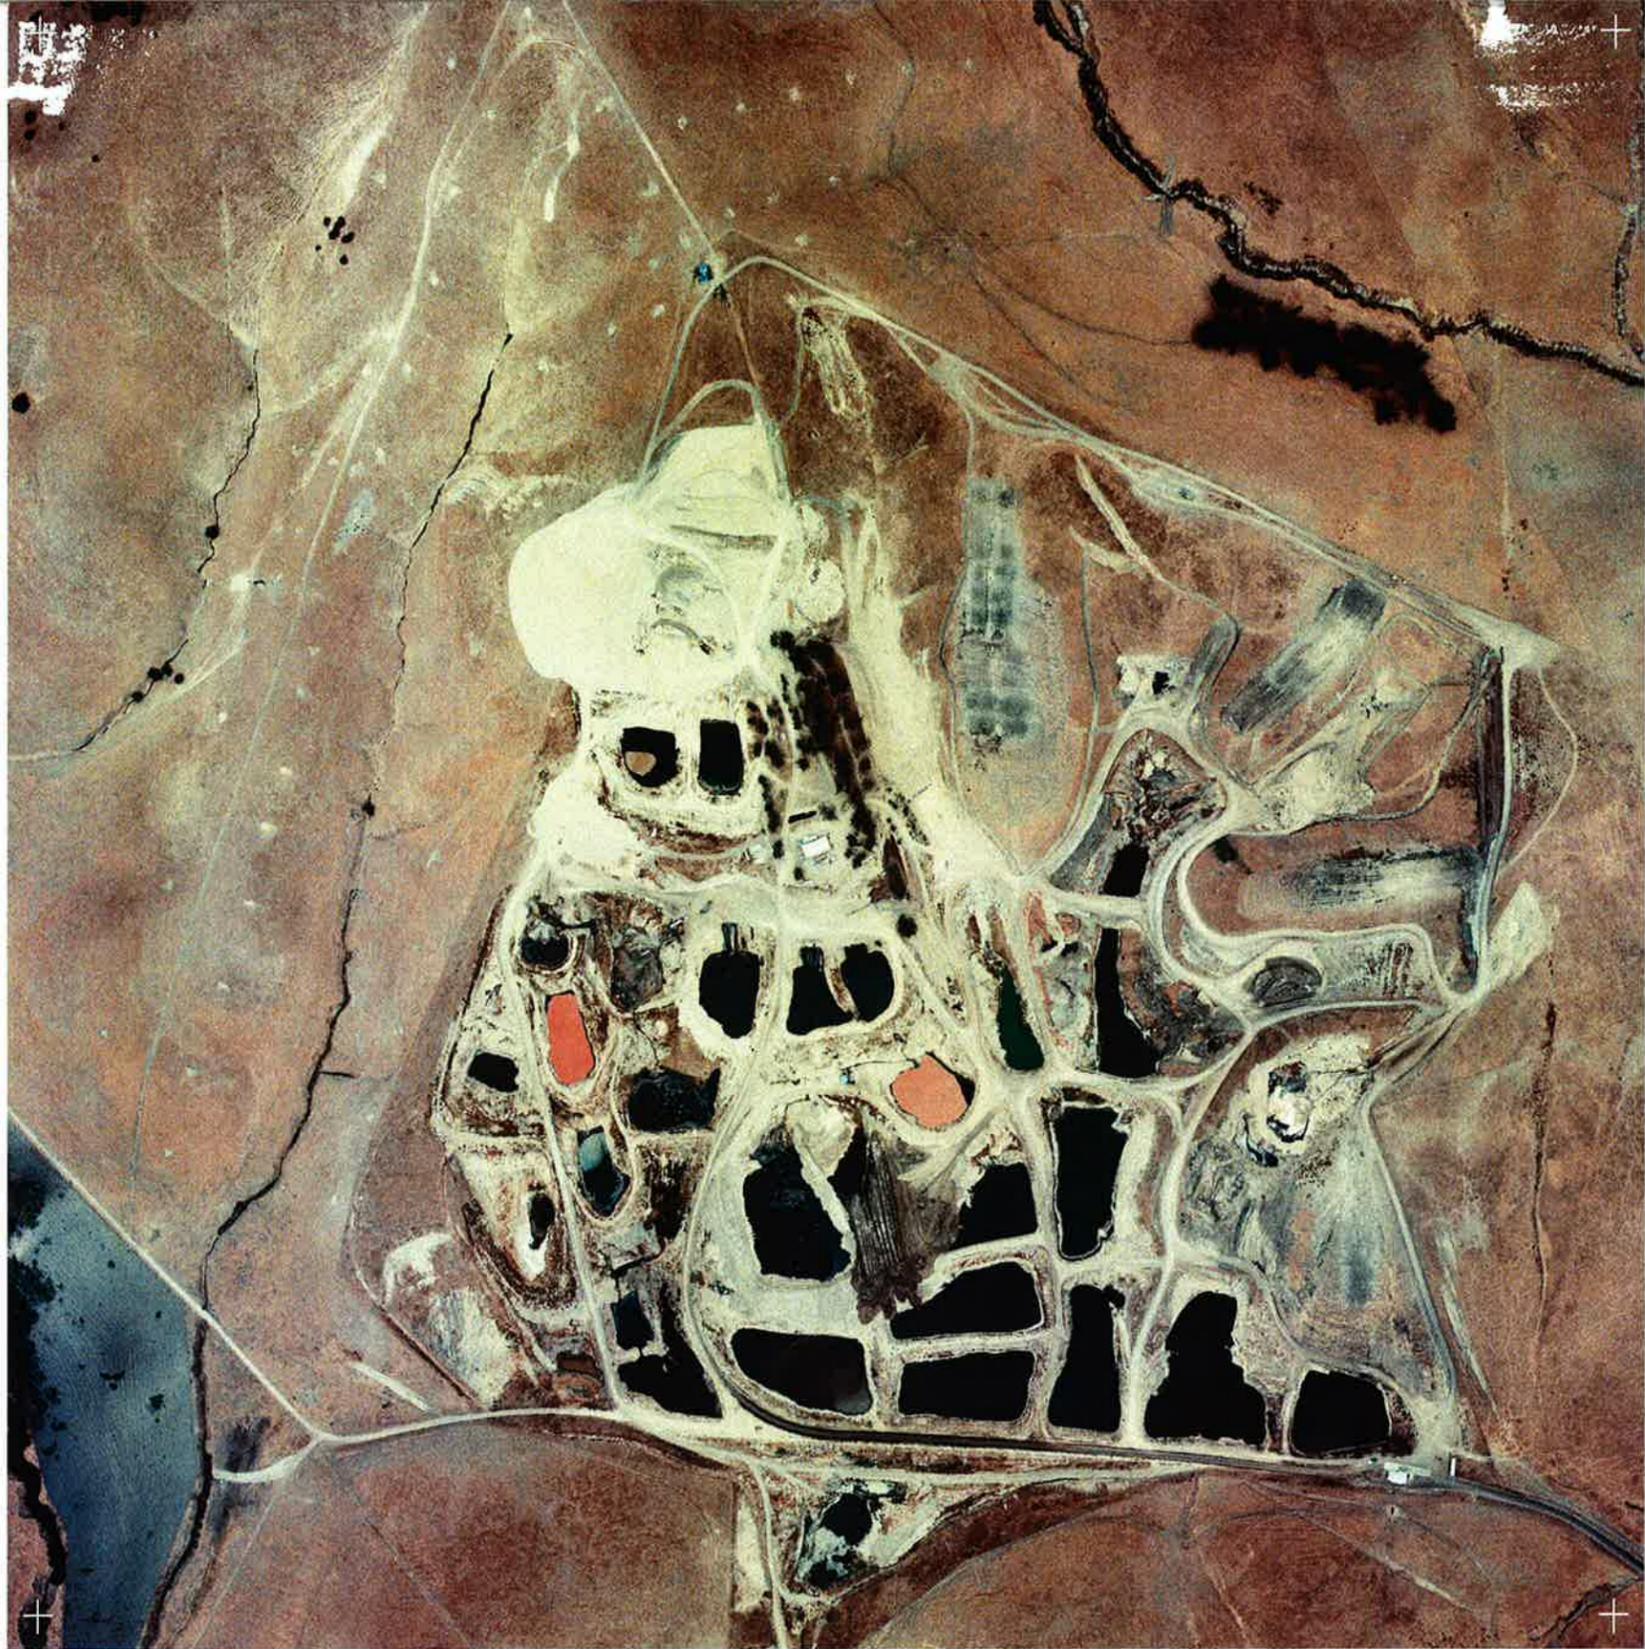
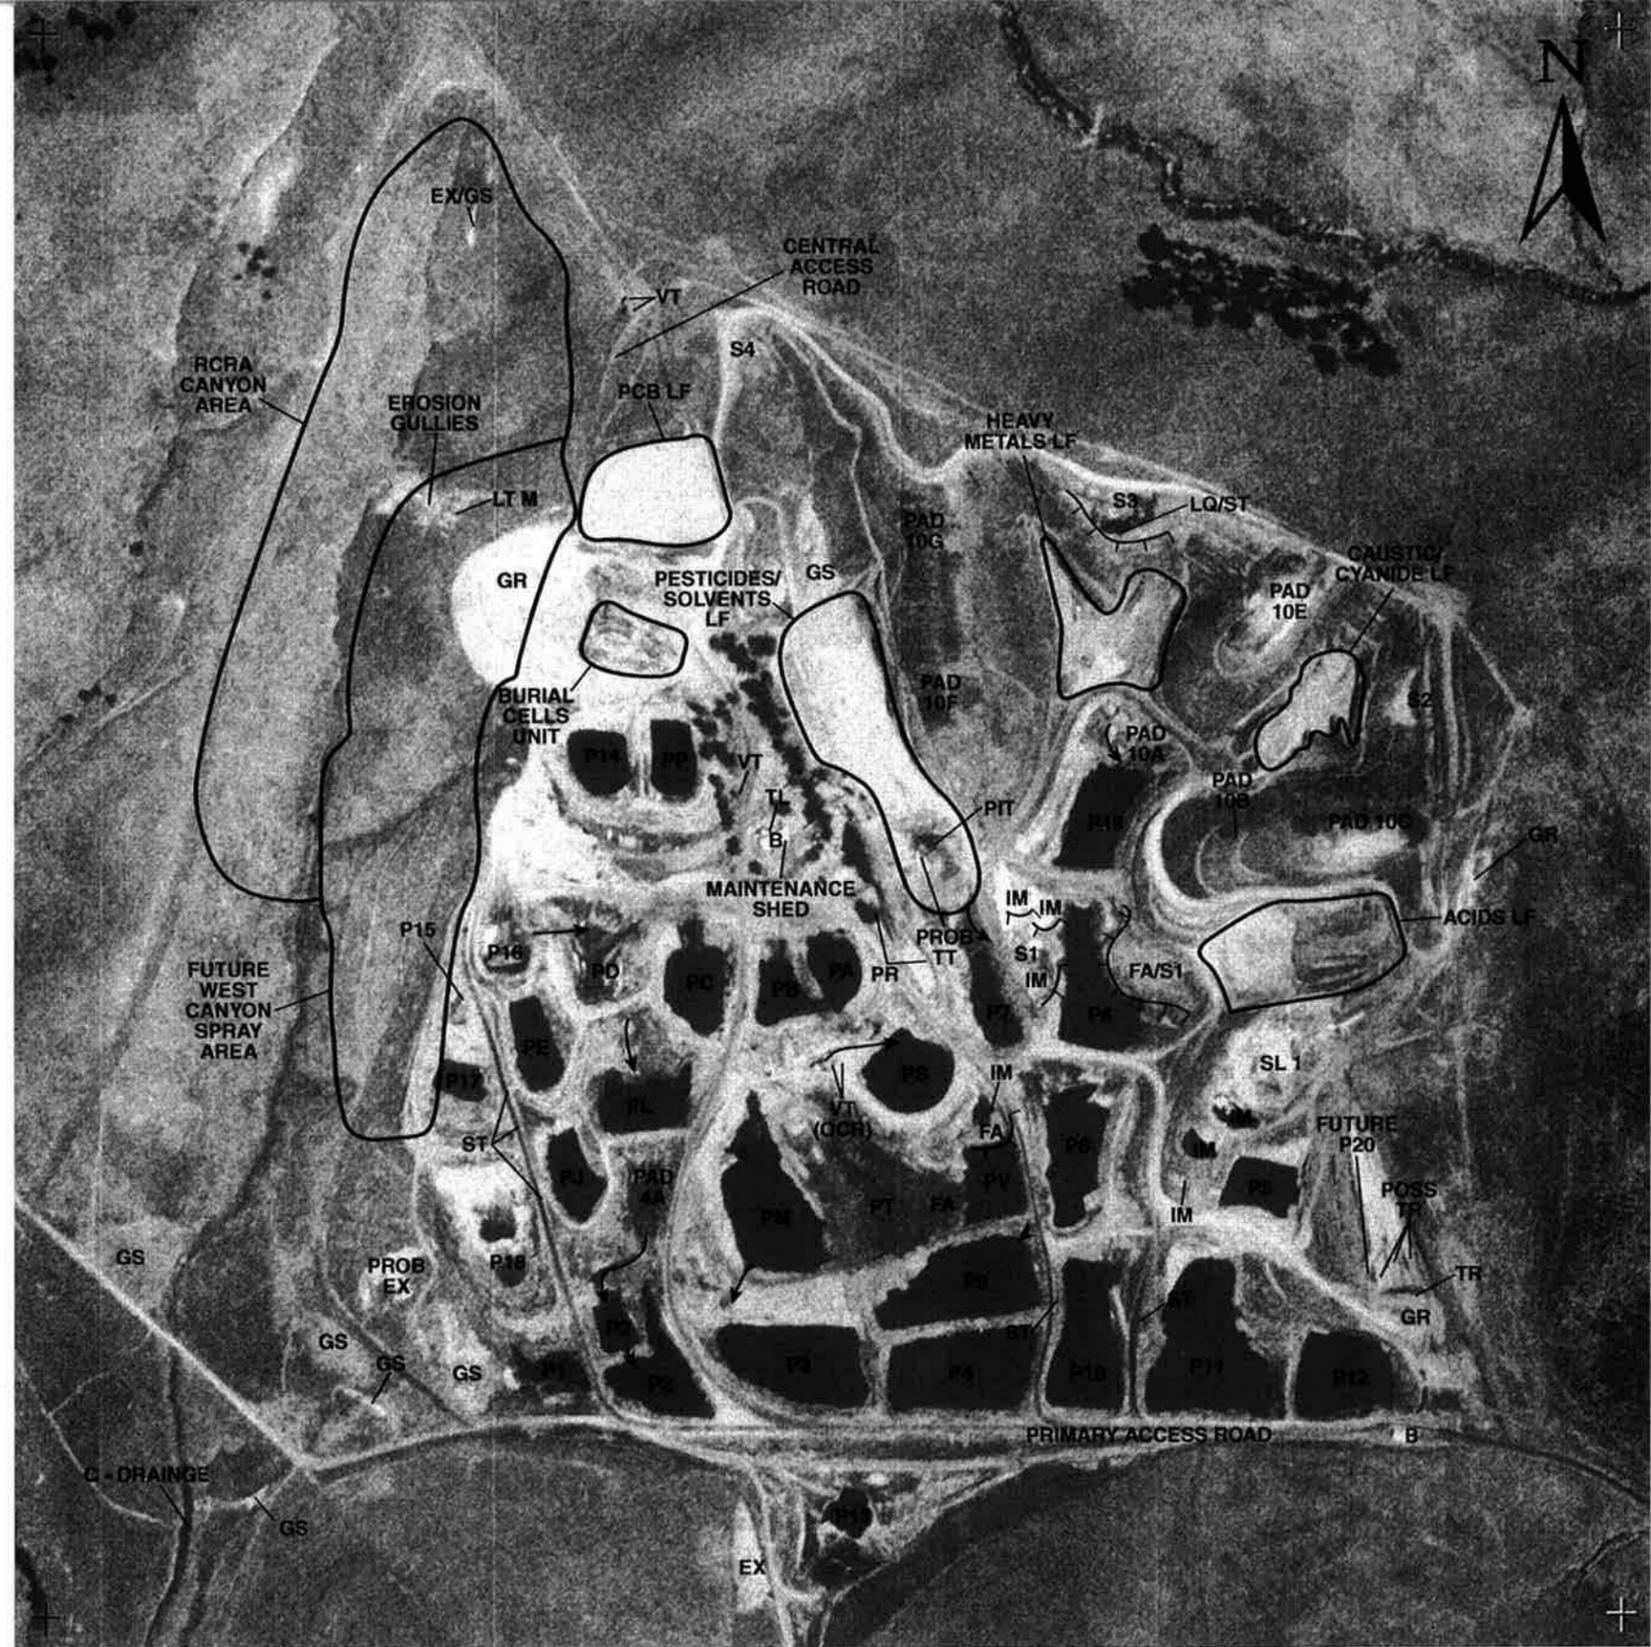
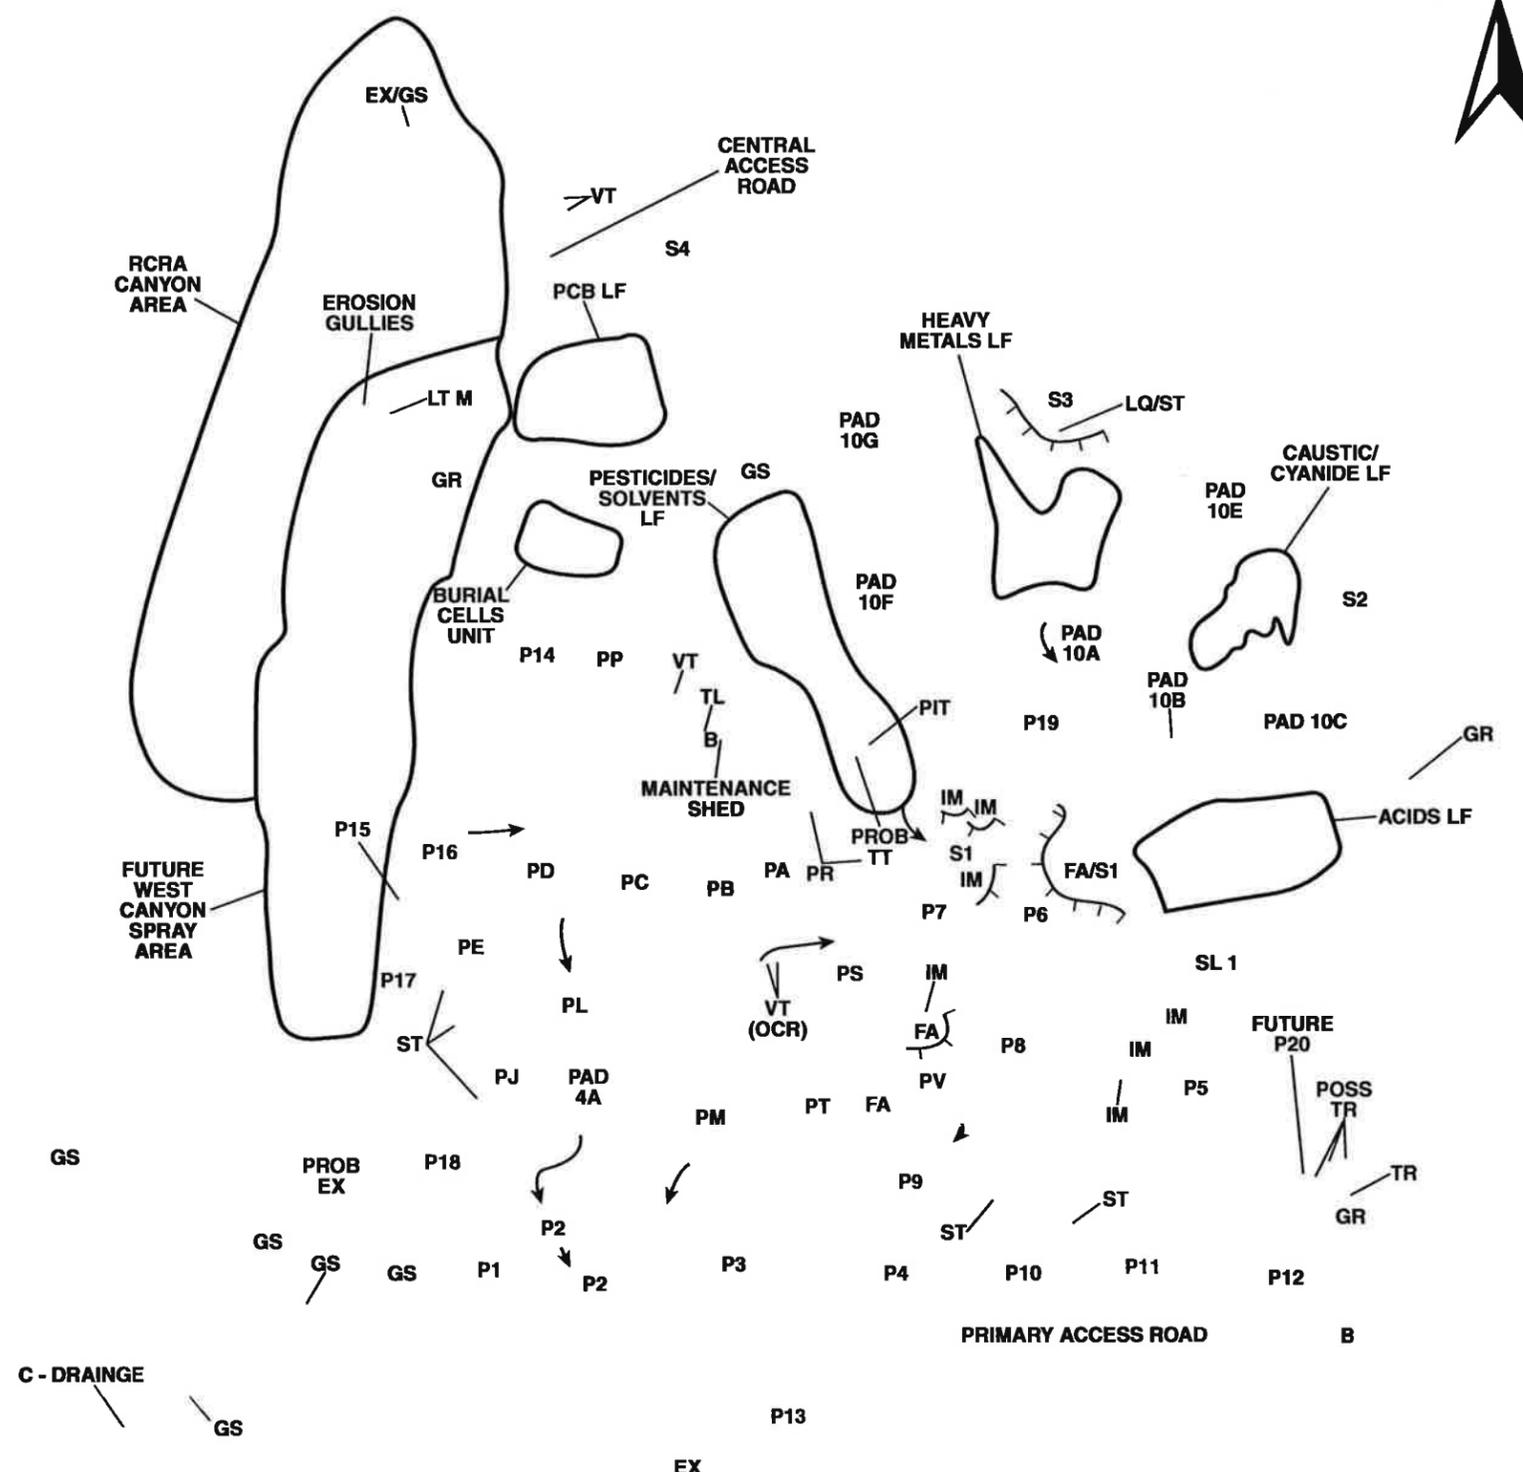
JUNE 18, 1981
FRAME: 61

Staining is seen on an access road in the western portion of the site between P17 and PE and PJ and on both sides of P10. Two vertical tanks remain on a hill in the northwestern portion of the site. A trailer at the administration building area has been removed.

P23	Not visible.
PA-1	A ground scar is visible in this vicinity.
PA-2	A ground scar is visible in this vicinity.
PA-3	A ground scar is visible in this vicinity.
PA-4	A ground scar is visible in this vicinity.
PA-5	A ground scar is visible in this vicinity.
PA-6	A ground scar is visible in this vicinity.
PA	Liquid is visible in the pond. Dark-toned liquid and staining or material are visible on the northern berm.
PB	Liquid is visible in the pond. Dark-toned liquid and staining or material are visible on the northern berm.
PC	Liquid is visible in the pond. Dark-toned liquid or material is visible on the northern berm.
PD	The pond contains light-toned material or sludge.
PE	Liquid is visible in the pond.
PJ	Liquid is visible in the pond.
PL	Liquid is visible in the southern portion of the pond. Light-toned material or sludge is visible in the northern portion. A drainage channel enters the pond from near PD .

PM	Liquid is visible in the pond. Dark-toned liquid or staining is visible in the northern portion of the pond near the northern berm. A stained area extends south from the southwest portion of the pond toward P3 .

PP	Liquid is visible in the pond. Dumping areas are visible in the eastern part of the northern berm and at the southeast corner of the pond.
PR	The pond now consists of two areas linked by a probable drainage channel. The northern part contains liquid and the southern part contains light-toned material or sludge.
PS	Liquid is visible in the pond. A drainage channel remains visible and extends from near the oil recovery unit east into the northern portion of PS .
PT	A fill area with staining is visible.
PV	Liquid is visible in the pond. Fill areas extend into the northern and western portions of the pond. An impoundment is seen north of the pond, created by the northern fill area.
PAD 4A	An impoundment containing areas dark-colored material or staining and possible liquid remains in this location. The pad drains to P2 .
PAD 8A	Graded.
PAD 10B	Possible staining is visible on this pad.
PAD 10C	Staining and a ground scar are visible on the pad.

PAD 10E	Probable staining and a ground scar are visible on this pad.
PAD 10F	Probable staining is visible on this pad.
PAD 10G	Probable staining is visible on this pad.
SL1	Light-toned sludge is visible in an impounded area in the northern portion of this area. Two other impounded areas are seen to the southwest. The northern one contains liquid and light-toned material. The southern one contains turbid liquid. Another impounded area farther to the south contains light-toned material or sludge.
MAINTENANCE SHED AREA	A vertical tank remains visible northwest of the Maintenance Shed. A trailer is also seen north of the shed. It cannot be determined whether the two probable horizontal tanks and one probable horizontal tank remain in this year of photography.
PCB LF	An excavated area is visible at the landfill. No other activity can be resolved.
PESTICIDES/ SOLVENTS LF	A pit with probable liquid is visible in the southern portion of the landfill. A probable tank trailer is seen backed up to the pit.

HEAVY METALS LF	Graded are visible.
CAUSTIC/ CYANIDE LF	excavating and filling continue northward.
ACIDS LF	Graded fill material is noted near the fill face.
Burial Cells Unit	Ground scars are seen in this area.
RCRA CANYON	A ground scar or excavation is seen in the RCRA Canyon area.

S1	Three impoundments are visible and contain light-toned material or sludge. The southernmost impoundment also contains liquid or staining.
S2	Light-toned material seen below access road on side of hill.
S3	A fill area with liquid and staining on it is seen on the side of the hill.
S4	Possible light-toned material is seen below an access road.
S5	Not visible.
S6	Not visible.

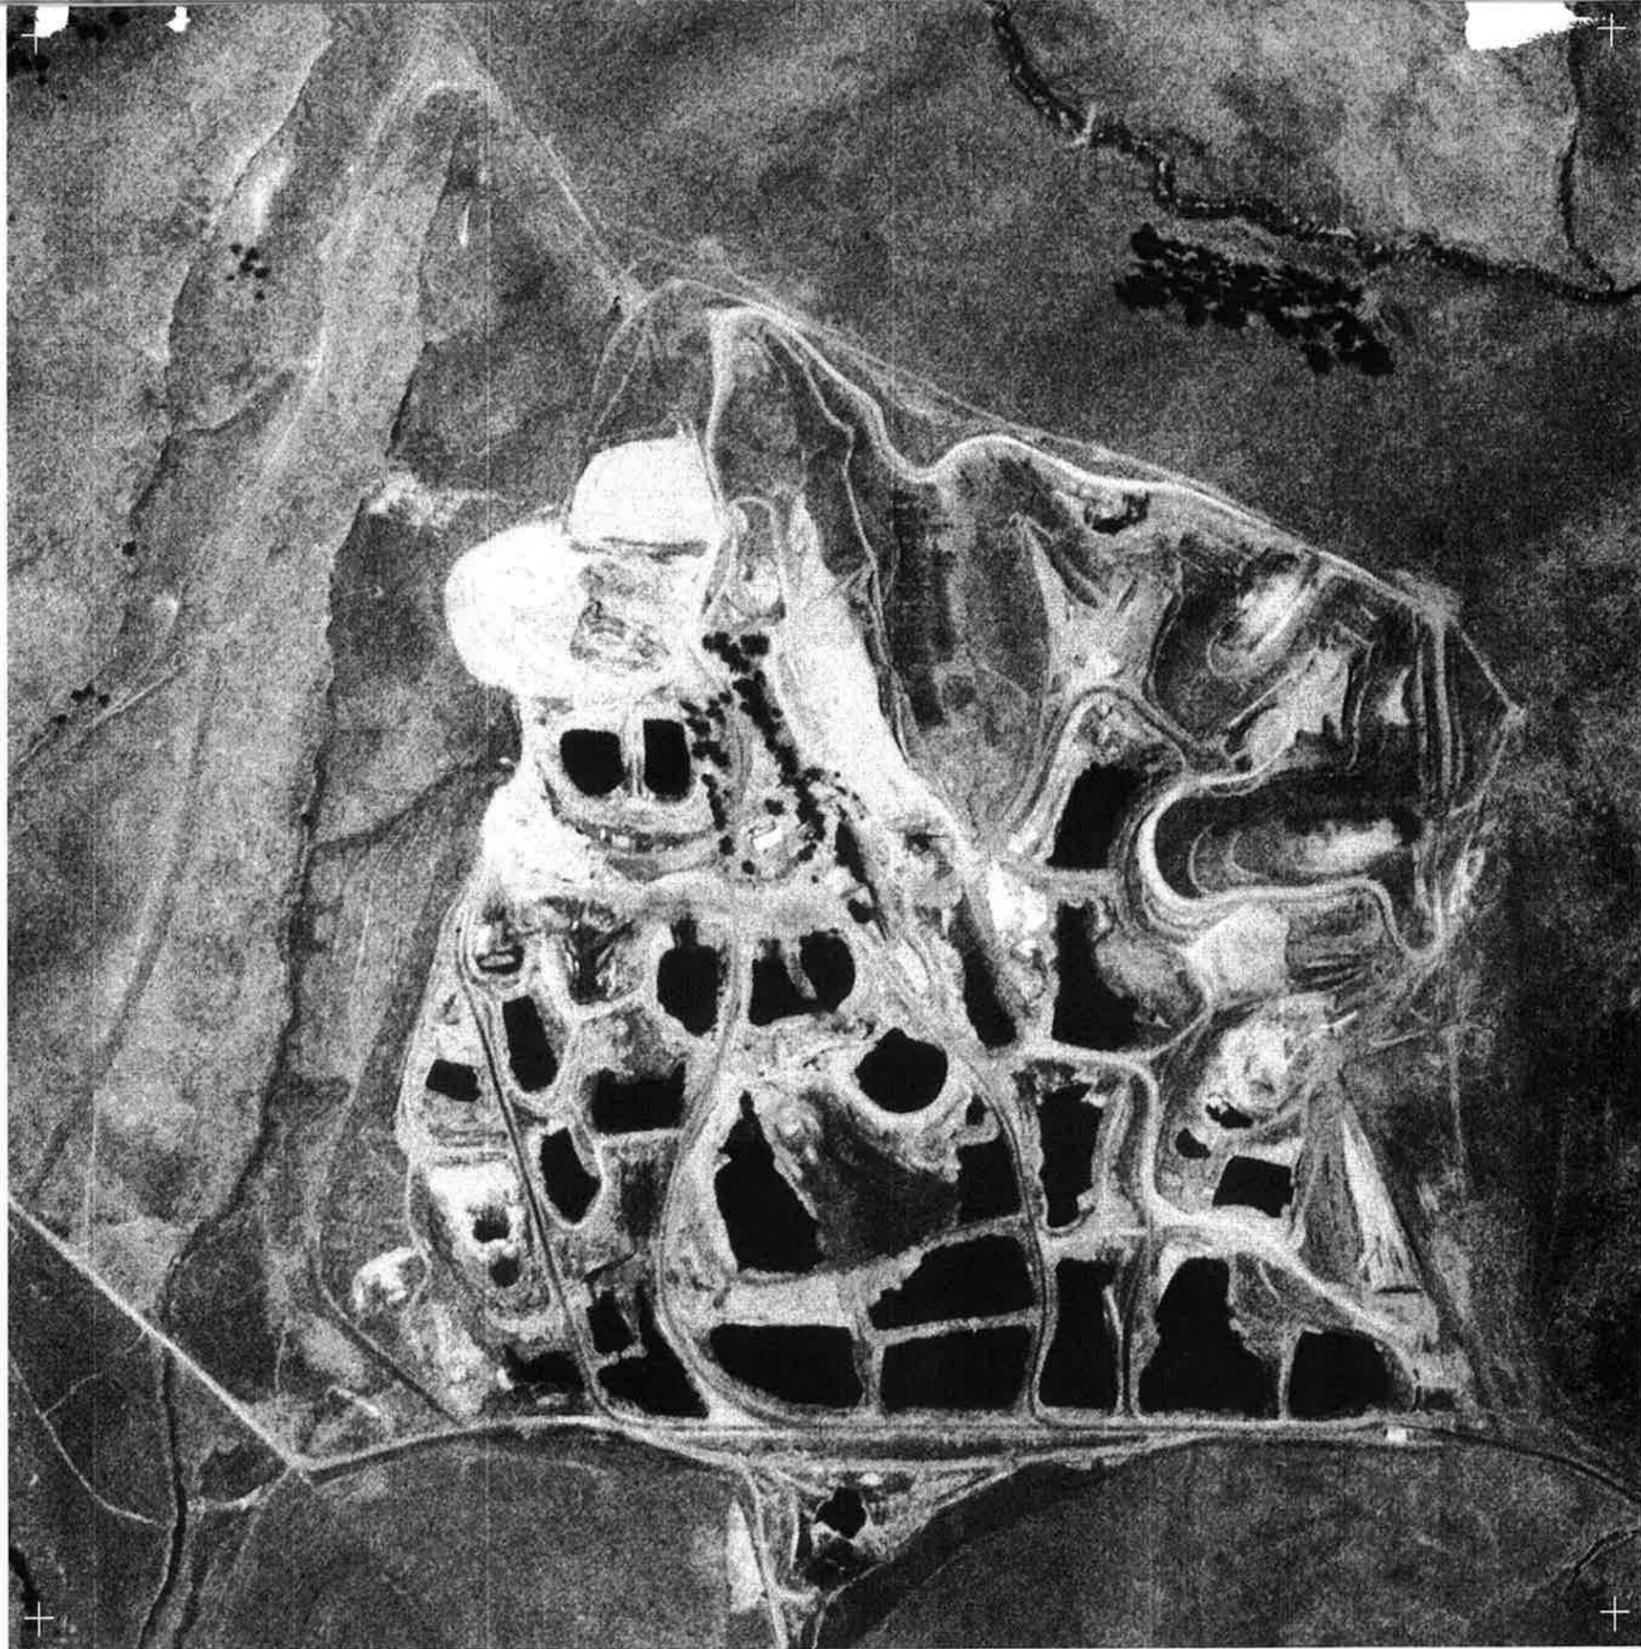
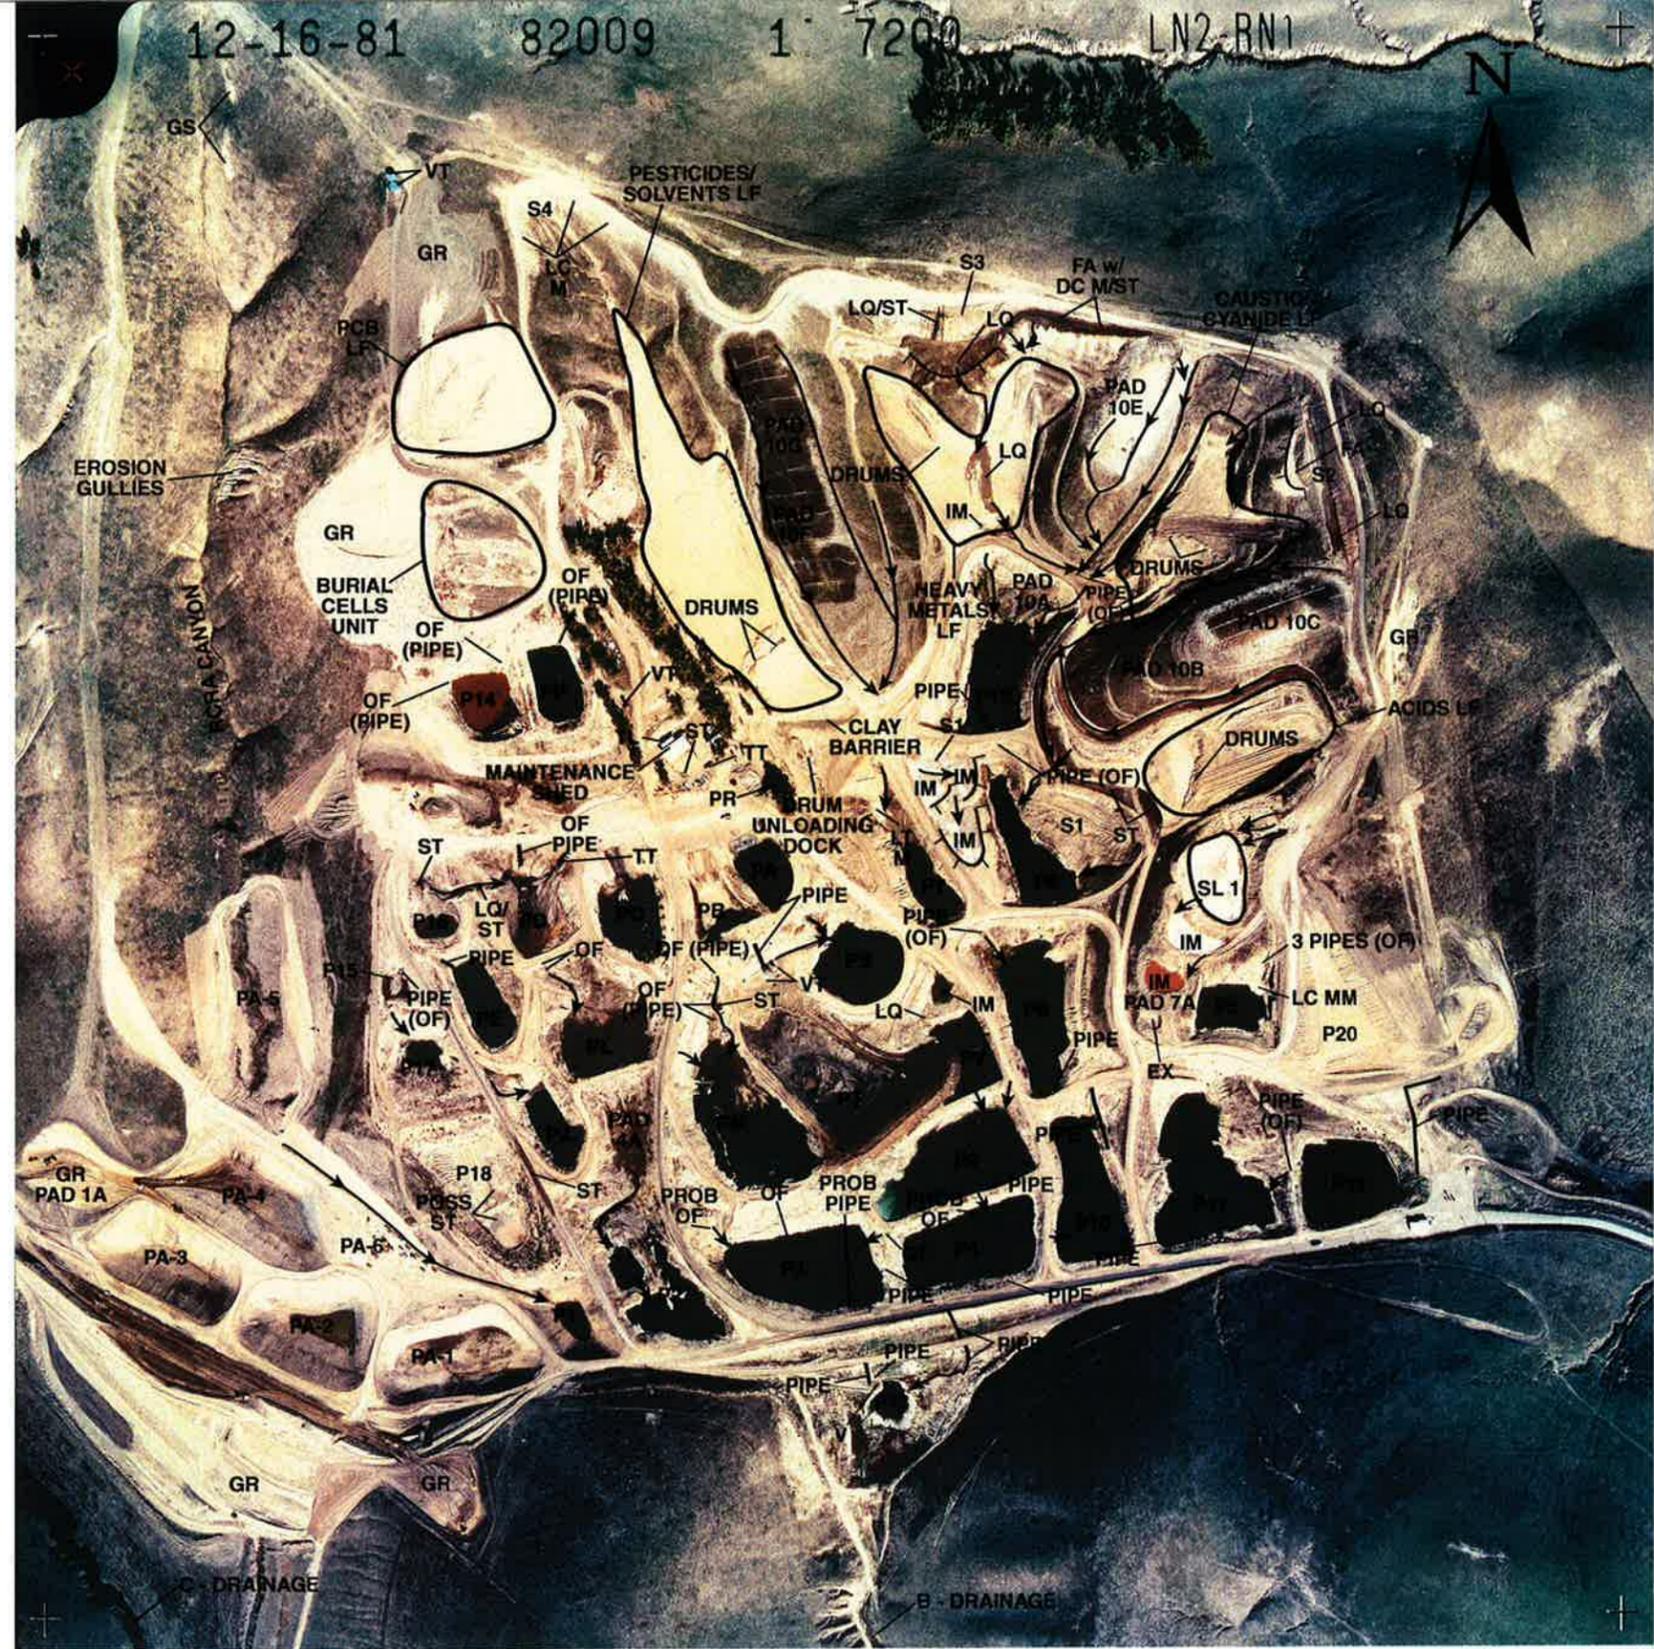
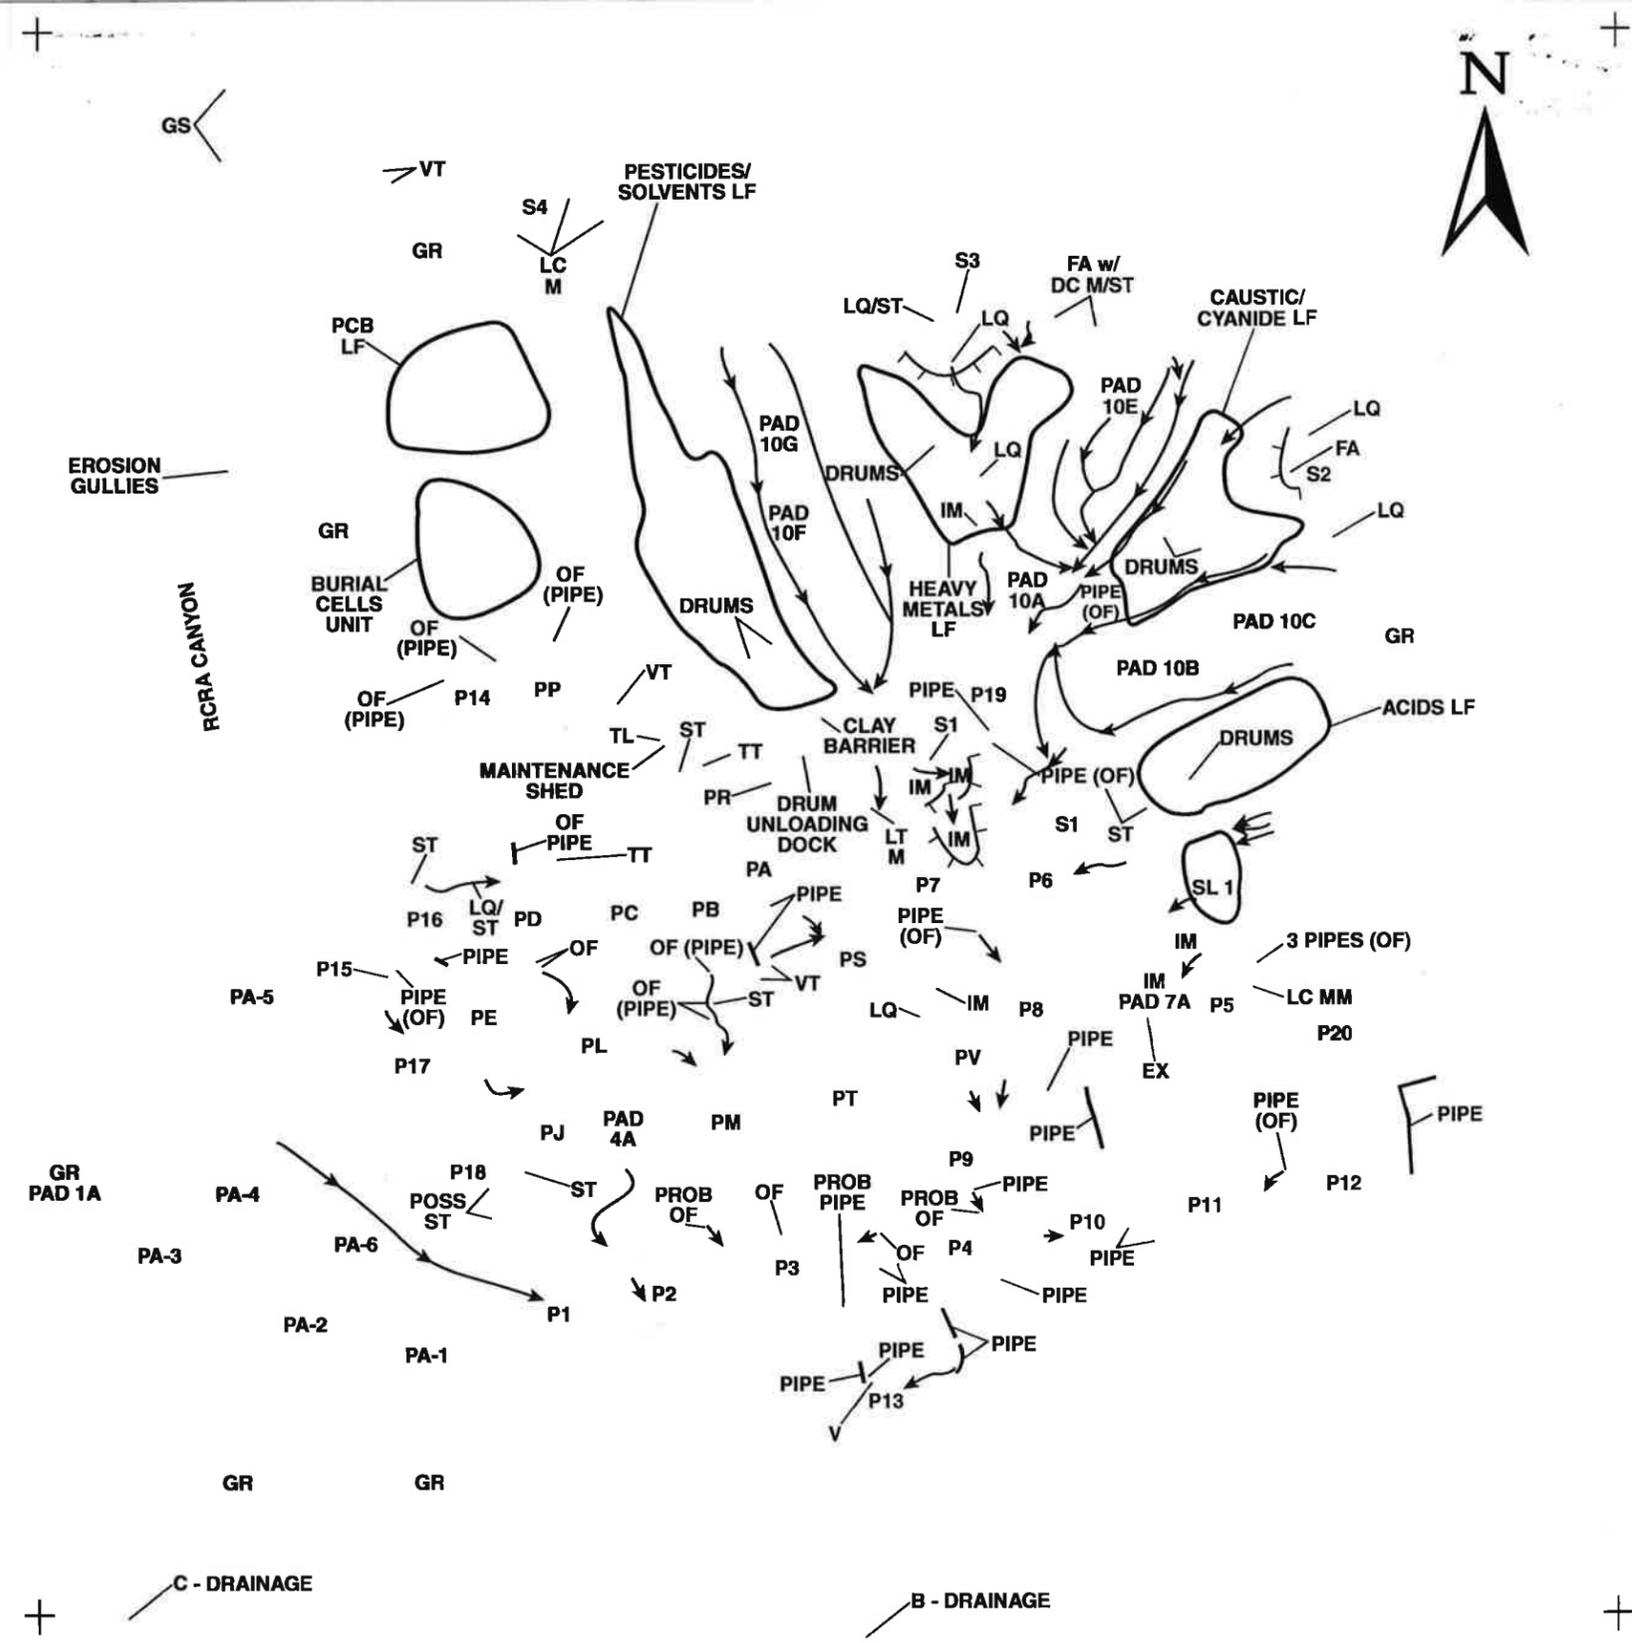
DECEMBER 16, 1981
FRAME: 6

A graded area is seen east of the Acids Landfill. Two horizontal tanks remain on the hill in the northern portion of the site. Staining is seen on an access road west of the Acids Landfill.

P17	Liquid is visible in the pond. A pipe is seen in the southern portion of the pond. Liquid is visible in the pond. A drainage channel enters the northwestern portion of the pond.
P18	The pond is graded and contains possible staining. Staining is also visible along the access road east of the pond.
P19	Liquid is visible in the pond. Drainage channels lead to the northern portion of the pond. A drainage channel in the northwest contains reddish/brown liquid. An outfall pipe is seen at the head of the drainage channel in the northeastern corner.
P20	The area is excavated for a future pond.

PA-1	The area is excavated for a future pond. Contains small amount of liquid.
PA-2	The area is excavated for a future pond. Contains small amount of liquid.
PA-3	The area is excavated for a future pond.
PA-4	Active grading for future pond is noted.
PA-5	Pond partially graded for future use.
PA-6	Pond not visible. This area serves as a parking area.
PA	Liquid is visible in the pond. Liquid is being discharged from a pipe (not annotated) on the northern berm. A pipe is also seen on the southern edge of this pond.
PB	The contents of the pond have been removed and the pond bottom is graded. A pipe (not annotated) is visible in the southern portion of the pond bottom. Staining or dark-colored material and light colored material are visible on the northern berm.
PC	A pipe (not annotated) is discharging liquid onto the northern berm of the pond. A pipe (not annotated) also borders the eastern edge of the pond. The pond contains liquid. Light- and dark-colored material are seen in the northern portion of the pond near the discharge point.

PP	Liquid is visible in the pond, most of which is turbid and green. An bulldozer (not annotated) is seen north of the pond near the dumping area. An outfall pipe is visible at the north end of the pond. Another dumping area is noted at the southwestern berm.

PAD 1A	Pad is graded.
PAD 4A	Pad is vegetated.
PAD 7A	SL1 currently visible in this area.
PAD 10A	Not visible.
PAD 10B	No activity other than that associated with Pad 10C is observed.
PAD 10C	Pad contains piping, which is spraying liquid. Light-colored material is visible on the pad. Staining is also noted on the pad.
PAD 10E	Pipes, liquid, staining, and light-colored material are seen on the pad. Drainage from the pad flows south to an underground culvert that most likely empties in a pipe seen northwest of P19 .
PAD 10F	Staining is noted around pipes, which are spraying liquid. Drainage channels containing liquid lead to the south.
PAD 10G	Staining is noted around pipes, which are spraying liquid. Drainage channels containing liquid lead to the south.
SL1	Light-colored sludge is visible in an impoundment in the northern portion of this area. Two other impoundments are observed to the southwest. The northern one contains light-colored sludge. The southern one contains turbid red/brown liquid. An excavation is noted in an area farther to the south contains light-toned material or sludge.

MAINTENANCE SHED AREA	A tank trailer with staining adjacent to it is visible southeast of the maintenance shed. Additional staining is noted to the west. A trailer remains visible north of the shed. A vertical tank remains visible northwest of the shed.
PCB LF	No active waste disposal is noted.

PESTICIDES/ SOLVENTS LF	Approximately 300 drums are visible at the fill face. A linear slightly bermed area of medium-toned material is seen south of the landfill. A linear area of medium-toned material (the clay barrier) is seen south of the landfill.
HEAVY METALS LF	Liquid and staining originating from S3 drains through this area. Some of the liquid is in an impoundment (seen previously). The liquid drains south where it joins drainage from Pad 10E. Approximately six drums are visible at the fill face of the landfill.
CAUSTIC/ CYANIDE LF	Approximately 20 drums are visible at the fill face of the landfill. Drainage from S2 enters the northern portion of the landfill.
ACIDS LF	Approximately 150 drums are visible at the fill face of the landfill.
Burial Cells Unit	Eight well caps are seen in this area.
RCRA CANYON AREA	Two ground scars are visible in the northern portion of this area.
S1	The area east of P6 is graded and does not appear to contain waste materials. Three impoundments containing light-colored material or sludge are visible in the area west of P6 . Both of the northern impoundments drain to the southern one.

S2	A graded fill area is observed on the side of the hill. Liquid seen along an access road up gradient from the fill area. Some of the liquid drains down gradient towards the Caustic/Cyanide Landfill.
S3	Liquid is seen in a fill area on the side of a hill. The fill area contains dark-colored material. Staining is seen on an access road north of the fill area (up gradient). Another access road on a fill area is seen on the hill to the northeast.
S4	Light-toned material is seen on the hill down gradient from an access road.
