**AERIAL PHOTOGRAPHIC ANALYSIS
CASMALIA DISPOSAL SITE
CASMALIA, CALIFORNIA**

August 25, 2003

**Prepared for:
The Casmalia Resources Site
Steering Committee (CSC)**

**Prepared by:
Environmental Research, Inc.
5267 John Marshall Highway
Suite C
Linden, VA 22642**

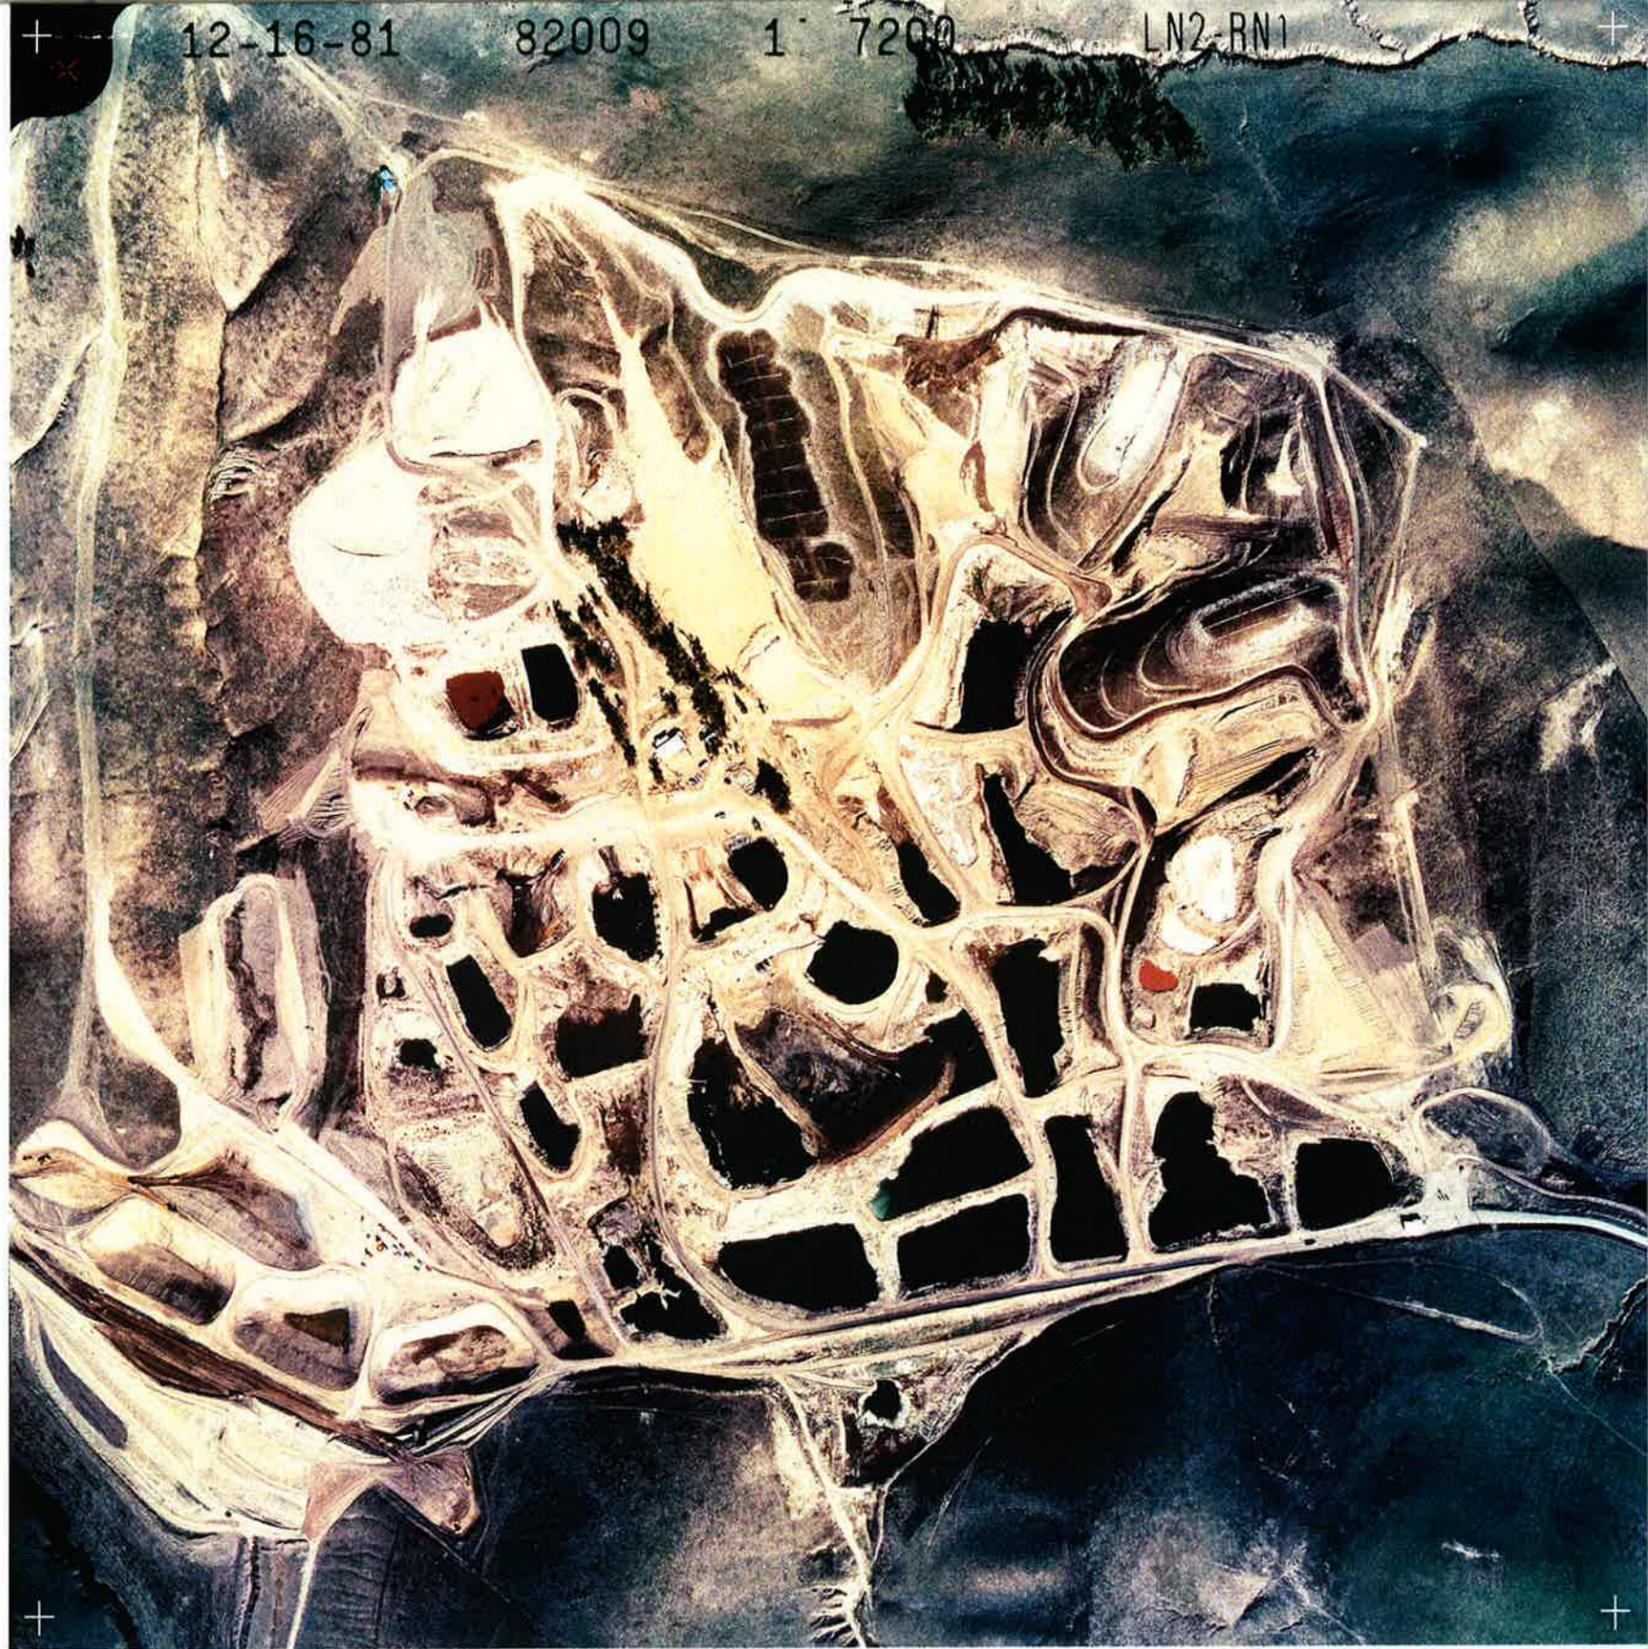
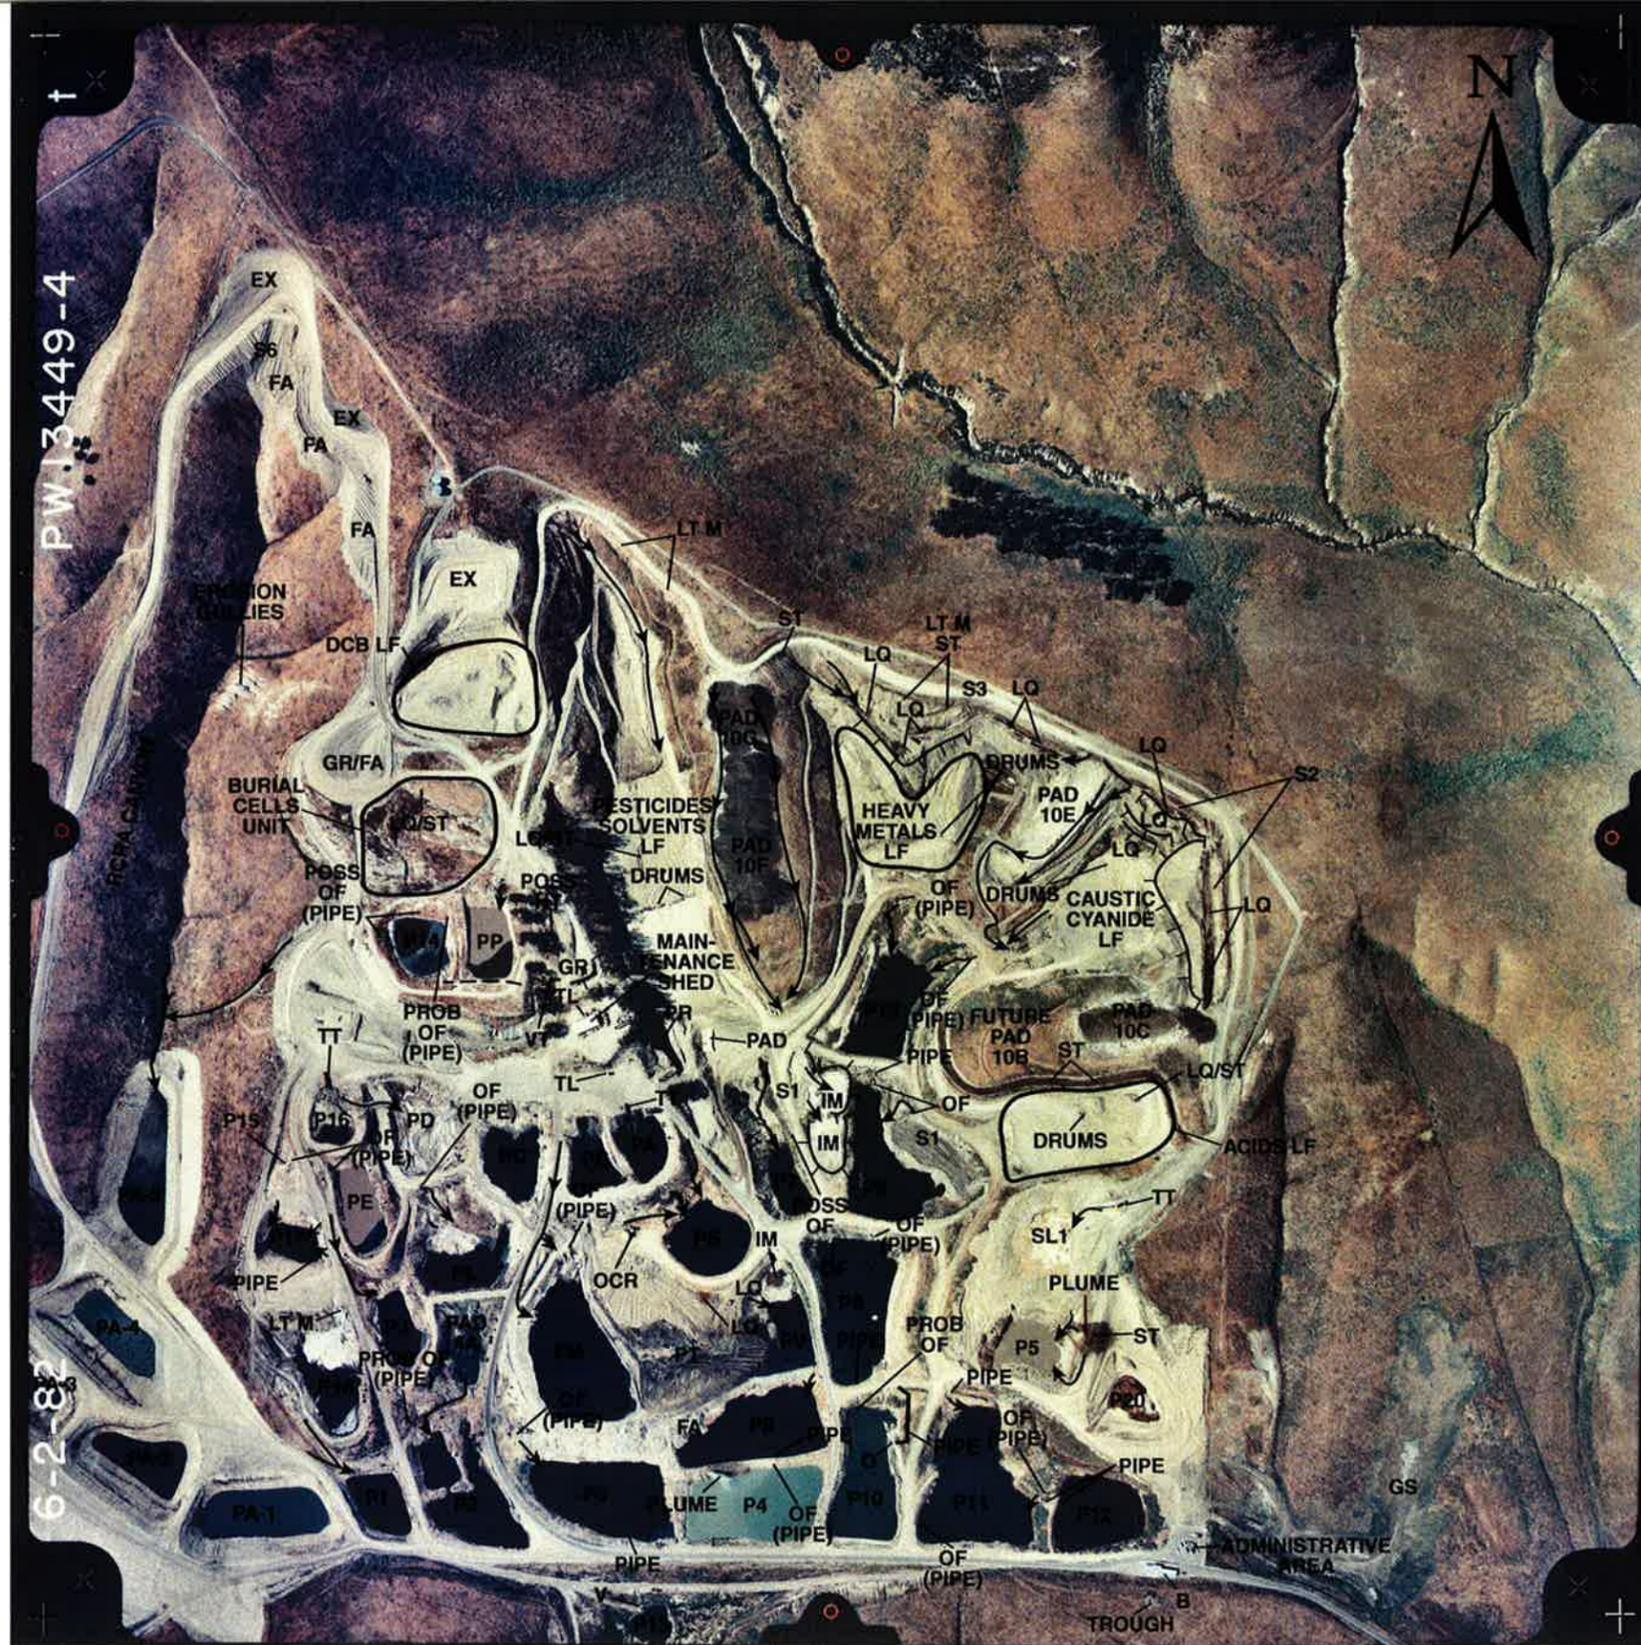
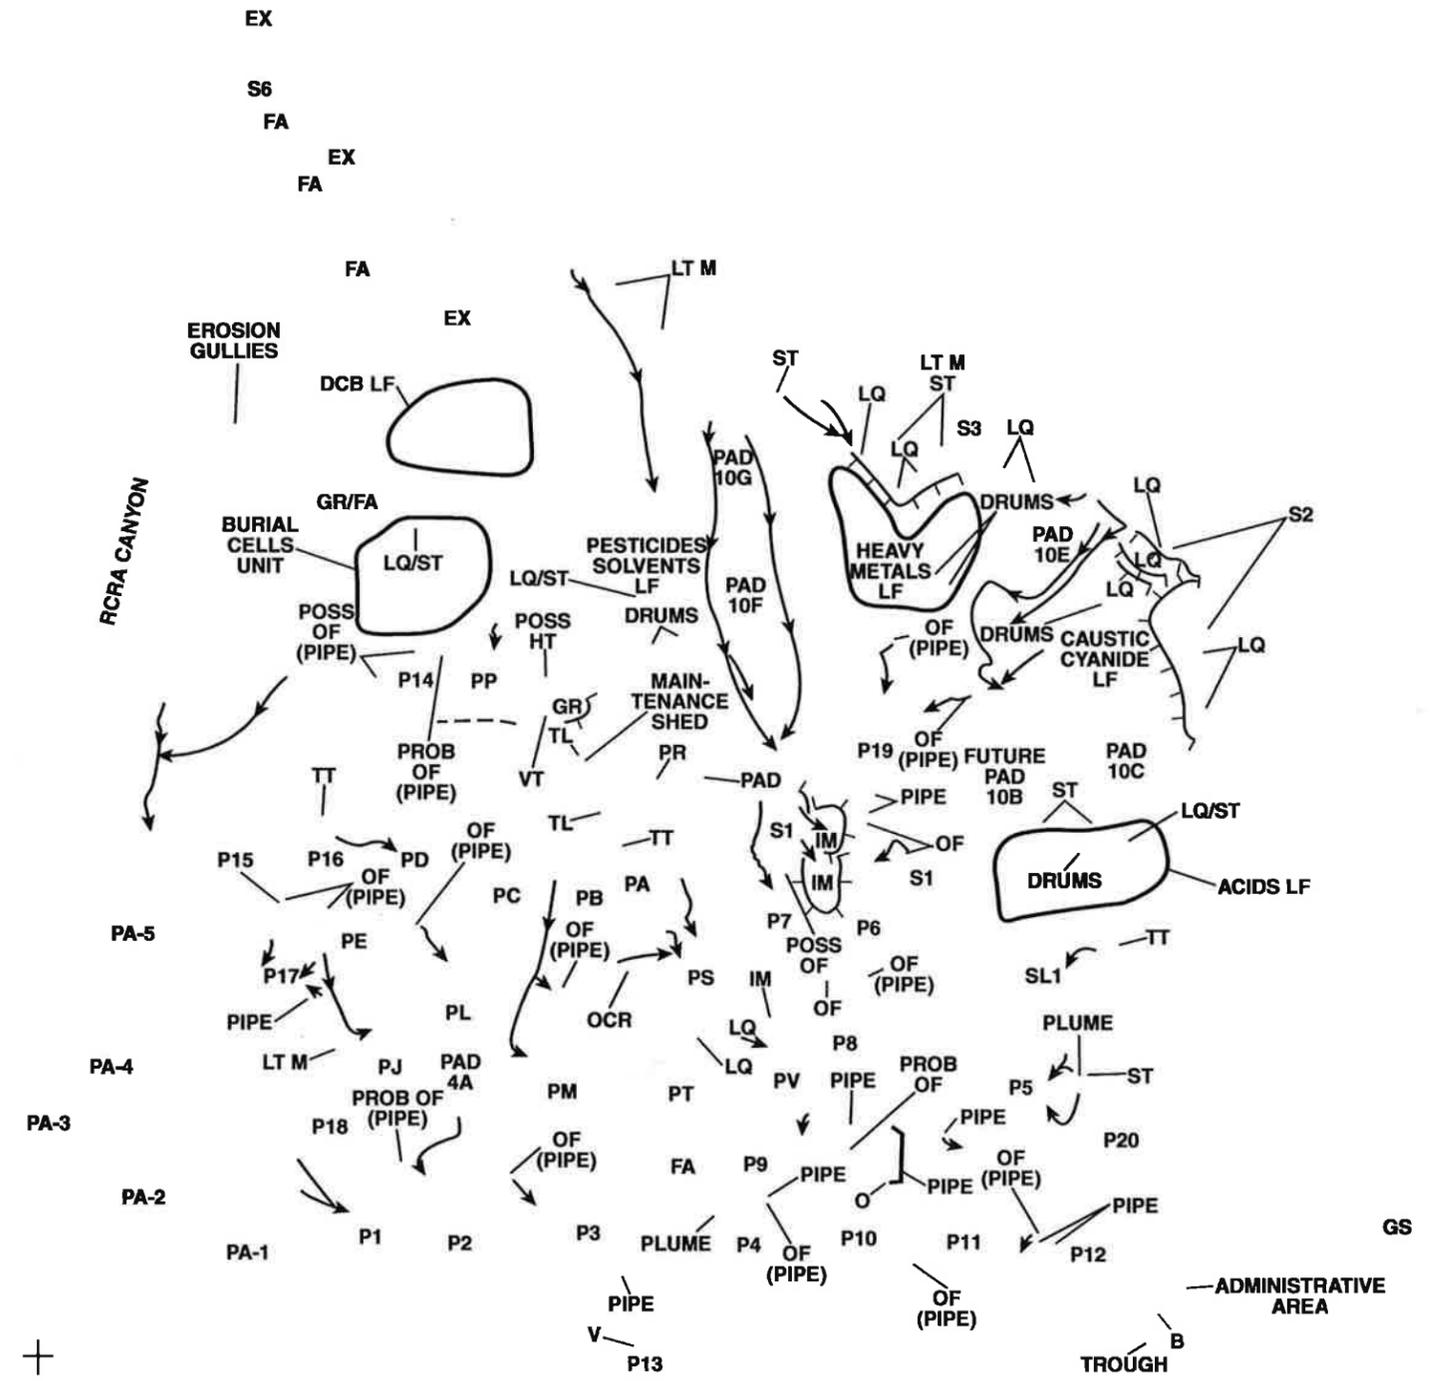
JUNE 2, 1982
FRAME: 4

Annotation	Description
P1	Liquid is visible in the pond. The pond receives drainage from a drainage channel that enters from the northwest. A pipe (not annotated) leads from the east to this pond. A pipe (not annotated) is also seen on the western berm.
P2	P2 is made up of two impounded areas, which are connected by a drainage channel. Liquid is visible in both impounded areas. A drainage channel extends from Pad 4A into the northern impoundment. A probable outfall from a pipe into the drainage channel is noted north of the pond. The drainage channel contains pooled liquid.

P13	Liquid is visible in the pond. An access road leads to this pond. A vehicle (V) is seen on the access road. Piping (not annotated) is seen near the vehicle.
P14	Two possible and one probable outfall pipes are visible in this pond. The pond contains liquid, some of which is turbid and light-colored. An access road from PD leads to the dumping area in the southeast corner of the pond.
P15	An outfall pipe is seen on the northeastern corner of the pond. Light-colored material and liquid are seen in the pond. Liquid and staining are seen southwest of the outfall pipe.
P16	Liquid and gray and white material are visible in the pond. A tanker truck is seen backed up to the northern berm of the pond. A drainage channel leads from the pond to PD .
P17	Liquid is visible in the pond. A pipe is seen in the southern portion of the pond. Three drainage channels lead into the pond.
P18	Liquid is visible in the pond. Light-colored material or sludge is visible on the northern berm and extends into the pond.

PB	Liquid is visible in the pond. Staining is visible on the northern berm.
PC	Gray and brown material is visible on the northern berm of the pond. Gray, white, and brown material are visible in the northern portion of the pond. The remainder of the pond contains liquid.

PAD 10C	The pad contains piping. Staining is noted on the pad.
PAD 10E	Pipes and light-colored material are seen on the pad. Liquid is seen in drainage channels surrounding the pad, which lead down gradient to the south.
PAD 10F	Staining is noted around pipes, which are spraying liquid. Drainage channels containing liquid lead to the south.

PAD 10G	Staining is noted around pipes, which are spraying liquid. Drainage channels containing liquid lead to the south.
SL1	Light-colored sludge is visible in an impoundment in the northern portion of this area. A tanker truck is backed up to the northeastern berm of the pond. This impoundment has expanded and incorporated the two impoundments previously seen to the southwest.
MAINTENANCE SHED AREA	A trailer is seen north and south of the Maintenance Shed Building. A graded area, vertical tank, and a possible horizontal tank are seen to the north. Drums (not annotated) are being stored adjacent to the north side of the maintenance shed.
PCB LF	No active waste disposal is noted. An excavation is seen north of the landfill. This area is probably being excavated for fill material in the landfill.
PESTICIDES/ SOLVENTS LF	Approximately 250 drums are visible at the fill face; some are partially covered with fill material. Active grading is seen in the landfill. Liquid and staining are noted on the landfill.

HEAVY METALS LF	Approximately 30 drums are seen at the fill face; some are partially covered with fill material. Active grading is seen in the landfill. Liquid and staining are noted in a graded area in the northeastern corner of the landfill.
CAUSTIC/ CYANIDE LF	Approximately 20 drums are visible at the fill face of the landfill.
ACIDS LF	Approximately 20 drums are visible at the fill face of the landfill. Liquid and staining are noted in the eastern portion of the landfill.
BURIAL CELLS UNIT	Five probable well caps are seen in this area. Liquid and staining are seen in the northern portion of this area.
RCRA CANYON	Erosion gullies remain visible in the northern portion of this area.
RCRA Landfill	No activity is notes here that is not related to S6 .
S1	The area east of P6 is graded stained. Three impoundments containing light-colored material or sludge are visible in the area west of P6 . Both of the northern impoundments drain to the southern one.

S2	This area contains three terraces of light-colored fill material with graded areas on them. The graded areas contain liquid. This liquid appears to have been dumped from the perimeter road that surrounds the site. Light-colored material and staining are seen south of the perimeter road.
S3	This area contains a large terrace with light-colored fill material. The terrace is graded and contains liquid. This liquid appears to have been dumped from the perimeter road that surrounds the site. Light-colored material and staining are seen south of the perimeter road.
S4	Light-toned material and liquid are seen on the hill below a perimeter road surrounding the site. Drainage from the spreading area flows to the Pesticides/Solvents Landfill.

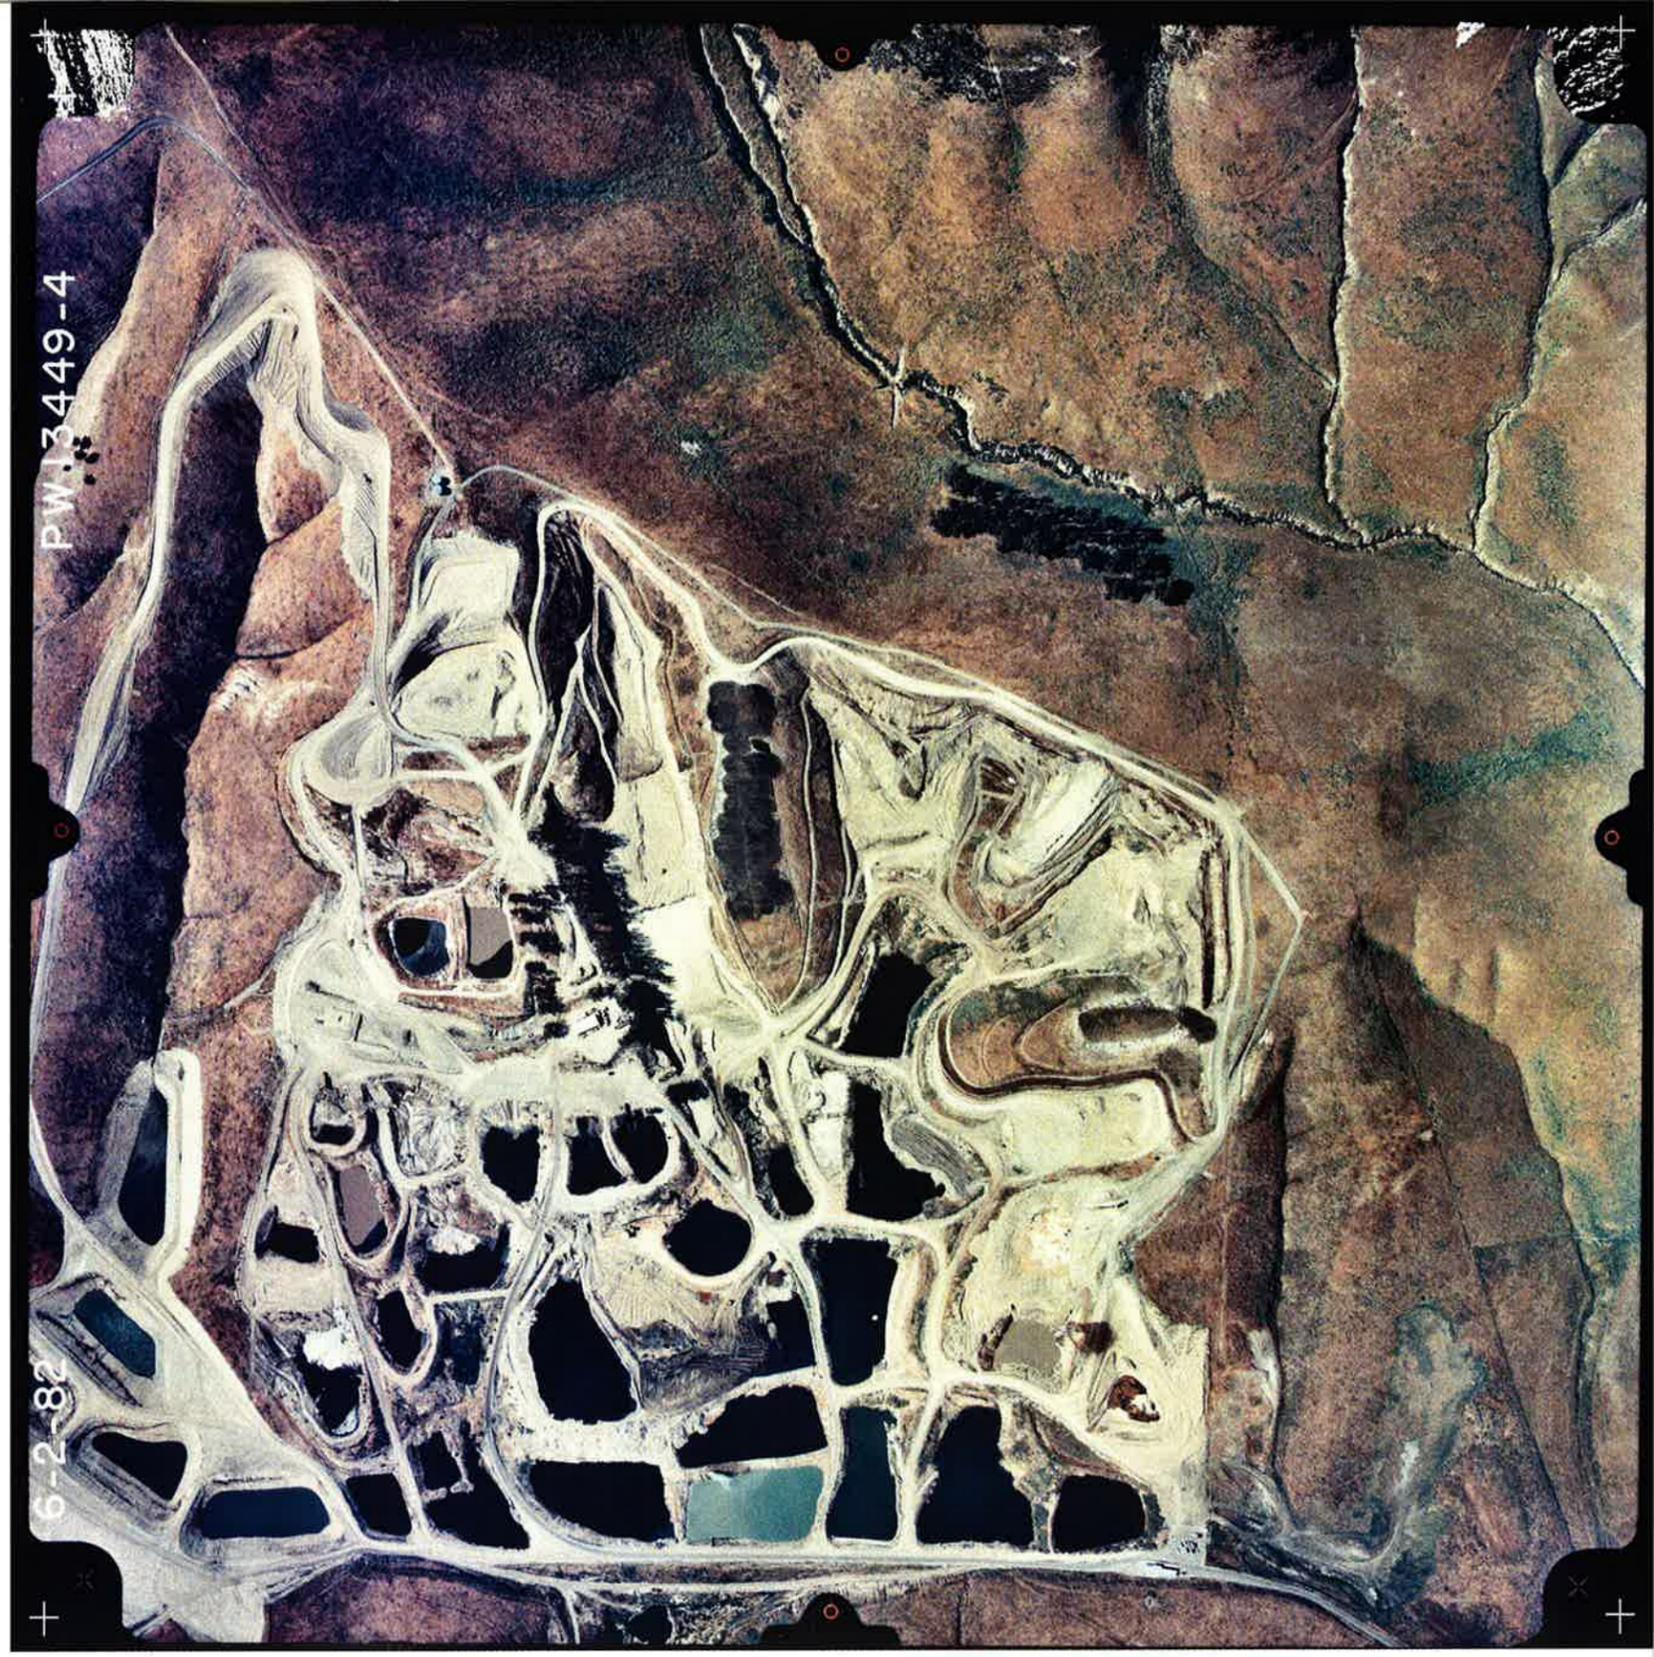
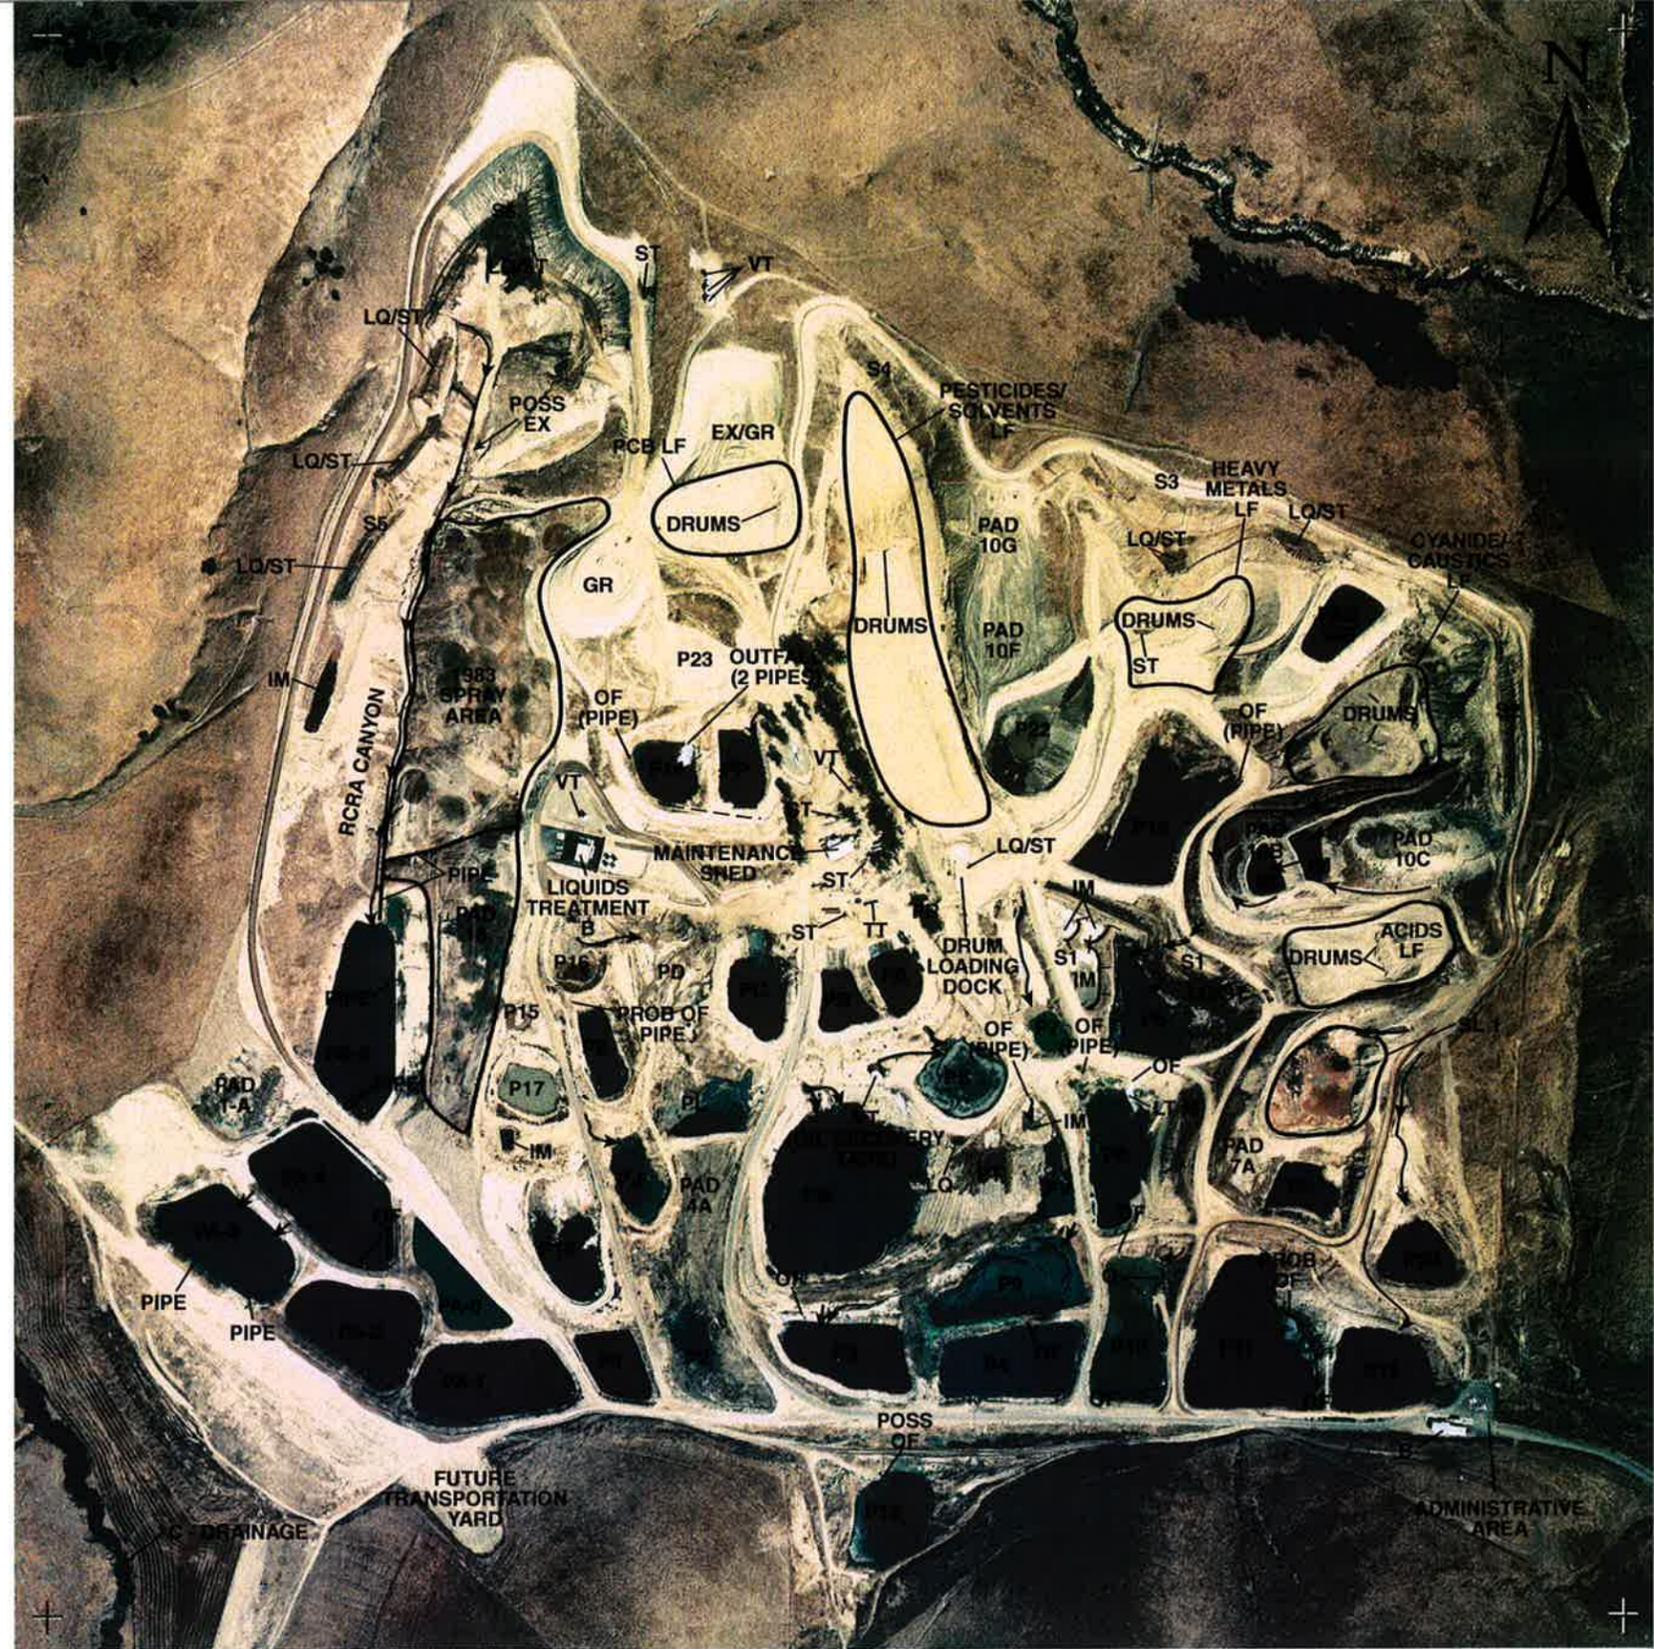
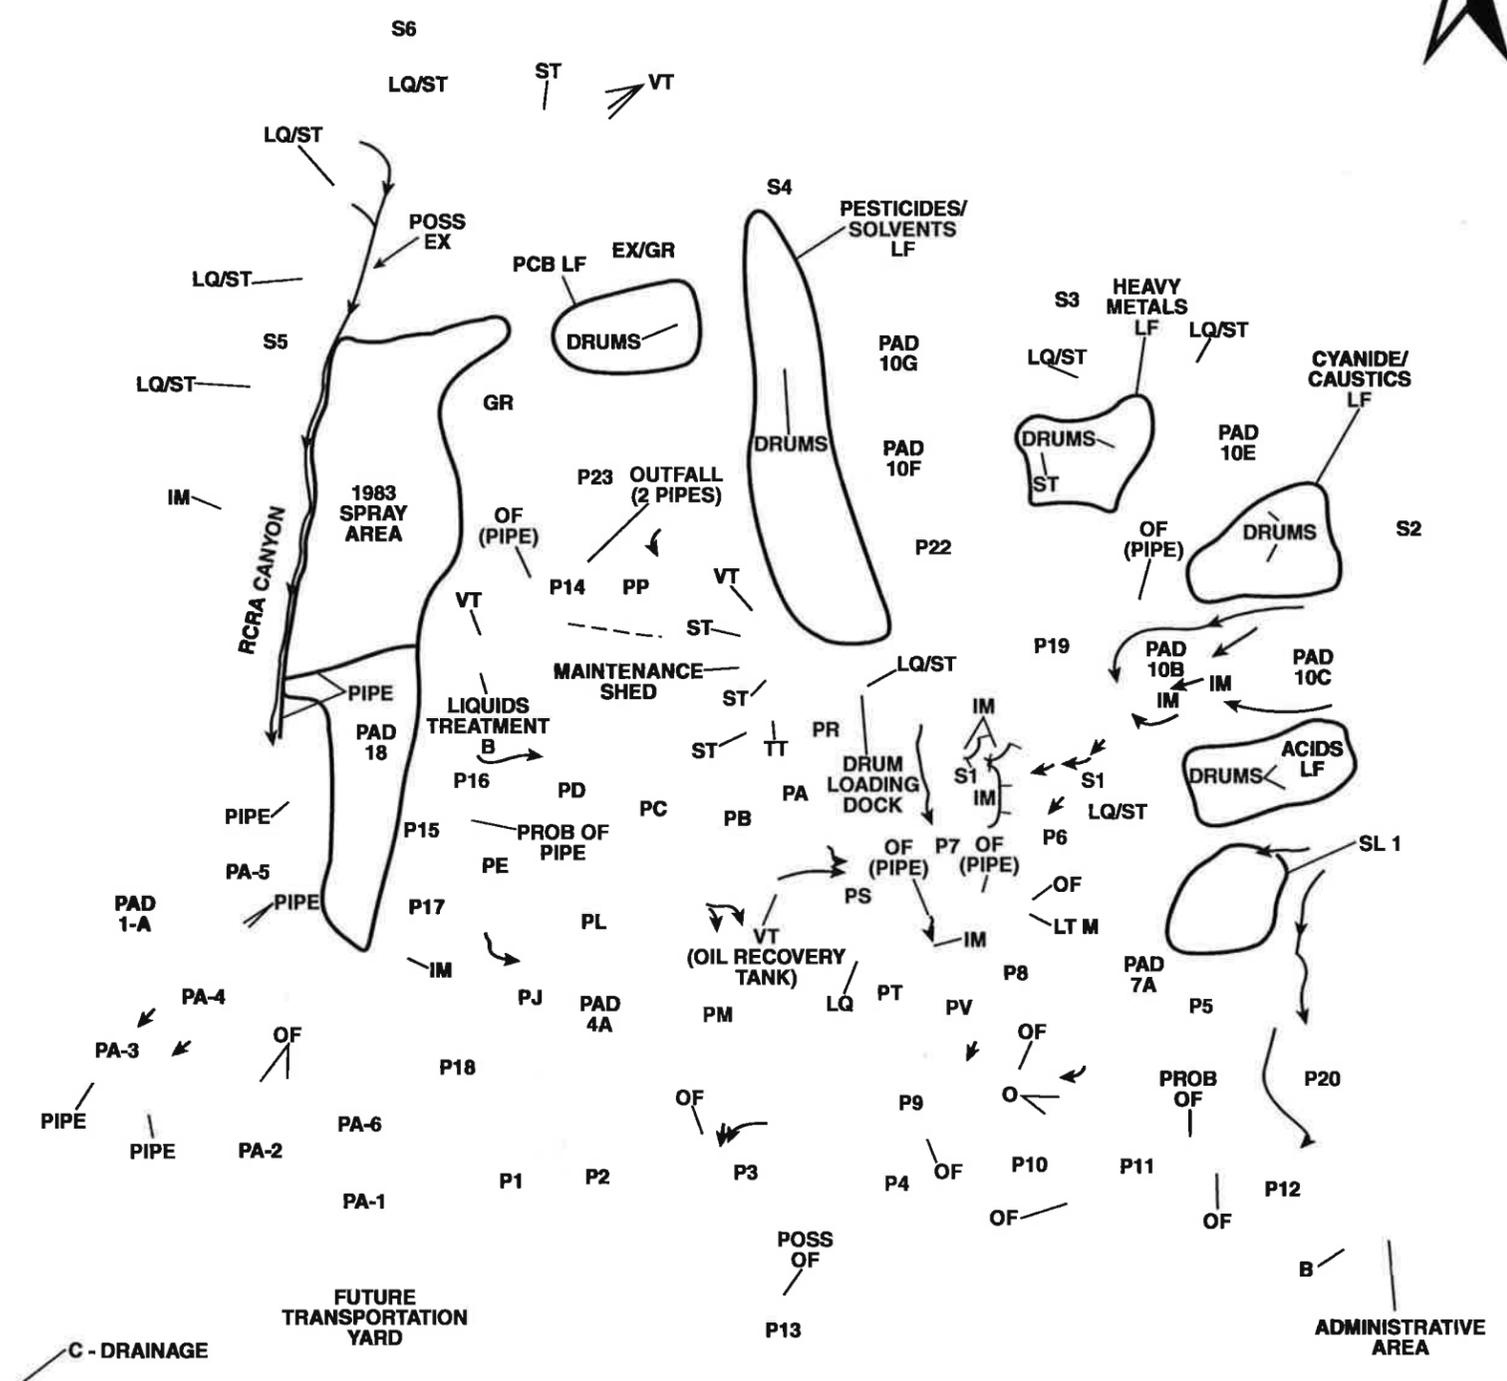
OCTOBER 6, 1983
FRAME: 1

Annotation	Description
P1	Liquid is visible in the pond.
P2	The pond is graded and contains liquid and staining in the graded areas. A large amount of liquid remains.
P3	Liquid is visible in the pond. An outfall is seen on the northern edge of the pond.
P4	Liquid is visible in the pond. An outfall is seen on the northern edge of the pond.
P5	Liquid is visible in the pond. Light-toned material is visible in the northeastern corner of the pond.
P6	Liquid and light-colored material are visible in the pond. S1 is seen on the eastern and western sides of the pond. S1 contains liquid and dark-colored staining and is in the process of being graded. Drainage channels are seen leading from S1 toward the pond.
P7	Pond contains green liquid. Light-colored material is seen in the northern portion of the pond. A drainage channel flows through the light-colored material.
P8	Liquid is visible in the pond. Two outfalls are seen along the northern edge of the pond. The eastern outfall is emanating light-colored liquid or material. A pipe (not annotated) is also seen along the southern edge of the pond.

P9	The pond contains liquid. A pipe (not annotated) surrounds the northern and western portions of the pond. Staining and liquid flow patterns are visible south of the length of the pipe along the northern boundary of the pond. A drainage pathway is seen in the northeast corner of the site.
P10	Liquid is visible in the pond. Two light-colored objects are visible in the pond. Outfalls are seen in the northern and the southern portion of the pond.

P11	Liquid is visible in the pond. An outfall and a probable outfall are noted in the eastern portion of the pond.
P12	Liquid is visible in the pond. A drainage channel north of the pond extends south toward the pond.
P13	Liquid is visible in the pond. A possible outfall pipe is seen in the northern portion of the pond.
P14	Liquid is visible in the pond. Three outfalls pipes are noted along the northern edge of the pond. An access road enters the southern portion of the pond. This area probably serves as a dumping area.
P15	Light-colored material and liquid are seen in the pond. Some of the liquid is brown.
P16	Liquid and gray and white material are visible in the pond. A pad with staining on it is seen north of the pond. A drainage channel leads from the pond to PD .
P17	Green liquid is visible in the pond. A pipe (not annotated) is seen in the southern portion of the pond.
P18	Liquid is visible in the pond. Multi-colored material or sludge is visible on the northern berm and washout pad and extends into the pond.

P19	Liquid is visible in the pond. An outfall pipe is seen in the northeastern corner of the pond.
P20	The pond contains liquid. A drainage channel leads to this pond from the north.
P22	Turbid liquid is visible in the pond. This pond is currently being graded.
P23	An area has been excavated in preparation for this pond.
PA-1	The pond contains liquid.
PA-2	The pond contains liquid.
PA-3	The pond contains liquid. Two pipes and two drainages are noted adjacent to this pond.
PA-4	The pond contains liquid. Two outfalls are seen in the eastern portion of this pond.
PA-5	The pond contains liquid. Drainage leads to this pond from the north where the 1983 Spray Area is located. Two pipes that begin in the eastern portion of the 1983 Spray Area lead to this pond.
PA-6	Liquid is visible in the pond.
PA	Liquid is visible in the pond. Liquid is being discharged from a pipe (not annotated) on the northern berm. Staining is also visible on this berm.

PB	Liquid is visible in the pond. Staining is visible on the northern berm.
PC	The pond contains liquid. Gray and brown material or liquid is visible on the northern berm of the pond.
PD	Multi-colored material or sludge is visible in the pond. Some of the material originated from a drainage channel from P16 .

PE	Liquid is visible in the pond. A probable outfall pipe is visible in the northwestern corner of the pond.
PJ	Liquid is visible in the pond. A drainage channel leads to the pond from the north.
PL	Liquid is visible in the southern portion of the pond. Gray and light-colored material or sludge is visible in the northern portion. An outfall pipe empties into a drainage channel, which enters the pond. The pipe is probably connected to PD .
PM	Liquid is visible in the pond. Staining is seen along drainage channels at the northwestern corner of the pond.
PP	Liquid is visible in the pond. The access road seen previously in the southern portion of the pond is inundated with liquid.
PR	Liquid is visible in the pond. A tanker truck is seen to the west.
PS	Turbid liquid is visible in the pond. A drainage channel remains visible and extends from near the oil recovery unit to the east and into the northern portion of PS . Another drainage channel with liquid or staining in it enters the pond from the north.

PT	The pond contains multi-toned material and areas of liquid (some of it turbid and brown). The pond is currently being graded with fill materials. The fill materials contain liquid and staining. Some of the graded material extends into PV .
PV	Liquid is visible in the pond. A graded fill area from PT extends into the western portion of the pond. An impoundment with liquid is seen to the north of the pond.
PAD 1A	The pad contains liquid and staining.
PAD 4A	The pPad is graded and contains possible staining, likely from P2 .
PAD 7A	The pad is graded.
PAD 10B	Two impoundments with liquid are seen here. These impoundments receive liquid from Pad 10C.
PAD 10C	Piping, staining and light-toned material are noted on the pad.
PAD 10E	An impoundment containing liquid is seen here.
PAD 10F	The pad is graded.
PAD 10G	The pad is graded.
1983 Spray Area	Circular areas containing staining are seen in this area.

SL1	Liquid and multi-colored sludge and material are visible in an impoundment.
Maintenance Shed Area	Drums (not annotated) are being stored adjacent to the north side of the Maintenance Shed. The vertical tank seen previously is seen lying on the ground horizontally north of the maintenance shed. Staining is noted to the north, south, and southeast of the Maintenance Shed.

PCB LF	Additional fill material has been added to the landfill. Approximately five drums are seen at the fill face in the landfill. More material has been excavated from the area to the north of the landfill.
PESTICIDES/ SOLVENTS LF	Approximately 60 drums are visible at the fill face.
HEAVY METALS LF	Approximately 20 drums are seen at the fill face. Active grading is seen in the landfill. Liquid and staining are noted on the landfill.
CAUSTIC/ CYANIDE LF	Approximately 20 drums are visible at the fill face of the landfill. Graded stained areas are visible on the surface of the landfill. The staining probably originates from drainage from S2.
ACIDS LF	Approximately 50 drums are visible at the fill face of the landfill.
Burial Cells Unit	An excavation for P23 has been constructed in the Burial Cells Unit area.
RCRA Landfill	A possible excavation is observed in the RCRA Canyon/Landfill Area. This activity could be related to the Spreading Areas. Due to the fact that stereo imagery was not available, it could not be determined whether this is positively an excavation.

S1	The area east of P6 is graded and stained. Three impoundments containing light-colored material or sludge are visible in the area west of P6 . Both of the northern impoundments drain to the southern one. The southern impoundment also contains gray liquid.
S2	Staining and multi-colored material is seen downhill from the perimeter road. Flow pattern staining extends downhill towards the Cyanide/Caustic Landfill.
S3	Two areas of liquid or staining are south of the perimeter road. Flow pattern staining extends downhill from the road.
S4	Light-toned material is seen on the hill below the perimeter road. Drainage from the Spreading Area flows to the Pesticides/Solvents Landfill.
S5	Three terraces (fill areas) with liquid and staining are seen on the side of RCRA Canyon. The southernmost impoundment contains the most liquid. Active grading is seen in the two northern impoundments.
S6	Heavy staining and liquid are seen south of the perimeter road. Some of the liquid is in a drainage channel at the bottom of RCRA Canyon, which drains to PA-5 . Staining is also seen on the north side of the perimeter road in the eastern portion of this area.

Liquids Treatment Area	Liquid Treatment Building is visible surrounded by a paved parking lot. A vertical tank is visible north of the Liquids Treatment Building. Four vertical tanks are seen in a group to the east of the building. An access road that surrounds this area is stained.
