**AERIAL PHOTOGRAPHIC ANALYSIS
CASMALIA DISPOSAL SITE
CASMALIA, CALIFORNIA**

August 25, 2003

**Prepared for:
The Casmalia Resources Site
Steering Committee (CSC)**

**Prepared by:
Environmental Research, Inc.
5267 John Marshall Highway
Suite C
Linden, VA 22642**

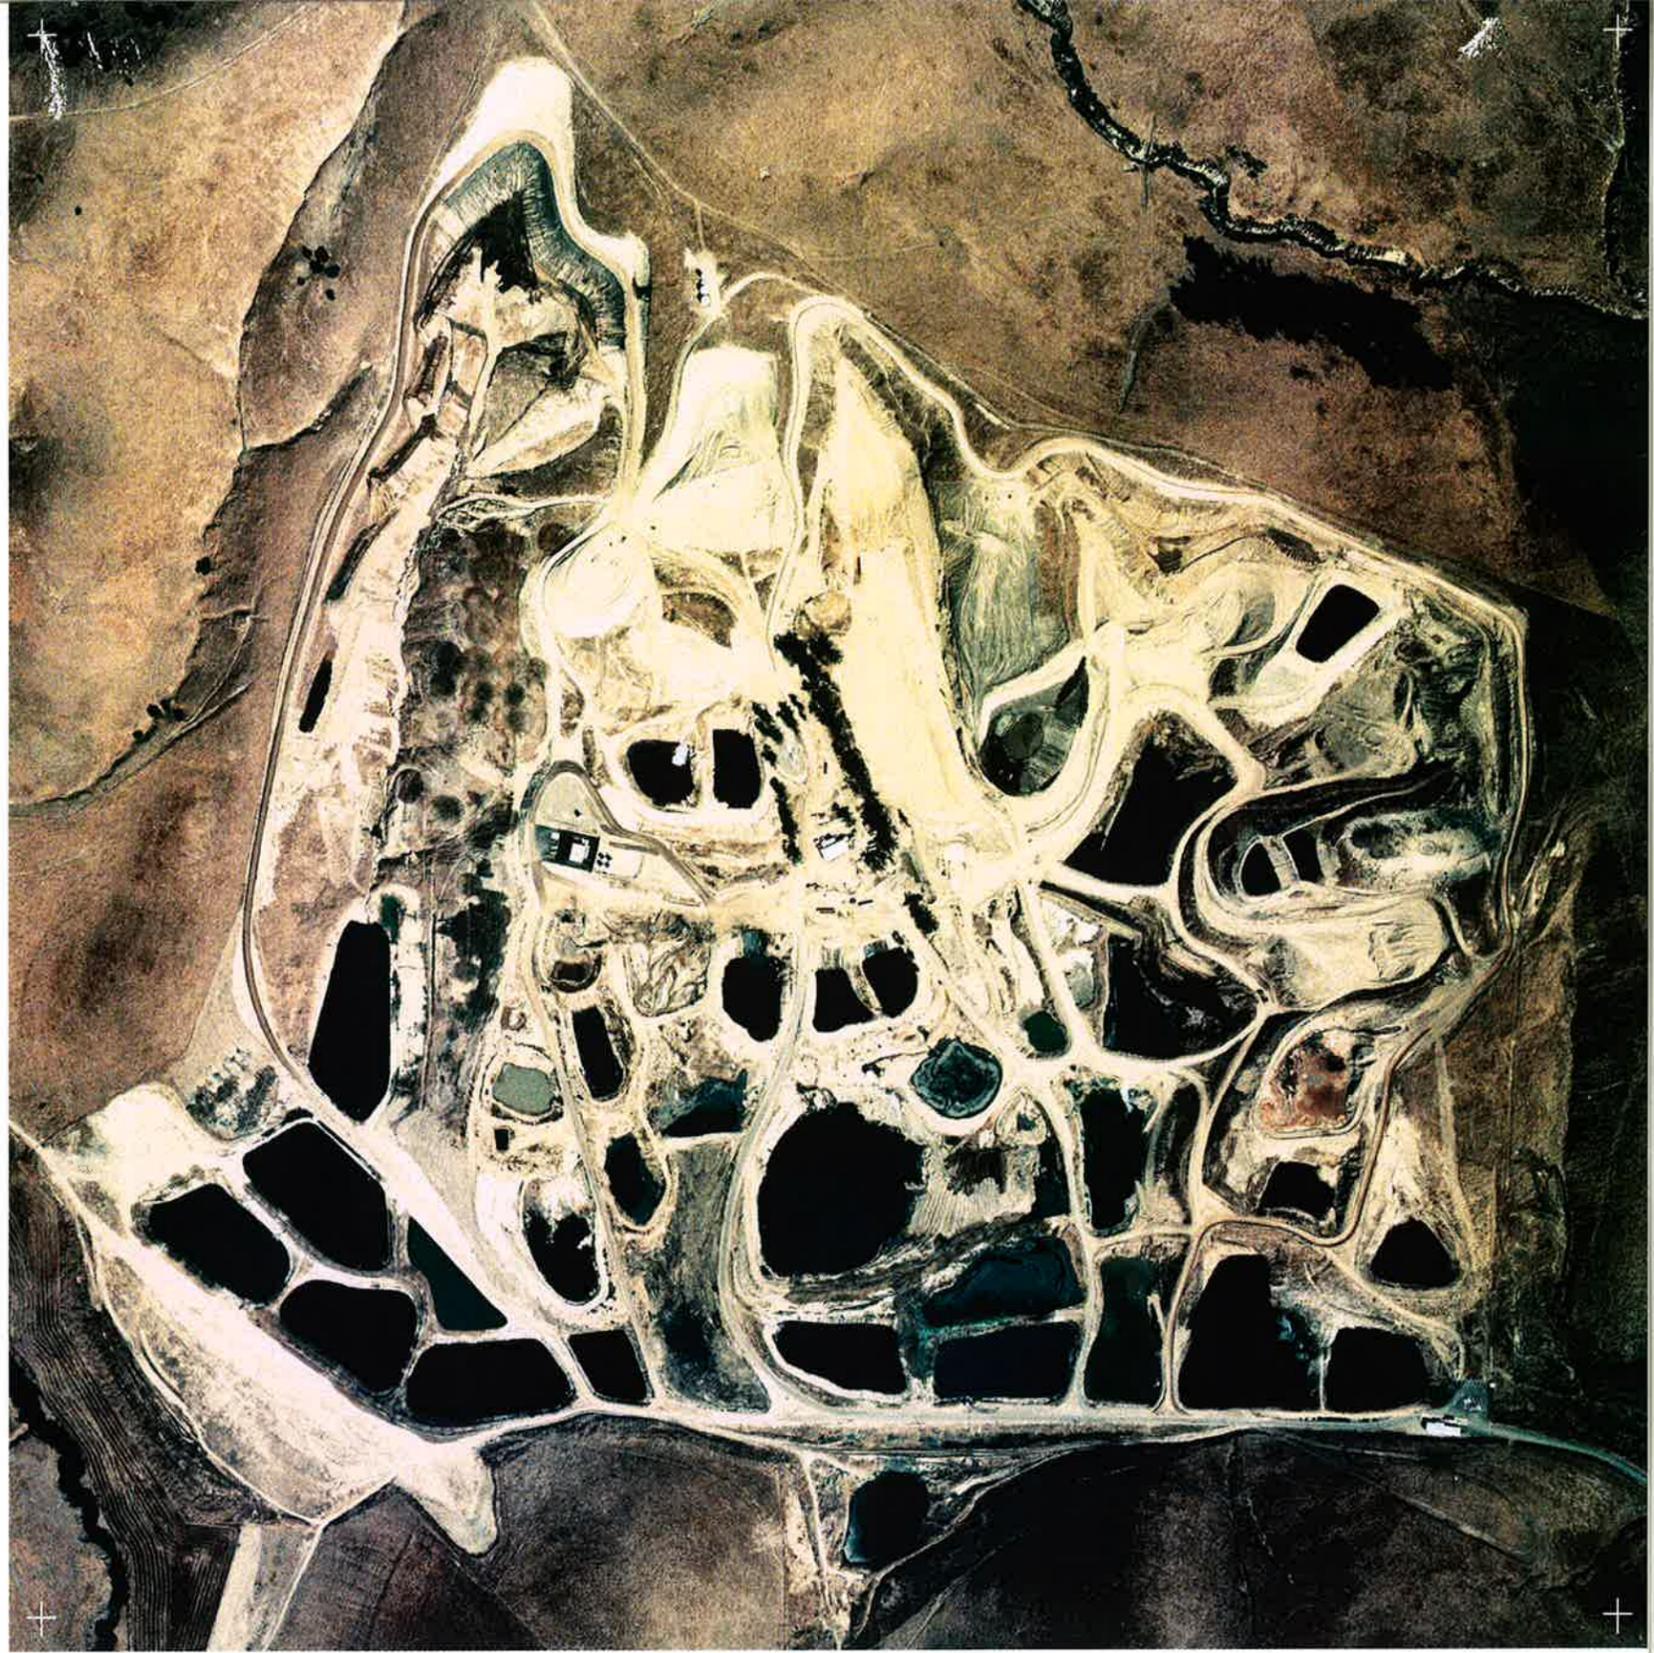
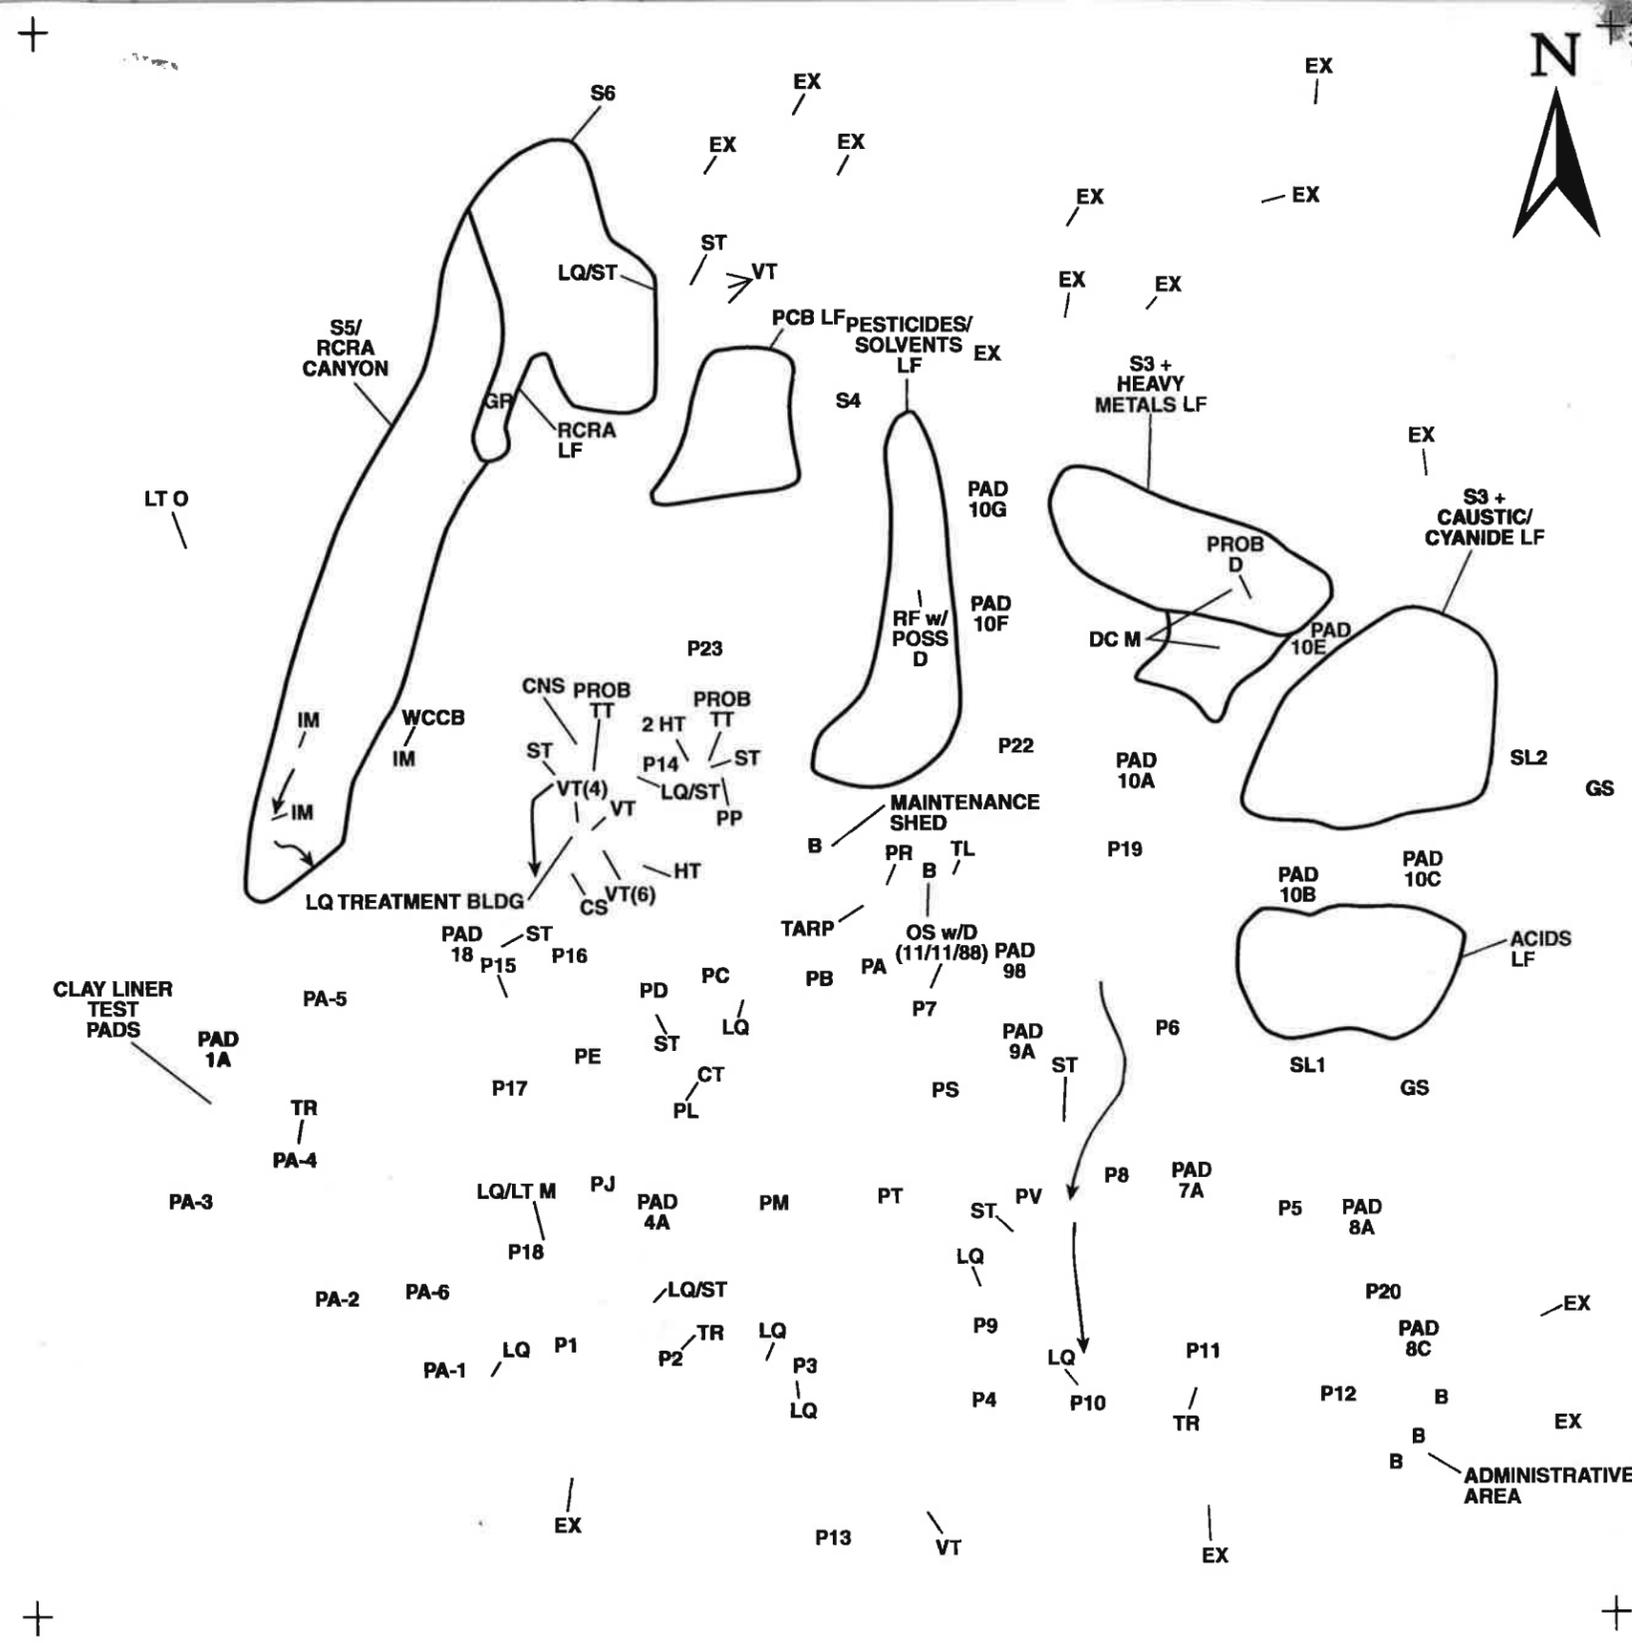
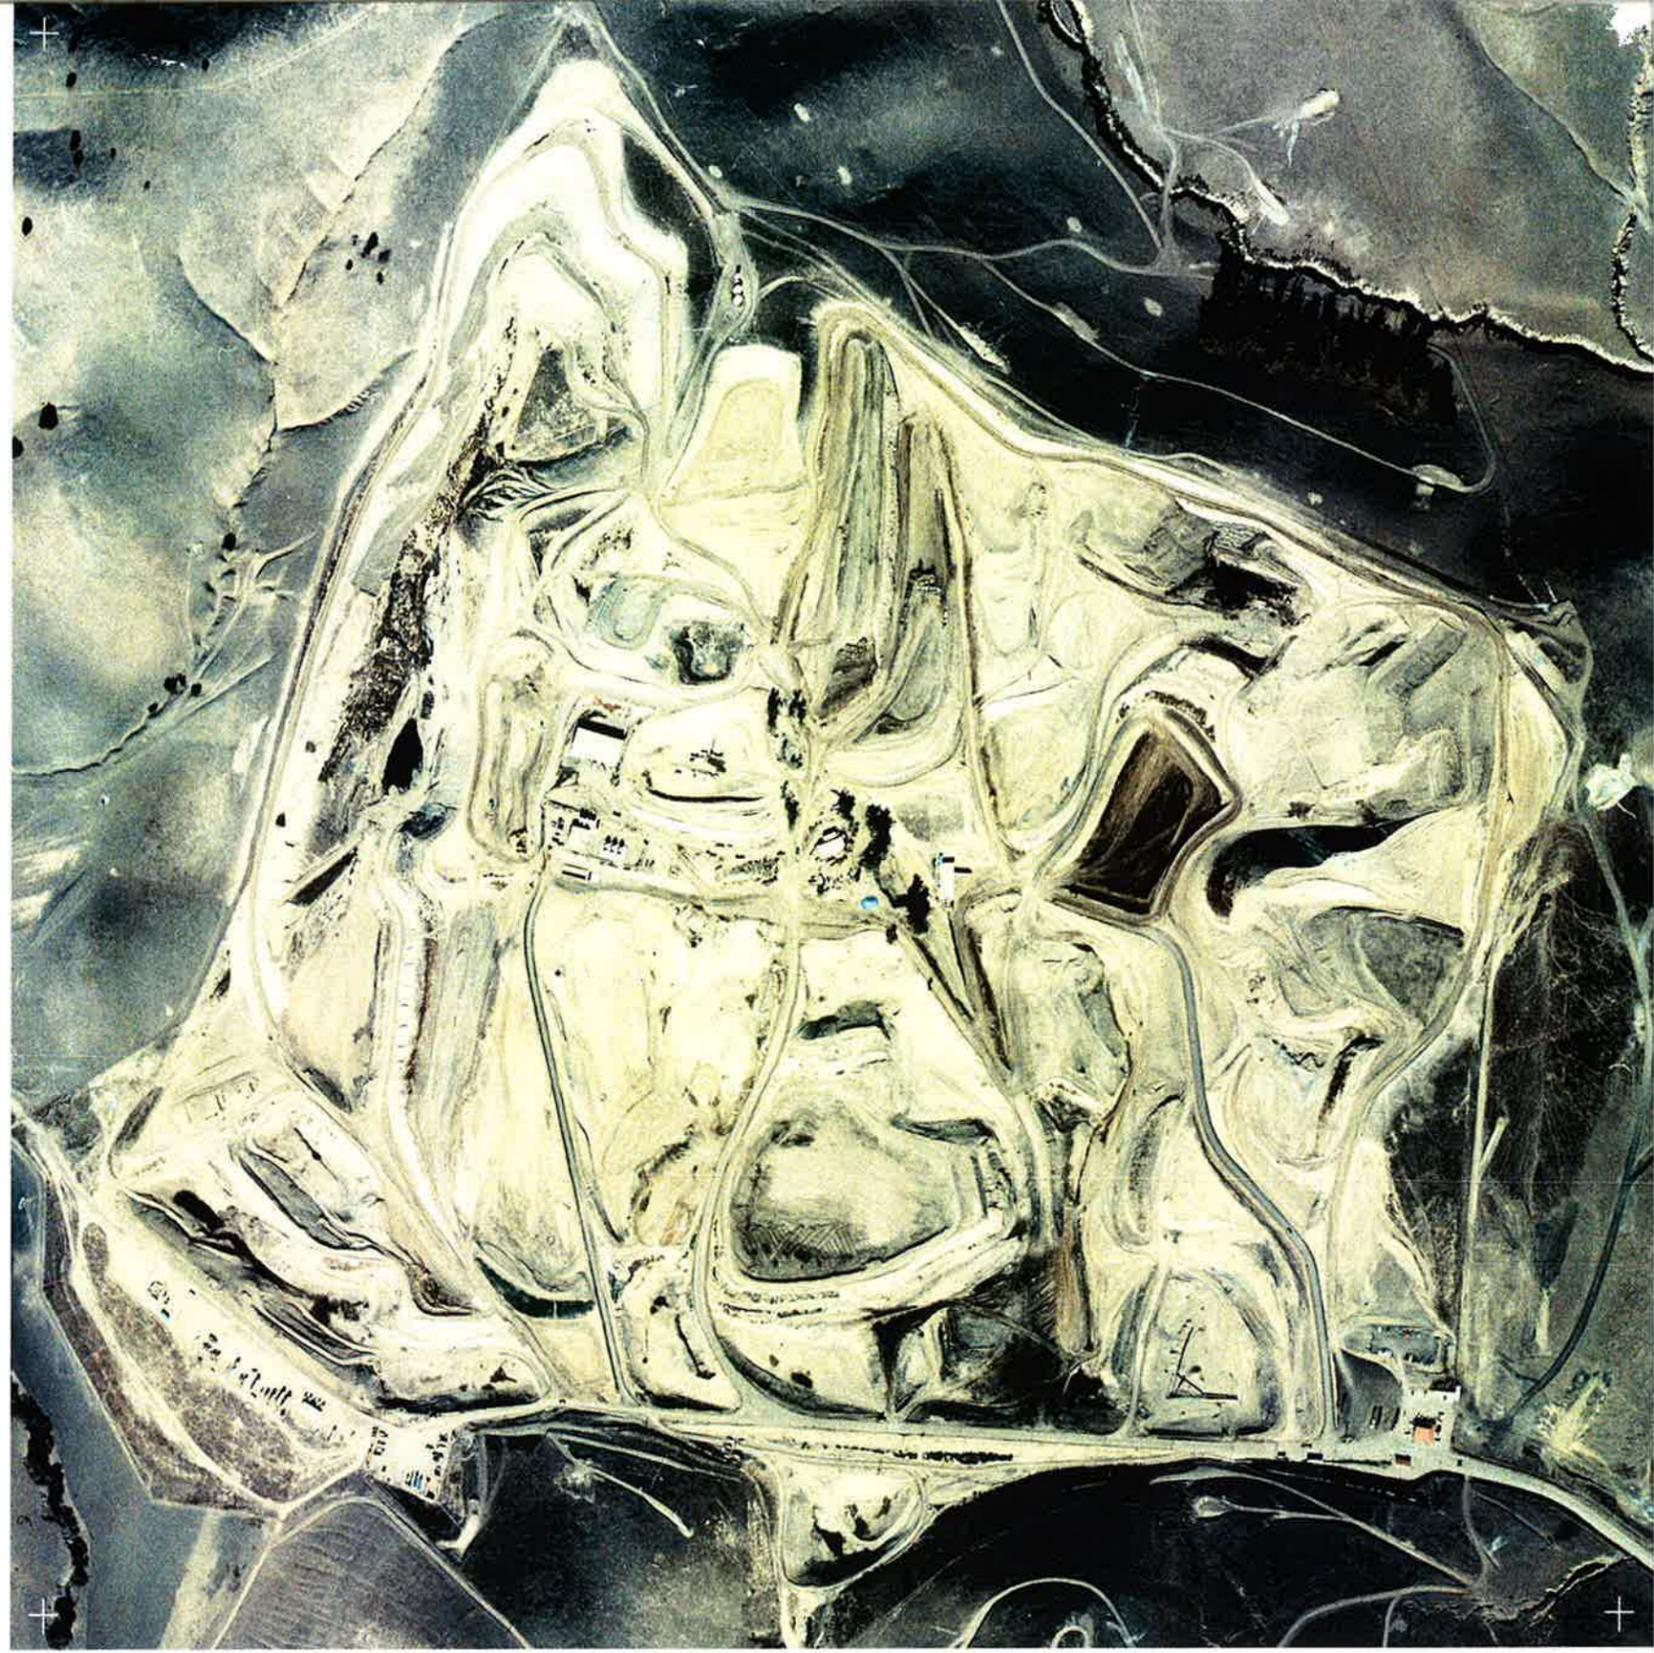
NOVEMBER 22, 1988
FRAME: 172

Annotation	Description
P1	The pond is backfilled.
P2	The contents are removed and the pond is graded. A trench is visible inside of excavation. Small pool of liquid or staining is seen in the northern portion.
P3	The contents are removed and pond is graded. Two small pools of liquid observed inside.
P4	The contents are removed and pond is graded. Staining over most of the area of former pond.
P5	Graded and probably filled. An access road has been constructed on a fill area through the former pond.
P6	The contents removed and pond is graded. An access road has been constructed on a fill area through the former pond.
P7	The contents removed and pond is graded.
P8	The contents removed and pond is graded.
P9	Most contents of the pond are removed. A stained graded area is visible. Small amount of pooled liquid is noted.
P10	Partially graded. Contains ponded liquid in southern portion.
P11	The contents are removed and pond is graded. A trench is seen at the bottom of the excavation.

P12	The contents are removed and pond is graded, probably filled with road constructed through it. Currently being used as a parking area.
P13	The contents are removed and pond is graded. Ponded liquid and staining are visible in the graded area. A vertical tank is seen east of the pond.
P14	The contents are removed and pond is graded. Vehicles and small amount of liquid and staining in the graded area.
P15	The contents are removed and pond is graded. Staining is seen in this vicinity.
P16	The contents are removed and pond is graded.
P17	The contents are removed and pond is graded.
P18	The contents are removed and pond is graded. A small amount of liquid or light-toned material is seen in the southern portion of the former pond.
P19	The contents are removed and pond is graded. Dark-toned material or staining is noted in the graded area.

P20	The contents are removed and pond is graded.
P22	The contents are removed and pond is graded.
P23	The pond contains vegetation, dark- and light- colored material. Piping (not annotated) is noted on the ground adjacent to northeastern side.
PA-1	Most contents removed and pond is graded. Staining seen in several areas. Some liquid remains in eastern area.
PA-2	Most contents removed and pond is graded. However, liquid and staining still seen in bottom of excavated area, The berm between PA-2 and PA-3 has been removed.
PA-3	Some grading is visible, but ponded liquid is still visible in the pond. The berm between PA-2 and PA-3 has been removed.
PA-4	The contents are removed and the pond is graded. Trench with liquid seen in excavated area.
PA-5	The contents are removed and the pond is graded.
PA	The contents are removed and the pond is graded.
PB	The contents are removed and the pond is graded.
PC	The contents are removed and the pond is graded. Small amount of liquid or staining is visible in the bottom of the excavated area.

PD	The contents are removed and the pond is graded. Small amount of staining in excavated area.
PE	The contents are removed and the pond is graded.
PJ	The contents are removed and the pond is graded.
PL	The contents are removed and the pond is graded. Small amount of staining seen in excavated area.
PM	The contents are removed and the pond is graded. Staining is noted throughout excavated area, except where covered with graded light-toned material.
PP	The contents are removed and the pond is graded. Vehicles (one with staining adjacent to it) and two horizontal tanks are visible in the excavated area.
PR	The contents are removed and the pond is graded.
PS	The contents are removed and the pond is graded.
PT	The contents are removed and the pond is graded. Staining (not annotated) is noted throughout the excavated area, except where covered with graded light-toned material.
PV	The contents are removed and the pond is graded. Staining is noted in the excavated area.

PAD 1A	Clay liner test pads are seen in this area.
PAD 4A	The contents are removed and the pad is graded. A small amount of staining is visible.
PAD 7A	The contents are removed and the pad is graded.

PAD 8A	The contents are removed and the pad is graded.
PAD 8C	The contents are removed and the pad is graded. Parking lot visible in this vicinity.
PAD 9A	The contents are removed and the pad is graded. Possible staining is noted to the south of the pad. Liquid or staining are noted in a drainage channel to the east.
PAD 9B	The contents are removed and the pad is graded. Possible staining (not annotated) seen.
PAD 10A	The contents are removed and the pad is graded. Staining is noted on the graded soil.
PAD 10B	The contents are removed and the pad is graded.
PAD 10C	The contents are removed and the pad is graded.
PAD 10E	The contents are removed and the pad is graded.
PAD 10F	The contents are removed and the pad is graded.
PAD 10G	The contents are removed and the pad is graded.
SL1	Contents are removed and area is graded. Dark-toned material (not annotated) is seen in the excavation.
SL2	Contents are removed and area is graded.

PCB LF	Landfill is inactive and covered.
PESTICIDES/ SOLVENTS LF	Refuse containing possible drums seen at fill face. Mounded material seen in western portion.
HEAVY METALS LF	Light-colored refuse, graded dark-toned material, and mounded material are observed.
CAUSTIC/ CYANIDE LF	Inactive and covered.
ACIDS LF	Inactive and covered.
RCRA LF	Inactive and covered.
S1	Graded
S2	Not visible. The Heavy Metals Landfill has expanded into this area.
S3	Graded.
S4	Graded.
S5	Two impoundments are seen in the southern portion of this area. The southern impoundment contains liquid. The northern impoundment contains staining or dark-colored material.
S6	Liquid and staining are seen in one area in the northeastern portion of this area. Liquid flow patterns remain below the access road that surrounds this area; however no additional staining is observed.
LIQUIDS TREAT- MENT AREA	The CNS building is visible to the north of the Liquids Treatment Building. Staining is seen south of the CNS Building. Six vertical tanks are seen to the east of the Liquids Treatment Building. Five more tanks are seen adjacent to the building to the north and northeast.
