## Memorandum

**Subject: Environmental Impact Assessment; Cordes Property**

**Summary:** Two unnamed tributaries to Doby Creek and one unnamed tributary to Duckett Creek, both tributaries to North Fork Cottonwood Creek, were negatively impacted by activities that substantially altered the streams' bed, bank and channel, and placed sediment and refuse where they can pass into waters of the state. These activities consisted of the reconstruction or new construction of three stream crossings and grading activities. They were conducted without written notification to the California Department of Fish and Wildlife (CDFW) or obtaining a Lake and Streambed Alteration (LSA) agreement, totaling 10 separate violations of Fish and Game Code (FGC).

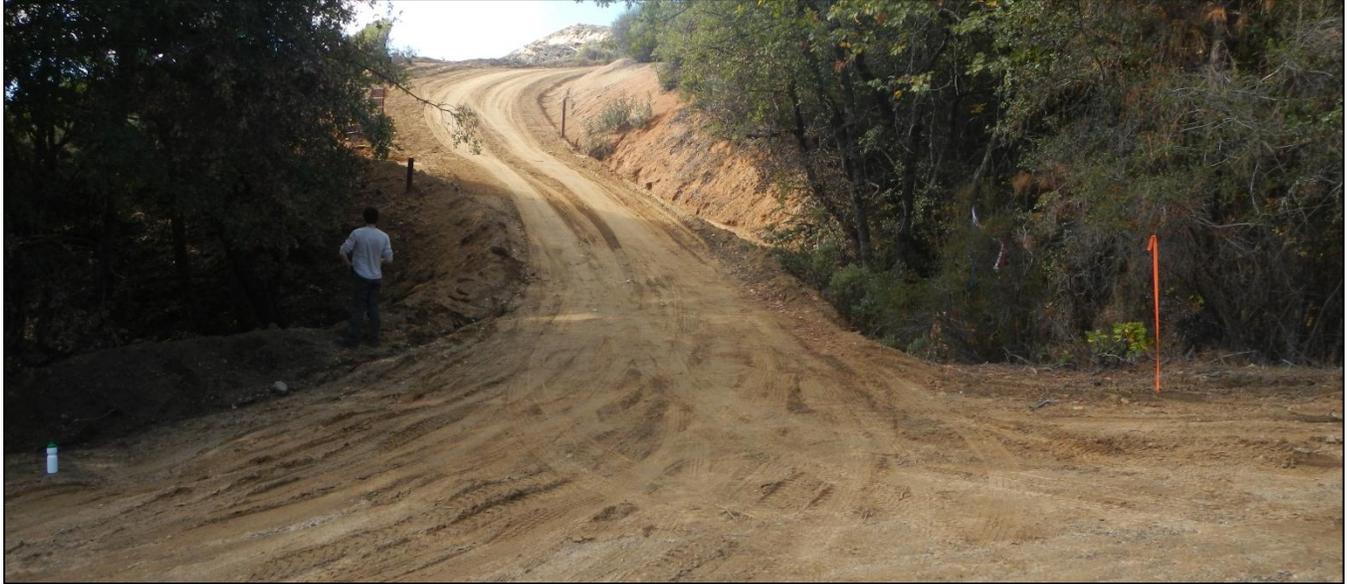
**Crossing 1:** Crossing 1 is located on an unnamed tributary to Doby Creek, not actively flowing at the crossing during both inspections however it was flowing approximately 0.75 mile downstream. This stream crossing was pre-existing, however, large quantities of sediment have been placed over the crossing to widen the road and raise the elevation (Figure 3).

**Figure 3.** The grading activity at Crossing 1 with no erosion control in place. October 28, 2014

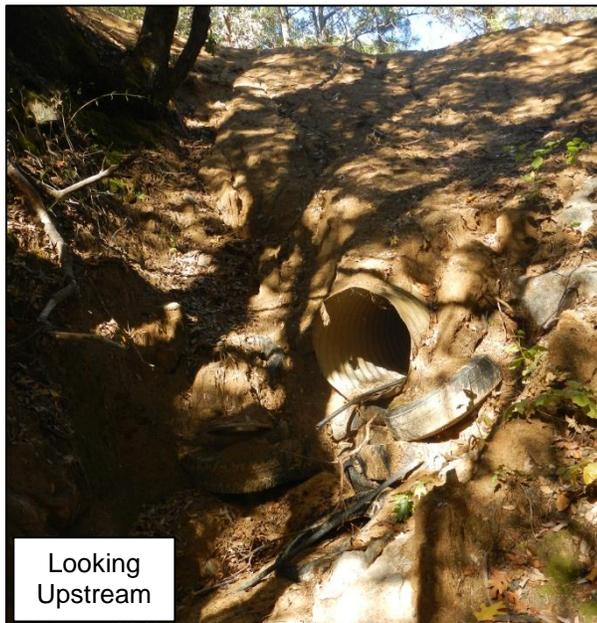
- The 24-inch culvert is undersized (Figure 4). It may have been adequate in its pre-existing state, if there was an armored critical dip to allow high flows to pass. However, with the raised road elevation an armored critical dip is not appropriate.

**Figure 4.** Crossing 1 looking at the downstream end of the culvert. The rust and waterline on the bottom of the culvert suggests it was pre-existing. Tires are visible underneath and to the right of the culvert, the assumption being they were used for erosion control. October 28, 2014

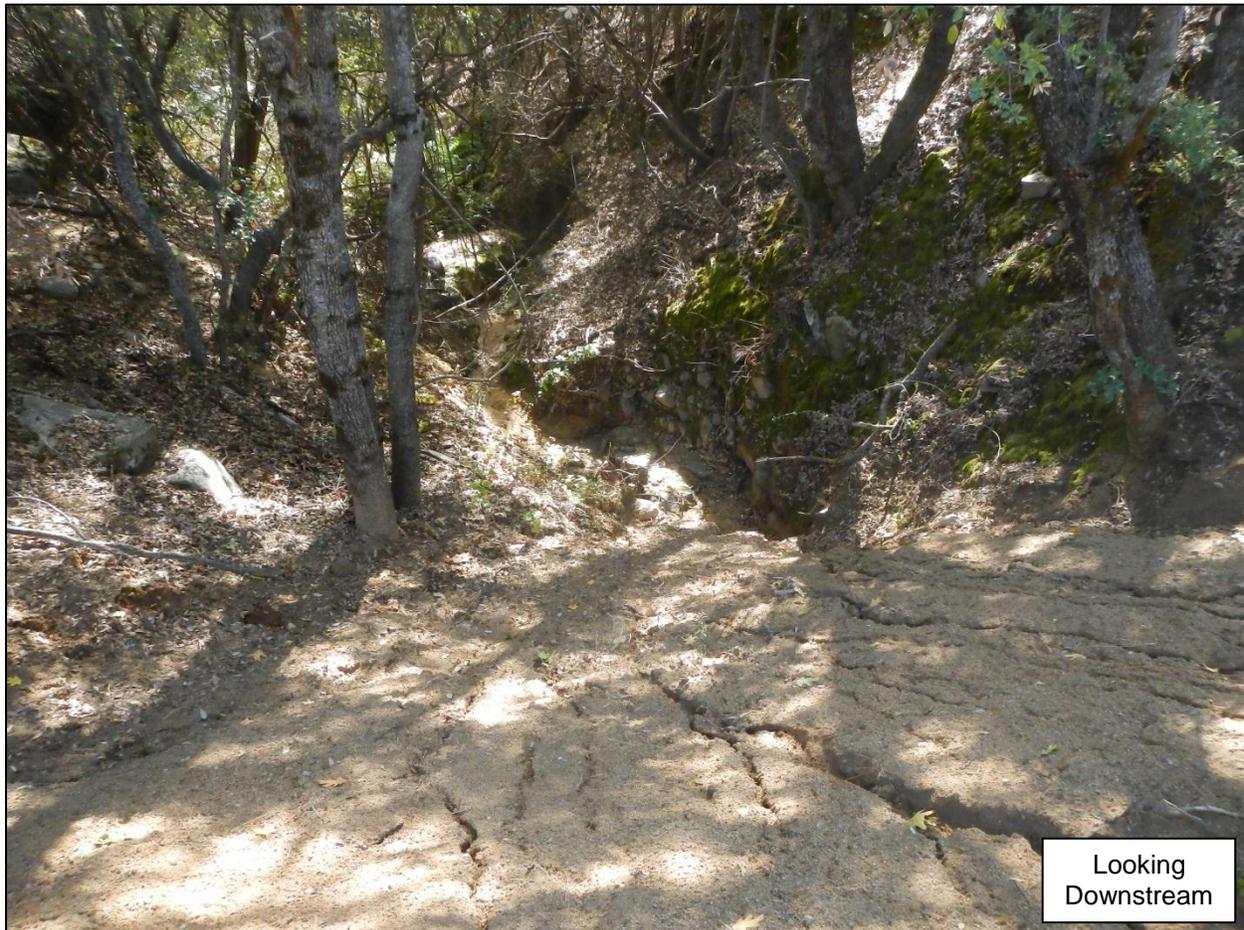
- The outlet and inlet of the culvert did not have erosion control installed, in the form of a concrete headwall or large rock cobble clean of fine sediment, to protect the fill slopes from the erosive activities of high flows and heavy rains (Figure 5). In fact, the only potential erosion control in place was in the form of tires which CDFW does not allow and considers deposition of refuse (Figure 4, 6 & 7). On perennial, intermittent and flashy ephemeral streams, erosion protection of stream crossing inlets and outlets are necessary. This is to not only protect the stream crossing from washing out but also to keep the fill material from eroding and the fine sediment from entering the watercourse, negatively impacting fish and wildlife resources within and downstream of the crossing site.

**Figure 5.** Looking down the fill slopes at Crossing 1 towards the outlet. Placement of fill material and erosion of that material is visible. October 28, 2014

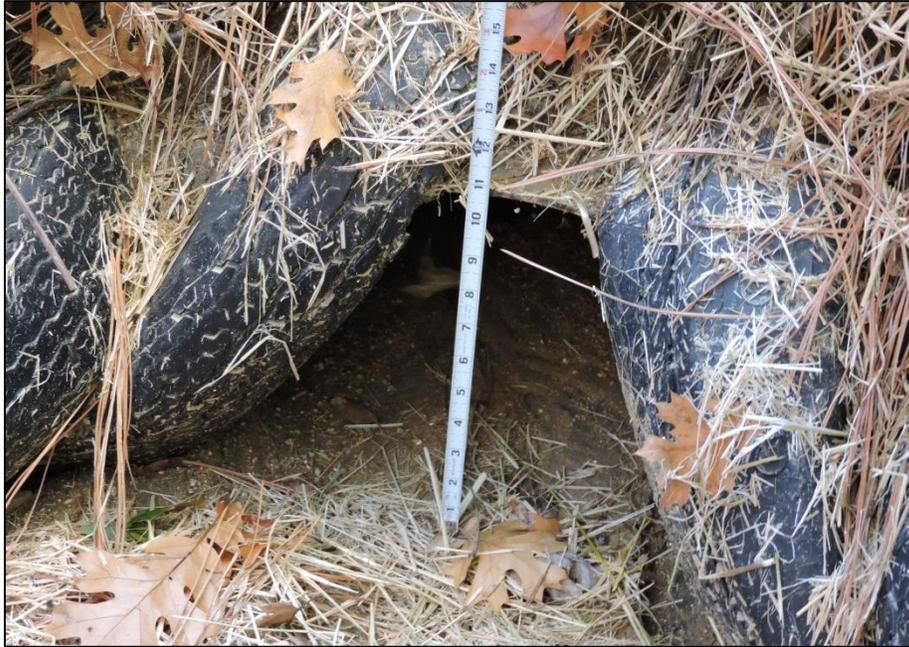
- The sediment placed over the existing crossing and undersized culvert created a kind of dam. Add to this the sediment, from unauthorized grading activities, that has been washed into the stream, settled out and plugged the culvert pipe to over half of its diameter (Figure 6) and an even more “dam-like” structure has been created (Figure 7). Stream crossings should be constructed to allow water, specifically a 100 year flood, to pass under or through the crossing, while dams are constructed to hold large quantities of water without diverting. A crossing does not have the structural integrity of a dam so the potential for a crossing to fail greatly increases when it is required to function as a

dam. When a crossing fails the fill material and infrastructure are released into the stream channel. When Crossing 1 fails it will release 224.7 cubic yards (cy) of material, which can cover a ten foot stream one inch in depth for approximately 7,280 feet, just short of 1½ miles (Table 1).

**Figure 6.** Crossing 1 inlet showing the culvert partially plugged with only 11-inches of 24-inch culvert left to pass flow. Tires are visible in the fill material, the assumption being they were used for erosion control. November 7, 2014

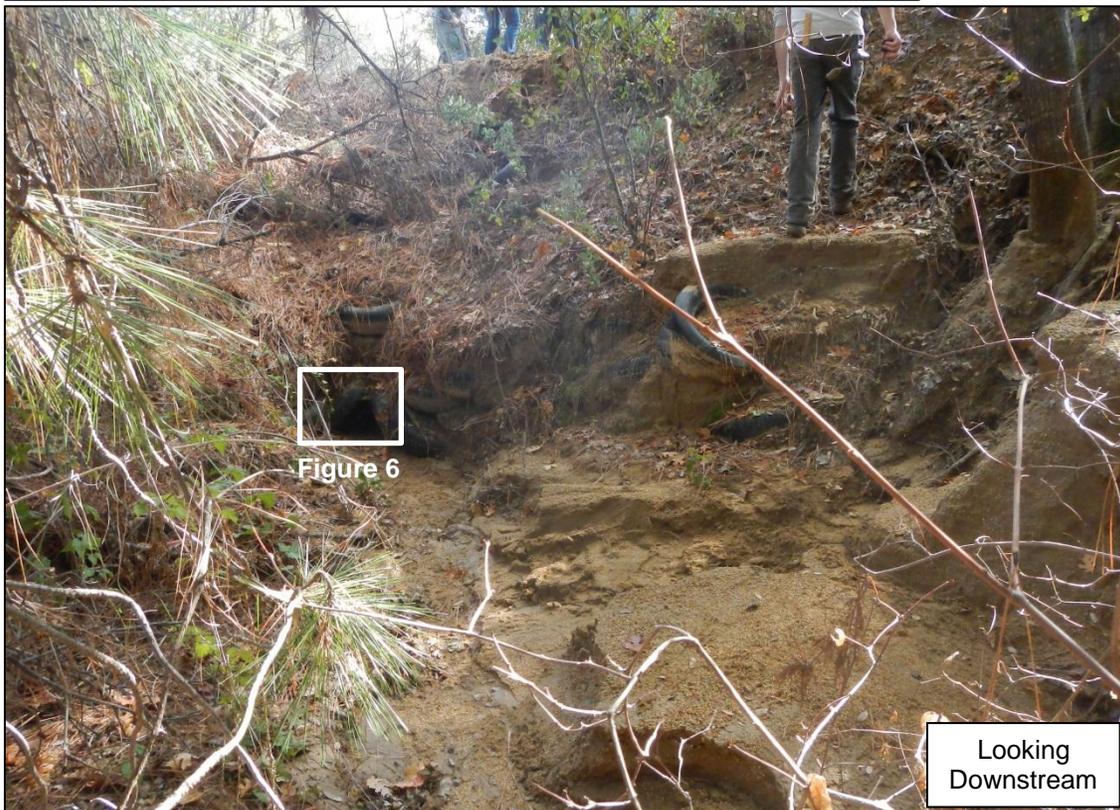
**Figure 7.** Crossing 1 looking towards the culvert inlet with the 12 foot high dam-like crossing structure evident. Large amounts of deposited sediment visible upstream of culvert. Tires visible in the fill material, the assumption being they were used for erosion control. October 28, 2014

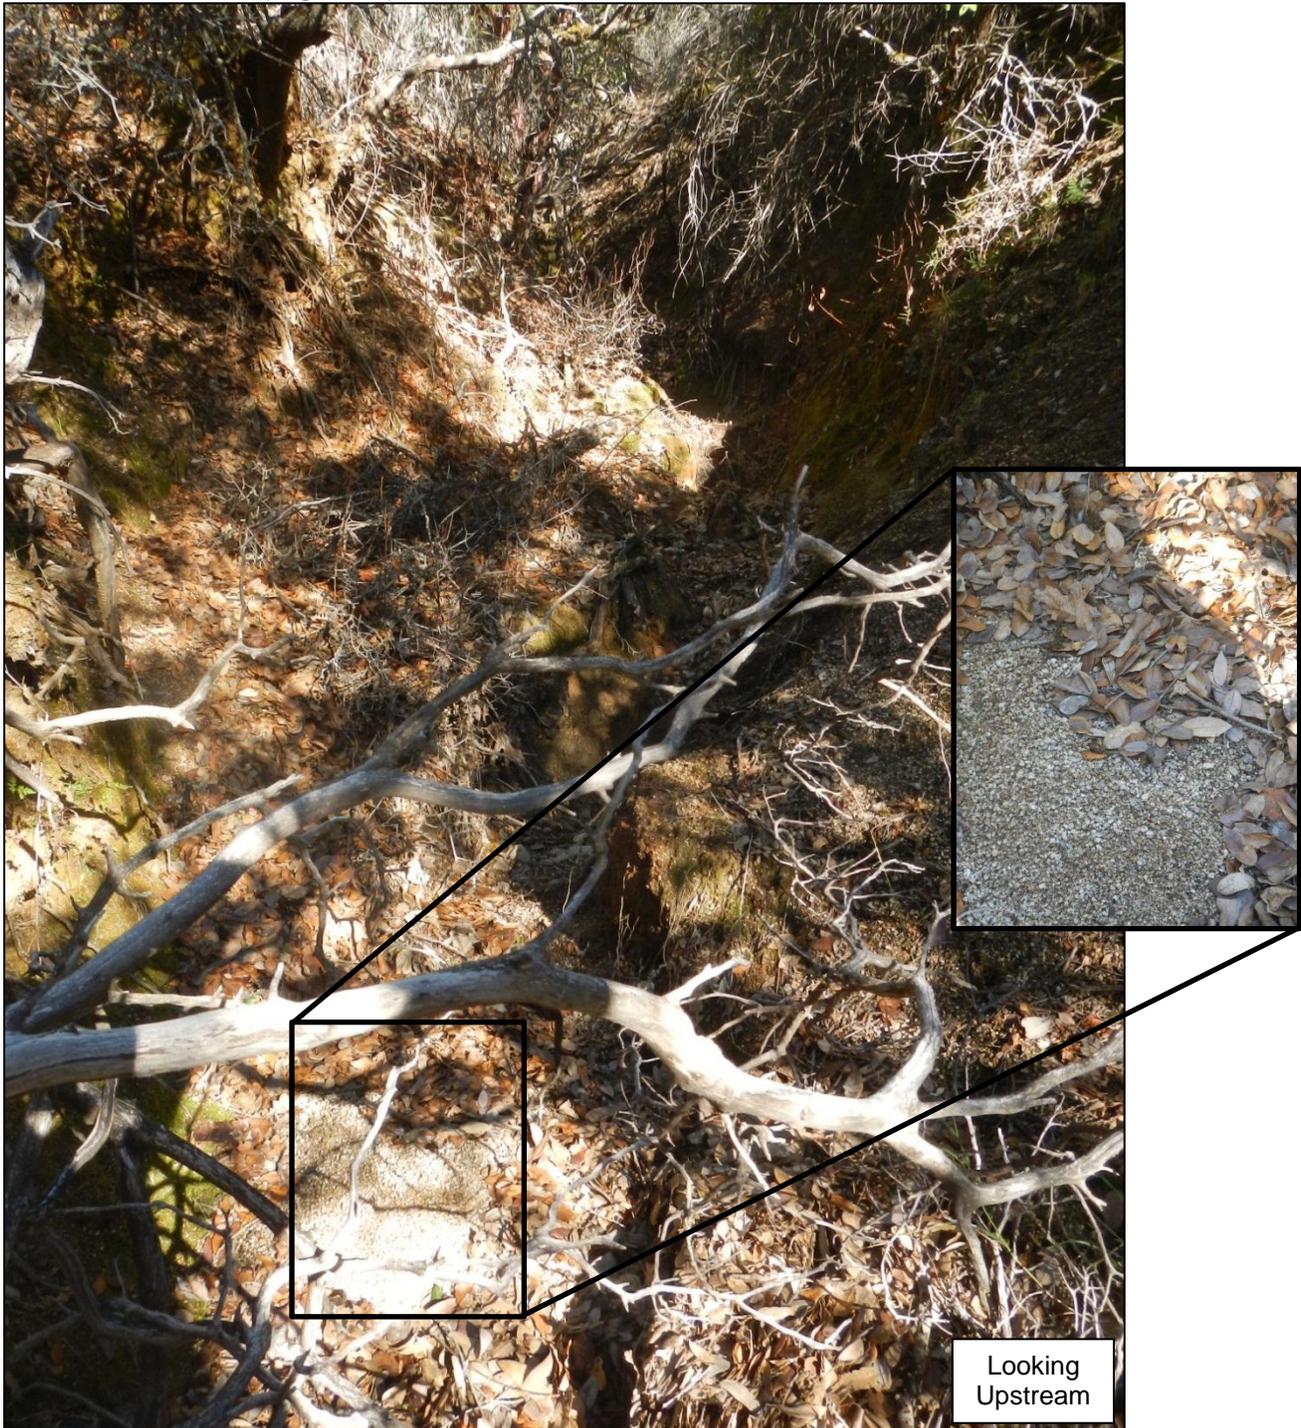
**Figure 8.** Evidence of scour and bed, bank or channel at Crossing 2. Inset shows close up of natural bed material upstream of crossing. October 28, 2014

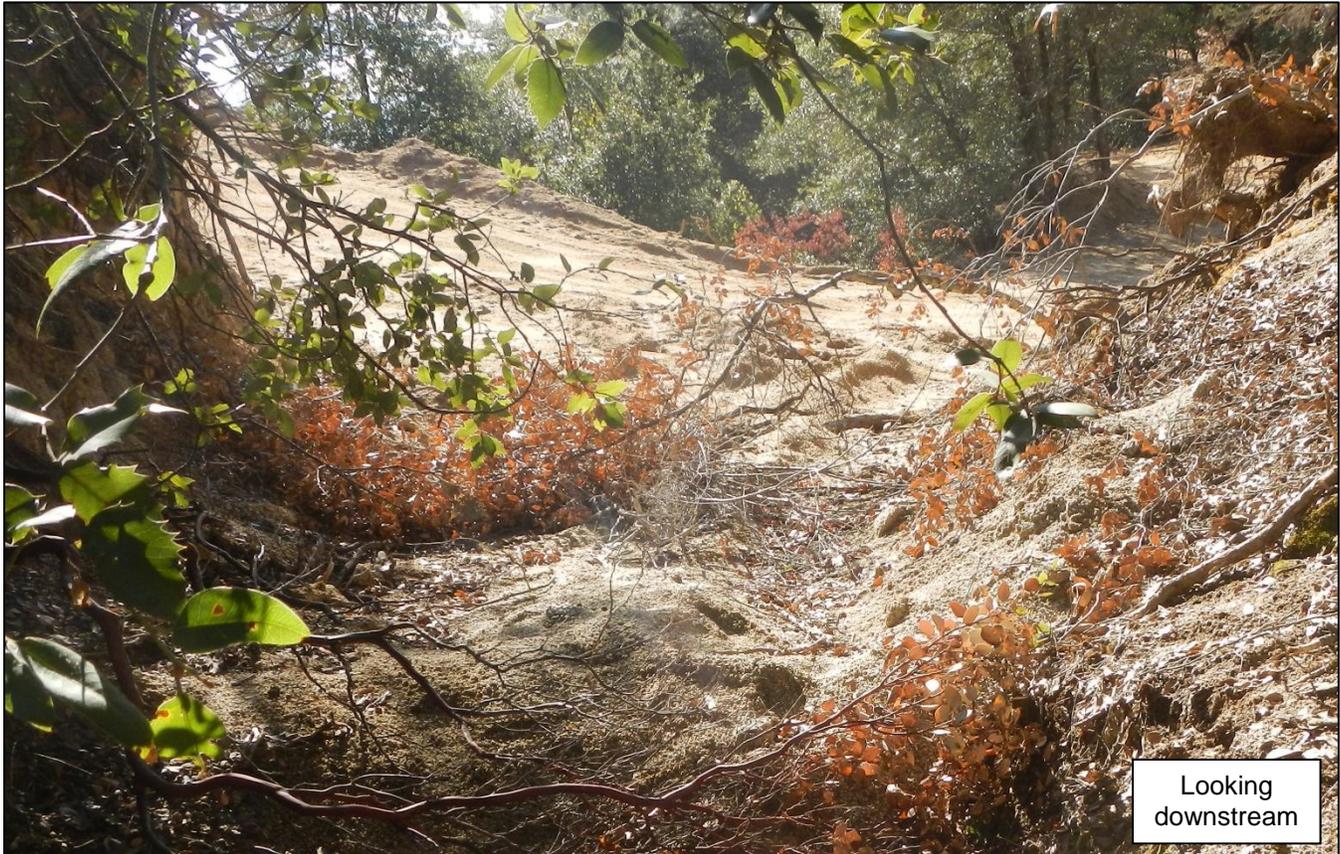
The stream crossing was constructed with no culverts to pass flow (Figure 9). With no culvert in place to pass flow the water will have to flow over the road fill. The road in this area has not been armored to protect itself against these flows and will easily erode. Once this erosion begins the stream crossing will easily fail passing all of the fill material (142.2 cy) into the stream. Also, to place fill within a stream channel for the ease of crossing substantially alters the bed, bank, and channel of the stream. This alteration is unavoidable due to the required grading and excavation activities. Furthermore, substantial environmental impacts have and will occur due to the substandard construction activities utilized as described below.

**Figure 9.** Crossing 2 constructed with no culvert to pass flow. October 28, 2014

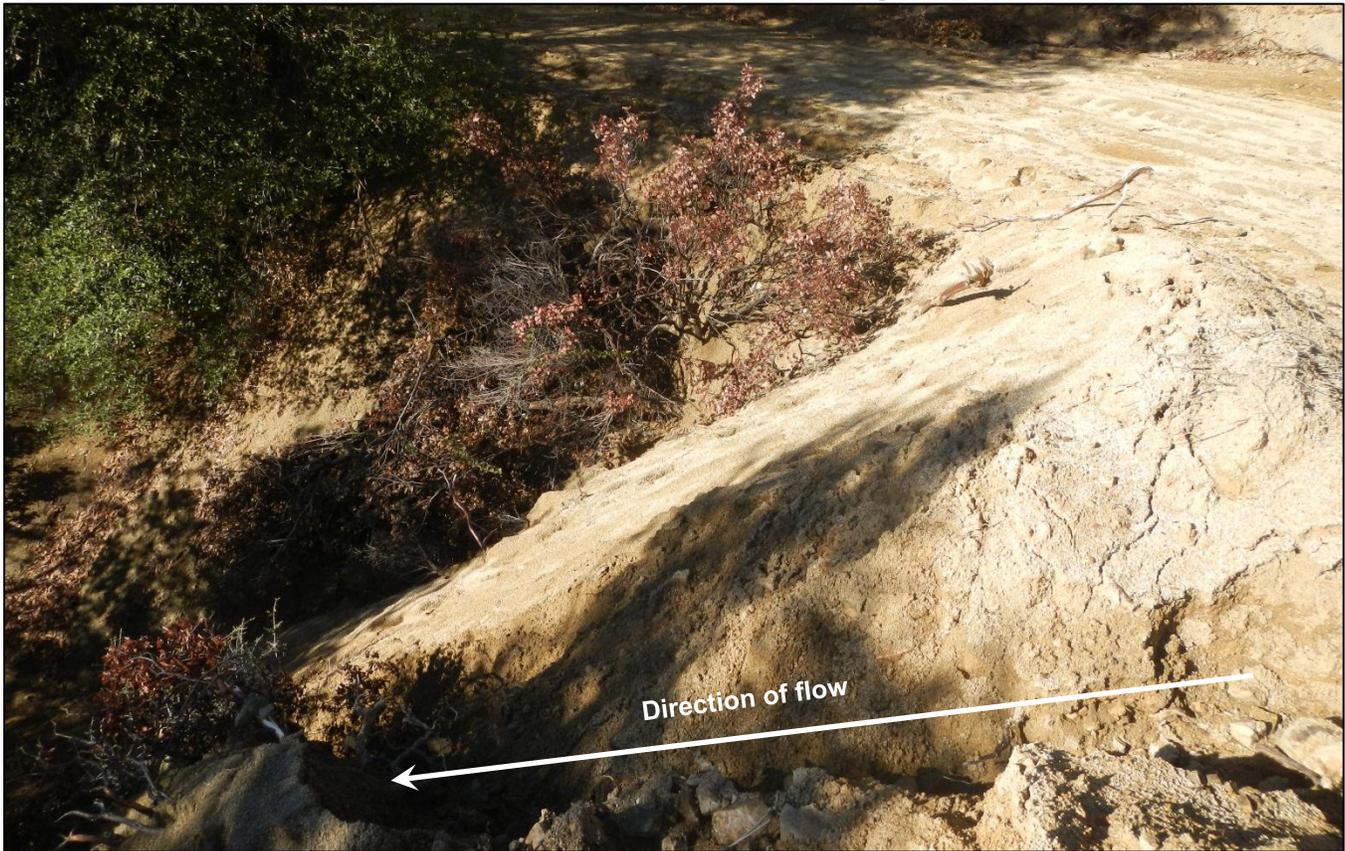
- No erosion control is installed on the fill slopes or over the road fill to protect against flowing water, that has nowhere else to go but across the road, or against heavy rainfall (Figure 9 & 10). The rock cobble placed on fill slopes should have 100% coverage and placed in an interlocking fashion. The areas unprotected by erosion control will allow fill material to be washed into the drainage by flows and rainfall. A stream crossing without culverts installed is considered a ford style crossing. If it is appropriate to design a ford type crossing specifically sized rock cobble should be placed across the fill in the area where water will flow. The flow topping the road due to no culvert installation weakens the integrity of the stream crossing greatly increasing the potential for the stream crossing to fail and washout releasing the fill material into the stream channel. When Crossing 2 fails it will release enough material to cover a ten foot stream one inch in depth for approximately 4,608 feet, just under one mile (Table 1). Erosion control not only protects the stream crossing from washing out and the fill material from eroding but

**Figure 10.** Downstream edge of Crossing 2 with no erosion control present. Evidence of scour is visible due to minimal rain events that have occurred prior to site inspections. October 28, 2014

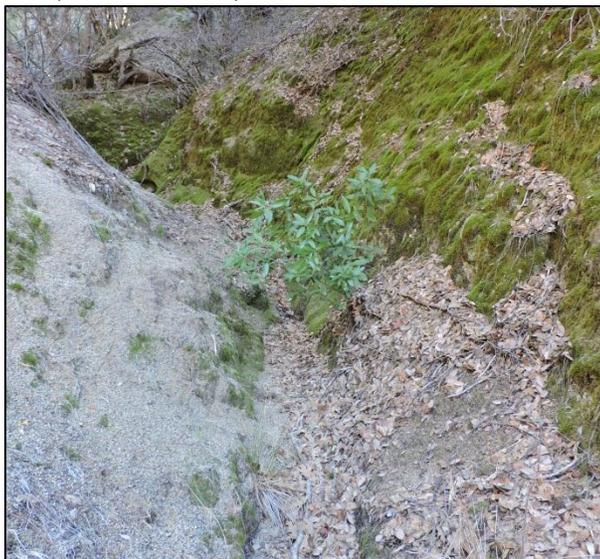
**Figure 11.** Evidence of scour and bed, bank or channel at Crossing 3. November 7, 2014

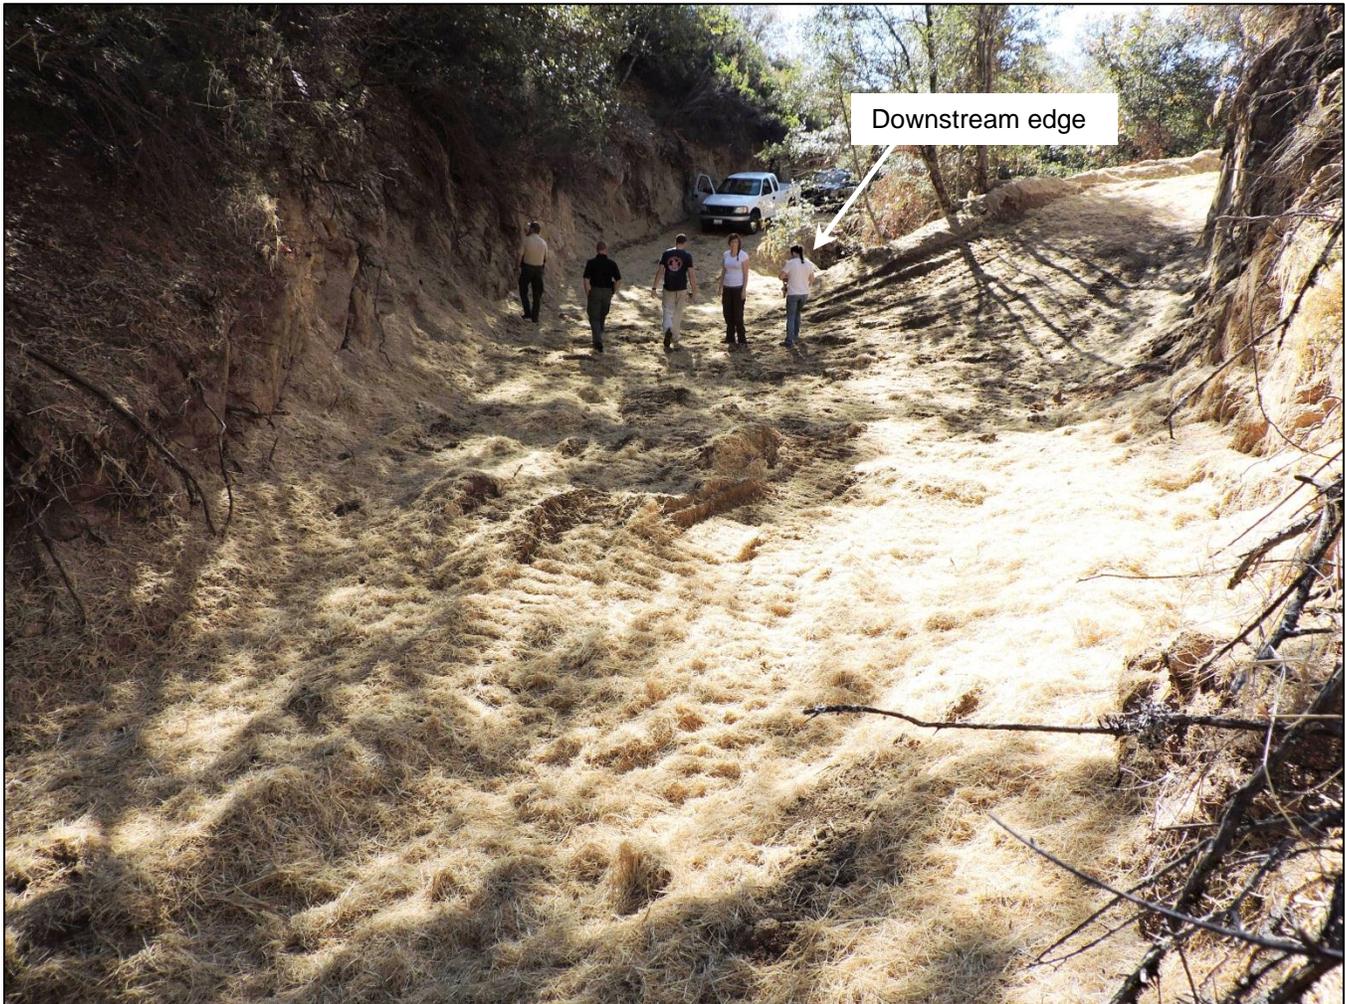
The stream crossing was constructed with no culverts to pass flow (Figure 12). With no culvert in place to pass flow the water will have to flow over the road fill. The road in this area has not been armored to protect itself against these flows and will easily erode. Once this erosion begins the stream crossing will easily fail passing all of the fill material (173.3 cy) into the stream. Also, to place fill within a stream channel for the ease of crossing substantially alters the bed, bank, and channel of the stream. This alteration is unavoidable due to the required grading and excavation activities. Furthermore, substantial environmental impacts have and will occur due to the substandard construction activities utilized as described below.

**Figure 12.** Crossing 3 constructed with no culvert to pass the flow. The photo was taken on the undisturbed edge upstream looking towards the downstream edge. The linear distance between these two points of altered stream channel was approximately 78 feet. November 7, 2014

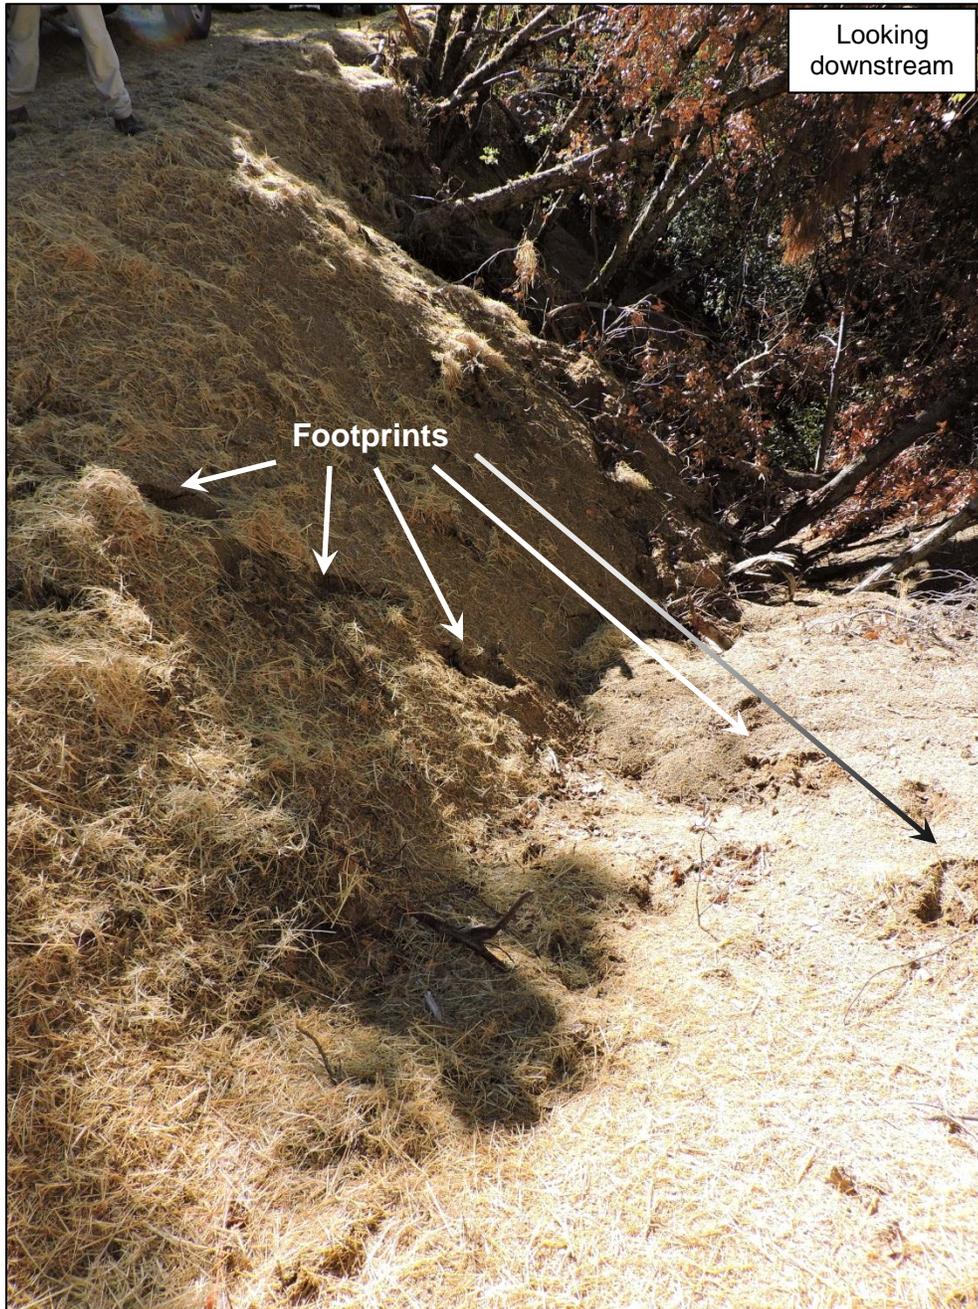
- No erosion control is installed on the fill slopes or over the road fill to protect against flowing water, that has nowhere else to go but across the road, or against heavy rainfall (Figure 12 & 13). The rock cobble placed on fill slopes should have 100% coverage and placed in an interlocking fashion. The areas unprotected by erosion control will allow fill material to be washed into the drainage by flows and rainfall. A stream crossing without culverts installed is considered a ford style crossing. If it is appropriate to design a ford type crossing specifically sized rock cobble should be placed across the

**Figure 13.** Looking down the fill slopes at Crossing 3. Footprints are visible in the fill material that when taken by the individual they sunk four to six inches into the fine, loose sediment. November 7, 2014

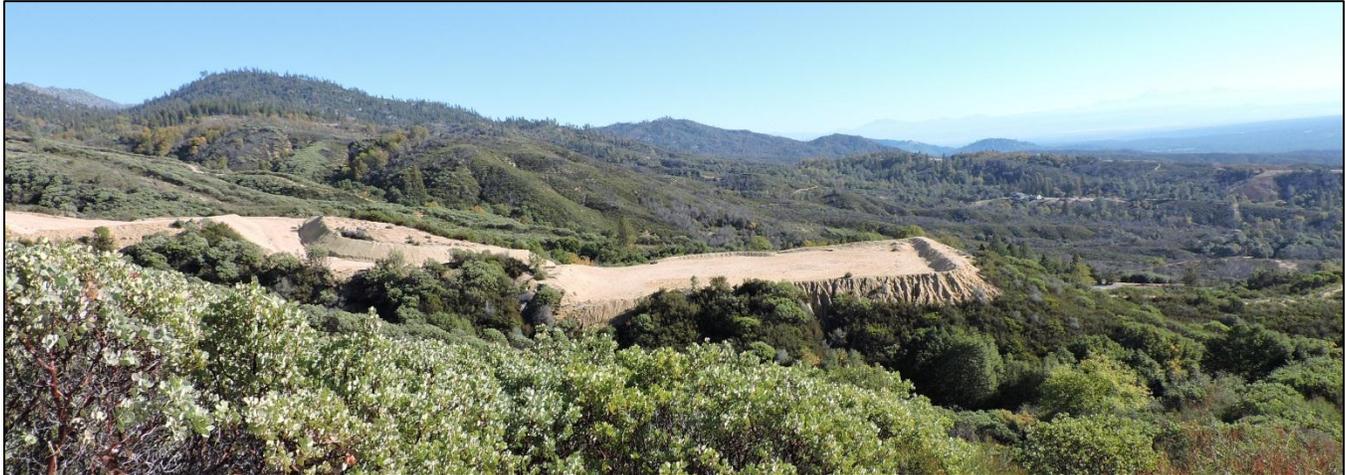
**Water Pollution: Sediment** - The extensive grading activity that occurred on the Cordes property will allow sediment to enter multiple unnamed tributaries to Doby Creek and Duckett Creek. It is likely that a portion of the grading activity occurred in trespass on adjacent landowner property (Figure 2). The two main streams where we concentrated our efforts and documented the discharge of sediment that had already occurred were the unnamed tributaries to the east and west of the large graded landings (Figure 2 & 14).

**Figure 14.** View of the graded landings from the ridge to the west. Erosion and rills in the excavated sediment is apparent even at this distance of about 500 feet. November 7, 2014

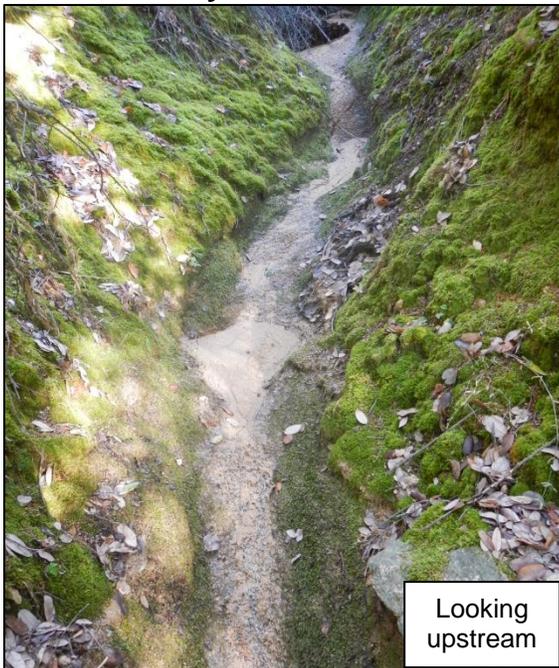
**Figure 15.** Evidence of fine sediment entering the west tributary. October 28, 2014

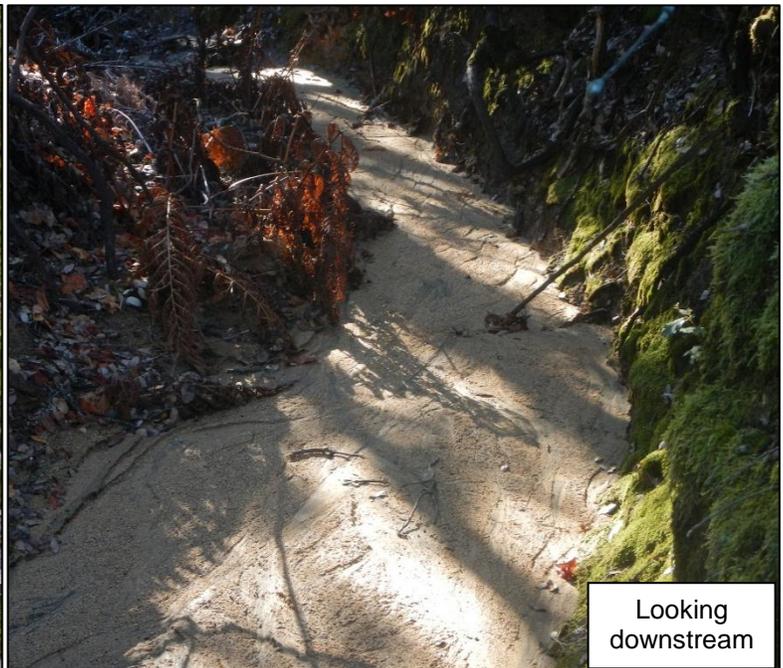
**Figure 16.** West tributary with evidence of large quantities of sediment washed into the stream. October 28, 2014

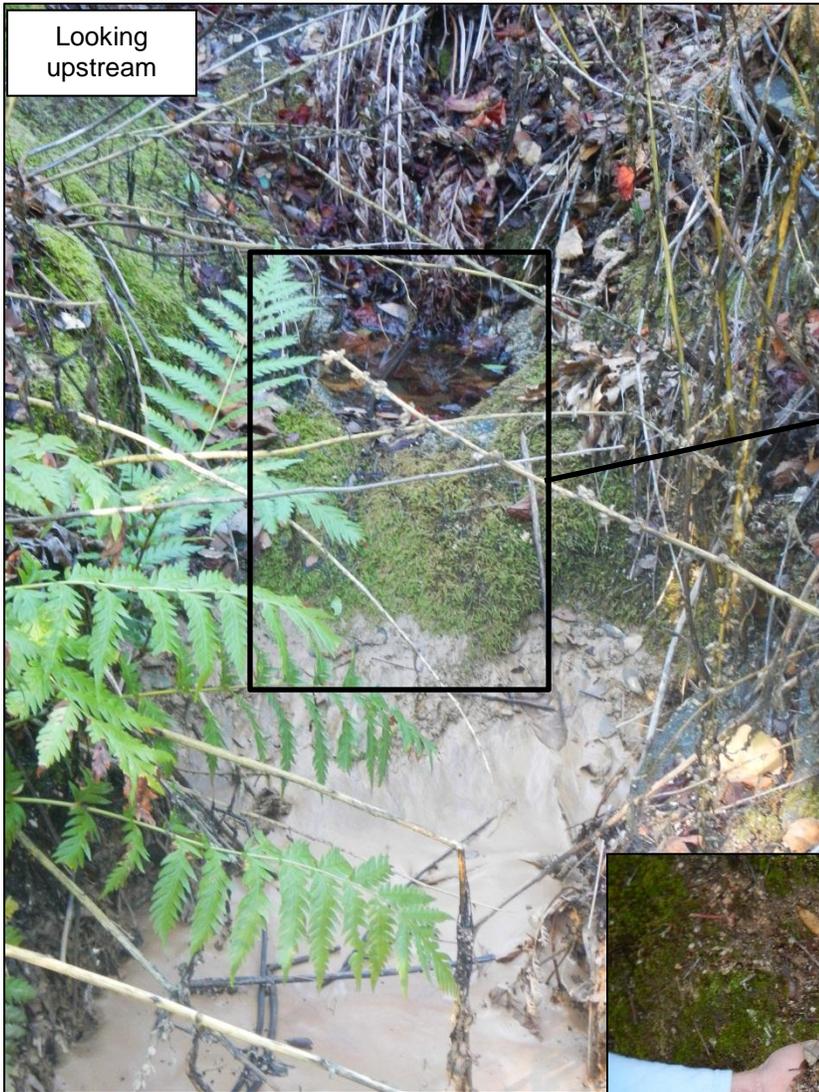
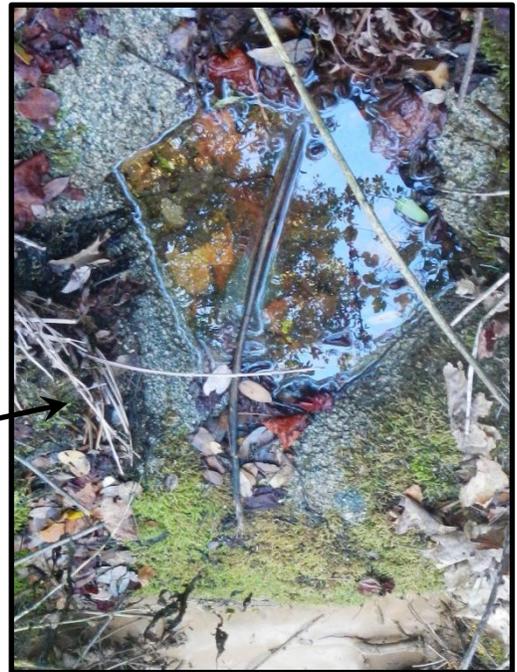
**Figure17.** Unaffected tributary entering the west side sediment laden stream (left). Inset photo shows how clear the pool is directly upstream (above). October 28, 2014

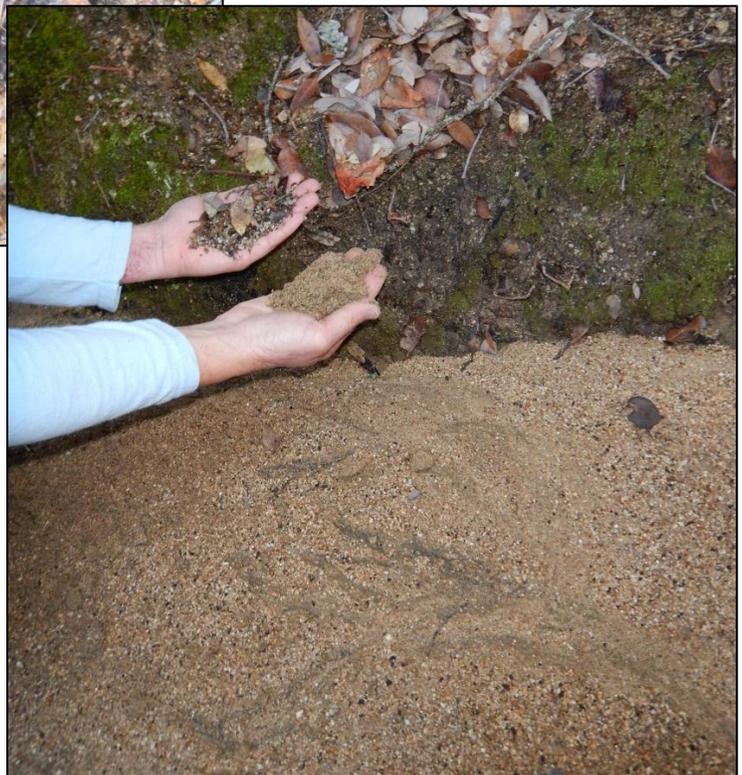
**Figure 19.** Comparison of naturally occurring streambed material, left hand (top), and fine sediment from grading activities entering the stream, right hand (bottom). October 28, 2014

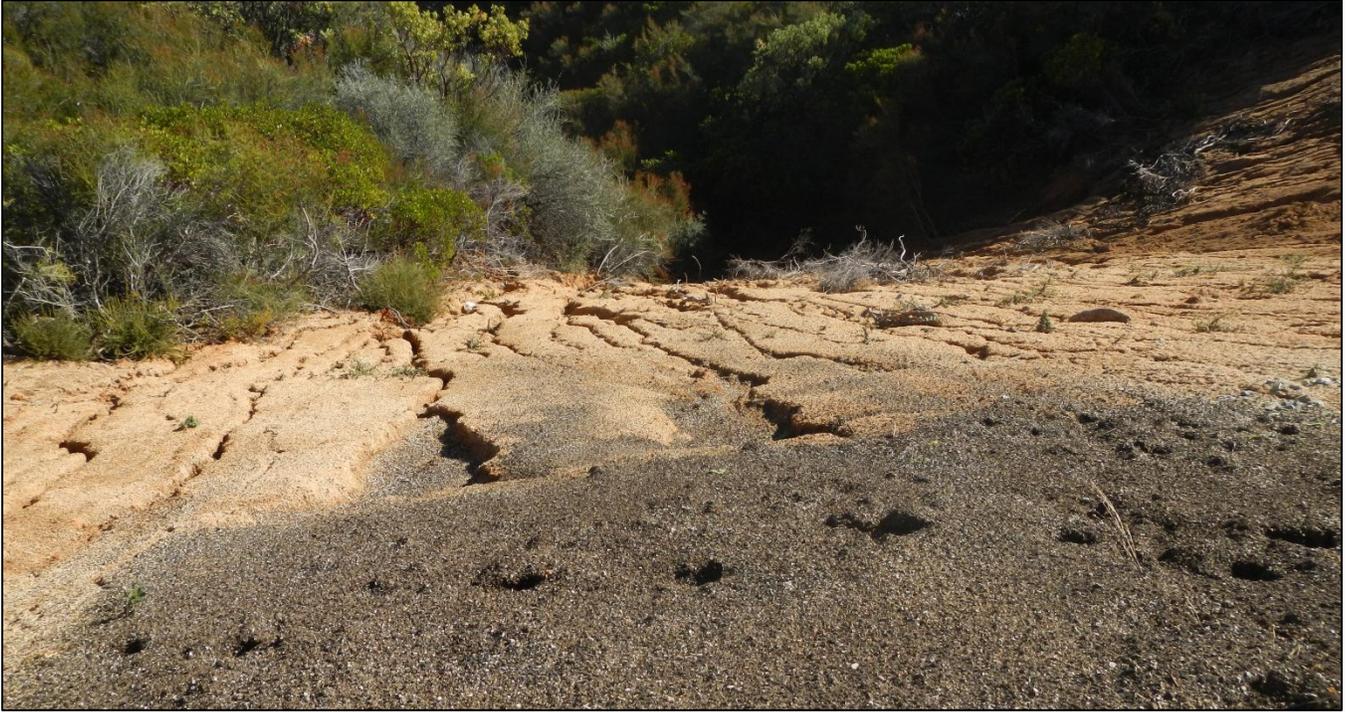
**Figure 20.** The side slope of one of the graded landings showing evidence of the fine sediment being eroded into the east side tributary. The darker material is potting soil that was placed along the top edge of the slope that is also being washed into the drainage. October 28, 2014

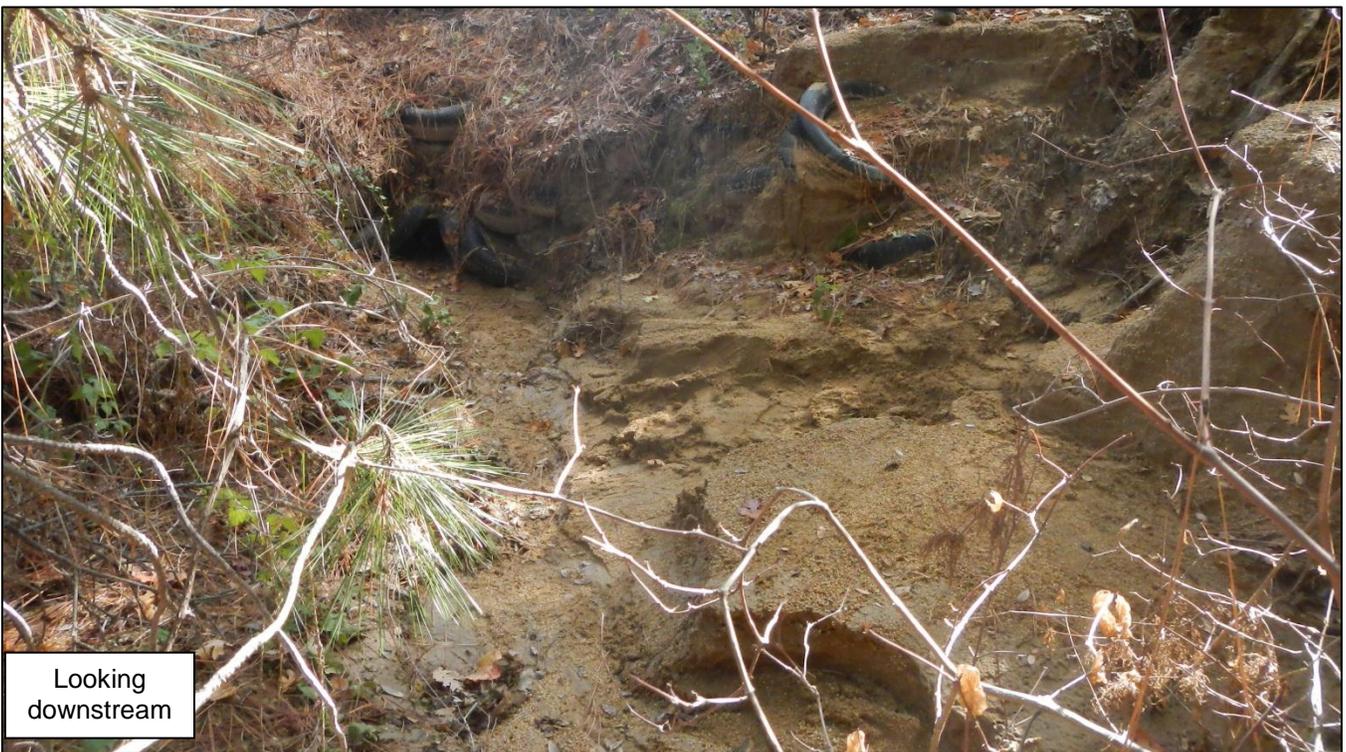
**Figure 21.** Evidence of large quantities of deposited sediment in the east side tributary that is entering and settling out directly upstream of the crossing. The culvert is already diminished in capacity by half from settled sediment (same as Figures 6 & 7; see for more detail). October 28, 2014

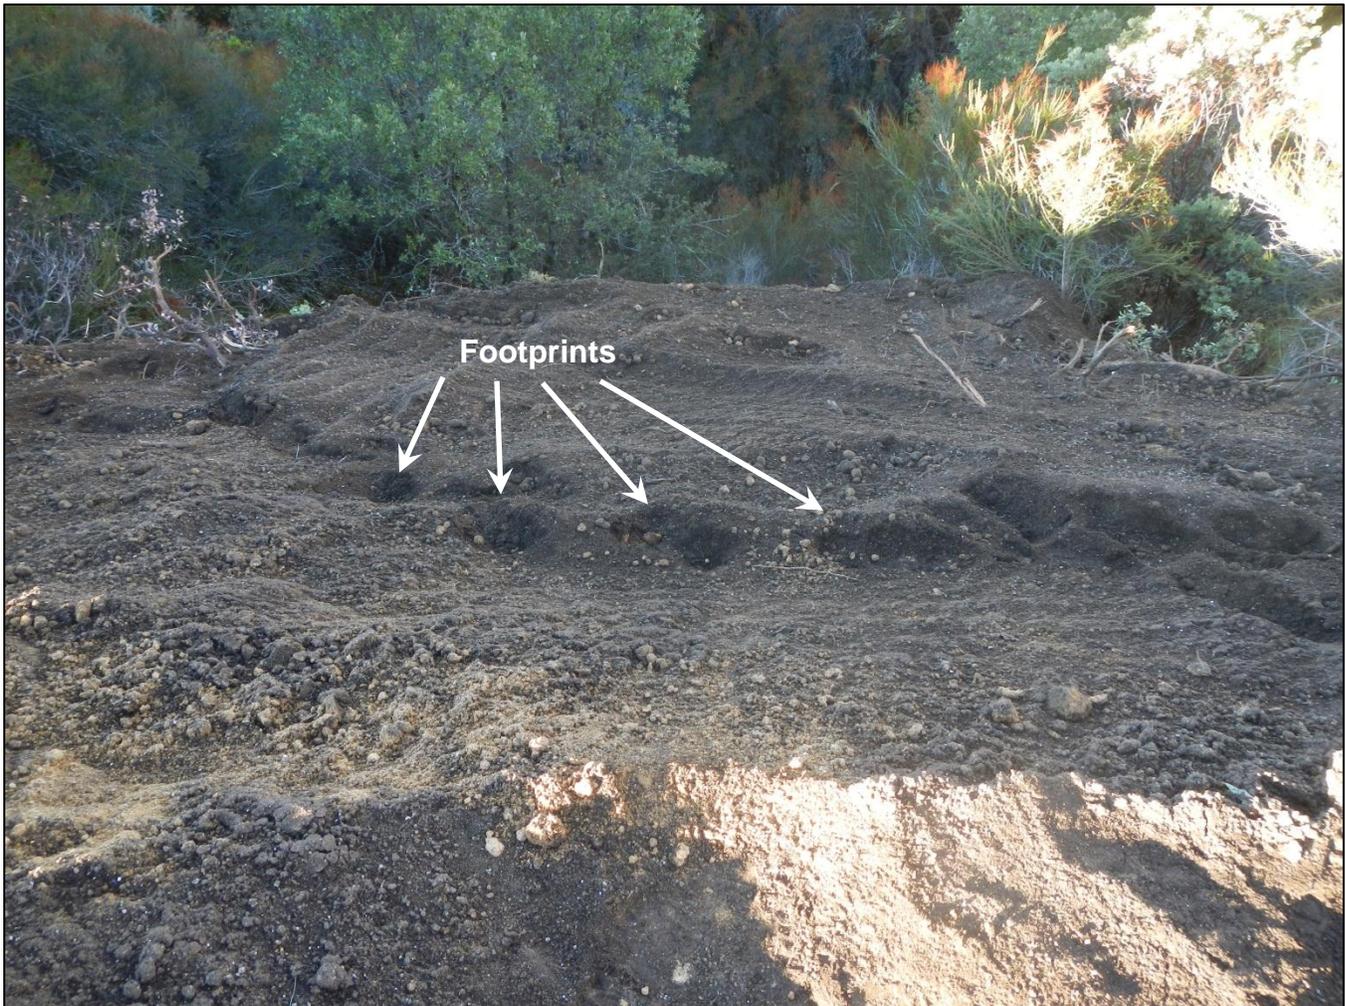
**Water Pollution: Potting Soil** – Large quantities of potting soil were discarded in areas that easily allowed the material to be washed into the streams (Figures 20 & 22). Potting soil contains perlite, which is a soil amendment added to provide aeration and optimize moisture retention; it is an amorphous volcanic glass that greatly expands when heated making it a bright white light weight material. Potting soil is not only detrimental to aquatic environments due to the deposition of soil and perlite but it also regularly contains quantities of gardening chemicals (e.g. fertilizers, insecticides, herbicides, rodenticides, etc) that are also detrimental if introduced into these environments. One method of determining if potting soil and its contaminants have entering an aquatic environment is by looking for or following deposited perlite that is easily transported by flowing water due to its buoyant nature.

**Figure 22.** Potting soil dumped onto a graded side slope where it has been eroding into the west tributary. Footprints are visible in the loose soil that are approximately 12 inches deep (See Figures 20 & 26 as well).  
October 28, 2014

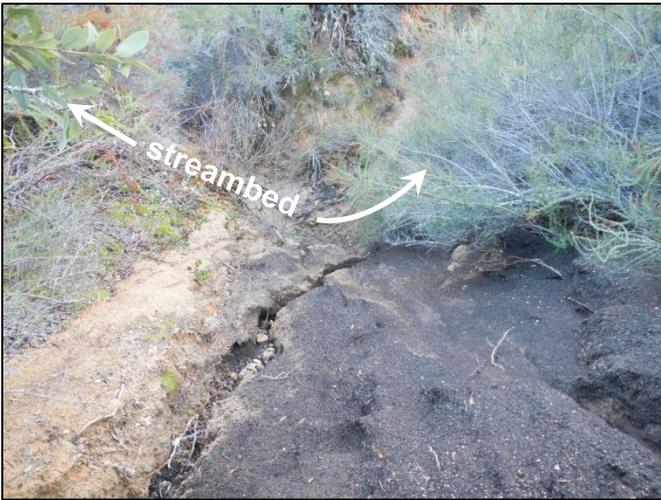
**Figure 23.** West side tributary showing evidence of erosion and deposition of potting soil. October 28, 2014

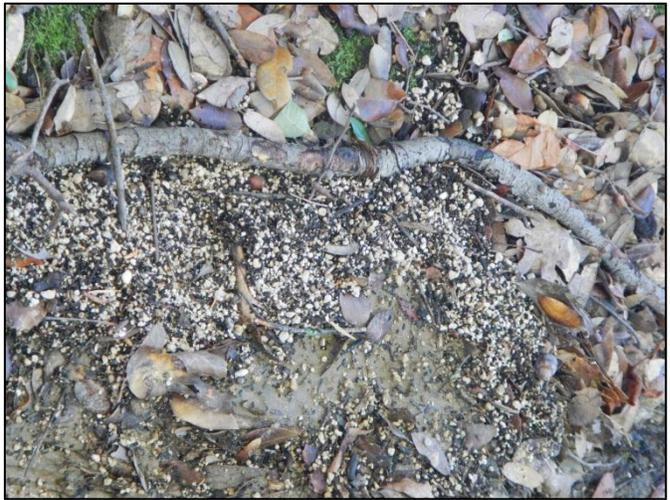
**Figure 24.** Evidence of potting soil and perlite that has entered the west side tributary and been relocated by flowing water and deposited downstream. October 28, 2014

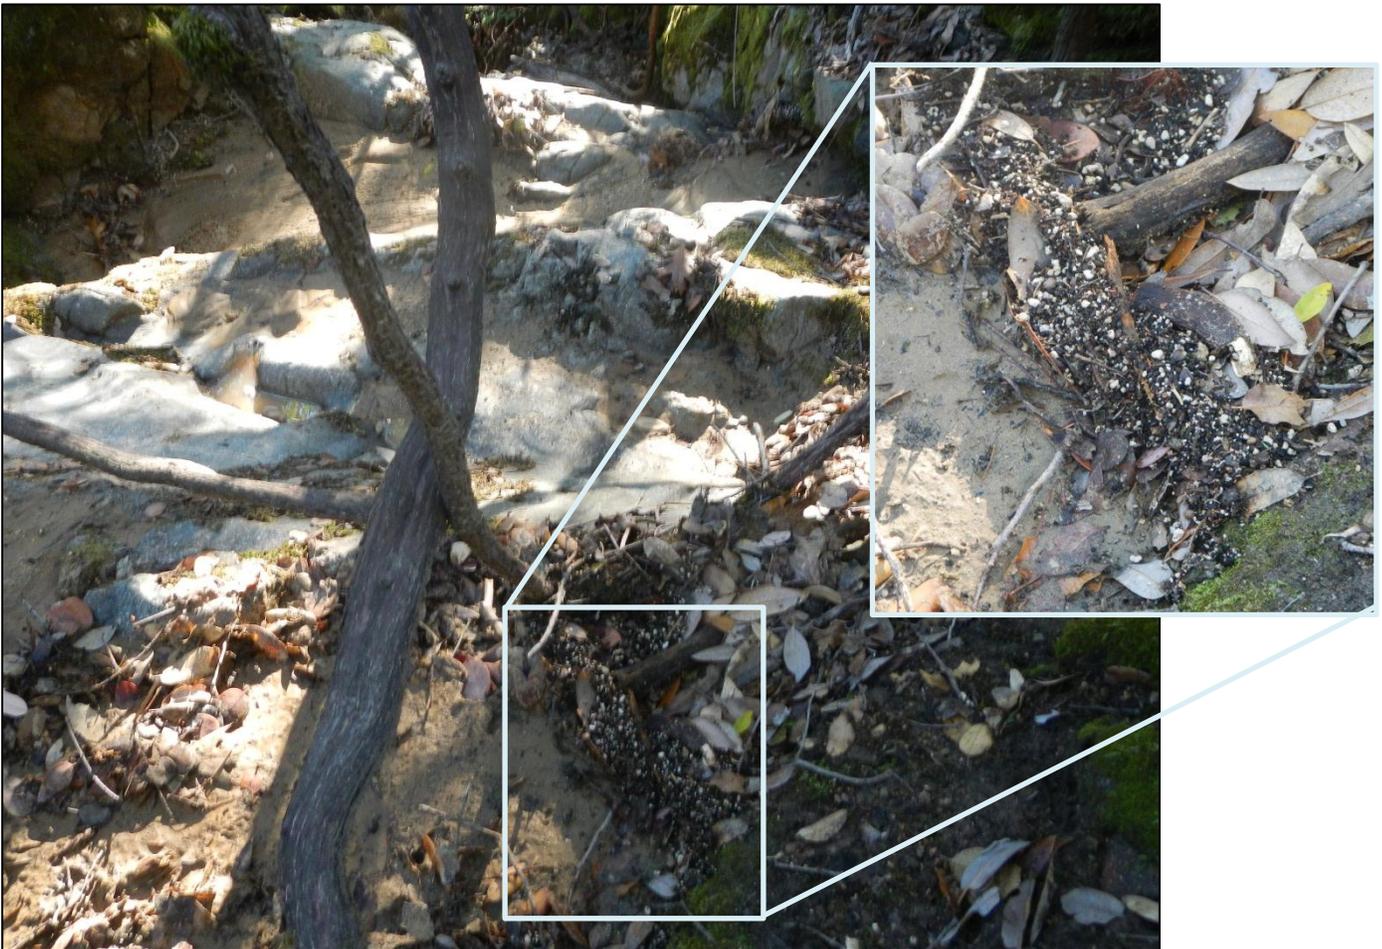
**Figure 25.** Evidence of potting soil and perlite found approximately 500 feet downstream of where it was originally permitted to pass into the stream (Figure 23). Perlite easily visible along the stream as evidenced in the inset photo. October 28, 2014
