## Memorandum

**Subject: Environmental Impact Assessment; Cordes Property**

**Summary:** Two unnamed tributaries to Doby Creek and one unnamed tributary to Duckett Creek, both tributaries to North Fork Cottonwood Creek, were negatively impacted by activities that substantially altered the streams' bed, bank and channel, and placed sediment and refuse where they can pass into waters of the state. These activities consisted of the reconstruction or new construction of three stream crossings and grading activities. They were conducted without written notification to the California Department of Fish and Wildlife (CDFW) or obtaining a Lake and Streambed Alteration (LSA) agreement, totaling 10 separate violations of Fish and Game Code (FGC).

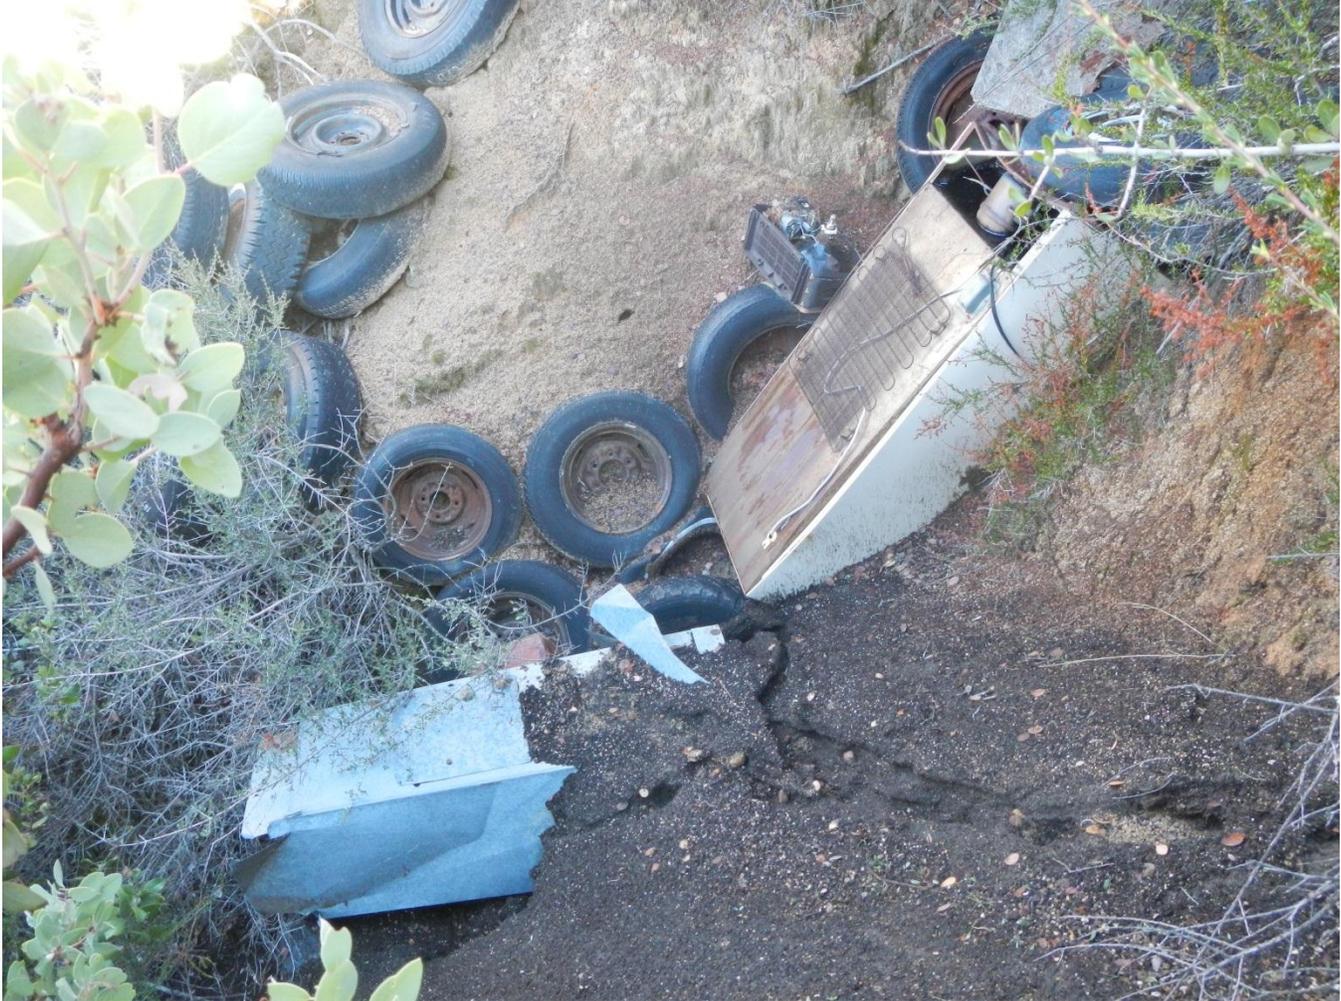
**Refuse Disposal:** It appears that garbage was purposefully pushed over the edge of one of the graded landings, within 150 feet of the west tributary. Instead of disposing of this refuse in a legal manner it is evident it was placed in this location during grading activities due to placed sediment, scour patterns and the discarded potting soil partially covering the waste. One of the pieces of refuse was an older refrigerator or freezer that could contain chlorofluorocarbon (CFC) which can/will leak into the environment if not disposed of properly. CFCs are heavily regulated because of their destructive effects on the ozone layer. CFCs are directly linked to the depletion of the ozone layer, global warming and climate change.

**Figure 26:** Refuse that had been dumped over the edge of one of the graded landings within 150 feet of the west tributary to Doby Creek. The side casting and erosion of the sediment and potting soil are also visible. October 28, 2014
