CLEANUP AND ABATEMENT ORDER R5-2013-0703, TRINITAS ALMOND PARTNERS II, L.P., STANISLAUS COUNTY

CLEANUP AND ABATEMENT ORDER NO.R5-2013-0703

FOR
TRINITAS ALMOND PARTNERS II, L.P.
STANISLAUS COUNTY

INSPECTION REPORT

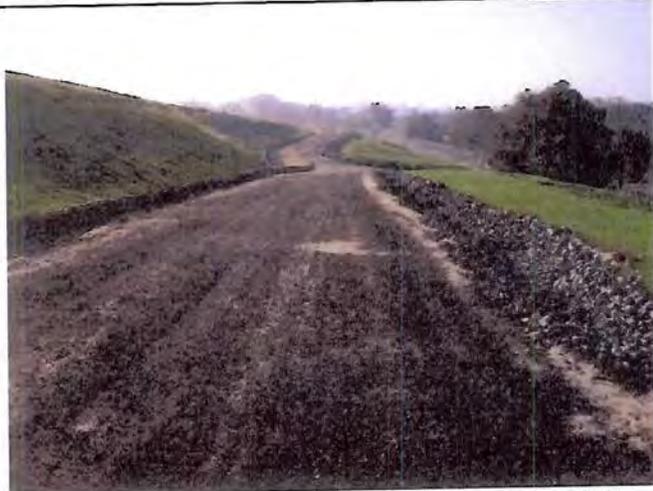
Photo 1: Waddles and rock lined water courses on the northeast portion of the project area (location A in Figure B). Hwy 108/120 is seen in the upper right of the photo.

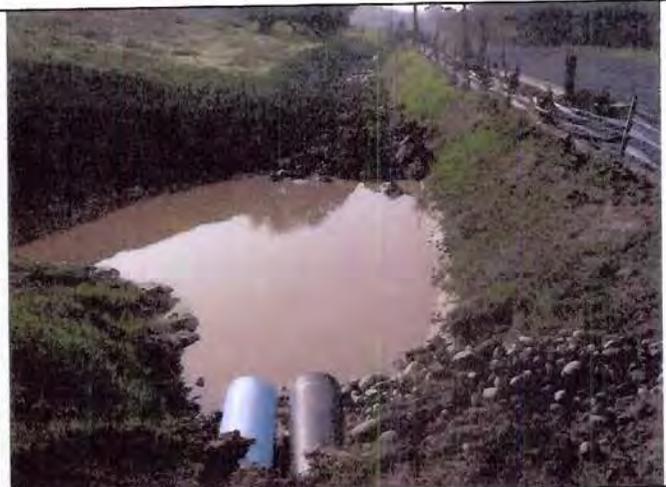
Photo 2: Rock lined water course, silt fence, and sediment pond at the northeast portion of the project area (location A in Figure B). Runoff from these areas can flow into Blitz Creek.

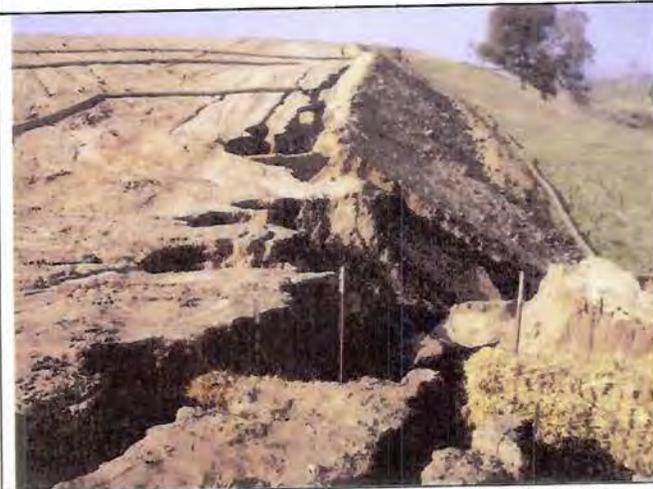
Photo 3: Gully erosion with straw bales (location B in Figure B).

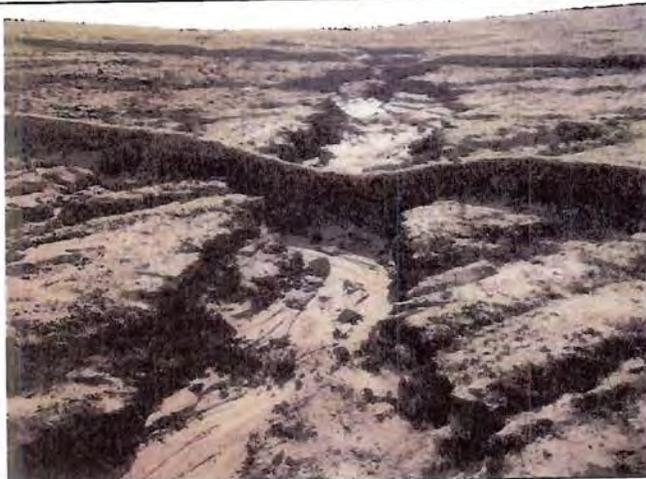
Photo 5: Waddles and rill/gully erosion on the plateau area (location B in Figure B).

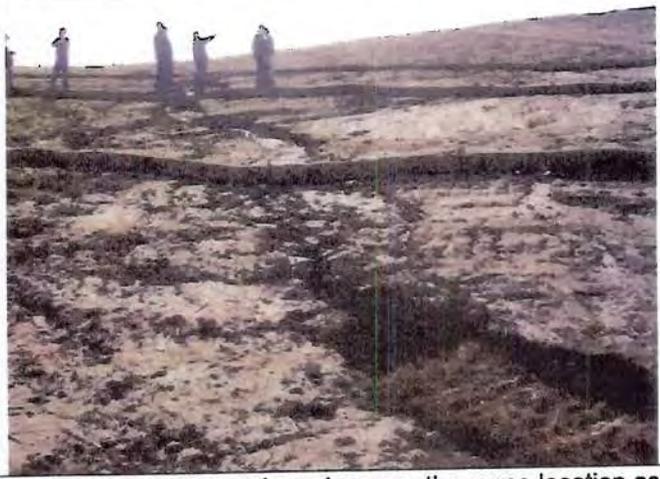
Photo 6: Waddles and erosion near the same location as Photo 5.

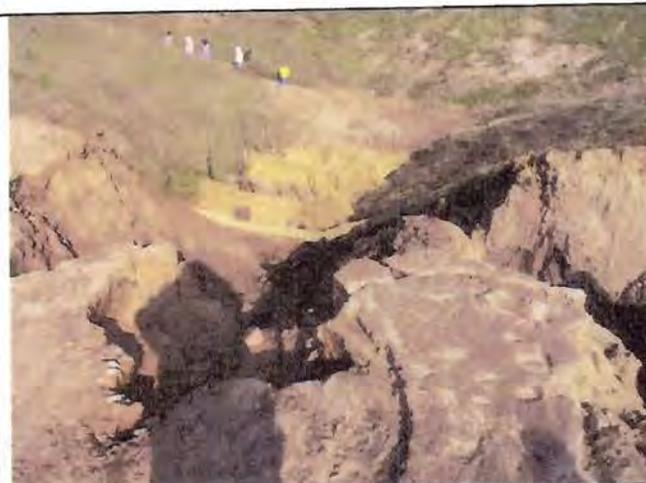
Photo 7: Blowout gully at location B in Figure B.

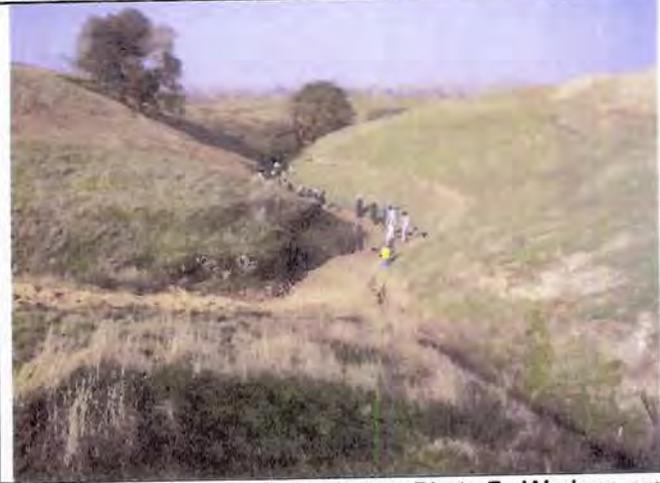
Photo 8: Looking north just below Photo 7. Workers are cleaning the excessive sediments that ran off of the plateau area. This water course goes to location D on Figure B, the western property drainage.

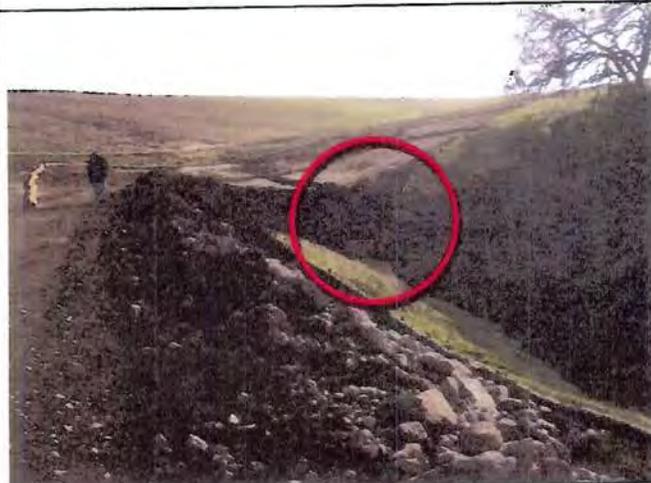
Photo 11: Looking south toward Photo 10. The berm blew out at the circled location. Waddles and straw bales have been installed to help prevent future sediment laden runoff.

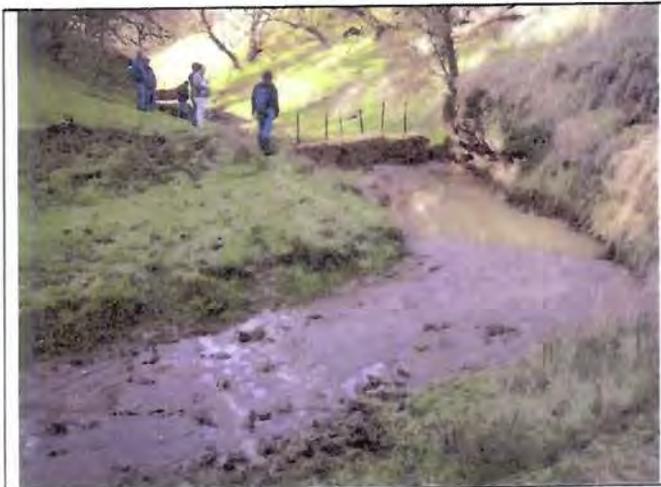
Photo 13: Looking at the un-named tributary downstream from Photos 11 and 12. Significant quantities of sediments were observed in the water course. A number of straw bale rows were installed at various locations down the water course.

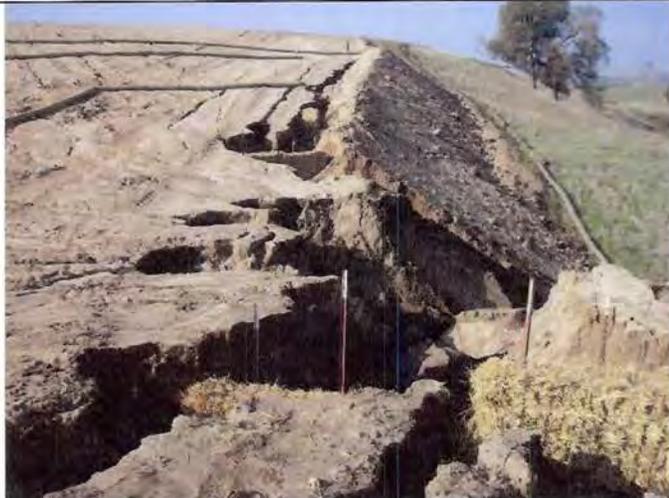
Photo 1: December 11, 2012 – Location B, Figure A
Close-up of the gully erosion.

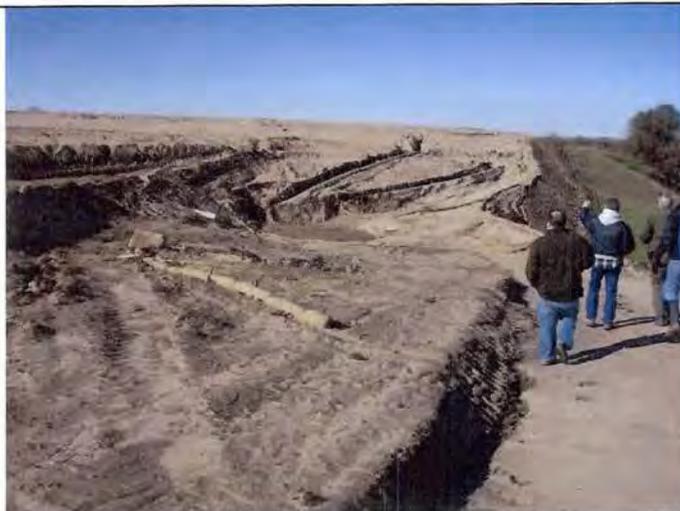
Photo 3: January 10, 2013 – Location B, Figure A
Looking at the same location as Photo 1. Two sediment capture ponds have been installed with straw waddles.

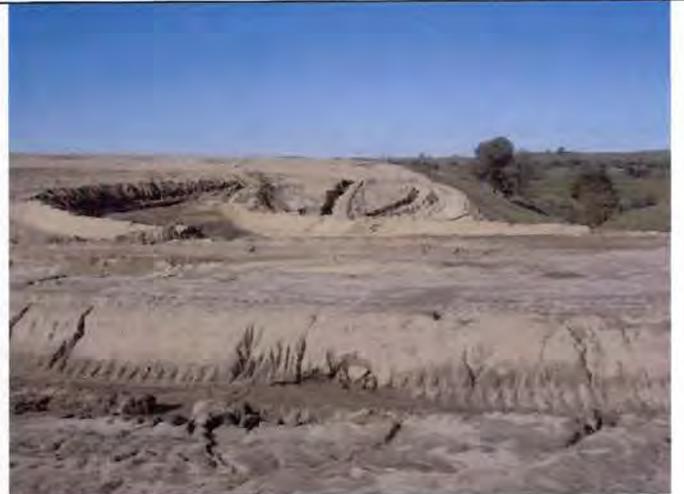
Photo 4: January 10, 2013 – Location B, Figure A
Looking at a broader view of Photo 3. There has been considerable regrading for berms and sediment basins. Numerous rill and small gully erosion channels from the previous rain event were observed.

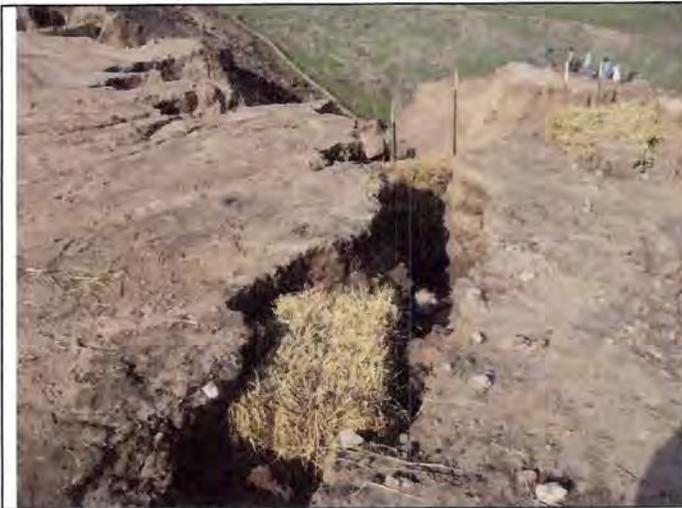
Photo 5: December 11, 2012 – Location B, Figure A
 Close-up of the gully erosion. It appears that there has been some erosion around the bales.

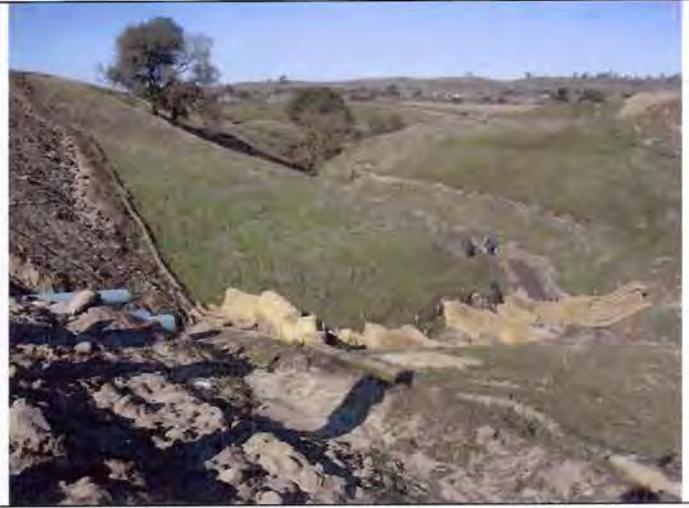
Photo 6: January 10, 2013 – Location B, Figure A
 The eroded gully has been regarded. Additional straw bales have been placed in the eroded channel. Work continues on removing eroded sediments from the water course (mid-right in the photo).

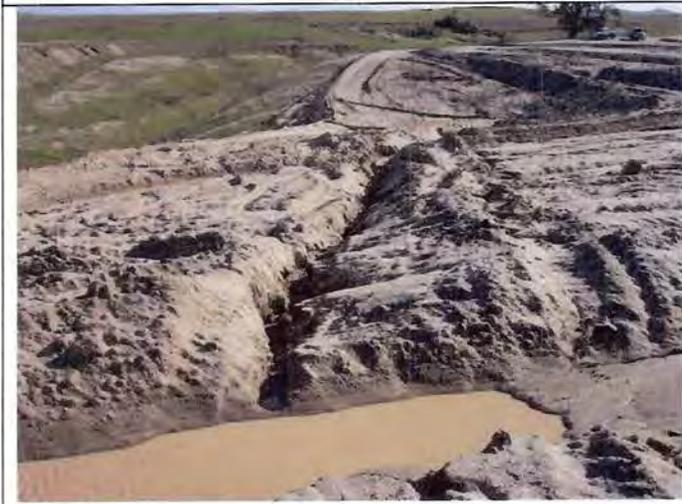
Photo 7a: January 10, 2013 – Location B, Figure A
 Looking south at the sediment ponds. A series of ditches have been installed to cross the direction of flow. These are intended to slow and capture some of the downhill stormwater flow. The gully in the foreground is an eroded gully from one of these channels. Note that the ponded water still has significant suspended sediments remaining from the January 5th and 6th rainfall events.

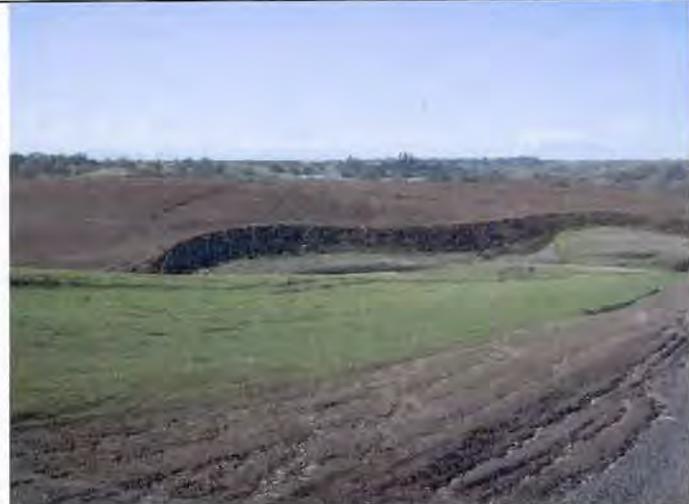
Photo 7b: January 10, 2013
 Other projects sites with potential erosion issues. The soil types varied throughout the project. Some soil types showed less erosion impacts. This location is farther east of Photo 7a. This photo and the top right of Photo 7a show that native grasses are starting to establish in some of the less disturbed ground.

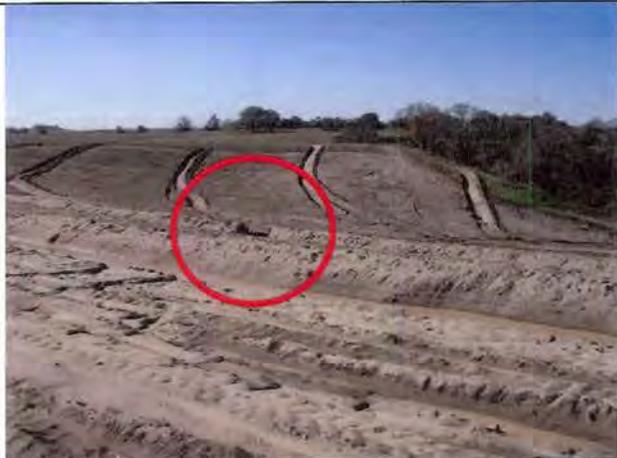
Location C – There was extensive modification compared to the December 11th inspection. As with the other site (Location A), channels have been installed across the flow gradient to help catch sediments and slow the surface runoff velocity. There were numerous signs of erosion, although not as extensive as in Location B. Some erosion of the channel berms was observed (See Photo 10).

Photo 10: January 10, 2013 – Location C, Figure A
Looking at the approximate location as Photo 8 showing a series of channels constructed across the direction of runoff to help capture and reduce the runoff velocity.

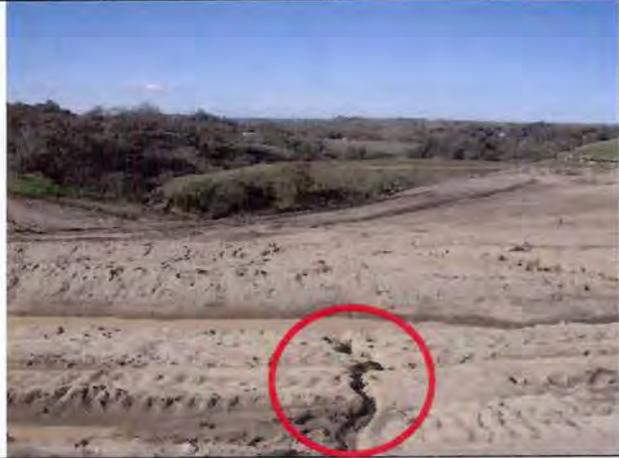
Photo 11: January 10, 2013 – Location C, Figure A
Portions of the channel banks had eroded through. Also, a number of rill and small gully erosion was observed, indicating that the soil type is very susceptible to erosion. Ponded water from the previous (January 5 & 6) rainfall events still had suspended solids indicating that the soil type is susceptible to both settleable and suspended solid sediment runoff.

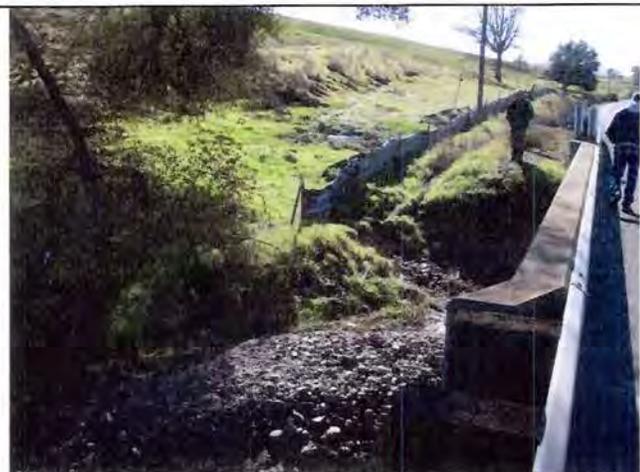
Location A – This is the northeastern corner of the project area. As noted in the December 11, 2012 inspection, the runoff from this portion of the project is relatively small compared the rest of the project watershed. Additional mitigation measures have been installed since the December 11th inspection. Lt. McKay showed the locations where he sampled runoff from the project into Blitz Creek and also the western drain. There was a noted difference observed at the Blitz Creek location were runoff from the project by the silt fence compared to opposite side of the creek bed (see photos 12 – 15).

Photo 12: January 10, 2013 – Location A, Figure A
Looking west across Blitz Creek at the silt fence on the project property.

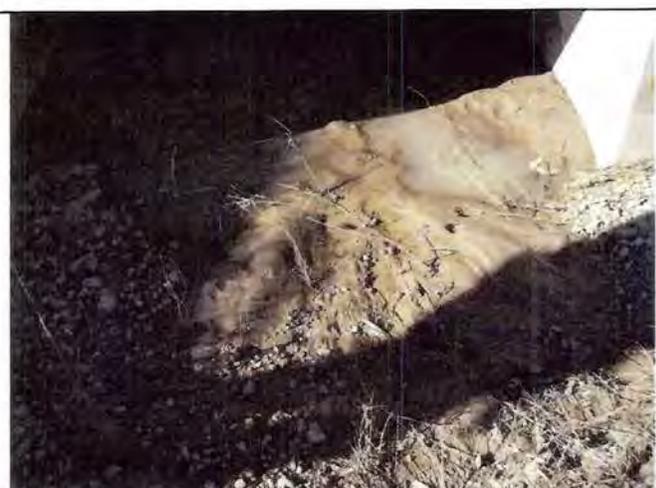
Photo 14: January 10, 2013 – Location A, Figure A
The runoff from the property project (Location A) flows into the creek along the west side. This is a close-up of the west side of the creek.

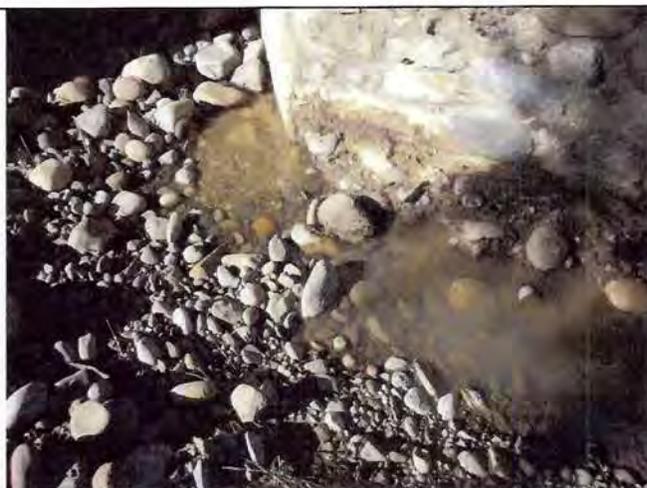
Photo 15: January 10, 2013 – Location A, Figure A
This is a close-up of the east side (or main channel) of the creek during lower flow events. During heavy flow events, the entire channel is full. The sediments seen in Photo 14 appear to be from runoff from the project property. The clearer water and significantly less sedimentation seen in Photo 15 indicated clearer water in Blitz Creek up-gradient side. Partially due to a lesser sediment load, as well as clearer water scouring sediments from the gravel.

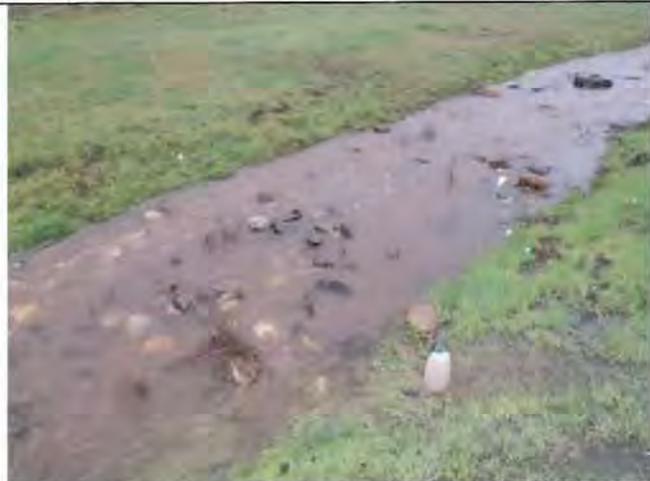
Photo 16: Photo submitted by DFG of the Dec. 23, 2012 discharge. Location A, Figure A
 Looking up-gradient at Blitz Creek.
 DFG reported sample data for December 23, 2012:
 Settleable Solids = ND
 Total Suspended Solids = 39.0 mg/L
 Turbidity = 85.4 NTU

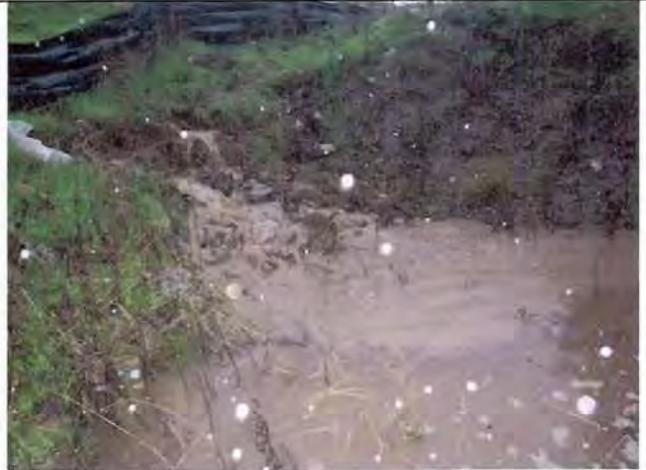
Photo 17: Photo submitted by DFG of the Dec. 23, 2012 discharge. Location A, Figure A
 Looking at the flow from the project property into Blitz Creek. Blitz Creek up-gradient from the confluence.
 DFG reported December 23, 2012 sample data flowing at the silt fence seen above:
 Settleable Solids = 0.4 mg/L
 Total Suspended Solids = 4,220 mg/L
 Turbidity = 3,190 NTU

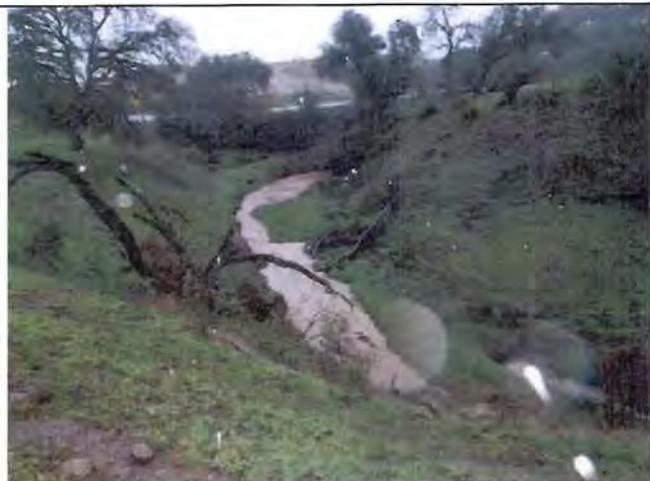
Photo 18: Photo submitted by DFG of the Dec. 23, 2012 discharge.
 Looking south toward Hwy 108 (off-property in the western drainage). DFG reported sample data for December 23, 2012:
 Settleable Solids = 5.0 mg/L
 Total Suspended Solids = 16,800 mg/L
 Turbidity = 610 NTU

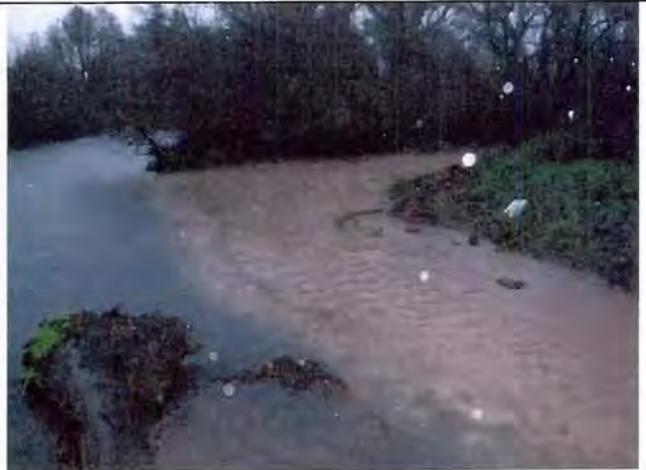
Photo 19: Photo submitted by DFG of the Dec. 23, 2012 discharge.
 The Stanislaus River looking up-river at the sediment in the Blitz Creek outfall. DFG reported sample data for December 23, 2012 of the creek outfall:
 Settleable Solids = 0.4 mg/L
 Total Suspended Solids = 3,580 mg/L
 Turbidity = 3,110 NTU
Up-gradient in the river:
 Settleable Solids = ND
 Total Suspended Solids = ND
 Turbidity = 3.9 NTU

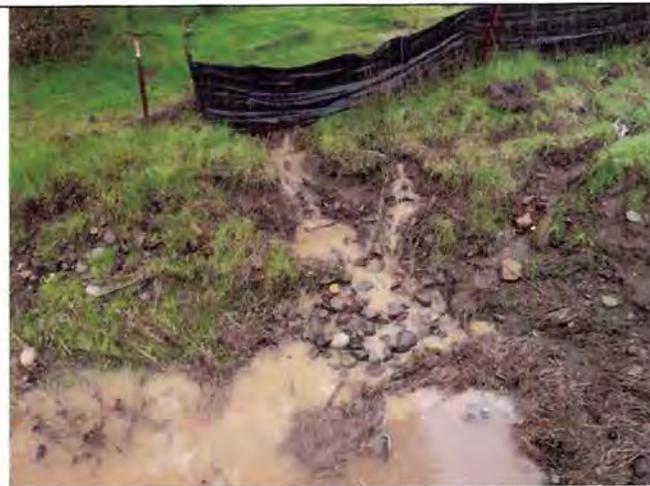
Photo 16: Photo submitted by DFG of the Jan 6, 2013 discharge. – Location A, Figure A
 Looking at the flow from the silt fence into Blitz Creek.
 From silt Fence: Settleable Solids = ND
 Total Suspended Solids = 1230 mg/L
 Turbidity = 1430 NTU
 Up-stream Blitz Creek: Settleable Solids = ND
 Total Suspended Solids = 10.0 mg/L
 Turbidity = 20.9 NTU

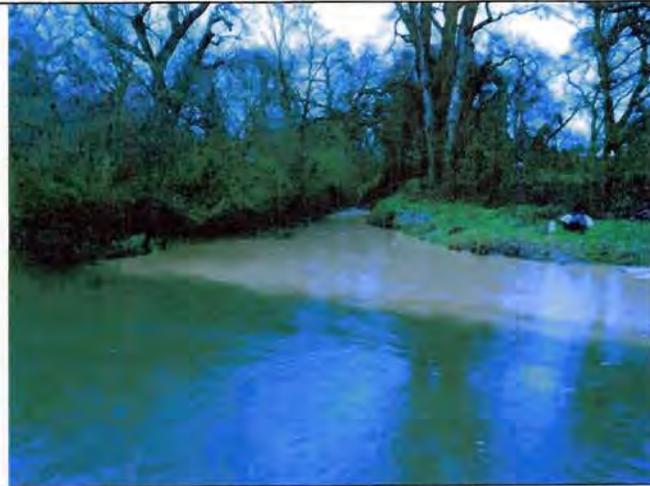
Photo 17: Photo submitted by DFG of the Jan 6, 2013 discharge.
 Stanislaus River looking across at the sediment flow in the Blitz Creek outfall (combined Blitz Creek and un-named tributary)
 Blitz Creek outfall: Settleable Solids = ND
 Total Suspended Solids = 350 mg/L
 Turbidity = 440 NTU
 Up-stream River: Settleable Solids = ND
 Total Suspended Solids = 5.0 mg/L
 Turbidity = 7.7 NTU
 Down-stream River : Settleable Solids = ND
 Total Suspended Solids = 310 mg/L
 Turbidity = 439 NTU

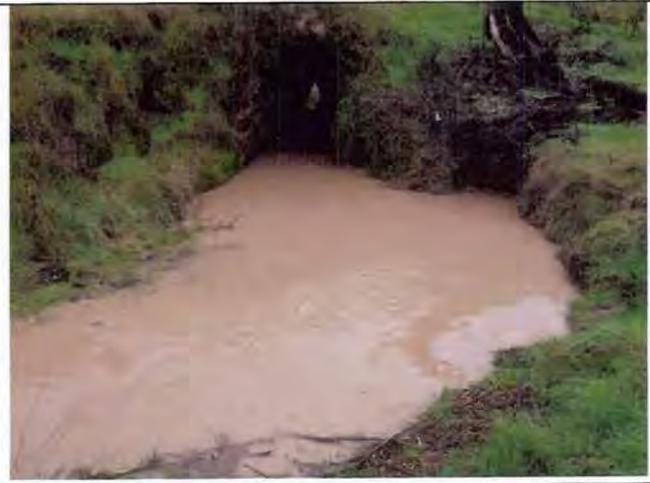
Photo 19: Photo submitted by DFG of the Jan 6, 2013 discharge.
 Looking north at the west side drainage where it flows under the highway off-property.
 West drain: Settleable Solids = ND
 Total Suspended Solids = 1330 mg/L
 Turbidity = 1420 NTU
