SITE INSPECTION REPORT FOR THE DELLAR TRUST PROPERTY, SACRAMENTO COUNTY

INSPECTION REPORT

DISCHARGER: City of Sacramento and Sylvia Dellar Trust

LOCATION & COUNTY: Sacramento, Sacramento County

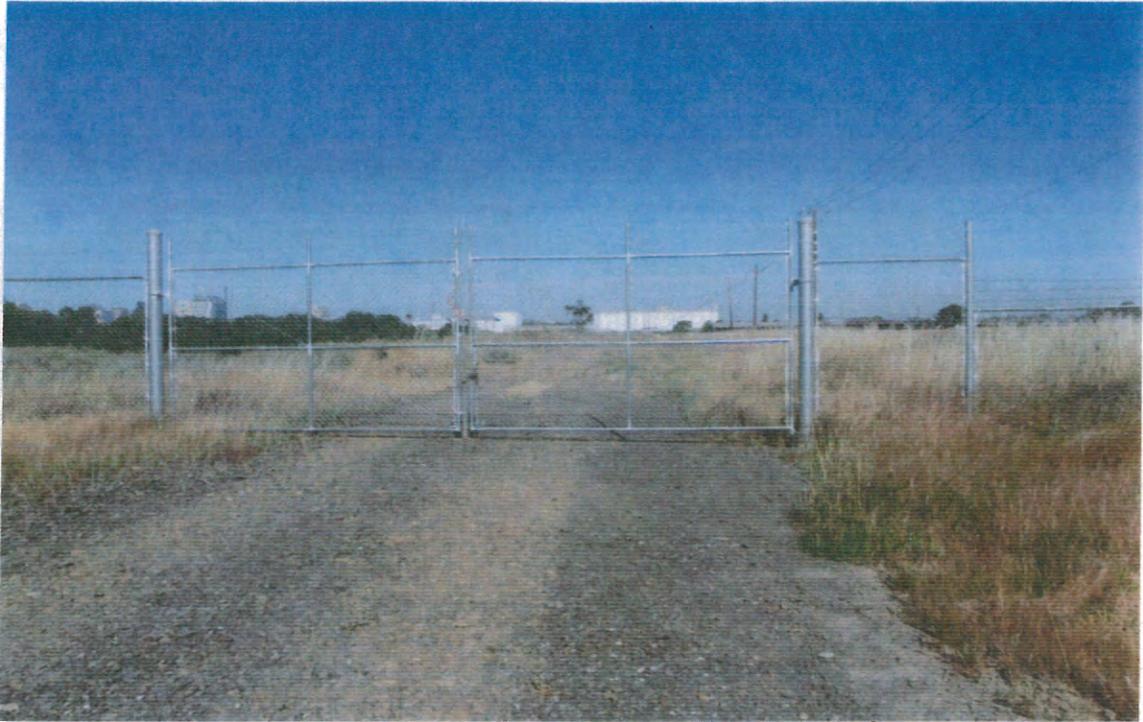
The purpose of site inspection was to observe any progress toward closure. New security fencing was installed as shown in Photo 1. The fencing wrapped the site and connected to the north fence adjacent to the American River levy. Debris or homeless were not spotted and the soil stockpile was recently disked to reduce weeds (Photo 2). Staff walked the site from front to back and was able to take pictures of Elderberry Bushes (Photo 3), which are well established at this site. Erosion of the soil stockpile or interim cover was not evident and no other winter related concerns were noted.

Photo 1: Newly erected security fence.

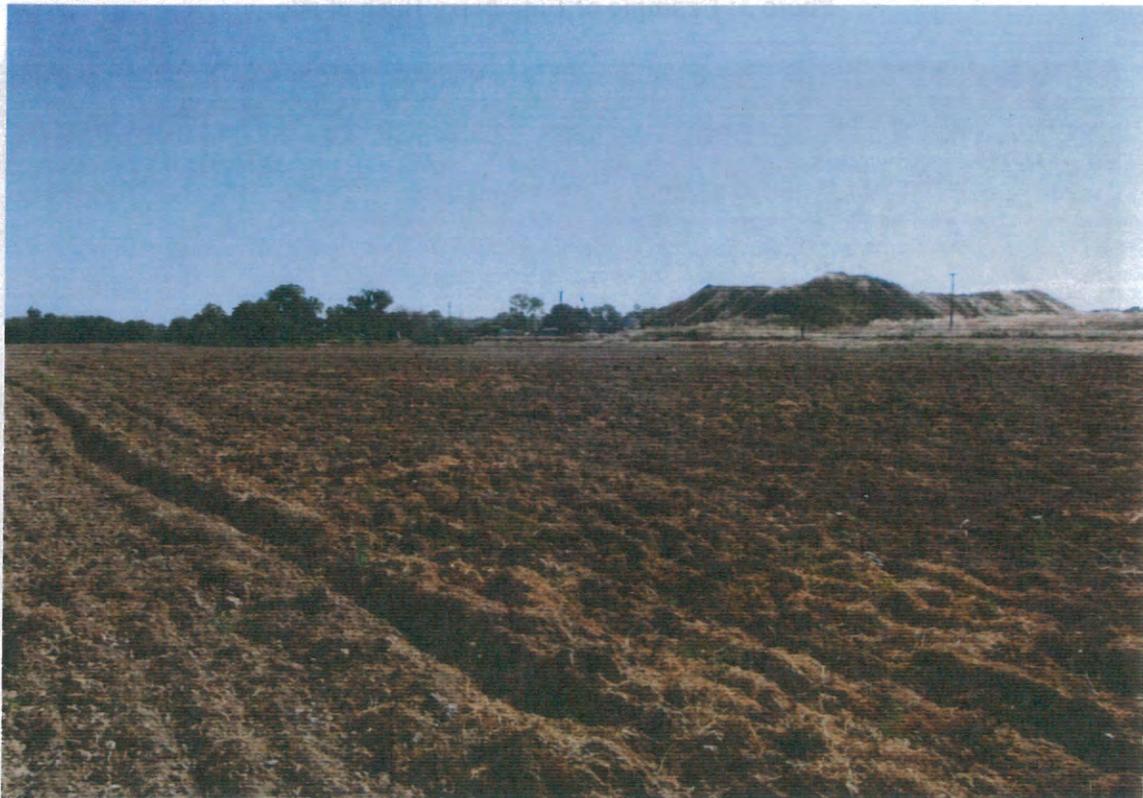
Photo 2: Soil stockpile recently disked. Photo looking north-northeast.

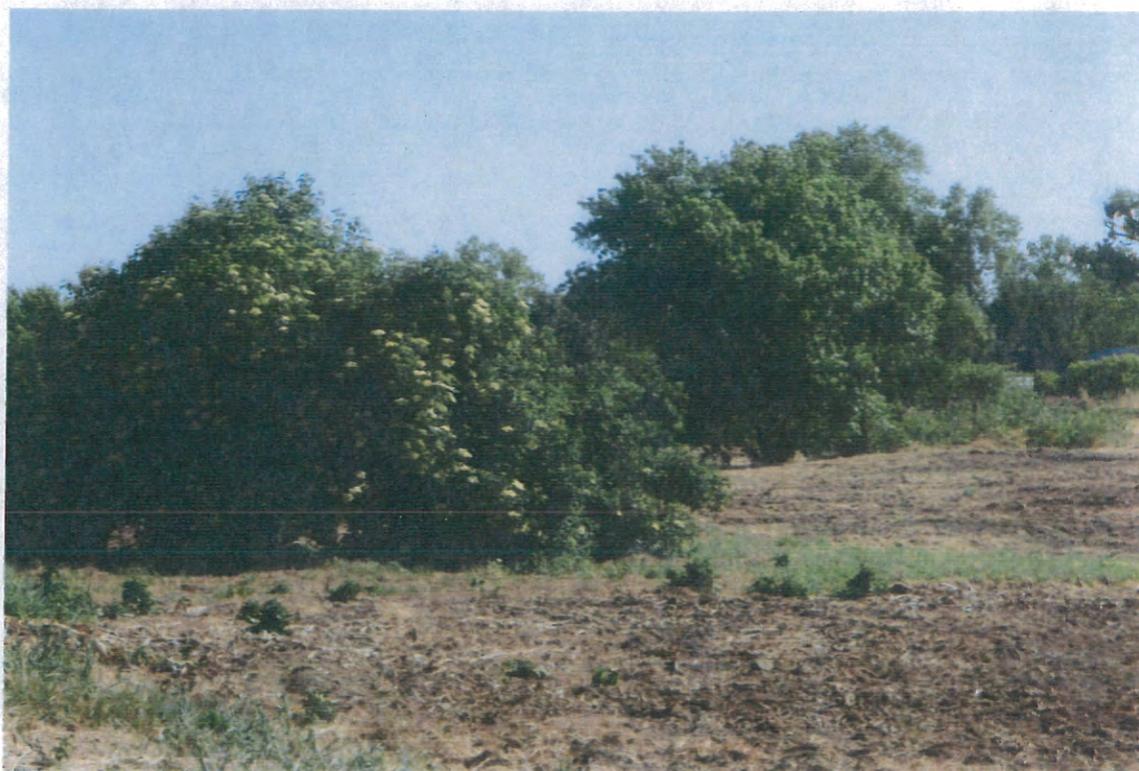
Photo 3: Example of Elderberry Bush at site.

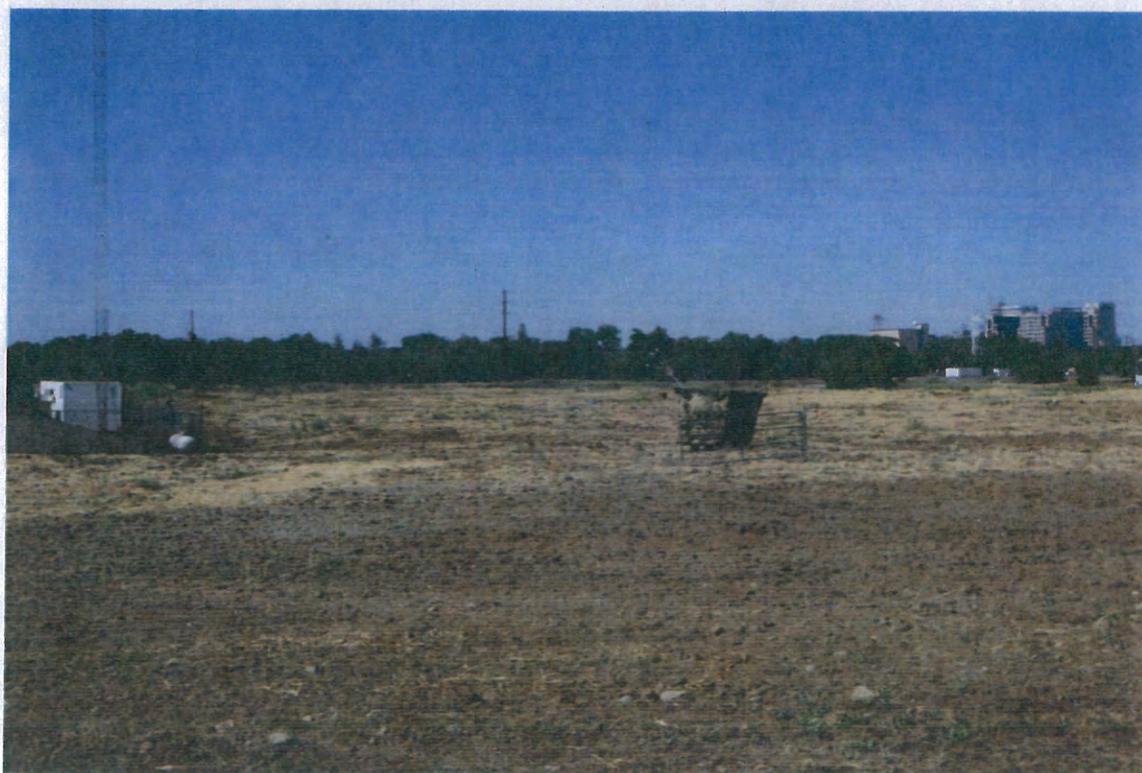
Photo 4: Landfill surface looking southwest. Note radio tower and anchor.
