Central Valley Regional Water Quality Control Board

INSPECTION REPORT, WESTERN REGIONAL SANITARY LANDFILL, PLACER COUNTY

INSPECTION REPORT

LOCATION & COUNTY: Western Regional Sanitary Landfill, Placer County

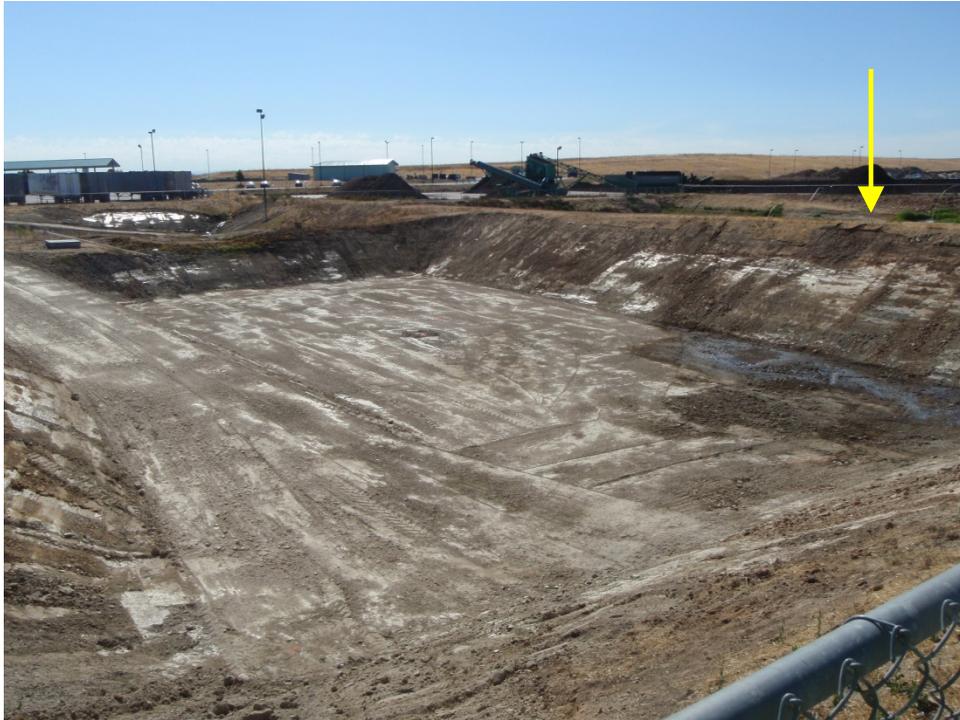
Figure 1

The MRF has a separate industrial stormwater permit from the landfill itself, and as seen in Figure 1, the stormwater retention basin for the MRF has recently been expanded.

Looking southeast across the MRF industrial stormwater pond. The yellow arrow points to the northern (old) composting process and stormwater retention pond, as seen in Figure 2.

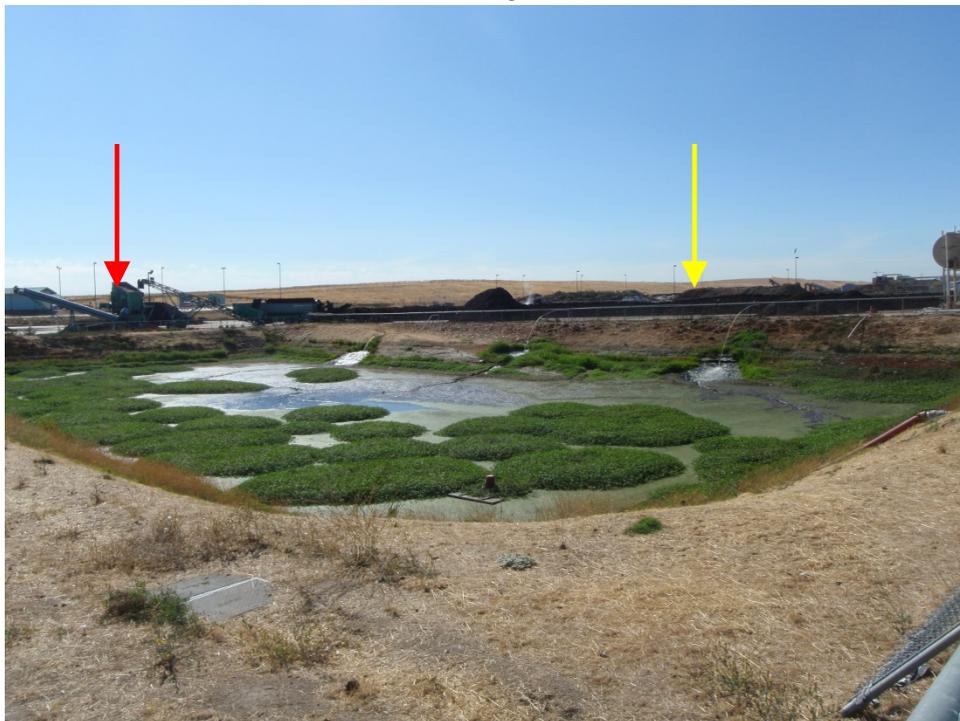
Just south of the MRF stormwater pond is one of the Site's two composting process and stormwater retention ponds, Figure 2. The pond in Figure 2 is the Site's older unlined northern composting pond, and all stormwater and process water generated across both the: 1) original concrete lined composting area and 2) green and wood waste processing area, drain into this pond. An accumulation of sediment is visible along the south end of the pond and heavy vegetation covers the northern half of the pond. The northern (old) composting pad and process area can also be seen in Figure 2, just beyond the northern pond.

Looking southeast across the northern (old) composting process and stormwater retention pond. The yellow arrow points to the northern (old) composting pad, located just south of the pond, and the red arrow points to the northern (old) composting processing area, located just east of the pond.

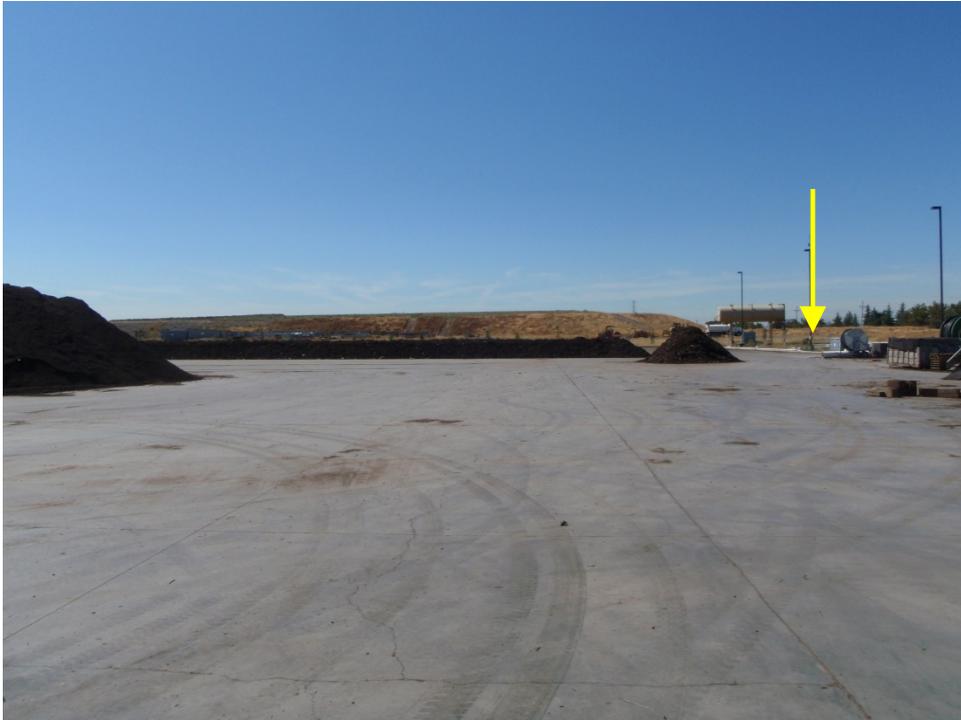
Figure 3

Looking south across the new southern composting pad. The yellow arrow points to the composting process and stormwater retention pond for the southern (new) composting pad.

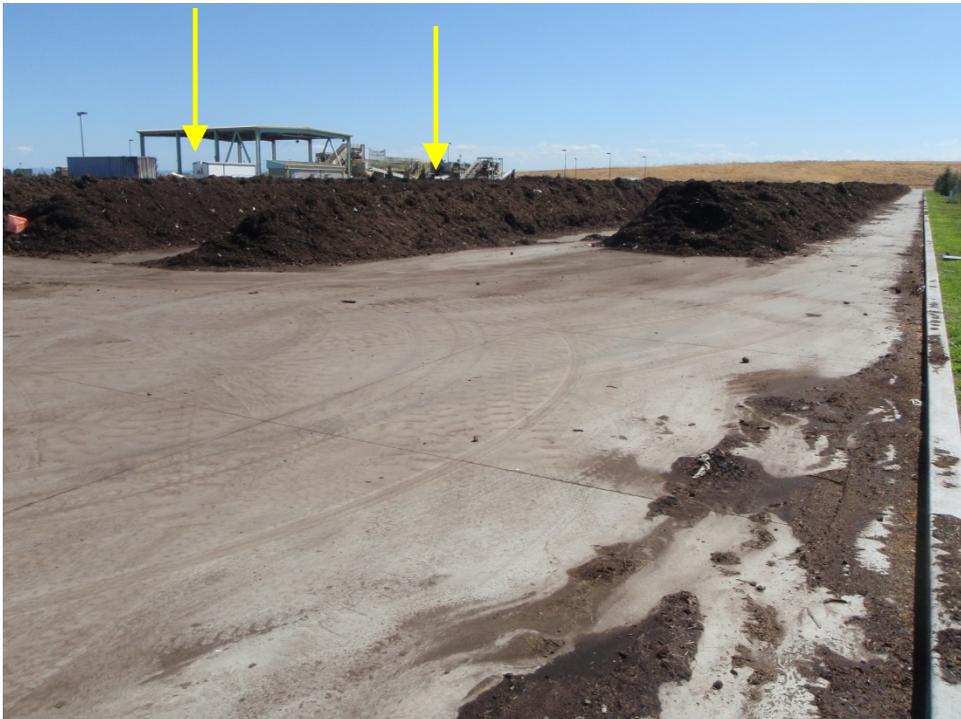
Figure 4

Standing near the southwestern corner of the southern (new) composting pad, looking northeast across the pad. The yellow arrows point to the wood and green waste processing area located just north of the southern composting pad.

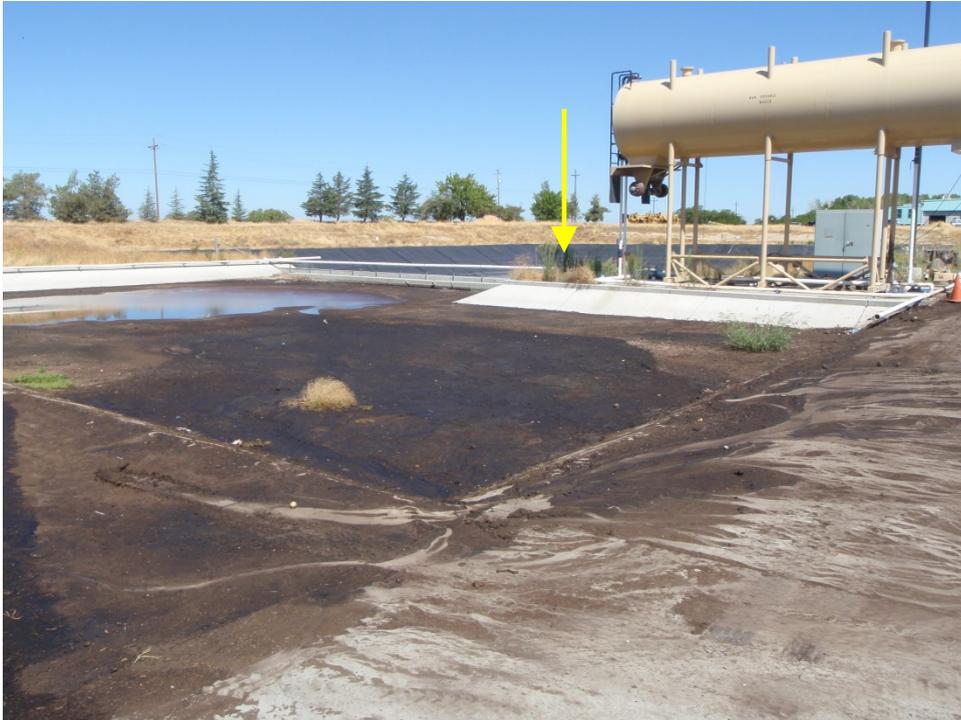
Figure 5

Standing in the same location as Figure 4, but looking northwest across the sedimentation basin for the southern (new) composting pad. The yellow arrow points to the southern composting process area stormwater retention pond as seen in Figure 6.

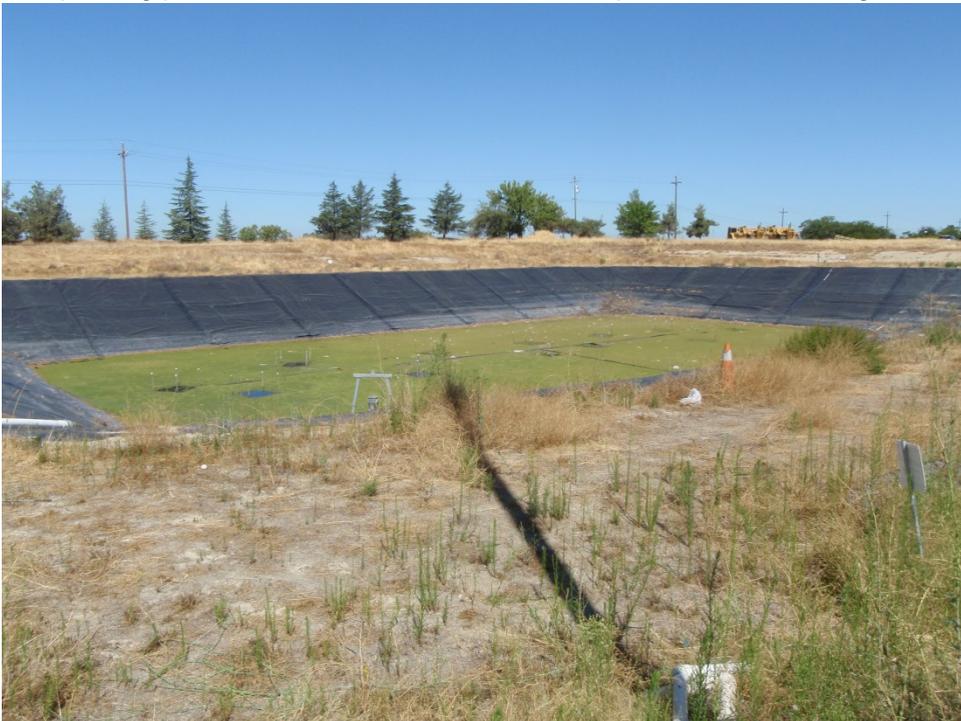
Figures 3 and 4 show sections of the new southern composting area, and Figure 5 shows the sedimentation basin for the new southern composting area process and stormwater retention pond. Figure 6 shows the new southern composting area pond itself. According to Mr. Schmitz, this southern composting area pond was being drained, so that it could be expanded this summer. This pond expansion project is scheduled for completion in October 2014. Mr. Schmitz also stated that water can be transferred from the new composting area pond to the old composting area pond; however, water cannot be transferred the other way. Figure 7 shows how water is transferred between ponds, primarily through gravity flow across concert pads, although at the time of this inspection, the water shown in Figure 7 was stated to be fresh water, not water from the new southern area pond.

Looking northwest across the southern (new) composting area process and stormwater retention pond. After flowing through the sedimentation as seen in Figure 5, all composting process and stormwater from the southern (new) composting area flows into this lined pond.

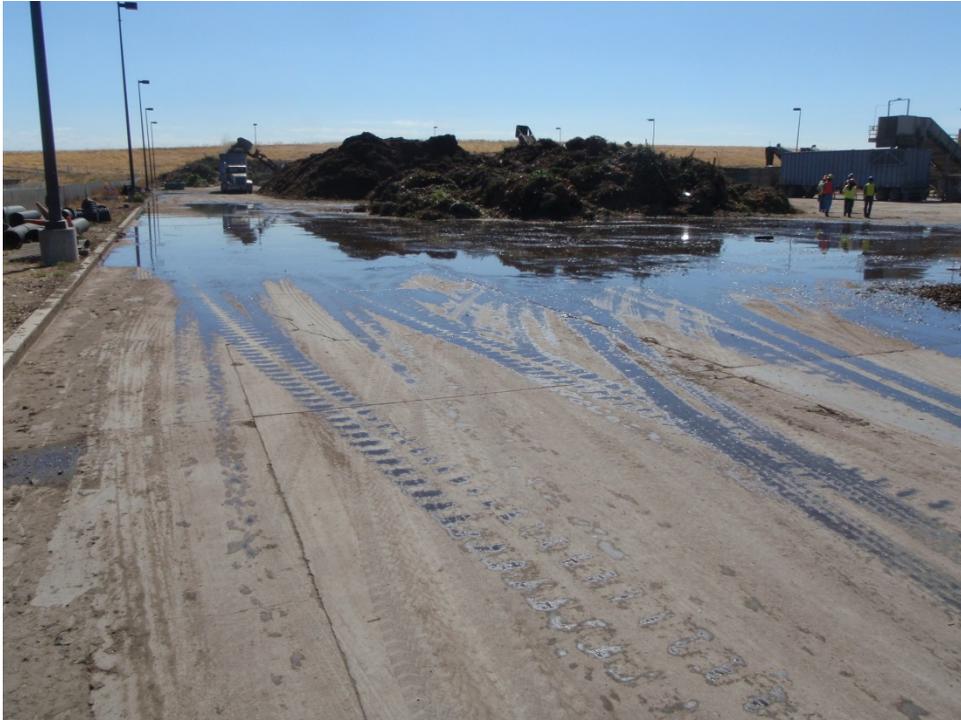
Figure 7

Looking east across the green and wood waste processing area at how water is transferred between the two composting process and stormwater retention ponds. The southern (new) composting pad is located to the right of this photo, and the northern (old) composting pad is located to the left of this photo.

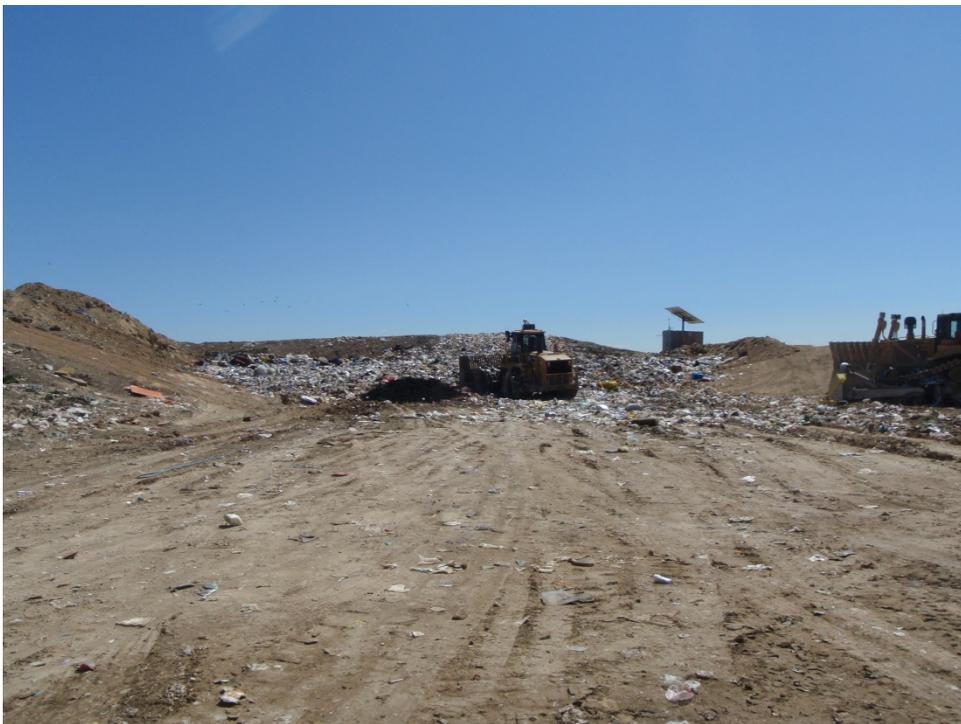
Figure 8

Looking east at the active working face of the landfill.

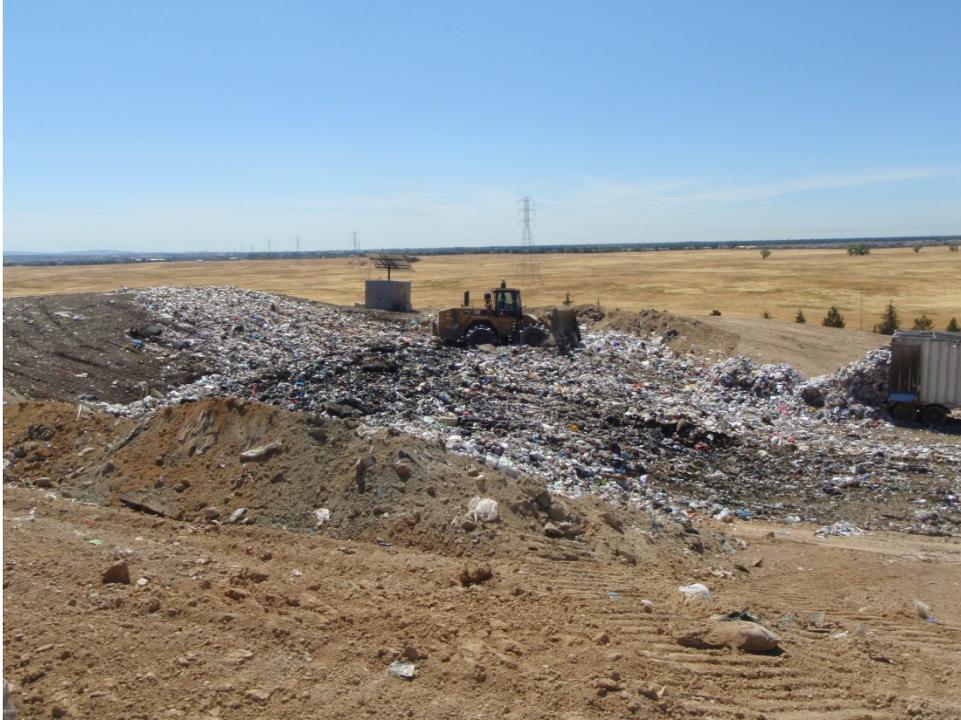
Figure 9
Looking north at the active working face of the landfill.

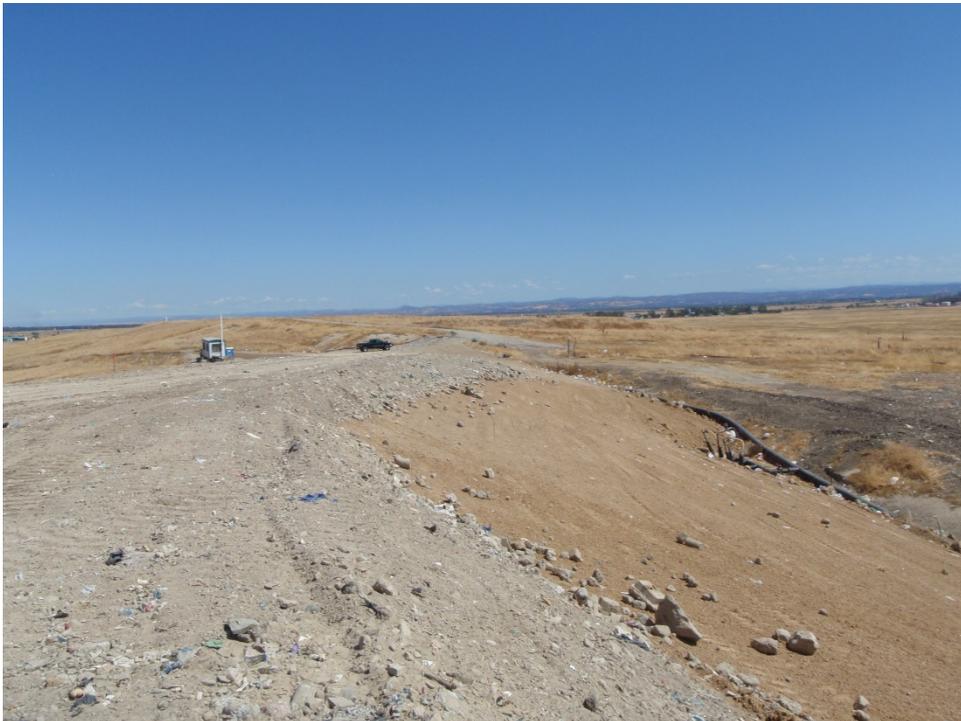
Figures 8 and 9 show the operating face of the landfill, which is currently located near the northern end of the Site; Modules 14, 15, and 16. Figure 10, which is taken looking north from atop Module 14, shows part of what will be the 2014/2015 winter pad, and the vegetative cover atop some of the eastern landfill modules.

Figure 10
Standing atop a portion of what will be the 2014/2015 winter pad, atop Module 14, looking north across the crest of the eastern landfill modules.
