**THREE INDEPENDENT ASSESSMENTS REPORTS HAVE
BEEN COMPLETED ON THE DRAINAGE, EROSION AND
DAMAGE OCCURING FROM I-80 TO THE GREEN POINT
SUBDIVISION**

**2. AN ASSESSMENT OF SURFACE WATER RUNOFF AND
EROSION ABOVE AND BELOW WEST REED AVENUE,
TRUCKEE, CA. BY INLAND ECOSYSTEMS, JULY 2006**

**3. TRUCKEE RIVER WATER SHED COUNCIL EROSION AND
WATER QUALITY REPORT & ASSESSMENT SUMMARY,
SEPTEMBER 16, 2016**

Proposed Montano Property Wetland Restoration Plan

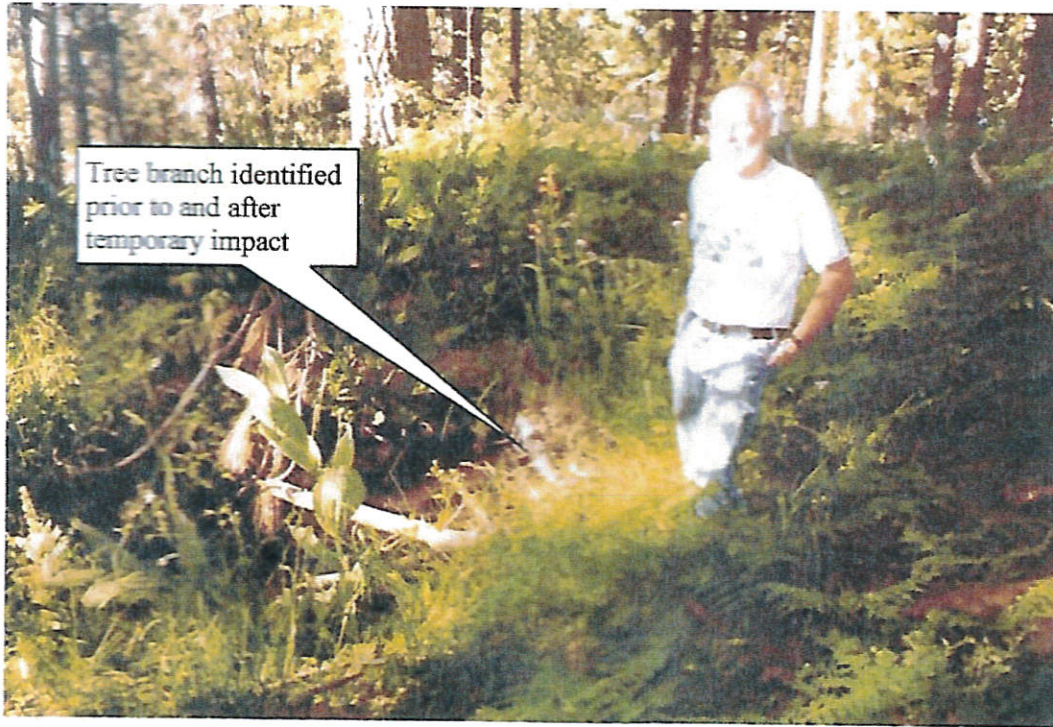
Photo 1. The seep-spring wetland prior to temporary impact.

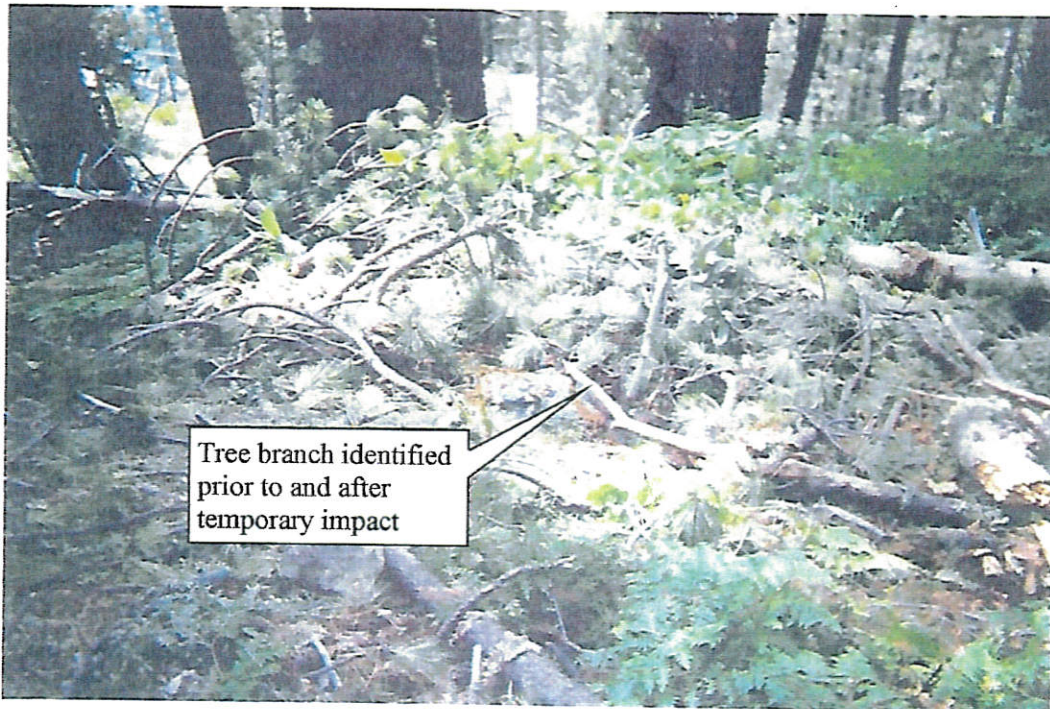
Impacts to this seep-spring wetland were classified as temporary. No heavy equipment had entered the wetland and the soils were not disturbed. The roots, rhizomes, and stolons of the wetland plants are intact, and there are no apparent alterations to the hydrology of the spring. Remediation measures have been implemented by the District and no permanent disturbance to the wetland occurred. There is no foreign material or unnatural debris left in the wetland (See Photo 2).

Photo 2. The seep-spring wetland after the initial temporary impact. The tree branch identified in both pictures were taken looking south toward Donner Lake from the newly excavated road.

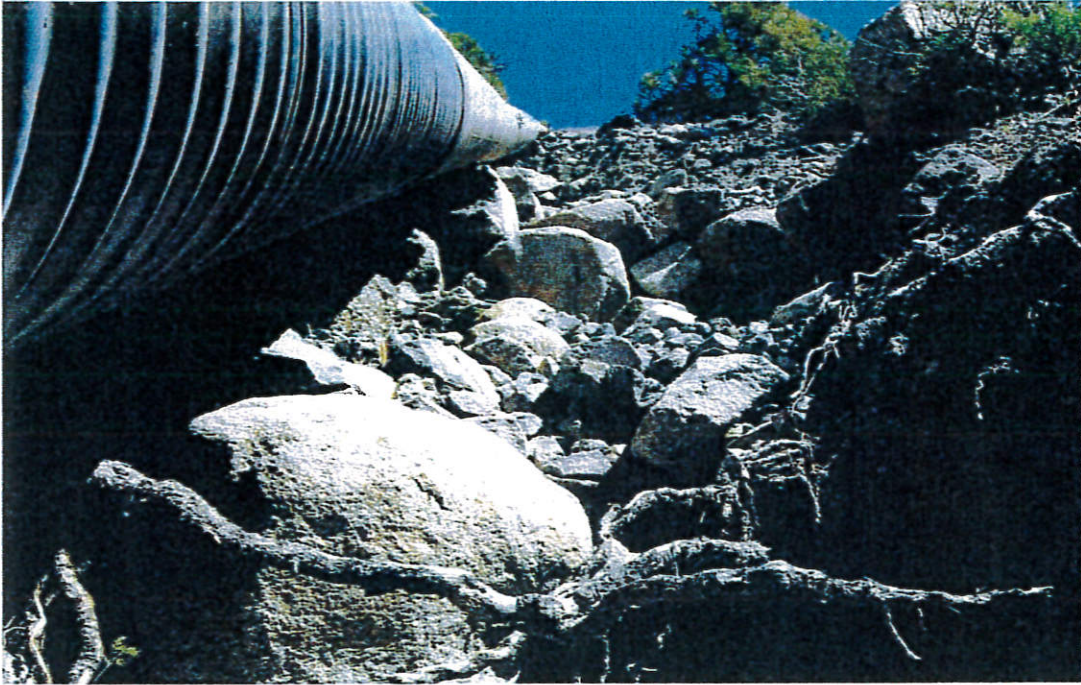
Photo 1. Looking upslope along at the Caltrans culvert on the east end of the hillside above West Reed Avenue. Photo taken June 6, 2006.

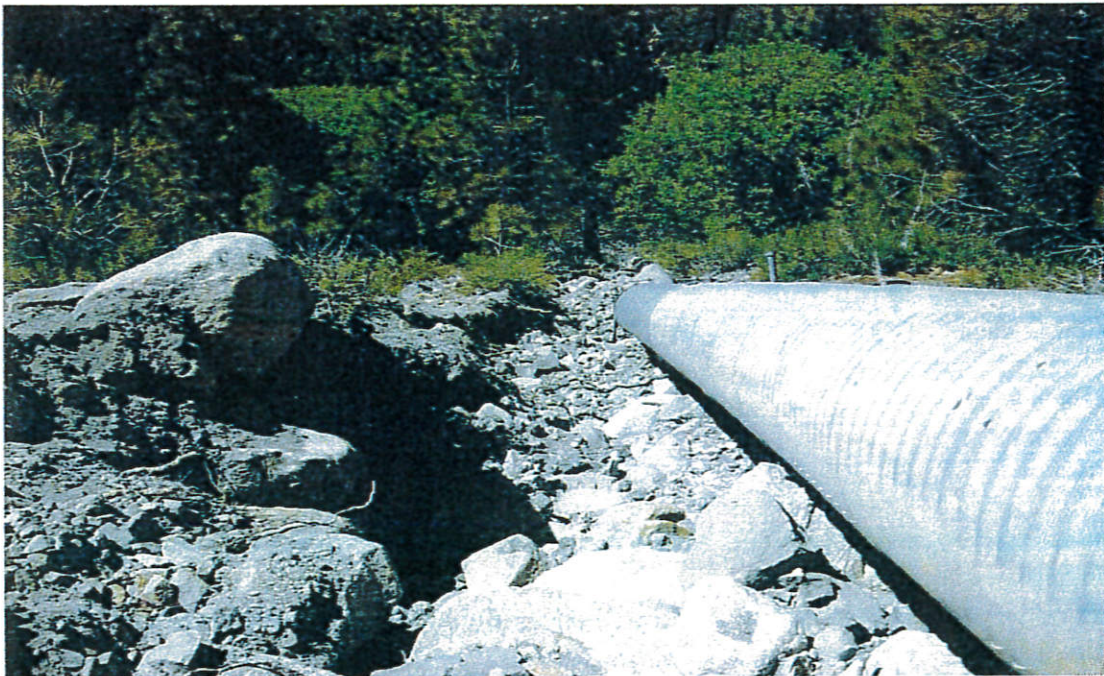
Photo 2. Looking downslope along the culvert where eroded material is being transported down the hillside above West Reed Avenue. Photo taken June 6, 2006.

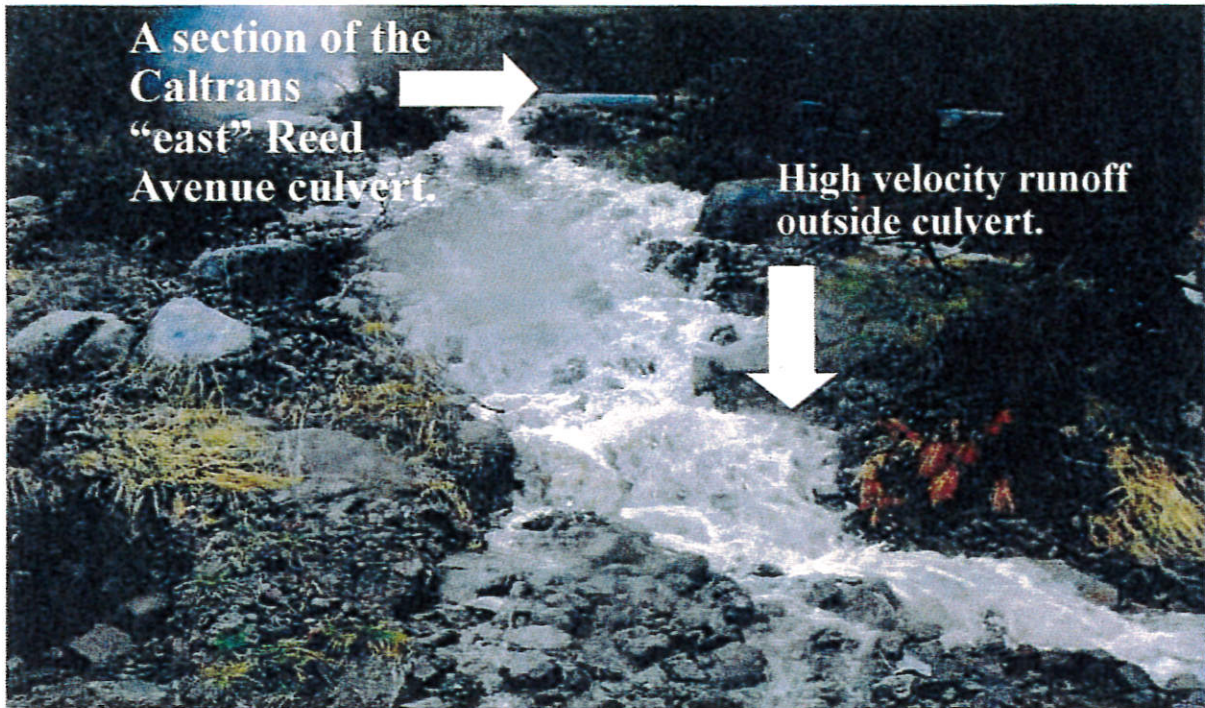
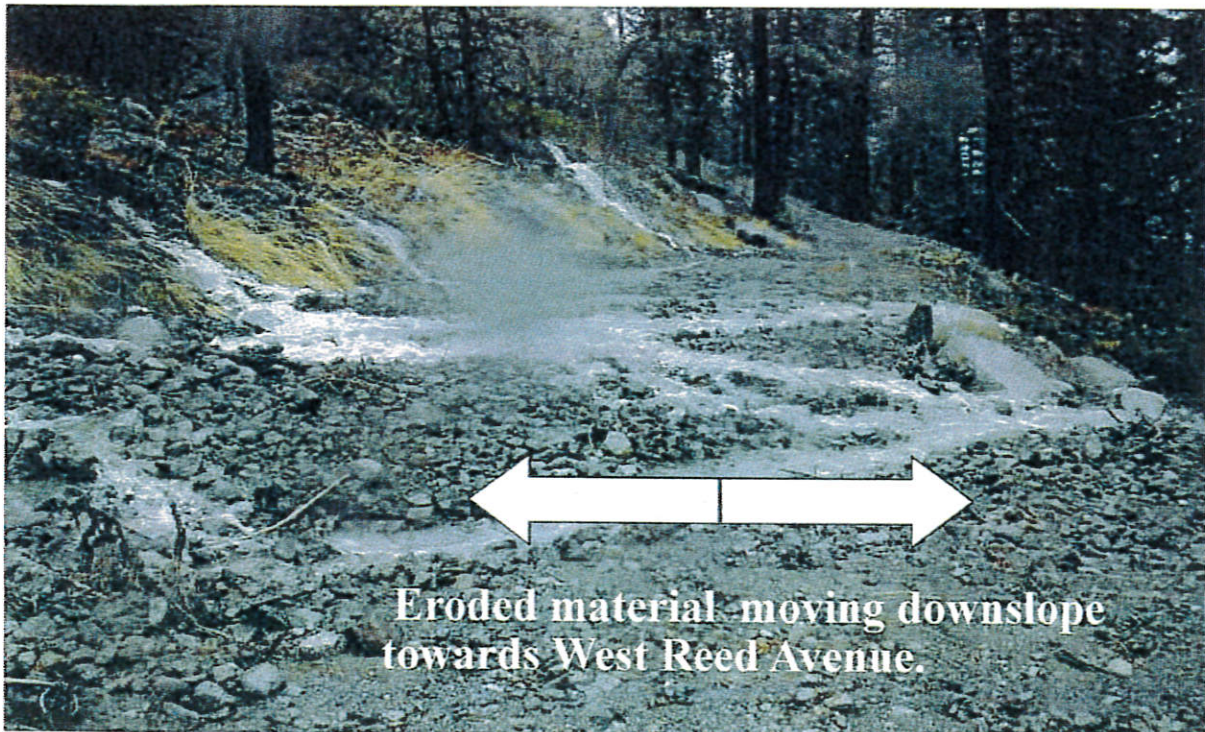
Photos 3 and 4. High velocity runoff outside Caltrans culvert and eroded material being transported downslope. Photo taken December 31, 2005.

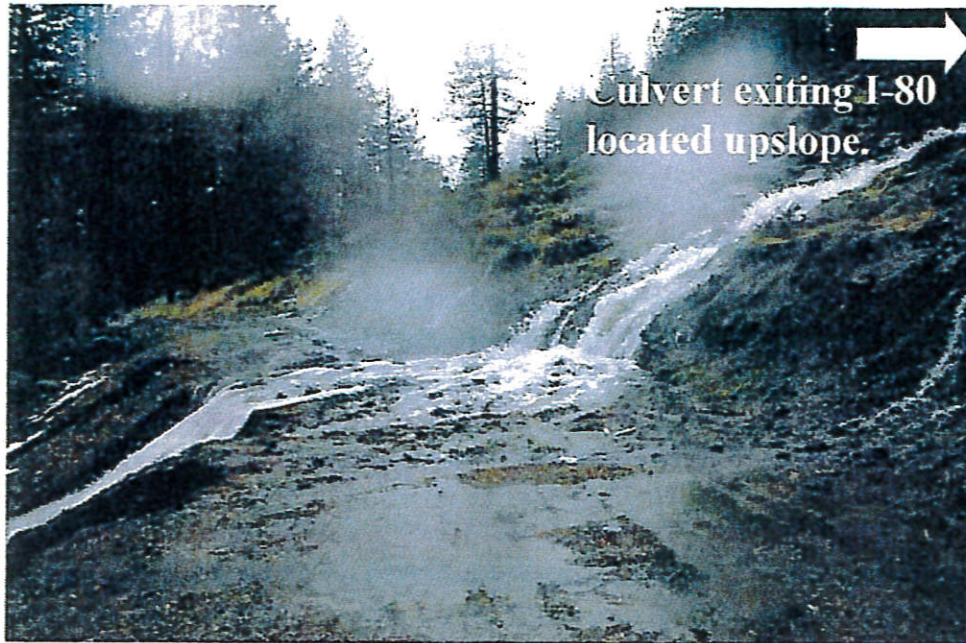
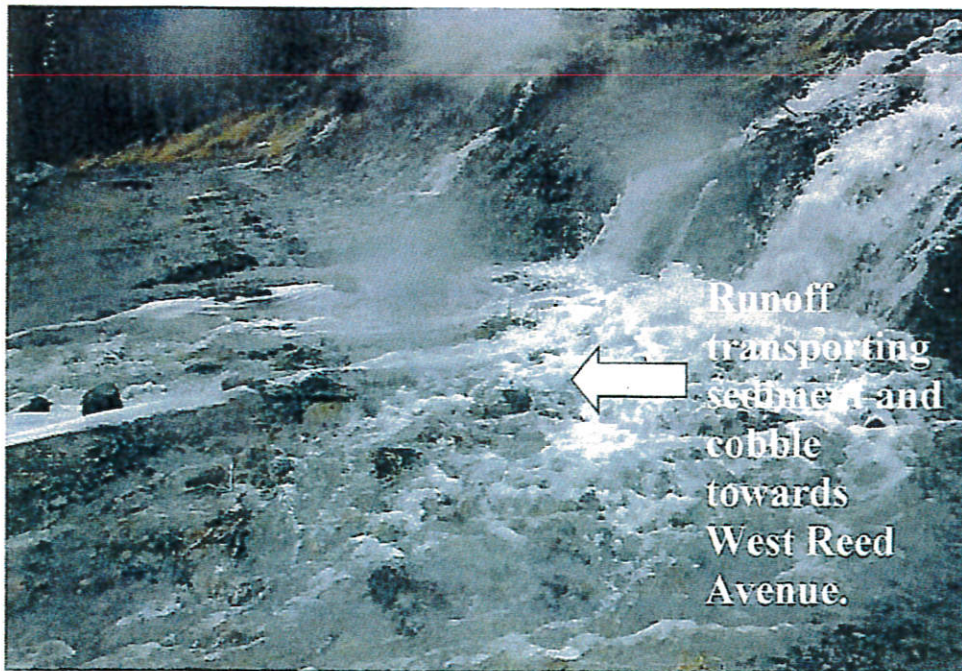
Photos 5 and 6. Culvert runoff from I-80 flowing towards West Reed Avenue. Photos taken December 31, 2005.

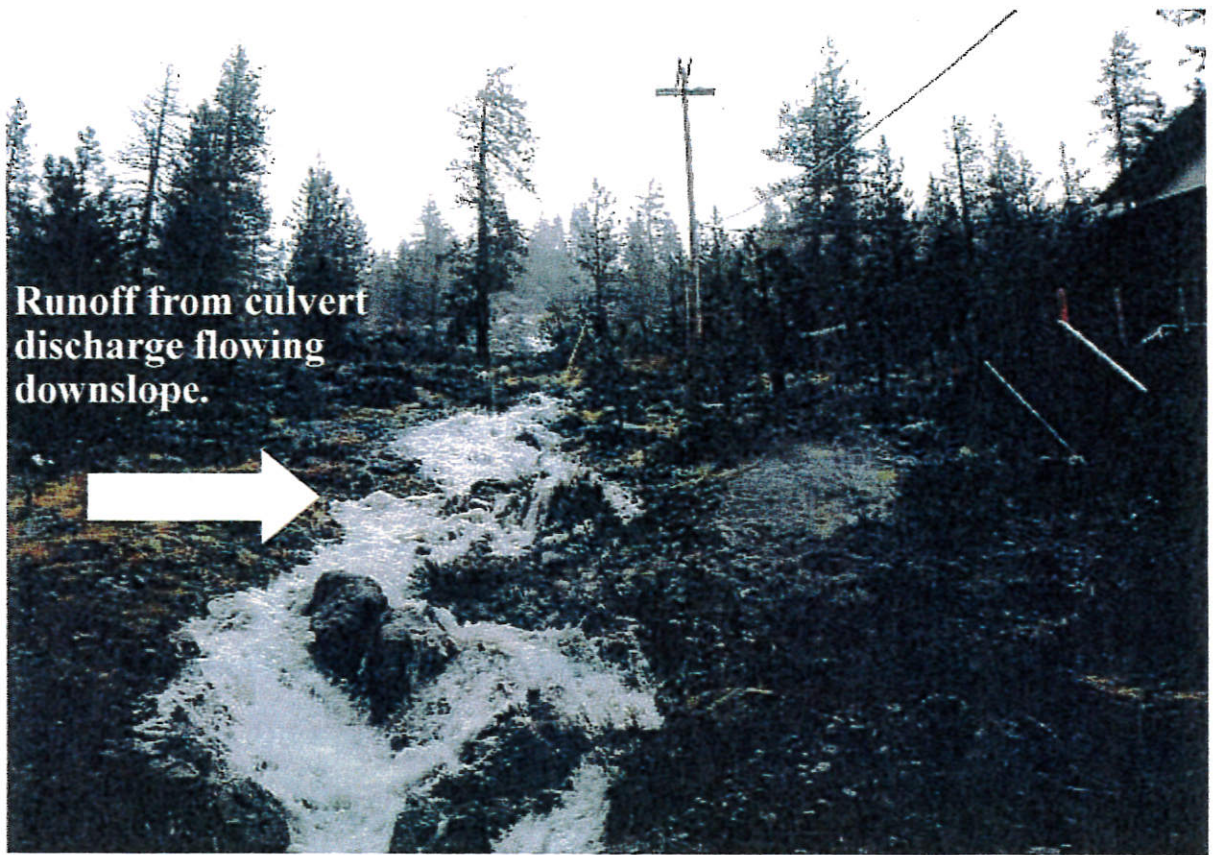
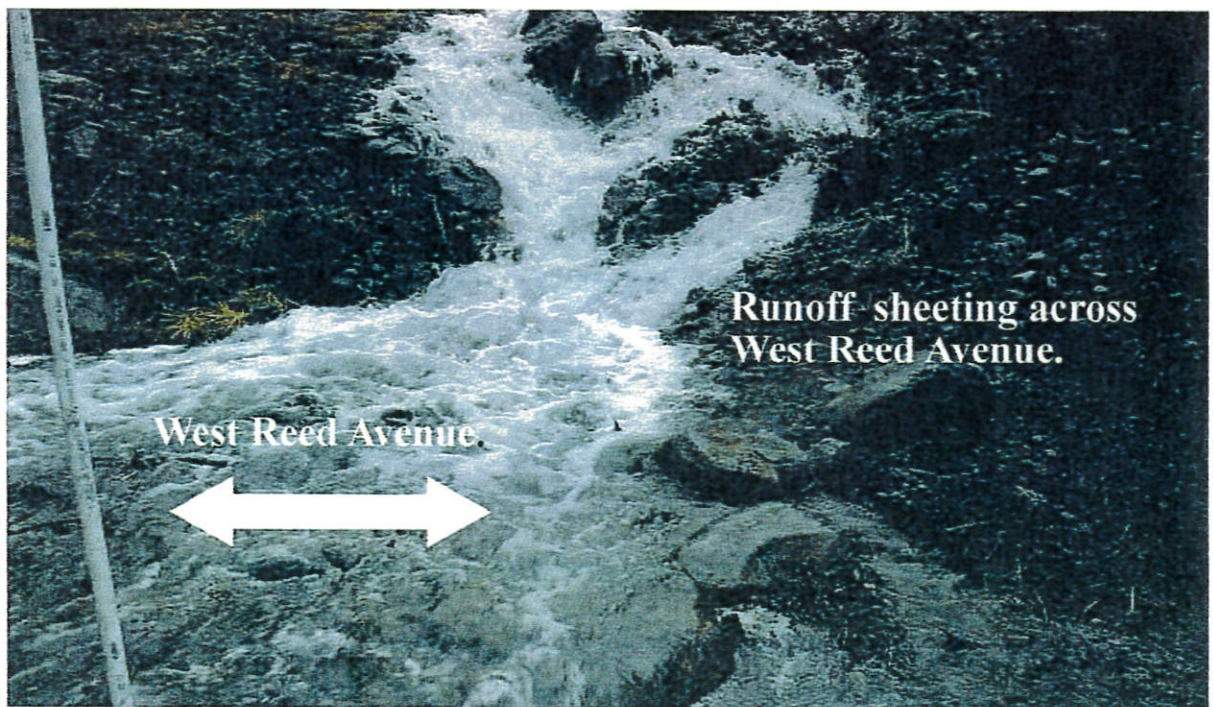
Photos 7 and 8. Runoff discharging from culverts under I-80 moving downslope towards West Reed Avenue. Photos taken December 31, 2005.

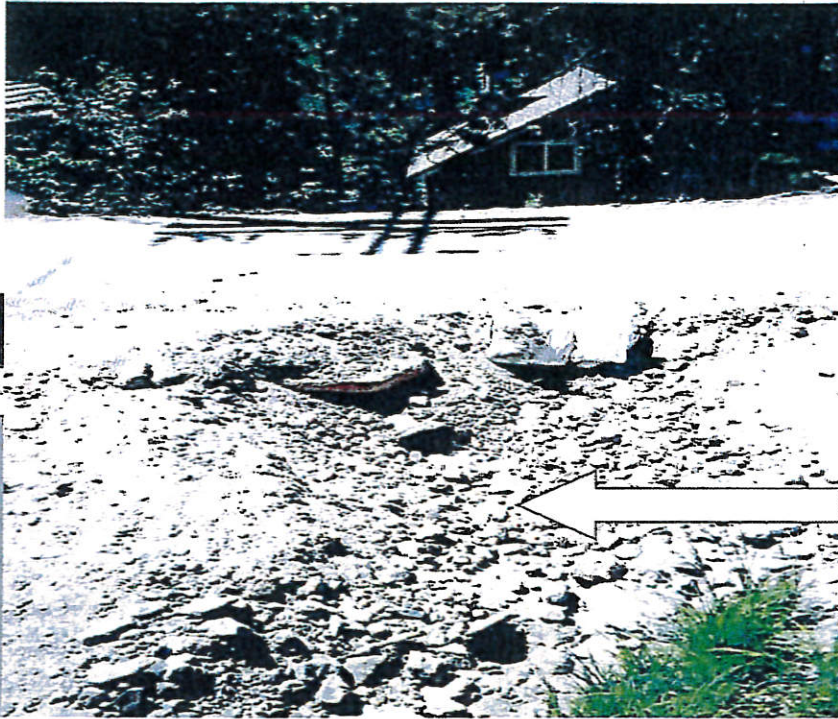
During substantial rainfall events such as the December 30, 2005 to January 2, 2006 storm, problems from hillside drainage and erosion occur along West Reed Avenue. During the May 29, 2006 survey, culverts on the north side of the road that should convey water under the road were clogged with sediment and cobble debris (See Photos 9 and 10). Hillside runoff observed on December 31, 2005 flowed over clogged culverts and across West Reed Avenue undermining water and gas utilities and washing out portions of the road (See Photos 11-13).

Culverts are clogged and one is completely buried with sediment, cobble, and gravel from uphill erosion.

Photo 9. Culverts on the north shoulder of West Reed Avenue have been clogged by debris transported down the hillside. Photo taken May 29, 2006.

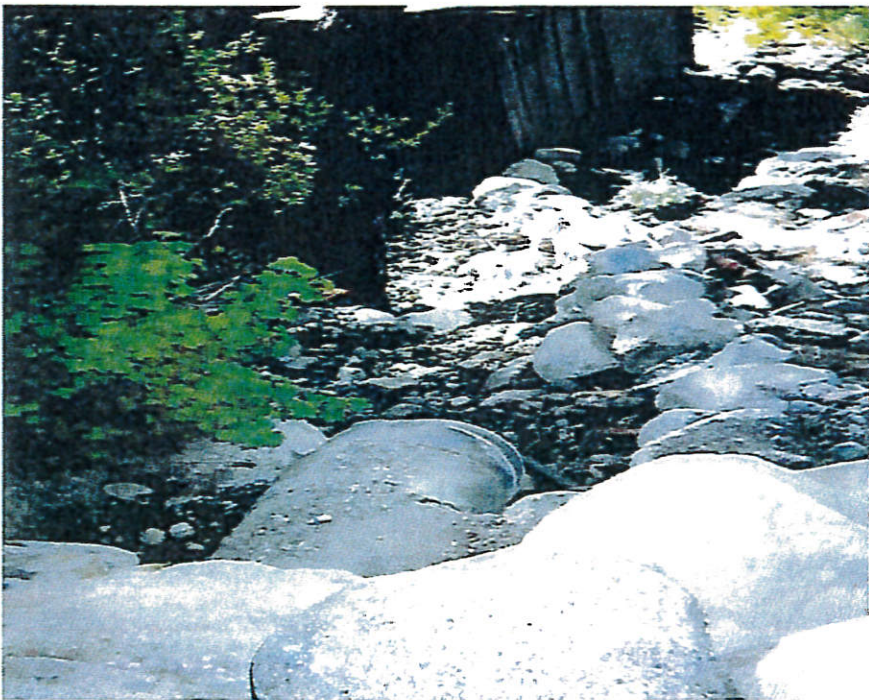
Photo 10. A culvert outfall on the south side of West Reed Avenue does not convey runoff effectively as debris clogs the inlet on the north side of the road. Photo taken May 29, 2006.

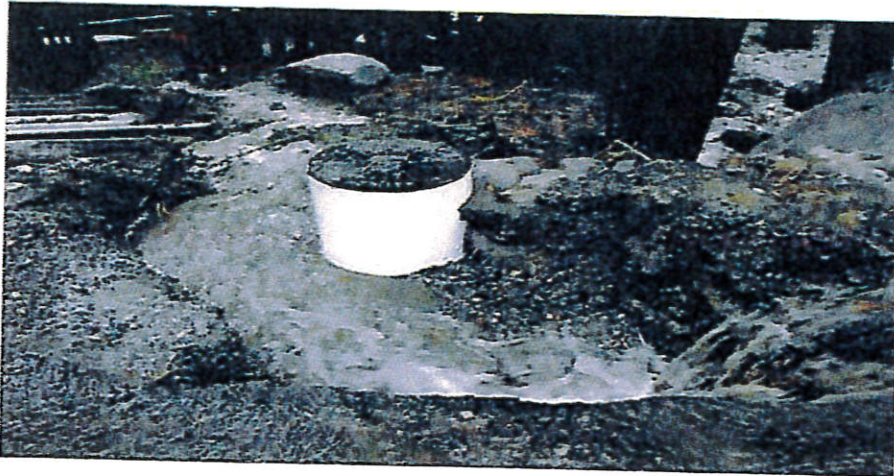
Photo 11.
Eroded water utilities on West Reed Avenue.

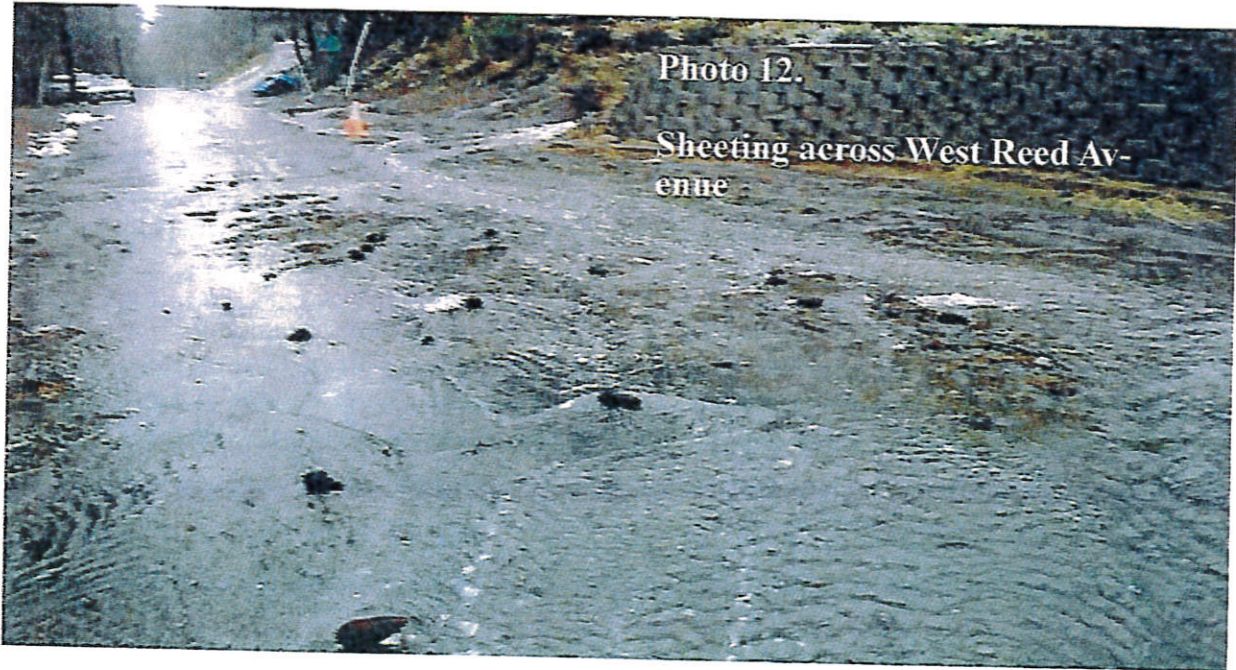
Photo 12.
Sheeting across West Reed Avenue

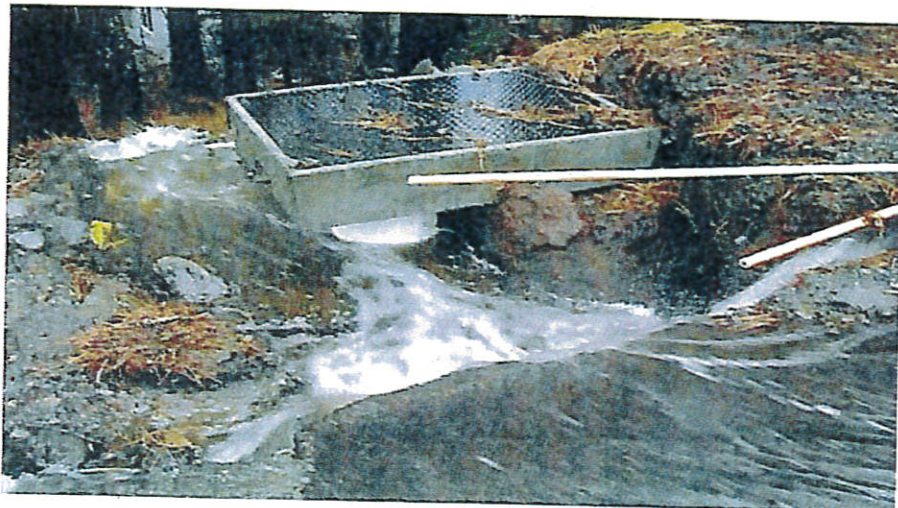
Photo 13.
Eroded water utilities on West Reed Avenue.

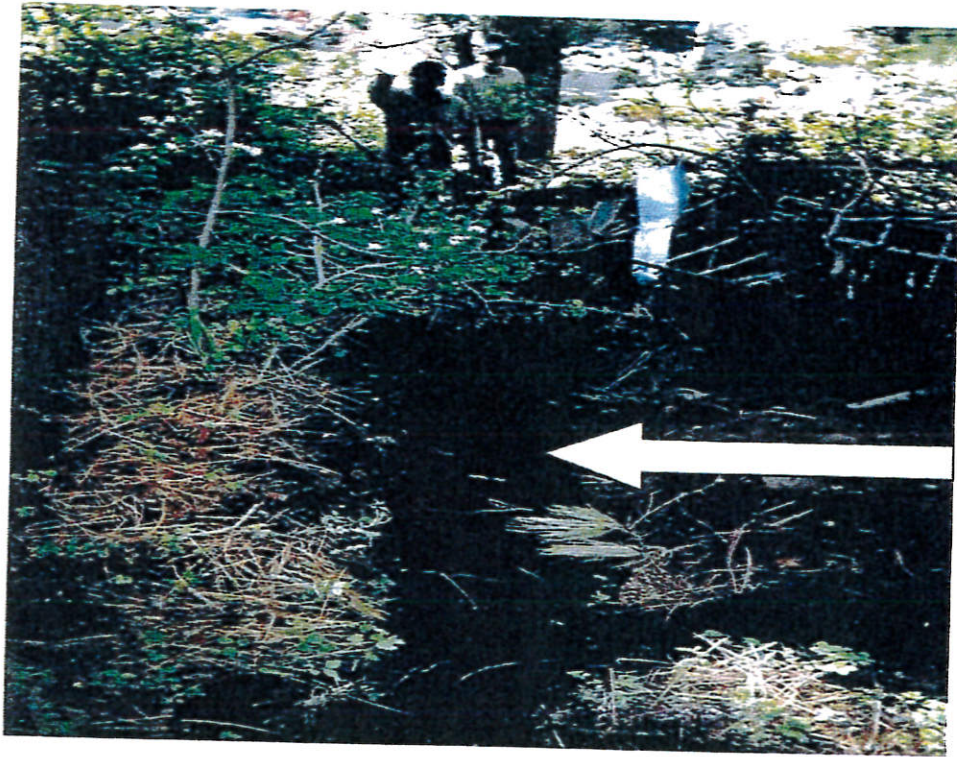
New
Drainage
Ditch.

Photo 14. A new drainage ditch below West Reed Avenue that was being dug on May 29, 2006 to convey runoff to Donner Pass Road.

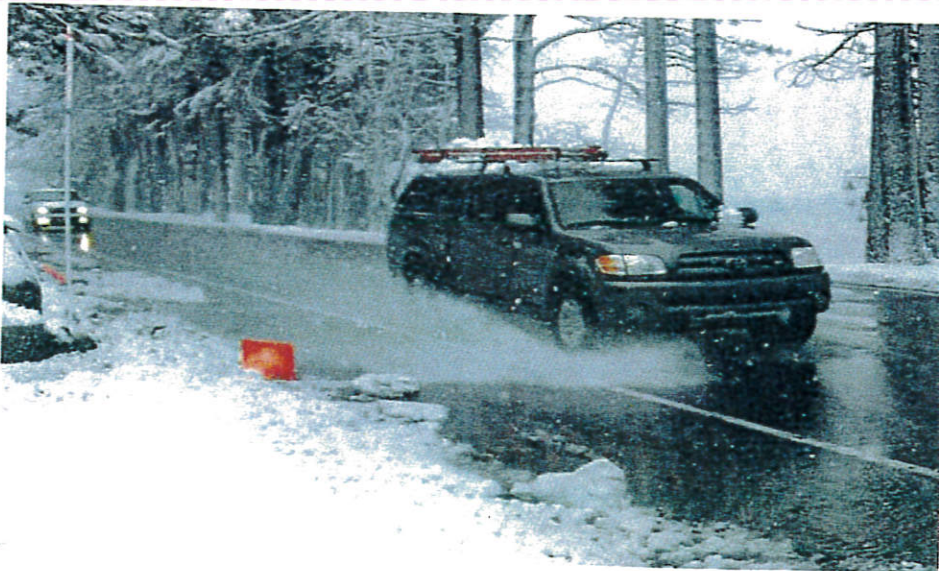
Photo 15. Between the residences of 15214 and 15234 Donner Pass Road runoff was observed sheeting across the road during several of the 2005/2006 rain storms (E. Kashtan, pers. comm. 2006). Vehicles kick up both water and erosion debris that can impact garages.

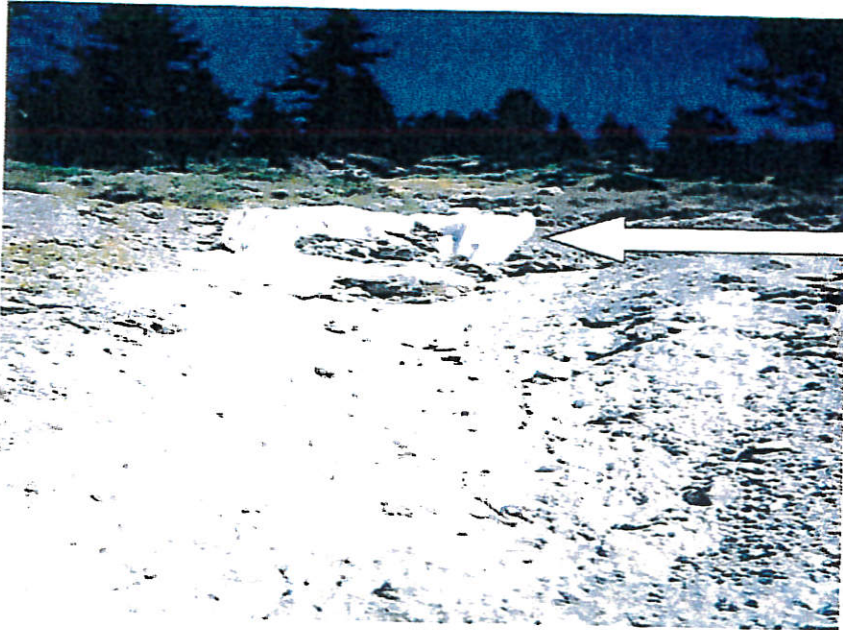
Erosion has occurred on the Cedar Point alignment from I-80 culvert runoff and needs to be repaired and restored.

Photos 21 and 22. Areas along the Cedar Point Pipeline Alignment that require improvements. Photos taken May 29, 2006.

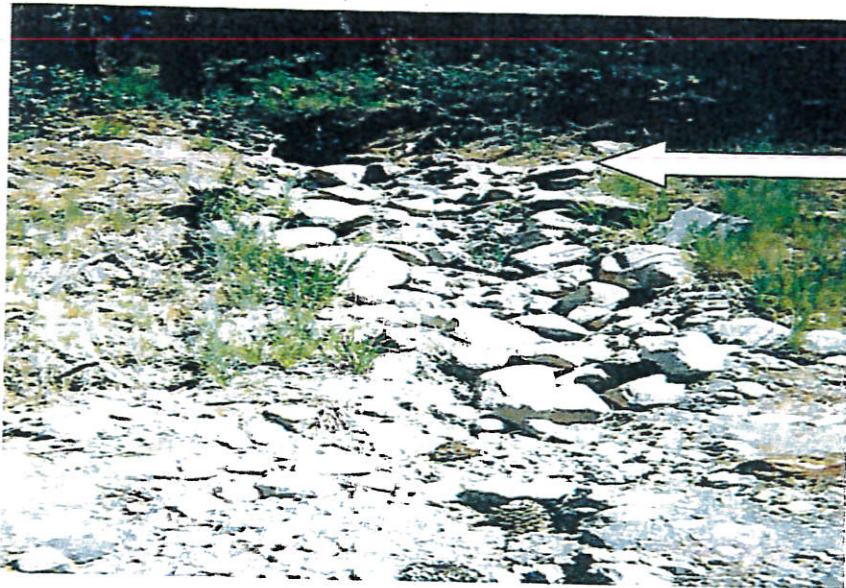
This drainage channel eroded due to high velocity runoff

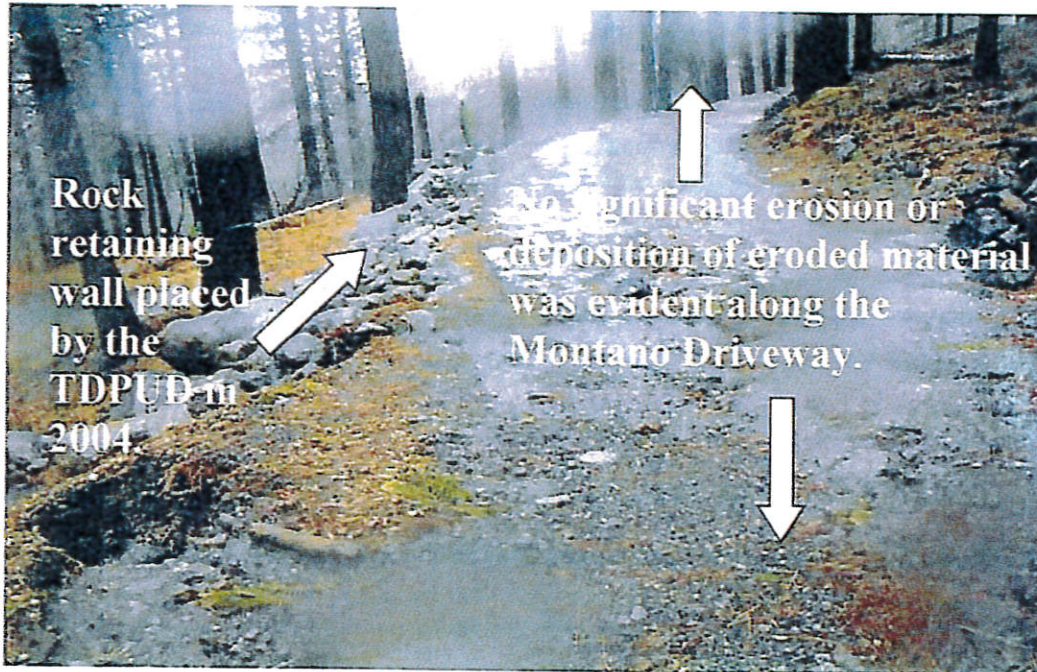
A section of the TDPUD's alignment crossed the west end of Mr. Robert Montano's property located above West Reed Avenue (See Photo 26). The area depicted in Photo 22 is planned for asphalt paving and will be used as a driveway by Mr. Montano. Inland Ecosystems found no substantial evidence that the installation of the Cedar Point pipeline significantly accelerated erosion above West Reed Avenue (See Photo 27).

Photo 26. The west end of the TDPUD's Cedar Point pipeline alignment through the Robert Montano property that is planned for asphalt paving. Photo taken December 31, 2005.

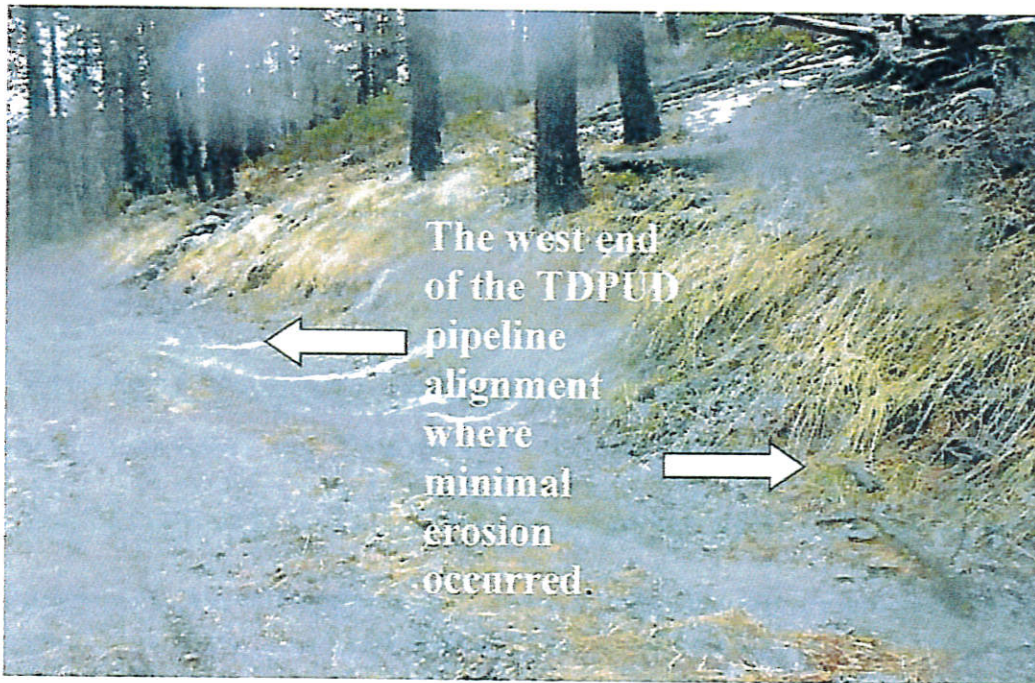
Photo 27. A section of the west end of the TDPUD's Cedar Point pipeline alignment. No substantial erosion is occurring along the alignment. Photo taken December 31, 2005.

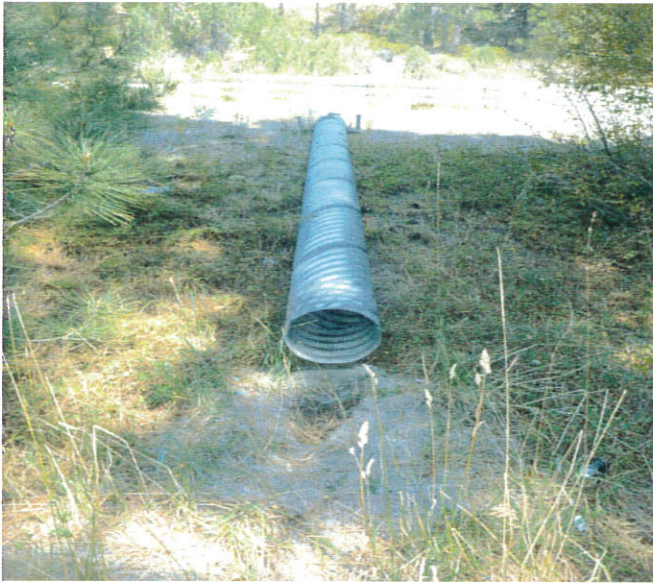
Terminus of culvert on west side of slope from east bound I80, does not drain into channel noted in photos below – flow is likely dispersed across landscape. Minimal erosion issues observed.

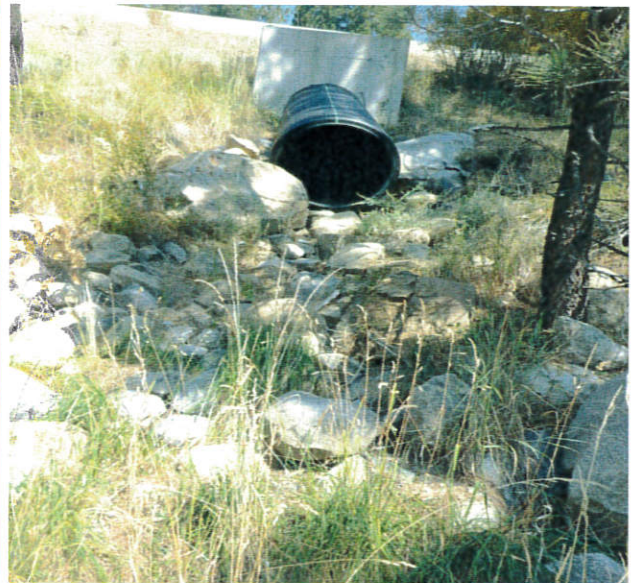
Terminus of culvert on east side of slope from east bound I 80. Good rock protection at terminus of culvert and minimal erosion issues noted, however flow from culvert likely eventually drains to channel noted in photos below.

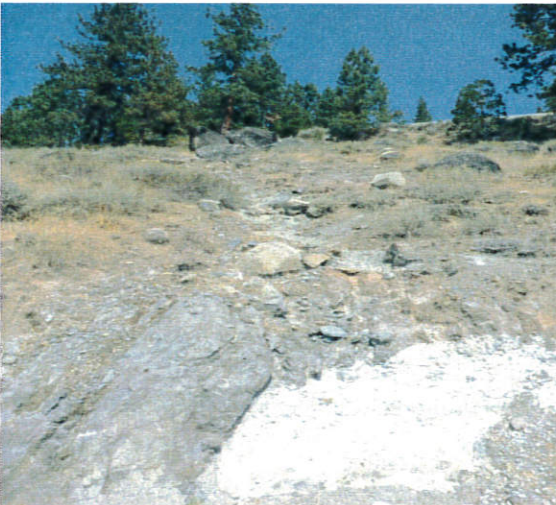
Channalization across bedrock material from I80 - top third of slope – looking uphill.

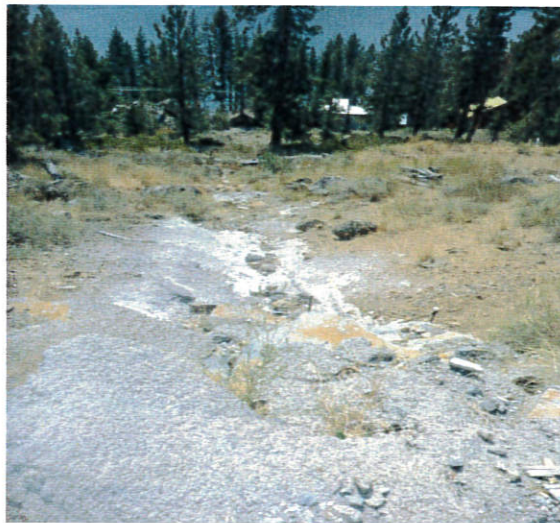
Heavy channalization from flow downslope of I80 - looking downslope @ terminus of lower TDPUD access road.

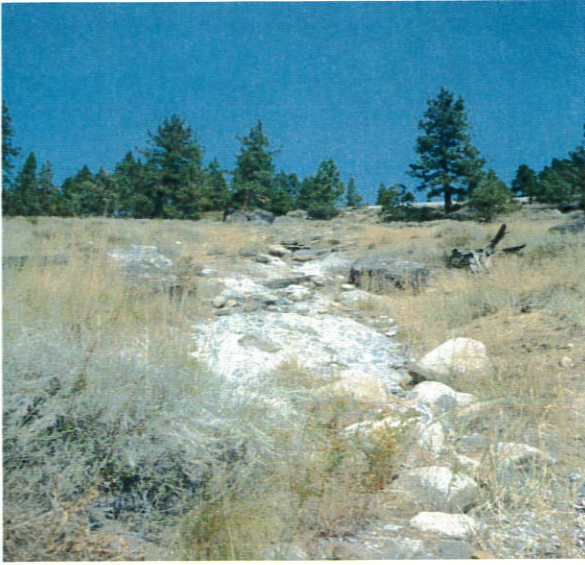
Channel characteristics downslope of I80 across bedrock material - looking upslope @ terminus of lower TDPUD access road.

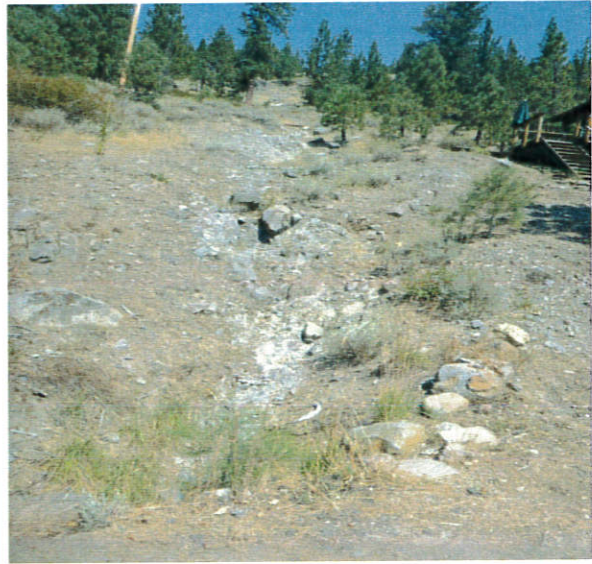
Increased channelization and incision downslope of I-80. Looking upslope from location of undersized culvert located on West Reed Avenue.

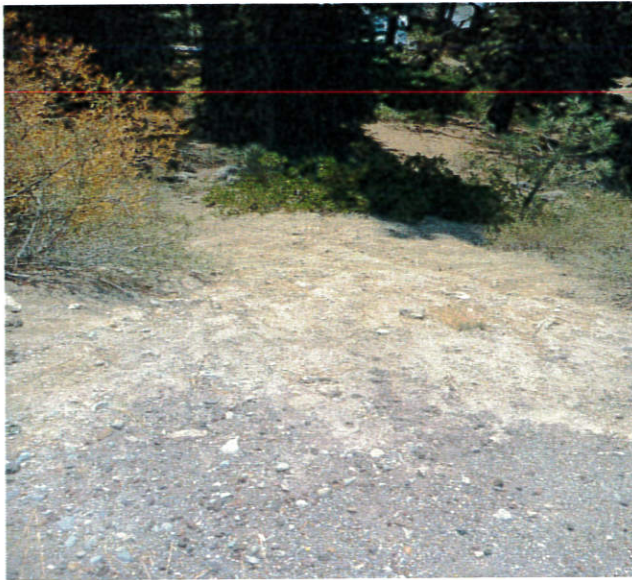
Hillslope failure & erosion just below culvert that is conveying water flow from natural seep/spring across of Donner Lake Road. No infrastructure in place to direct stormwater flow and minimize erosion.

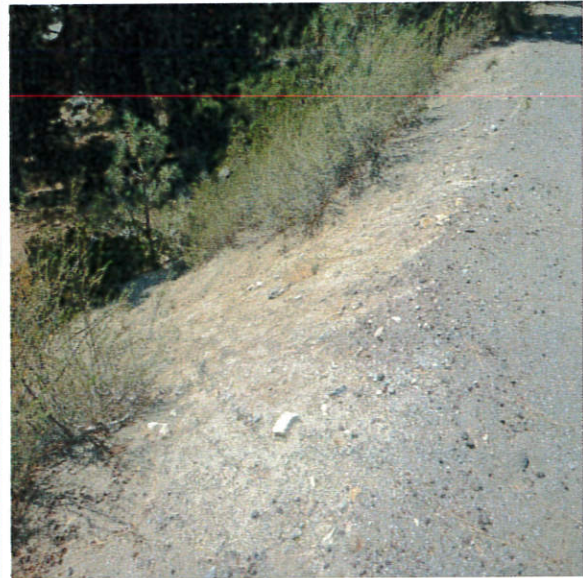
Looking downslope in area in previous photo: below culvert that is conveying water flow from natural seep/spring across of Donner Lake Road. No infrastructure in place to direct stormwater flow and minimize erosion.

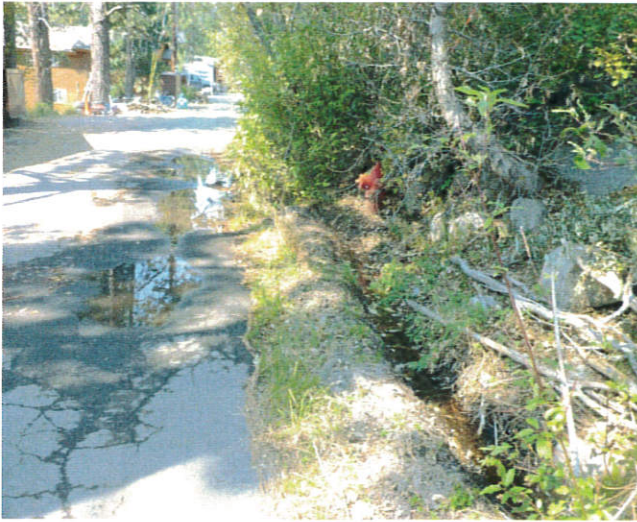
Natural seep below 15014 West Reed Avenue – no infrastructure in place to direct stormwater flow resulting in overtopping and flooding of roadway.

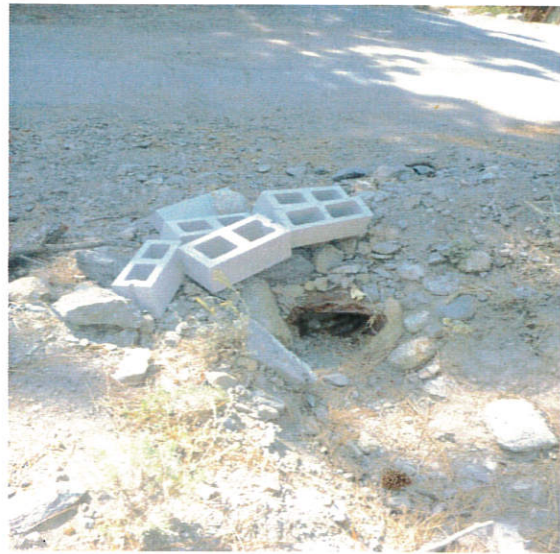
Deteriorated, undersized and unmaintained culvert crossing West Reed Avenue – inlet for flow from channel located below I 80 in photos 1-4 above.

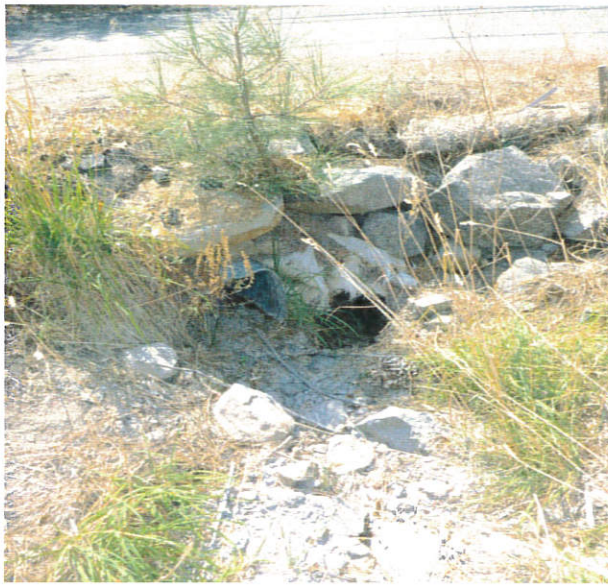
Deteriorated, undersized and unmaintained culvert crossing West Reed Avenue - potential for flooding & compromising of utility lines

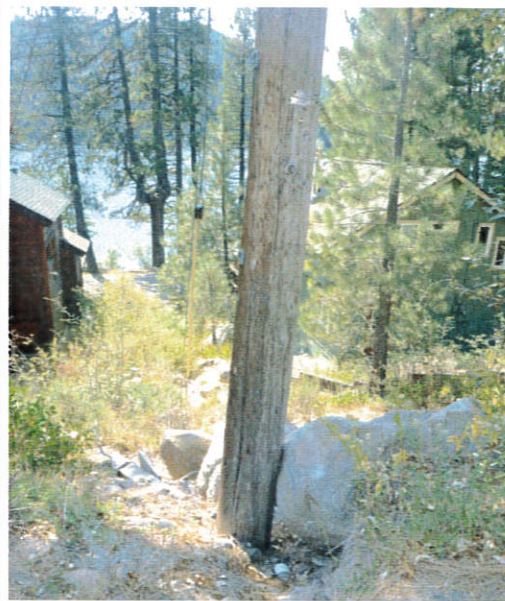
Utility pole across the street from culvert in previous photo - signs

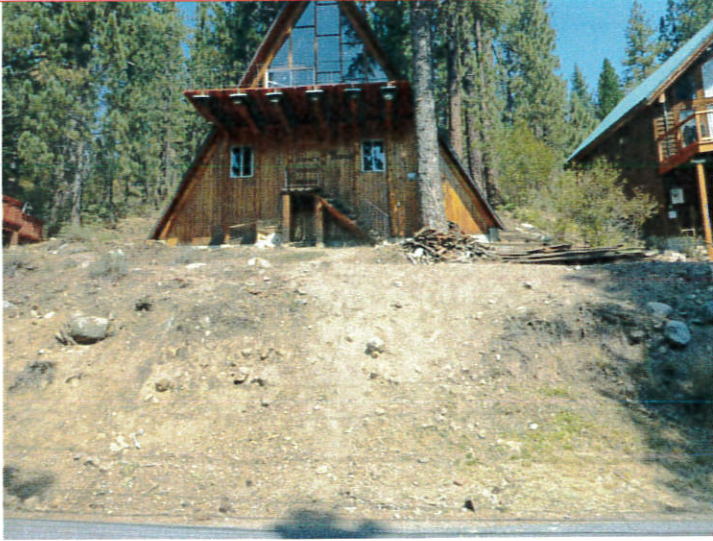
Denuded hillslope on private property residence located upslope from West Reed Avenue – unprotected hillslope likely to contribute excess sedimentation to public and private properties downslope including Donner Lake.

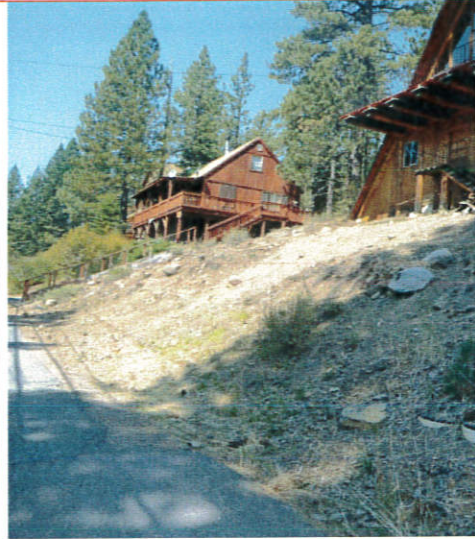
Denuded hillslope on private property residence looking west along West Reed Avenue - unprotected hillslope and lack of stormwater drainage ditches likely to contribute excess sedimentation to public and private properties downslope including Donner Lake.
