**CALIFORNIA REGIONAL WATER QUALITY CONTROL BOARD - SAN DIEGO REGION
WATERSHED MANAGEMENT PROGRAM**

FACILITY INSPECTION REPORT

INSPECTION DATE: December 3, 2007 TIME: 1 pm WDID: 9 37C322900

Sprinter Rail Project
FACILITY OR DEVELOPER NAME (if different from owner)

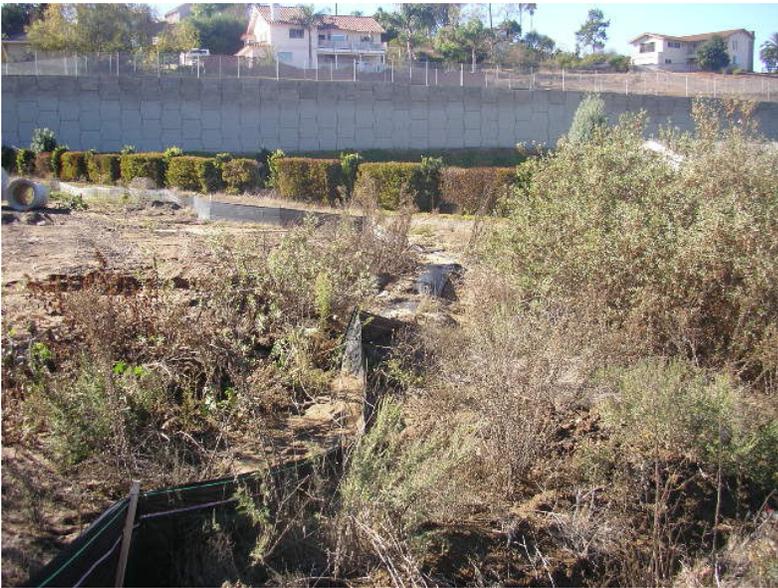
Silt fence that had failed in the Friday rainstorms had not been corrected (Photos 1, 2, and 8). Culverts providing storm water run on through the exposed soils at the construction yard had not been redirected to minimize contact with disturbed areas (Photos 3, 4, 5 and 7). Slopes on the south of the storage yard adjacent to the tracks did not have erosion control measures applied. The slopes had large erosion gullies (Photo 6). A pallet of construction material buckets and containers had not been covered or contained. On the previous Friday, this pallet gave off a visible rainbow sheen in the storm water run off.

1. Silt fencing is collapsed from concentrated flows full of sediment. The storm drain inlet is off to the right of this photo.

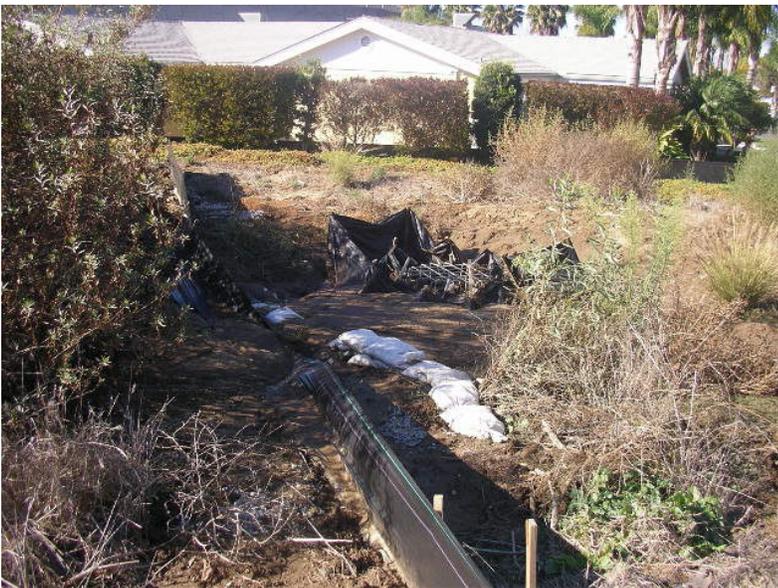
2. Multiple lines of silt fence have collapsed around this storm drain inlet.

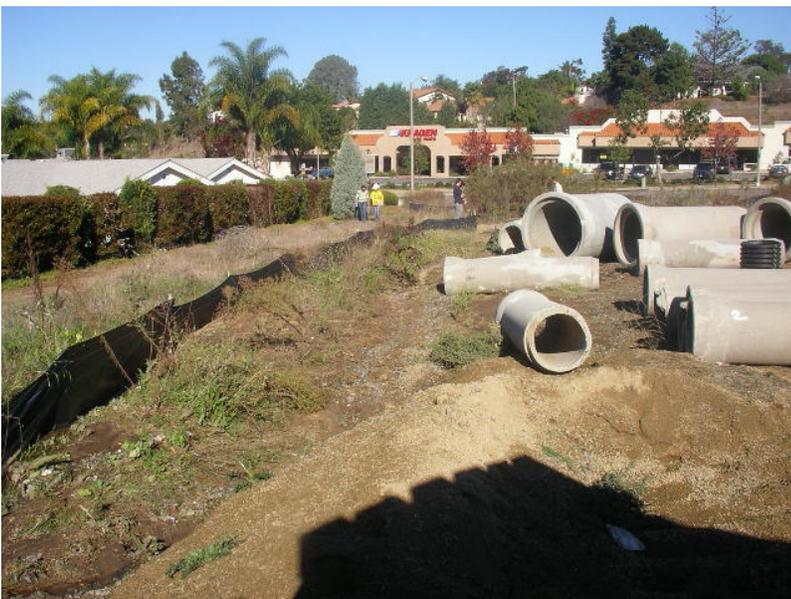
3. Concentrated flows of storm water run on discharge here through the construction storage yard.

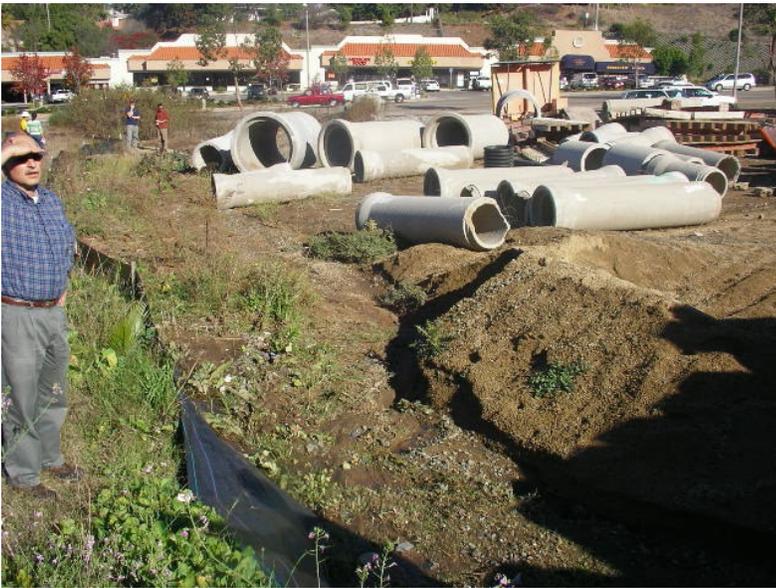
4. Concentrated run on flows have eroded away this dirt stockpile.

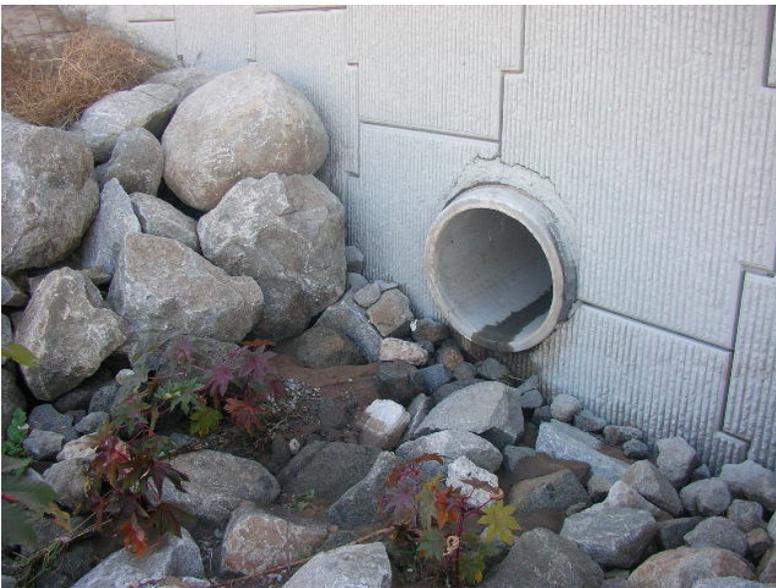
5. This culvert is the source of the run on coming through the storage yard.

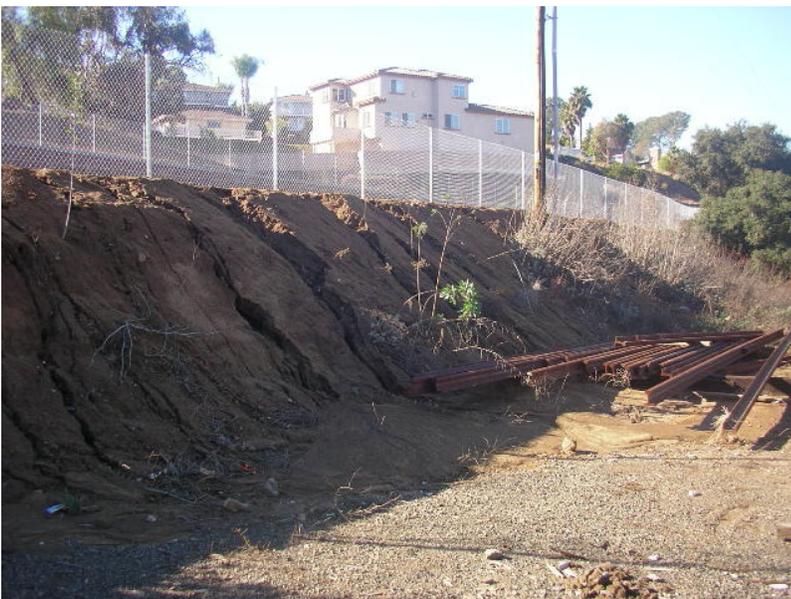
6. This slope is without erosion controls and is severely eroding away. This slope's lack of erosion control was also noted in the February 20, 2007 inspection.

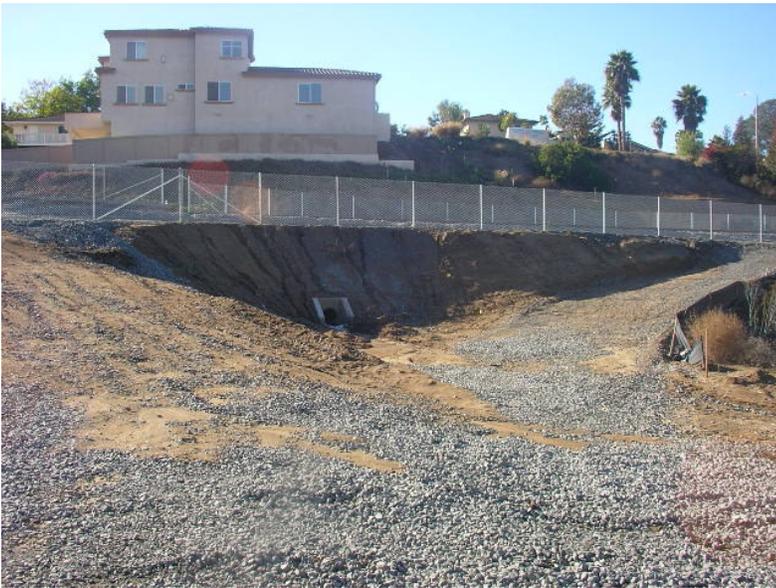
7. Another culvert that provides storm water run onto the construction storage yard is not redirected away from disturbed soils.

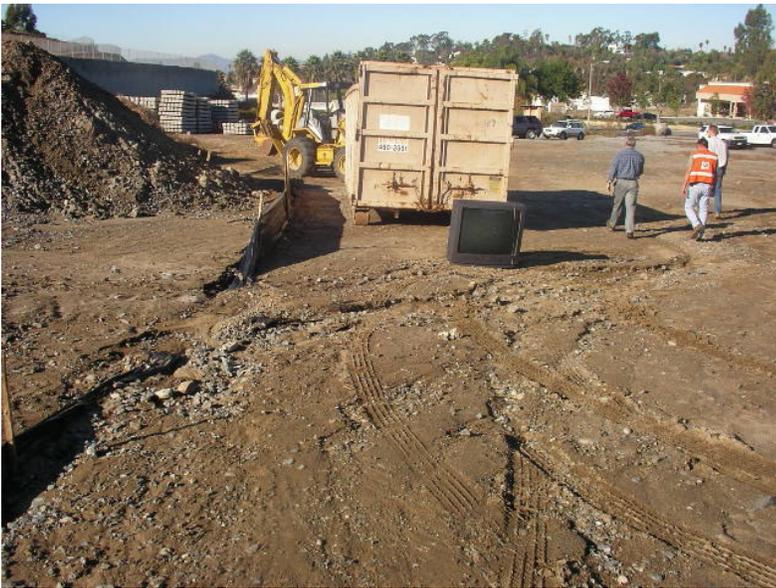
8. Silt fence has failed around this soil stockpile.
