NCTD

November 7, 2007

Re: Required Technical Report in Response Notice of Violation NO. R9-2007-0208, reference number CWU:10-3022900.02:neilb

**REQUIRED TECHNICAL REPORT IN RESPONSE TO SAN DIEGO
REGIONAL WATER QUALITY CONTROL BOARD NOTICE OF VIOLATION
R9-2007-208**

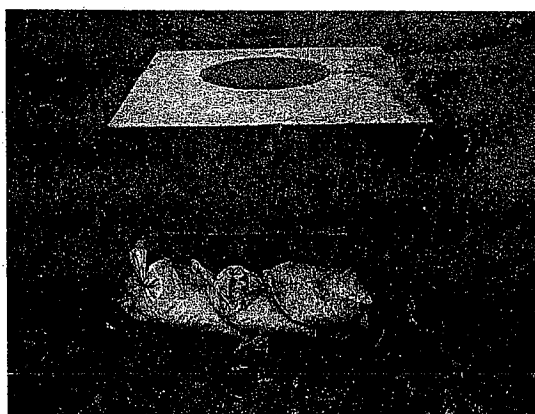
NOV Photo 2

The inlet shown in report had several gravel bags at the opening during the inspection although they were in need of maintenance. The “white trash” mentioned in the report is actually an exposed portion of an existing gravel bag. Also included is a photo of the inlet after being maintained on October 30th.

Immediate Actions: NCTD Contractors performed maintenance to the existing Best Management Practices (BMPs) at the respective inlets. The broken gravel bags were replaced, more gravel bags were placed around the drainage inlet to provide the necessary level of protection for the inlet and trash accumulated near the inlets were removed.

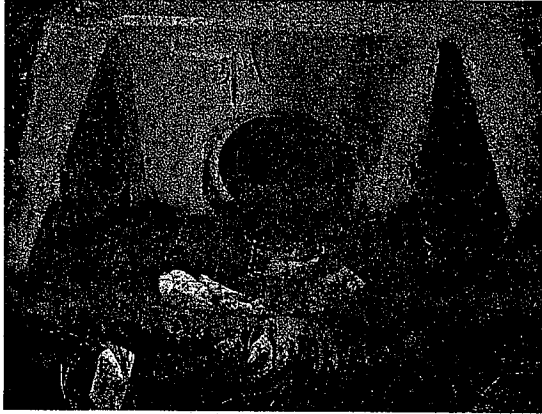
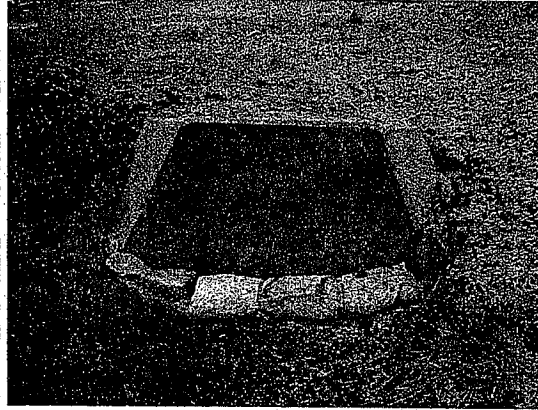
NOV Photos 3& 4

The headwall inlet show in NOV Photos 3 and 4 appears to be the same inlet just taken at different angles. This inlet was also mentioned as being “without sediment controls” although there were gravel bags at the opening in need of maintenance. Also included is a photo of the inlet after being maintained on October 30th.

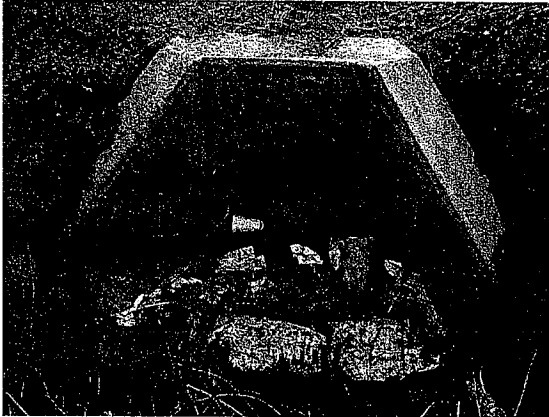
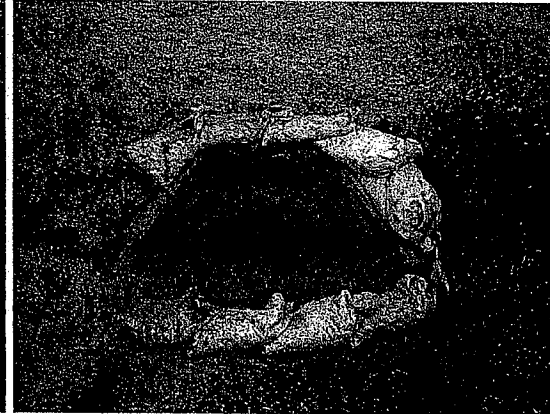
This inlet in NOV Photo 5 was also mentioned as being “without sediment controls” although there were gravel bags at the opening in need of maintenance. Also included is a photo of the inlet after being maintained on October 30th.

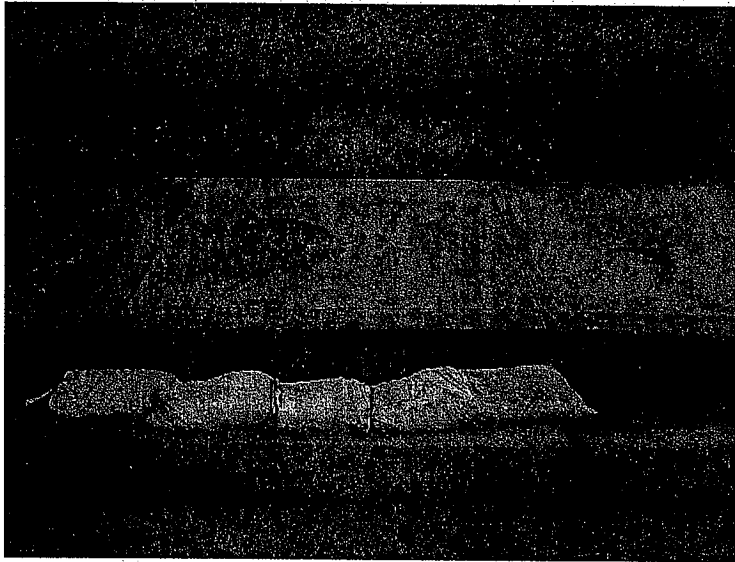
The inlet in NOV Photo 7 had gravel bags placed in the gutter but they had become weathered and needed replacement. Note that this inlet flows to the outlet shown in photo 9, which is further protected for sediment control by additional gravel bag check dams located in the earthen ditch. The photo below shows the inlet after being maintained on October 30th.

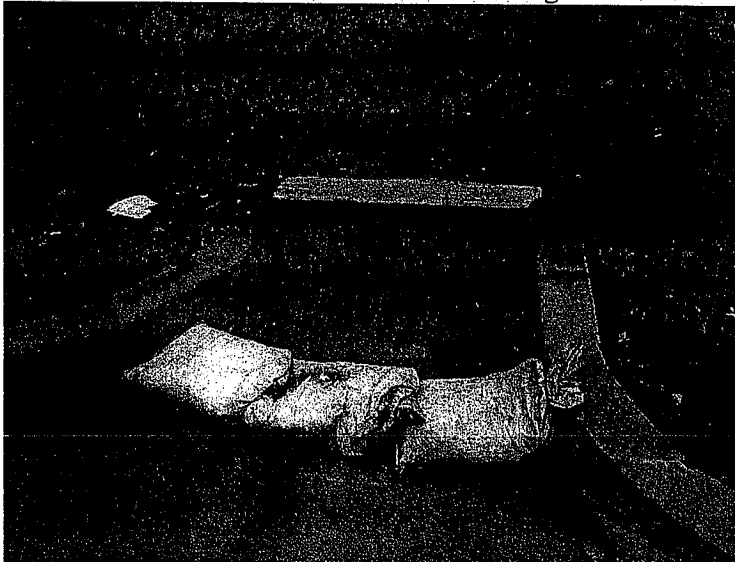
The inlet shown in NOV Photo 8 shows an inlet with gravel bags that need replacement. The photo below shows the inlet after being maintained on October 30th.

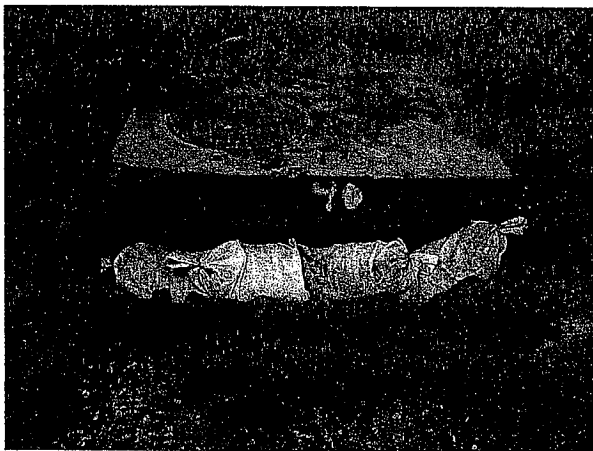
The storm drain inlet shown in NOV Photo 11 had existing BMP's that required maintenance. A contractor for the City of Escondido was performing work throughout the Citricado intersection. This had a negative impact on the existing BMP's causing them to need maintenance. The photo below shows the inlet after being maintained on October 30th by NCTD contractor crews.

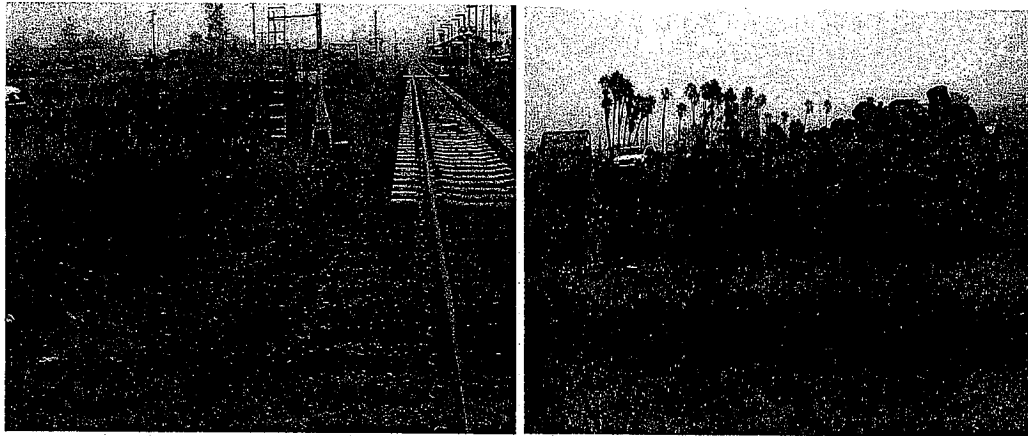
NOV Photos 12 through 15 depict several areas of silt fence that has fallen down or been torn. The silt fence in these areas is not necessary and therefore was removed by NCTD contractors. Additionally, this parking lot is currently a staging area for jobsite debris until the grading operations begin the week of November 5th, 2007. At that time, all debris from this lot will be loaded into dump trucks and hauled to the nearest disposal facility. No permanent drainage structures have been constructed in this parking lot which could potentially carry the run off into the adjacent storm drain systems. In this region the run off from a potential rain event would simply travel to the low lying areas on the side of the track bed. The photos below shows the site after the silt fence had been removed on October 30th.

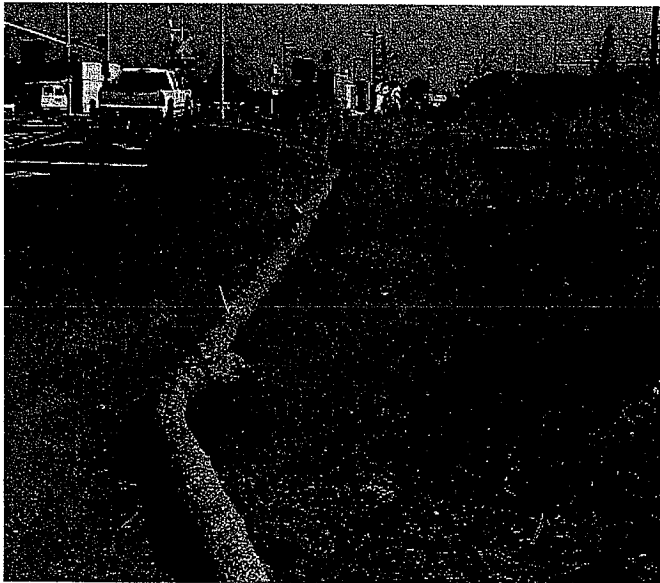
The area depicted in NOV Photos 18 & 19 belong to the City of San Marcos, and are not part of the Sprinter Project site. Nonetheless, as shown in the photo below the old silt fence has been replaced with new fiber roll along the edge of the traveled way. The fiber roll placed by NCTD contractors will help to contain sediment from leaving the site in the event of rainfall.

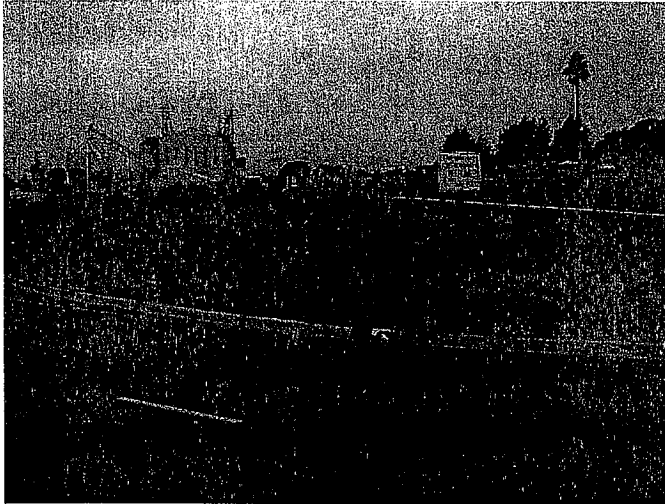
The gravel bags shown in NOV Photo 20 were placed by a contractor working for the City of San Marcos. The area is not part of the Sprinter Project site, and NCTD is not required to maintain it. As depicted in the below photo, this area is quite a distance from the NCTD right of way fencing.

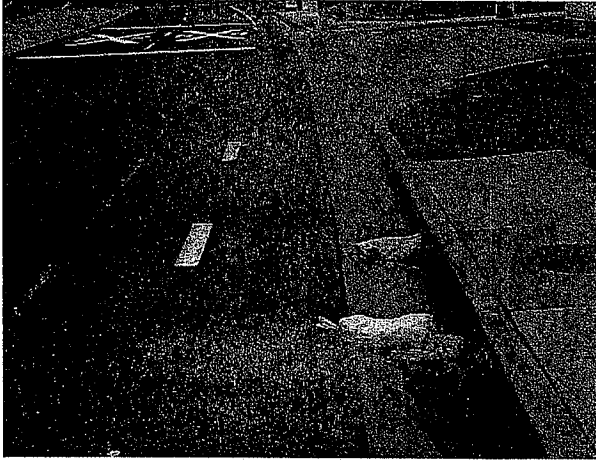
The inlet shown in NOV Photo 34 had an existing gravel bag but was noted as being an inadequate sediment control. NCTD contractors placed additional bags at this location on October 30th as seen in the photo below.

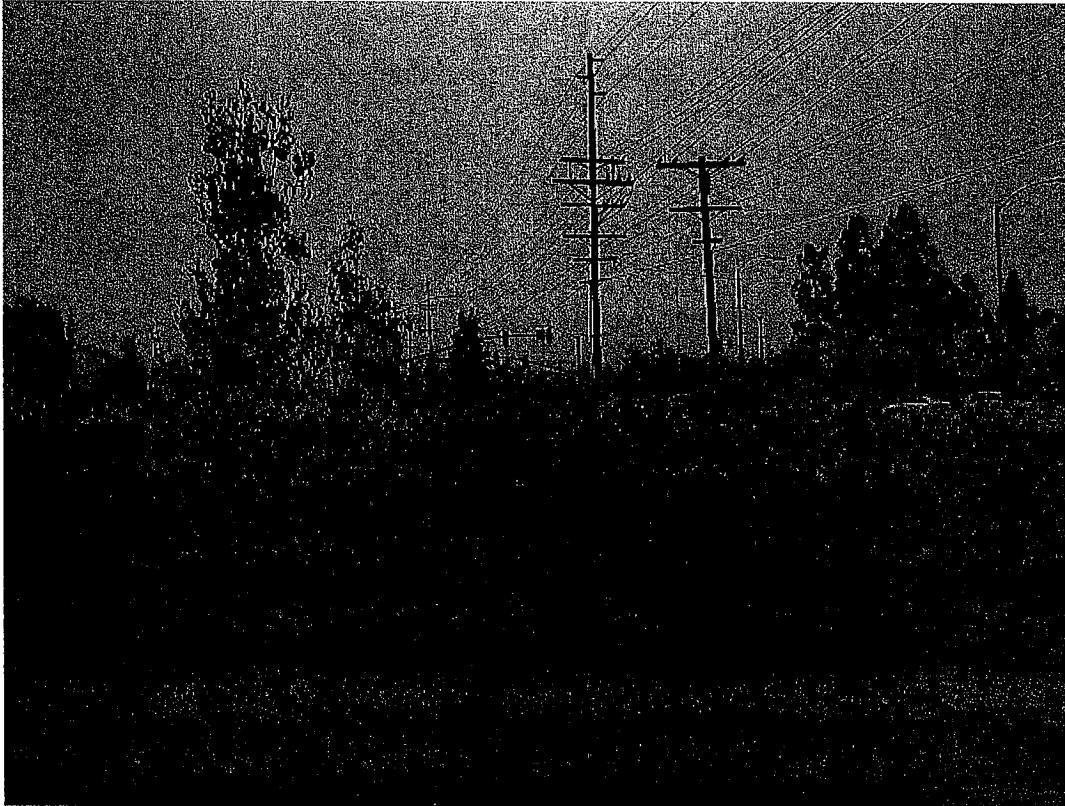
Observation 2: At the intersection of Washington Avenue and Mission Road, a large area of soil was exposed with no sediment control BMPs or soil stabilization (Photo 6).

NOV Photo 6 identifies a large bare area of dirt at the intersection of Mission Rd. and Washington Ave. as having “no sediment protections or soil stabilization.” NCTD may hydroseed this area for aesthetic purposes along the bikepath, however, it should be noted that this area is not part of the Sprinter Project site, and NCTD is not required to maintain it.

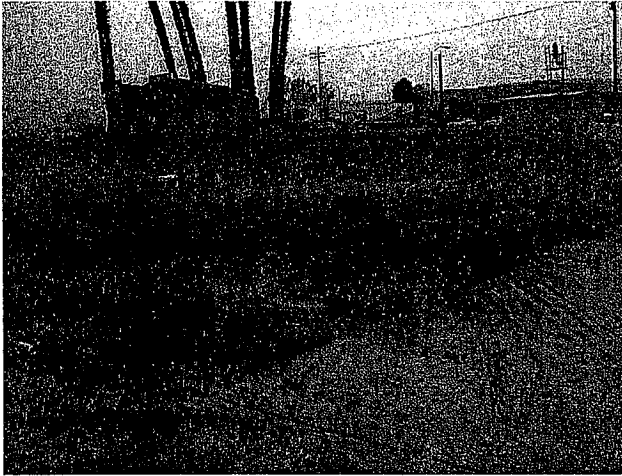
The construction entrance/exit shown in NOV Photo 10 has ballast spread out for approximately 50 feet before the entrance however; there is a short gap of dirt just behind the sidewalk. NCTD contractors did place a construction entrance which was removed by a City contractor performing work at the Citricado intersection. Rumble plates and

additional ballast were replaced at this location on October 30th as seen in the photo below. The jobsite street sweeper also makes multiple passes through this area on a daily basis.

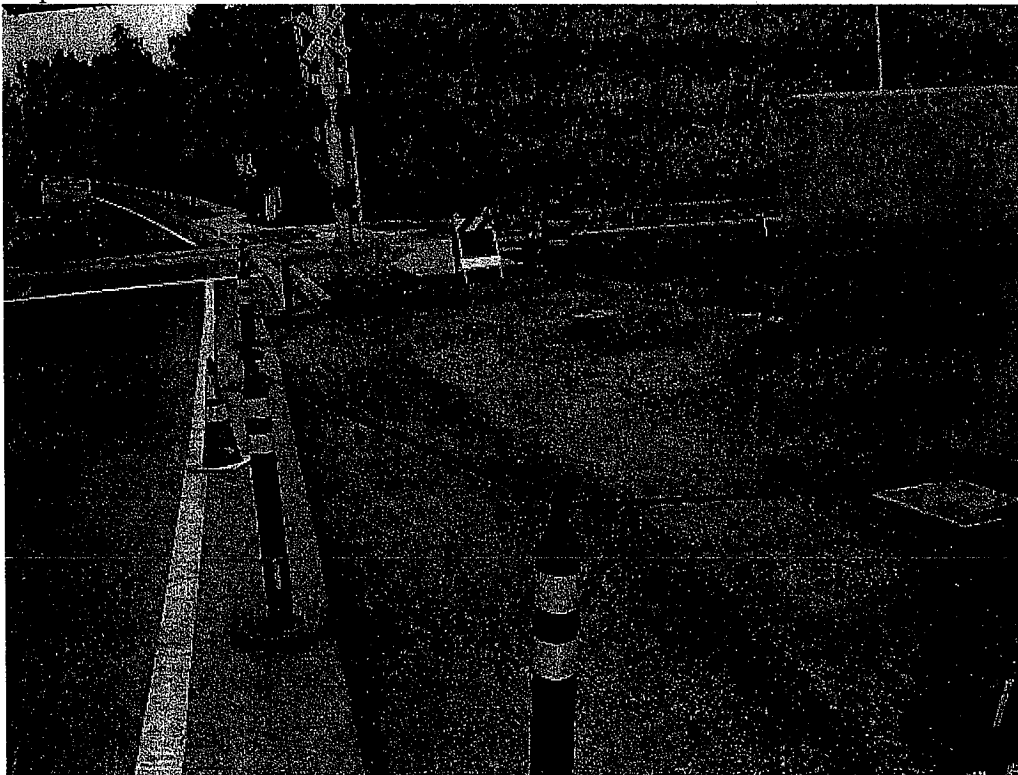
The entrance/exit at Rancho del Oro shown in NOV Photo 32 is actually a permanent driveway under construction and was not designated as an entrance/exit point but, was used incorrectly by site crews. The current condition of this driveway as of October 30th can be seen in the photo below. This driveway and adjoining sidewalk are scheduled to be poured on November 7th.
