CALIFORNIA REGIONAL WATER QUALITY CONTROL BOARD - SAN DIEGO REGION
WATERSHED MANAGEMENT PROGRAM

FACILITY INSPECTION REPORT

INSPECTION DATE: January 25, 2008 TIME: 1:00 pm WDID: 9 37C322900

Sprinter Rail Project
FACILITY OR DEVELOPER NAME (if different from owner)

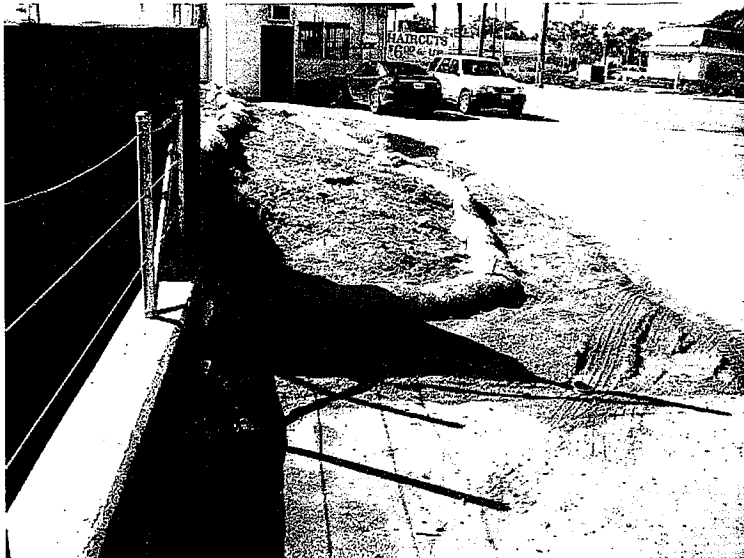
1. Crouch Street Station in Oceanside - This station is located near the intersection of Crouch Street and Oceanside Boulevard. Exposed dirt behind curbs lacked adequate sediment controls and inlet protection nearby was also lacking (Photos 1 and 2). There was significant trash near the inlet as well. These same conditions had been observed during prior inspections (e.g., inspection of November 27, 2007).

1. Sediment encroaching into a
parking lot north of the Crouch
Street Station.

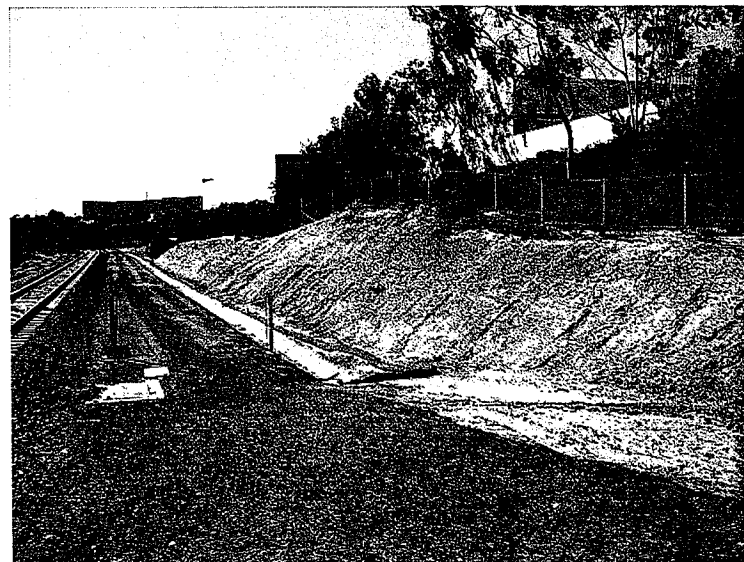
2. Railway crossing at Temple Heights Drive in Oceanside - This is a location where the Sprinter Rail tracks cross Temple Heights Drive about a quarter of a mile southeast of Oceanside Boulevard. Bonded fiber matrix (BFM) had been applied to slopes, but as shown in photos 3, 4 and 6, soil has eroded away after the application of the BFM. The discoloration of the eroded areas (indicating exposed soil and lack of BFM) shows that the erosion occurred after the BFM was applied. It is advisable to provide immediate, permanent stabilization on such slopes. Photo 5 shows a significant accumulation of sediment and gravel in the concrete-lined ditch that runs parallel to the track.

3. Steep slopes exhibit significant
erosion in the form of rills, despite
bonded fiber matrix (BFM)
application.

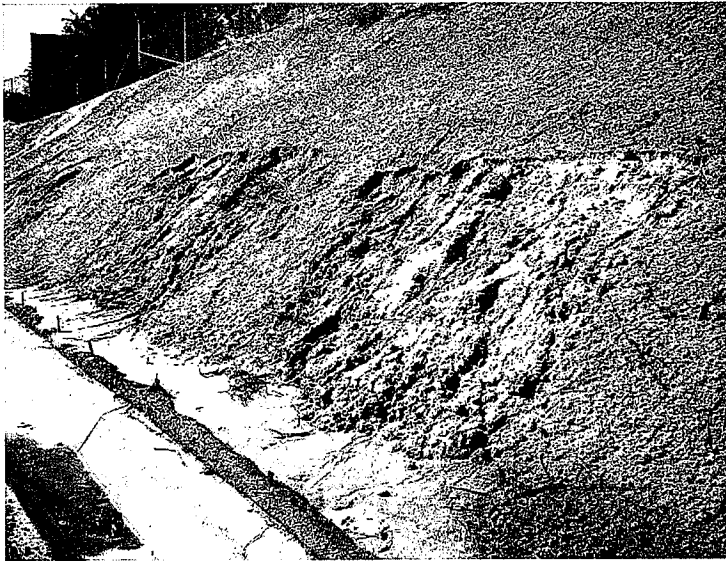
4. Another view of eroded areas where BFM had been applied. The lighter color of the eroded sections indicate that BFM failed to prevent erosion.

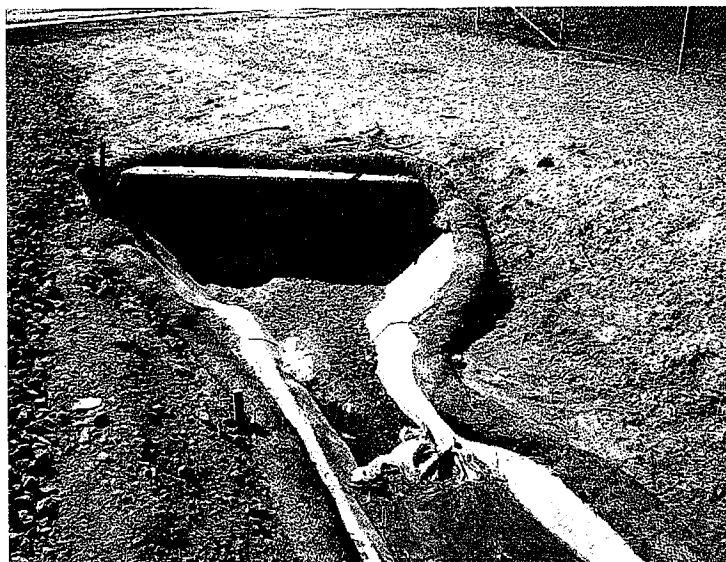
5. Concrete-lined ditch is nearly filled with sediment near a culvert. Worn out gravel bags have been overwhelmed.

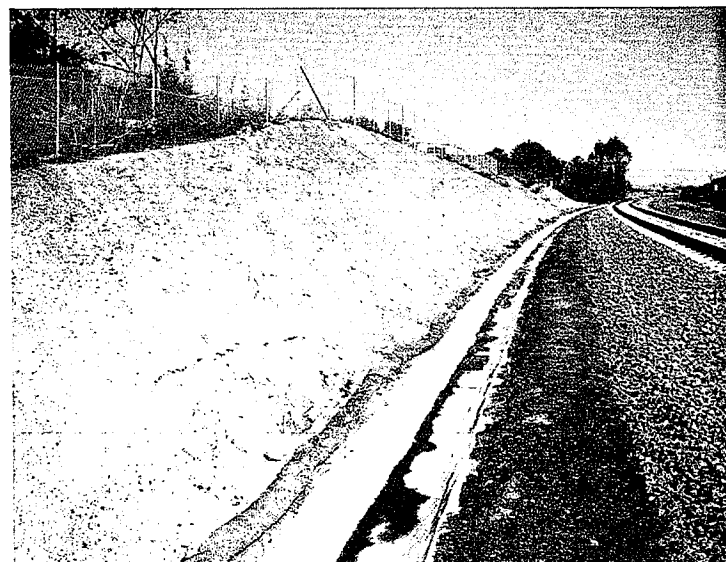
6. Slumped off soil at the bottom of the slope is evidenced by discoloration. BFM did not hold.

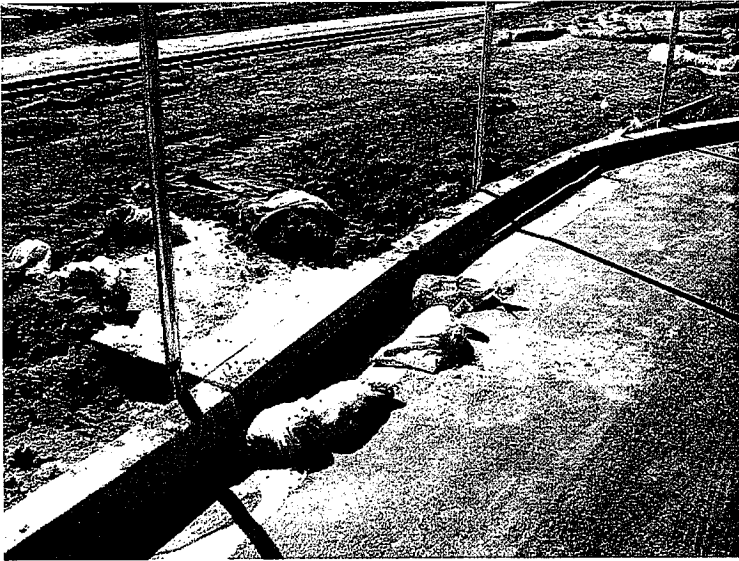
3. Melrose Station in Oceanside - This station is on the southwest corner of Melrose Drive and Oceanside Boulevard next to a convenience store. The headwaters to Loma Alta Creek flow adjacent to the south side of the tracks. Station construction appears to be nearly complete with the exception of landscape installation. A storm drain inlet at this location lacked adequate protection (Photo 7). A gap in the gravel bags will allow sediment-laden flows to directly enter the inlet.

7. Gravel bags do not completely surround the drain inlet. Insufficient protection.

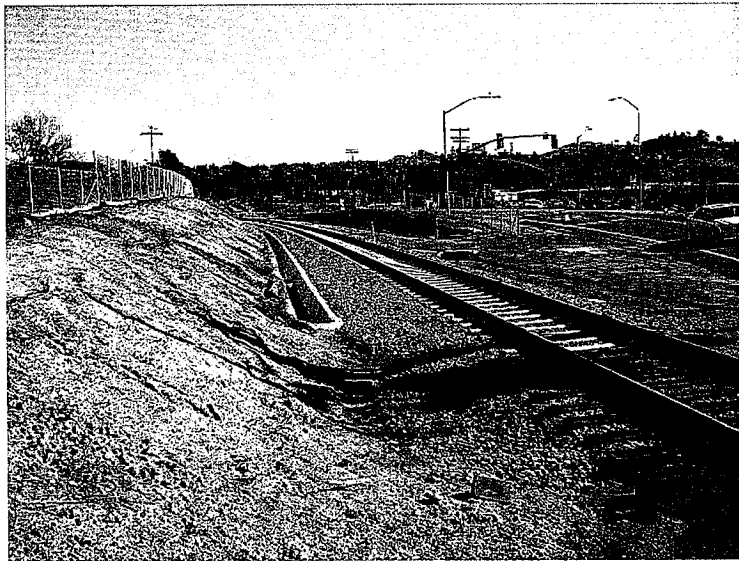
4. York Drive-Santa Fe Drive crossing in Vista - This is a location where the tracks cross Santa Fe Drive near the intersection of Santa Fe Drive and York Drive. Once again, slopes had been treated with BFM, but rills (Photo 8) and slumped sections of soil (Photo 9) show that the application was ineffective. Again, immediate, long-term stabilization is advisable. Photo 10 shows an earthen channel running along the tracks which lacks any stabilization. Sediment accumulations are shown in a concrete ditch running along the channel in Photos 11 and 12. Photo 11 also shows a fiber roll that is in need of maintenance.

8. Rills have formed on slopes, again despite BMP application.

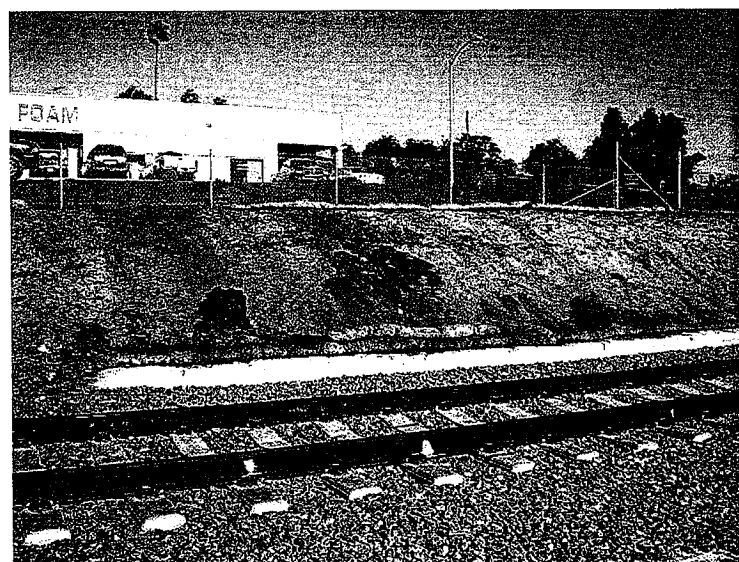
9. Again, slumped off soil at the bottom of the slope is evidenced by discoloration. BMP did not hold.

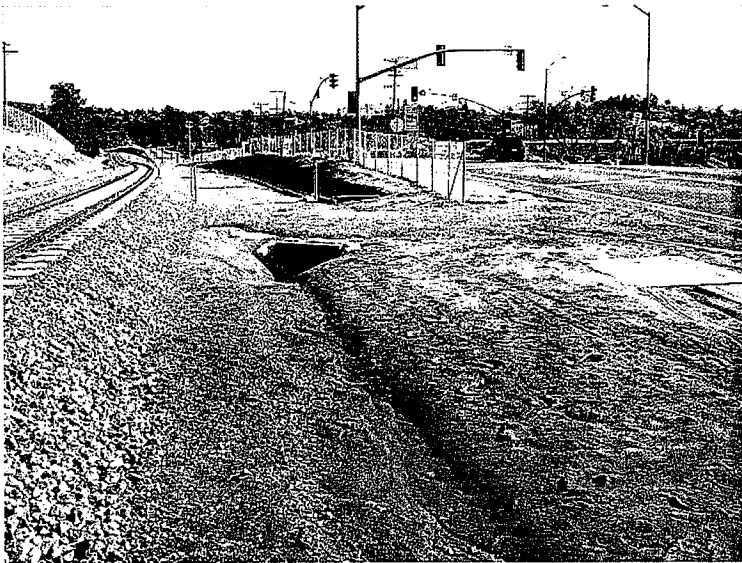
10. Earthen channel lacks stabilization.

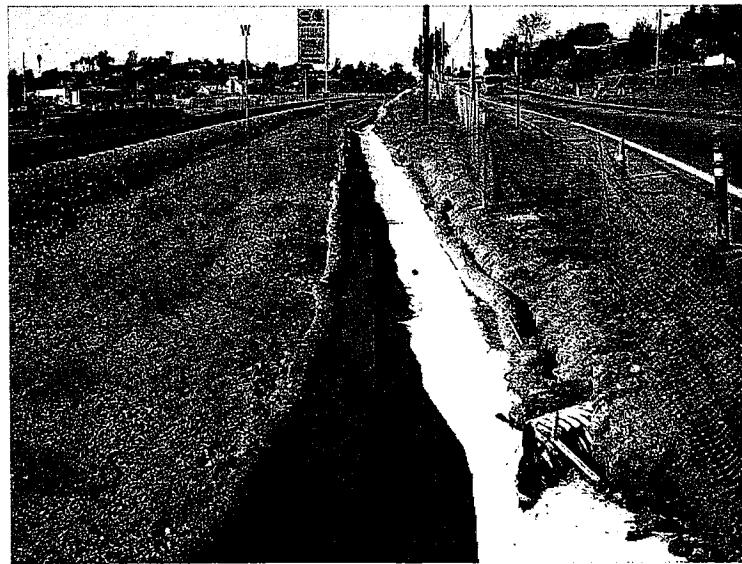
12. Concrete-lined ditch leading to culvert inlet shown in Photo 11. More accumulated sediment.
