CALIFORNIA REGIONAL WATER QUALITY CONTROL BOARD - SAN DIEGO REGION
WATERSHED MANAGEMENT PROGRAM

FACILITY INSPECTION REPORT

INSPECTION DATE: December 28, 2007 TIME: Noon WDID: 937C322900

Sprinter Rail Project
FACILITY OR DEVELOPER NAME (if different from owner)

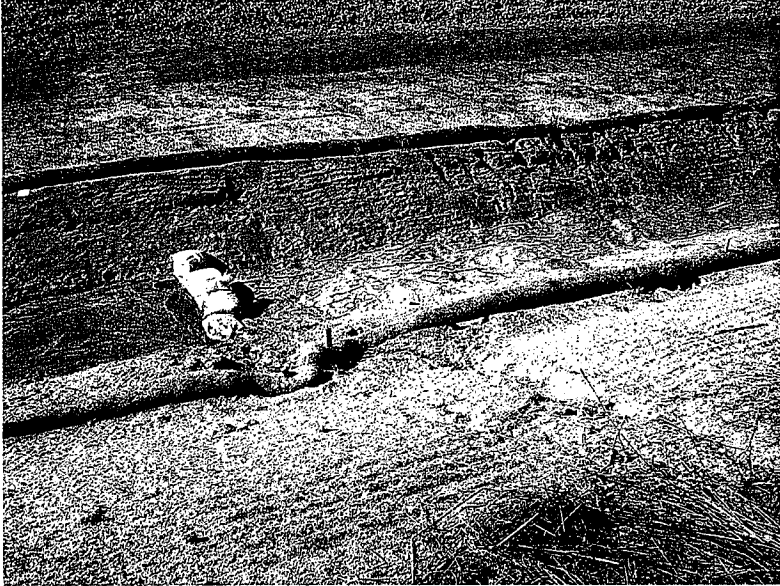
The train ride started in Oceanside, CA. Prior to boarding the train at the Oceanside Transit Center, we inspected the surrounding area. The storm water conveyance ditches continue to be inadequately stabilized dating back to the November 30, 2007 inspection (Photos 1, 2, 4, and 5). Erosion was present on the banks of these ditches. The storm drain inlet did not have adequate sediment controls (Photo 3). A close examination of the erosion control application appeared to be light (Photo 6).

1. Photo shows unstabilized dirt channel and erosion gullies are along the slopes.

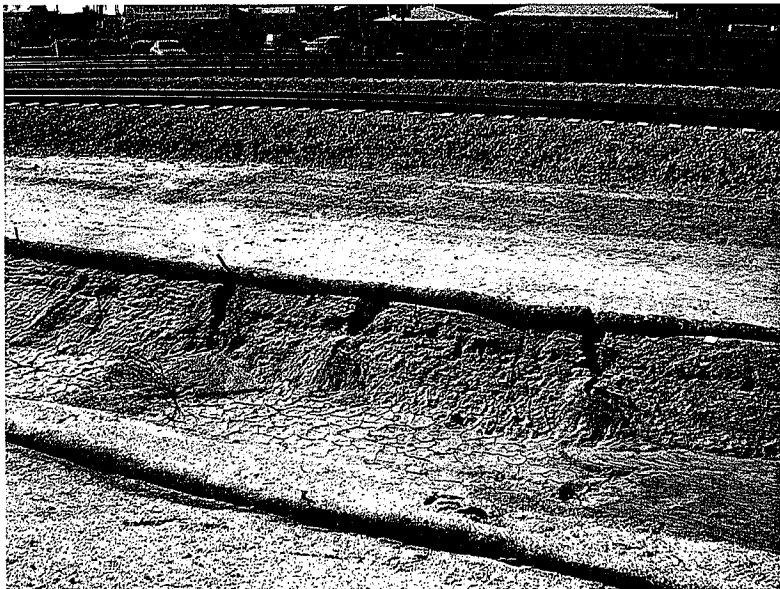
2. Erosion gullies are on the bank slopes. The channel has not been stabilized.

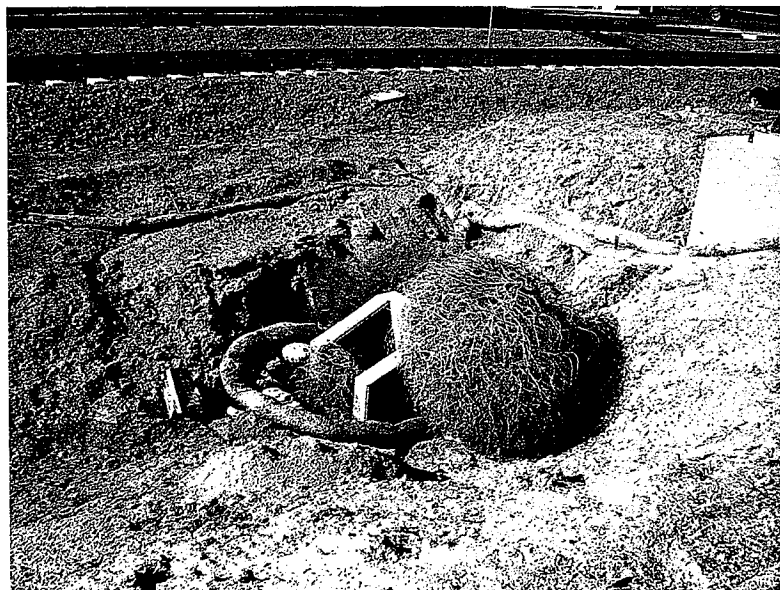
3. Storm drain inlet south of Wisconsin Street shows trash, inadequate inlet protection and unstabilized soils.

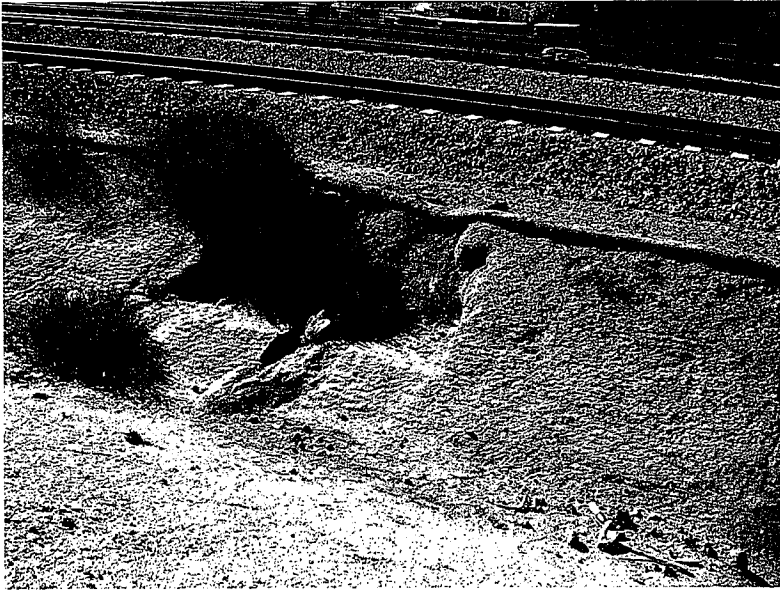
4. An erosion gully is present on the bank of the unstabilized channel.

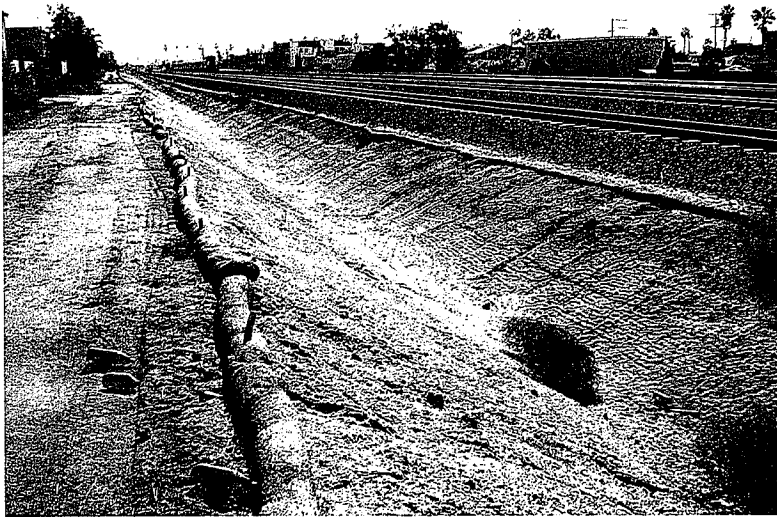
5. A long expanse of the channel is unstabilized.

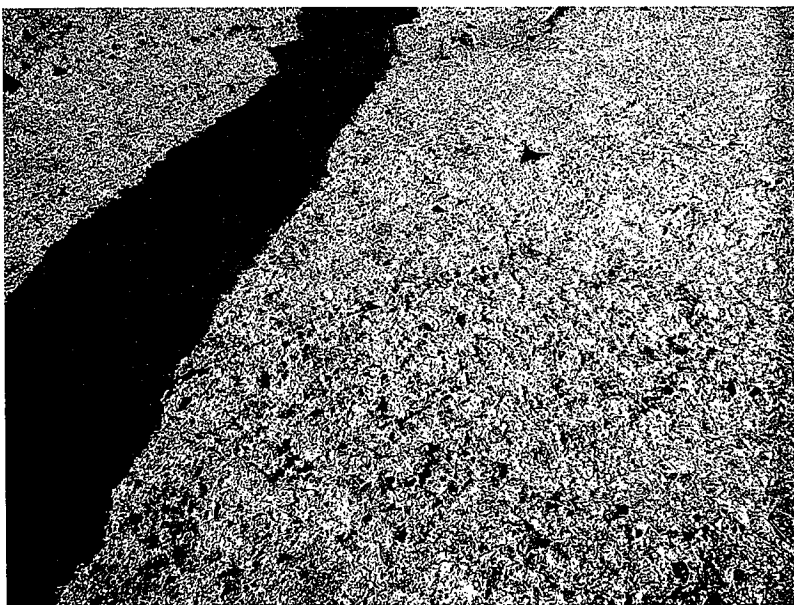
6. Although some erosion control was applied, it was a light application whose effectiveness is questionable.

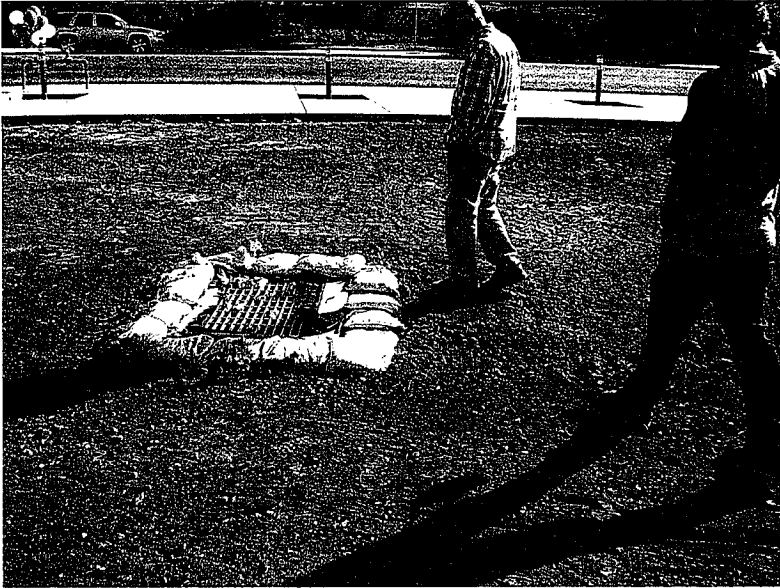
After arriving at the Escondido Transit Center, we inspected the station. Storm drain inlets were protected with gravel bags (Photos 7, 8, 9). Near one of the storm drain inlets, a hole appears to drain storm water bypassing the inlet (Photo 9 and 10). At the west end of the station is a large bare dirt lot. Currently some large sections of concrete pipe are stored here on their end. Inside one of these large concrete pipe sections, paint and other construction materials was stored without proper containment or cover to prevent storm water contact (Photo 11). South of the tracks near the bridge crossing Escondido Creek, silt fence was in disrepair and needed maintenance (Photo 12). This was previously noted on the December 7, 2007 inspection.

7. Storm drain inlet is protected.

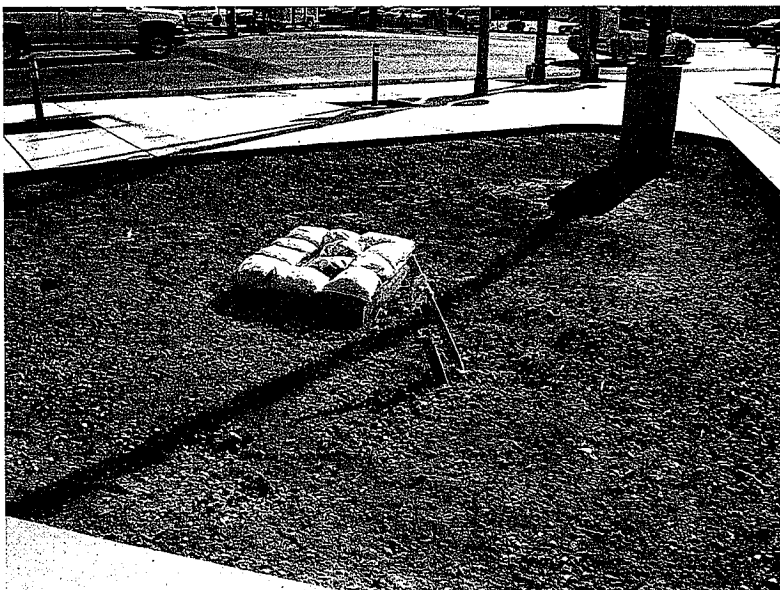
8. Another inlet has been protected. Previously a hole was present in the soil near the inlet that has since been fixed.

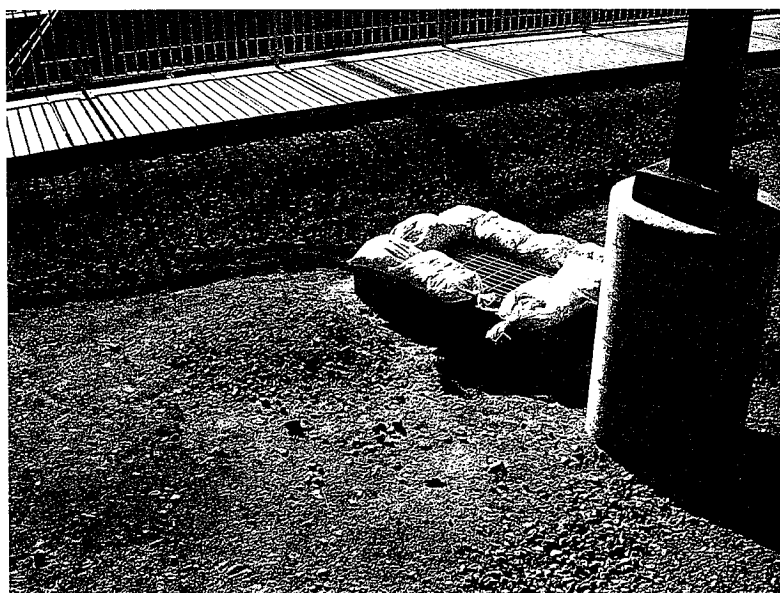
9. Another inlet that has been protected. This inlet does have a hole in the soil near the inlet suggesting that storm water bypasses the inlet and drains through this hole.

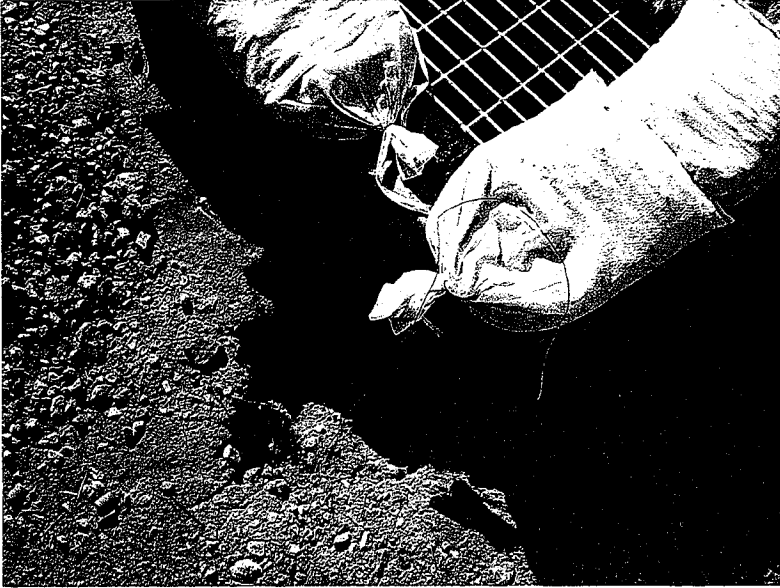
10. Photo shows a closer look at the hole near the storm drain inlet.

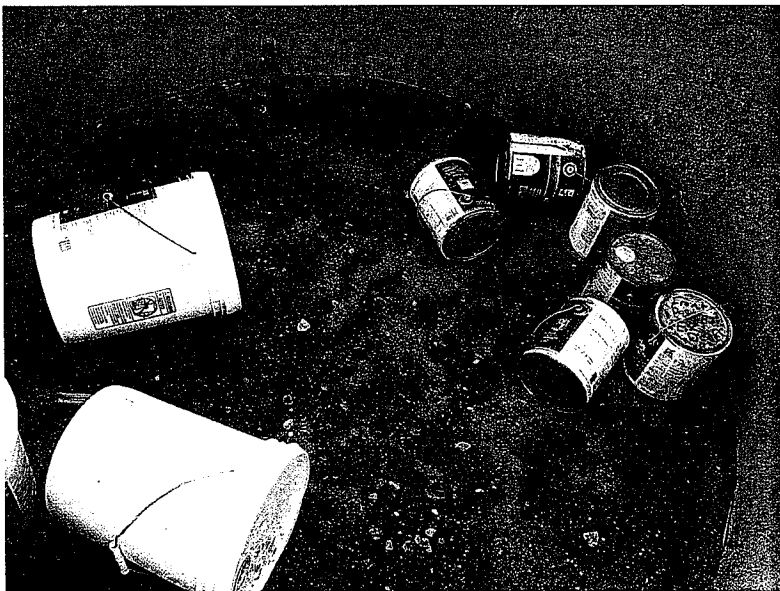
11. At the north west corner of the Escondido Transit Center, large concrete pipe sections were standing on end. Inside one of these pipe sections was stored paint and other construction materials without proper cover or containment to prevent contamination of potential storm water contact.

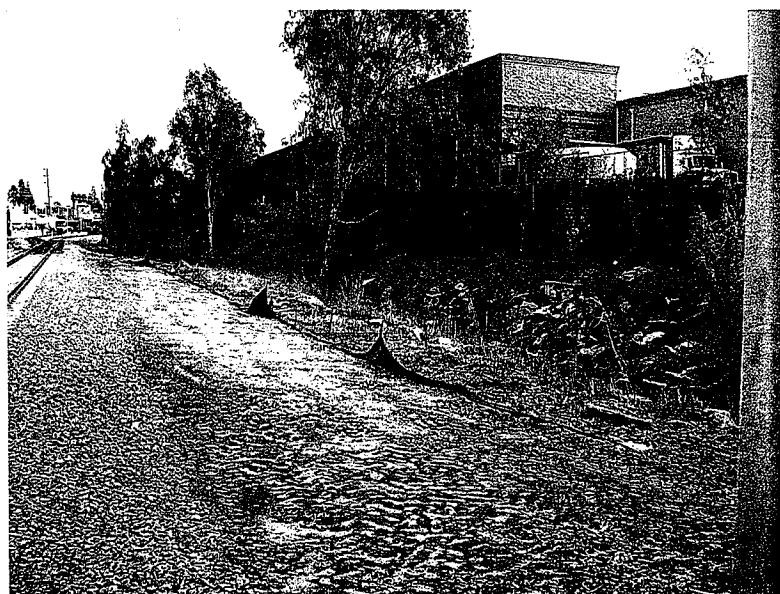
12. At the west end of the Escondido Avenue Center and south of the tracks near the bridge over Escondido Creek, an old silt fence has not been maintained and may become a potential trash pollutant in the nearby channel.
