**CALIFORNIA REGIONAL WATER QUALITY CONTROL BOARD - SAN DIEGO REGION
WATERSHED PROTECTION PROGRAM**

FACILITY INSPECTION REPORT

FACILITY: Del Sur/Unit 14 **INSPECTION DATE/TIME:** 12/22/2010; 1400

Facility: Del Sur Unit 14
Inspection Date: 12/22/2010

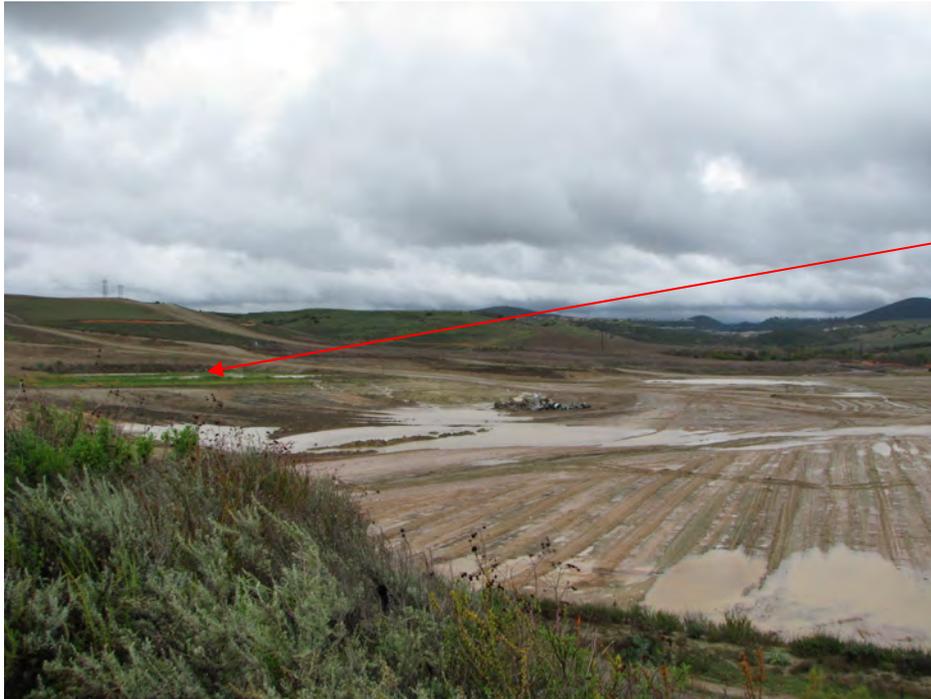
Storm water detention basin used to detain offsite run on from upstream development

Figure 3. Construction site looking northeast

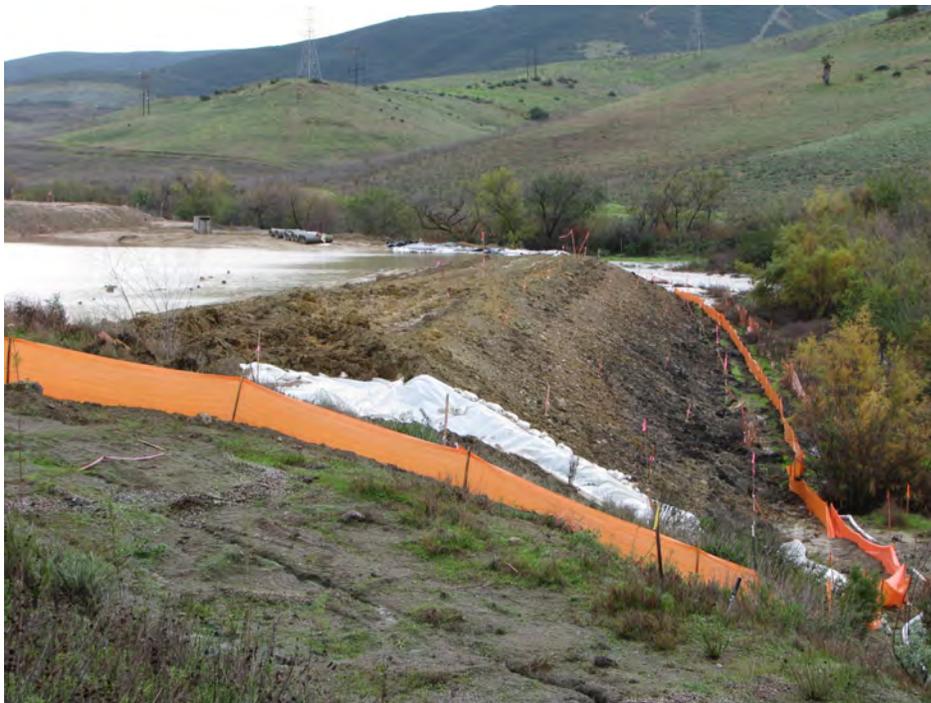
4. The berm at the perimeter that was used to temporarily detain the storm water was overwhelmed by recent storms. Sediment-laden storm water breached the berm in at least two places and entered Lusardi Creek (Figures 4-9).

Note slopes have no erosion control

Figure 4. Berm used to detain storm water

1. Given the size of the construction site, volume of disturbed sediment, and proximity to Lusardi Creek, the site lacks adequate sediment and erosion control BMPs.
2. Sediment control basins can be used provided they are designed with adequate capacity to capture and treat sediment-laden storm water generated from the site. Implementation of sediment basins should have been done at the onset of rough grading, as described in the SWPPP Site Maps (see Exhibit Showing

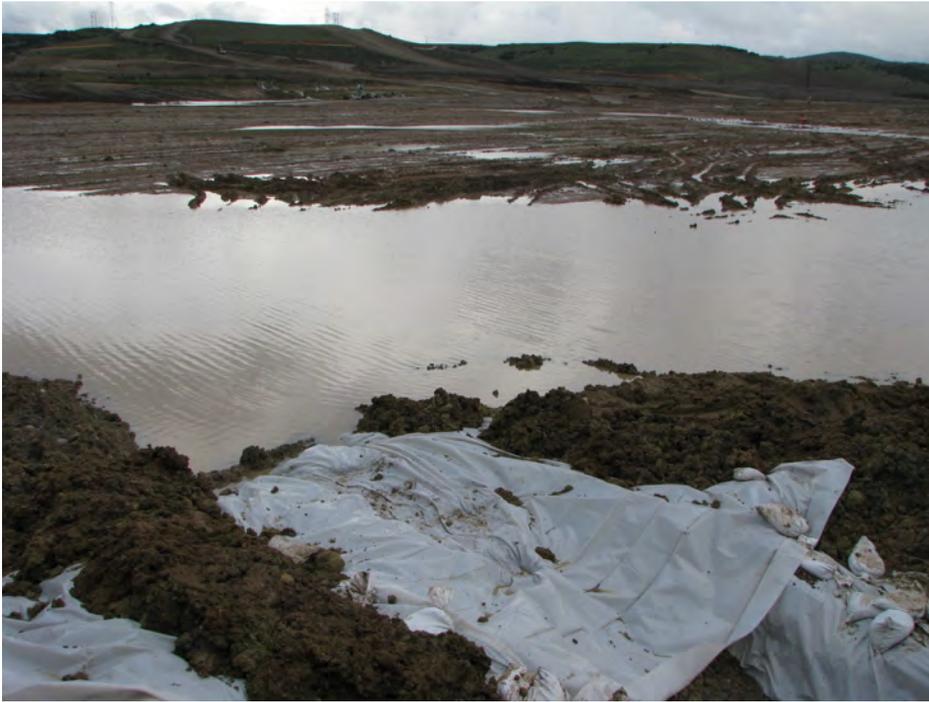
Figure 5. Construction site looking upstream from location of breach
