**Subject: Notice of Violation No. R9-2010-0146 and Water Code Section 13267
Technical Report, Casa Mira View**

NOTICE OF VIOLATION No. R9-2010-0146

FACILITY INSPECTION REPORT

FACILITY: Casa Mira View **INSPECTION DATE/TIME:** 10/25/2010; 1330

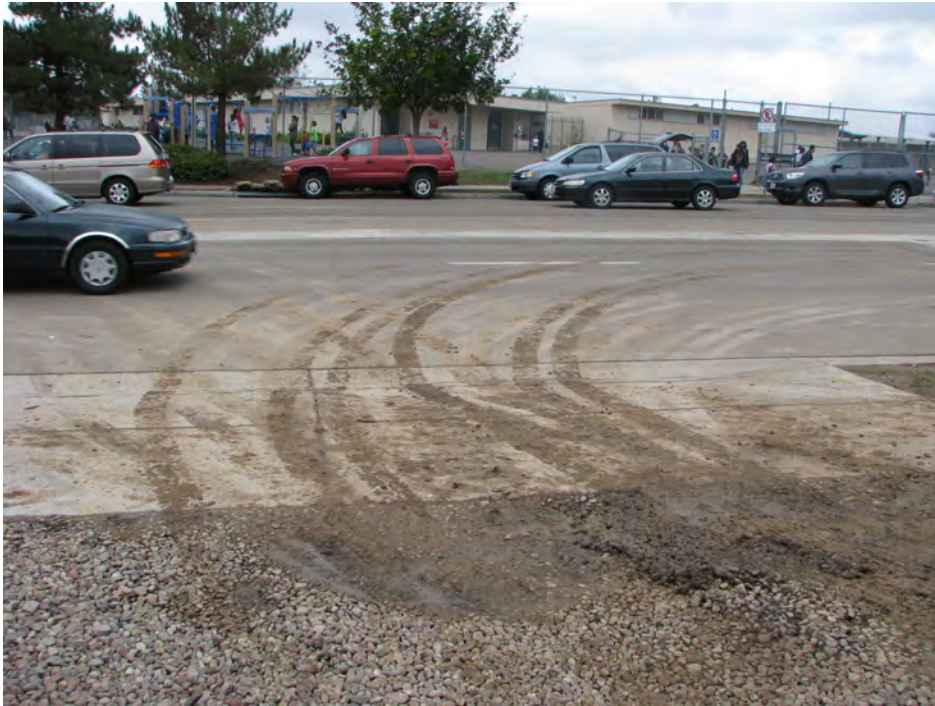
Figure 1. Construction site entrance

Note sediment on street. Gravel BMP in poor condition and in need of maintenance.

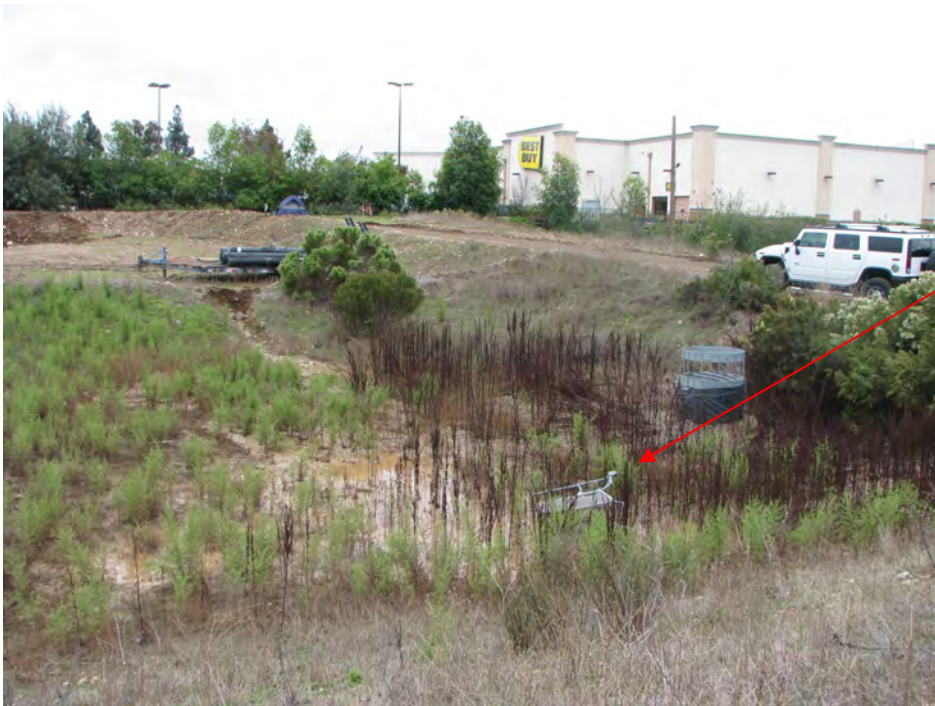
Figure 2. Desilting basin inside project boundaries

Shopping cart in desilting basin should be removed.

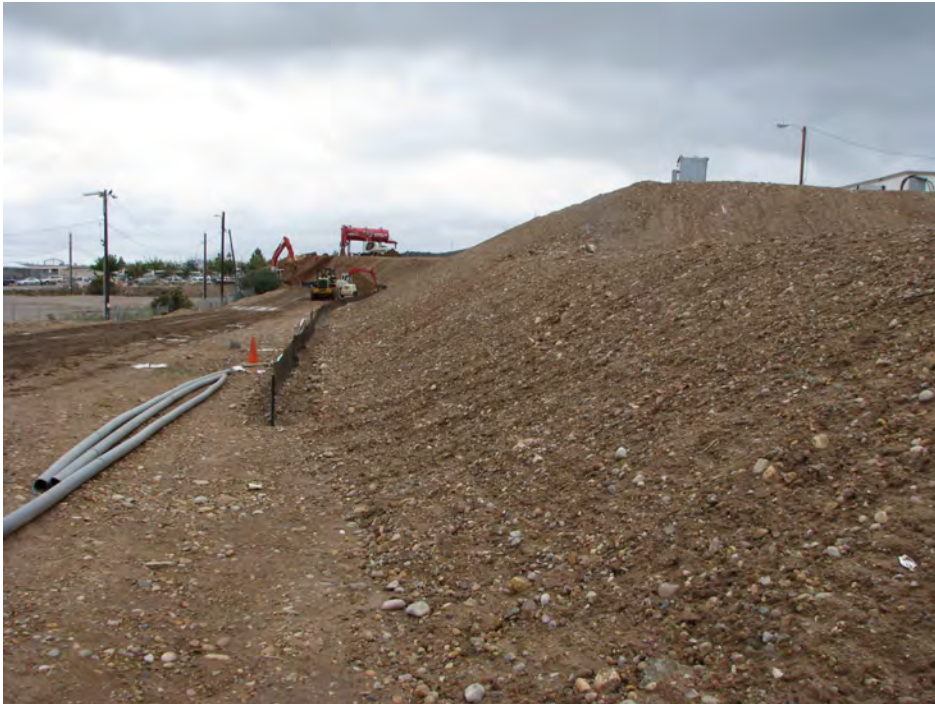
Figure 3. Uncovered slope (inside property)

Erosion control measures must be applied to slopes.

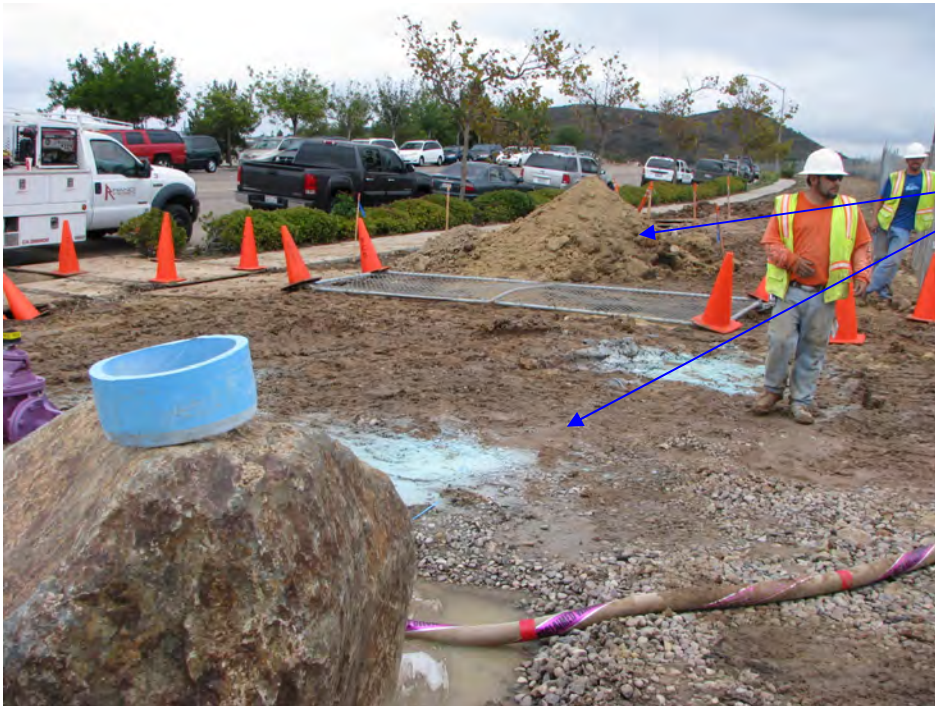
Figure 4. Project site at street level

Note uncovered stockpile and blue dust from pipe cutting

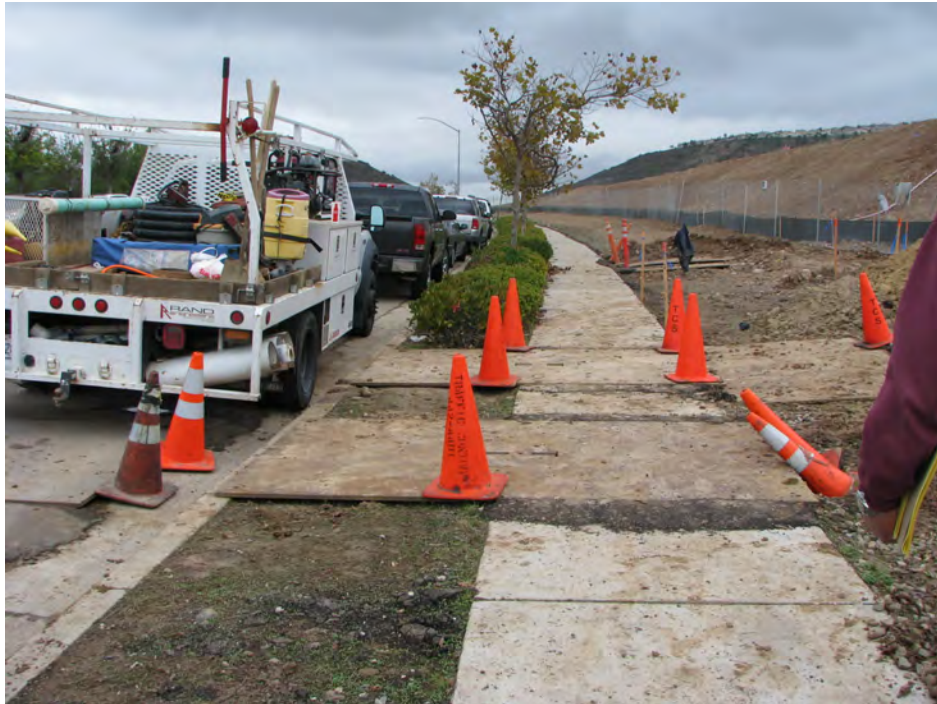
Figure 5. Sidewalk adjacent to project site

Project sediment is on sidewalk and street.

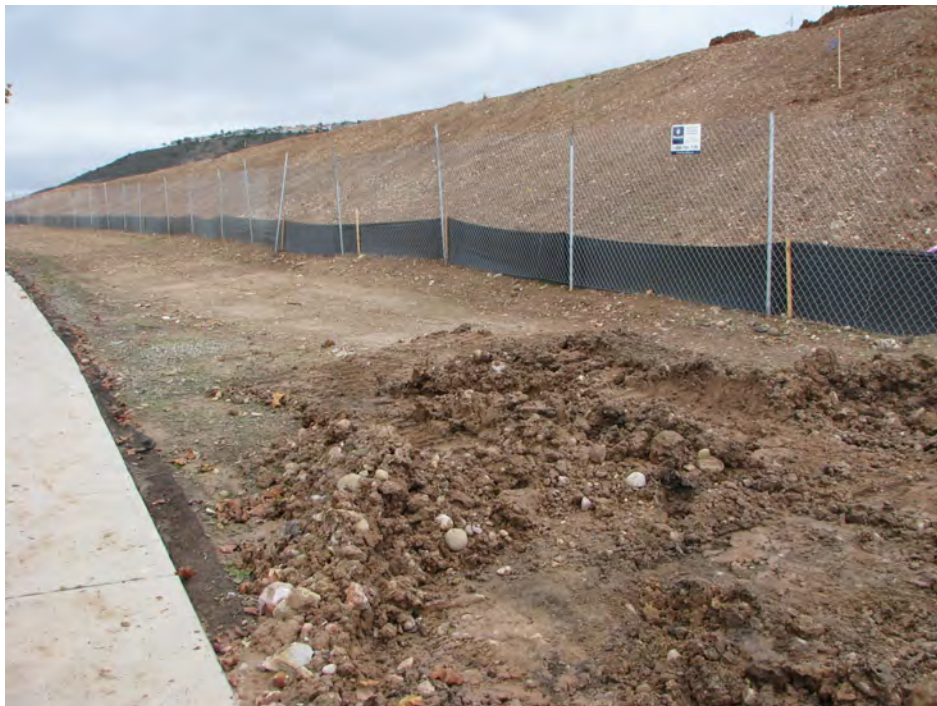
Figure 6. Slope and project material at perimeter

Slopes on West side (perimeter) of site have no erosion control BMPs. Also, disturbed sediment near sidewalk should be covered or removed.

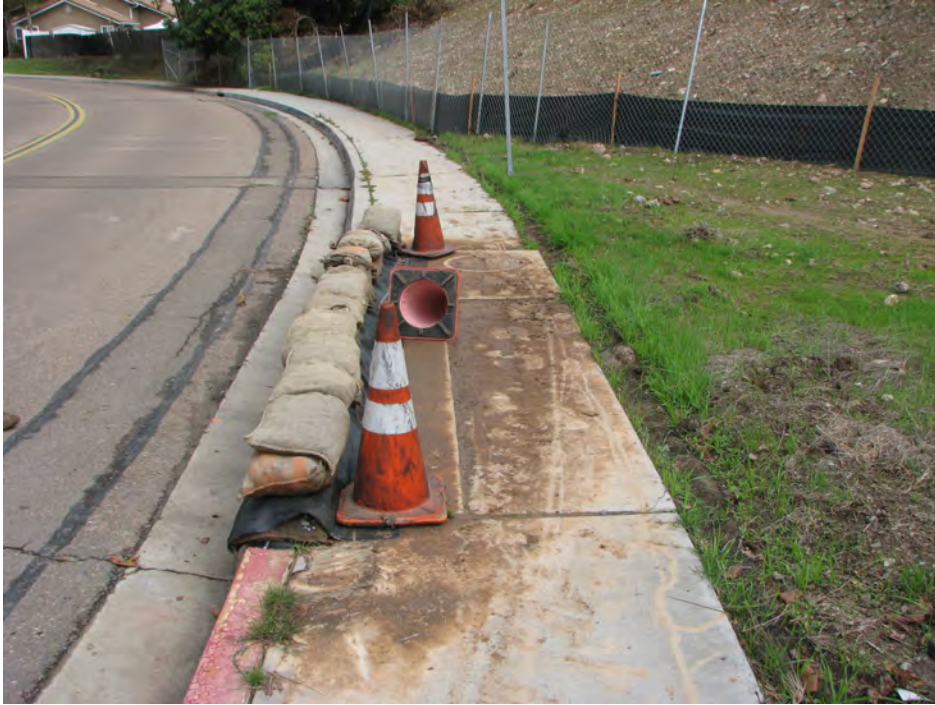
Figure 7. Storm drain inlet at North side of property

Area near storm drain inlet should be swept.

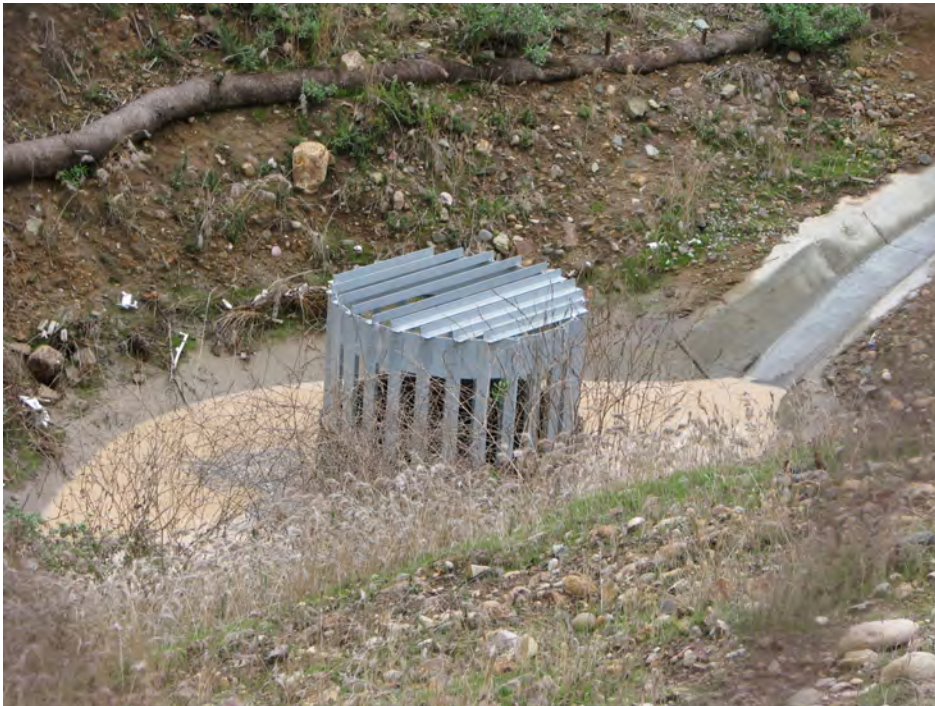
Figure 8. Storm drain on Caltrans right of way (East side project boundary)

Riser pipe is wrapped with filter fabric. Note turbid water surrounding pipe entering via concrete swale.

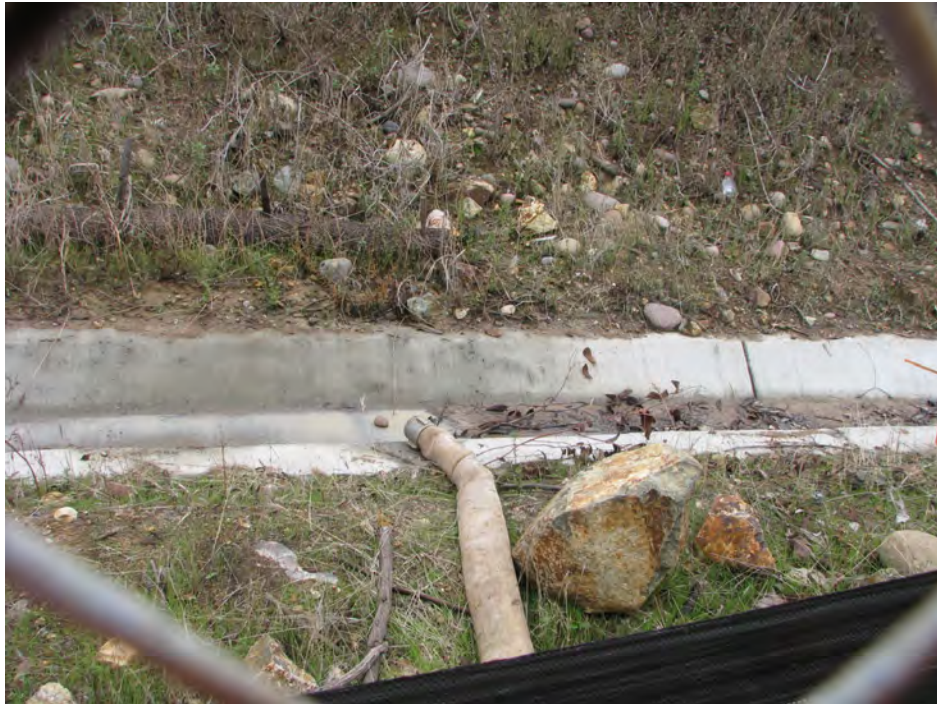
Figure 9. Outlet pipe of illegal discharge

Source of turbid water is illegal discharge from project site.

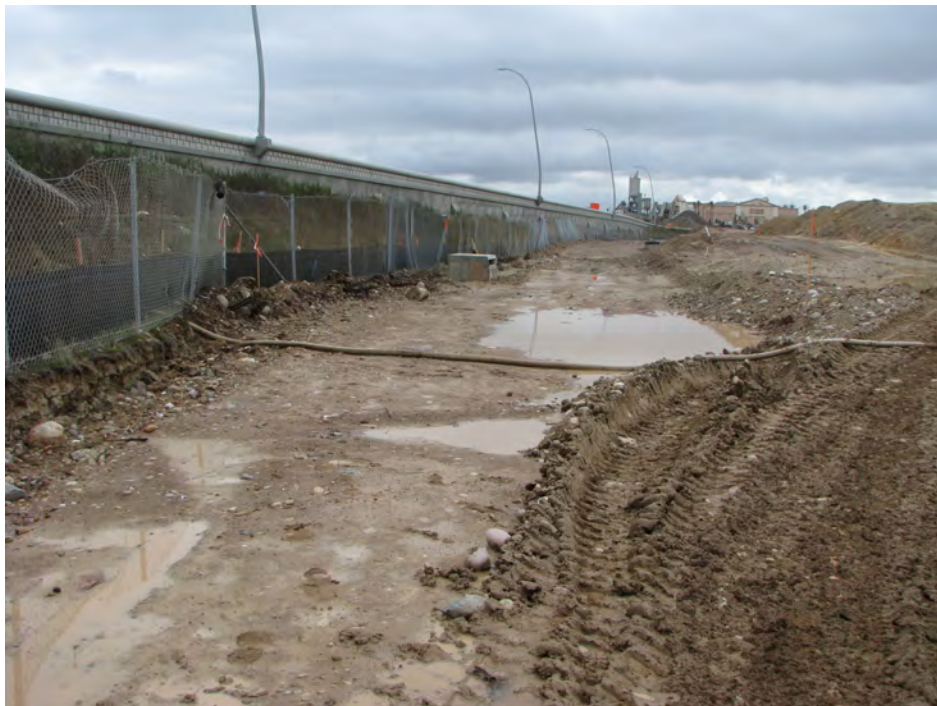
Figure 10. Pipe leading off property (from pump)

Pipe from project site was placed through chain link fence to concrete swale.

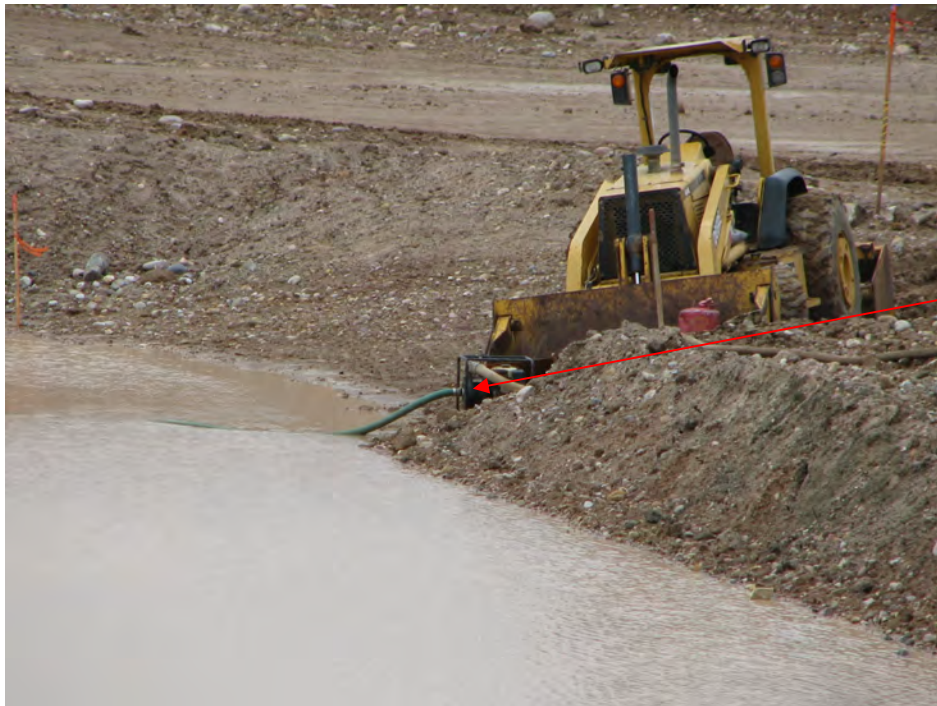
Figure 11. Pump intake

Pump intake line

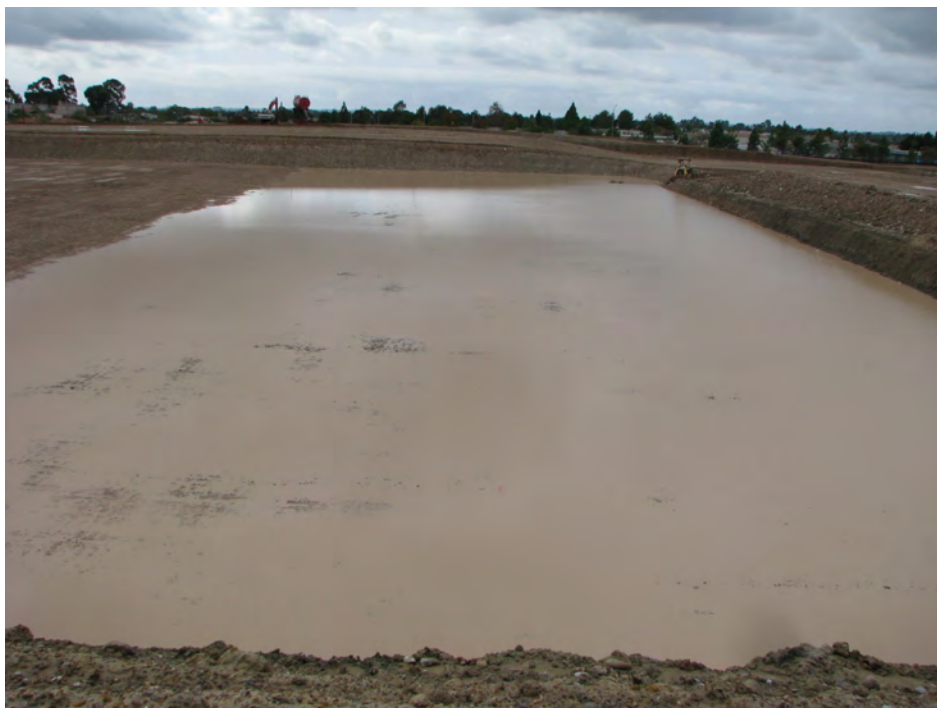
Figure 12. Dewatering area

Area of construction site being dewatered.
