**Subject: Notice of Violation No. R9-2010-0135 and Water Code Section 13267
Technical Report, City of San Diego**

NOTICE OF VIOLATION No. R9-2010-0135

FACILITY INSPECTION REPORT

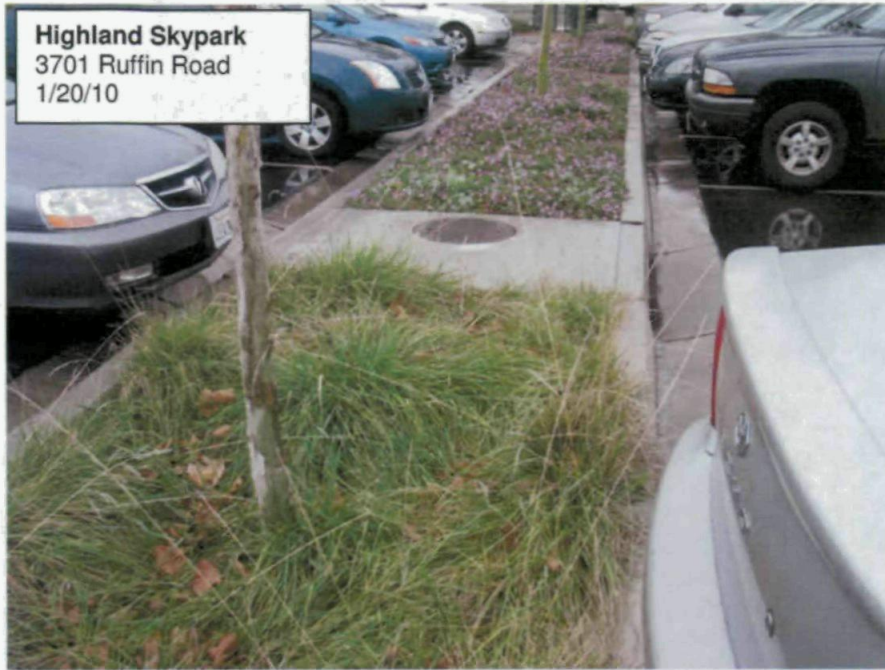
Figure 1. Top of Bioswale 1

On January 20, 2010, Christina Arias inspected bioswales in a business park located at 3701 Ruffin Road. Figures 1-4 show the bioswales. Note there are no curb cuts, and subsequently runoff from the parking lot is not channeled into the bioswales. The engineering specifications available in the Water Quality Technical Report (WQTR; Figure 15) likewise do not indicate that runoff from the parking lot is intended to be channeled into the bioswales. The specifications include hatch marks near the bioswales, but it is not clear that these markings pertain to the intended flow of storm water. Storm water from the parking lot appears to leave the site with little to no treatment.

1. The City of San Diego should verify whether or not the bioswales at Highland Skypark (which do not treat polluted storm water) were designed or constructed incorrectly, or both.

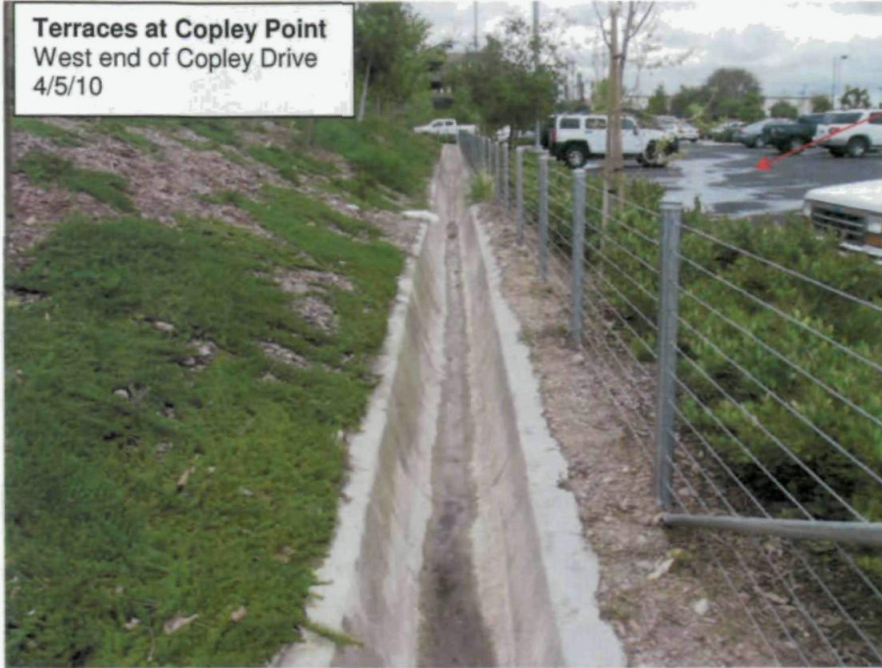
Runoff generated in parking lot....

Figure 5. Parking lot and U-ditch at Copley Point

2. The City of San Diego should verify that runoff from the parking lot at the Terraces at Copley Point receives treatment via the CDS unit.
3. The City of San Diego should locate the WQTR for Carmax Kearny Mesa and verify that the bioswales were constructed per the engineering specifications.

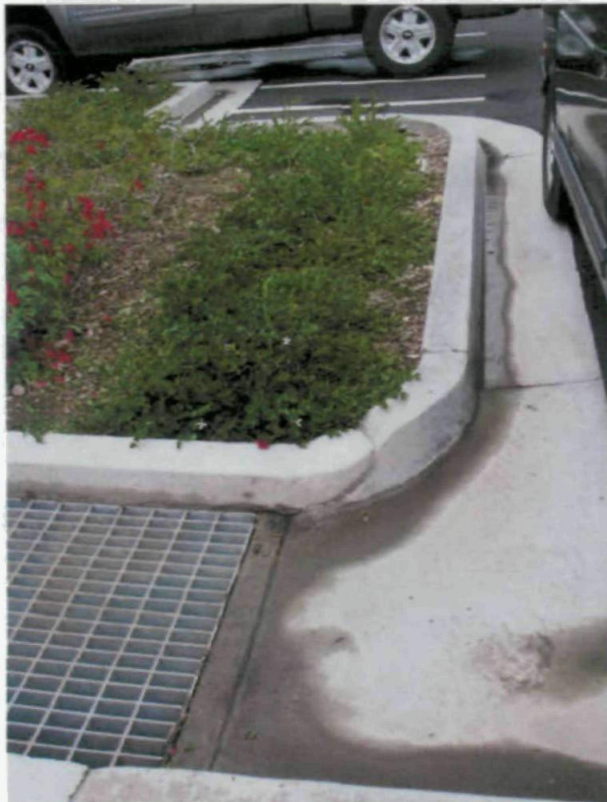
...flows into this storm drain

Figure 6. Storm drain receiving runoff from parking lot

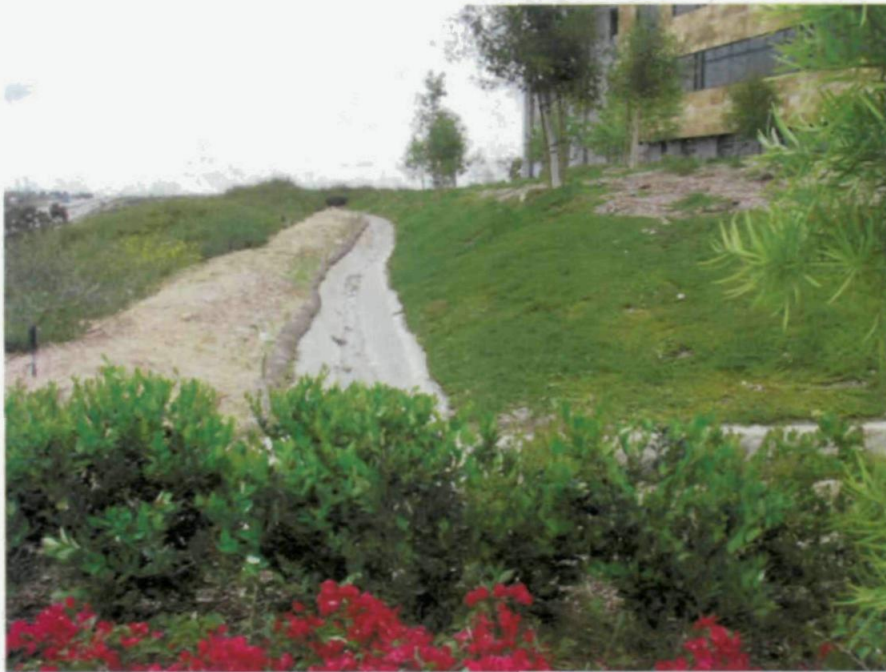
Runoff from west side of development transported in U-ditch...

Figure 7. U-ditch receiving runoff from West side of buildings

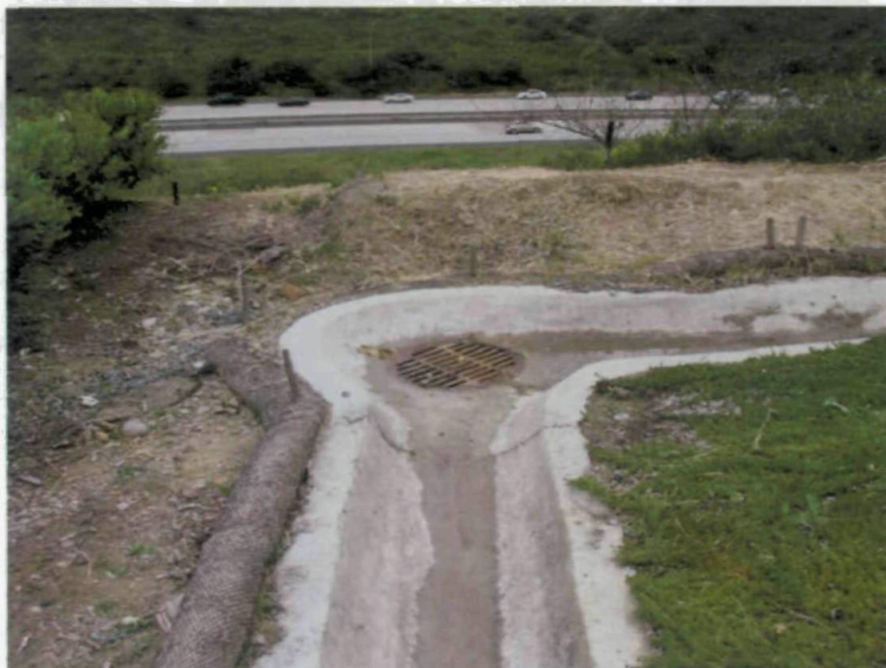
...to this drain (which also receives runoff from parking lot. Storm water in this drain may leave site without treatment.

Figure 8. Storm drain receiving runoff from parking lot before leaving site

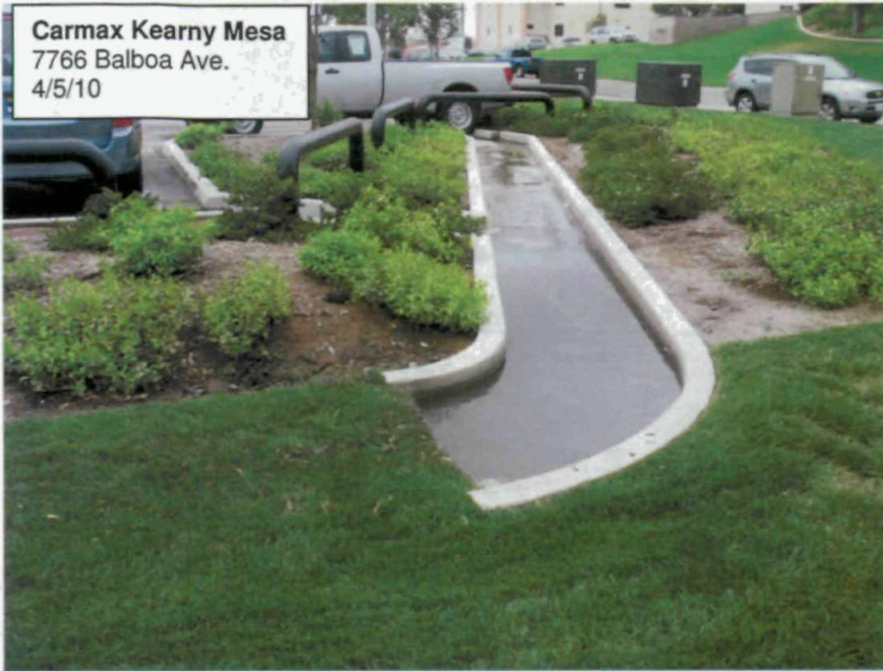
Figure 9. Inlet for Bioswale 1

On April 9, 2010, Ben Neill and Christina Arias inspected two bioswales to treat runoff from the used car parking lot. The storm water runoff appeared to be untreated,

bypassing the bioswales (see Figures 9-14). Additionally, the bioswales did not appear to have the 3:1 side slopes or 4'-6" grass height recommended by CASQA. Engineering specifications and the WQTR for this location were not available.

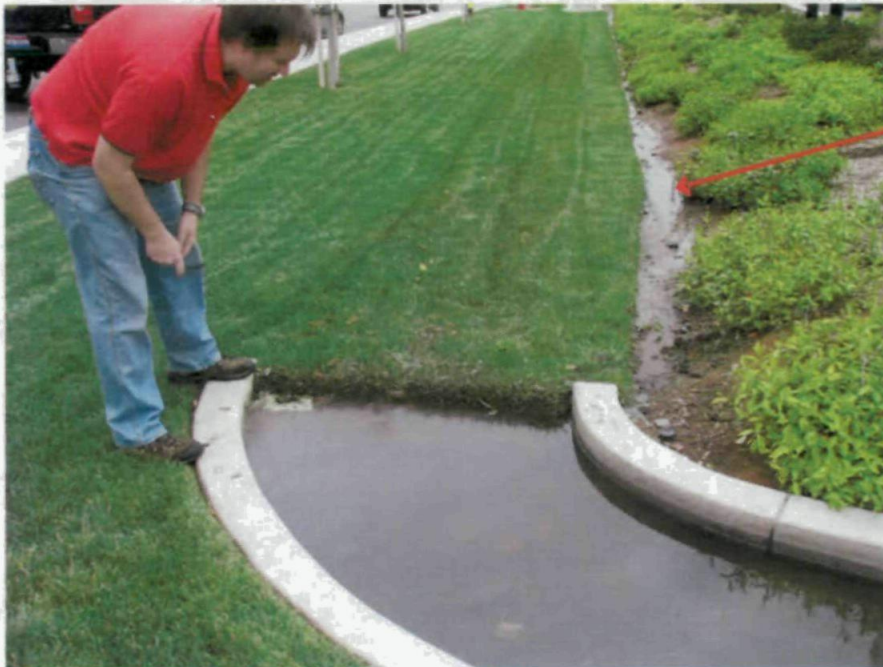
Figure 10. Inlet for Bioswale 1 looking downstream

Runoff seen short-circuiting bioswale and receiving little to no treatment

Runoff from parking lot contains oily sheen, sediment

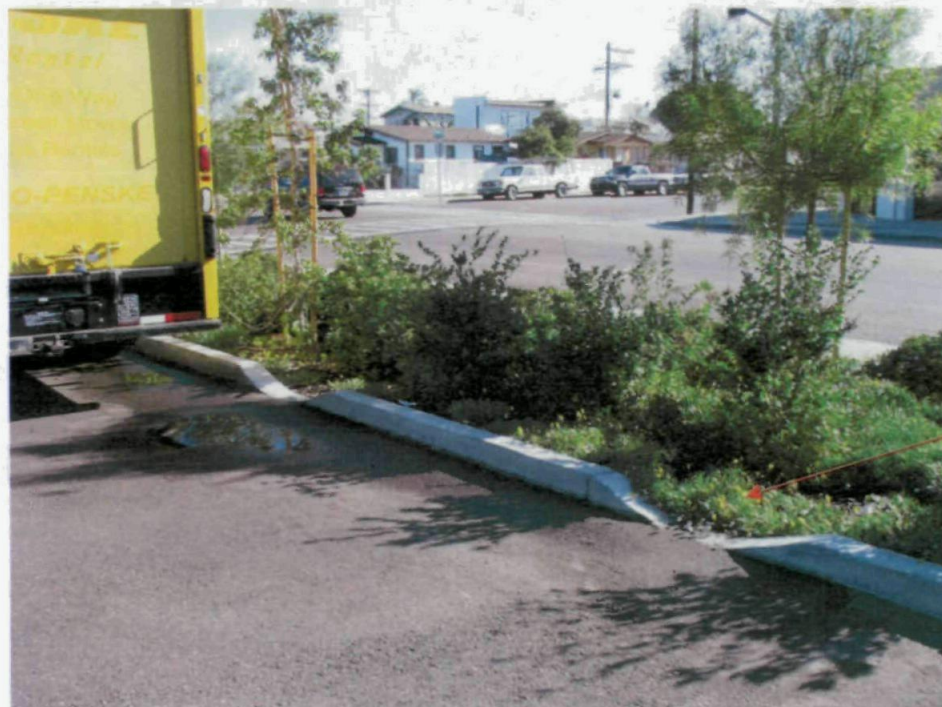
Figure 2. Vegetated swale—Fairmount Ave.

Vegetation at entrance may block storm water from entering swale

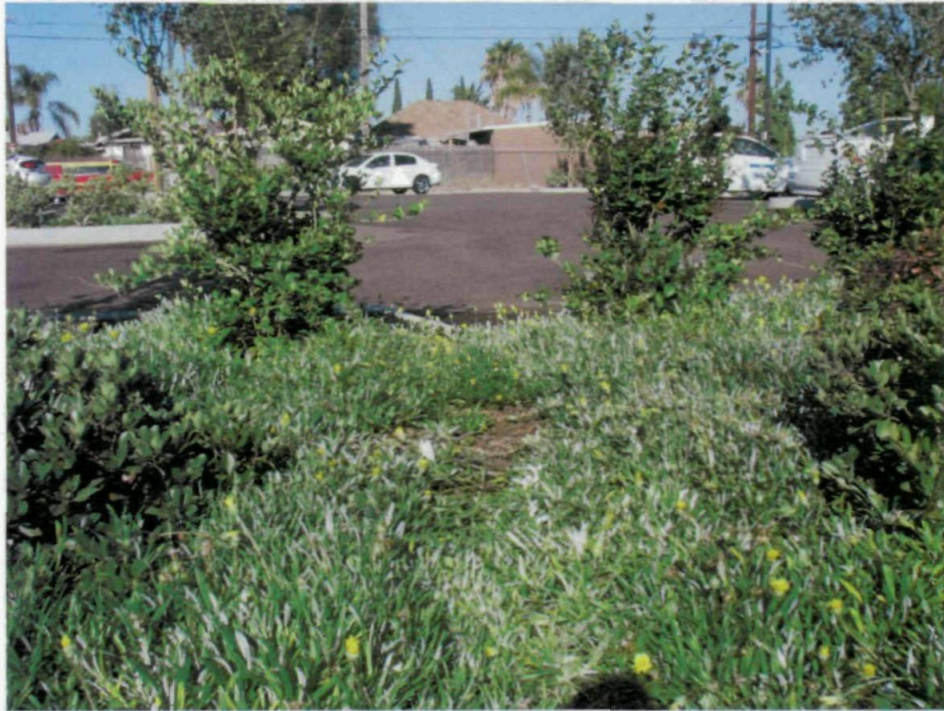
Figure 3. Vegetated swale—Fairmount Ave.

Elevation of swale is higher than parking lot

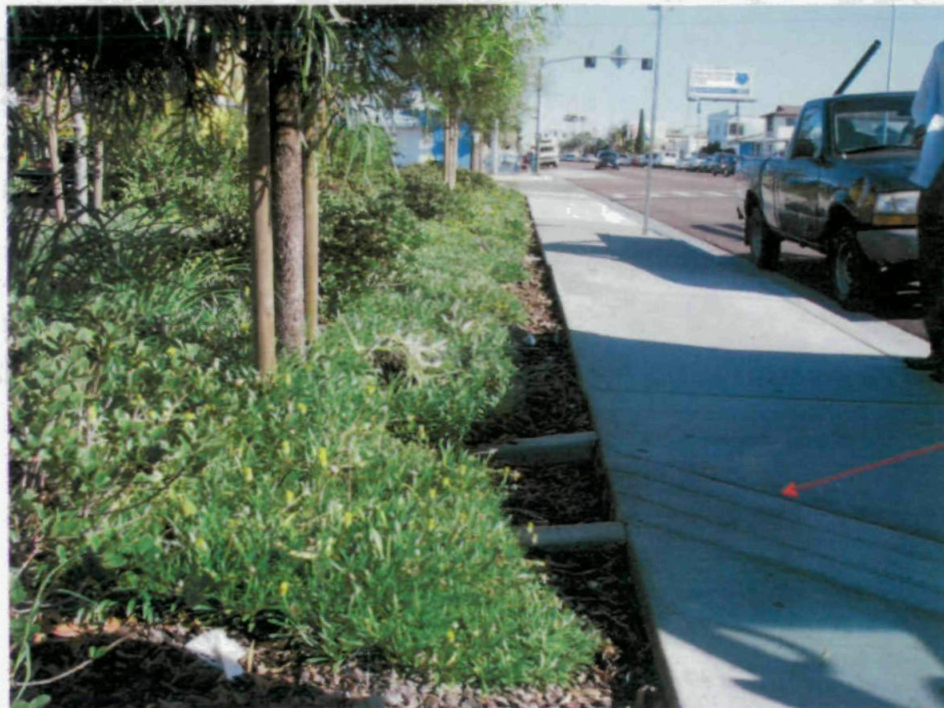
Figure 4. Vegetated swale—Fairmount Ave.

Overflow pipe connected to MS4

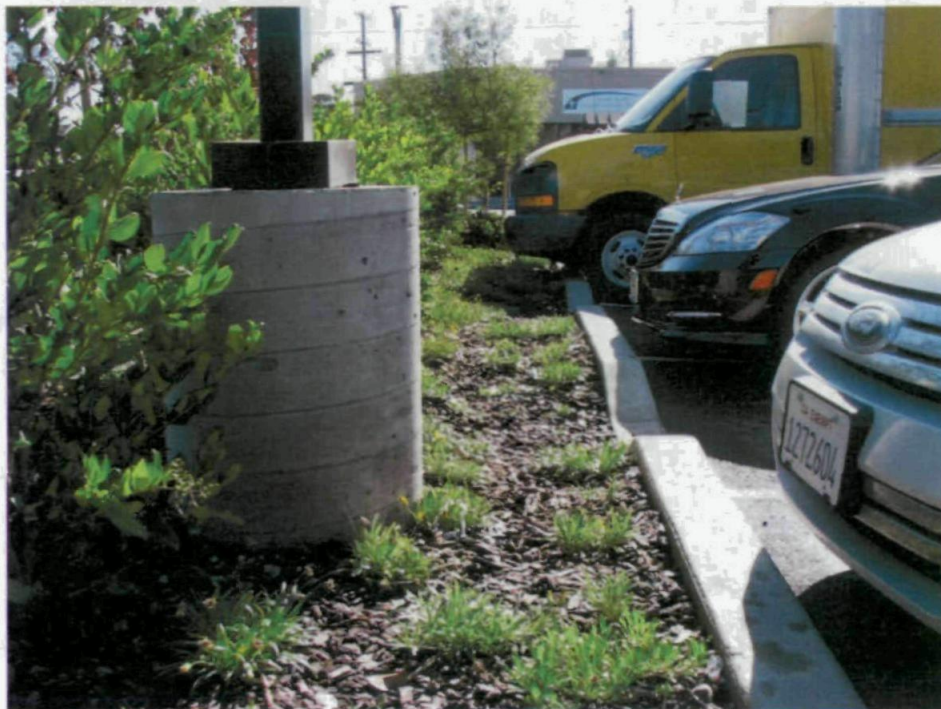
Figure 6. Vegetated swale—Dwight St.

Except at inlet, swale elevation is higher than parking lot

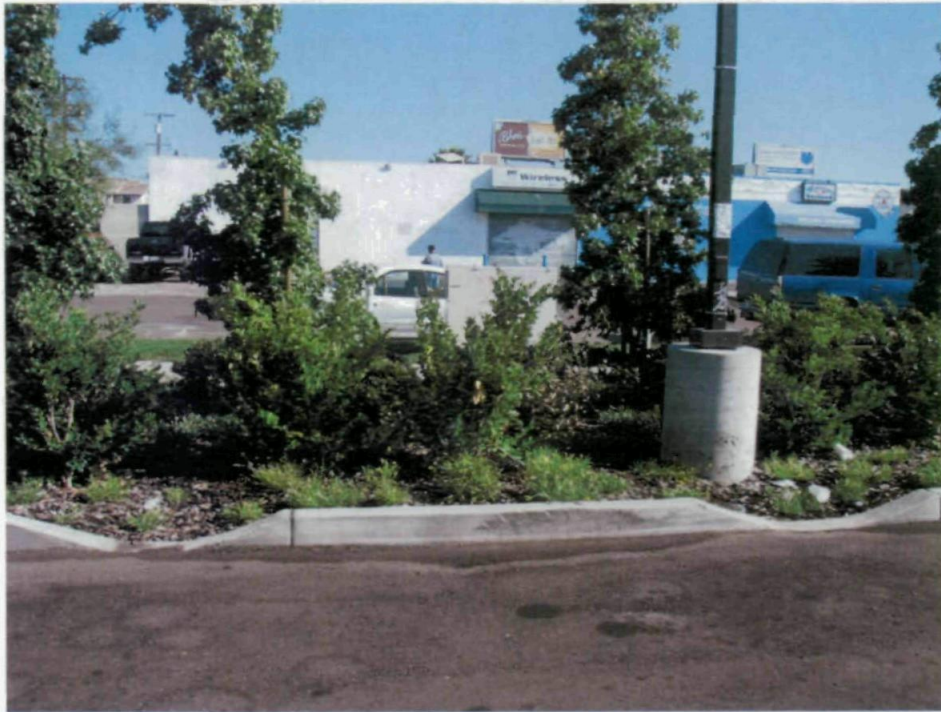
Figure 7. Vegetated swale—Dwight St.

A significant amount of trash was observed on the property and in the swales. Roof downspout filters on the engineering plans could not be located, and may be located inside the building.

Styrofoam cups and food wrappers littered the swales

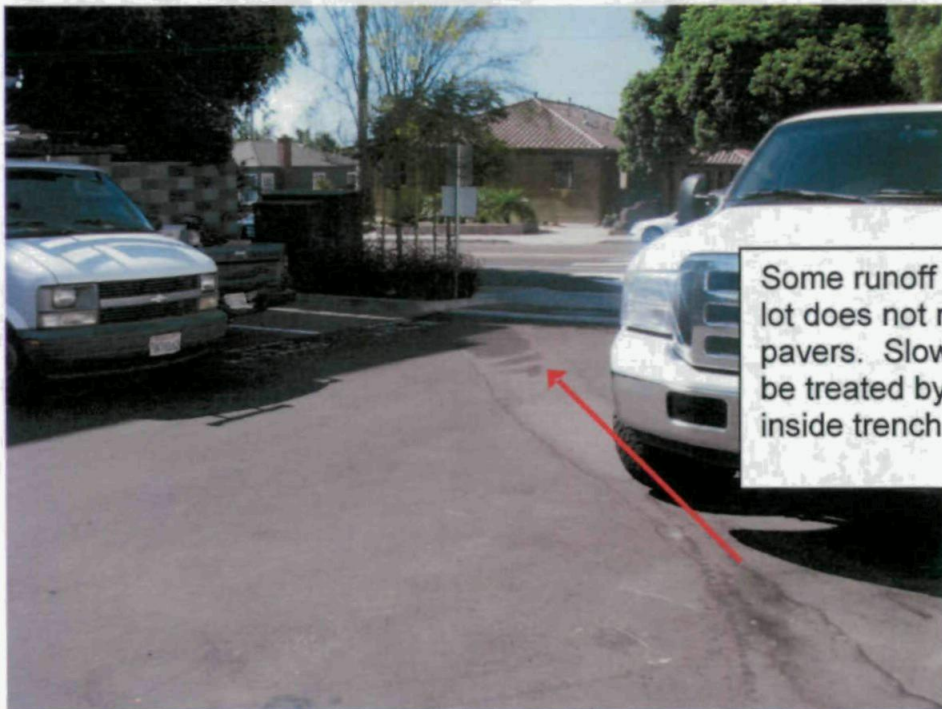
The south side of the parking lot has a 3.9 percent grade towards the street. Figure 12 shows water stains from the high point of the parking lot flowing towards the street.

Some runoff from parking lot does not reach pervious pavers. Slower flows may be treated by filter insert inside trench drain.

Figure 12. Water stain on impervious asphalt

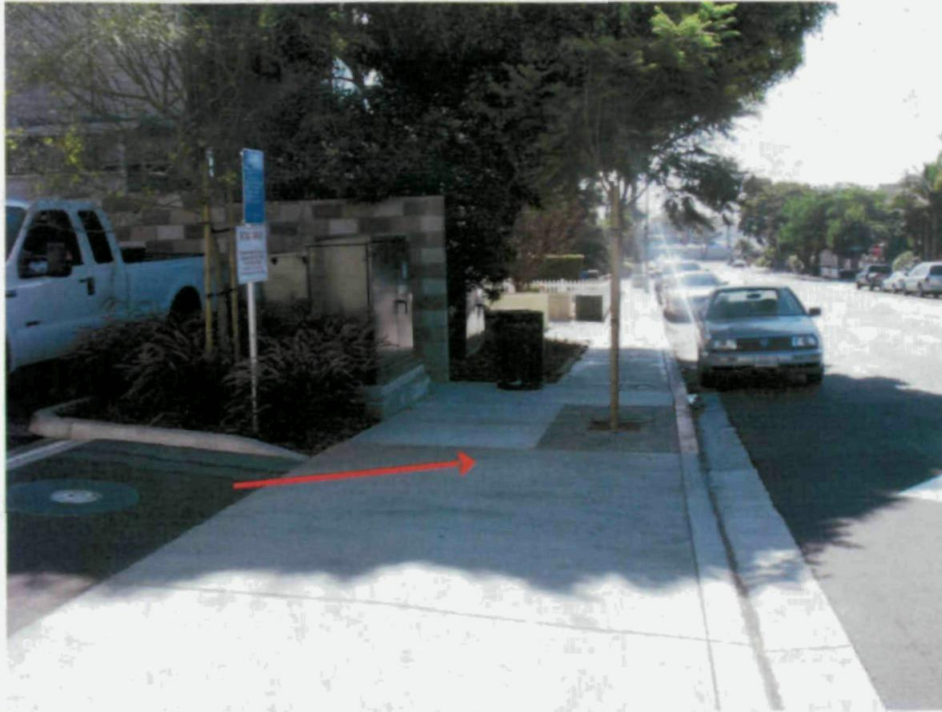
Figure 13. Driveway to Rosecrans Commercial Center

Overflow from parking lot may reach the pervious pavers in tree wells

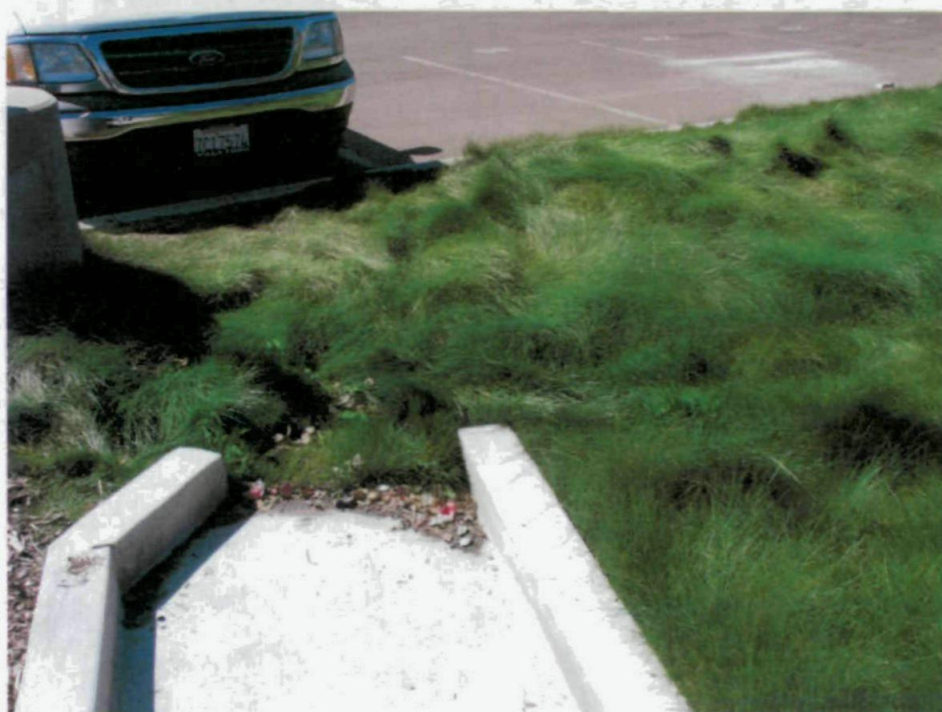
Figure 16. Grass swale inlet

Overgrown grass may inhibit flow of storm water into swale

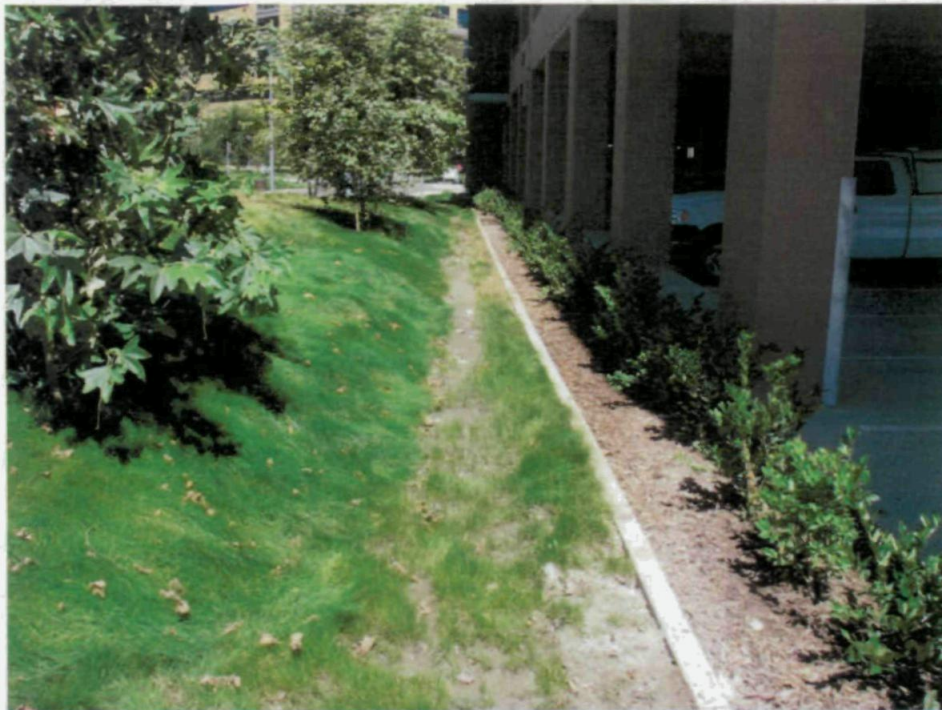
Figure 19. Grass swale adjacent to parking lot

Note bottom of swale has eroded

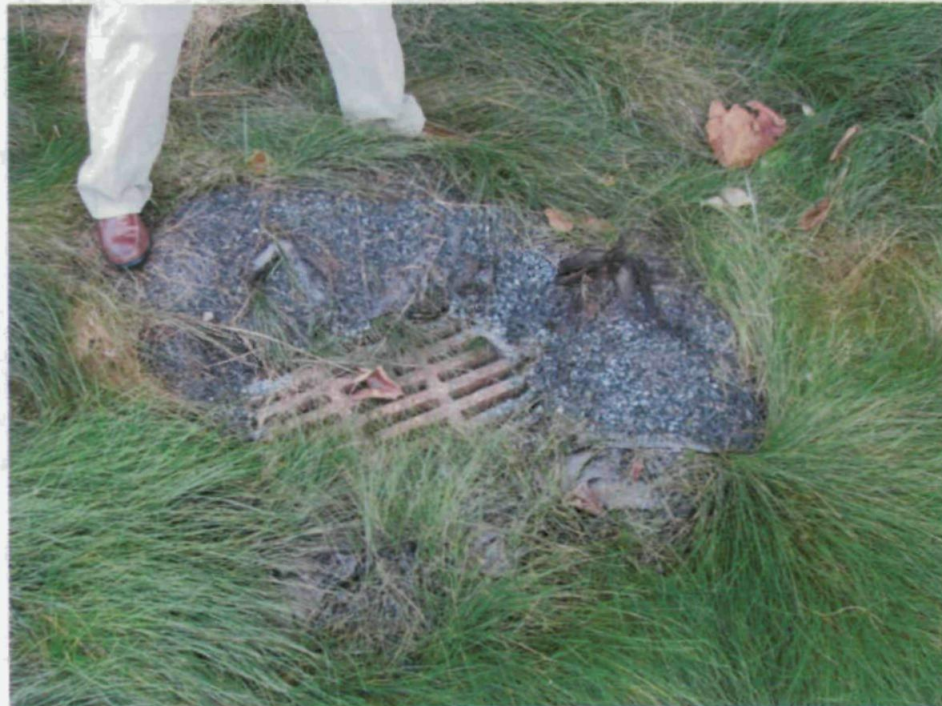
Figure 20. Grass swale outlet

Gravel bags leftover from construction activities have degraded

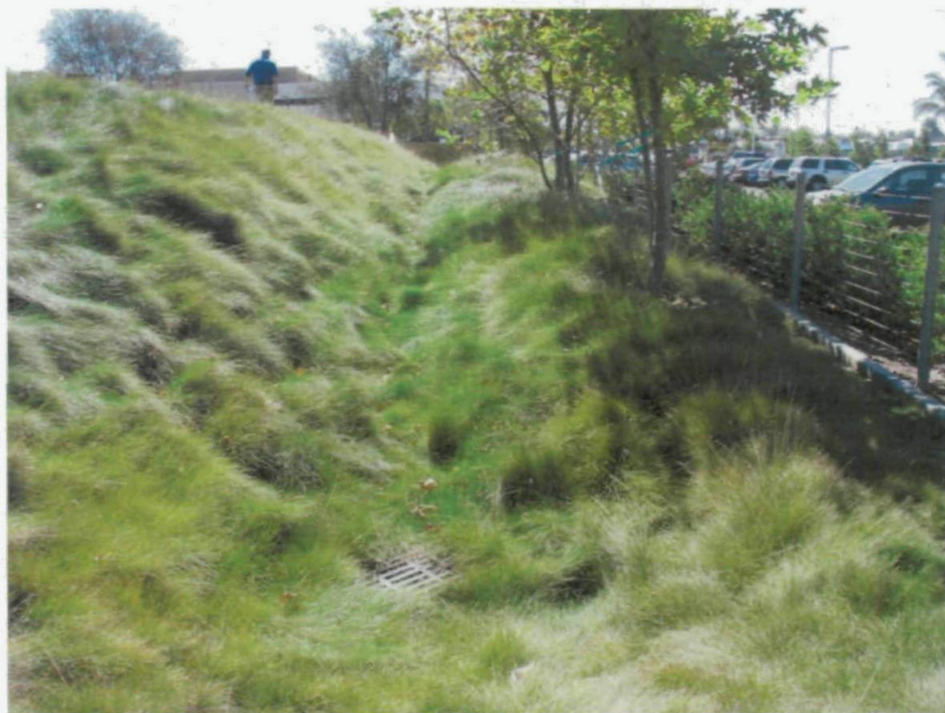
Figure 21. Grass swale on west side

Storm water carrying pollutants from parking lot is not able to enter swale

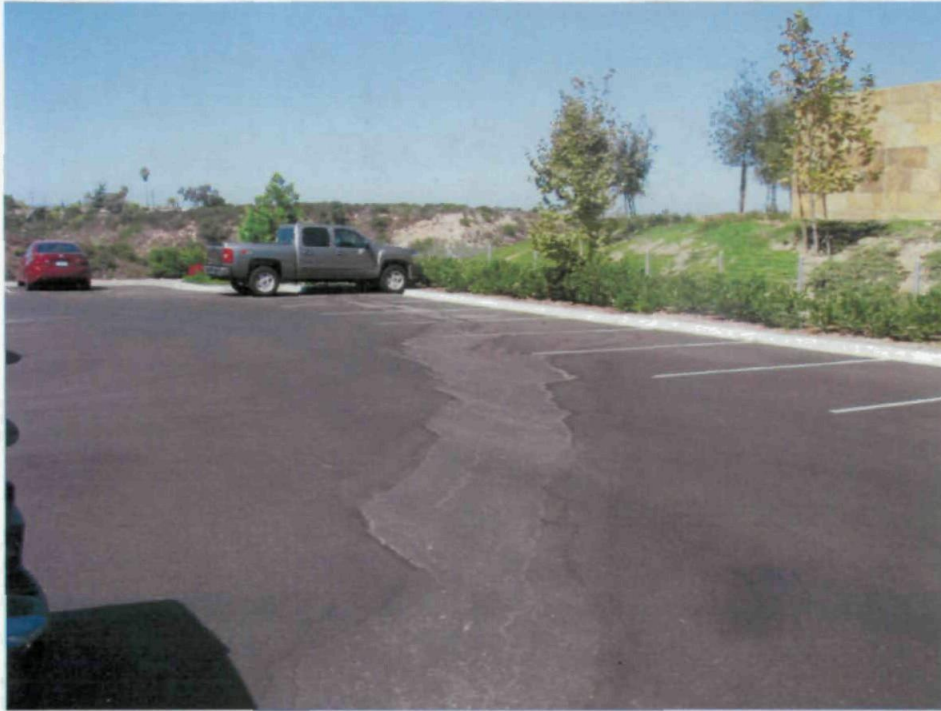
Figure 23 shows water stains across the parking lot. Runoff from this area eventually reaches a curb and enters a storm drain. Figure 24 shows a storm drain that receives runoff from the North side of the property. Runoff shown in Figures 23 and 24 enter a pipe network that is directed to a CDS unit on the SE corner of the site before being discharged from the site (this needed to be verified from the earlier site inspection in April, 2010). Note: no runoff from this lower parking lot is directed to any sort of vegetated/pervious area, even though opportunities for such treatment exist among landscaped medians within the parking lot and landscaping along the perimeter of the property (Figures 23-25).

Storm water is directed to CDS unit without passing through pervious area first

Figure 23. Water stain on asphalt approaches SW corner of lot

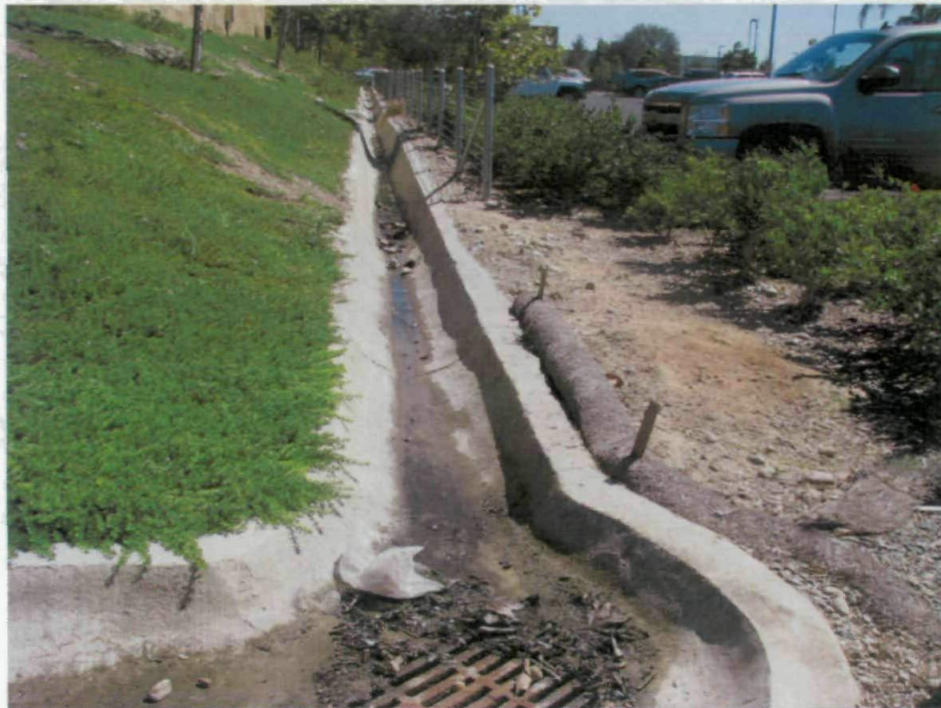
Channel requires maintenance before start of rainy season

Figure 24. Storm drain system with irrigation runoff
