California Regional Water Quality Control Board, San Diego Region

Subject: Compliance Inspection, Bradley Park Landfill, San Marcos, California

Landfill Inspection Report

**Bradley Park Landfill
June 26, 2012 Inspection Pictures**

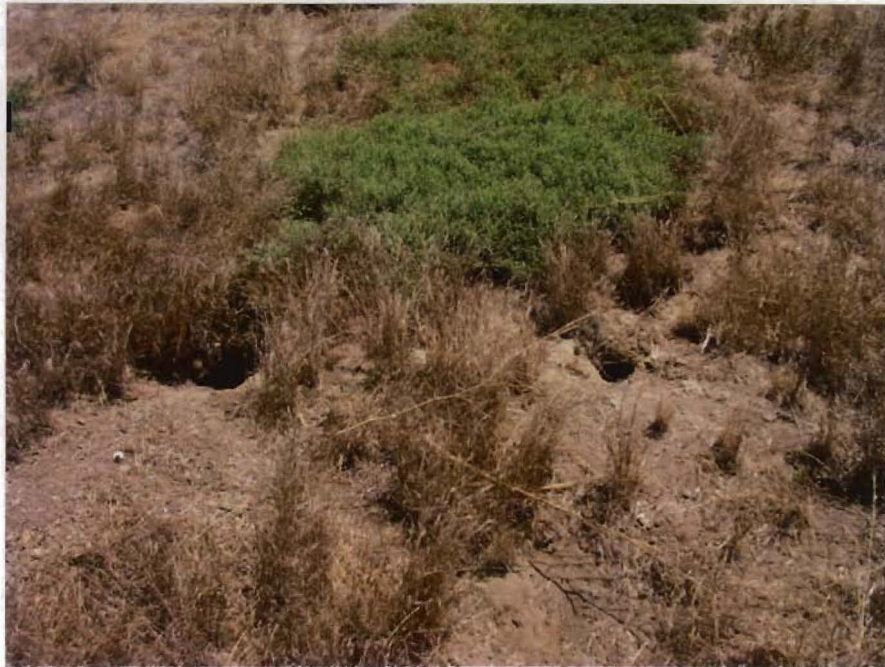
Rodent holes and mounds in the cover in the southeastern quadrant of the Landfill near Pacific Street.

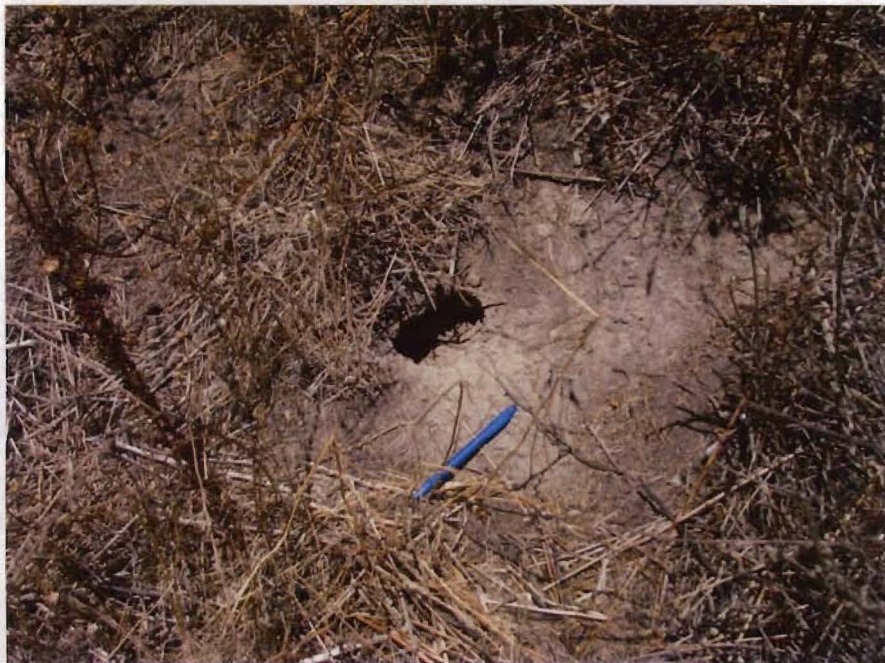
Rodent holes and mounds in the cover in the southeastern quadrant of the Landfill near Pacific Street.

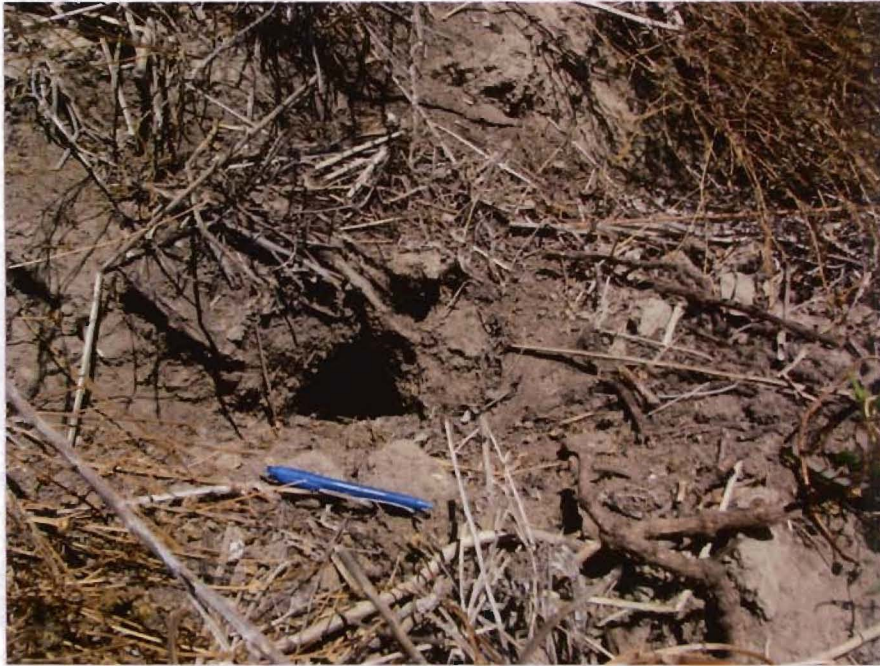
Rodent holes and mounds in the cover in the southeastern quadrant of the Landfill near Pacific Street.

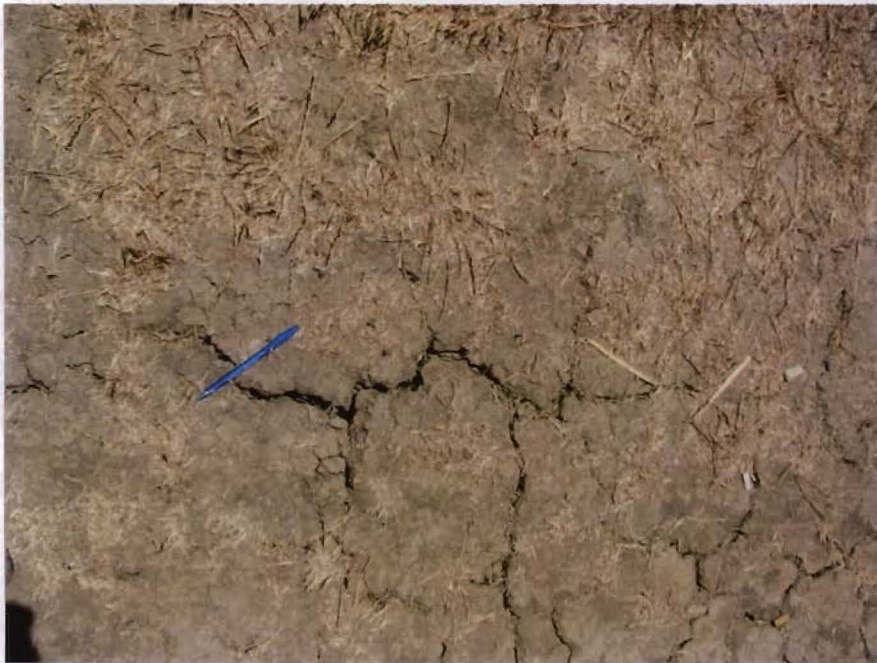
Cracks in the perimeter road in the southeastern quadrant of the Landfill.

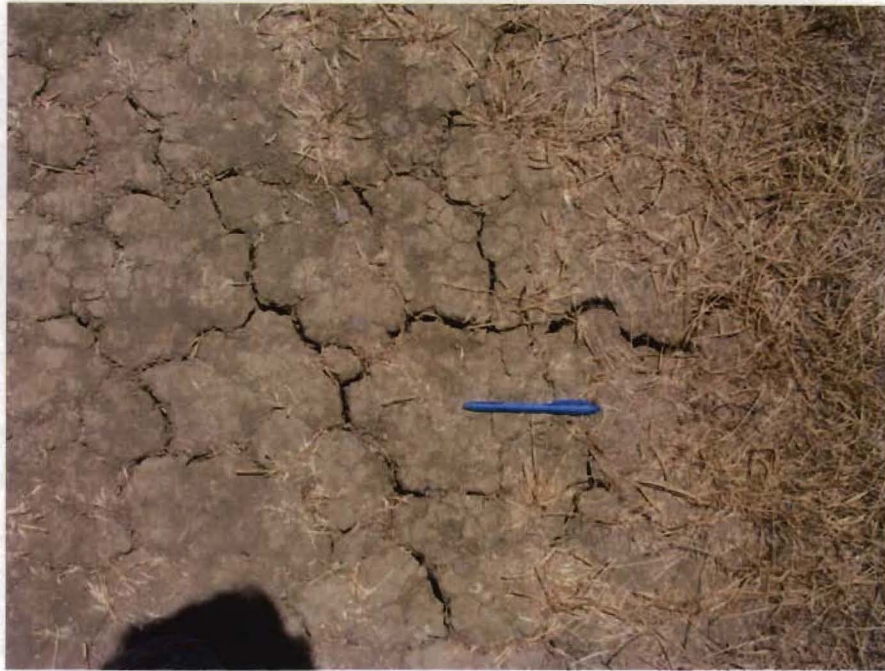
Cracks in perimeter road in the southeastern quadrant of the Landfill.

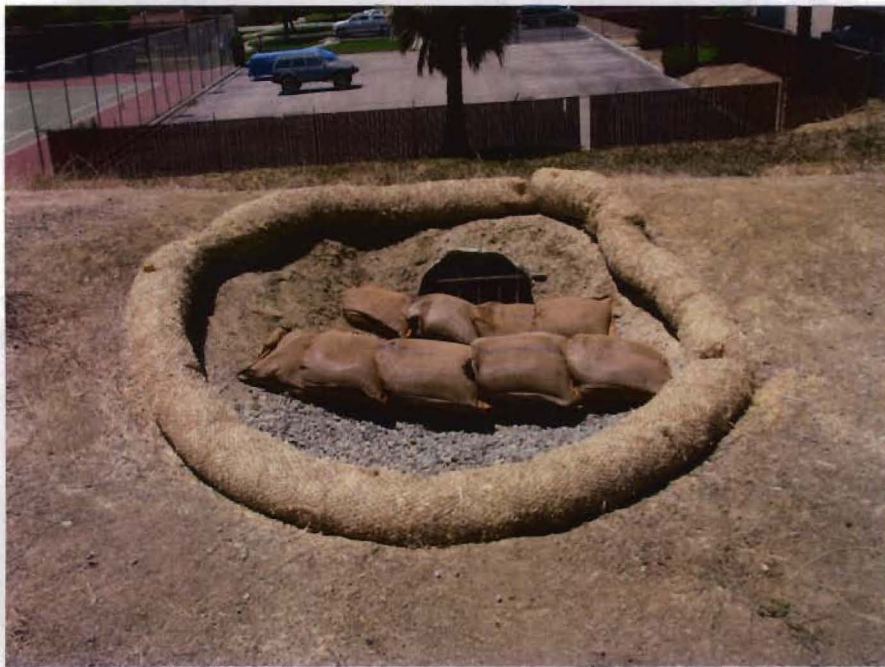
Stormwater BMPs located in the western portion of the Landfill.

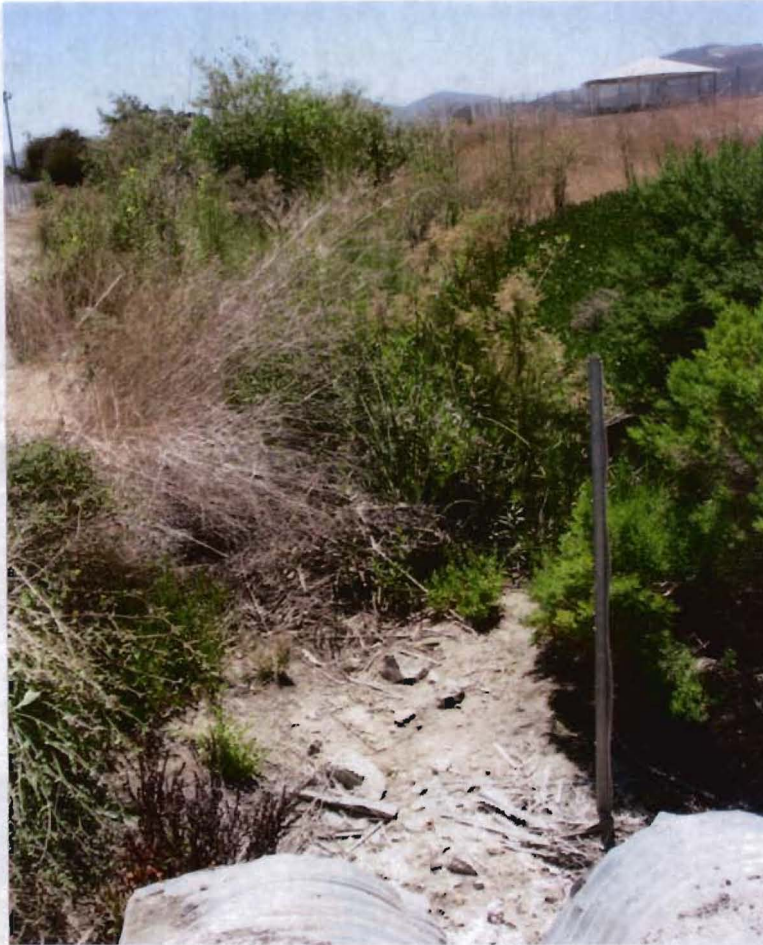
Stormwater channel between the burn ash and municipal solid waste portions of the Landfill.

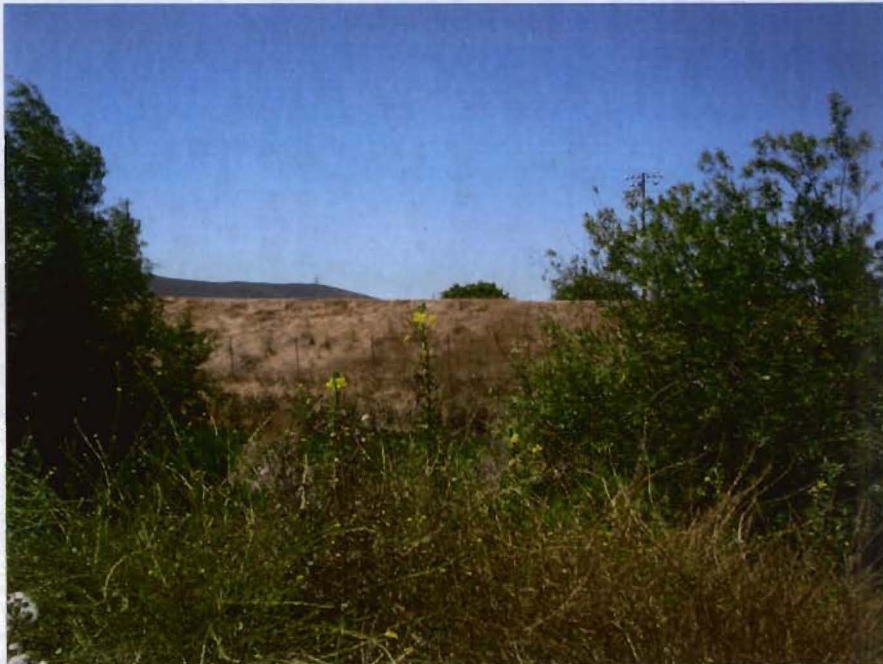
Dense vegetation in the stormwater channel between the burn ash and municipal solid waste portions of the Landfill.
