California Regional Water Quality Control Board, San Diego Region

Subject: SAN DIEGO WATER BOARD INSPECTION OF OTAY LANDFILL

Landfill Inspection Report

Name of Facility: Otay Landfill **Date:** March 12, 2013
Owner: Otay Landfill, Inc. **WDR No.:** 90-09
Operator: Otay Landfill Inc. **Inspection Type:** B
Facility Address: 1700 Maxwell Road, Chula Vis **Mgr./Sup. Of Site:** Paul Lozano
RB Inspector: Carol Tamaki

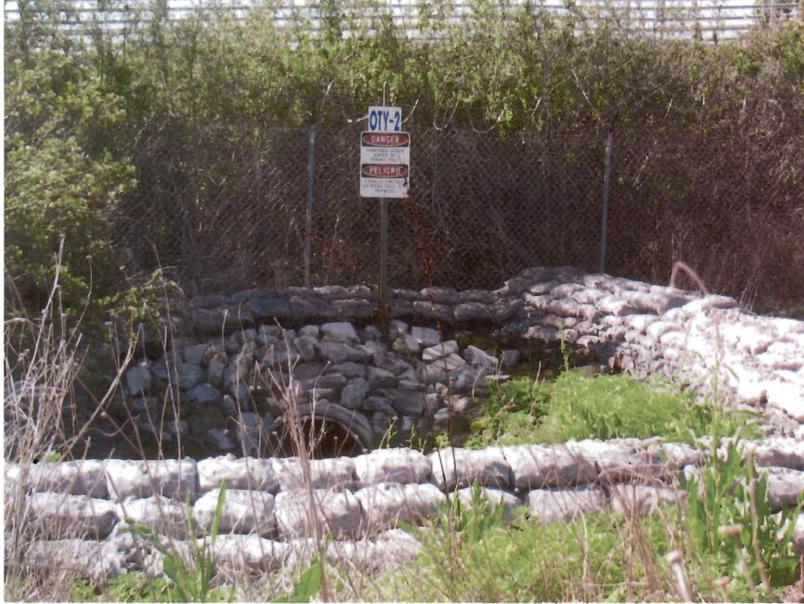
Area of concern: Gravel bags need to be replaced by OTY-2.

Gravel bags need to be replaced at stormwater sampling point OTY-2.
