California Regional Water Quality Control Board, San Diego Region

NOTICE OF VIOLATION
No. R9-2014-0149

La Jolla Del Rey Phase 2 Construction Project
PIN No. SM-827215:wchiu

FACILITY INSPECTION REPORT

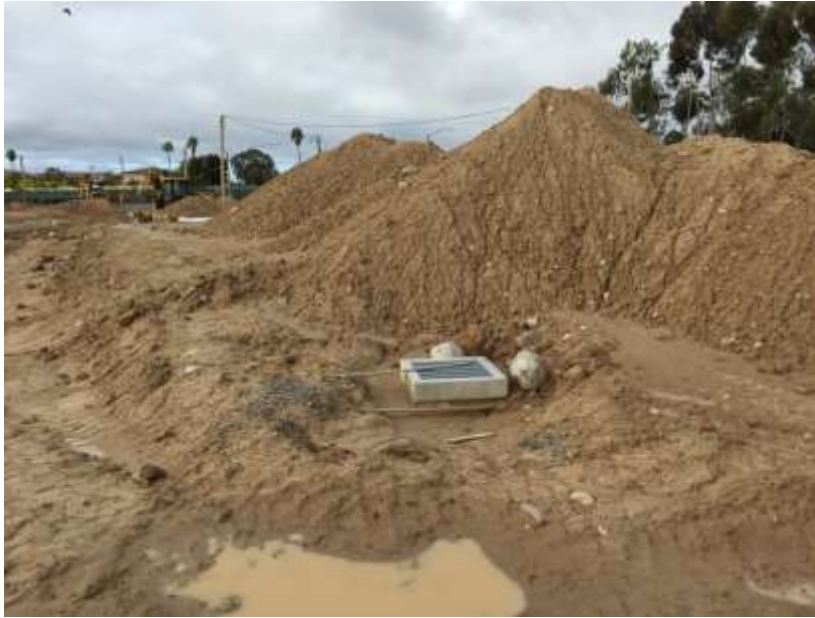
- a. **Pursuant to Provision IX and Section B.1.a of Attachment C of State Water Board Order No. 2009-0009-DWQ:** Risk Level 1 dischargers are required to cover and berm loose stockpiled construction materials that are not actively being used (i.e. soil, spoils, aggregate, fly-ash, stucco, hydrated lime, etc.).
- b. **Pursuant to Provision IX and Section B.2.f of Attachment C of State Water Board Order No. 2009-0009-DWQ:** Risk Level 1 dischargers are required to contain and securely protect stockpiled waste material from wind and rain at all times unless actively being used.
- c. **Observation:** During the December 4, 2014 inspection, the San Diego Water Board inspector observed soil stockpiles without adequate cover, berm, containment or

protection, resulting in erosion and sediment transport. See attached December 4, 2014 Facility Inspection Report Photo 1.

2. Construction waste stockpile observed without adequate cover or containment (See Photo 1). Evidence of erosion and sediment transport from the stockpile observed during the inspection. All construction sites are required to contain and securely protect stockpiled waste material from wind and rain at all times unless actively being used.

Photo 1 shows soil stockpile without adequate cover or containment next to a storm drain inlet. Evidence of erosion and sediment transport along that base of the stockpile.

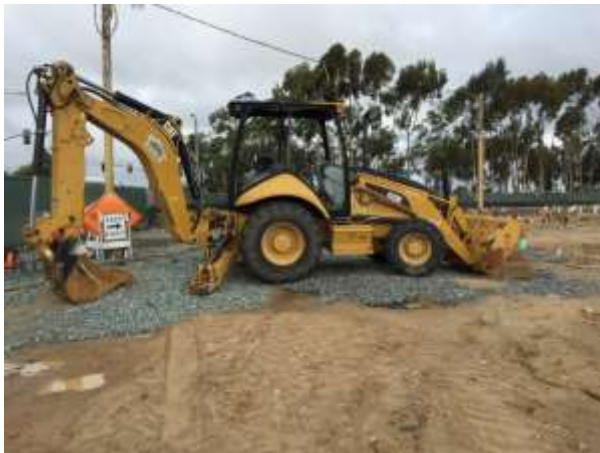
Photo 2

- a. **Pursuant to Provision IX and Section B.3.a of Attachment C of State Water Board Order No. 2009-0009-DWQ:** Risk Level 1 dischargers are required to prevent oil, grease, or fuel to leak in to the ground, storm drains or surface waters.
- b. **Pursuant to Provision IX and Section B.3.b of Attachment C of State Water Board Order No. 2009-0009-DWQ:** Risk Level 1 dischargers are required to place all equipment or vehicles, which are to be fueled, maintained and stored in a designated area fitted with appropriate BMPs.
- c. **Observation:** During the December 4, 2014 inspection, the San Diego Water Board inspector several construction vehicles stored without appropriate BMPs to prevent oil, grease or fuel to leak in to the ground, storm drains or surface waters. See attached December 4, 2014 Facility Inspection Report Photos 2 and 3.

3. Construction equipment and vehicles observed without appropriate BMPs (e.g. drip pans) to prevent oil, grease, or fuel to leak in to the ground, storm drains, or surface waters (See Photos 2 and 3). All construction sites are required to prevent oil, grease or fuel to leak in to the ground, storm drains, or surface waters, and to place all equipment and vehicles, which are to be fueled, maintained and stored in a designated area fitted with appropriate BMPs.

Photos 2 and 3 show construction equipment and vehicles without appropriate BMPs (e.g. drip pans) to prevent oil, grease, or fuel to leak in to the ground, storm drains, or surface waters.

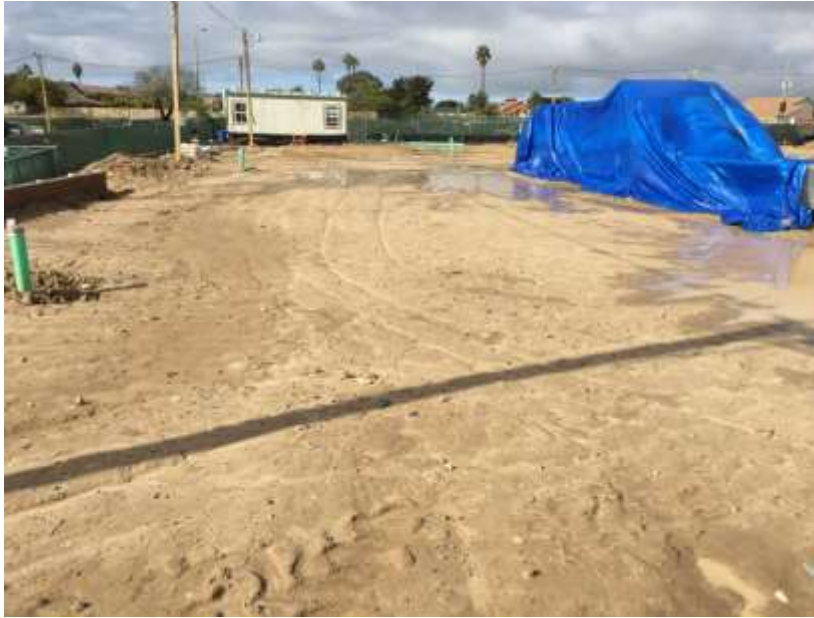
- a. **Pursuant to Provision IX and Section D.2 of Attachment C of State Water Board Order No. 2009-0009-DWQ:** Risk Level 1 dischargers shall provide effective soil cover for inactive areas and all finished slopes, open space, utility backfill, and completed lots.
- b. **Observation:** During the December 4, 2014 inspection, the San Diego Water Board inspector observed several areas of the site that appeared to be inactive, or could be scheduled to be inactive, without effective soil cover or other BMPs that could prevent erosion. In particular, two completed building pads and a slope adjacent to the pads lacked any effective soil cover for erosion control. Evidence of erosion and sediment transport due to lack or erosion control measures were observed throughout the site during the inspection. See attached December 4, 2014 Facility Inspection Report Photos 4 through 9.

4. Several areas were observed to be inactive, or could be scheduled to be inactive, without effective soil cover to control potential erosion. In particular, two completed building pads and a slope (See Photos 4 and 5), which had not been disturbed for at least a month according to Mr. Underwood, lacked any effective soil cover for erosion control. The lack of erosion controls in these areas contributed to unauthorized sediment discharges from the site (See Photos 5 and 6). All construction sites are required to provide effective soil cover for inactive areas (i.e. areas that have been disturbed and not scheduled to be re-disturbed for at least 14 days) and all finished slopes, open space, utility backfill, and completed lots.

6. Lack of effective runoff controls observed within and around the site which contributed to sediment discharges from the site (See Photos 4 and 9). All construction sites are required to effectively manage run-on, all runoff within the site and all runoff that discharges off the site.

Photo 4 shows completed building pads without any erosion controls or runoff controls and evidence of erosion and sediment transport. .

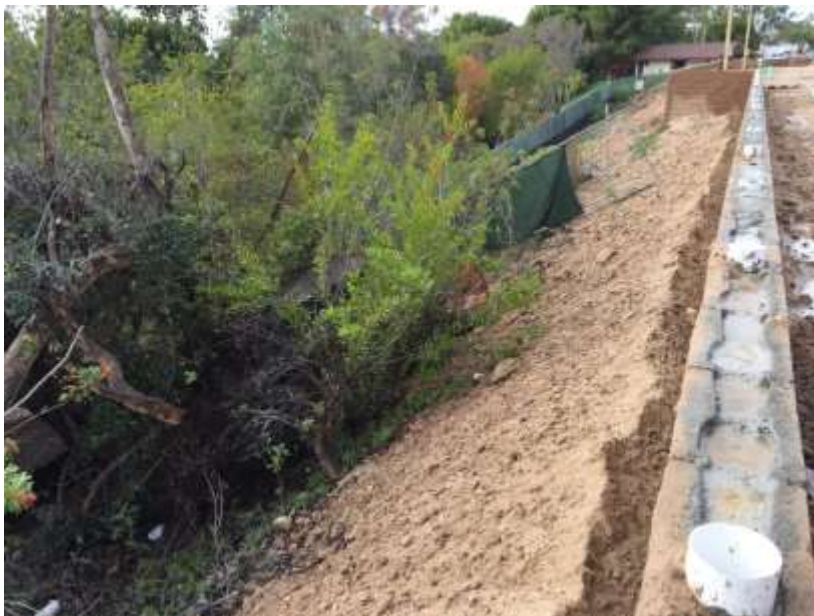
Photo 5 shows slope adjacent to completed building pad without any erosion controls.

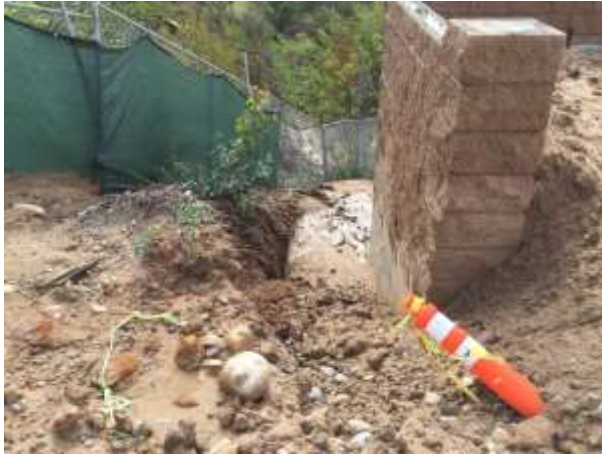
- a. **Pursuant to Provision IX and Section E.1 of Attachment C of State Water Board Order No. 2009-0009-DWQ:** Risk Level 1 dischargers shall establish and maintain effective perimeter controls and stabilize all construction entrances and exits to sufficiently control erosion and sediment discharges from the site.
- b. **Observation:** During the December 4, 2014 inspection, the San Diego Water Board inspector observed several areas of the site where perimeter controls were not established or maintained to sufficiently control erosion and sediment discharges

from the site. See attached December 4, 2014 Facility Inspection Report Photos 6 and 9.

5. Lack of effective perimeter sediment controls observed in several locations of the site which resulted in unauthorized sediment discharges from the site (See Photos 6 through 9). All construction sites are required to establish and maintain effective perimeter controls and stabilize all construction entrances and exits to sufficiently control erosion and sediment discharges from the site.

Photos 6 through 9 show inadequate implementation of perimeter sediment controls to prevent discharges of sediment from the site. Photo 6 shows evidence of erosion and sediment transport from completed building pads that contributed to an offsite discharge of sediment, with accumulation of sediment in a v-ditch outside of the site boundaries due to lack of perimeter controls at the base of the slope. Photos 7 and 8 shows evidence of erosion and sediment transport from the site that contributed to an offsite discharge of sediment and sediment-laden storm water due to inadequately installed perimeter controls. Photo 9 shows evidence of sediment transport through the site with lack of runoff controls and perimeter controls along the chain-link fence to prevent sediment discharges from the site.

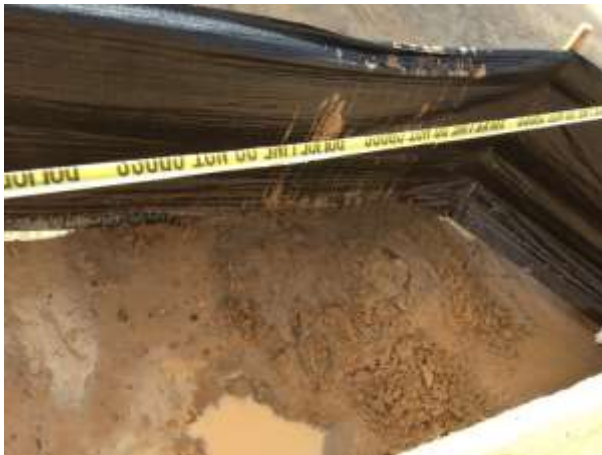
Photo 8

Legally Responsible Person (LRP) enrolled under the Construction General Permit (CGP) for the site. On December 4, 2014, the San Diego Water Board inspector observed evidence of sediment discharged from the site due to inadequate and ineffective implementation of best management practices (BMPs), constituting an unauthorized discharge of sediment from the site. See attached December 4, 2014 Facility Inspection Report Photos 8, 10, and 11.
