## California Regional Water Quality Control Board, San Diego Region

**Subject: Inspection Report for Miramar Greenery at West Miramar Landfill**

## Miramar Greenery at West Miramar Landfill

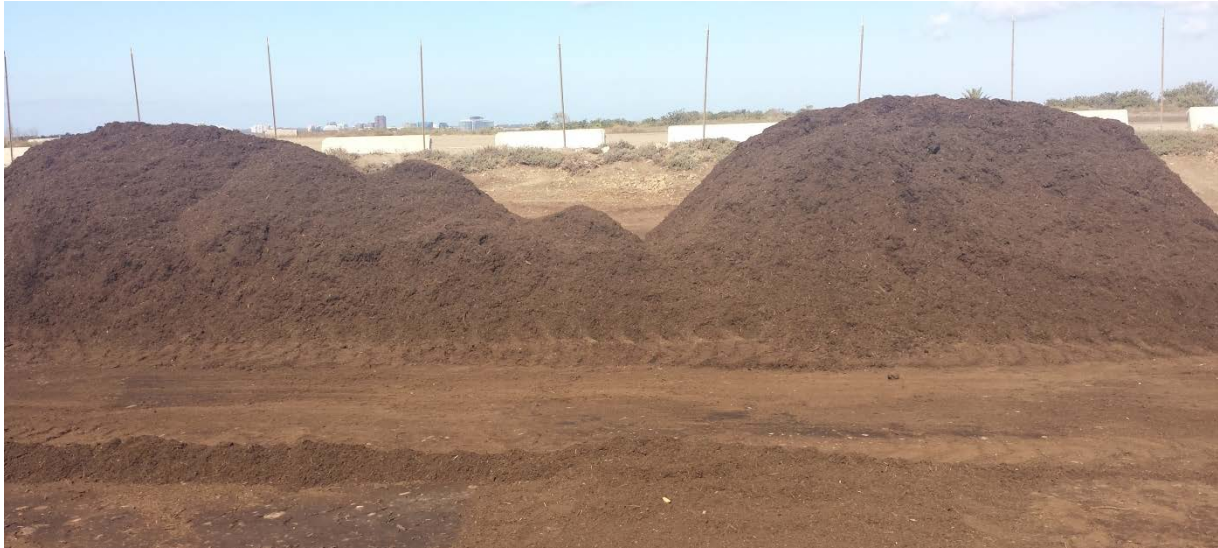
Figure 1: Photo of mulch pile, located in green waste area.

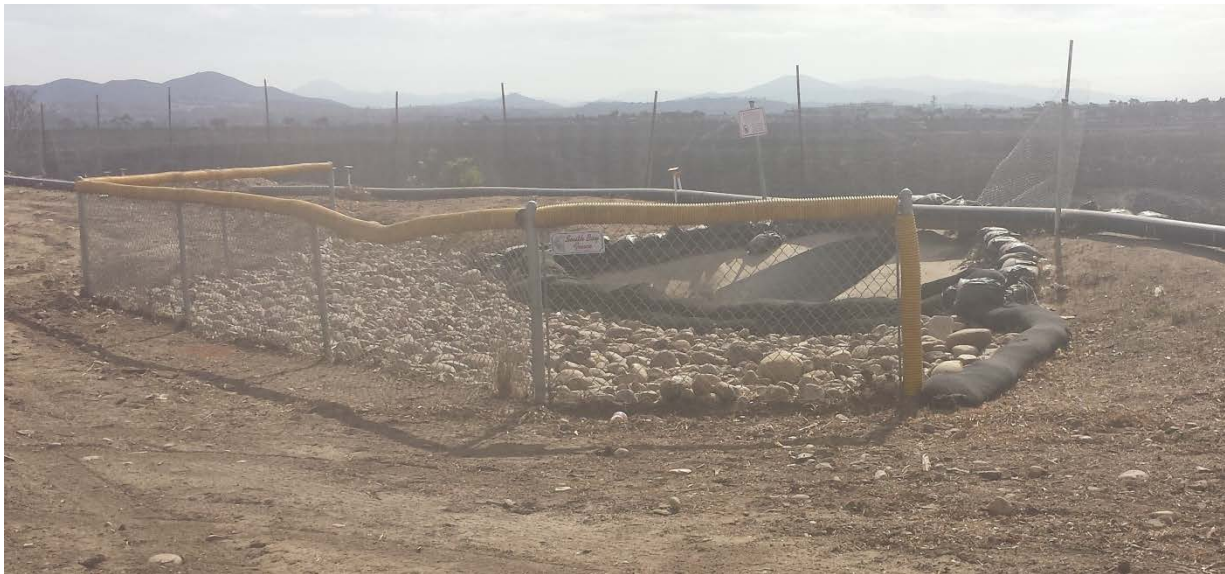
Figure 2: Photo of perimeter drain.

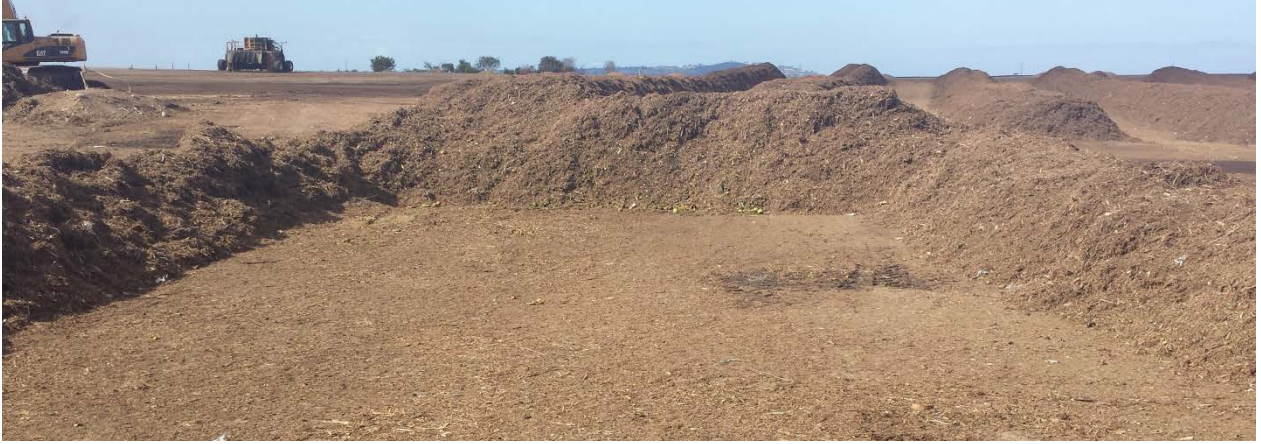
**Figure 3: Photo of "horseshoe" for containing food waste drop-offs.**

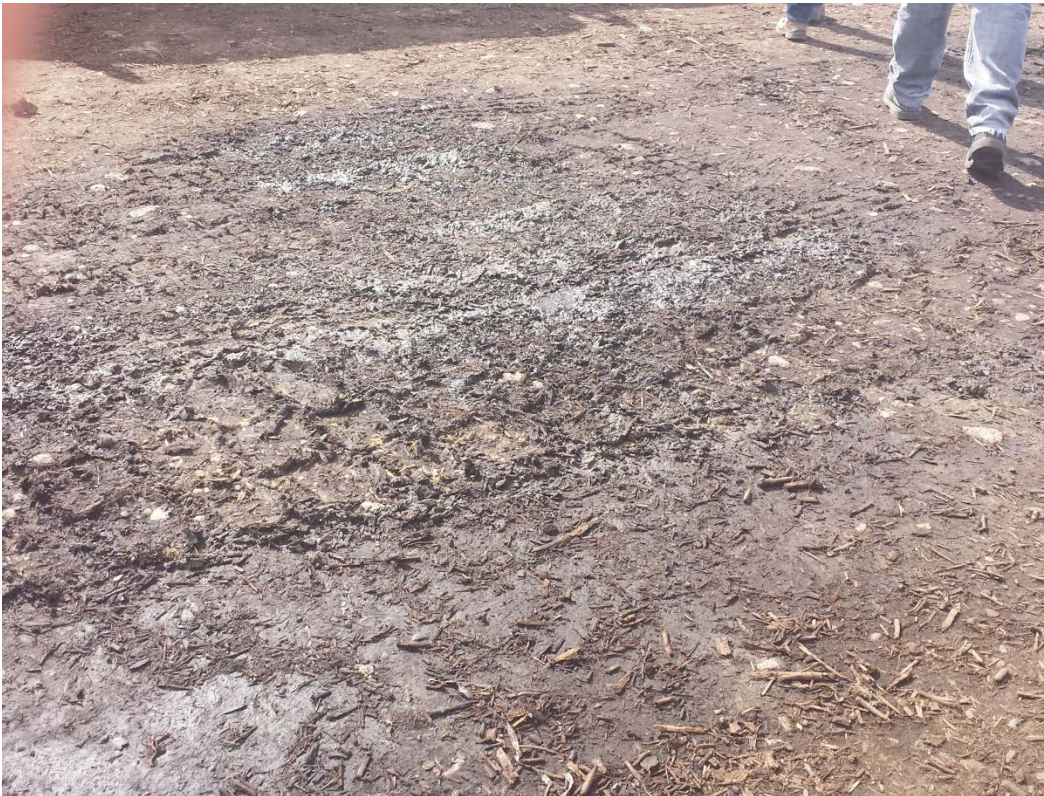
1. Overwatering for dust control was observed (Figure 4).

**Figure 4: Photo of overwatering from dust control truck.**

**Additional Comments, description of violations or areas of concern: 1. Signs of overwatering for dust control. 2. Use of recycled water for dust control and composting operation.**

The items listed above constitute either a violation of Waste Discharge Requirements, another Order issued by the San Diego Water Board, or areas of concern and potential violations for this Site. Please take steps to correct these violations as soon as possible.
