California Regional Water Quality Control Board, San Diego Region

**Subject: Inspection of Viejas Sanitary Landfill
Order No. 95-024**

Facility Name: Viejas Sanitary Landfill
 Facility Address: 7850 Campbell Ranch Road, Alpine, CA
 91901
 Owner: San Diego Cnty Dept of Public Works
 Operator: San Diego Cnty Dept of Public Works
 Site Supervisor/Contact: Jason Forga

Inspection Date: 11-19-2014
 Inspection Type: Type B Compliance
 RB Inspector: Alex Cali/Leah Canada
 RB Order No.: 95-24

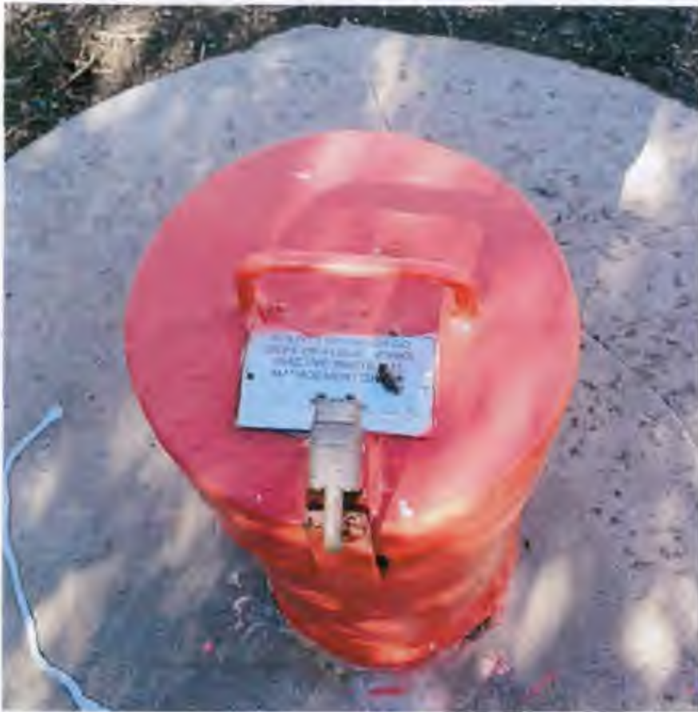
1. The groundwater monitoring wells were observed to be in good condition, capped, and locked (Figure 1).
2. The drainage channels were observed to be clear with the exception of minor sediment in the eastern perimeter drainage channel (Figures 9 and 10).
3. Rodent holes were evident at the Facility; however rodent measures were at the Facility to mitigate the issue (Figures 6 and 7).
4. The slopes at the Facility were observed to be mowed recently (Figure 8).
5. The northern drainage chute was observed to be cleared (Figure 4).
6. BMPs near the drainage channel were observed to be in good condition and properly installed (Figures 2 and 3).

Figure 1- Groundwater Monitoring Well VIGW-3

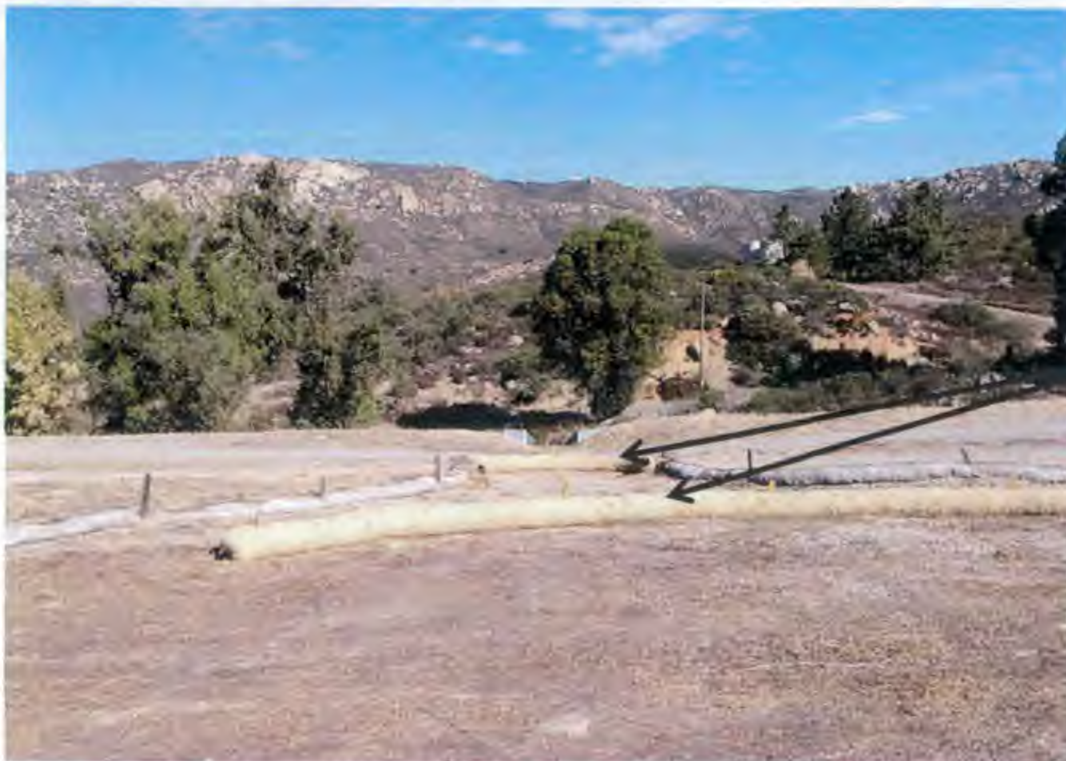
New straw wattles installed in preparations for the rainy season.

Figure 2- BMPs Implemented in front of Drainage Chute Facing North

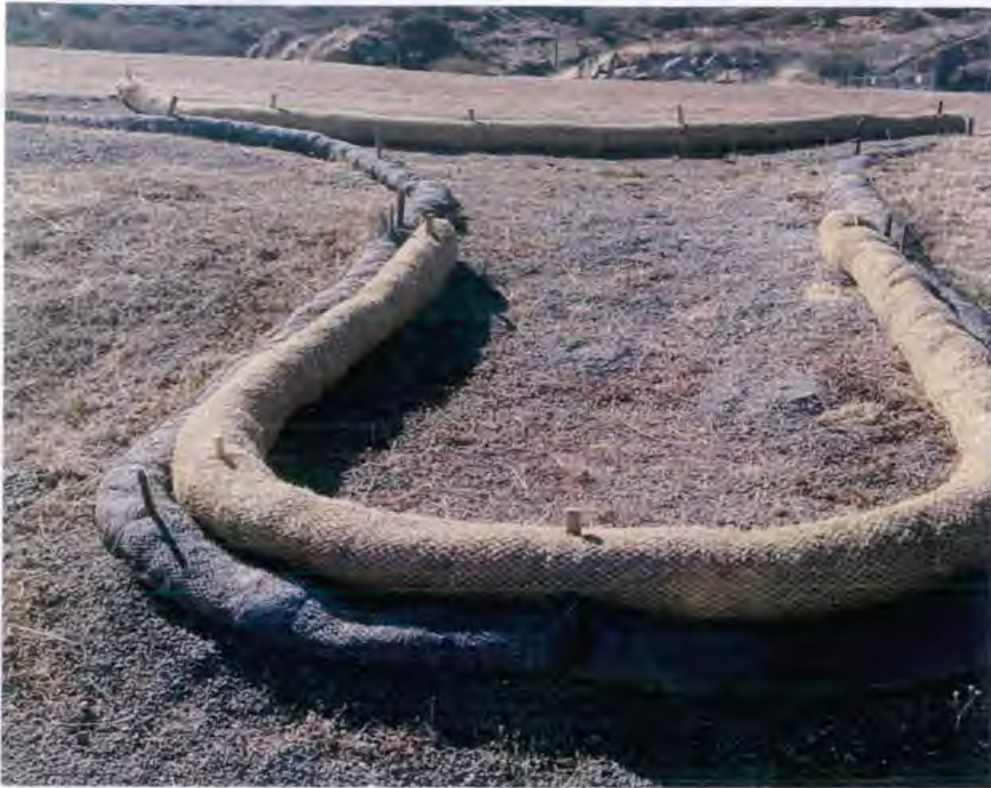
Figure 3- BMPs Installed near Drainage Chute Facing South

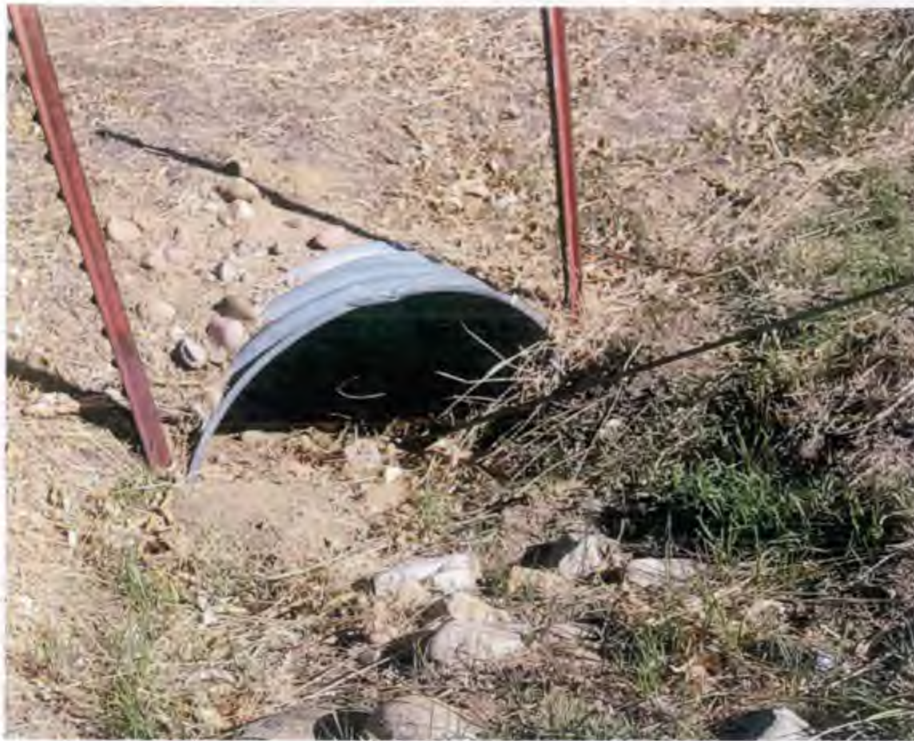
1. The northern perimeter drain inlet needs to be cleared of accumulated sediment and debris (Figure 5). The current condition could create ponding by hindering the flow of run-off to the intended perimeter drain. Provide photographs documenting that this maintenance has taken place.

Drainage inlet needs to be cleared.

Figure 5-Perimeter Drainage Outlet

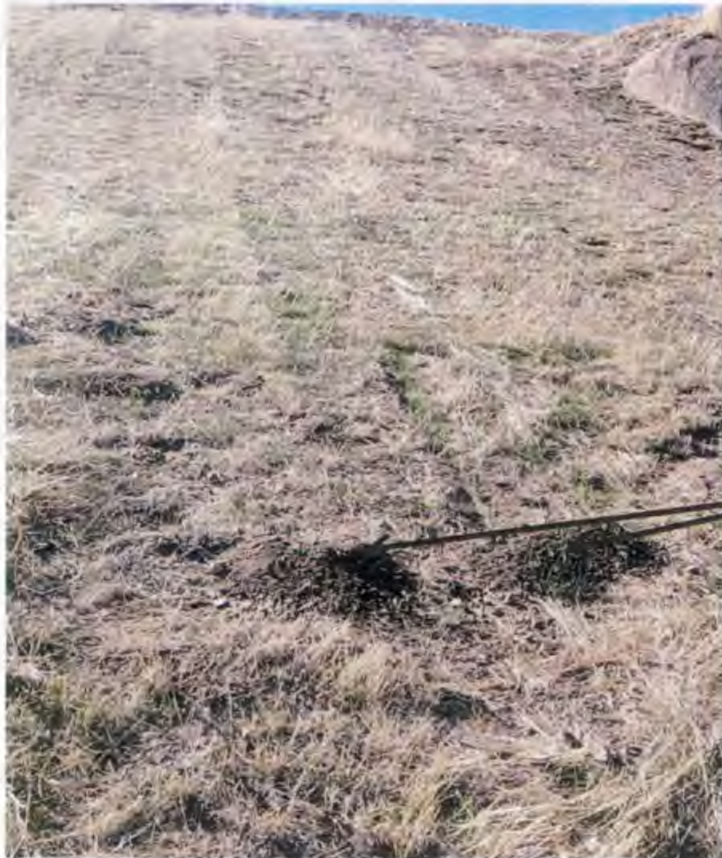
Rodent holes evident.

Figure 6- Northern Face of Landfill

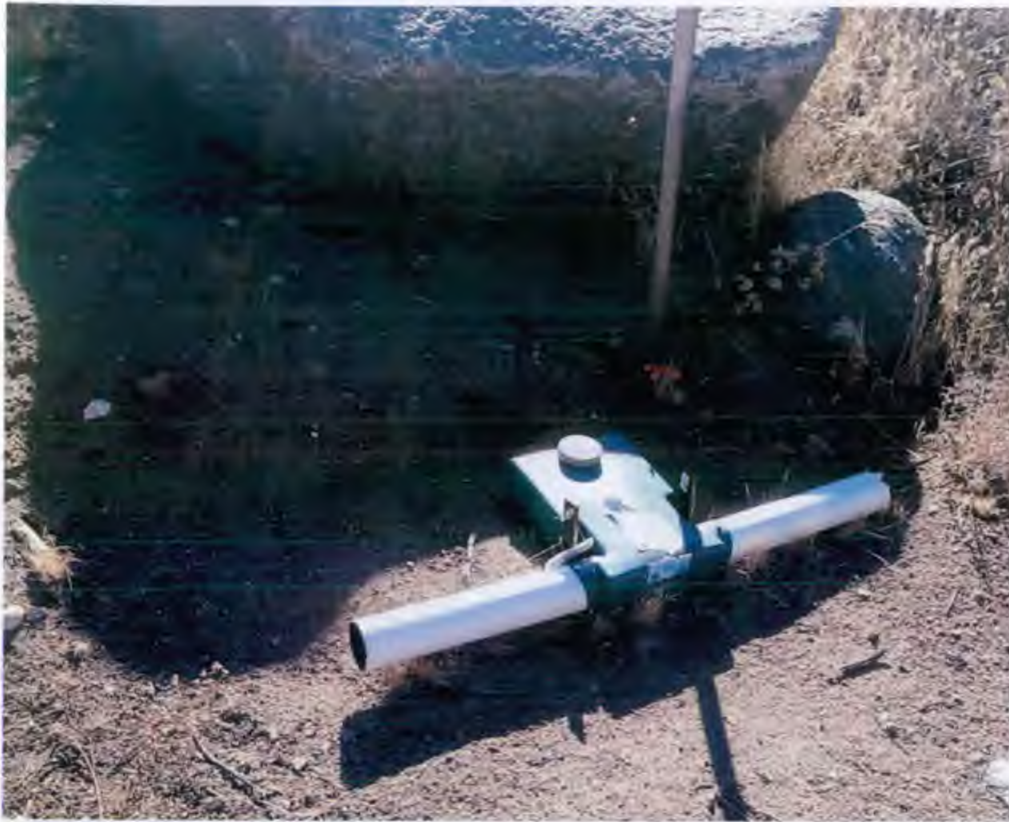
Figure 7- Rodent Control Measures

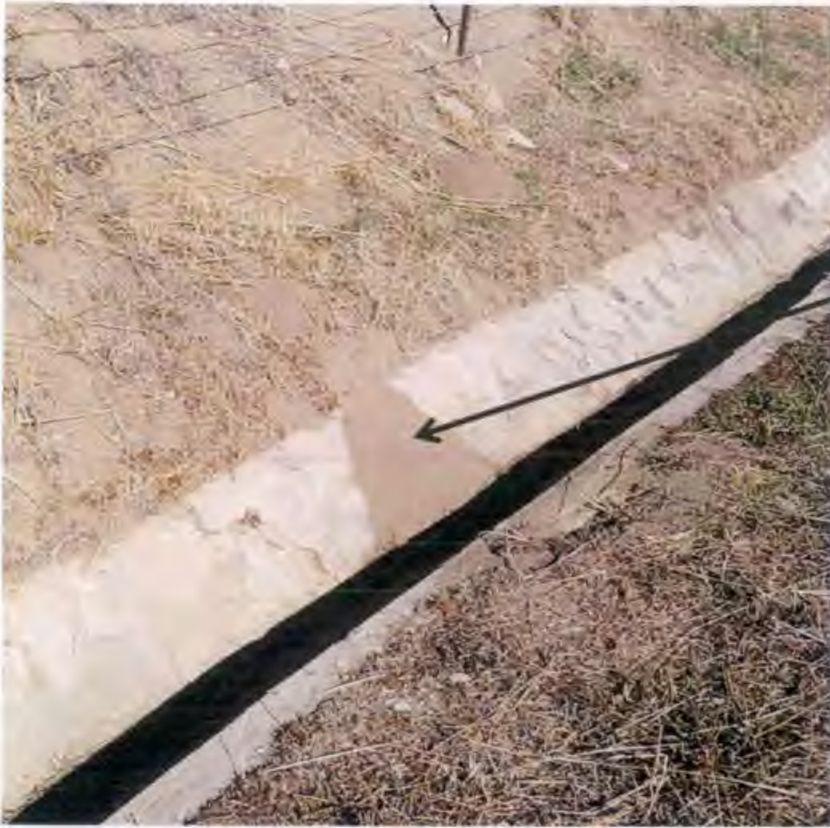
Minor sediment observed
in drainage channel.

Figure 9- Easter Drainage Channel

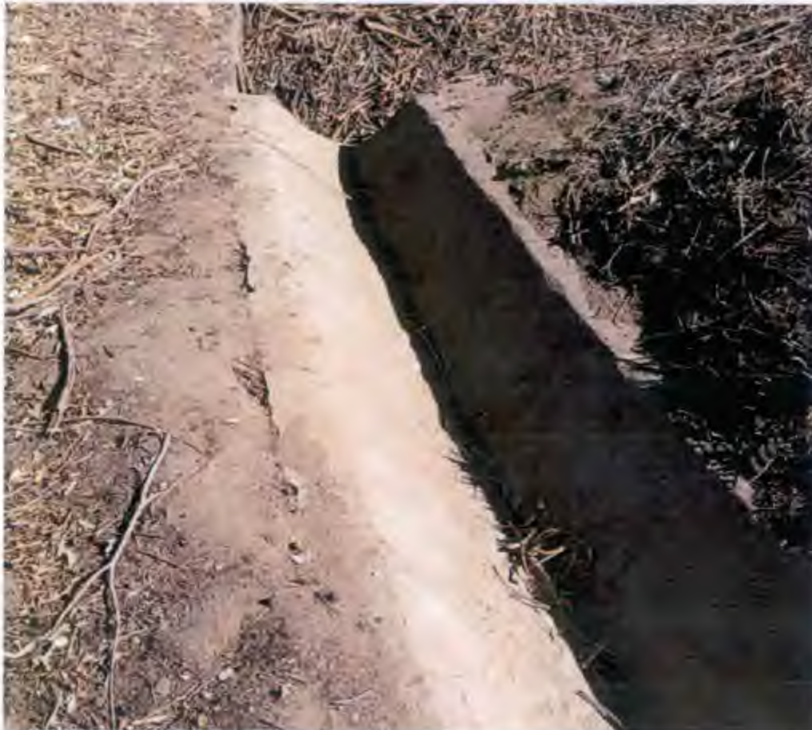
Figure 10- End of Eastern Perimeter Drainage Channel
