**Subject: Notice of Violation No. R9-2015-0032, Laurel Pointe Construction Project, Order No. 2009-0009-DWQ, NPDES Permit No. CAS000002, Construction General Permit**

NOTICE OF VIOLATION
No. R9-2015-0032

**FACILITY INSPECTION REPORT**

**FACILITY:** Laurel Pointe

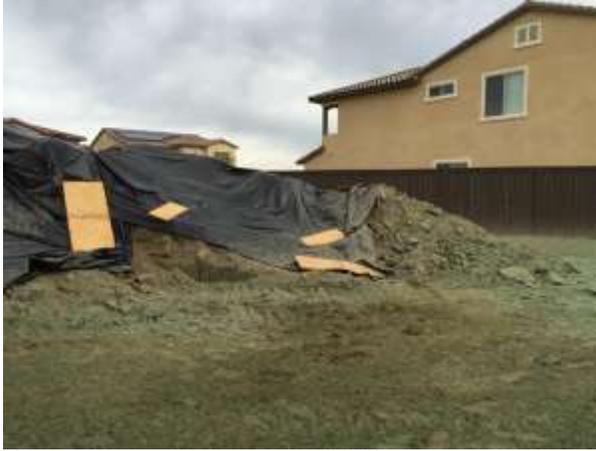
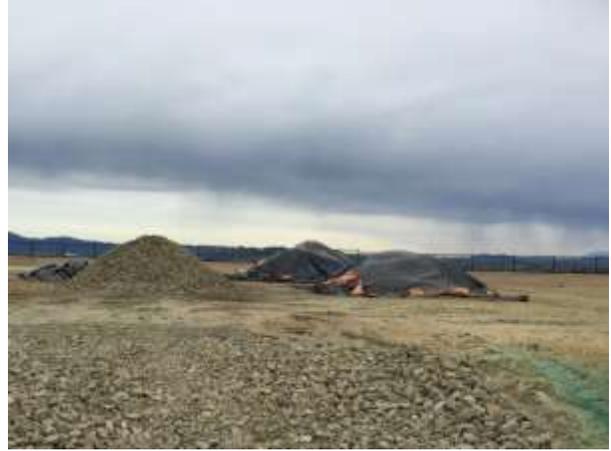
- b. **Pursuant to Provision X and Section B.2.f of Attachment D of State Water Board Order No. 2009-0009-DWQ:** Risk Level 2 dischargers are required to contain and securely protect stockpiled waste material from wind and rain at all times unless actively being used.
- c. **Observation:** During the January 29, 2015 inspection, the San Diego Water Board inspector observed soil stockpiles throughout the site without adequate berm or containment. See attached January 29, 2015 Facility Inspection Report Photos 1 and 2.

1. Stockpiles throughout the site observed without adequate containment (See Photos 1 and 2). All construction sites are required to contain and securely protect stockpiled waste material from wind and rain at all times unless actively being used.

1. There is evidence that good site management "housekeeping" BMPs for stockpiles were not being adequately implemented (See Finding 1). The City's December 31, 2014 Notice of Violation and Stop Work Order also describes inadequate stockpile management, which is at least 30 days of non-compliance.

**Photos 1 and 2** show examples of soil stockpiles observed through the site without adequate containment. Most stockpiles observed during inspection were covered with plastic, but did not have containment.

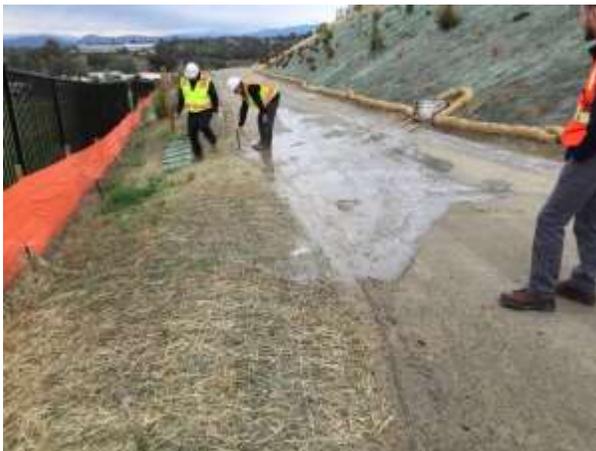
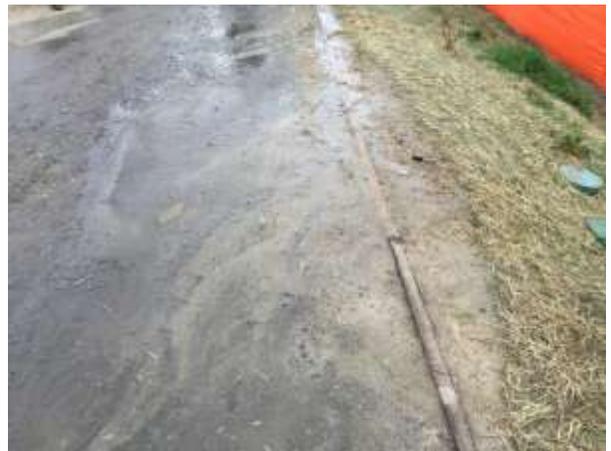
- a. **Pursuant to Provision X and Section C.1 of Attachment D of State Water Board Order No. 2009-0009-DWQ:** Risk Level 2 dischargers shall implement measures to control all non-storm water discharges during construction.
- b. **Observation:** During the January 29, 2015 inspection, the San Diego Water Board inspector observed inadequate implementation of measures to prevent and control discharges of non-storm water runoff. See attached January 29, 2015 Facility Inspection Report Photos 3 and 4.

2. Inadequate implementation of measures to control discharges of non-storm water runoff observed (See Photos 3 and 4). All construction sites are required to implement measures to control all non-storm water discharges during construction.

**Photos 3 and 4** show inadequate implementation of measures to control discharges of non-storm water to the MS4. Photo 3 shows runoff from broken sprinkler head flowing across unpaved road and transporting sediment to v-ditch that discharges to MS4 inlet. Photo 8 shows evidence of sediment transport that has been occurring over time, indicating lack of adequate inspections to identify erosion due to non-storm water flows.

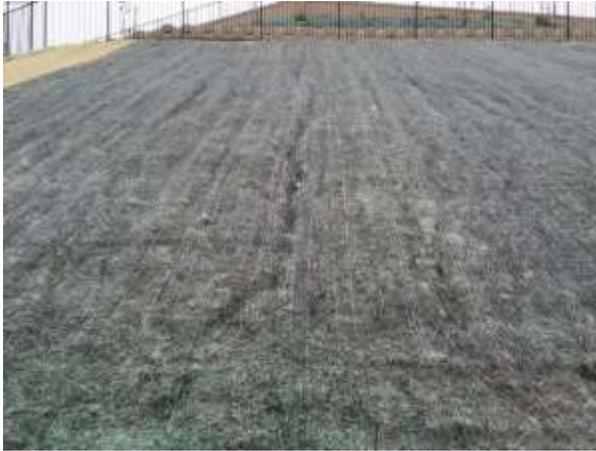
3. The entire site has been subject to a Stop Work Order since December 31, 2014, so the entire site is inactive. Several inactive areas were observed without effective soil cover to control potential erosion (See Photos 5 through 7). All construction sites are required to provide effective soil cover for inactive areas (i.e. areas that have been disturbed and not scheduled to be re-disturbed for at least 14 days) and all finished slopes, open space, utility backfill, and completed lots.

5. Rills and other signs of erosion on slopes and pads have not been repaired throughout the site (See Photos 5, 6, and 10).
6. There was evidence observed during the inspection that the site has not implemented BMPs to meet BCT Technology Based Effluent Limitations (TBELs) under Section V.A.2 of the CGP, as required for all construction sites. The inadequate implementation of BMPs resulted in the unauthorized discharges from the site in March and December 2014 (See Compliance History discussion).

**Photos 5 through 7** show several areas of the site that lack effective soil cover, or inadequate maintenance of effective soil cover. Photos 5 through 7 also show lack of linear sediment controls along the toe of the slope, face of the slope, and/or at the grade breaks.

Photo 5 shows a completed slope with degraded erosion control blanket that is no longer effective and rill erosion can be observed on the slope under the blanket. Photo 6 shows a slope adjacent to a completed building pad with evidence of rill erosion, due to lack of effective cover or inadequate maintenance of cover. Photo 7 shows an area on a completed lot where hydromulch was not applied.

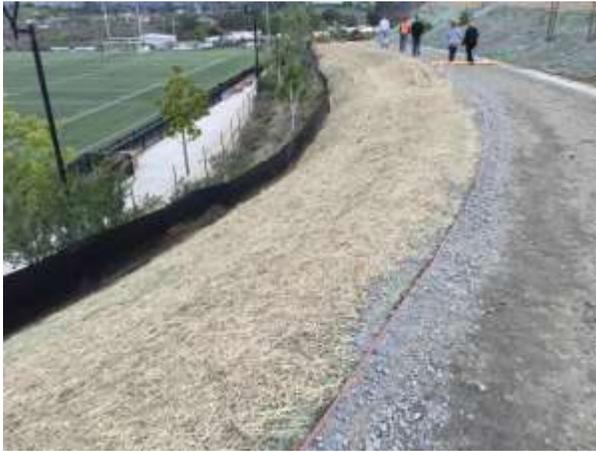
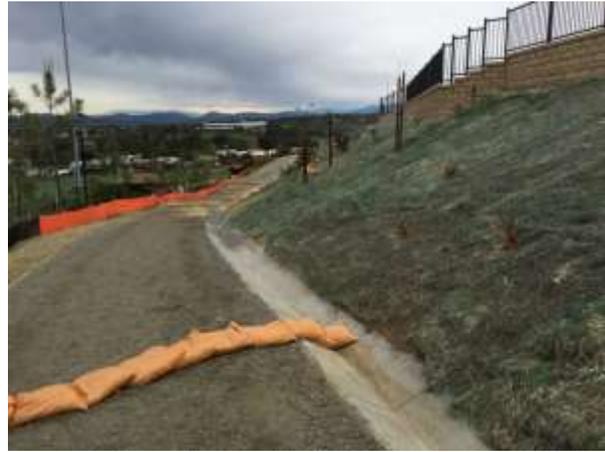
4. Several slopes throughout the site were observed to lack linear sediment controls along the toe and grade breaks of exposed slopes (See Photos 5 through 10). Risk Level 2 construction sites are required to apply linear sediment controls along the toe of the slope, face of the slopes, and at the grade breaks of exposed slopes to comply with sheet flow lengths given in Table 1 of Attachment D to the CGP.

**Photos 8 through 10** show several exposed slopes that lack linear sediment controls required for Risk Level 2 construction sites. Photo 8 shows a slope with erosion control blanket and linear control at toe of slope, but no linear controls at the grade break. Photo 9 shows a slope with degraded erosion control blanket recently planted, with a v-ditch at the base of the slope that leads to a storm drain inlet, but no controls to prevent runoff from slope to transport sediment to v-ditch. Photo 10 shows a completed building pad and adjacent slope with no linear sediment control and evidence of significant gully erosion.

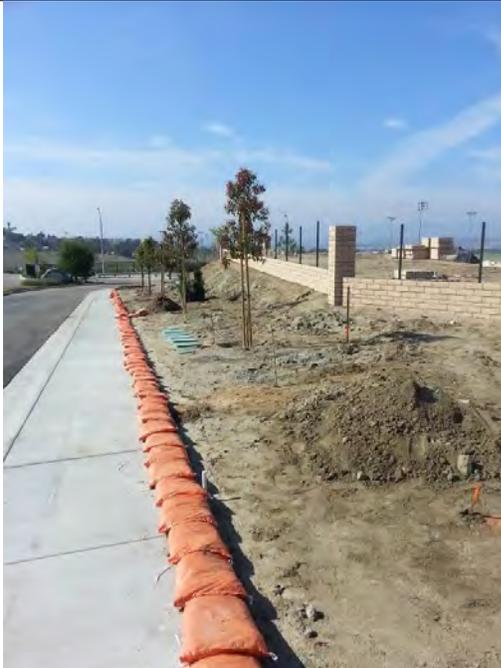
As seen in Figures 2-5, erosion control BMPs were not installed on the slope nearest the street prior to the rain event that began on February 28, 2014. Erosion control and sediment control BMP materials were present on Site as seen in Figures 6, 7, and 11, however the slope in Figure's 2 and 3 did not have erosion control along with sediment control BMPs in place prior to the rain event. The gravel bags used for sediment control BMPs (see Figures 2-4) were inundated due to lack of adequate erosion control BMPs and caused a discharge of sediment from the Site to the MS4.

1. The discharger is in violation of Attachment D, provision D.2, for failing to provide effective soil cover for inactive areas and all finished slopes, open space, utility backfill, and completed lots (see Figures 2-5, and 8).

Figure 2: Slope along North Santa Fe Ave where discharge of sediment occurred due to a failure of the erosion control and sediment control BMPs in place at the time of the qualifying rain event on 2/27-29/14. Erosion control included mulch on slope. Sediment control included gravel bags at toe of slope.

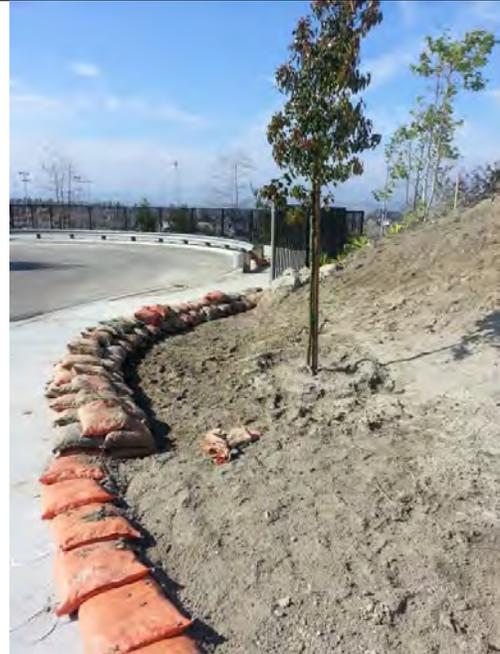
Figure 3: Sediment discharged at the bottom of the North Santa Fe Avenue. Note sediment laden gravel bags replaced after cleanup of sediment discharged to storm drain on North Santa Fe Avenue occurred.

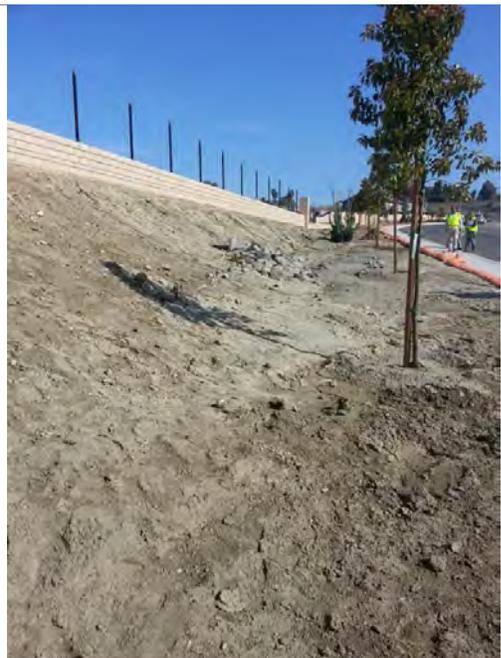
Figure 4: Photo shows no erosion control present on slope where erosion and sedimentation occurred causing the discharge of sediment into the storm drain inlet at the bottom of North Santa Avenue.

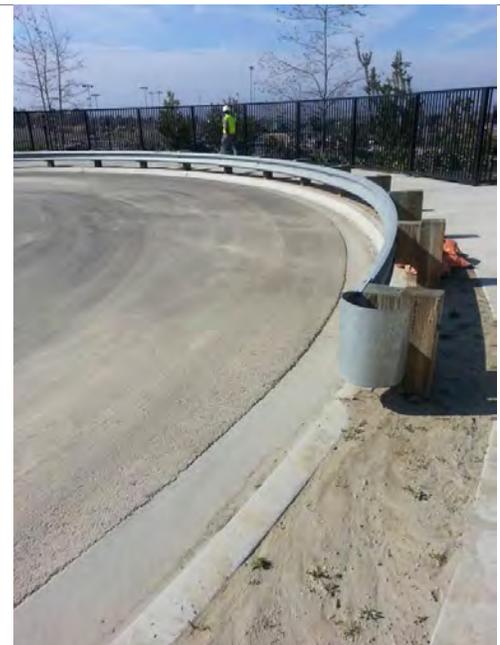
Figure 5: Evidence of sediment discharge seen by erosion rills on unvegetated area just prior to curb and sediment remnants in street after street sweeping efforts occurred.

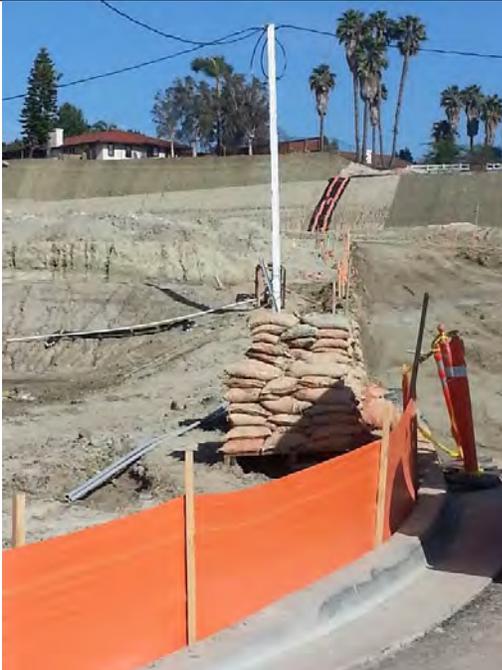
Figure 6: Silt fence as sediment control present around curbs and erosion control present on interior slopes.

The maintenance of erosion control BMPs on interior slopes of the Site is needed to fix existing erosion (see Figure 6 and 8) and install additional BMPs to prevent future erosion. Significant erosion on the slopes of the detention basin was noted during the inspection (see Figure 8). Erosion control measures are needed on these slopes to prevent future erosion or slope failure.

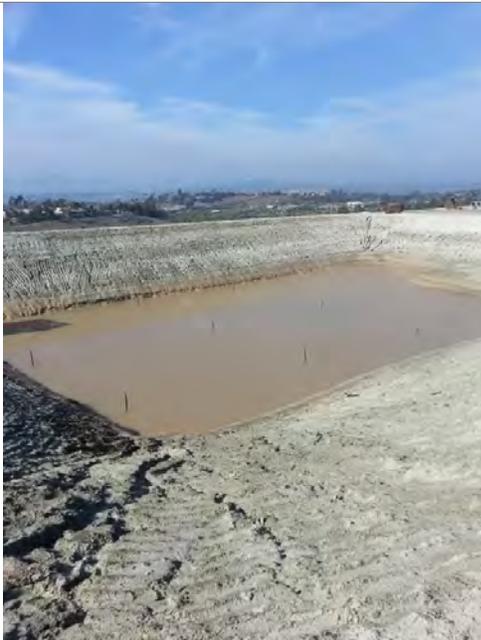
Figure 8: Detention basin on site shows runoff collected during Feb 28-March 2, 2014 rain event. Signs of erosion present on the slopes.

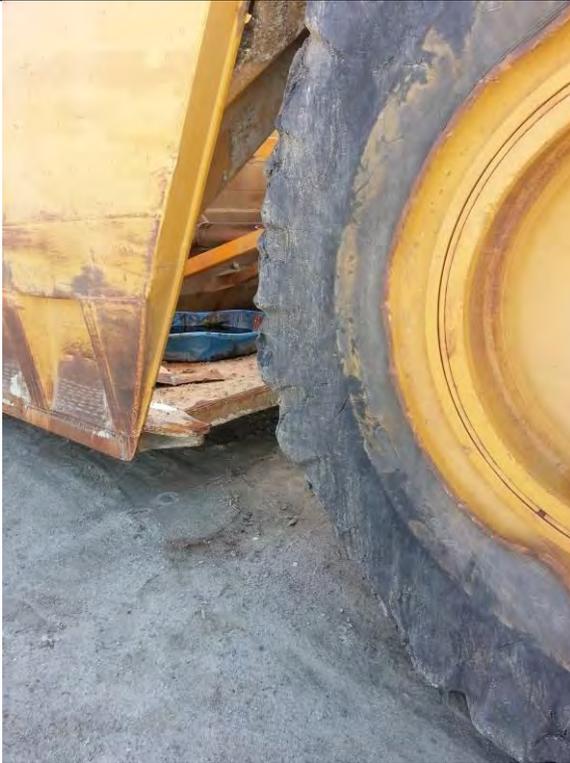
A plastic pool filled with used oil and rainwater was stored on the Site in the hopper of a scraper (see Figure 10). Used oil should be properly disposed of and not stored onsite in the manner found during this inspection.

4. The discharger is in violation of Attachment D, provision B.2, of the CGP for failing to implement good housekeeping BMPs for waste management on the Site.

Figure 10: Kiddy pool filled with oil and rain water found in scrapper on site. Scrapers were reportedly being repainted on site.

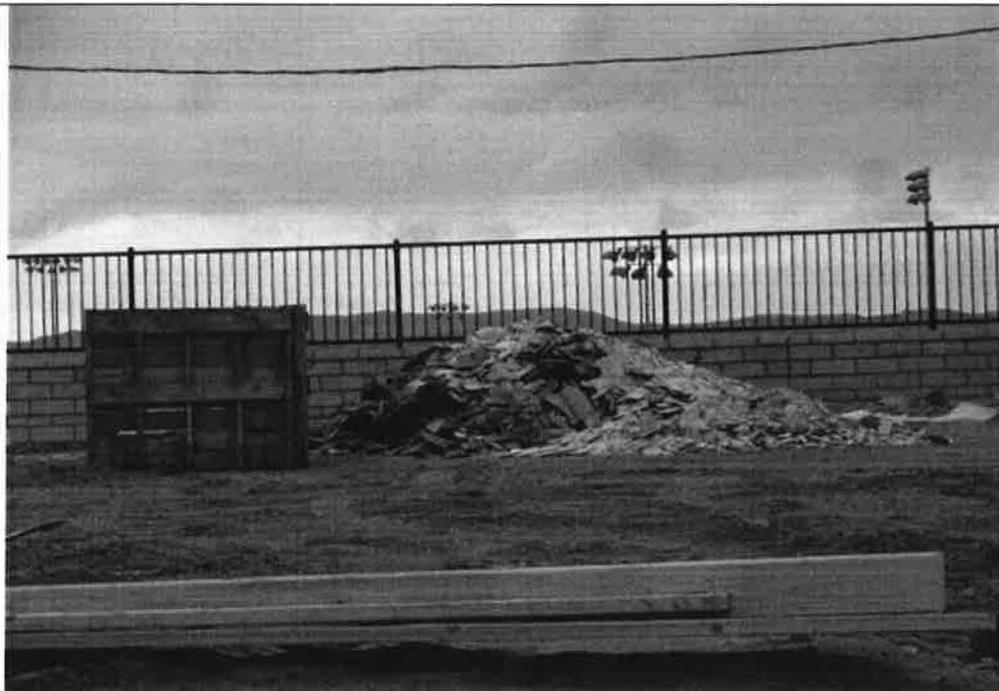
3 [Click here to enter text.](#)

**Materials/Trash  
uncovered**

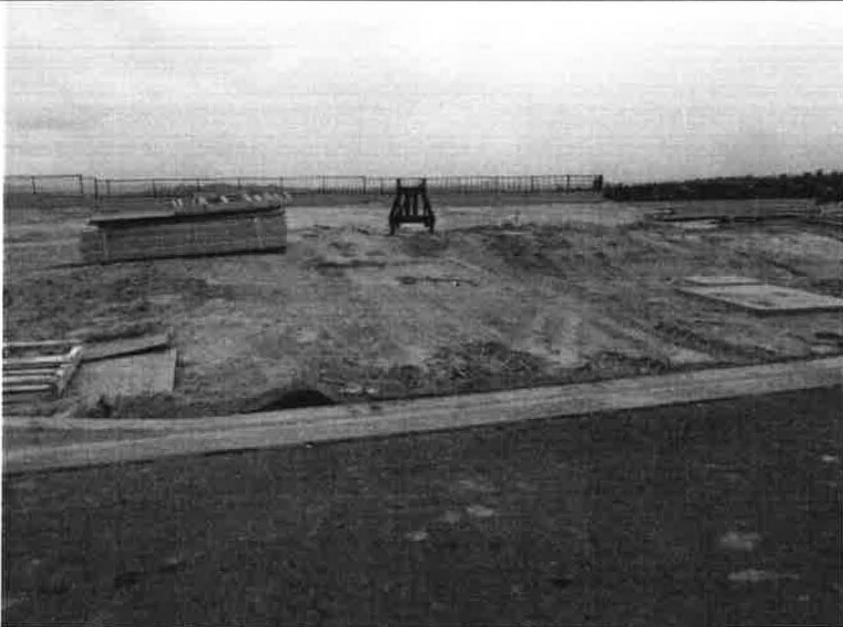
5 [Click here to enter text.](#)

**Ineffective BMP**

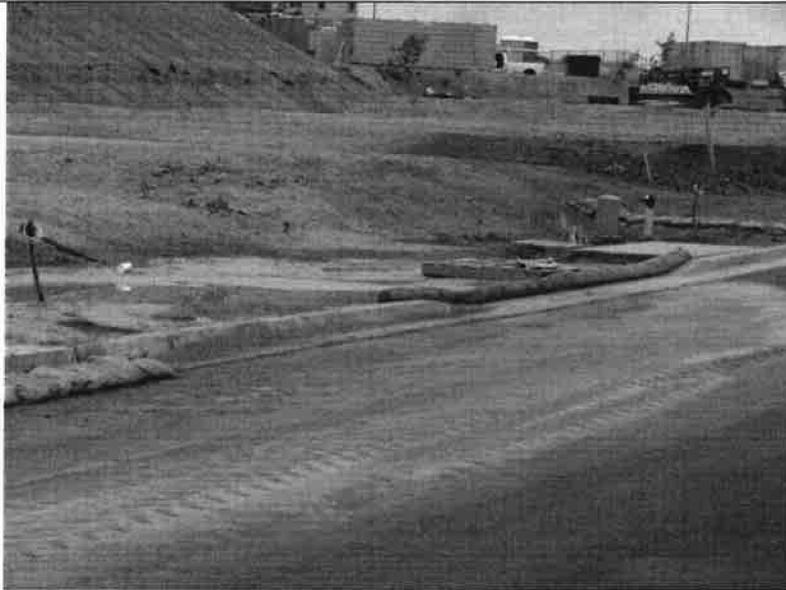
Sediment not swept  
up before storm  
event

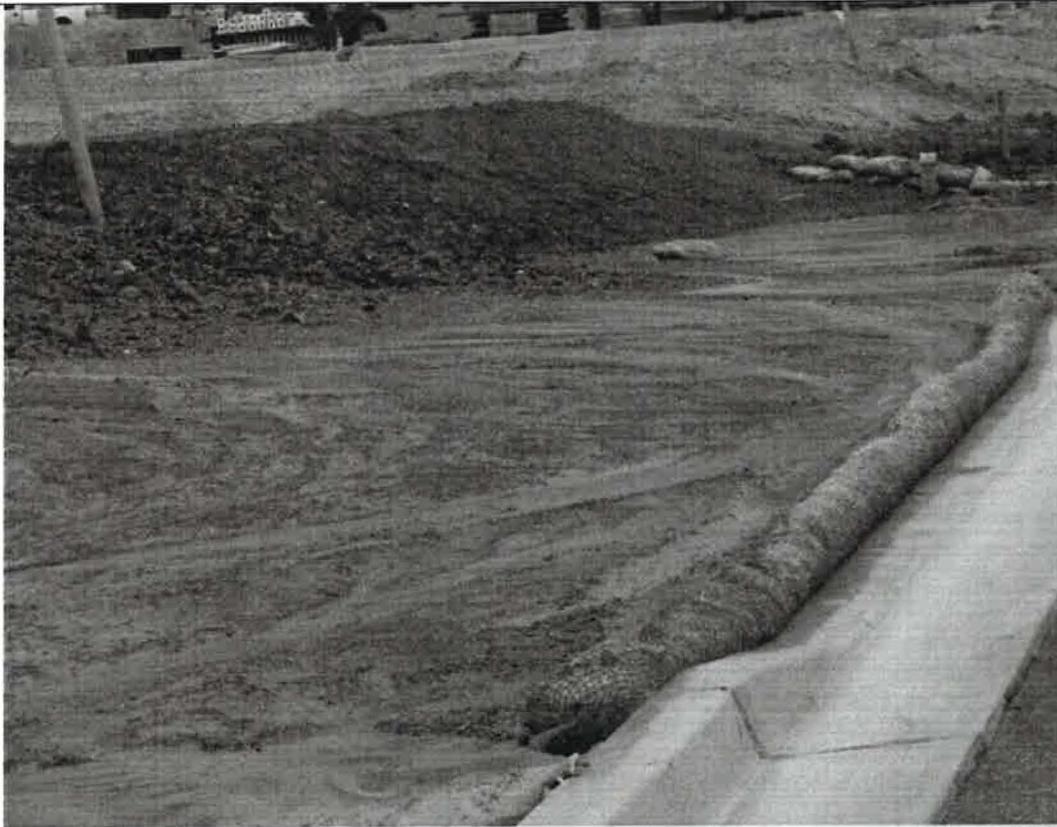
8 Click here to enter text.

*Ineffective  
BMP*

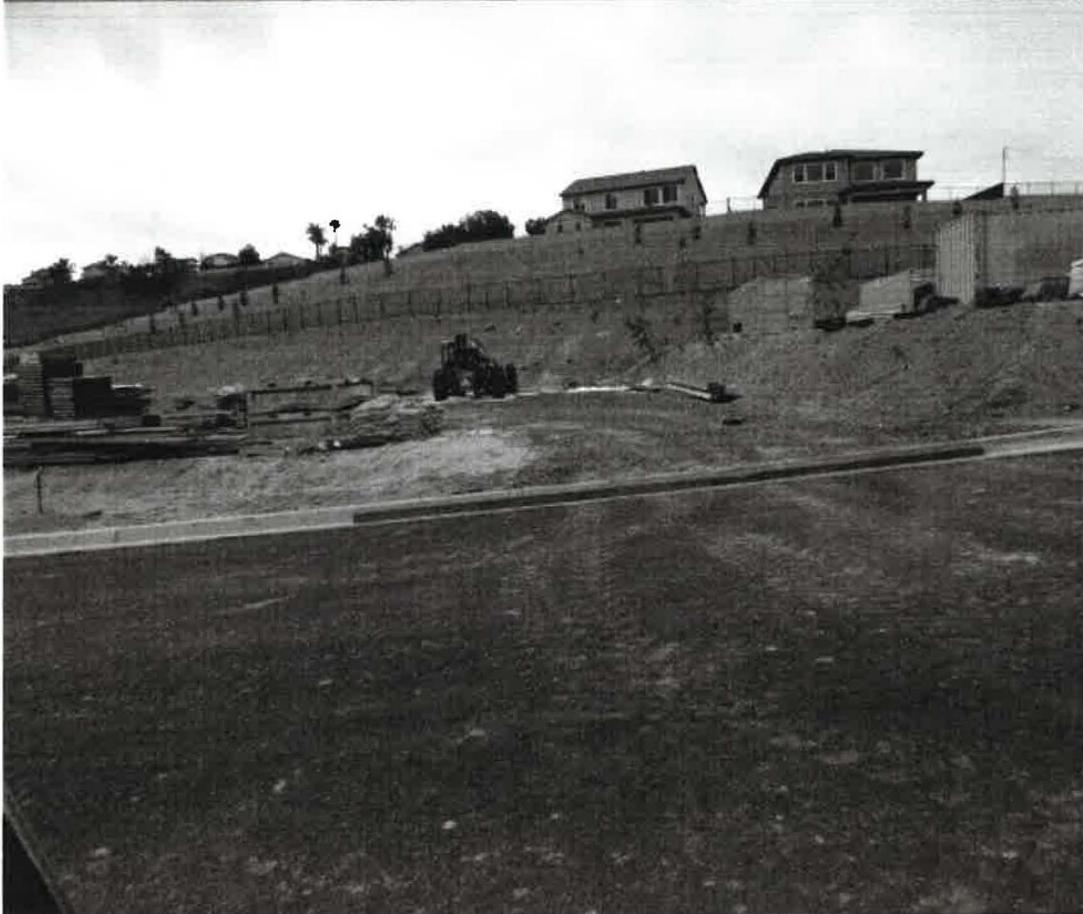
*Sediment  
tracking*

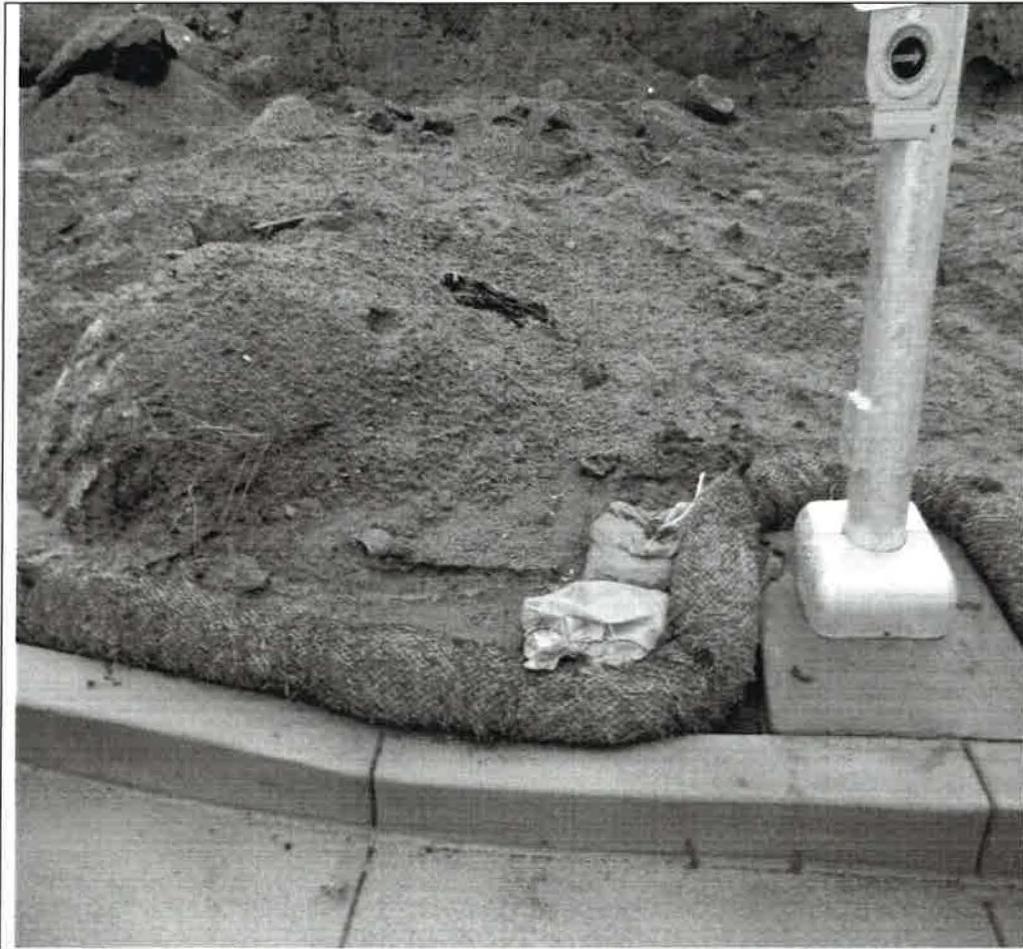
Discharge  
to MS4

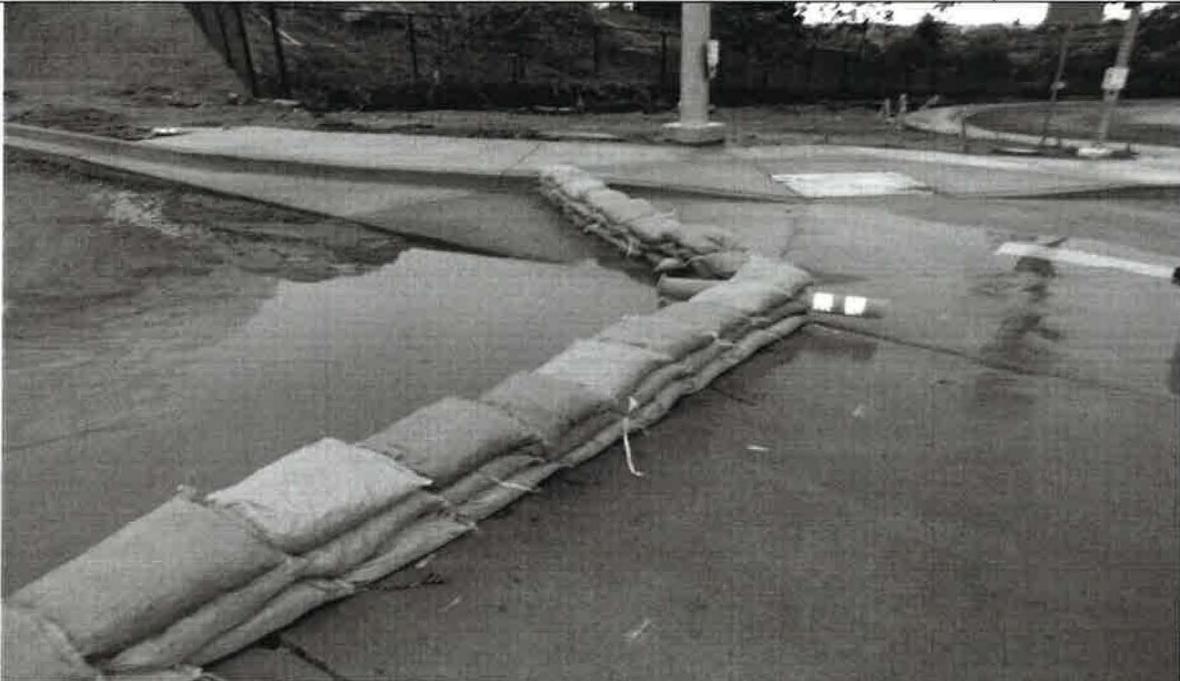
Discharge  
to  
MS4

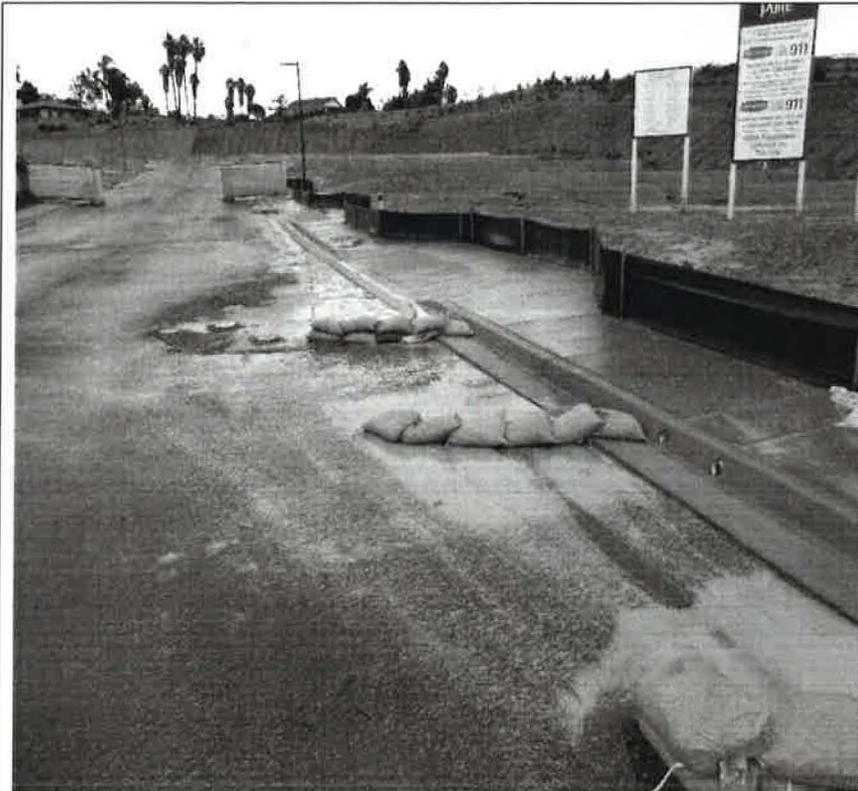
NOV previously issued  
for this area  
BMP's remain  
ineffective 10

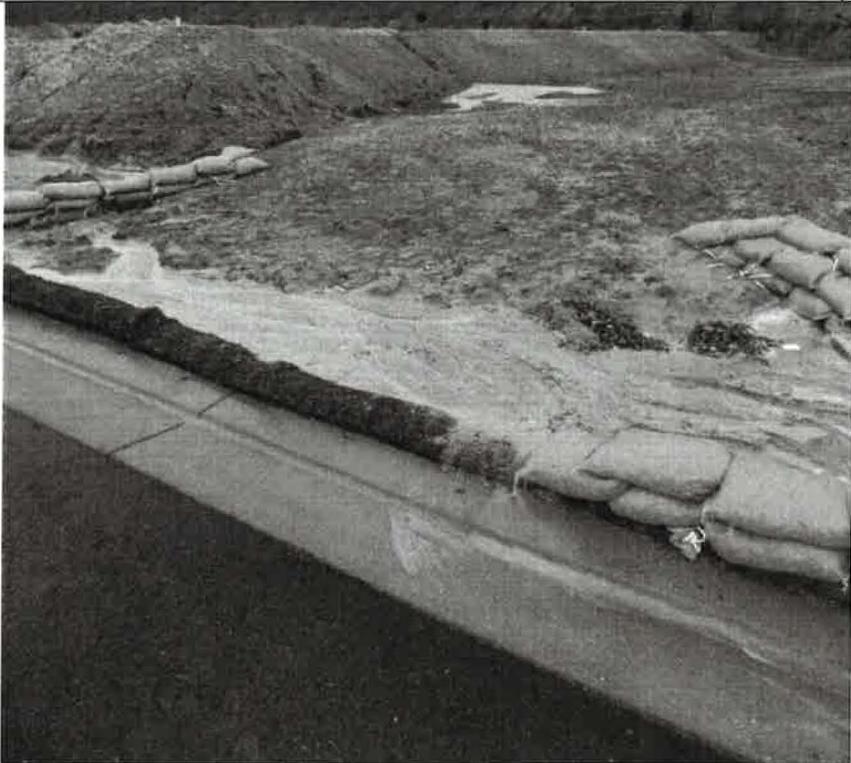
Ineffective  
erosion control  
same area as  
before. 12

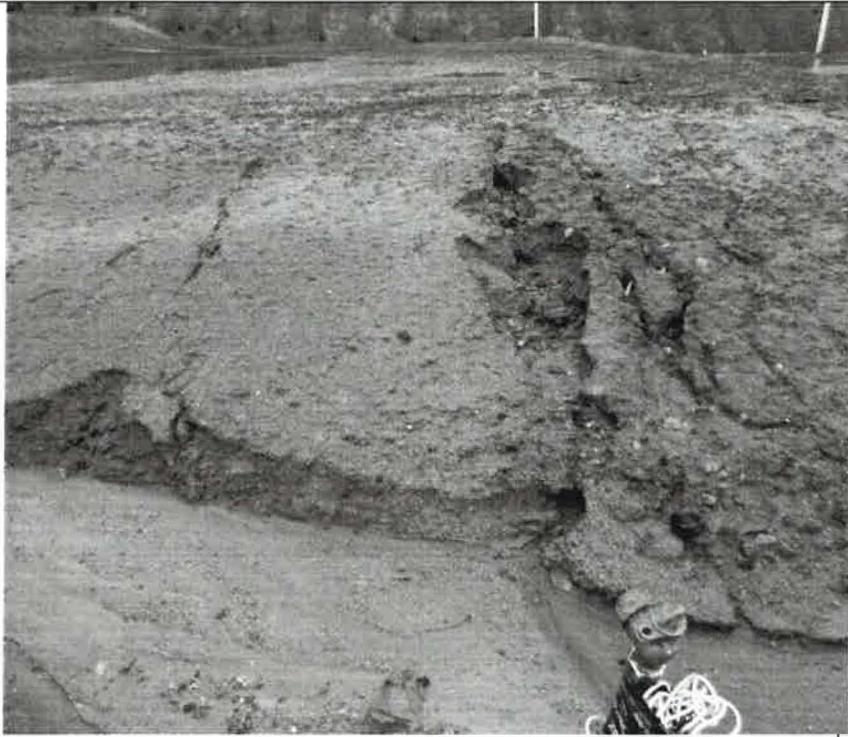
13

*BFM no longer  
effective*

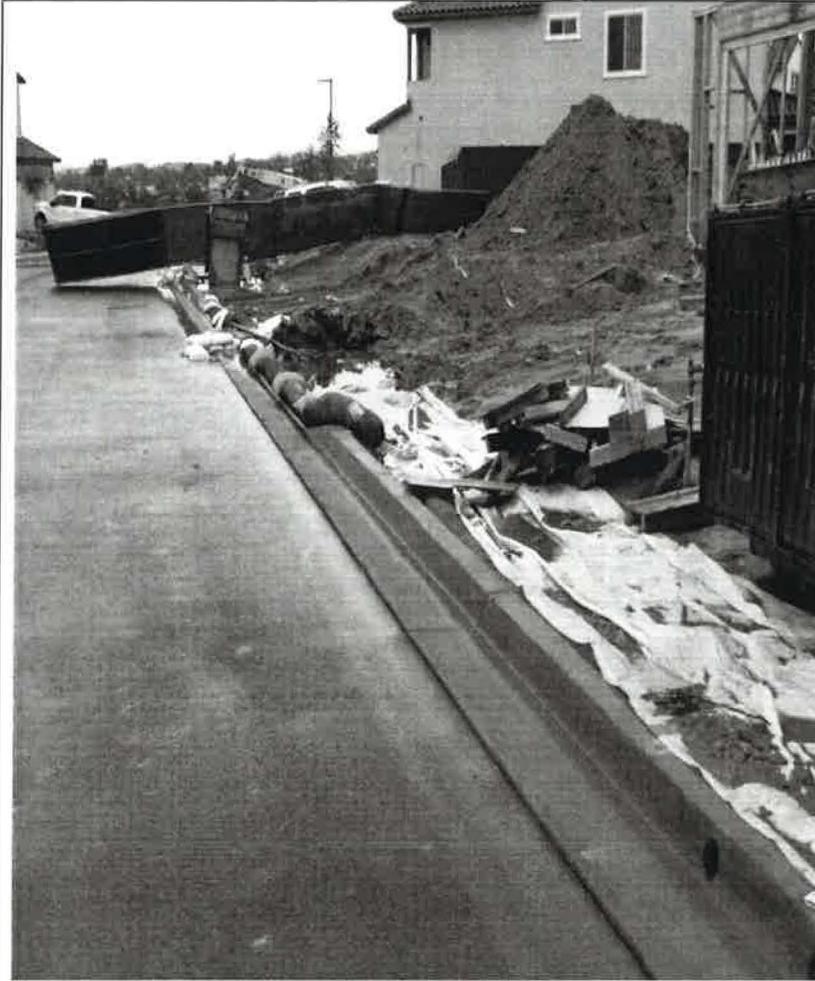
15

- Poorly maintained materials
- No protection for stockpile

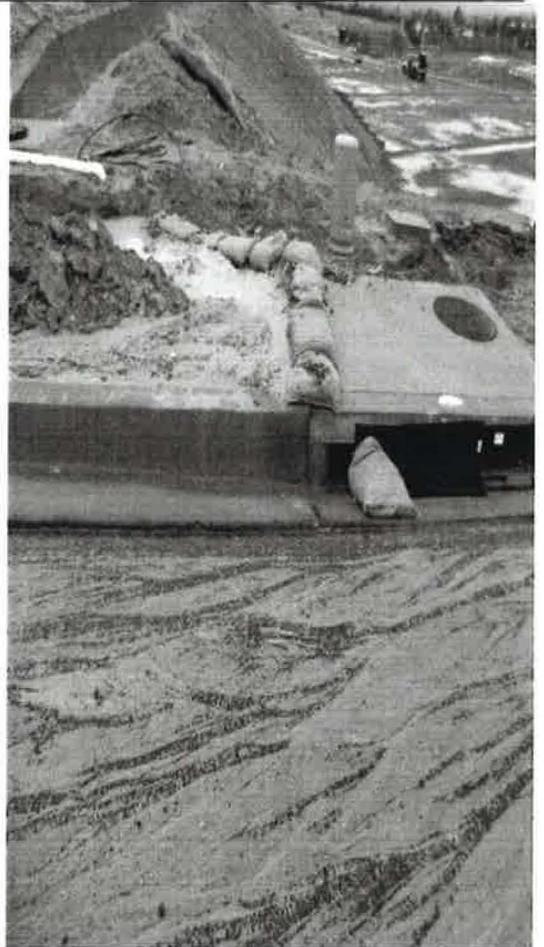
16

Ineffective erosion control.
