California Regional Water Quality Control Board, San Diego Region

NOTICE OF VIOLATION
No. R9-2015-0093

Pacific Gateway Ltd
San Diego Marriott Marquis & Marina
Construction Project
PIN No. SM-831060:wchiu

FACILITY INSPECTION REPORT

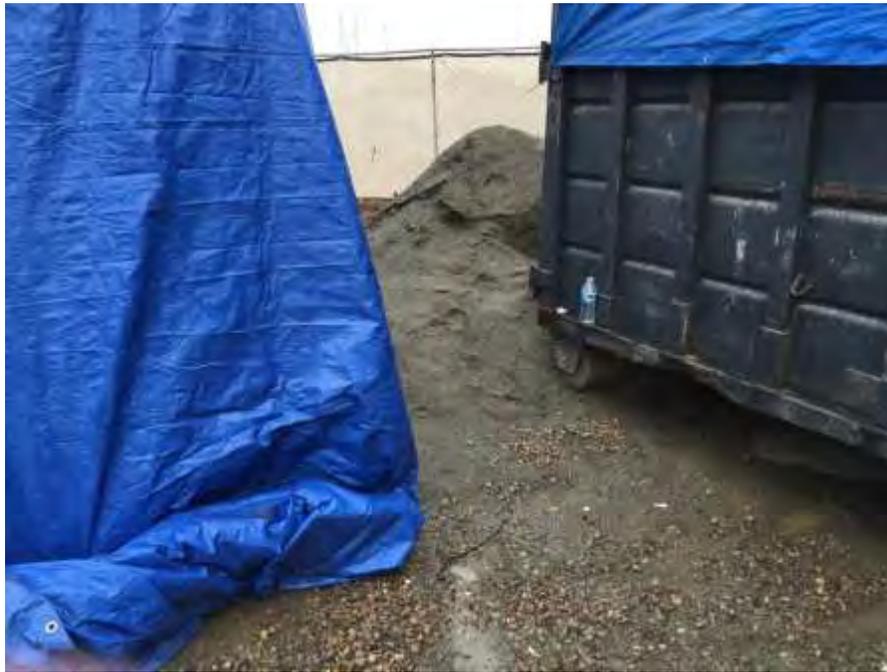
Photo 1

c. Observation: During the May 15, 2015 inspection, the San Diego Water Board inspector observed soil stockpiles without adequate cover, berm, containment or protection, resulting in erosion and sediment transport. See attached May 15, 2015 Facility Inspection Report Photos 1 and 2.

3. Several stockpiles observed without adequate containment (See Photos 1 and 2). All construction sites are required to contain and securely protect stockpiled waste material from wind and rain at all times unless actively being used.

Photos 1 and 2 shows soil stockpiles without adequate containment and protection during a rain event.

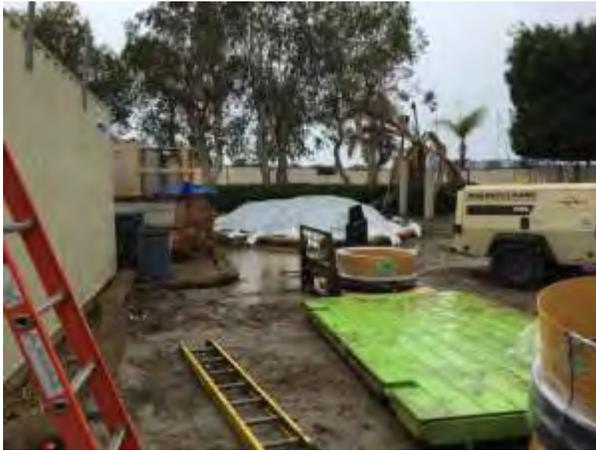
Photo 3

b. Observation: During the May 15, 2015 inspection, the San Diego Water Board inspector observed several areas of the site that appeared to be inactive, or could be scheduled to be inactive, without effective soil cover or other BMPs that could prevent erosion. Evidence of erosion and sediment transport due to lack or erosion control measures were observed throughout the site during the inspection. See attached May 15, 2015 Facility Inspection Report Photos 3 through 5.

4. Several areas were observed to be inactive, or could be scheduled to be inactive, without effective soil cover to control potential erosion (See Photos 3 through 5). All construction sites are required to provide effective soil cover for inactive areas (i.e. areas that have been disturbed and not scheduled to be re-disturbed for at least 14 days) and all finished slopes, open space, utility backfill, and completed lots.

Photos 3 through 5 show areas within the Site that are inactive or could be sectioned off and made inactive without an erosion control measures implemented to provide effective soil cover.

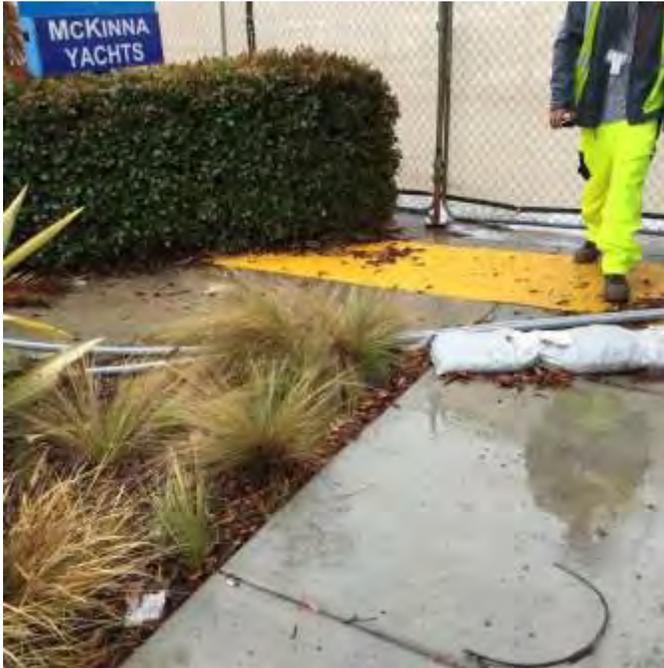
- b. **Observation:** During the May 15, 2015 inspection, the San Diego Water Board inspector observed an area of the Site where perimeter controls were not established or maintained to sufficiently control erosion and sediment discharges from the site. See attached May 15, 2015 Facility Inspection Report Photo 6.

5. Lack of effective perimeter sediment controls observed (See Photo 6). All construction sites are required to establish and maintain effective perimeter controls and stabilize all construction entrances and exits to sufficiently control erosion and sediment discharges from the site.

Photo 6 shows part of the Site perimeter where perimeter sediment controls have not been adequately established to sufficiently control erosion and sediment discharges from the Site.

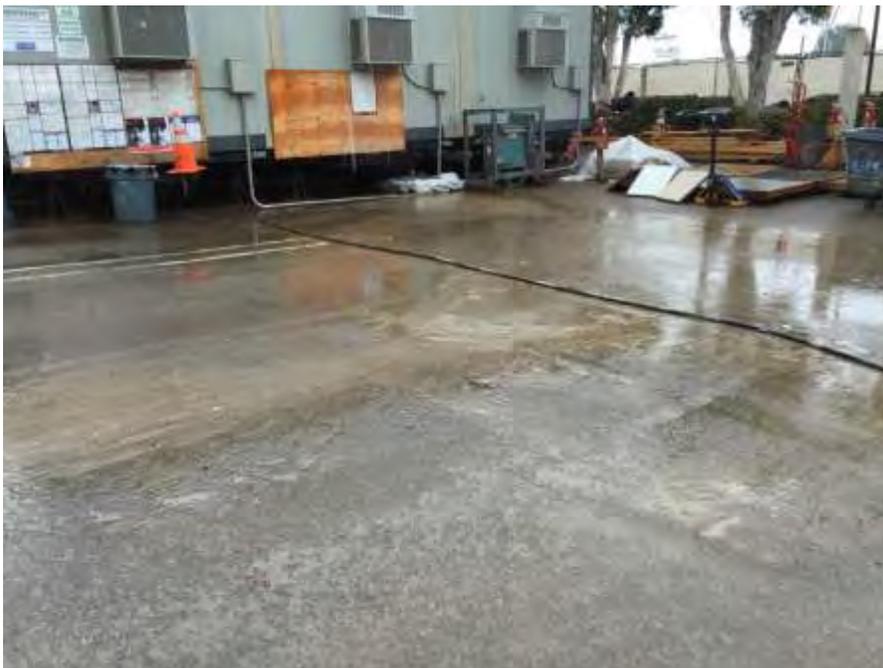
- a. **Pursuant to Provision IX and Section F.1 of Attachment C of State Water Board Order No. 2009-0009-DWQ:** Risk Level 1 shall effectively manage all run-on, all runoff within the site and all runoff that discharges from the site. Run-on from off site shall be directed away from all disturbed areas or shall collectively be in compliance with the effluent limitations in the CGP.
- b. **Observation:** During the May 15, 2015 inspection, the San Diego Water Board inspector observed inadequate runoff controls within the Site, and at least one area where perimeter controls were not established or maintained to prevent runoff from the Site. See attached May 15, 2015 Facility Inspection Report Photos 6 and 7.

6. Lack of effective run-on and runoff controls observed within and around the site (See Photo 7). All construction sites are required to effectively manage run-on, all runoff within the site and all runoff that discharges off the site.

Photo 7 shows sediment laden water buildup at a storm drain inlet that discharges to San Diego Bay without additional internal runoff controls to reduce sediment before getting to the storm drain inlet.
